Area in Need of Redevelopment Investigation

TODD-South Study Non-condemnation
City of Plainfield, New Jersey

Preliminary Investigation for a Determination of Area in Need of Redevelopment and/or Rehabilitation

September 5, 2019

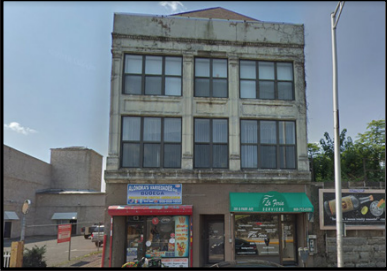
Lot	Address	Site Description	Site Issues	Lot Area	Redevelopment								Sec 3	Photo
					A	B	C	D	E	F	G	H		
1	300-302 Park Ave	3 Story, Mixed-use, 5 Units w/ 2 Storefronts, Built in 1905	<ul style="list-style-type: none"> Does not meet the minimum height requirement 	14,175 sq. ft.							X	X	X

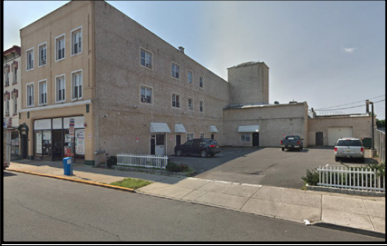
2	304-310 Park Ave	3 Story; Mixed-use; 9 Units, Office space, 1 Storefront; Built in 1900	<ul style="list-style-type: none"> Environmental Contamination Low Improvement Ratio Does not meet the minimum height requirement 	25,269 sq. ft.				X			X	X

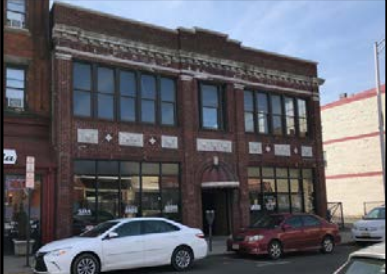
3	312-314 Park Ave	3 Story; Mixed-use; 2 Units, 1 Storefront; Built in 1894	<ul style="list-style-type: none"> Undersized lot 	2,171 sq. ft.							X	X	X	 
4	316-322 Park Ave	Irregular shaped parcel; 2 Story; Commercial; Built in 1925	<ul style="list-style-type: none"> Environmental Contamination Does not meet the minimum height requirement 	14,932 sq. ft.				X			X	X

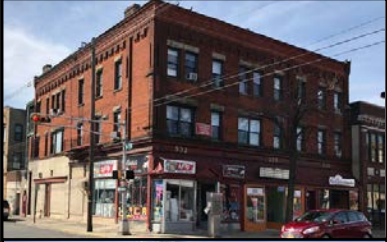
Lot	Address	Site Description	Site Issues	Lot Area	Redevelopment								Sec 3	Photo
					A	B	C	D	E	F	G	H		
5	324-332 Park Ave	3 Story; Mixed-use; 8 Units; 3 Storefronts; Built in 1910	<ul style="list-style-type: none"> Vacant Storefront Does not meet the minimum height requirement 	6,075 sq. ft.		X					X	X

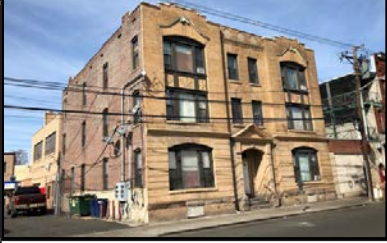
6	108-110 W. 4th St	3 Story, Residential, 6 Units, Built in 1845	<ul style="list-style-type: none"> Does not meet the minimum height requirement Undersize lot Nonconforming use 	2,936 sq. ft.							X	X	X

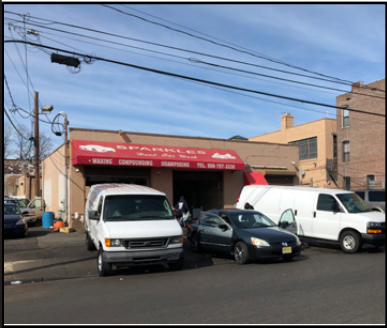
7	114-120 W. 4th St	Irregular shaped parcel, Multiple structures on parcel, Built in 1930	<ul style="list-style-type: none"> Obsolete site layout Deficient Buffering Land use with adverse impacts Excessive impervious coverage Environmental contamination Low improvement ratio Nonconforming use Does not meet the minimum height requirement 	15,309 sq. ft.				X			X	X

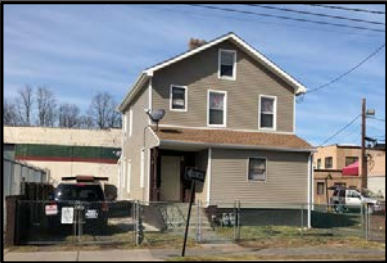
Lot	Address	Site Description	Site Issues	Lot Area	Redevelopment								Sec 3	Photo
					A	B	C	D	E	F	G	H		
8	122-124 W. 4th St	2 Story, 2 Units, Built in 1905	<ul style="list-style-type: none"> Chain link fence Low Improvement ratio Non-conforming use 	3,485 sq. ft.							X	X	X

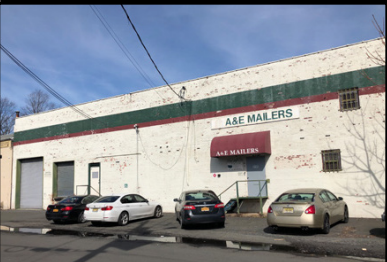
9.01	130-132 W. 4th St	Irregular shape parcel, Fronts on two street, 1 story, commercial, Built in 1930	<ul style="list-style-type: none"> Deficient Buffering Chain link fence Obsolete site layout Nonconforming Use 	19,712 sq. ft.							X	X	X

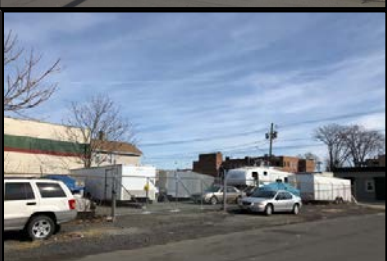
10	130-132 W. 4th St	Vacant land	<ul style="list-style-type: none"> Chain link fence Obsolete site layout Excessive impervious coverage Deficient Buffering Low Improvement Ratio 	4,748 sq. ft.			X	X			X	X

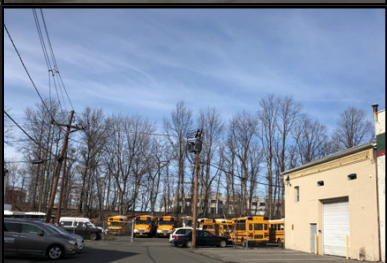
12	200-214 W. 3rd St.	Irregular shaped parcel, 1 Story, Multiple structures parcel, Built in 1930	<ul style="list-style-type: none"> Chain link fence Excessive impervious coverage Deficient Buffering Low Improvement Ratio Nonconforming Use 	33,819 sq. ft.				X			X	X

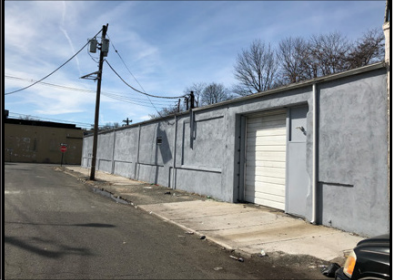
Lot	Address	Site Description	Site Issues	Lot Area	Redevelopment								Sec 3	Photo
					A	B	C	D	E	F	G	H		
13	223-229 Madison Ave	1 Story building, Commercial, Built in 1930	<ul style="list-style-type: none"> Land use with adverse impacts Non-conforming use 	13,108 sq. ft.							X	X	X

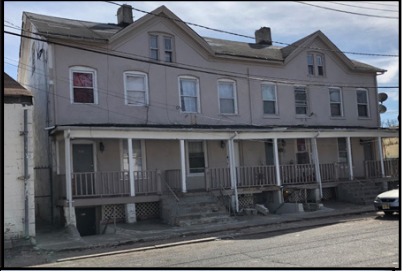
Lot	Address	Site Description	Site Issues	Lot Area	Redevelopment								Sec 3	Photo
					A	B	C	D	E	F	G	H		
1	211-217 W. 3rd St	2 Story, Residential, 7 Units, Built in 1925		6,921 sq. ft.							X	X	X

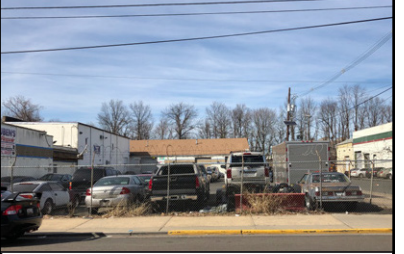
2	200-214 W. 4th St	1 Story, Commercial, Built in 1985	<ul style="list-style-type: none"> Excessive Impervious Coverage Chain link fence Deficient Buffering 	20,745 sq. ft.				X			X	X

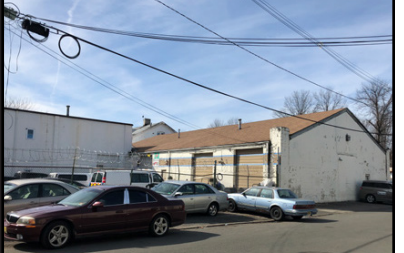
2.01	201-209 W. 3rd St	1 Story, Commercial	<ul style="list-style-type: none"> Excessive Impervious Coverage Chain link fence Deficient Buffering Non-conforming Use 	10,520 sq. ft.				X			X	X

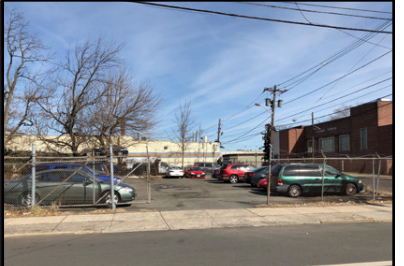
3	315-317 Madison Ave	Parking Lot	<ul style="list-style-type: none"> Excessive Impervious Coverage Chain link fence Deficient Buffering Low Improvement Ratio 	5,270 sq. ft.				X			X	X

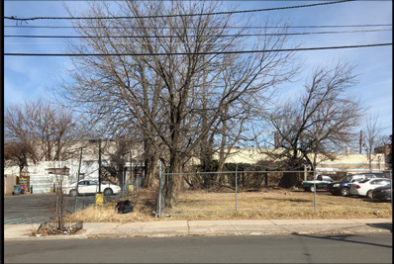
Lot	Address	Site Description	Site Issues	Lot Area	Redevelopment								Sec 3	Photo
					A	B	C	D	E	F	G	H		
4	311-313 Madison Ave	Vacant parcel	<ul style="list-style-type: none"> Chain link fence Deficient Buffering Low Improvement Ratio 	5,843 sq. ft.			X	X			X	X

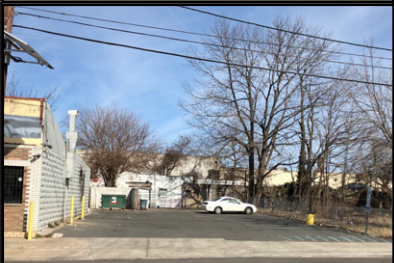
5.01	305-309 Madison Ave	1 Story, Garage, Built in 1955	<ul style="list-style-type: none"> Deficient Buffering Excessive Impervious Coverage Environmental Contamination Low Improvement Ratio 	6,047 sq. ft.				X			X	X

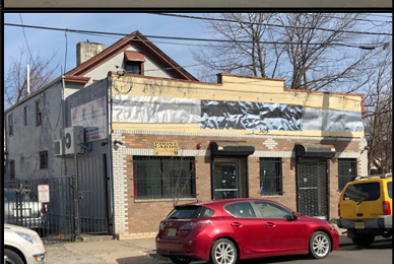
7	303 Madison Ave	2 Story, Livestock Meat Market, Commercial	<ul style="list-style-type: none"> Low Improvement Ratio Non-conforming Use 	2,723 sq. ft.				X			X	X	X

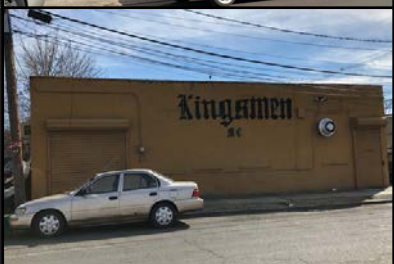
8	219-225 W. 3rd St	1 Story, Commercial, Motorcycle Club, Built in 1950	<ul style="list-style-type: none"> Deficient Buffering Obsolete Site Layout Low Improvement Ratio Non-conforming Use 	2,510 sq. ft.				X			X	X

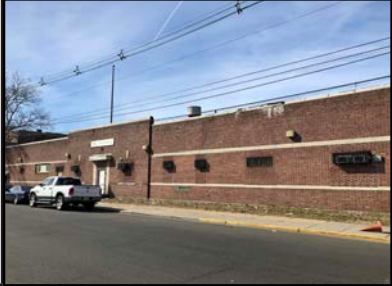
Lot	Address	Site Description	Site Issues	Lot Area	Redevelopment								Sec 3	Photo
					A	B	C	D	E	F	G	H		
1	300-324 Madison Ave	1 Story, Industrial, Irregular shaped parcel, Built in 1935	<ul style="list-style-type: none"> Chain link fence Lack of sidewalk Excessive Impervious Coverage Low Improvement Ratio Non-conforming Use 	50,469 sq. ft.				X			X	X

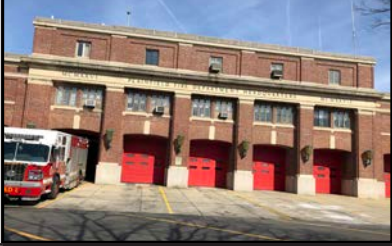
2	315-329 Central Ave	3 Story, Fire House, Built in 1925	<ul style="list-style-type: none"> Chain link fence Environmental Contamination Non-conforming use 	29,856 sq. ft.							X	X	X

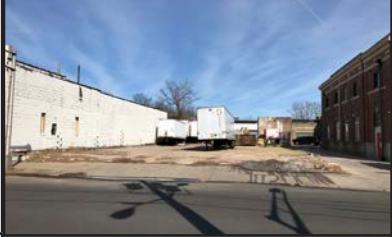
3	309-313 Central Ave	Vacant land	<ul style="list-style-type: none"> Obsolete site layout Deficient Buffering Low Improvement Ratio 	9,759 sq. ft.			X	X			X	X

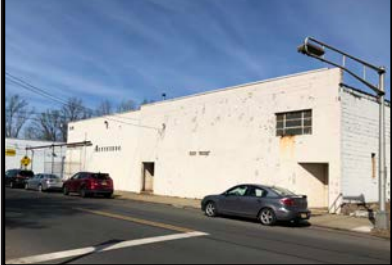
4	301-307 Central Ave	1 Story, Commercial, Built in 1945	<ul style="list-style-type: none"> Chain link fence Excessive Impervious Coverage Lack of Lighting Lack of Sidewalk Nonconforming Use 	11,513 sq. ft.				X			X	X

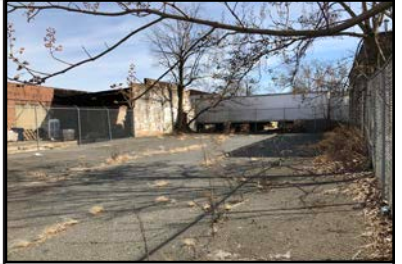
Lot	Address	Site Description	Site Issues	Lot Area	Redevelopment								Sec 3	Photo
					A	B	C	D	E	F	G	H		
5	313-315 W. 3rd St	Vacant Land	<ul style="list-style-type: none"> Chain link fence Excessive Impervious Coverage Deficient Buffering Lack of sidewalk Low improvement ratio 	5,494 sq. ft.			X	X	X		X	X

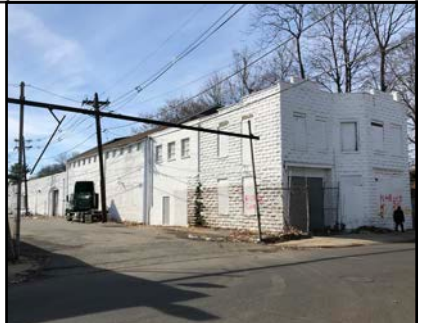
Redevelopment									
Lot	Address	Site Description	Site Issues	Lot Area	A	B	C	D	E	F	G	H	Sec 3	Photo
1	300-330 W. 3rd St	1 Story, Commercial, Built in 1940	<ul style="list-style-type: none">• Lack of sidewalk• Lack of lighting• Excessive Impervious Coverage	24,258 sq. ft.				X			X	X

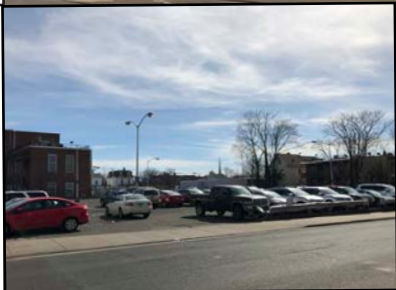
2	111-127 W. 4th St	Irregular shaped parcel, City owned, Parking lot with small structure	<ul style="list-style-type: none">Excessive Impervious CoverageDeficient BufferingLack of sidewalkEnvironmental ContaminationLow Improvement Ratio	46,981 sq. ft.				X			X	X

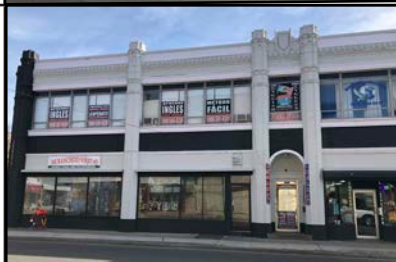
3	400-402 Park Ave	2 Story, Commercial, Built in 1930 HR	<ul style="list-style-type: none">Does not meet the minimum height requirement	4,172 sq. ft.							X	X	X

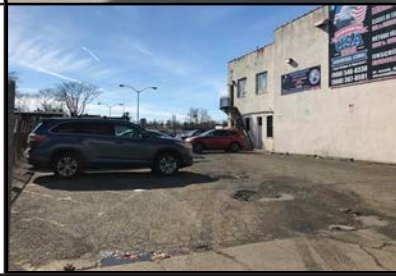
4	404-406 Park Ave	Parking lot, Irregular shaped parcel L, CF, DB, OL, LL	<ul style="list-style-type: none">Low Improvement RatioChain Link FenceDeficient BufferingObsolete Site LayoutLack of Lighting	6,600 sq. ft.				X			X	X

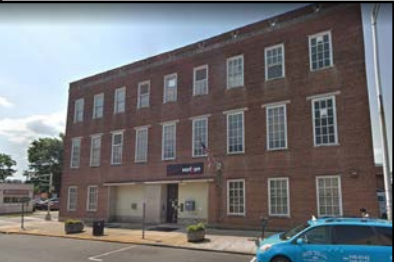
Lot	Address	Site Description	Site Issues	Lot Area	Redevelopment								Sec 3	Photo
					A	B	C	D	E	F	G	H		
5	408-422 Park Ave	3 Story, Commercial, Built in 1945, Irregular shaped parcel	<ul style="list-style-type: none"> Does not meet the minimum height requirement 	41,218 sq. ft.							X	X	X

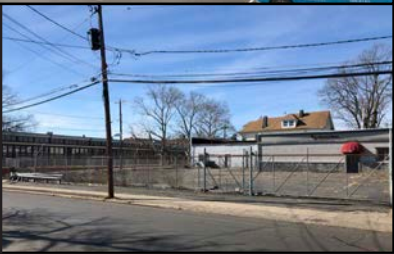
6	120-128 W. 5th St	1 Story, Commercial, Built in 1930	<ul style="list-style-type: none"> Chain link fence Excessive Impervious Coverage Vacant Structure 	14,089 sq. ft.		X		X			X	X

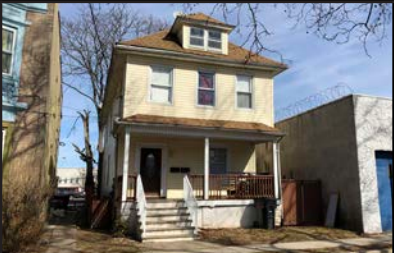
7	413-415 Arlington Ave	2 Story, Residential, 2 Units, Built in 1911	<ul style="list-style-type: none"> Non-conforming use 	2,615 sq. ft.							X	X	X

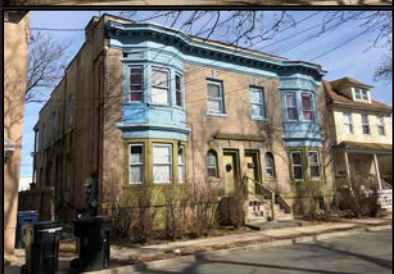
8	409-411 Arlington Ave	2 Story, Residential, 4 Units, Built in 1911	<ul style="list-style-type: none"> Non-conforming use 	4,691 sq. ft.							X	X	X

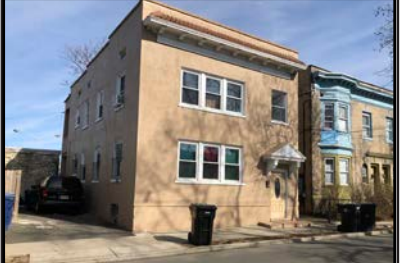
Lot	Address	Site Description	Site Issues	Lot Area	Redevelopment								Sec 3	Photo
					A	B	C	D	E	F	G	H		
9	405-407 Arlington Ave	2 Story, Residential, 2 Units, Built in 1916	<ul style="list-style-type: none"> Non-conforming use 	1,795 sq. ft.							X	X	X

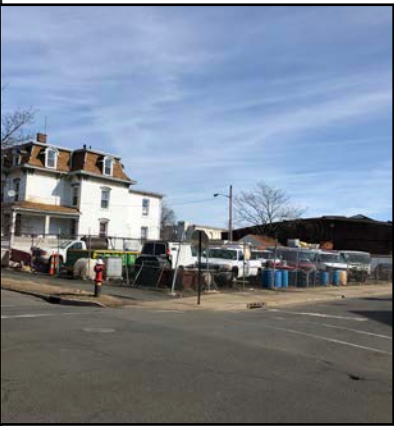
Lot	Address	Site Description	Site Issues	Lot Area	Redevelopment								Sec 3	Photo
					A	B	C	D	E	F	G	H		
1	123-125 W. 5th St	Paved parcel, Commercial	<ul style="list-style-type: none"> Lack of lighting Deficient Buffering Excessive Impervious Coverage Obsolete Layout Chain link fence Land use with adverse affects Nonconforming Use Environmental Contamination Low Improvement Ratio 	8,276 sq. ft.				X			X	X

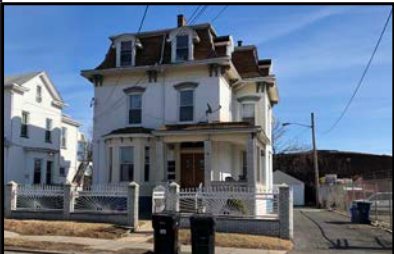
2	119-121 W. 5th St	3 Story, Residential, 3 Units, Built in 1856	<ul style="list-style-type: none"> Non-conforming use 	7,248 sq. ft.							X	X	X

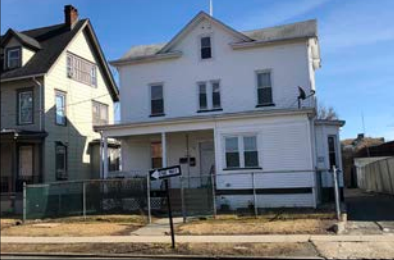
3	115-117 W. 5th St	2 Story, Residential, 2 Units, Built in 1911	<ul style="list-style-type: none"> Chain link fence Non-conforming use Low Improvement Ratio 	7,248 sq. ft.							X	X	X

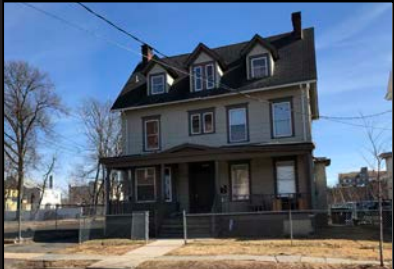
Lot	Address	Site Description	Site Issues	Lot Area	Redevelopment								Sec 3	Photo
					A	B	C	D	E	F	G	H		
4	111-113 W. 5th St	2 Story, Residential, 3 Units, Built in 1890	<ul style="list-style-type: none"> Chain link fence Non-conforming use 	7,152 sq. ft.							X	X	X

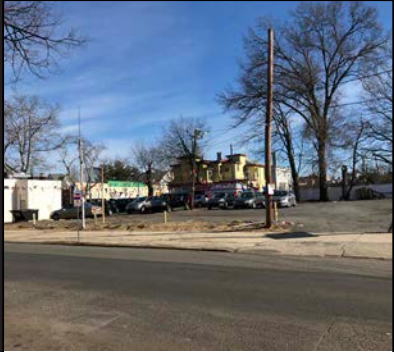
5	500-510 Park Ave	1 Story, Commercial, Built in 1945	<ul style="list-style-type: none"> Does not meet the minimum height requirement Deficient Buffering Lack of lighting Excessive Impervious Coverage Non-conforming use Low Improvement Ratio 	15,481 sq. ft.				X			X	X

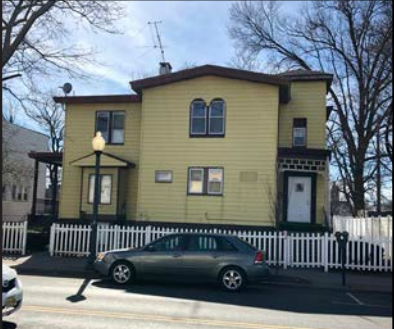
6	512-516 Park Ave	2 Story, Residential, 4 Units, Built in 1896	<ul style="list-style-type: none"> Non-conforming use 	10,881 sq. ft.							X	X	X

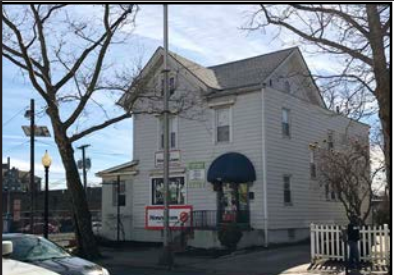
Lot	Address	Site Description	Site Issues	Lot Area	Redevelopment								Sec 3	Photo
					A	B	C	D	E	F	G	H		
7	518-520 Park Ave	2 Story, Commercial, Built in 1920	<ul style="list-style-type: none"> Does not meet the minimum height requirement Low Improvement Ratio 	7,071 sq. ft.							X	X	X

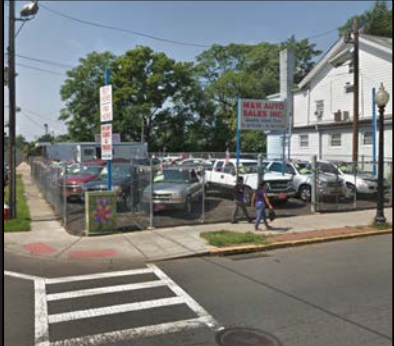
8	522-526 Park Ave	Paved lot, Commercial	<ul style="list-style-type: none"> Chain link fence Deficient Buffering Obsolete layout Excessive Impervious Coverage Non-conforming Use Environmental Contamination Low Improvement Ratio 	6,308 sq. ft.		X		X			X	X

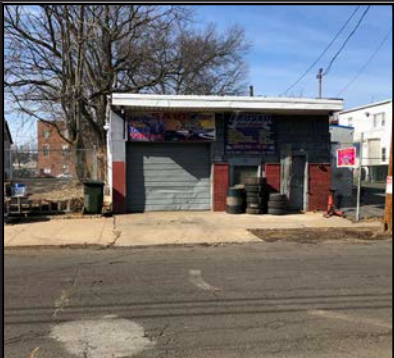
9	108 W. 6th St	1 Story, Commercial	<ul style="list-style-type: none"> Land use with adverse impacts Non-conforming use Does not meet the minimum height requirement Environmental Contamination Low Improvement Ratio 	1,159 sq. ft.				X			X	X

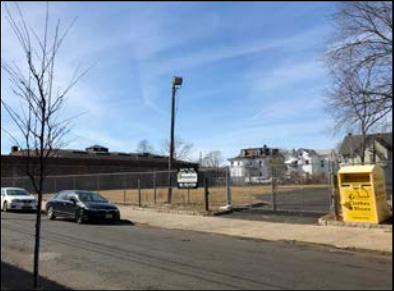
Lot	Address	Site Description	Site Issues	Lot Area	Redevelopment								Sec 3	Photo
					A	B	C	D	E	F	G	H		
10	107-109 W. 5th St	Vacant parcel	<ul style="list-style-type: none"> Deficient Buffering Chain Link Fence Environmental Contamination Low Improvement Ratio 			X		X			X	X

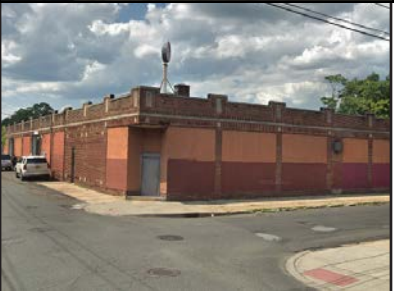
11	122-130 W. 6th St	1 Story, Built in 1926	<ul style="list-style-type: none"> Environmental Contamination Low Improvement Ratio 	14,959 sq. ft.				X			X	X

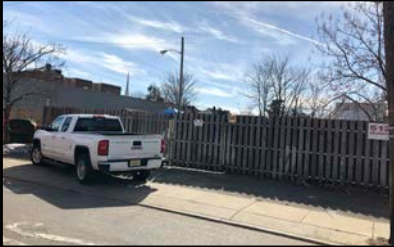
4	512-514 Arlington Ave	Asphalt Paving	<ul style="list-style-type: none">• Non-conforming use• Low Improvement Ratio	6,681 sq. ft.				X			X	X

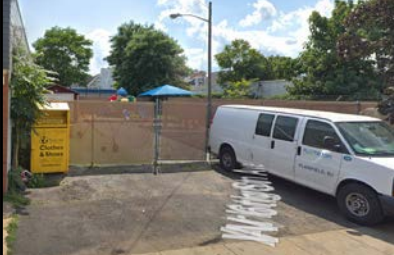
5	516-518 Arlington Ave	Daycare Playground	<ul style="list-style-type: none">• Chain link fence• Low Improvement Ratio	3,977 sq. ft.							X	X	X

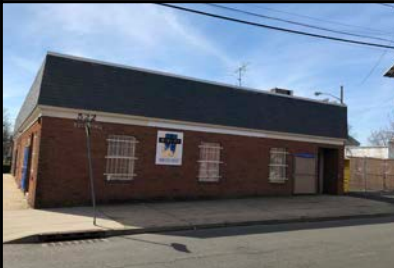
6	520-522 Arlington Ave	1 Story, Commercial, Built in 1977		4,283 sq. ft.							X	X	X

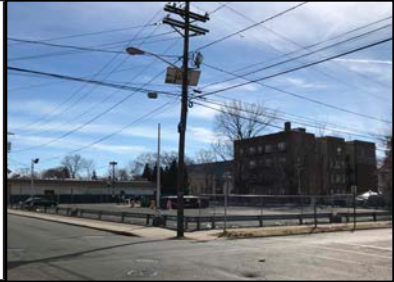
Lot	Address	Site Description	Site Issues	Lot Area	Redevelopment								Sec 3	Photo
					A	B	C	D	E	F	G	H		
1	201-211 W. 6th St	Parking lot	<ul style="list-style-type: none"> Low Improvement Ratio Deficient Buffering Excessive Impervious Coverage Chain link fence 	25,984 sq. ft.				X			X	X

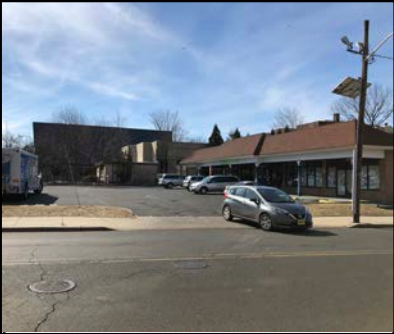
2	202-208 W. 7th St	1 Story, Commercial, Strip Mall, Built in 1988	<ul style="list-style-type: none"> Deficient Buffering Vacant Storefront Lack of Lighting Excessive Impervious Coverage Low Improvement Ratio 	25,025 sq. ft.		X		X			X	X

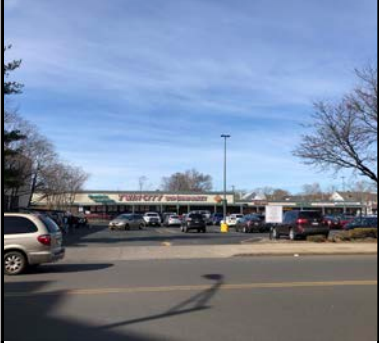
Lot	Address	Site Description	Site Issues	Lot Area	Redevelopment								Sec 3	Photo
					A	B	C	D	E	F	G	H		
1	600-628 Park Ave	Irregular shaped, 1 Story, Commercial, Strip Mall, Built in 1980	<ul style="list-style-type: none"> Does not meet the minimum height requirement Deficient Buffering Excessive Impervious Coverage Lack of Lighting Environmental Contamination Low Improvement Ratio 	122,582 sq. ft				X			X	X

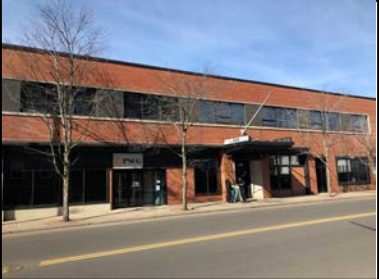
2	120-128 W. 7th St	2 Story, Commercial, Built in 1948		29,333 sq. ft.							X	X	X

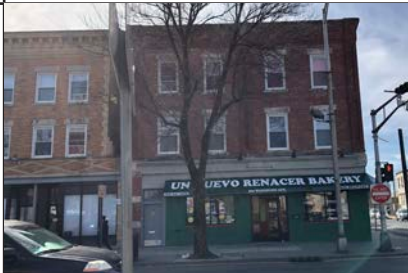
Redevelopment										
Lot	Address	Site Description	Site Issues	Lot Area	A	B	C	D	E	F	G	H	Sec 3	Photo	
1	500-504 Watchung Ave	3 Story, Mixed-use, 4 Units, 1 Storefront, Built in 1897	<ul style="list-style-type: none">Does not meet the minimum height requirementUndersized lot	3,852 sq. ft.							X	X	X

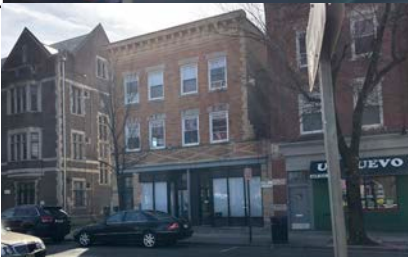
2	506 Watchung Ave	3 Story, Mixed-use, 4 Units, 2 Storefronts, Built in 1902	<ul style="list-style-type: none">Vacant StorefrontDoes not meet the minimum height requirementUndersized lot	4,439 sq. ft.		X					X	X

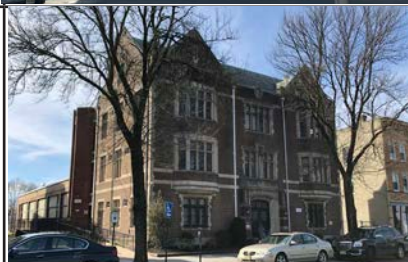
3	508-510 Watchung Ave	3 Story, City Hall Annex, Built in 1929, Historic District	<ul style="list-style-type: none">Undersized lot	3,594 sq. ft.							X	X	X

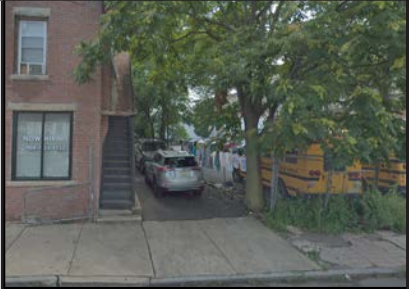
Lot	Address	Site Description	Site Issues	Lot Area	Redevelopment								Sec 3	Photo
					A	B	C	D	E	F	G	H		
6	146 E. 5th St	Vacant Parcel, City Owned, Public Right of Way	<ul style="list-style-type: none"> Undersized lot Does not meet the minimum height requirement Low Improvement Ratio 	854 sq. ft.			X	X			X	X

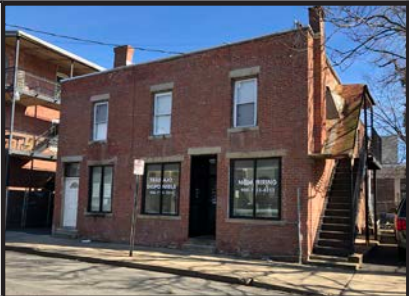
7	148-150 E. 5th St	2 Story, Mixed Use (Office & 2 Units) Built in 1900	<ul style="list-style-type: none"> Undersized lot Non-conforming front yard setback 	1,648 sq. ft.							X	X	X

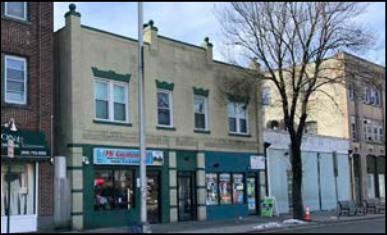
Lot	Address	Site Description	Site Issues	Lot Area	Redevelopment								Sec 3	Photo
					A	B	C	D	E	F	G	H		
2	406-408 Watchung Ave	2 Story, Mix-use, 4 Units, 2 Storefronts, Built in 1930	<ul style="list-style-type: none"> Does not meet the minimum height requirement Vacant Storefront 	4,979 sq. ft.		X					X	X

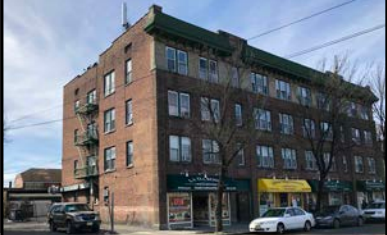
3	410-420 Watchung Ave	4 Story, Mixed-use, 19 Units, 4 Storefronts	<ul style="list-style-type: none"> Environmental Contamination Vacant Storefront 	14,052 sq. ft.		X		X			X	X

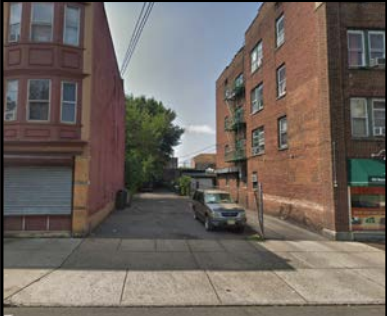
4	422 Watchung Ave	Parking lot	<ul style="list-style-type: none"> Chain link fence Lack of Lighting Deficient Buffering Excessive Impervious Coverage Obsolete Layout Environmental Contamination Undersized lot 	3,149 sq. ft.				X			X	X

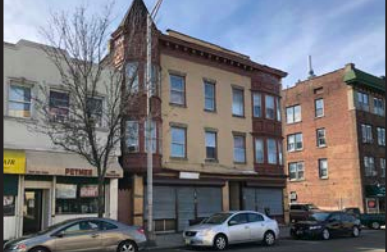
5	424-428 Watchung Ave	3 Story, Mixed-use, Built in 1910	<ul style="list-style-type: none"> Vacant Storefront Environmental Contamination Non-conforming front yard setback 	7,148 sq. ft.		X		X			X	X

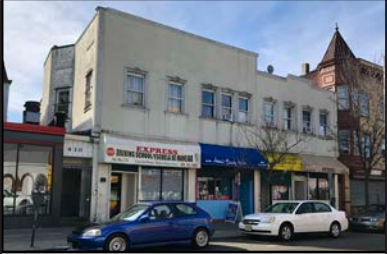
Lot	Address	Site Description	Site Issues	Lot Area	Redevelopment								Sec 3	Photo
					A	B	C	D	E	F	G	H		
6	430-432 Watchung Ave	2 Story, Mixed Use, 4 Units, 4 Storefronts, Built in 1900	<ul style="list-style-type: none"> Environmental Contamination Low Improvement Ratio 	7,281 sq. ft.		X		X			X	X

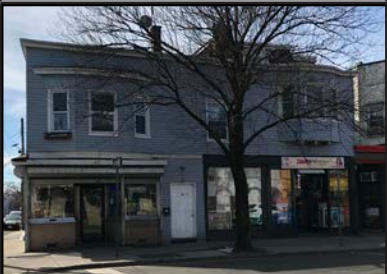
7	434-438 Watchung Ave	2 Structures on parcel, 2 Story, Mixed use, 3 Storefronts, 1 Commercial building, 4 Units, Built in 1909	<ul style="list-style-type: none"> Vacant Storefront Environmental Contamination Code Information Violation 	4,607 sq. ft.		X		X			X	X

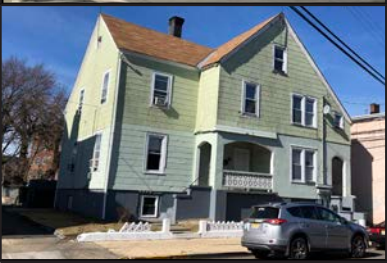
8	147-149 E. 5th St	2 Story, Residential, 3 Units, Built in 1924	<ul style="list-style-type: none"> Environmental Contamination Undersized lot Non-conforming Use 	2,791 sq. ft.		X					X	X

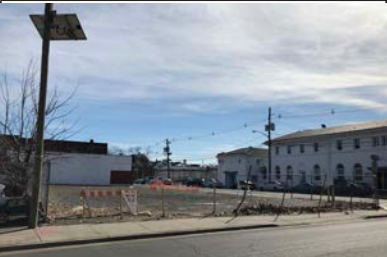
15.01	401-411 Cleveland Ave	City owned, Parking Lot	<ul style="list-style-type: none"> Chain link fence Lack of lighting Deficient Buffering Environmental Contamination Low Improvement Ratio 	12,600 sq. ft.			X	X			X	X

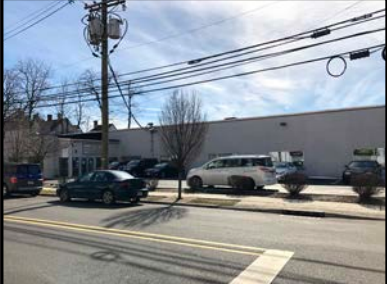
Lot	Address	Site Description	Site Issues	Lot Area	Redevelopment								Sec 3	Photo
					A	B	C	D	E	F	G	H		
1.01	110-138 E. 5th St	1 Story, Commercial	<ul style="list-style-type: none"> Does not meet the minimum height requirement Environmental Contamination Low Improvement Ratio 	34,503 sq. ft.							X	X	X

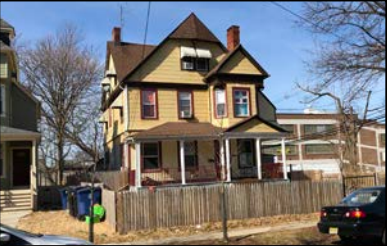
2	127-129 E. 6th St	2 Story, Residential, 2 Units, Built in 1896	<ul style="list-style-type: none"> Non-conforming use Does not meet the minimum height requirement 	6,900 sq. ft.							X	X	X

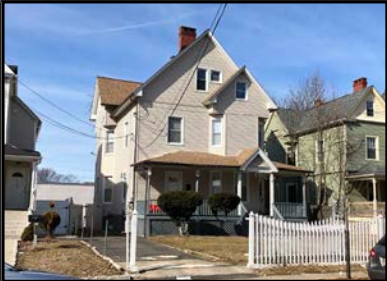
4	119-121 E. 6th St	2 Story, Residential, 3 Units, Built in 1896	<ul style="list-style-type: none"> Non-conforming use Does not meet the minimum height requirement Low Improvement Ratio 	6,904 sq. ft.							X	X	X

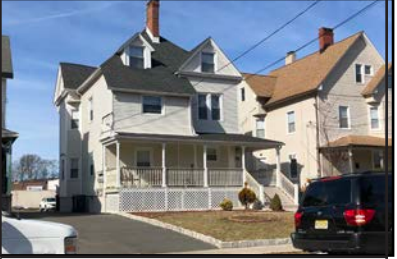
Lot	Address	Site Description	Site Issues	Lot Area	Redevelopment								Sec 3	Photo
					A	B	C	D	E	F	G	H		
5	115-117 E. 6th St	2 Story, Residential, 3 Units, Built in 1896	<ul style="list-style-type: none"> Non-conforming use Does not meet the minimum height requirement 	6,954 sq. ft.							X	X	X

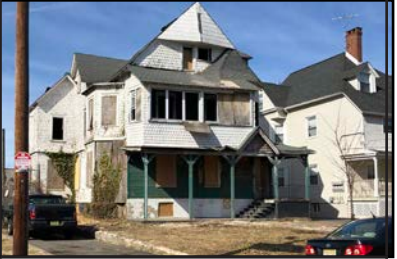
Lot 6 can be placed under Criteria A. The existing structure has experienced several fires within the past ten years to where the house is inhabitable. The deterioration is so severe to where it can be seen from an exterior inspection of the area. The property is hazardous to the neighboring residential property and brings down the value of the properties along East 6th Street.

Lot 6 can be classified under the D criterion. Lot 6 is structurally deteriorated, dilapidated and a safety hazard. This parcel has a negative impact on the surrounding neighborhood and can detract private investors, therefore should be included in the redevelopment area.

6	111-113 E. 6th St	2 Story, Residential, 3 Units, Built in 1901	<ul style="list-style-type: none"> Vacant structure Non-conforming use Does not meet the minimum height requirement 	6,963 sq. ft.	X			X			X	X

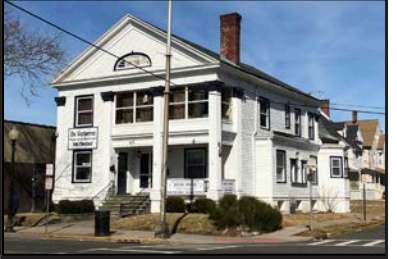
7	523 Park Ave	2 Story, Mixed Use, 1 Office, 2 Units, Built in 1906	<ul style="list-style-type: none"> Does not meet the minimum height requirement 	5,872 sq. ft.							X	X	X

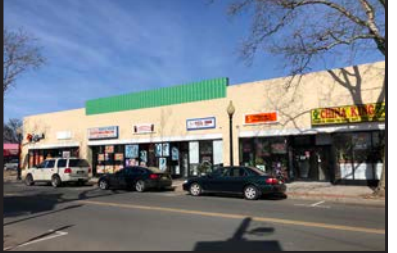
8	513-521 Park Ave	1 Story, Commercial, Built in 1947	<ul style="list-style-type: none"> Does not meet the minimum height requirement Vacant Storefront 	13,377 sq. ft.		X					X	X

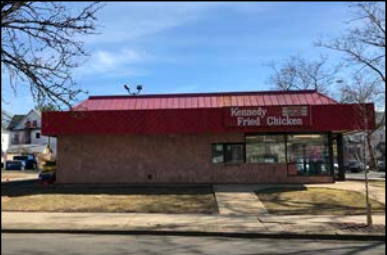
Lot	Address	Site Description	Site Issues	Lot Area	Redevelopment								Sec 3	Photo
					A	B	C	D	E	F	G	H		
9	501-511 Park Ave	1 Story, Commercial	<ul style="list-style-type: none"> Does not meet the minimum height requirement 	15,612 sq. ft.							X	X	X

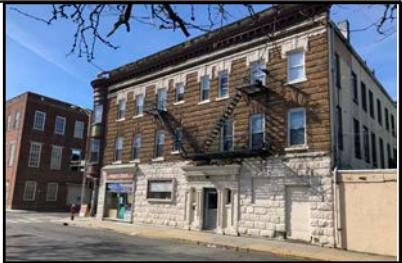
Lot	Address	Site Description	Site Issues	Lot Area	Redevelopment								Sec 3	Photo
					A	B	C	D	E	F	G	H		
9	435 Park Ave	3 Story, Mixed Use, Built in 1915	<ul style="list-style-type: none"> Does not meet the minimum height requirement Undersized lot 	2,888 sq. ft.							X	X	X

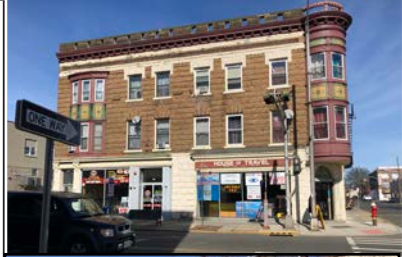
10	431-433 Park Ave	3 Story, Mixed Use, Built in 1903	<ul style="list-style-type: none"> Does not meet the minimum height requirement Undersized lot 	2,945 sq. ft.							X	X	X

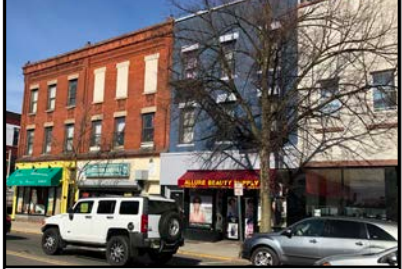
14	409-411 Park Ave	3 Story, Mixed Use, 1 Story, 4 Units, Built in 1897	<ul style="list-style-type: none"> Does not meet the minimum height requirement Undersized lot 	1,852 sq. ft.							X	X	X

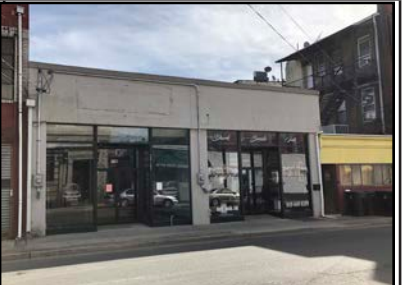
17	108-110 E. 4th St	1 Story, Commercial	<ul style="list-style-type: none"> Does not meet the minimum height requirement Environmental Contamination Low Improvement Ratio Undersized lot 	1,803 sq. ft.				X			X	X

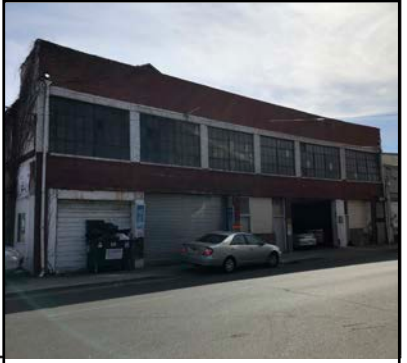
Lot 18 can be placed under the Criteria B designation. This parcel contains two automobile serving spaces in which one is currently vacant. The parcel displays signs of vacancy due to covered window and door openings and inactivity during regular business hours in addition to lacking access to light and air which are not conducive to healthy working conditions. Vacant commercial buildings/storefronts are a usually an indication of a blighted area and therefore should be included in the redevelopment area.

Lots 17 and 18 can be classified under the D criterion. Lots 17 and 18 are suspected of having environmental contamination conditions. Lot 17 is listed on the City's database as having a potential petroleum contamination. Lot 18 is a designated Remedial Action Outcome, Area of Concern (RAO-A) by the NJDEP, further investigation must be conducted in order to determine whether these sites are fully remediated. Lots 17 and 18 have low improvement ratios which indicate that little to no improvements have been made to theses parcels. Given the age of these structures regular maintenance is needed in order to prevent the property from falling into a state of disrepair. Lack of investment can result in a negative impact on the surrounding neighborhood and can detract private investors, therefore these parcels should be included in the redevelopment area.

Lot	Address	Site Description	Site Issues	Lot Area	Redevelopment								Sec 3	Photo
					A	B	C	D	E	F	G	H		
18	112-118 E. 4th St	2 Story, Commercial, Built in 1927	<ul style="list-style-type: none"> Land use with adverse impact Does not meet the minimum height requirement Environmental Contamination Non-conforming use Vacant commercial space 	11,955 sq. ft.		X		X			X	X

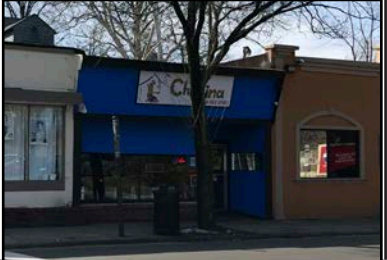
Lot	Address	Site Description	Site Issues	Lot Area	Redevelopment								Sec 3	Photo
					A	B	C	D	E	F	G	H		
2	314 Watchung Ave	1 Story, Commercial, Built in 1910	<ul style="list-style-type: none"> Undersized lot Does not meet the minimum height requirement Environmental Contamination 	1,798 sq. ft.				X			X	X

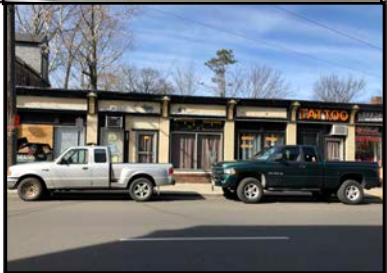
3	316 Watchung Ave	1 Story, Commercial, Built in 1920	<ul style="list-style-type: none"> Undersized lot Does not meet the minimum height requirement Vacant Storefront 	2,261 sq. ft.		X					X	X

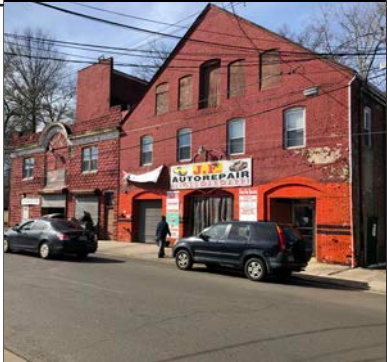
Lots 2, 5, and 7.01 can be classified under the D criterion. Lots 5 and 7.01 are listed on the City's Brownfield database as suspected of having petroleum contamination. Lot 5 has a low improvement ratio which indicates that little to no improvements have been made to theses parcels. Given the age of these structures regular maintenance is needed in order to prevent a property from falling into a state of disrepair. This property has defects that included peeling paint, cracked windows and masonry, and rotting wood. Lack of investment can result in a negative impact on the surrounding neighborhood and can detract private investors, therefore should be included in the redevelopment area.

5	143-151 E. 4th St	3 Story, Commercial	<ul style="list-style-type: none"> Land use with adverse impact Non-conforming use Does not meet the minimum height requirement Environmental Contamination Low Improvement Ratio 	9,042 sq. ft.				X			X	X

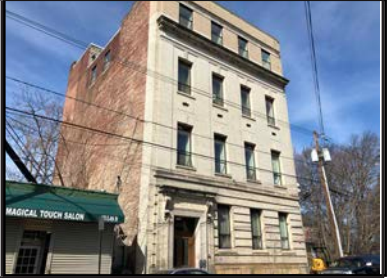
Lot	Address	Site Description	Site Issues	Lot Area	Redevelopment								Sec 3	Photo
					A	B	C	D	E	F	G	H		
7.01	109-121 4th St	Irregular shaped parcel, 4 Story, Residential, 8 Units, Built in 1906	<ul style="list-style-type: none"> Environmental Contamination 	9,674 sq. ft.				X			X	X

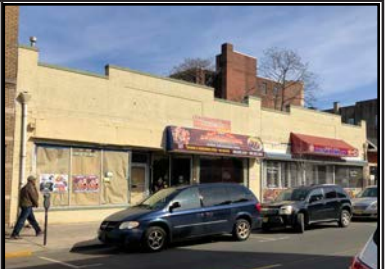
13	315-323 Park Ave	1-2 Story, 2 Structures, Commercial, Built in 1925	<ul style="list-style-type: none"> Vacant storefront Does not meet the minimum height requirement Low Improvement Ratio 	10,968 sq. ft.		X					X	X
