AREA IN NEED OF REDEVELOPMENT & REHABILITATION INVESTIGATION

East Second Street Commercial Corridor Study

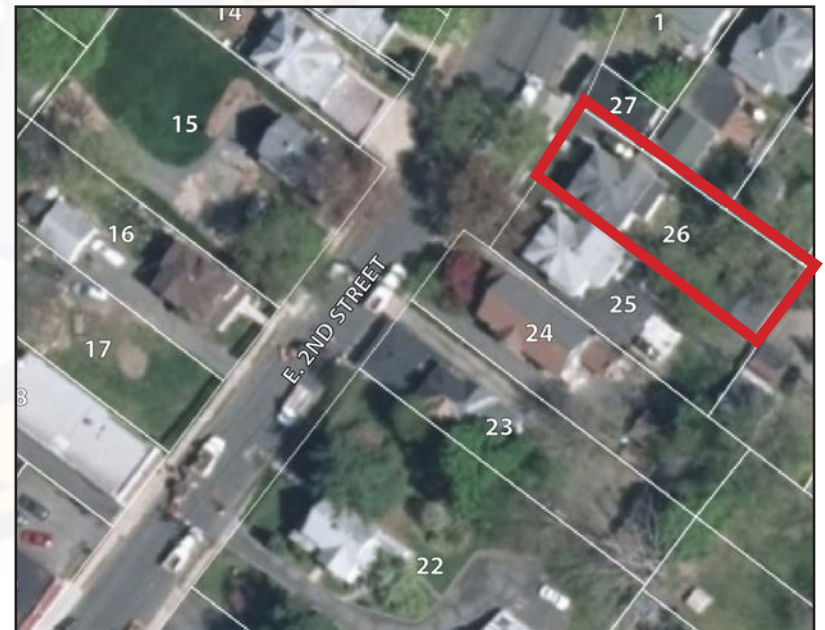
Block 411, Lot 25. 1130-1132 E. 2nd Street
Neighborhood Commercial

Property Description:	Block 411, Lot 25. 1130-1132 E. 2nd Street The property contains a well-maintained two-story, single-family home that measures 1,562 square feet. The house was built in 1921. The building is in good condition.
Site Issues:	None
Satisfies LRHL Criteria:	G: Located in the City's Urban Enterprise Zone.
Satisfies Rehabilitation Criteria:	2. More than half of the housing stock in the delineated area is at least 50 years old. 6. Sanitary sewer infrastructure is more than 50 years old.
Recommendation:	The property meets G criteria for area in need of redevelopment and criteria 2 and 6 for area in need of rehabilitation. Since the house is more than 50 years old, the sanitary sewer infrastructure is about 90 years old and is situated in a UEZ, the parcel should be considered as an area in need of redevelopment and an area in need of rehabilitation.

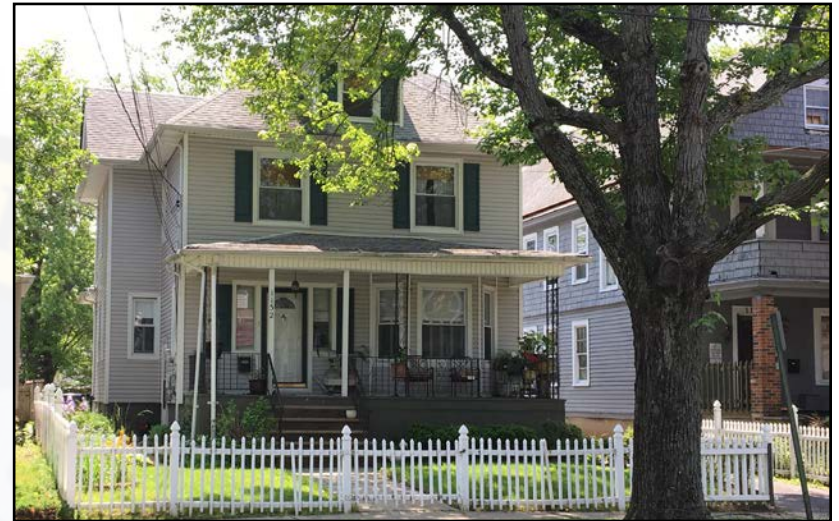
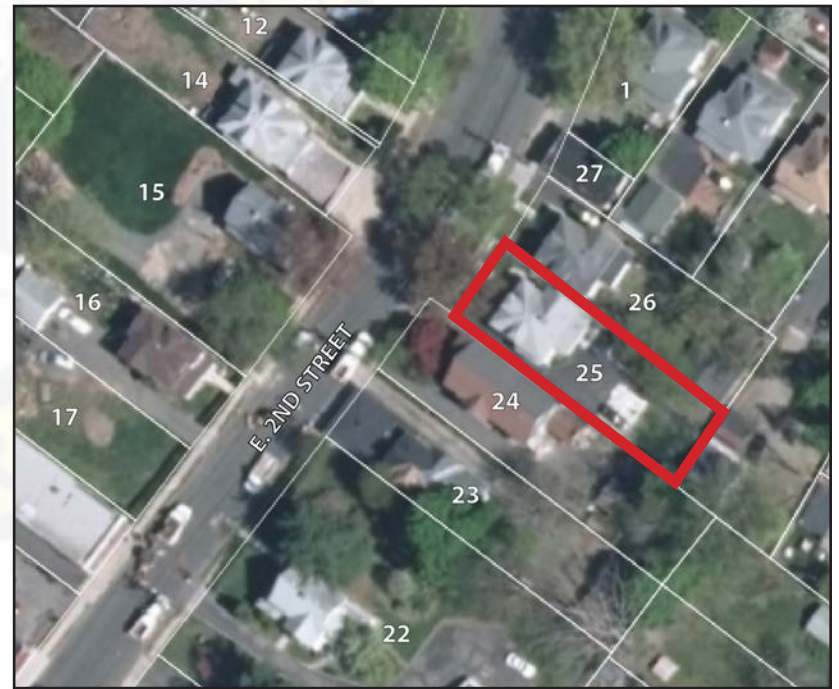
Block 411, Lot 24. 1126-1128 E. 2nd Street
Neighborhood Commercial

Property Description:	Block 411, Lot 24. 1126-1128 E. 2nd Street The property contains a two-story, single family home. Built in 1921, the house is 2,344 square feet in size.
Site Issues:	The City Tax Collector reported that the property has outstanding taxes. Division of Inspection reported the following past violations: <ul style="list-style-type: none"> • Maintenance of exterior of premises and structures; appearance of exterior of premises and structures; • Appearance of exterior of premises and structures including, stairs and railing; and, • Structural soundness.
Satisfies LRHL Criteria:	G: Located in the City's Urban Enterprise Zone.
Satisfies Rehabilitation Criteria:	2. More than half of the housing stock in the delineated area is at least 50 years old; 4. Persistent arrearage of property tax. 6. Sanitary sewer infrastructure is more than 50 years old.
Recommendation:	The property meets G criterion for area in need of redevelopment and criteria 2, 4 and 6 for area in need for rehabilitation. Since the house is more than 50 years old, the property has tax delinquency of more than 12 months, has sanitary sewer infrastructure that is about 90 years old and is also located in a UEZ, the parcel should be considered as an area in need of redevelopment and an area in need of rehabilitation.

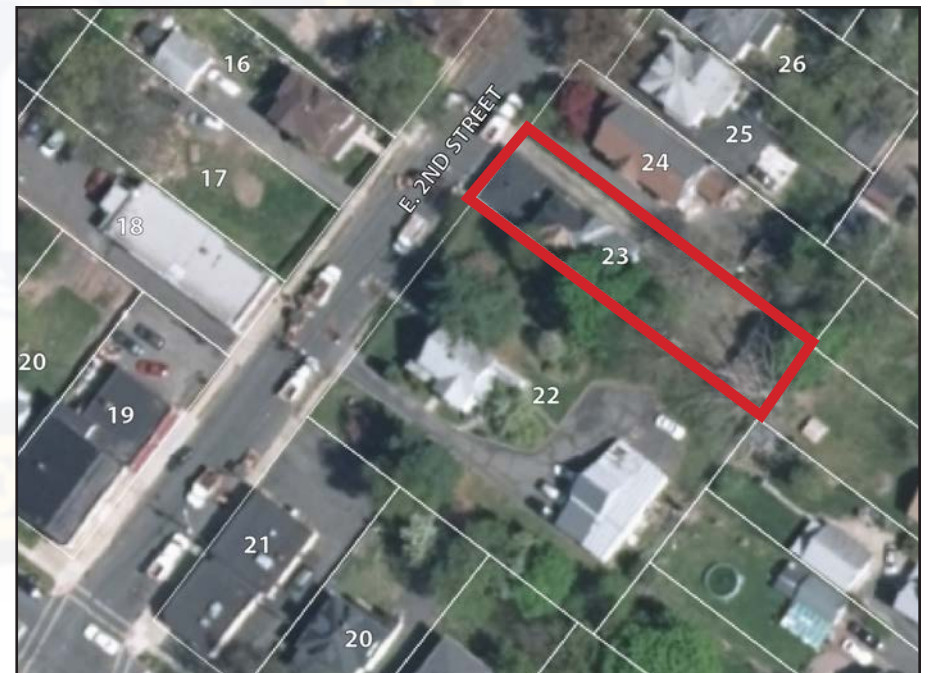
Block 411, Lot 22. 1110-1120 E. 2nd Street
Neighborhood Commercial

Property Description:	Block 411, Lot 22. 1110-1120 E. 2nd Street The property contains a two-family home with the parking located to the rear side of the house. Built in 1921, the house is 1,500 square feet in size. The building is in good condition.
Site Issues:	The siding on the building façade is peeling and requires proper maintenance. Division of Inspection reported past violations for trash, debris, litter and rubbish around the entire property.
Satisfies LRHL Criteria:	G: Located in the City's Urban Enterprise Zone.
Satisfies Rehabilitation Criteria:	2: More than half of the housing stock in the delineated area is at least 50 years old. 6. Sanitary sewer infrastructure is more than 50 yrs. old.
Recommendation:	The property meets G criteria for area in need of redevelopment and criteria 2 and 6 for area in need of rehabilitation. Since the house is more than 50 years old, has sanitary sewer infrastructure that is about 90 years old and is situated in a UEZ, the parcel should be considered as an area in need of redevelopment and an area in need of rehabilitation.

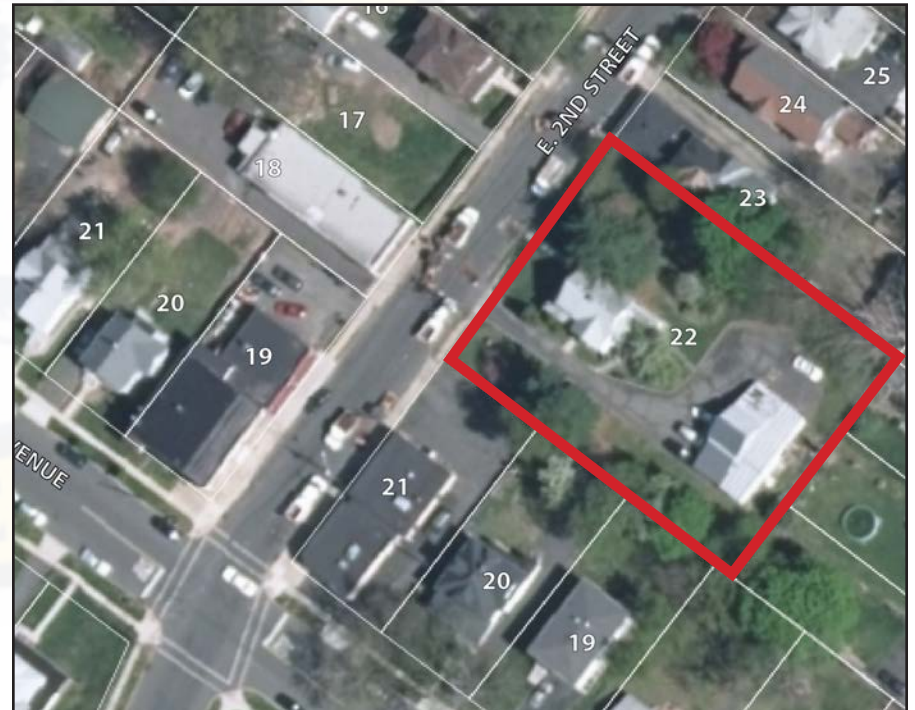
Block 411, Lot 21. 201-203 Netherwood Avenue
Neighborhood Commercial

Property Description:	Block 411, Lot 21. 201-203 Netherwood Avenue The property contains a single-story commercial building that is currently vacant and the associated parking. Built in 1925, the building measures 2,452 square feet in size.
Site Issues:	Vacant building with poorly maintained parking lot. Division of Inspection reported past violation for structural paint chipping. Parking area in poor condition.
Satisfies LRHL Criteria:	D: undefined and poorly defined parking and lack of any landscape buffer. G: located in the City's Urban Enterprise Zone.
Satisfies Rehabilitation Criteria:	3: Pattern of vacancy. 6. Sanitary sewer infrastructure is more than 50 years old.
Recommendation:	The property meets D and G criteria for area in need of redevelopment and criteria 3 and 6 for area in need of rehabilitation. Since the property has been vacant, has sanitary sewer infrastructure that is about 90 yrs. old, has undefined parking and lacks landscape buffer and is situated in a UEZ, the parcel should be considered as an area in need of redevelopment and an area in need of rehabilitation.

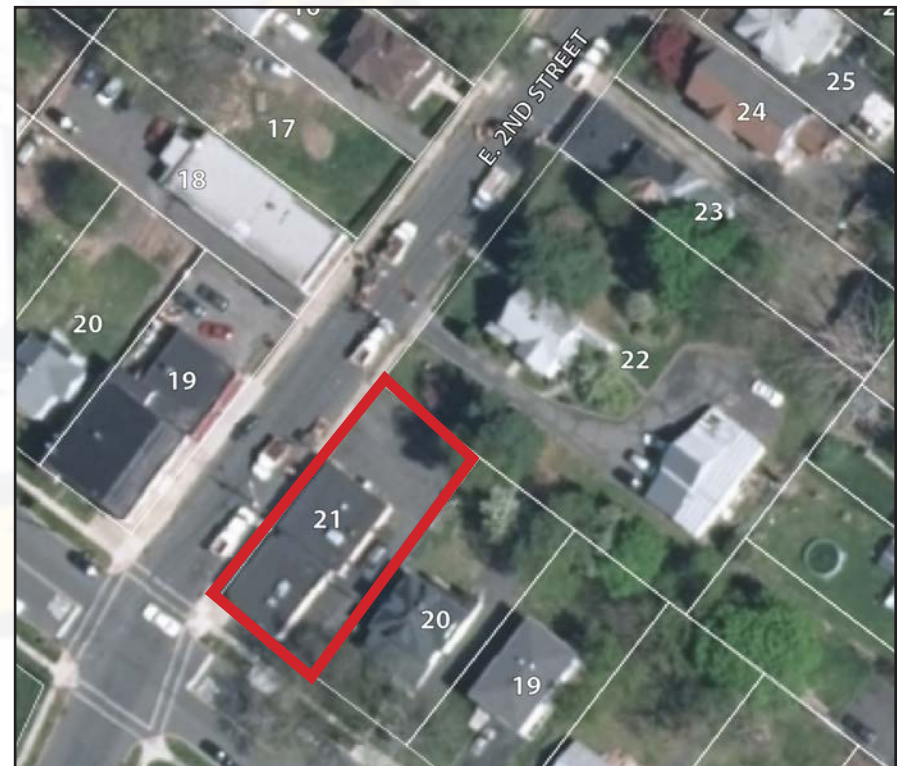
Block 411, Lot 20. 205-207 Netherwood Avenue
Neighborhood Commercial

Property Description:	Block 411, Lot 20. 205-207 Netherwood Avenue The property contains a single-family home. Built in 1921, the house measures 1,799 square feet. The building is in good condition.
Site Issues:	Division of Inspection reported past violation for lack of maintenance of lawn and curb area.
Satisfies LRHL Criteria:	G: Located in the City's Urban Enterprise Zone.
Satisfies Rehabilitation Criteria:	2: More than half of the housing stock in the delineated area is at least 50 years old. 6. Sanitary sewer infrastructure is more than 50 years old.
Recommendation:	The property meets G criteria for area in need of redevelopment and criteria 2 and 6 for area in need of rehabilitation. Since the home is more than 50 years old, has sanitary sewer infrastructure that is 90 years old and is situated in a UEZ, the parcel should be considered as an area in need of redevelopment and an area in need of rehabilitation.

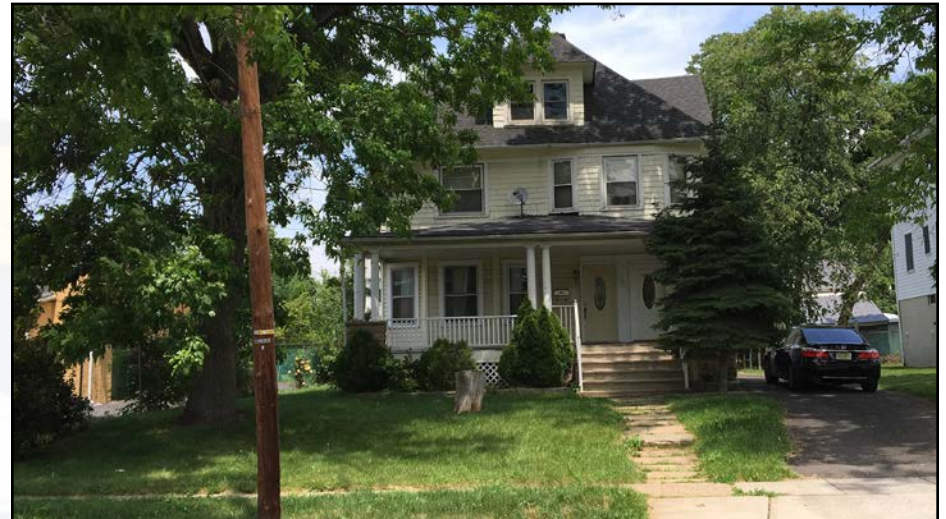
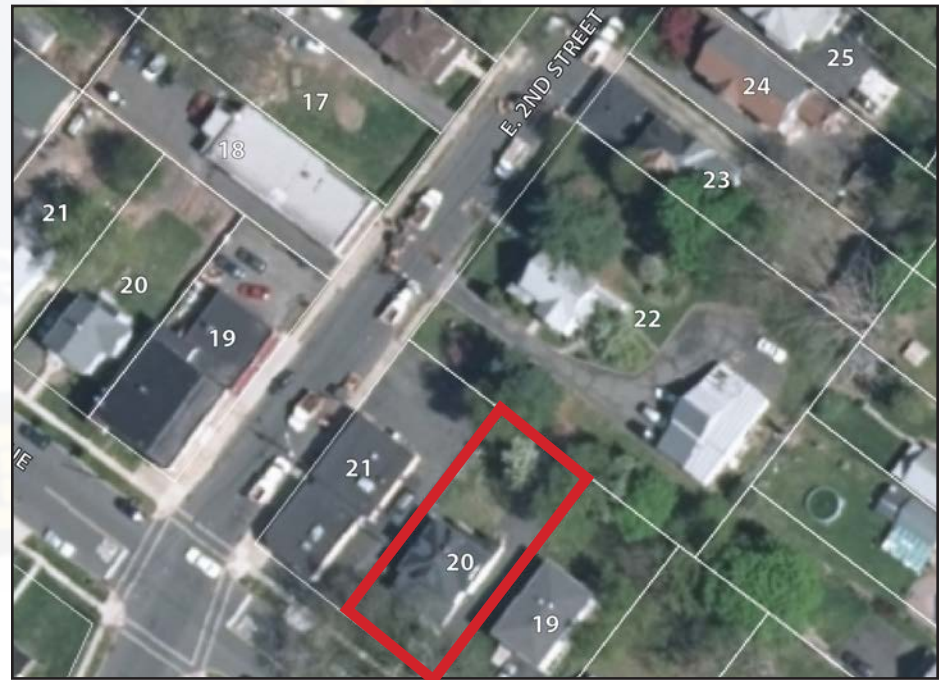
Block 331, Lot 12. 1135-1137 E. 2nd Street
Neighborhood Commercial

Property Description:	Block 331, Lot 12. 1135-1137 E. 2nd Street The site contains a single-family home. Built in 1926, the house measures 1,440 square feet. The house is in good condition.
Site Issues:	Peeling paint on the siding. The Division of Inspections reported the following past violations: <ul style="list-style-type: none"> • Appearance of exterior of premises and structure; and, • Maintenance of exterior of premises and structures, structural soundness.
Satisfies LRHL Criteria:	G: Located in the City's Urban Enterprise Zone.
Satisfies Redevelopment Criteria:	2: More than half of the housing stock in the delineated area is at least 50 years old. 6. Sanitary sewer infrastructure is more than 50 yrs old.
Recommendation:	The property meets G criteria for area in need of redevelopment and criteria 2 and 6 for area in need of rehabilitation. Since the home is more than 50 years old, has sanitary sewer infrastructure is about 90 years old and is situated in a UEZ, the parcel should be considered as an area in need of redevelopment and an area in need of rehabilitation.

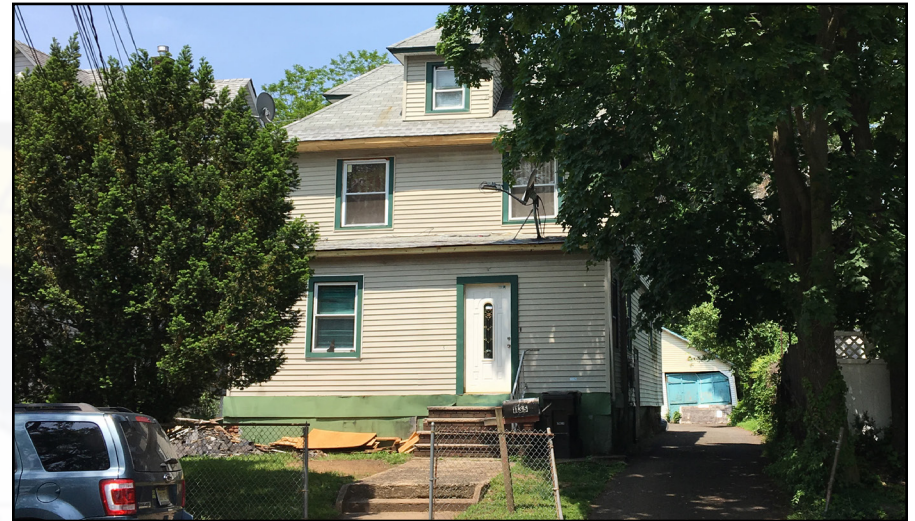
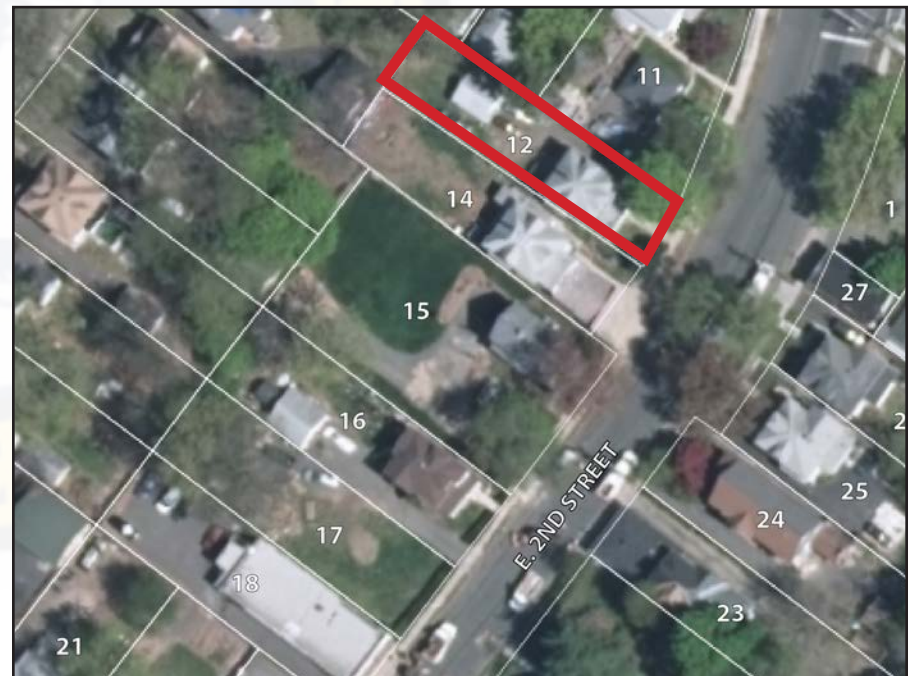
Block 331, Lot 13. 1135A E 2nd Street
Neighborhood Commercial

Property Description:	Block 331, Lot 13. 1135A E 2nd Street The property is an undersized, narrow, vacant lot. The property is municipally owned and is tax-exempt.
Site Issues:	Vacant
Satisfies LRHL Criteria:	C: Municipally owned vacant land. G: Located in the City's Urban Enterprise Zone.
Satisfies Rehabilitation Criteria:	6. Sanitary sewer infrastructure is more than 50 years old.
Recommendation:	The property meets C and G criteria for area in need of redevelopment and criterion 6 for area in need of rehabilitation. This property is very narrow and undersized and should be combined/merged with the adjacent property when redevelopment occurs. Since the property is a municipally-owned parcel, has sanitary sewer infrastructure that is about 90 years old and is situated in a UEZ, the parcel should be considered as an area in need of redevelopment and an area in need of rehabilitation.

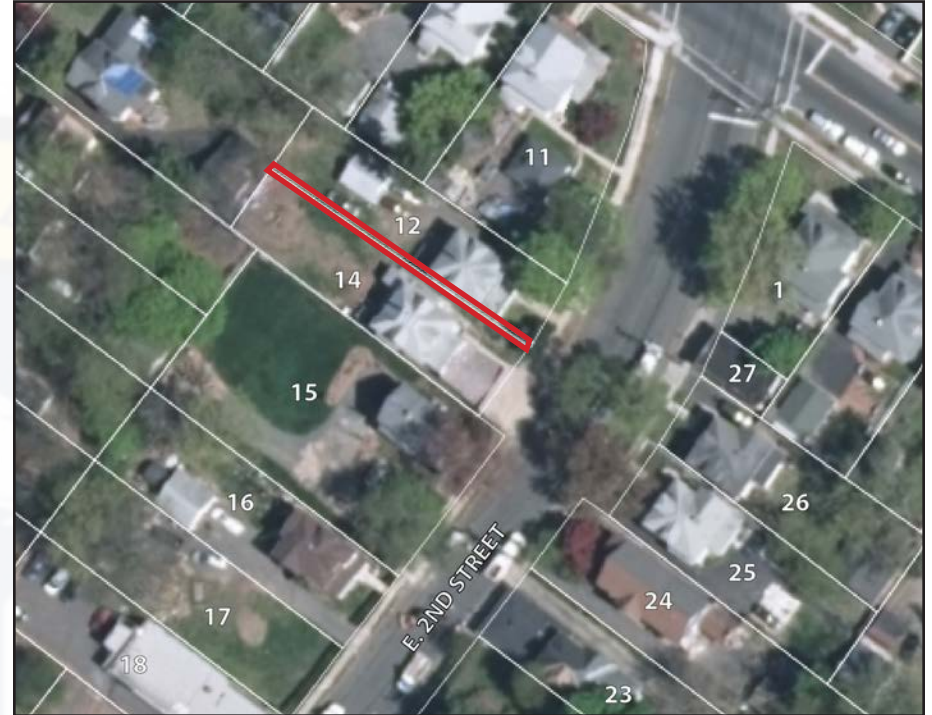
Block 331, Lot 14. 1131-1133 E. 2nd Street
Neighborhood Commercial

Property Description:	Block 331, Lot 14. 1131-1133 E. 2nd Street The property contains a mixed-use building with commercial/retail use in the front portion of the building. The front portion of the building is a single-story structure that contains a popular store (Big Daddy) in the neighborhood. The remainder portion of the building is a two-story residential building. Built in 1925, the property size is 1,521 square feet.
Site Issues:	The site is devoid of any off-street parking. The Fire Division reported an incident of fire in the building in 2010.
Satisfies LRHL Criteria:	G: Located in the City's Urban Enterprise Zone.
Satisfies Rehabilitation Criteria:	2: More than half of the housing stock in the delineated area is at least 50 years old. 6. Sanitary sewer infrastructure is more than 50 years old.
Recommendation:	The property meets G criterion for area in need of redevelopment and criteria 2 and 6 for area in need of rehabilitation. Since the building is more than 50 years old, has sanitary sewer infrastructure that is about 90 years old and is situated in a UEZ, the parcel should be considered as an area in need of redevelopment and an area in need of rehabilitation.

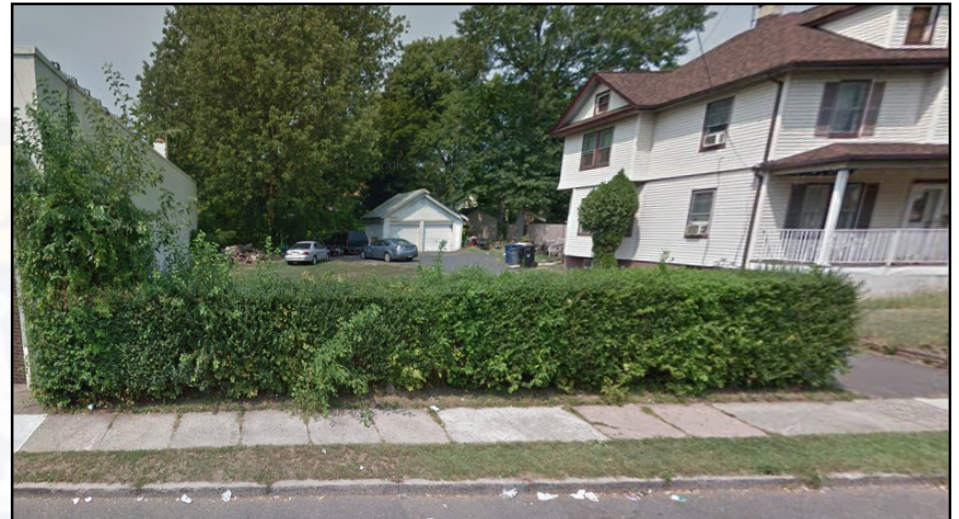
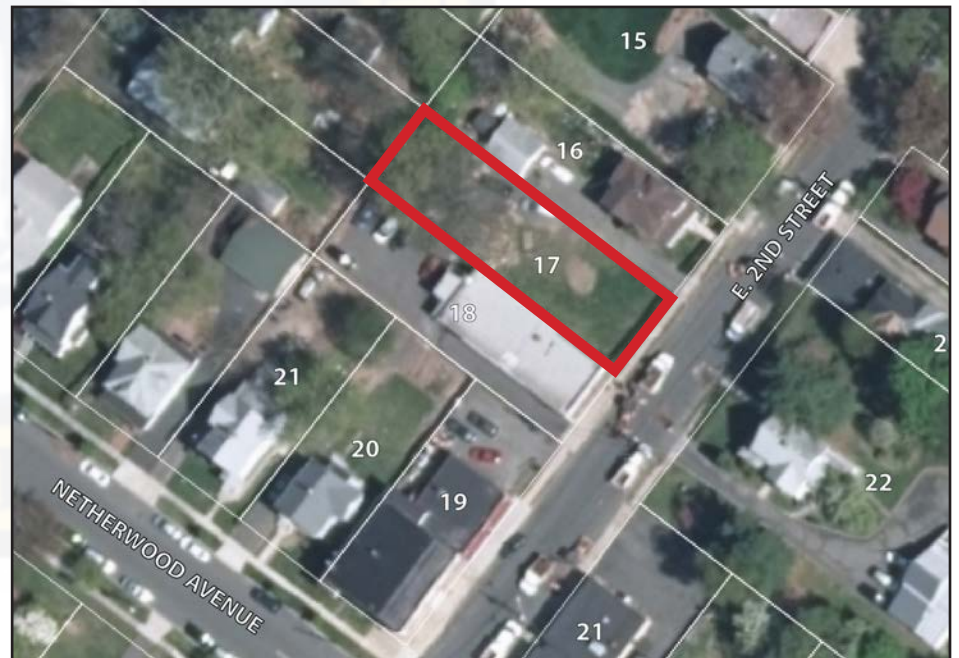
Block 331, Lot 18. 1111-1113 E. 2nd Street
Neighborhood Commercial

Property Description:	Block 331, Lot 18 1111-1113 E. 2nd Street One-story house of worship building. Built in 1965; the building is 2,458 square feet in size.
Site Issues:	The Division of Inspection reported violations for property maintenance and chipping paint in 2015.
Satisfies LRHL Criteria:	G: Located in the City's Urban Enterprise Zone.
Satisfies Rehabilitation Criteria:	6. Sanitary sewer infrastructure is more than 50 years old.
Recommendation:	The property meets G Criterion for area in need of redevelopment and criterion 6 for area in need of rehabilitation. The property to the north of the church is a vacant lot and is recommended for redevelopment and rehabilitation similarly, the property to the south is also recommended for redevelopment rehabilitation. When development occurs, these 3 properties may be developed together and be a part of a larger project. Since the sanitary sewer infrastructure is about 90 years old and is situated in a UEZ, the parcel should be considered as an area in need of redevelopment and an area in need of rehabilitation.

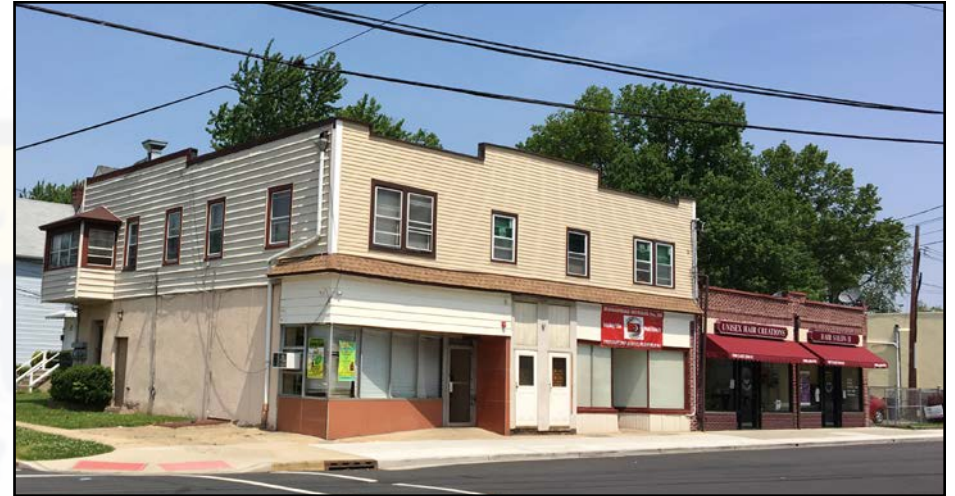
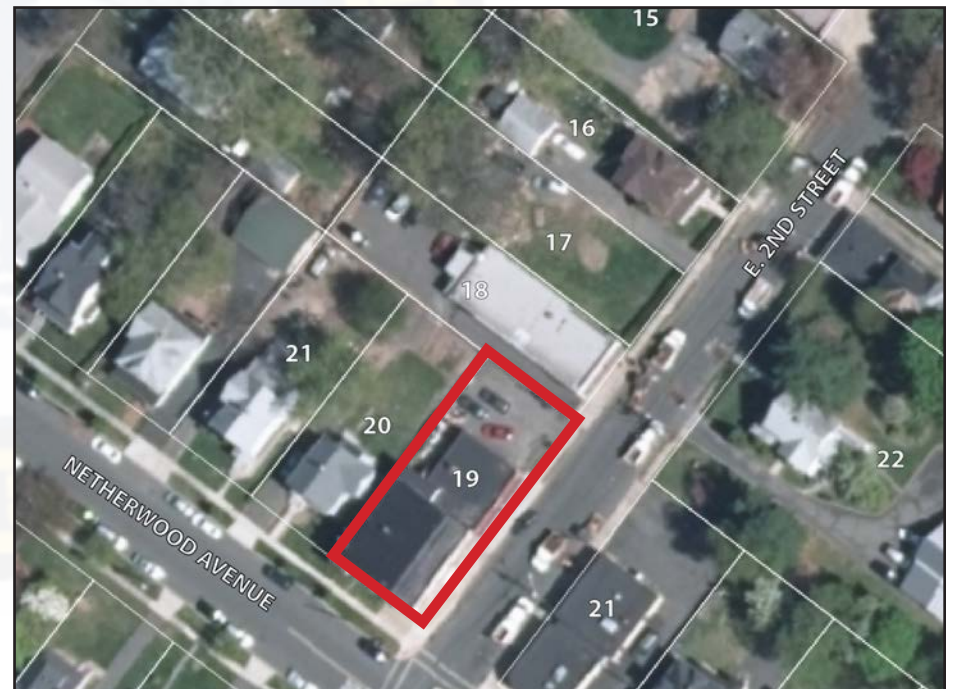
Block 331, Lot 19.1101-1109 E. 2nd Street
Neighborhood Commercial

Property Description:	Block 331, Lot 19. 1101-1109 E. 2nd Street The site contains two buildings; one, one-story retail use building that currently contains a hair salon and another, two-story mixed-use building with a retail use and house of worship on the ground floor and 3 apartments on the second floor. Built in 1935.
Site Issues:	The retail store is currently vacant. Other site issues include, excessive land coverage, poorly maintained parking lot. The Fire Division reported an incident of fire in the building in 2014. Division of Inspection reported the following past violations: <ul style="list-style-type: none"> • Lack of maintenance of lawn and curb area; and, • Trash, debris, litter and rubbish around the entire property.
Satisfies LRHL Criteria:	D: undefined and poorly defined parking. G: Located in the City's Urban Enterprise Zone.
Satisfies Rehabilitation Criteria:	2: More than half of the housing stock in the delineated area is at least 50 years old. 3. pattern of vacancy. 6. Sanitary sewer infrastructure is more than 50 years old.

Recommendation:	The property meets D and G criteria for area in need of redevelopment 2, 3 and 6 criteria for area in need of rehabilitation. Since portions of the property are currently vacant, the building is more than 50 years old, has sanitary sewer infrastructure that is about 90 years old and is situated in a UEZ, the parcel should be considered as an area in need of redevelopment and an area in need of rehabilitation.

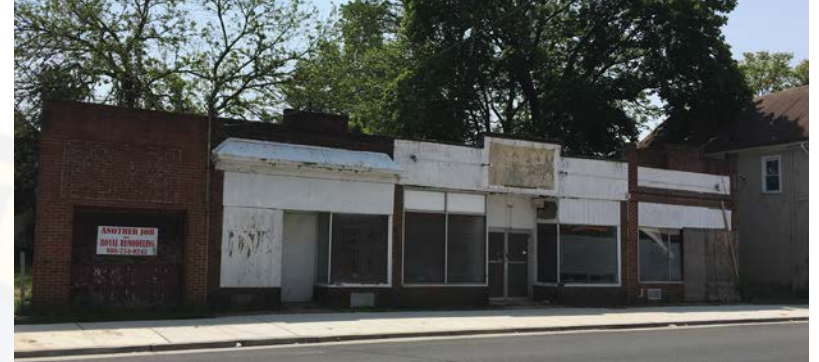
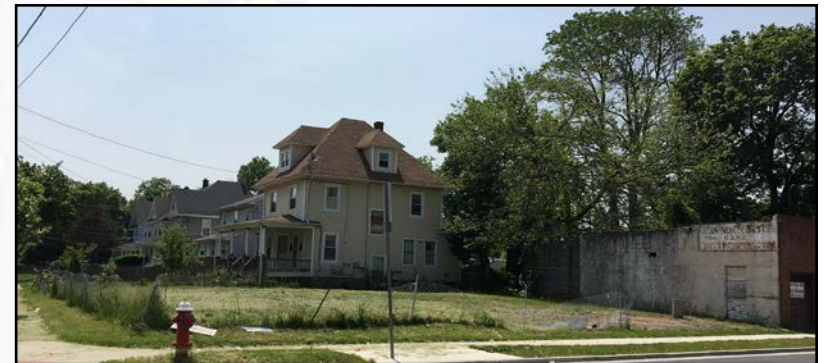
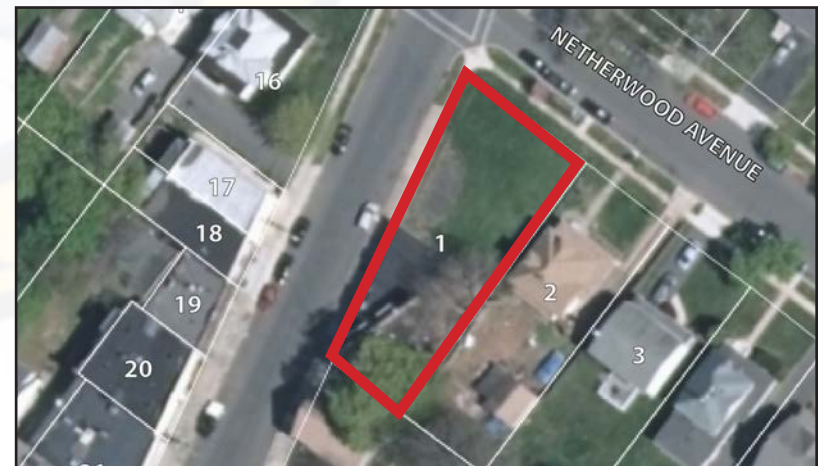
Block 410, Lot 1. 200-202 Netherwood Avenue
Neighborhood Commercial

Property Description:	Block 410, Lot 1. 200-202 Netherwood Avenue The property contains a vacant building with the associated parking. Built in 1930; the building is 3,346 sq ft. in size.
Site Issues:	Vacant abandoned building with poorly maintained parking lot. The Division of Inspections reported the following violations for two consecutive years: <ul style="list-style-type: none"> • Damaged fence; • Defective section of public sidewalk; • Lack of maintenance of lawn and curb area; and, • Trash, debris, litter and rubbish around the entire property.
Satisfies LRHL Criteria:	D: Undefined and poorly defined parking area and lack of landscaping G: Located in the City's Urban Enterprise Zone.
Satisfies Rehabilitation Criteria:	3: There is a pattern of vacancy, abandonment or underutilization of properties in the area. 6. Sanitary sewer infrastructure is more than 50 years old.
Recommendation:	The property meets D and G criteria for area in need of redevelopment and criteria 3 and 6 for area in need of rehabilitation. Since the property has been vacant, contains an undefined parking area, has sanitary sewer infrastructure that is about 90 years old and is situated in a UEZ, the parcel should be considered as an area in need of redevelopment and an area in need of rehabilitation.

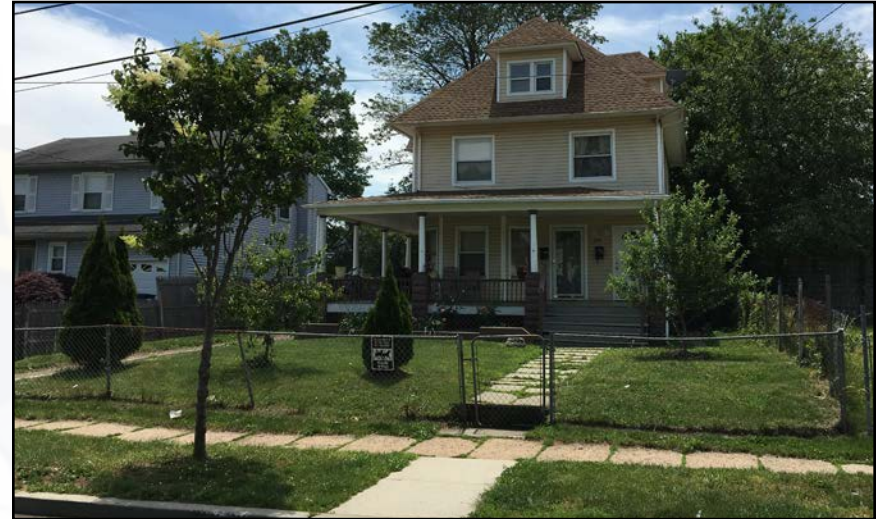
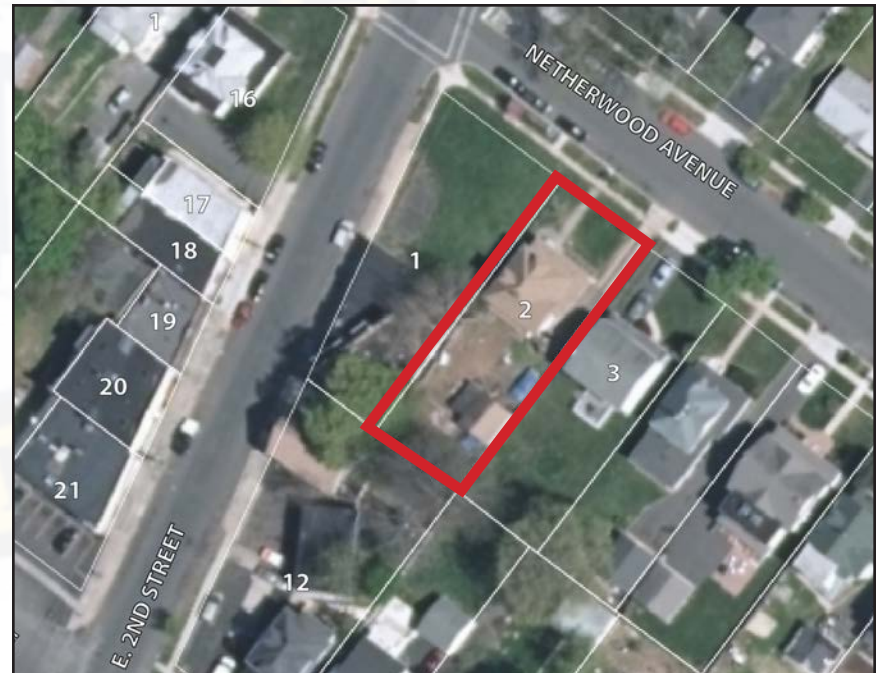
Block 410, Lot 2.01. 208-210 Netherwood Avenue
Neighborhood Commercial

Property Description:	Block 410, Lot 2.01. 208-210 Netherwood Avenue The site contains a single-family house. Built in 1990. The building is in good condition.
Site Issues:	None.
Satisfies LRHL Criteria:	G: Located in the City's Urban Enterprise Zone.
Satisfies Rehabilitation Criteria:	6. Sanitary sewer infrastructure is more than 50 yrs. old.
Recommendation:	The property meets only G criterion for area in need of redevelopment and criterion 6 for area in need of rehabilitation. Since the property has sanitary sewer infrastructure that is about 90 years old and is situated in a UEZ, the parcel should be considered as an area in need of redevelopment and an area in need of rehabilitation.

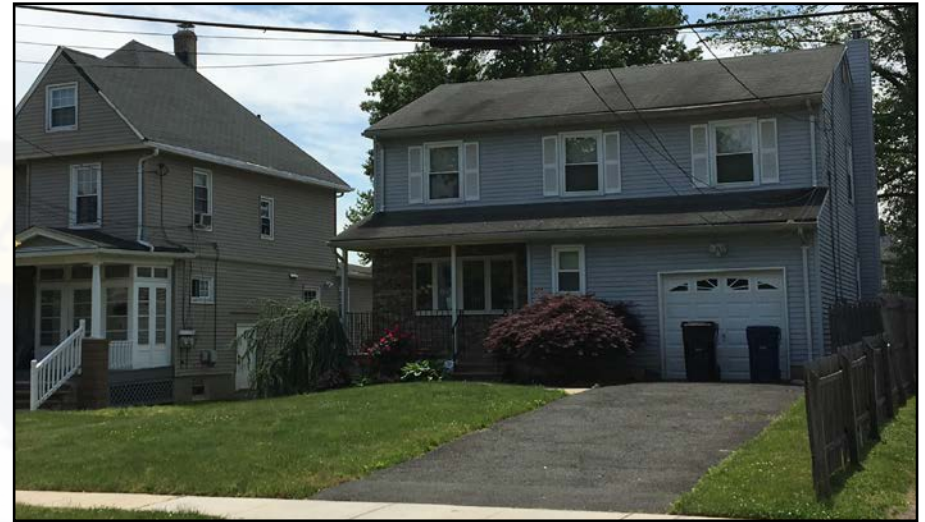
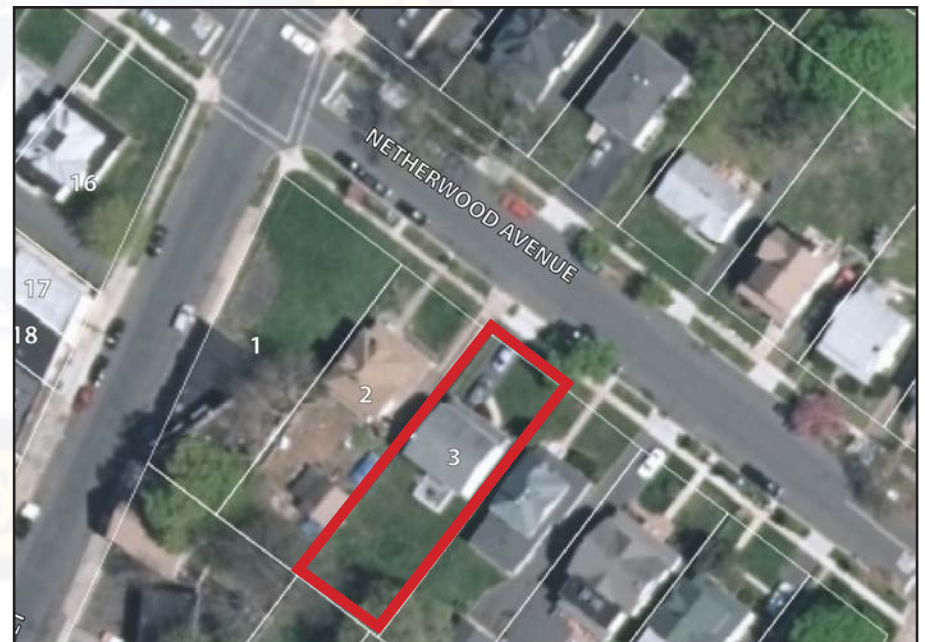
Block 410, Lot 11. 205 Garfield Avenue
Neighborhood Commercial

Property Description:	Block 410, Lot 11. 205 Garfield Avenue The site contains a single-family house. Built in 1941; the house measures 1,300 sq ft in size. The building is in good condition.
Site Issues:	None.
Satisfies LRHL Criteria:	G: Located in the City's Urban Enterprise Zone.
Satisfies Rehabilitation Criteria:	2: More than half of the housing stock in the delineated area is at least 50 years old. 6. Sanitary sewer infrastructure is more than 50 years old.
Recommendation:	The property meets only G criterion for area in need of redevelopment and criteria 2 and 6 for area in need of rehabilitation. Since the house is more than 50 yrs. old, has sanitary sewer infrastructure that is about 90 years old, and is situated in a UEZ, the parcel should be considered as an area in need of redevelopment and an area in need of rehabilitation.

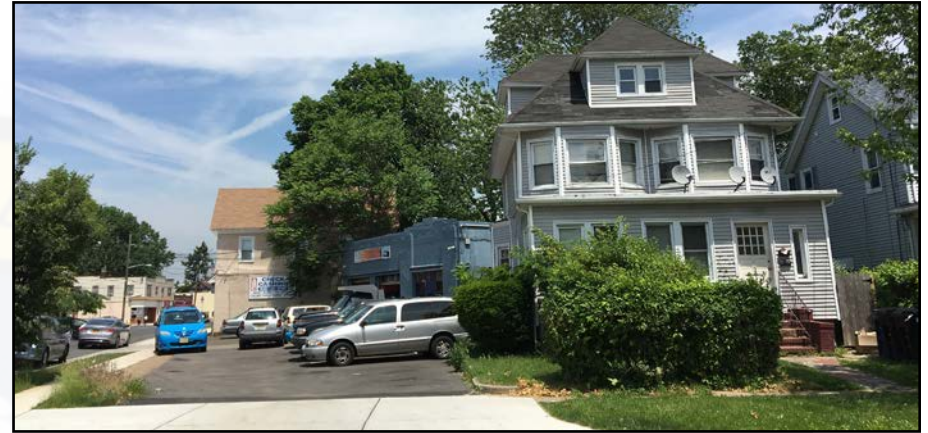
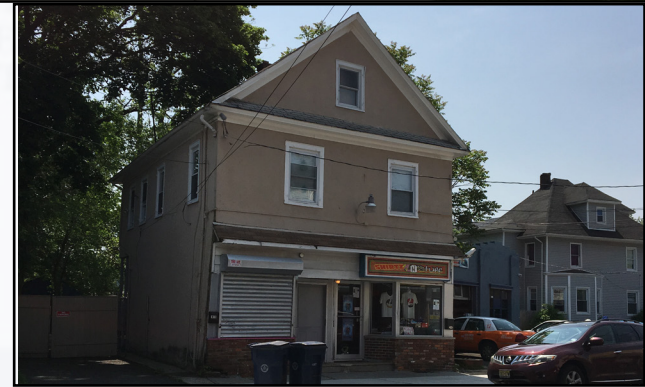
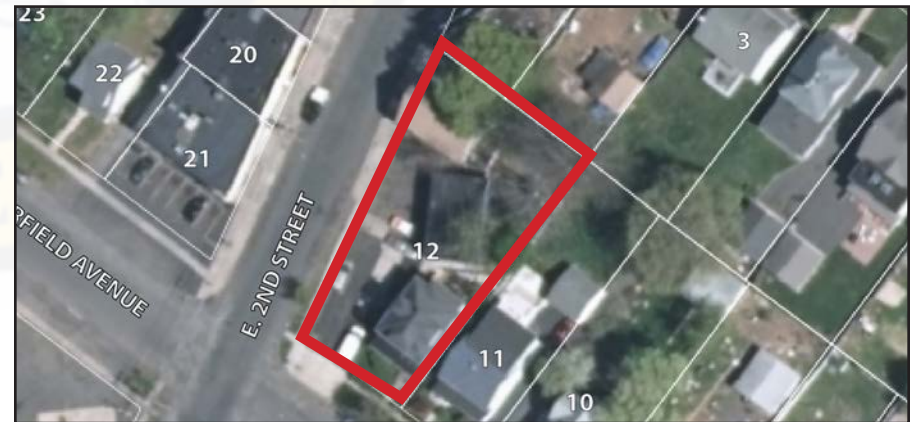
Block 410, Lot 12. 200-216 Garfield Avenue
Neighborhood Commercial

Property Description:	<p>Block 410, Lot 12. 201-203 Garfield Avenue</p> <p>The property contains 3 buildings; a single-family home with frontage along Garfield Avenue and King's Brother Garage and a mixed-use building (commercial on ground floor with apartments above) with frontage and access along 2nd Street. Built in 1915; the building is 1,030 sq. ft. in size</p>
Site Issues:	<p>Multiple uses lead to overcrowding on site. The retail use is non-operational. The traffic circulation within the garage portion of the property is detrimental to the health and safety of the users. In 2014, the Fire Division reported violations on the property including, outdoor storage of piles of debris (tires and brush). The Planning Division has this property listed as a brownfield site. Pursuant to the City's Master Inventory list this site was a former gas station. NJDEP records indicate that a LSRP has been retained. The property has significant building and impervious coverage. Division of Inspection reported the following violations in the past two years: lack of maintenance of lawn and curb area; damaged sidewalk, foundation wall, roof, and front door; lack of maintenance of lawn and curb area, and; trash, debris, litter and rubbish around the entire property</p>

Satisfies LRHL Criteria:	<p>D: Brownfield site, over-crowding, faulty arrangement, obsolete layout and deleterious land use.</p> <p>G: Located in the City's Urban Enterprise Zone.</p>
Satisfies Rehabilitation Criteria:	<p>3: Pattern of vacancy</p> <p>2: The house is more than 50 yrs. old.</p> <p>6. Sanitary sewer infrastructure is more than 50 years old.</p>
Recommendation:	<p>The property meets D and G criteria for area in need of redevelopment and criteria 2, 3 and 6 for area in need of rehabilitation. Since portion of the property has been vacant, it is a brownfield site with obsolete layout, the house and the sanitary sewer infrastructure is more than 50 years old and the property is situated in a UEZ, the parcel should be considered as an area in need of redevelopment and an area in need of rehabilitation.</p>

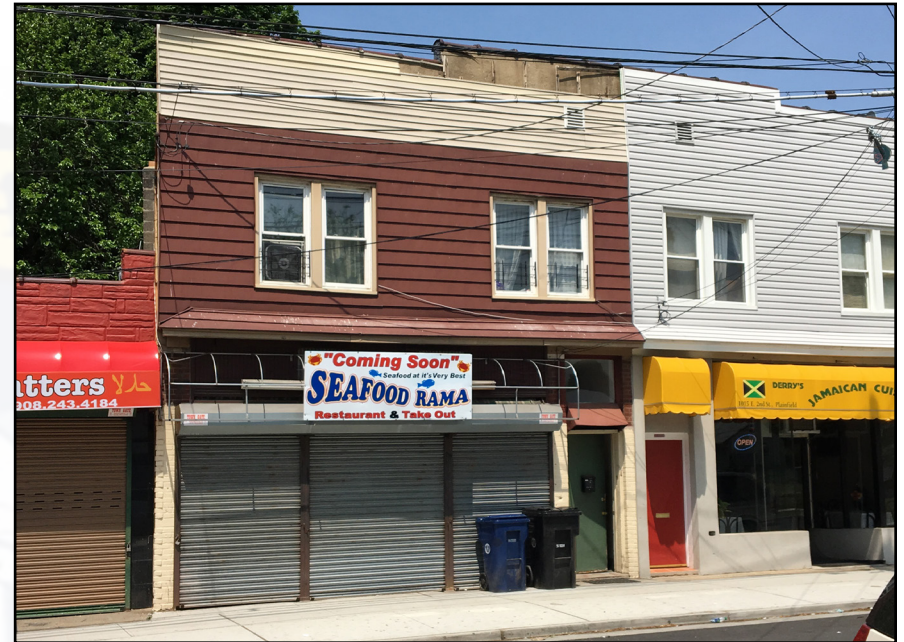
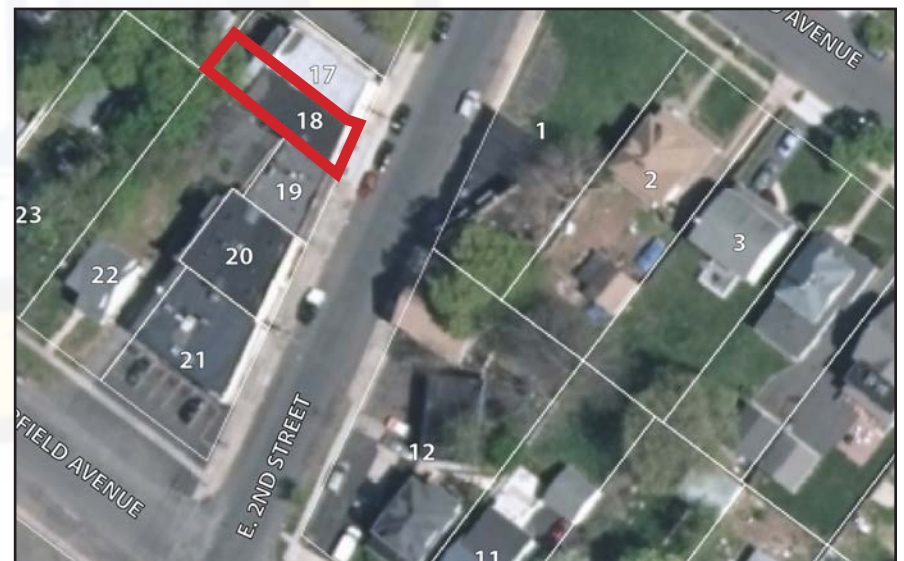
Block 332, Lot 18. 1013 E. 2nd Street
Neighborhood Commercial

Property Description:	Block 332, Lot 18. 1013 E. 2nd Street The site contains a mixed-use building with commercial use on the ground floor and an apartment above it. A restaurant occupied the commercial space in the past; however, the business has closed down and the space is currently vacant. Built in 1925; the building is 2,632 square feet in size.
Site Issues:	Unabated violations- Property needs Life Hazard Use Registration, water heater needs to be properly sealed (2016). The site has excessive land coverage and is devoid of any parking spaces. Part of the building (ground floor) is vacant. The Fire Division reported unabated violations. The property needs Life Hazard Use Registration. The water heater needs to be properly sealed.
Satisfies LRHL Criteria:	G: located in the City's Urban Enterprise Zone.
Satisfies Rehabilitation Criteria:	3: Vacancy. 6. Sanitary sewer infrastructure is more than 50 years old

Recommendation:	The property meets G criterion for area in need of redevelopment and criteria 3 and 6 for area in need of rehabilitation. Since portion of the property is vacant, has sanitary sewer infrastructure that is about 90 years old and is situated in a UEZ, the parcel should be considered as an area in need of redevelopment and an area in need of rehabilitation.

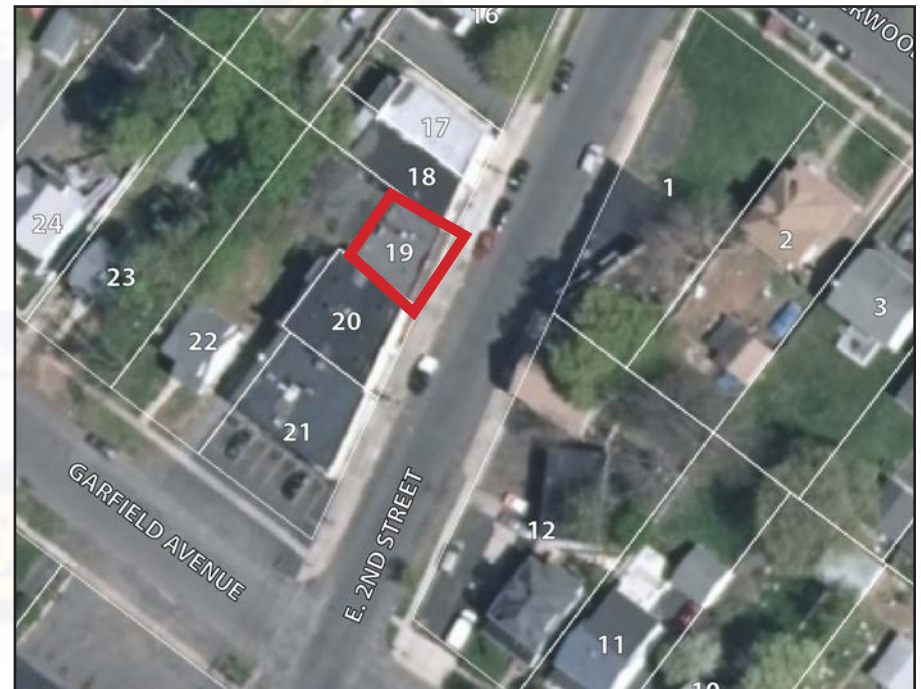
Block 332, Lot 20. 1007-1009 E. 2nd Street
Neighborhood Commercial

Property Description:	Block 332, Lot 20. 1007-1009 E. 2nd Street The site contains a mixed-use building with two retail spaces on the ground floor and an apartment above it. While one of the stores is still operating, the other store has closed down and the space is currently vacant. Built in 1932; the building is 3,924 square feet in size.
Site Issues:	Part of the building is currently vacant. Division of Inspection reported the following past violations for trash, debris, litter and rubbish around the entire property. The property has inadequate parking and loading area.
Satisfies LRHL Criteria:	G: Located in the City's Urban Enterprise Zone.
Satisfies Rehabilitation Criteria:	3: Pattern of vacancy 6. Sanitary sewer infrastructure is more than 50 years old
Recommendation:	The property meets G criterion for area in need of redevelopment and criteria 3 and 6 for area in need of rehabilitation. Since portions of the property are vacant, has sanitary sewer infrastructure that is about 90 years old and is situated in a UEZ, the parcel should be considered as an area in need of redevelopment and an area in need of rehabilitation.

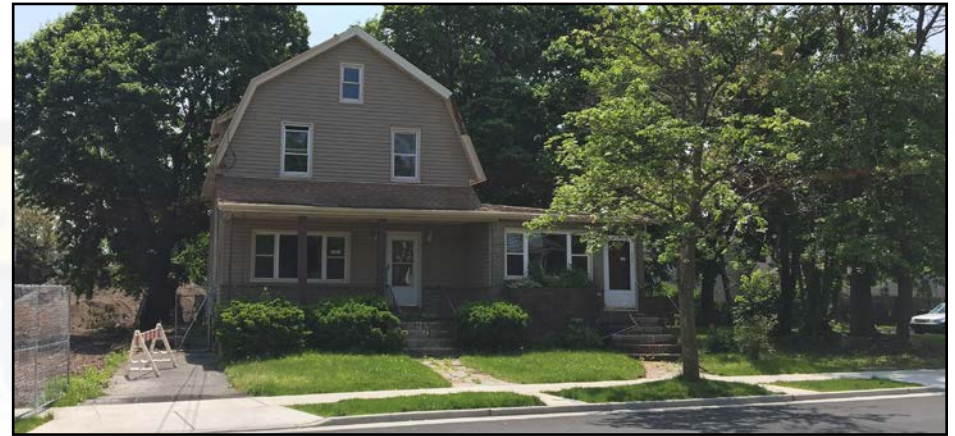
Block 334, Lot 1. 912-914 E. 2nd Street
Neighborhood Commercial

Property Description:	Block 334, Lot 1. 912-914 E. 2nd Street Two-story, single-family house. Built in 1906; the house measures 1,908 sq ft in size. The building is in poor condition.
Site Issues:	The building is structurally sound but, has been vacant. At the time of the visit, it was noted that the windows of the house were broken indicating that the house was vandalized.
Satisfies LRHL Criteria:	D: The vacancy lends itself to nefarious activities. G: Located in the City's Urban Enterprise Zone.
Satisfies Rehabilitation Criteria:	2: More than half of the housing stock in the delineated area is at least 50 years old. 6. Sanitary sewer infrastructure is more than 50 years old
Recommendation:	The property meets D and G criteria for area in need of redevelopment and 2 criterion for area in need of rehabilitation. Since the property is more than 50 years old, has sanitary sewer infrastructure that is about 90 years old, the house was vandalized and the property is situated in a UEZ, the parcel should be considered as an area in need of redevelopment and an area in need of rehabilitation.

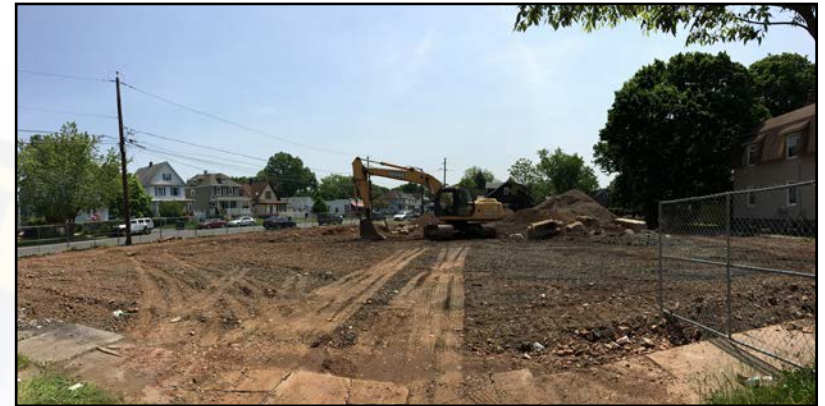
Block 334, Lot 2. 909 E 2nd Street
Neighborhood Commercial

Property Description:	Block 334, Lot 2. 200-216 Garfield Avenue Vacant lot. The site was a former meat market.
Site Issues:	<p>Currently vacant. In the past the following unabated violations were noted on the site by the Fire Division prior to the demolition of the building: exterior openings are not properly secured, combustible material from interior and exterior of the building is not removed and lastly, the building is not structurally stable were noted. Division of Inspection reported the following past violations:</p> <ul style="list-style-type: none"> • Lack of maintenance of lawn and curb area; and, • Trash, debris, litter and rubbish around the entire property. <p><i>However, an application proposing a three-story mixed-use building with 7,570 square feet of retail space, twenty (20) residential apartments, and 54 on-site parking spaces has been filed with the ZBA. The application requires a use variance (density) and is scheduled before the Zoning Board of Adjustment on September 7, 2016.</i></p>

Satisfies LRHL Criteria:	G: Located in the City's Urban Enterprise Zone.
Satisfies Rehabilitation Criteria:	6. Sanitary sewer infrastructure is more than 50 years old
Recommendation:	The property meets G criterion for area in need of redevelopment and 6 criterion for area in need of rehabilitation. Since the sanitary sewer infrastructure is about 90 years old and is situated in a UEZ, the parcel should be considered as an area in need of redevelopment and an area in need of rehabilitation.

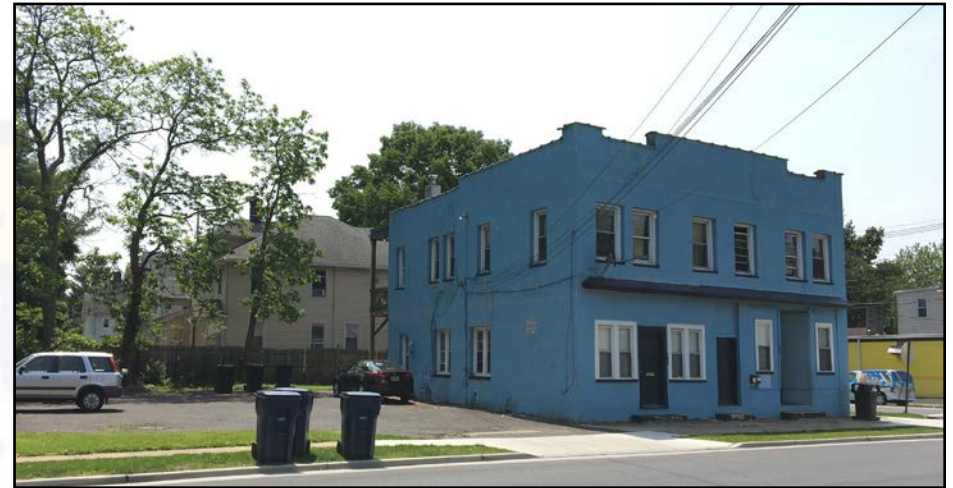
Block 334, Lot 11. 201-203 Johnston Avenue
Neighborhood Commercial

Property Description:	Block 334, Lot 11. 201-203 Johnston Avenue Two-story, multi-family building. Built in 1921; the building is 2,292 sq ft. in size. The building is in fair condition.
Site Issues:	<p>The building is unattractive with the siding of the building façade peeling. The site contains a poorly maintained parking area. The parking is located in the side yard with access from 2nd street. It appears that the building was once used for commercial activity and later was converted to a multi-family use. The parking lot allows easy access for people to loiter around. Inadequate trash location areas with trash bins exposed and scattered throughout the parking area. No screening or fence provided. The property has outstanding taxes. The Division of Inspections reported the following past violations:</p> <ul style="list-style-type: none"> • Maintenance of exterior of premises and structures; and, • Trash, debris, litter and rubbish around the entire property.

Satisfies LRHL Criteria:	<p>D: lack of screening along the parking area, outdoor storage, undefined and poorly defined parking.</p> <p>G: Located in the City's Urban Enterprise Zone.</p>
Satisfies Rehabilitation Criteria:	<p>2: More than half of the housing stock in the delineated area is at least 50 years old.</p> <p>6. Sanitary sewer infrastructure is more than 50 yrs. old</p>
Recommendation:	The property meets D and G criteria for area in need of redevelopment and criteria 2 and 6 for area in need of rehabilitation. Since the property is more than 50 years old, has sanitary sewer infrastructure that is about 90 years old and is situated in a UEZ, the parcel should be considered as an area in need of redevelopment and an area in need of rehabilitation.
