AREA IN NEED OF REDEVELOPMENT & REHABILITATION INVESTIGATION

East Second Street Commercial Corridor Study

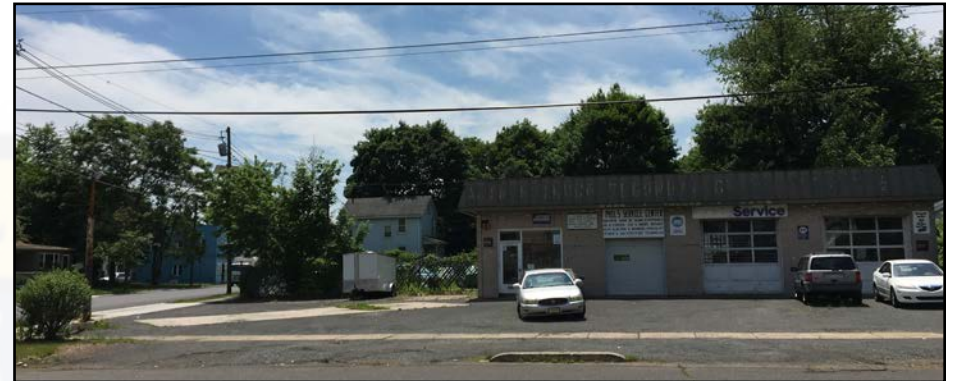
Block 333, Lot 15.148-154 Garfield Avenue
Neighborhood Commercial

Property Description:	Block 333, Lot 15. 148-154 Garfield Avenue The site contains a commercial use, Phil's Garage. Built in 1940; the building measures 1,696 square feet.
Site Issues:	The site is poorly maintained with vehicles parked in the front yard. The use is not a permitted use in the zone. The front yard parking area does not have appropriate screening along the property line. The curb is not well-defined, therefore, allowing wider turn for vehicles turning in and out of the property. The rear side of the building is used for storing vehicles. It appears that they are inoperable. The site is on the City's Master Inventory list as brownfield site.
Satisfies LRHL Criteria:	D: Brownfield site, lack of landscape buffer along the front parking area, faulty arrangement and obsolete layout G: Located in the City's Urban Enterprise Zone.
Satisfies Rehabilitation Criteria:	5. Environmental constraints. 6. Sanitary sewer infrastructure is more than 50 years old

Recommendation:	The property meets D and G criteria for area in need of redevelopment and criteria 5 and 6 for area in need of rehabilitation. Since the sanitary sewer system is more than 50 years old, is a brownfield site and is situated in a UEZ, the parcel should be considered as an area in need of redevelopment and an area in need of rehabilitation.

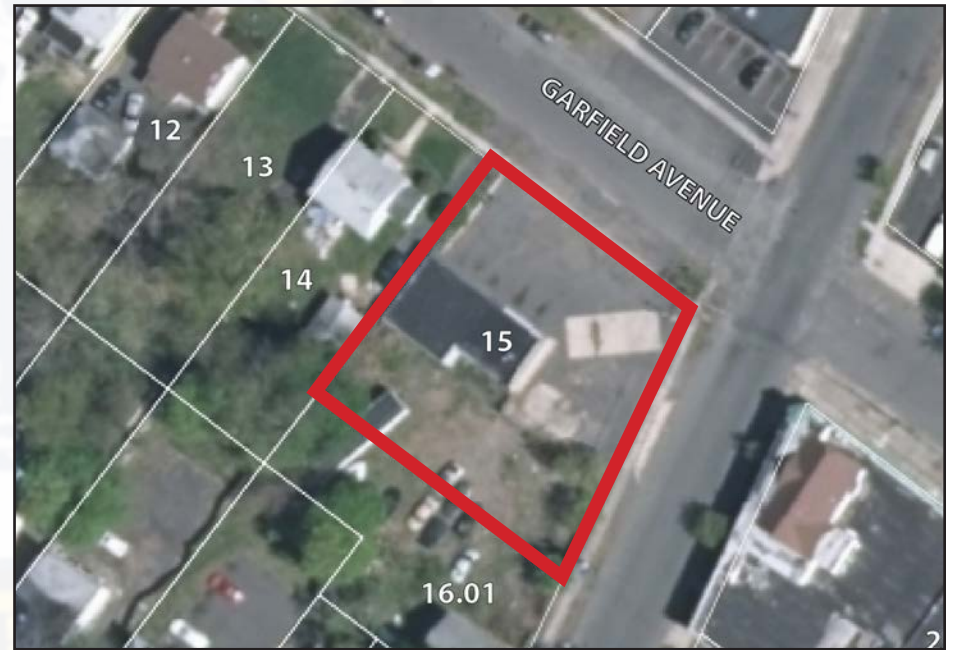
Block 333, Lot 16.01. 909-911 E. 2nd Street
Neighborhood Commercial

Property Description:	Block 333, Lot 16.01. 909-911 E. 2nd Street The site contains a parking lot used for storing vehicles and a single family home. Built in 1921; the house is 864 square feet in size.
Site Issues:	The site is poorly maintained with inoperable and un-registered vehicles parked all over the property. The site contains tall grass/weeds and is an eye-sore. Division of Inspection reported violations for lack of maintenance of lawn and curb area.
Satisfies LRHL Criteria:	D: Code violations for outdoor storage, faulty arrangement and obsolete layout G: Located in the City's Urban Enterprise Zone.
Satisfies Rehabilitation Criteria:	2: More than half of the housing stock in the area is at least 50 years old. 6. Sanitary sewer infrastructure is more than 50 yrs old.
Recommendation:	The property meets D and G criteria for area in need of redevelopment and criteria 2 and 6 for area in need of rehabilitation. Since the property is more than 50 years old, has sanitary sewer infrastructure that is about 90 years old and is situated in a UEZ, the parcel should be considered as an area in need of redevelopment and an area in need of rehabilitation.

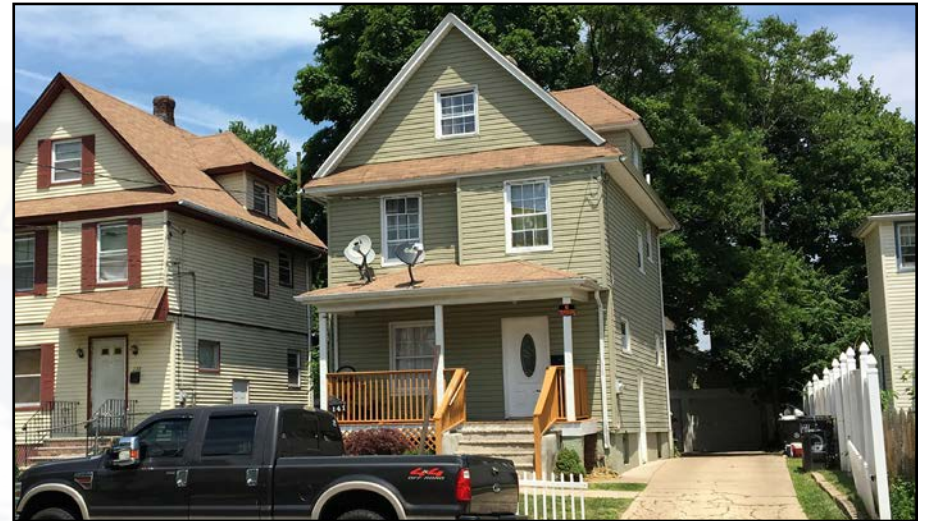
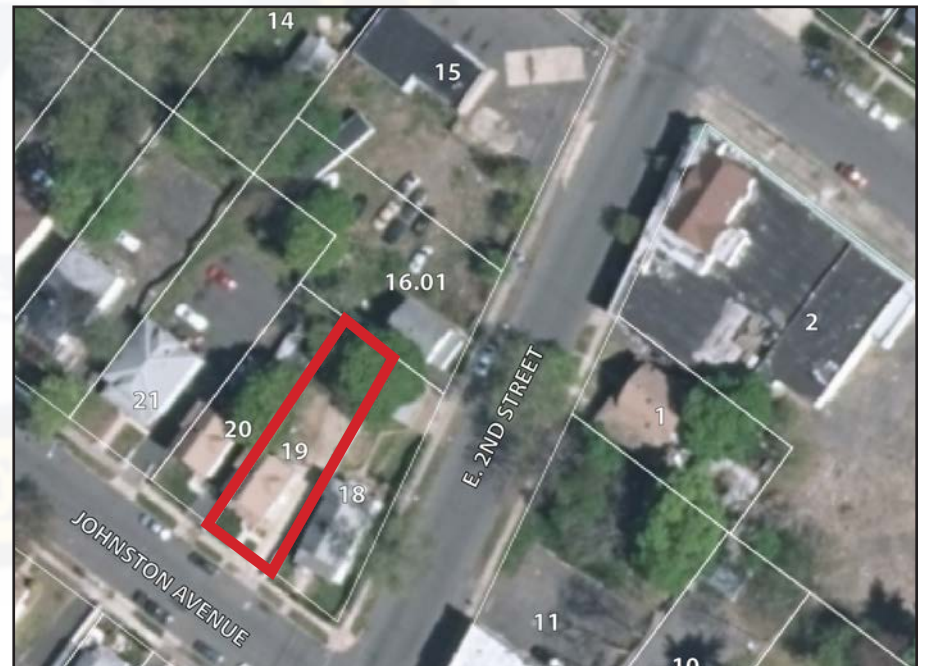
Block 333, Lot 19. 141 Johnston Avenue
Neighborhood Commercial

Property Description:	Block 333, Lot 19. 141 Johnston Avenue Single family home. Built in 1921; the house is 1,076 square feet in size. The building is in good condition.
Site Issues:	The house is in good condition; however, the driveway is poorly maintained and has cracked paving. Division of Inspection reported past violations for trash, debris, litter and rubbish around the property.
Satisfies LRHL Criteria:	G: Located in the City's Urban Enterprise Zone.
Satisfies Rehabilitation Criteria:	2: More than half of the housing stock in the delineated area is at least 50 years old. 6. Sanitary sewer infrastructure is more than 50 years old
Recommendation:	The property meets G criterion for area in need of redevelopment and criteria 2 and 6 for area in need of rehabilitation. Since the property is more than 50 years old, has sanitary sewer infrastructure that is about 90 years old and is situated in a UEZ, the parcel should be considered as an area in need of redevelopment and an area in need of rehabilitation.

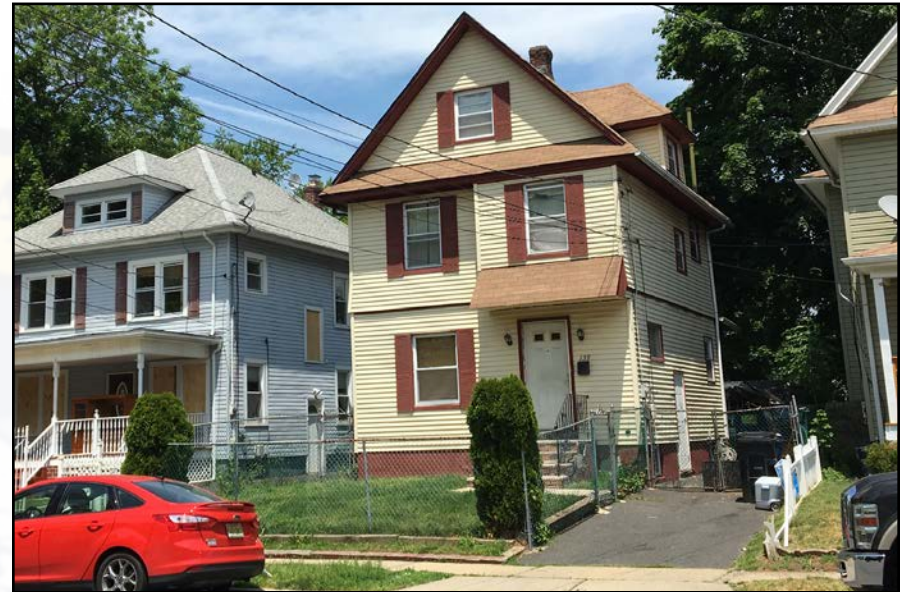
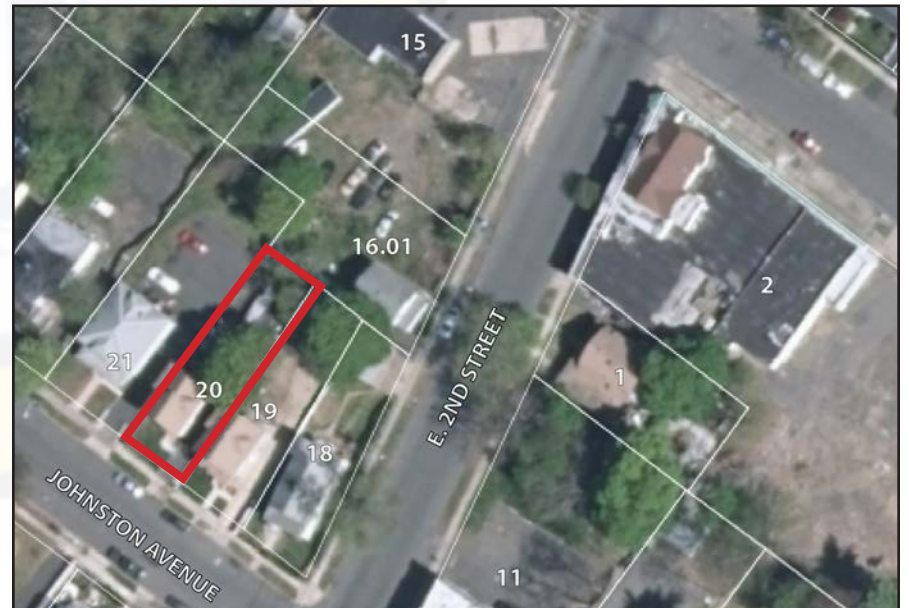
Block 333, Lot 20. 139 Johnston Avenue
Neighborhood Commercial

Property Description:	Block 333, Lot 20. 139 Johnston Avenue Single family home. Built in 1921; the house is 1,081 square feet in size. The building is in good condition.
Site Issues:	None.
Satisfies LRHL Criteria:	G: Located in the City's Urban Enterprise Zone.
Satisfies Rehabilitation Criteria:	2: More than half of the housing stock in the delineated area is at least 50 years old. 6. Sanitary sewer infrastructure is more than 50 years old
Recommendation:	The property meets G criterion for area in need of redevelopment and criteria 2 and 6 for area in need of rehabilitation. Since the property is more than 50 years old, has sanitary sewer infrastructure that is about 90 years old and is situated in a UEZ, the parcel should be considered as an area in need of redevelopment and an area in need of rehabilitation.

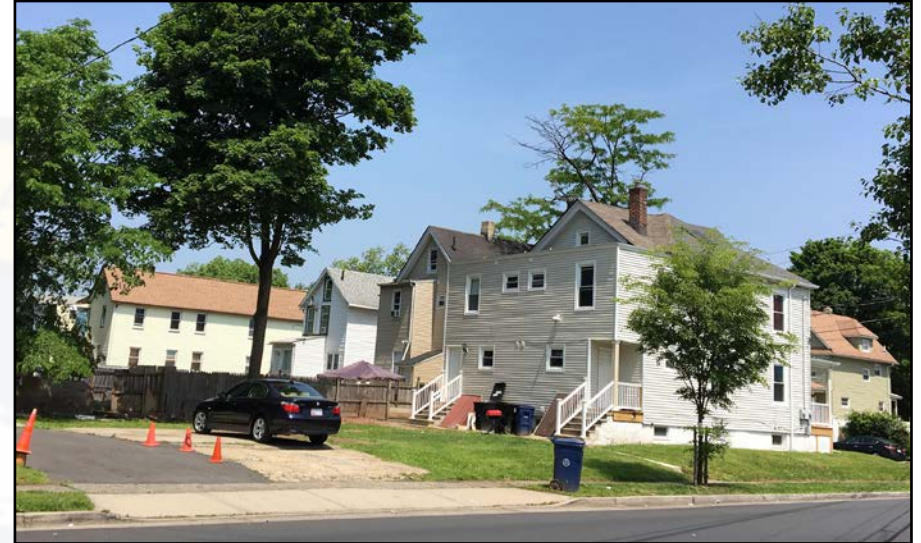
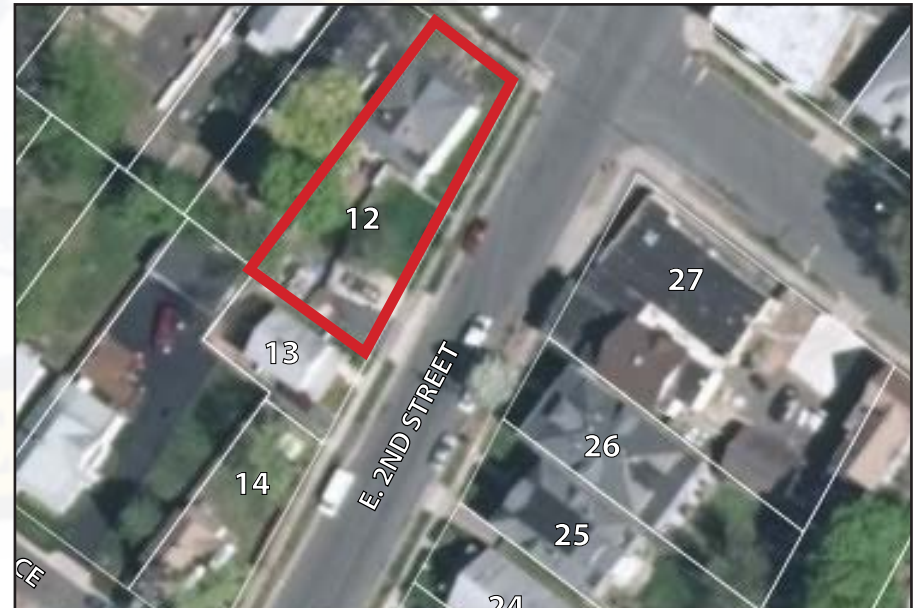
Block 328, Lot 12. 144-146 Johnston Avenue
Neighborhood Commercial

Property Description:	Block 328, Lot 12. 144-146 Johnston Avenue Two story, two family home. The property being a corner lot has two frontages; one along Johnston Avenue and the other along 2nd Street. The driveway is in good condition. Built in 1931; the house is 2,304 square feet in size. The building is in good condition.
Site Issues:	The property being a corner lot has two frontages; one along Johnston Avenue and the other along 2nd Street. The lawn and fence (along the common property line) located to the rear side of the house is visible when traversing along 2nd Street and needs maintenance. The driveway is in good condition. Division of Inspection reported the following past violations: <ul style="list-style-type: none"> • Lack of maintenance of maintenance of lawn and curb area; • Maintenance of exterior of premises and structures; • Lack of snow and ice removal; and, • Trash, debris, litter and rubbish around the entire property.

Satisfies LRHL Criteria:	G: Located in the City's Urban Enterprise Zone.
Satisfies Rehabilitation Criteria:	2: More than half of the housing stock in the delineated area is at least 50 years old. 6. Sanitary sewer infrastructure is more than 50 years old
Recommendation:	The property meets G criterion for area in need of redevelopment and criteria 2 and 6 for area in need of rehabilitation. Since the property is more than 50 years old, has sanitary sewer infrastructure that is about 90 years old and is situated in a UEZ, the parcel should be considered as an area in need of redevelopment and an area in need of rehabilitation.

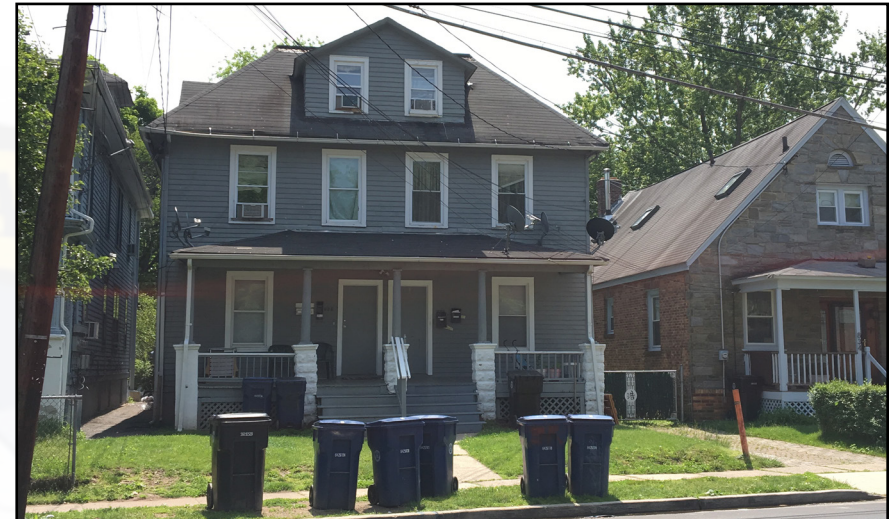
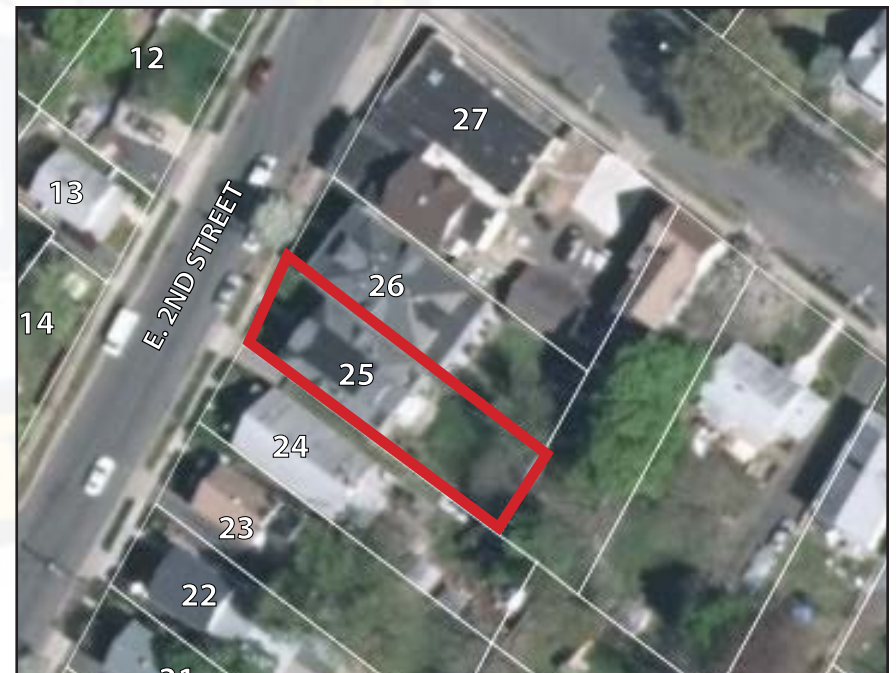
Block 335, Lot 25. 836-838 E. 2nd Street
Neighborhood Commercial

Property Description:	Block 335, Lot 25. 836-838 E. 2nd Street Two-story, four-family house built in 1921; the house is 1,440 sq ft. in size. The building is in good condition.
Site Issues:	The Division of Inspections reported the following past violations: <ul style="list-style-type: none"> • Defective foundation wall; • Structure paint chipping; • Defective lattice; and, • Rear yard porch in need of repair.
Satisfies LRHL Criteria:	G: Located in the City's Urban Enterprise Zone.
Satisfies Rehabilitation Criteria:	2: More than half of the housing stock in the delineated area is at least 50 years old; 6. Sanitary sewer infrastructure is more than 50 years old
Recommendation:	The property meets G criterion for area in need of redevelopment and criteria 2 and 6 for area in need of rehabilitation. Since the property is more than 50 years old, has sanitary sewer infrastructure that is about 90 years old and is situated in a UEZ, the parcel should be considered as an area in need of redevelopment and an area in need of rehabilitation.

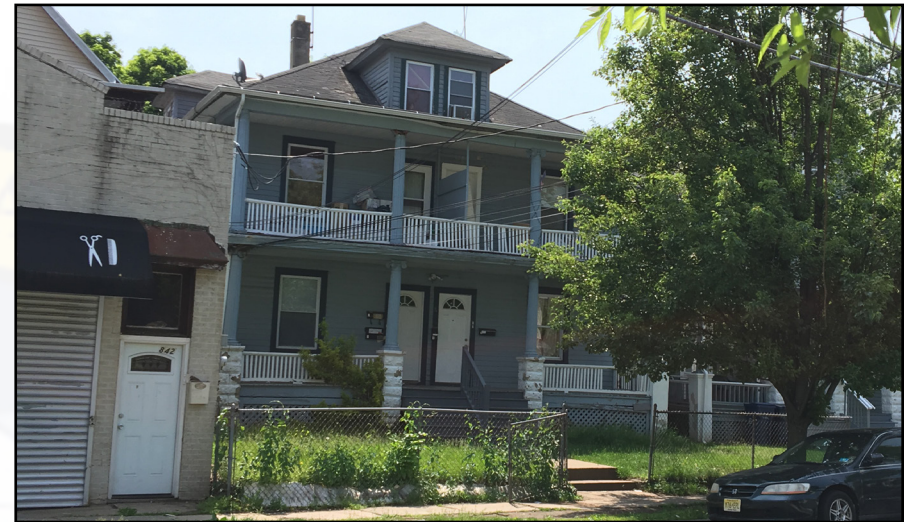
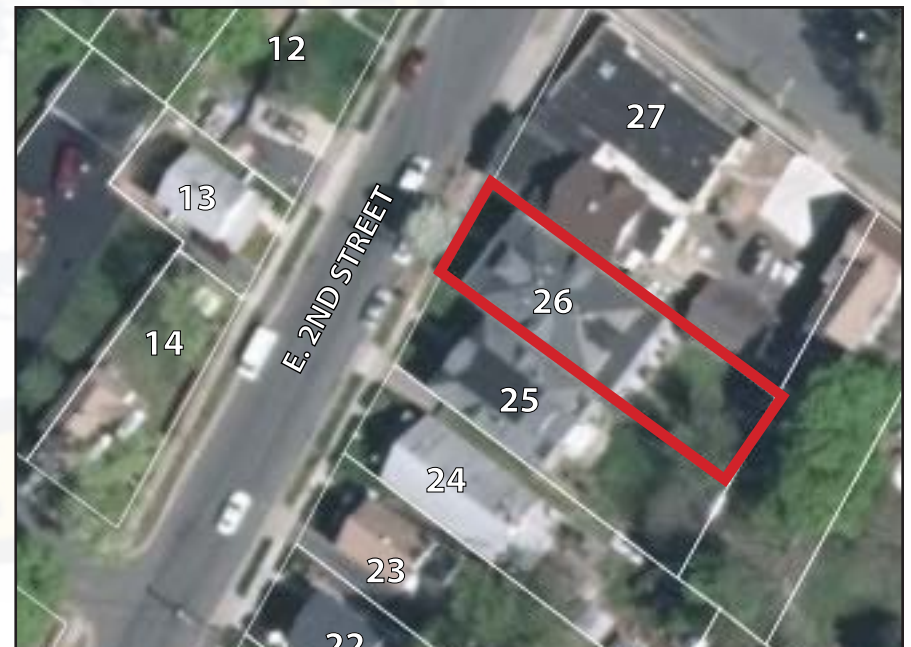
Block 335, Lot 26. 840 E. 2nd Street
Neighborhood Commercial

Property Description:	Block 335, Lot 26. 840 E. 2nd Street Two story, four family home. Built in 1921; the house is 1,744 sq ft.
Site Issues:	The Fire Department reported a carbon monoxide incident and a gas leak incident in the past two years. In 2014 and 2015, the Fire Dept. reported a gas leak and carbon monoxide leak incident, respectively at this location. The Division of Inspections reported the following past violations: <ul style="list-style-type: none"> • Trash, debris, litter and rubbish around the entire property; and, • Obstruction on front porch.
Satisfies LRHL Criteria:	G: Located in the City's Urban Enterprise Zone.
Satisfies Rehabilitation Criteria:	2: More than half of the housing stock in the delineated area is at least 50 years old. 6. Sanitary sewer infrastructure is more than 50 years old
Recommendation:	The property meets G criterion for area in need of redevelopment and criteria 2 and 6 for area in need of rehabilitation. Since the property is more than 50 years old, has sanitary sewer infrastructure that is about 90 years old and is situated in a UEZ, the parcel should be considered as an area in need of redevelopment and an area in need of rehabilitation.

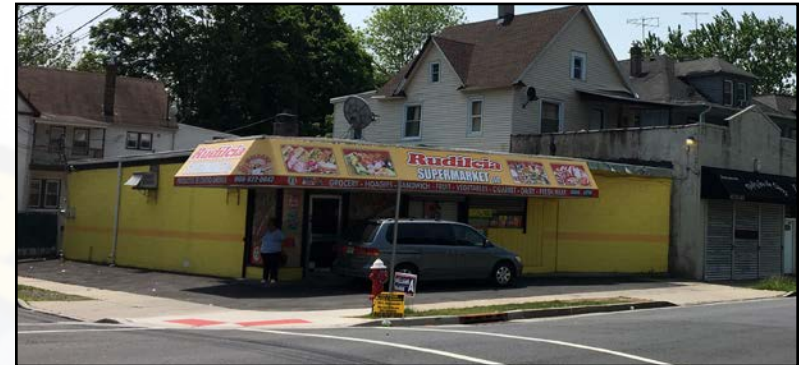
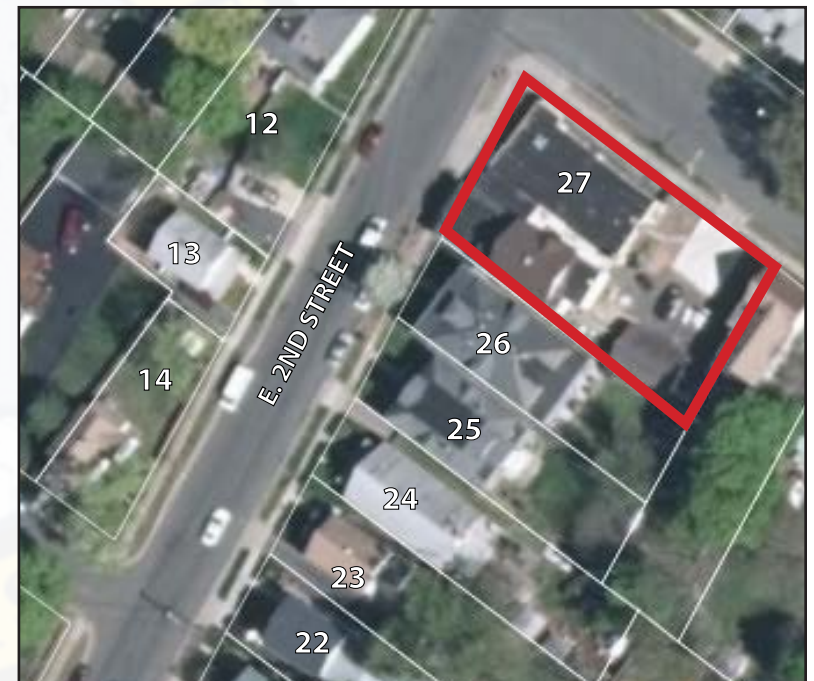
Block 335, Lot 27. 842-846 E. 2nd Street
Neighborhood Commercial

Property Description:	<p>Block 335, Lot 27. 842-846 E. 2nd Street</p> <p>The site is a corner lot and contains a single-story building that contains a supermarket (grocery store) and a mixed use building. The mixed use building has a one-story retail use building along 2nd Street and a two story residential use to the rear side of the store. There exists a driveway that wraps along the front of the supermarket and the side-street property line. Parking is located to the rear side. Access to the parking area is from Johnston Avenue. Built in 1945; the building is 4,509 sq ft. in size.</p>
Site Issues:	<p>The following site issues were noted including, obsolete layout and faulty site arrangement and inadequate and insufficient parking with deficient internal traffic flow. The site has access along both, 2nd Street and Johnston Avenue. The internal ingress and egress driveway is inadequate and incorrectly designed. The driveway provides two-way access and wraps around the front and side of the building causing pedestrian and vehicular conflict. No loading areas. Parking area is poorly maintained and is devoid of stripping.</p> <p>Division of Inspection reported the following past violations:</p> <ul style="list-style-type: none"> • Trash, debris, litter and rubbish around the entire property; and, • Lack of maintenance of lawn and curb area.

Satisfies LRHL Criteria:	<p>D: Faulty arrangement or design.</p> <p>G: Located in the City's Urban Enterprise Zone.</p>
Satisfies Rehabilitation Criteria:	<p>2. housing stock is 50 years old.</p> <p>6. Sanitary sewer infrastructure is more than 50 years old</p>
Recommendation:	<p>The property meets D and G criteria for area in need of redevelopment and criteria 2 and 6 for area in need of rehabilitation. Since the property is more than 50 years old, has sanitary sewer infrastructure that is about 90 years old and is situated in a UEZ, the parcel should be considered as an area in need of redevelopment and an area in need of rehabilitation.</p>
