NORTH AVENUE STREETSCAPE AND PEDESTRIAN MALL
HPO Project #21-1463-2 North Avenue Commercial Historic District
Plainfield, Union Co., New Jersey

North Avenue Streetscape and Pedestrian Mall
Schematic Design

The Plainfield Railroad Station Plainfield, NJ

AN HISTORICAL INVESTIGATION

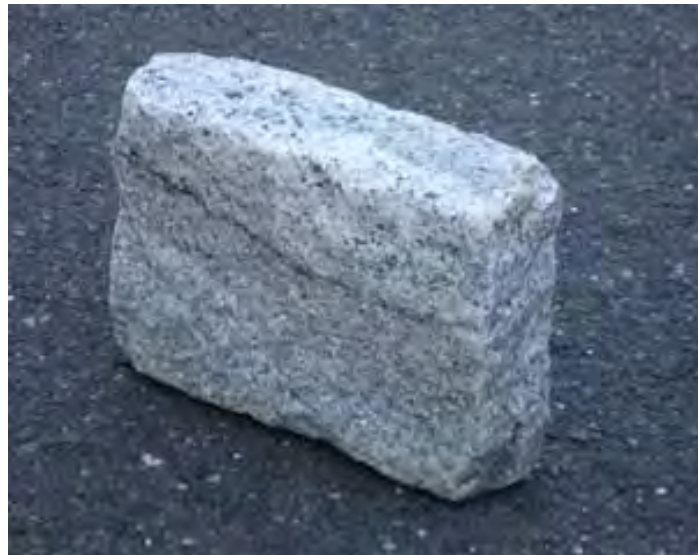
Belgian Block – Jumbo 11" X 8" X 4"
Use: Installed as driveway edging / curbing cemented into the ground with typ. desired 3" reveal above the driveway surface and 8" below. Used at a diagonal angle to transition areas of the property where there is a grade change. Gray Jumbo Estimated Cost: \$3.85 each

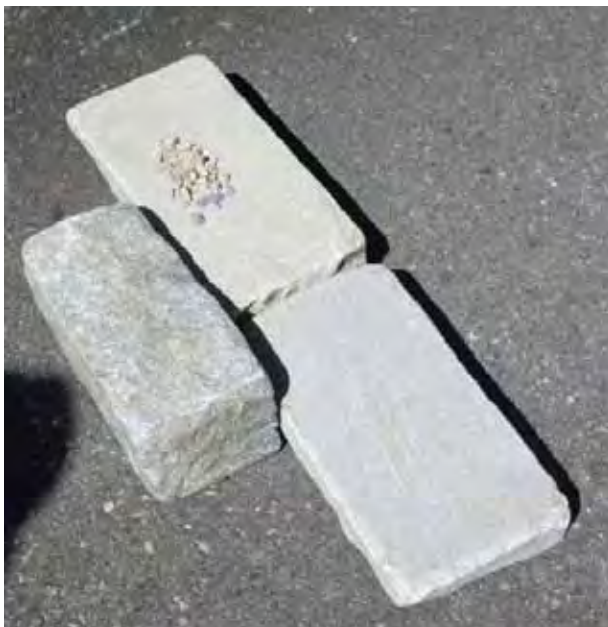
Cobblestone – Bedminster “Tan” color 12" X 6" X 4" and mixed pallet 12" X 12" X 4" 12" X 18" X 4" 12" X 24" X 4"
Use: Installed as a drive apron paver installed into the ground flush with the driveway surface. Can be dry laid or set with a concrete grout. Cover with an environmentally safe clear coat product for added protection.

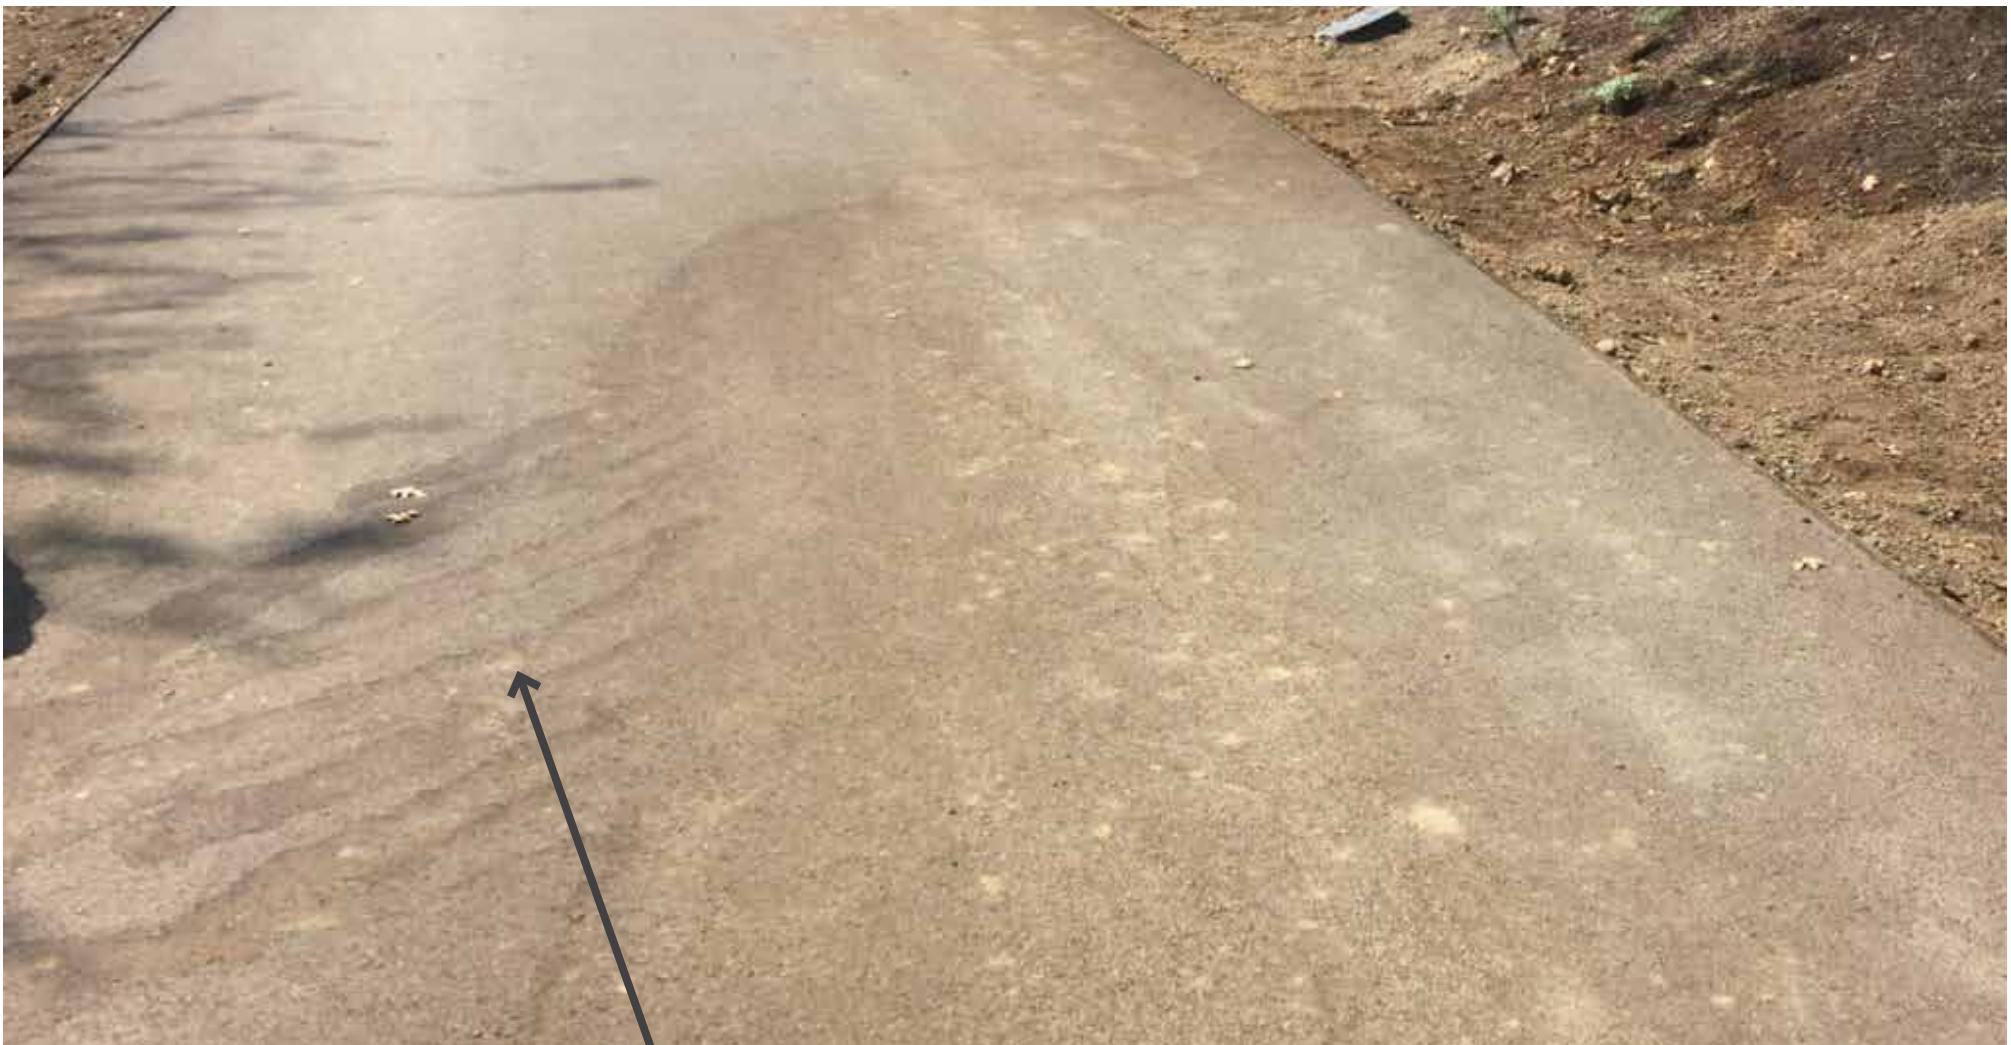
100lb Hot Mix Asphalt color additive to match historic appearance

Note circa 1907 postcard with block curbing and chip seal paving

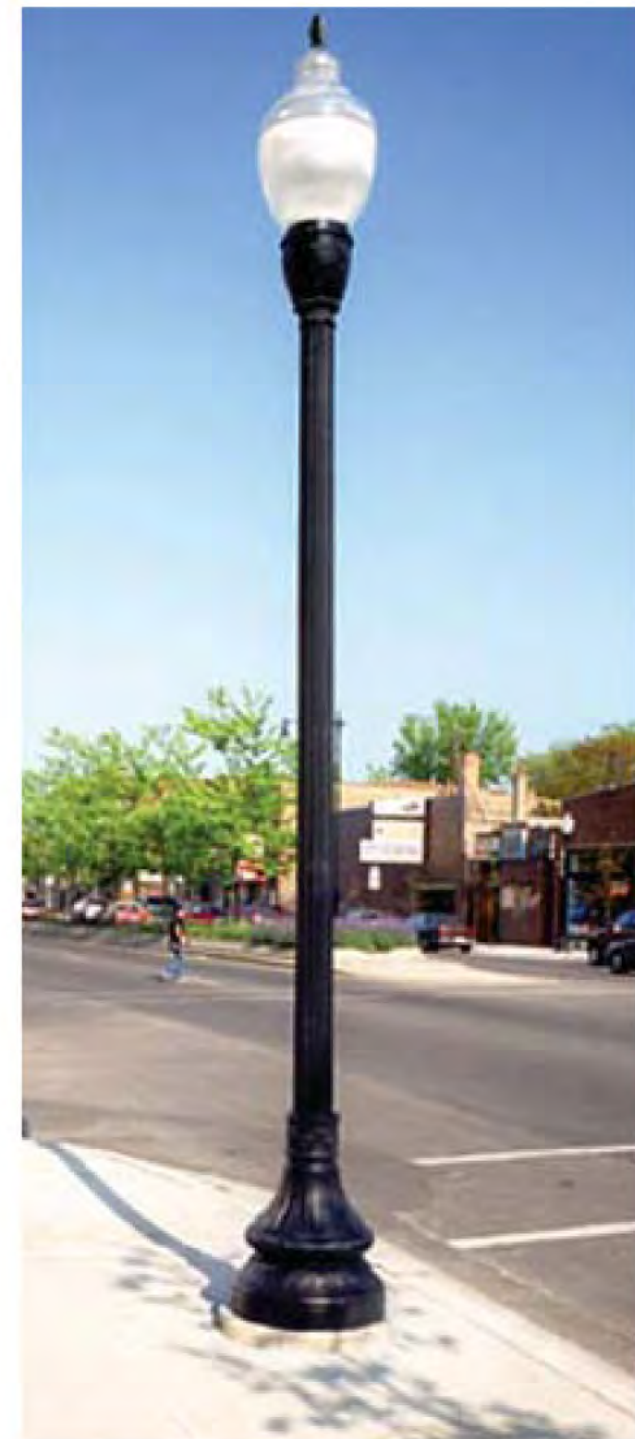
16' high Acorn Pedestrian Pole

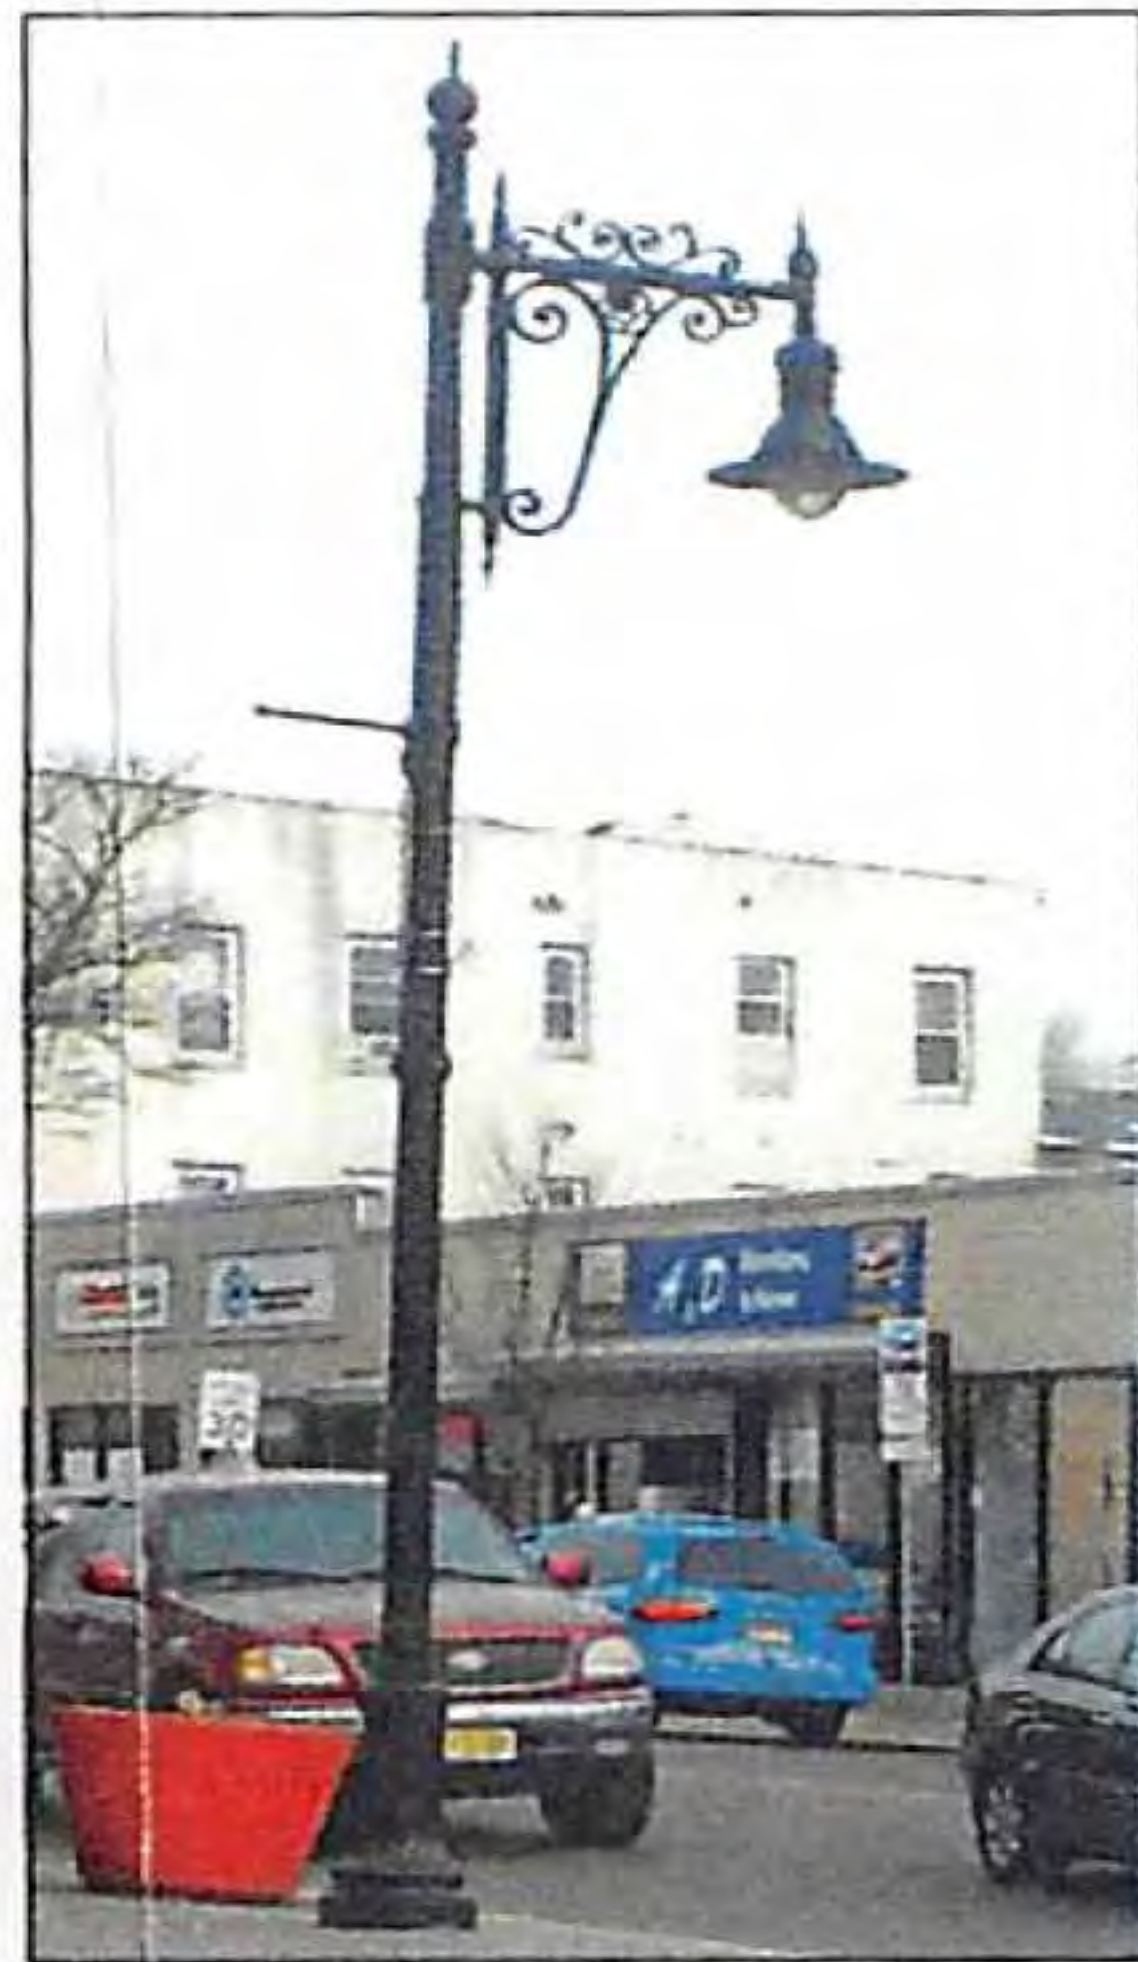
TYPICAL CITY OF PLAINFIELD
ARCHITECTURAL LIGHTING FIXTURE
(INTERSECTION)

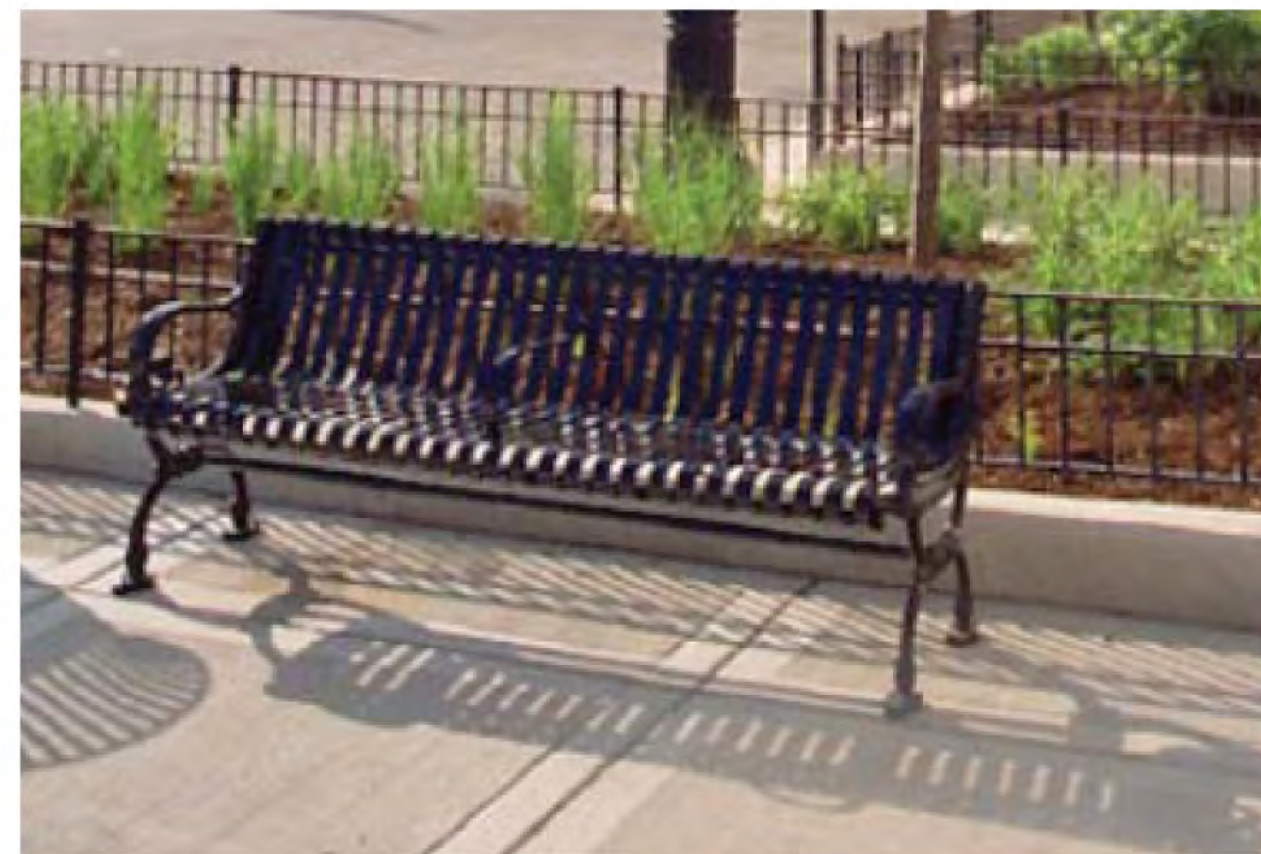
Victor Stanley Ornamental Bench (C-10), Black

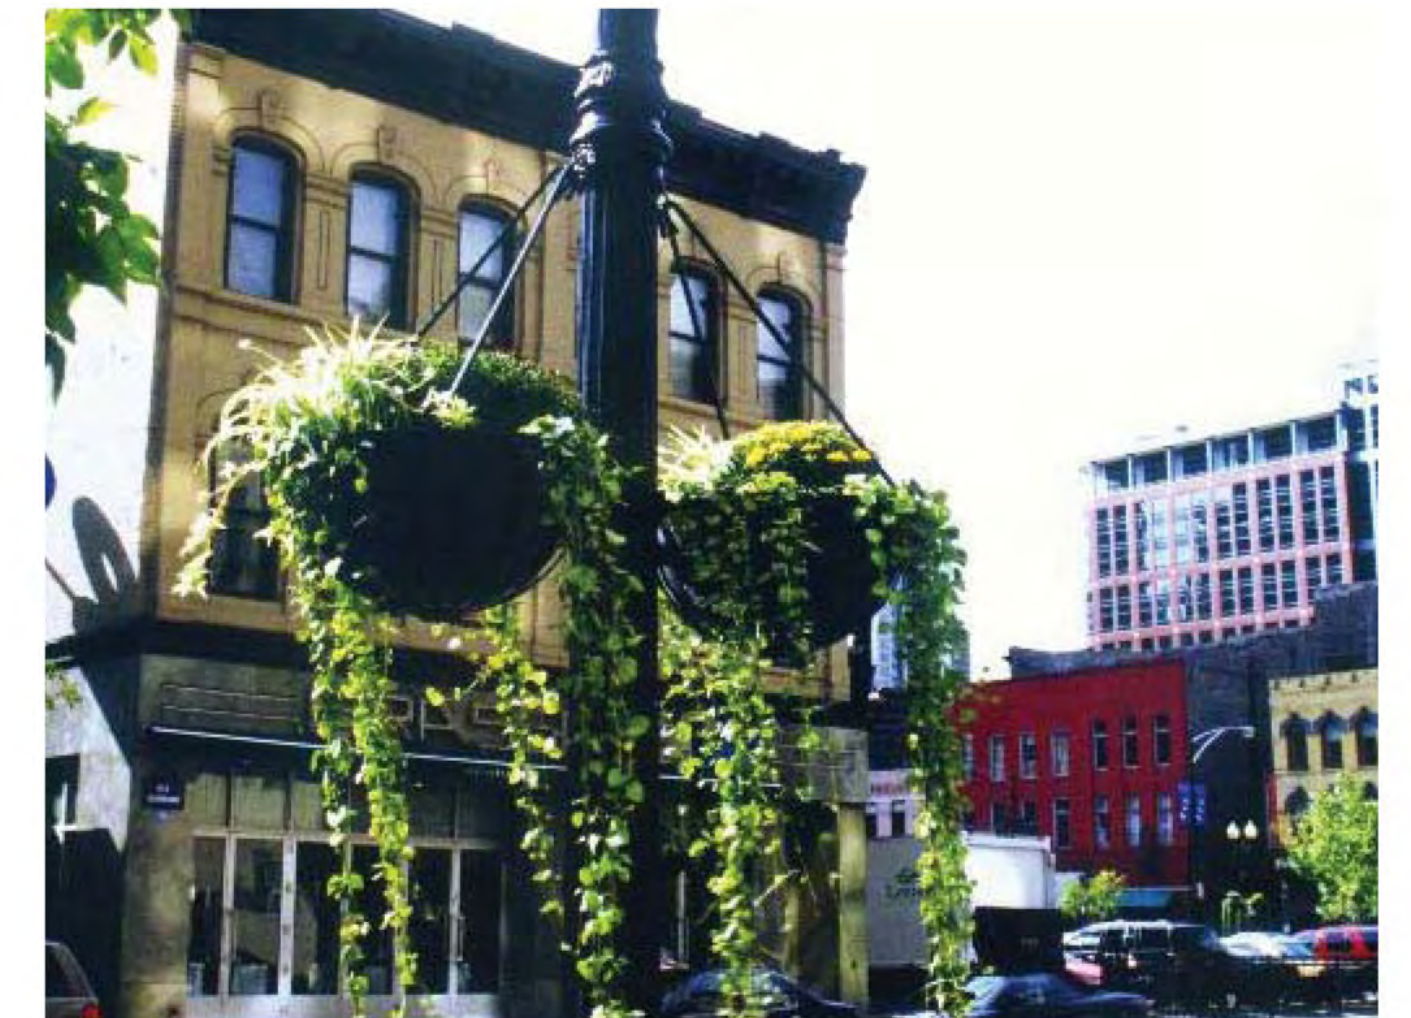
Hanging Baskets with Light Pole Bracket (for 34' High Gateway 2000 Pole only)

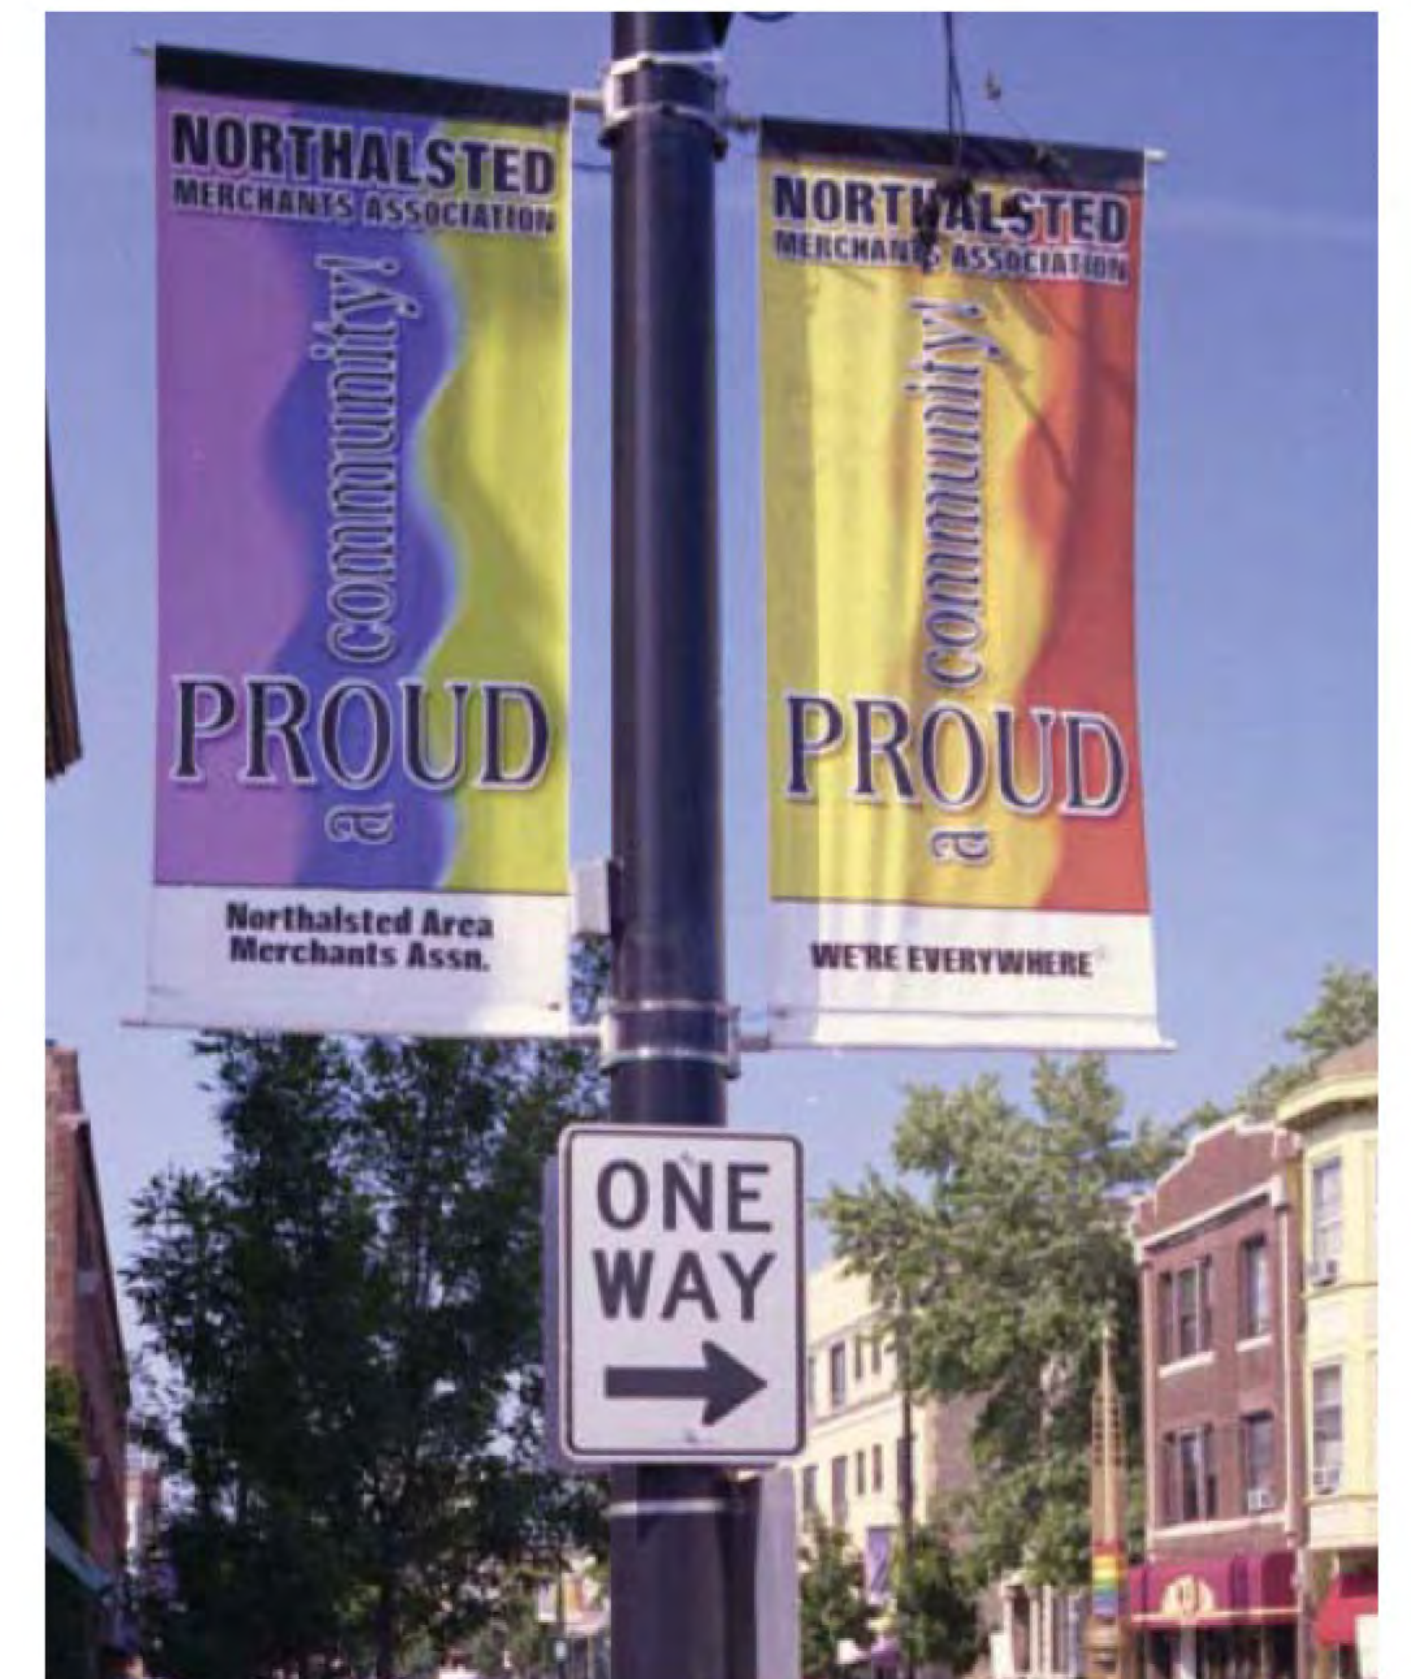
Banners with Light Pole Bracket (for 34' High Gateway 2000 Pole only)

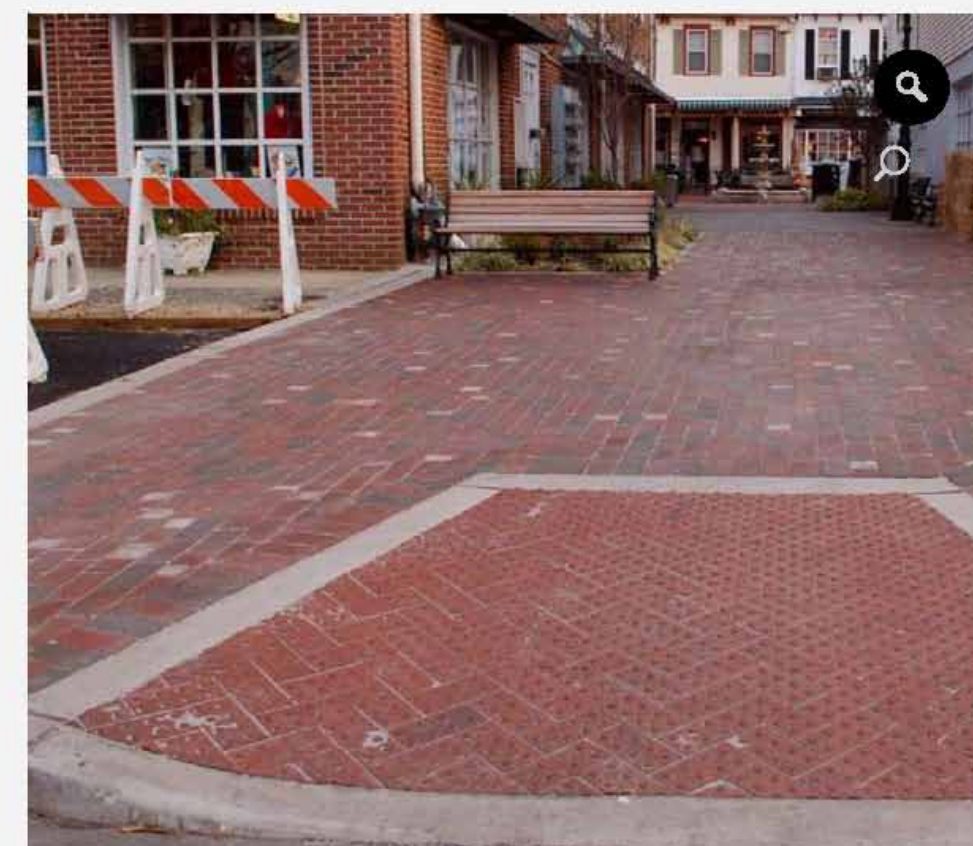
ADA Truncated Dome Paver

Pine Hall Brick Truncated Dome ADA pavers comply with the ADA requirement for detectable warnings for use in the Public Right Of Way according to R304 Guidelines. Red in-stock. Dark Accent, Full Range, Autumn, Rose and Cocoa available as a special order.

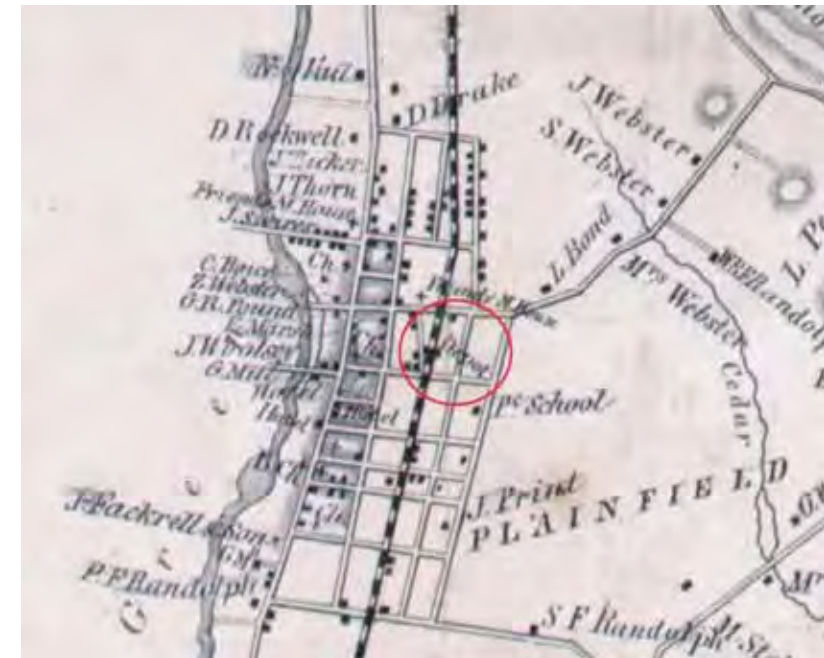
1850 J. C. Sidney Map of Essex County, New Jersey with the Depot noted within the circle.

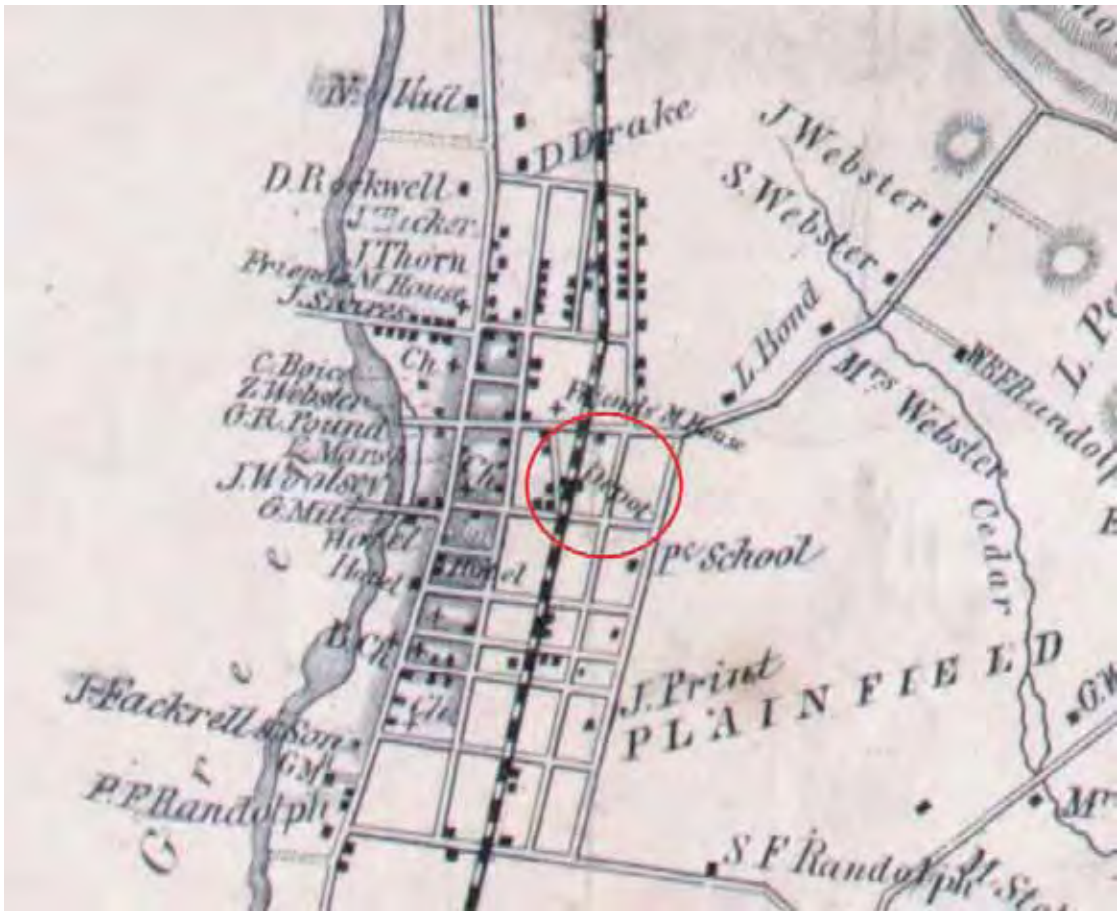
Above is the 1850 J. C. Sidney. *Map of Essex County, New Jersey*²⁸ with the depot noted within the circle. This is the only pre-1875 map showing a structure south of the tracks in proximity to the station. All other maps indicate the station to the north, thus it is unclear what the building was.

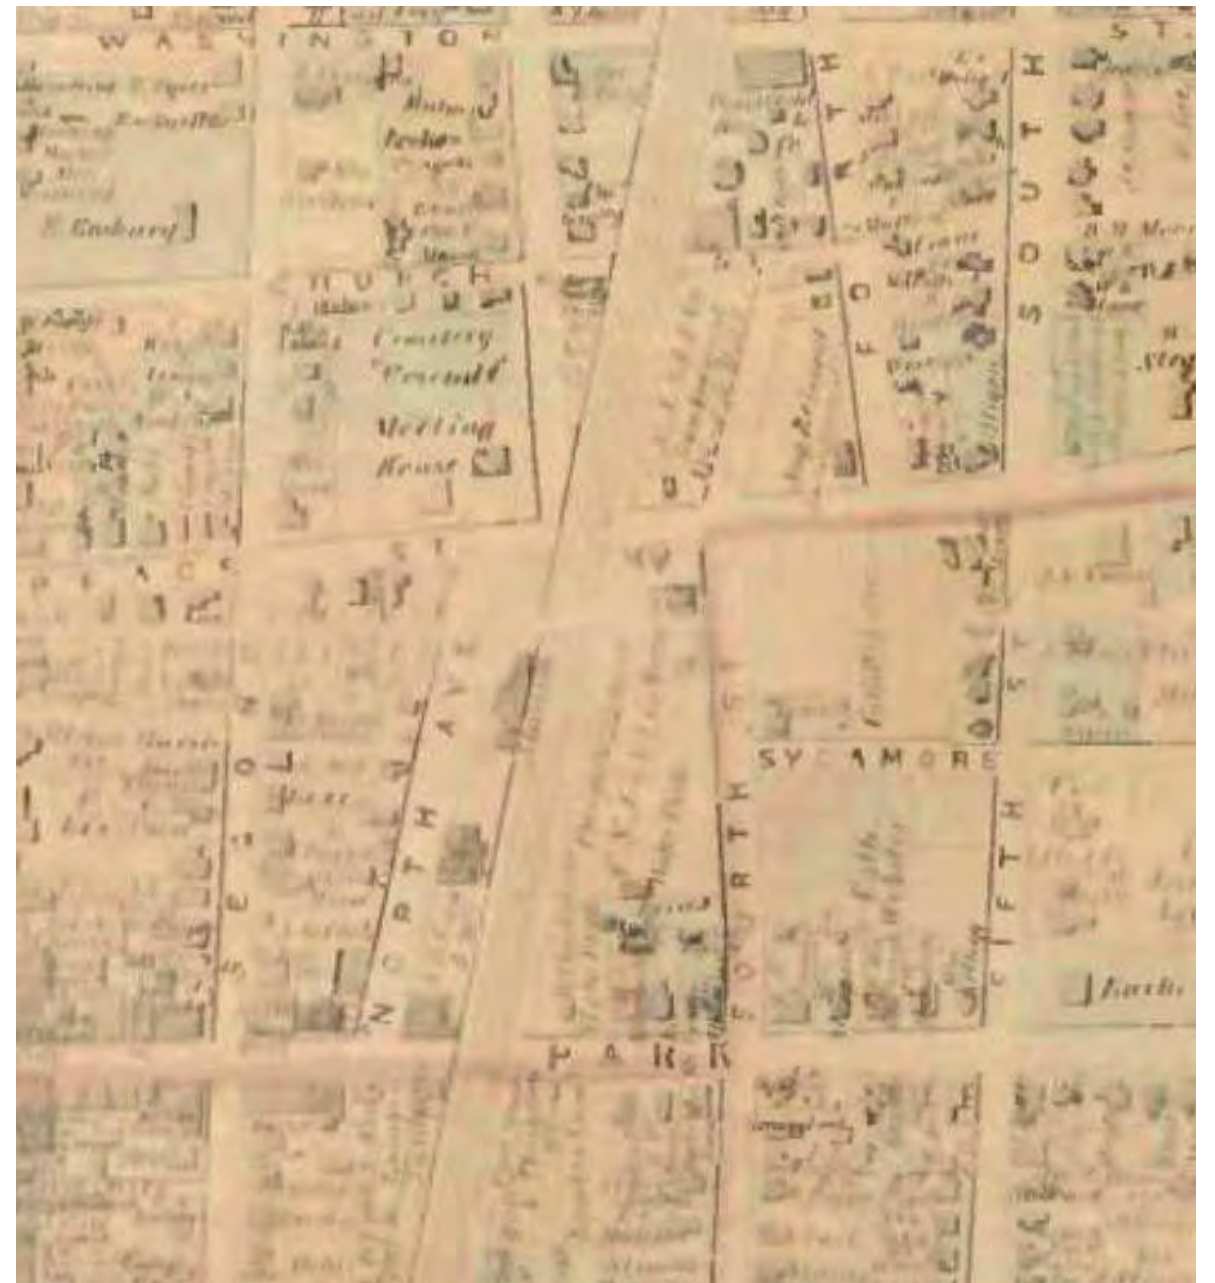
This 1878 *Map of Plainfield, N.J.*³¹ is the first map showing the station completed in 1875. Unfortunately, the resolution of the map from the Rutgers collection is poor, but the station is visible south of North Avenue abutting the tracks.

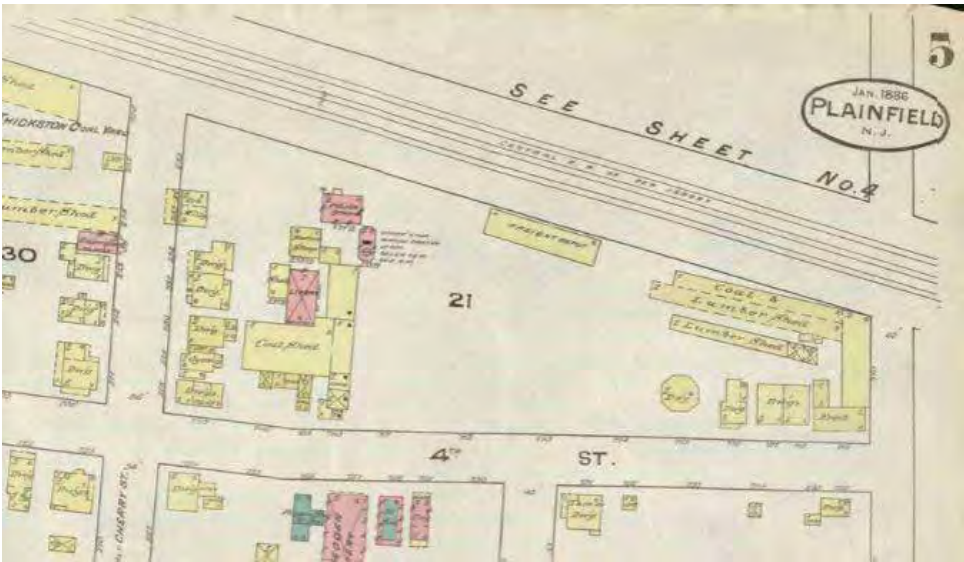
These two 1886 *Sanborn Fire Insurance Map* Plainfield sheet sections³³ show the station as a masonry structure with a perimeter wood roof assembly. The station had the main passenger area in the center flanked by open passageways on each side, a large smoking room was to the east, and baggage room and freight office was to the west. Note that street in front of the station runs straight in line. To the south of the tracks a frame freight depot stood in an open area, logically facilitating wagon traffic.

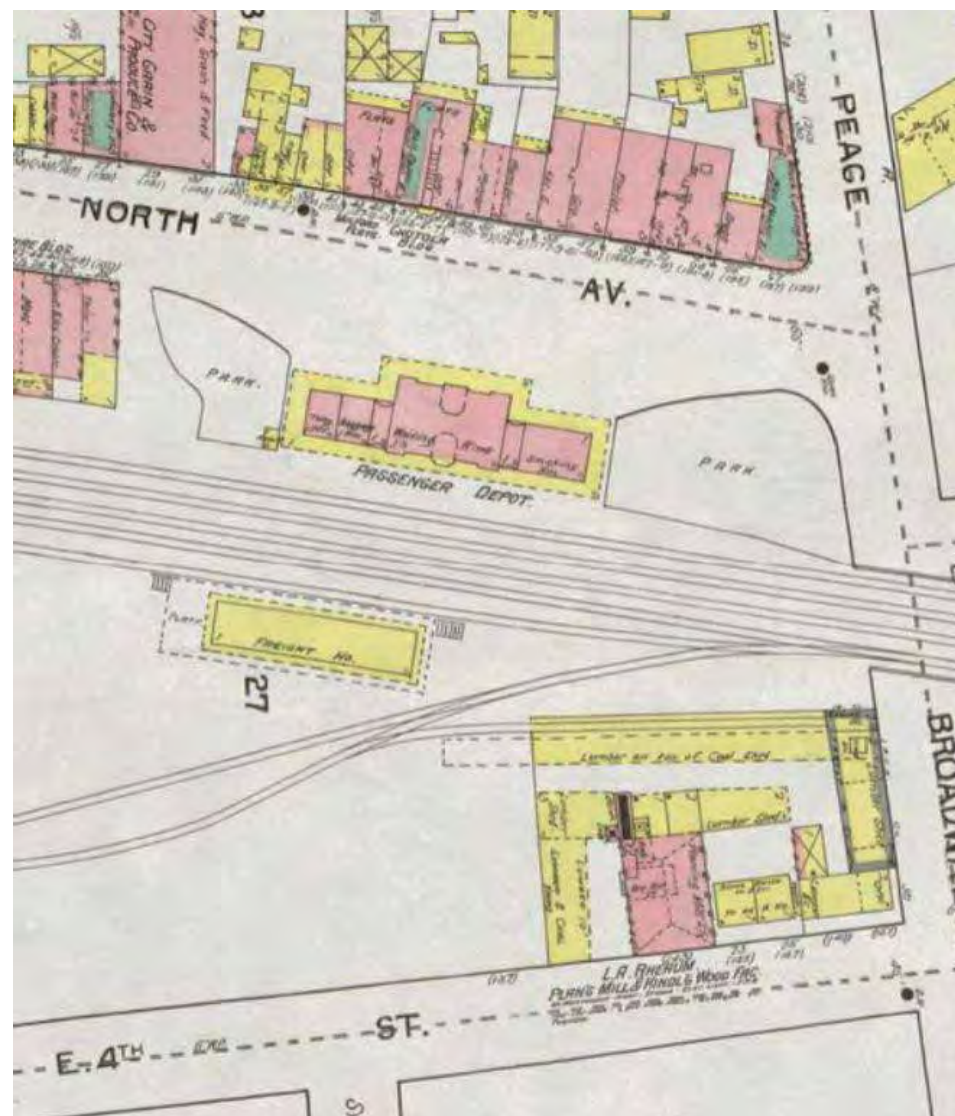
This 1892 *Sanborn Fire Insurance Map* Plainfield sheet section³⁴ shows the station as a masonry structure with a perimeter wood roof assembly. There is detail in main passenger waiting area that shows the ticket booth layouts. Also, there is detail concerning the front of the building, where the ends extend outward slightly. Again, the center area is shown flanked by open passageways on each side, a large smoking room was to the east, and baggage room and freight office was to the west. Note that the street in front of the station no longer runs straight in line, thus allowing for parking, and parks were created on each side. To the south of the tracks the frame freight depot no longer stands in a clearly open area, as tracks are now shown there. Note the steps and ramp to the freight platform.

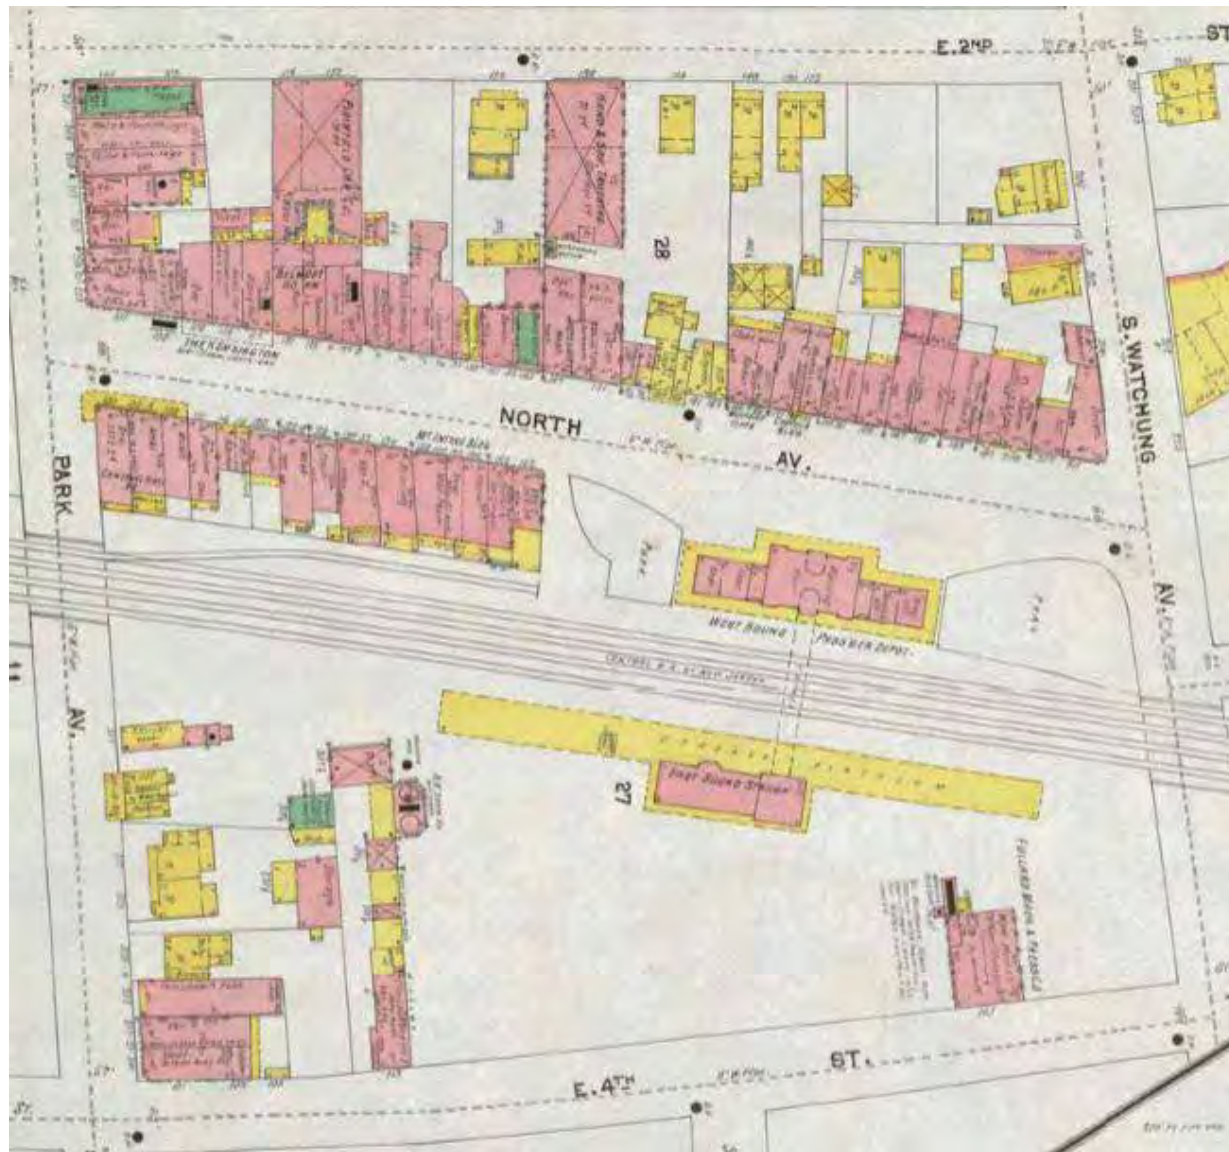
This 1904 *Sanborn Fire Insurance Map* Plainfield sheet section³⁹ shows the center section of the west bound station unchanged from the 1897 Sanborn map (page 17). The former eastern smoking room is now the baggage room and the telegraph office. And the western section now contains two express offices. To the south of the tracks the new eastbound station building is shown as a mainly one-story masonry structure, with a square two-story section to the east. Covered wood platforms surround the structure and extend along the tracks (note the newspaper stand on the platform). Note the tunnel under the tracks. The park areas flanking the mains westbound station are again shown, but on East 4th Street no parks, drives, and or parking areas are shown here (again Sanborn maps rarely fully show landscape features).

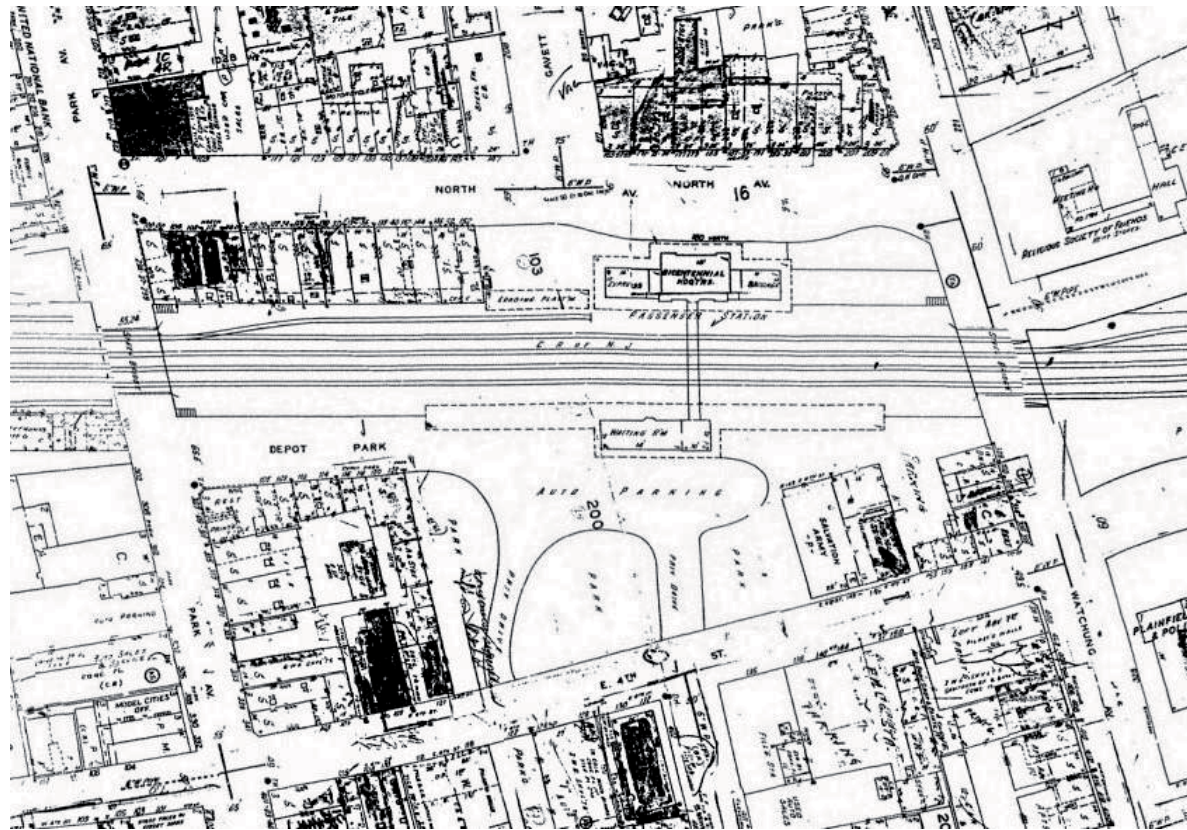
This 1982 *Sanborn Fire Insurance Map* Plainfield sheet section⁴⁵ is virtually identical to the 1950 Sanborn map section (page 22), the 1956 Sanborn map section (page 23), and the 1963 Sanborn map section (page 24). It is presented here solely to show that no distinguishable changes to the station areas were made at this time.

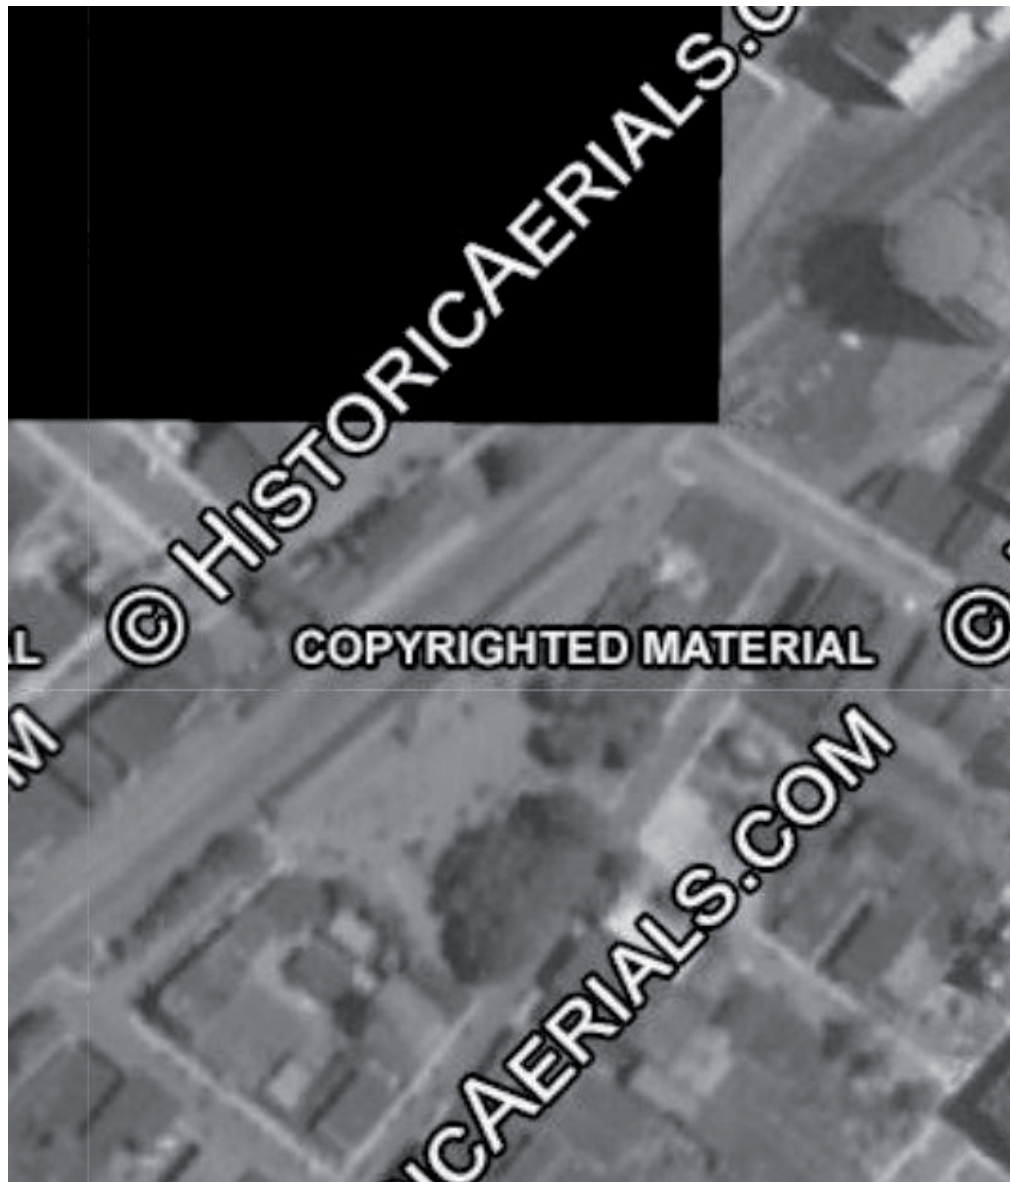
This 1940 image⁴⁷ is unfortunately incomplete, but the area around the eastbound station is visible. The building itself is relative to the map images. Here we see trees west of the station along the tracks, and south of that is a driveway. The two drives from East Fourth Street are evident and vegetation is seen between the drives - and flanking them. No distinguishable delineated parking spaces are noted.

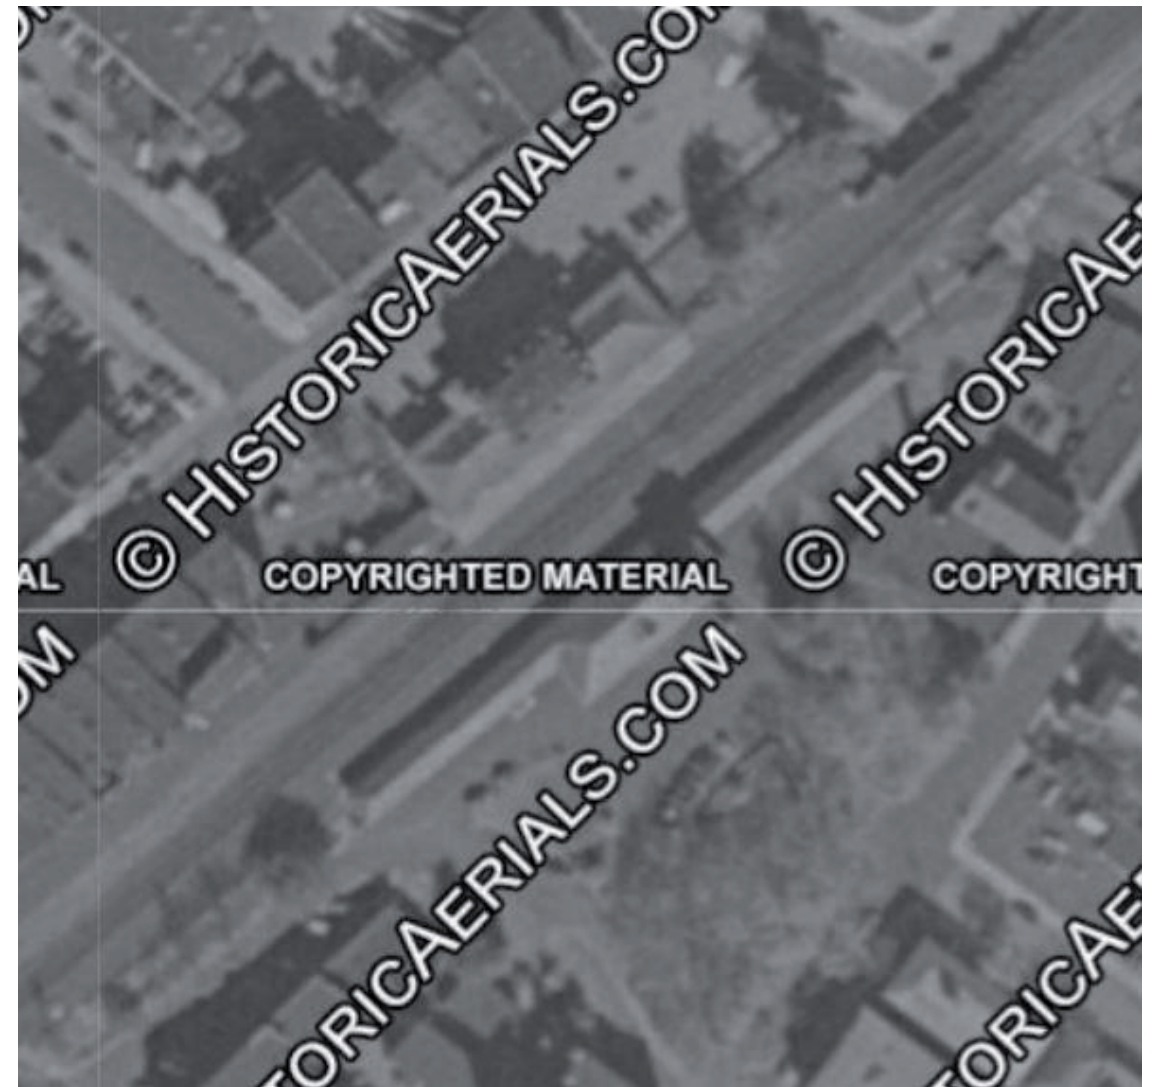
This 1947 image⁴⁸ shows both station buildings. The image was taken at a time (likely winter) when long shadows were cast, and thus some details are obscured. The buildings appear relative to the photographic images. The details concerning the areas surrounding the buildings are largely unchanged from the 1940 image (page 27).
