NORTH AVENUE STREETSCAPE AND PEDESTRIAN MALL
HPO Project #21-1463-2 North Avenue Commercial Historic District
Plainfield, Union Co., New Jersey

North Avenue Streetscape and Pedestrian Mall
Schematic Design

The Plainfield Railroad Station Plainfield, NJ

AN HISTORICAL INVESTIGATION

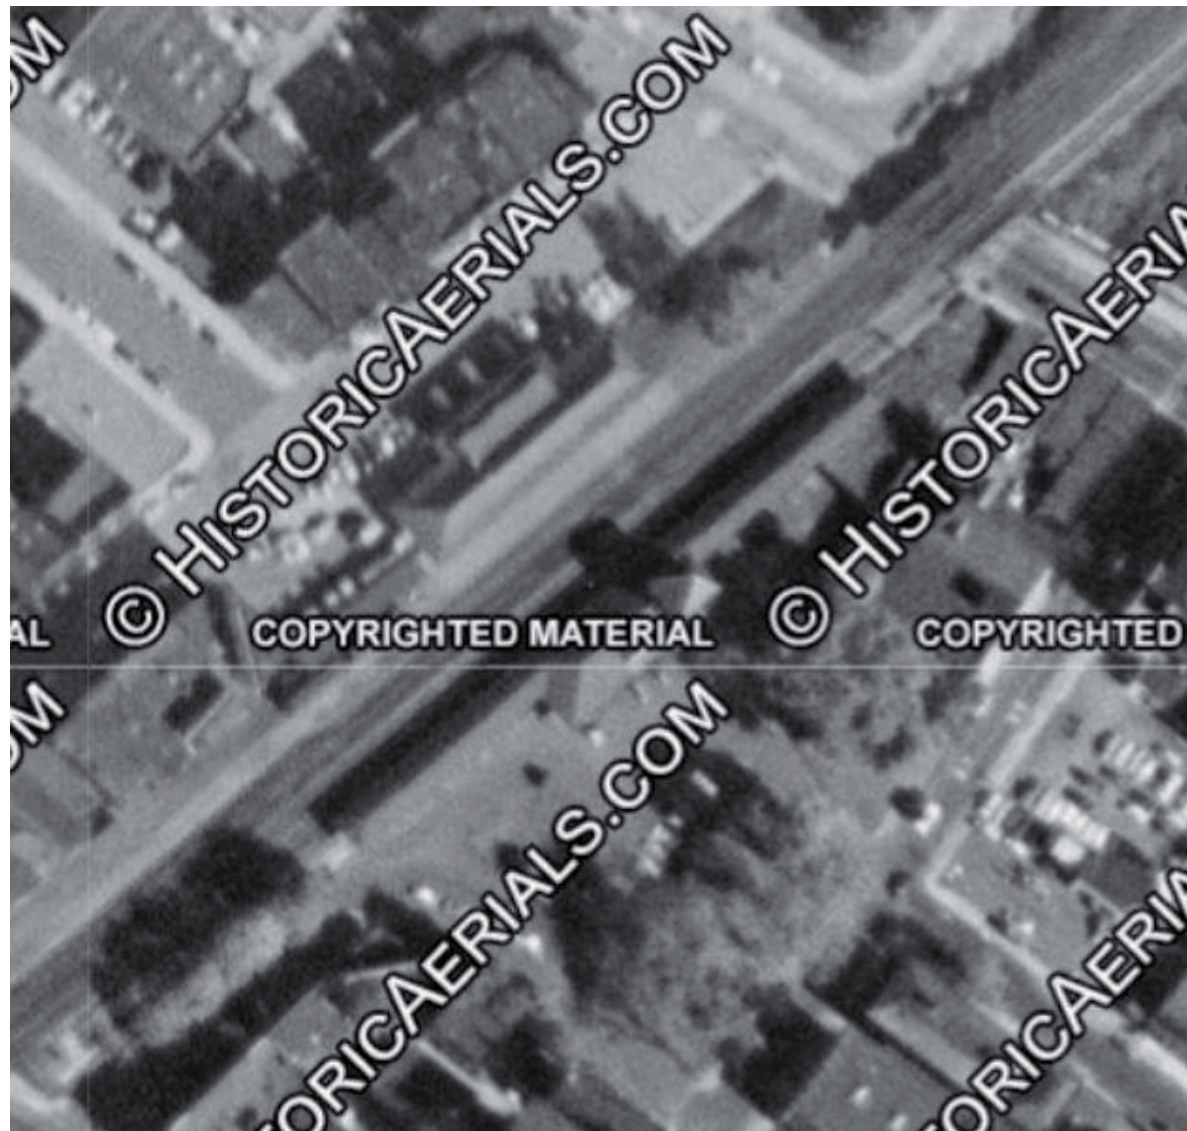
This 1957 image⁴⁹ for the first time shows the then altered westbound station, and the tower on the eastbound station (previously obscured). Shadows of the trees are notable, and automobiles are visible parked in various locations.

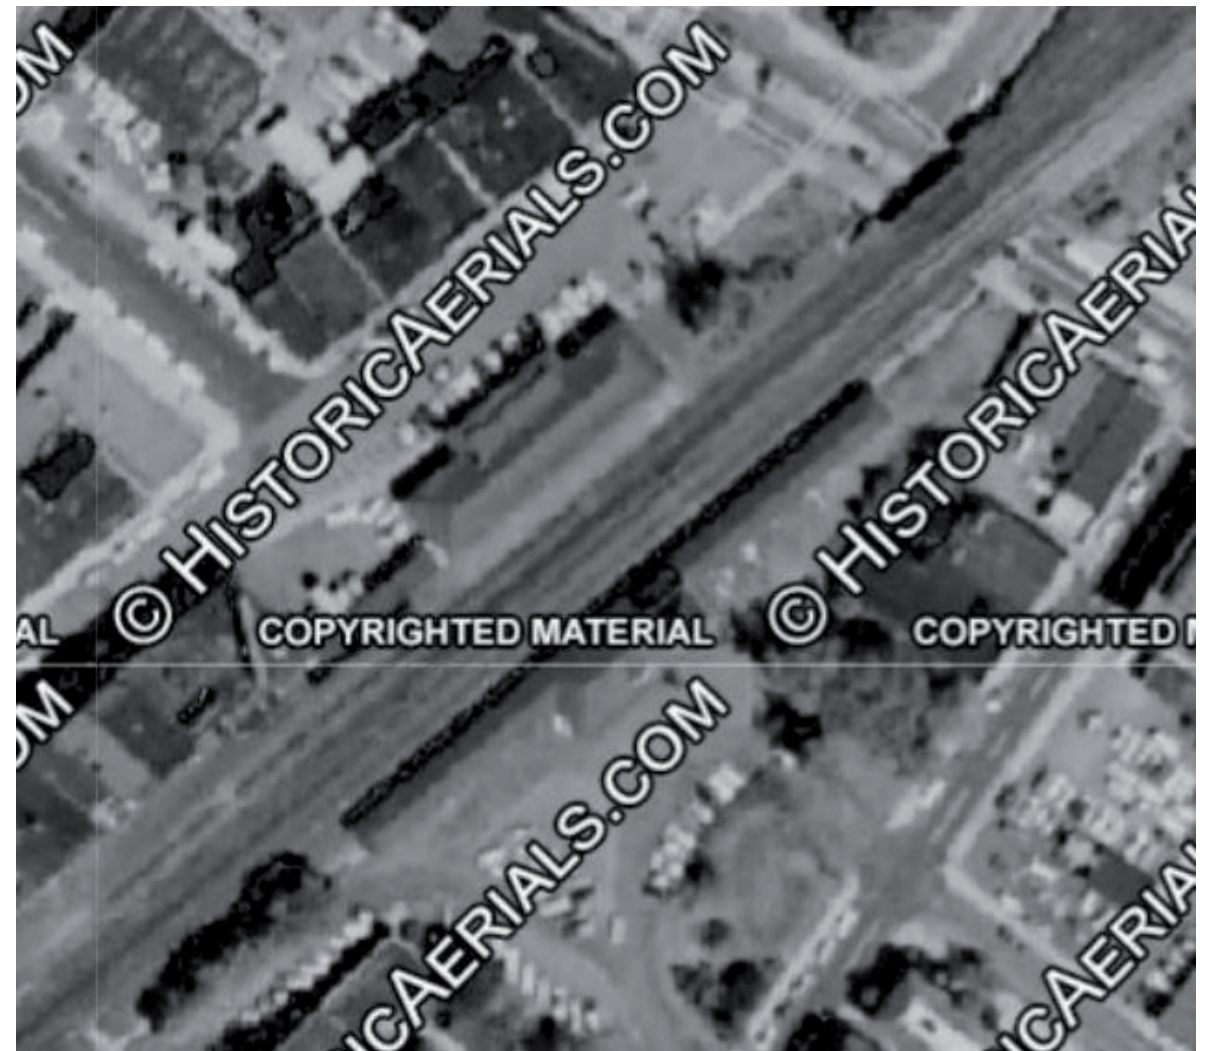
This 1963 image⁵⁰ shows both station buildings unchanged from the previous image. The trees are evident (and without shadows). Here the multiple parking areas can be clearly seen, with numerous vehicles parked.

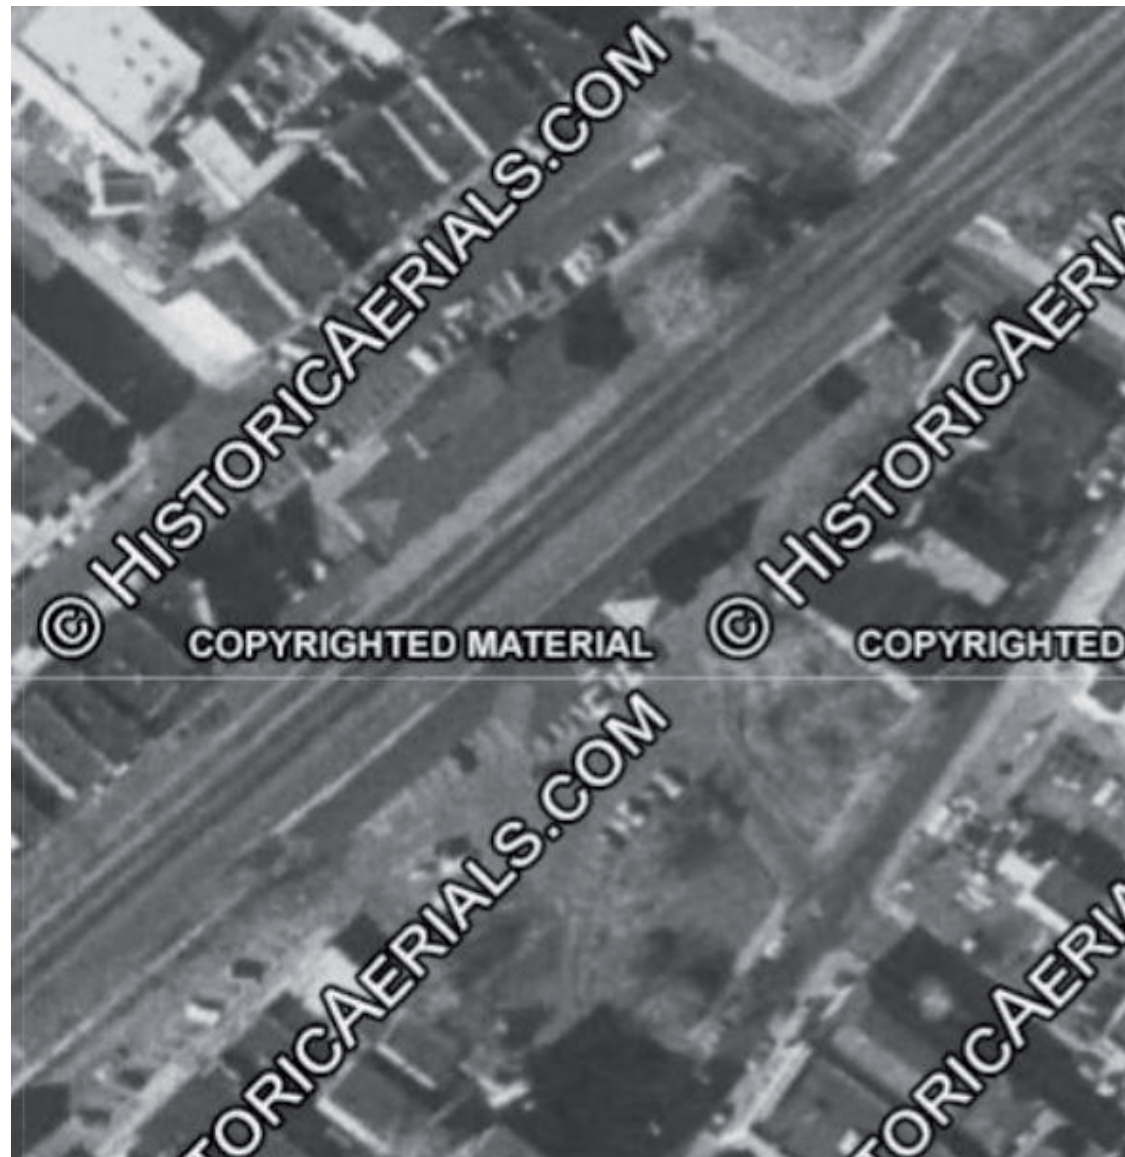
This 1970 image⁵¹ shows both station buildings unchanged from the previous image. The trees are evident, and grassy areas appear to be seen. Here the multiple parking areas can be clearly seen, with numerous vehicles parked, and with delineated painted parking space lines.

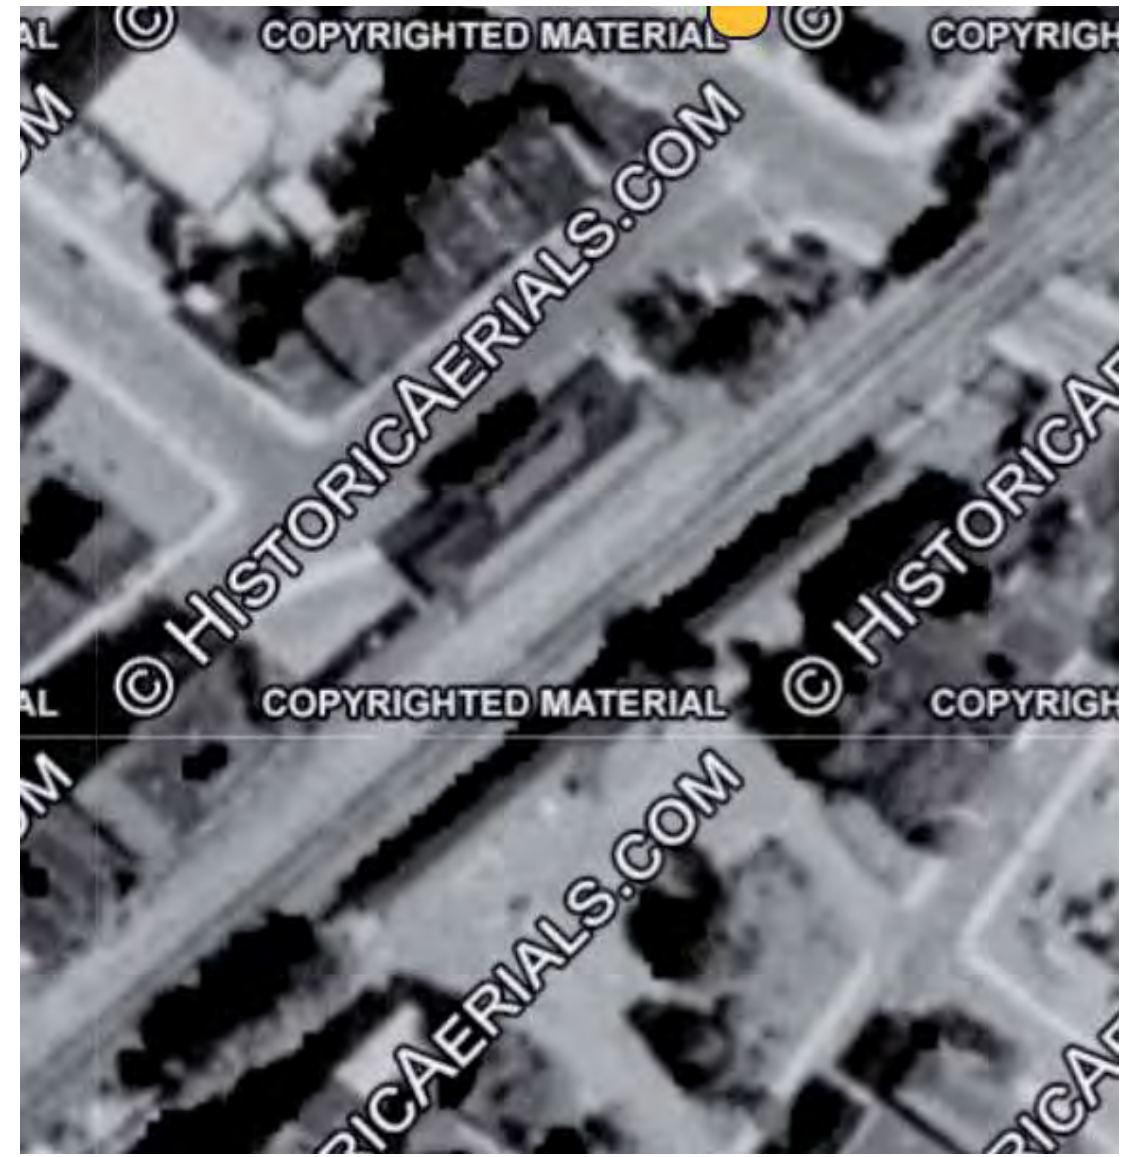
This 1972 image⁵² is less clear, although it shows both station buildings unchanged from the previous image. The trees are evident, and grassy areas appear to be seen. Here the parking areas cannot be distinguished. Not seen are the expected numerous vehicles, thus leading one to believe the image may have been taken on a Sunday.

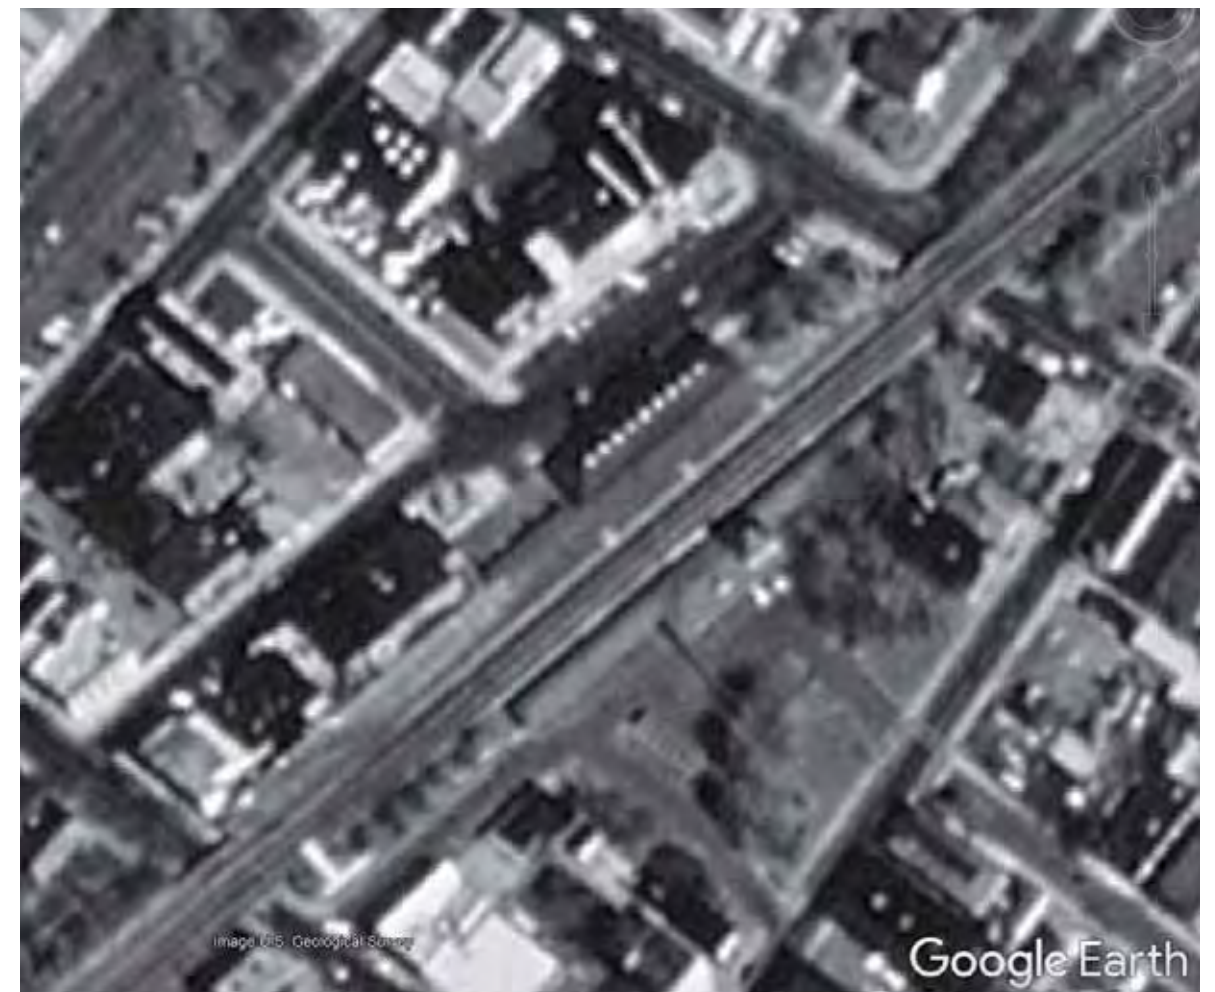
This 1995 image⁵⁴ is less clear than the previous image, although it shows both station buildings largely unchanged from the previous images. The trees are evident, and grassy areas appear to be seen. Here the parking areas cannot be fully distinguished. Not seen are the expected numerous vehicles, thus leading one to believe the image may have been taken on a Sunday.

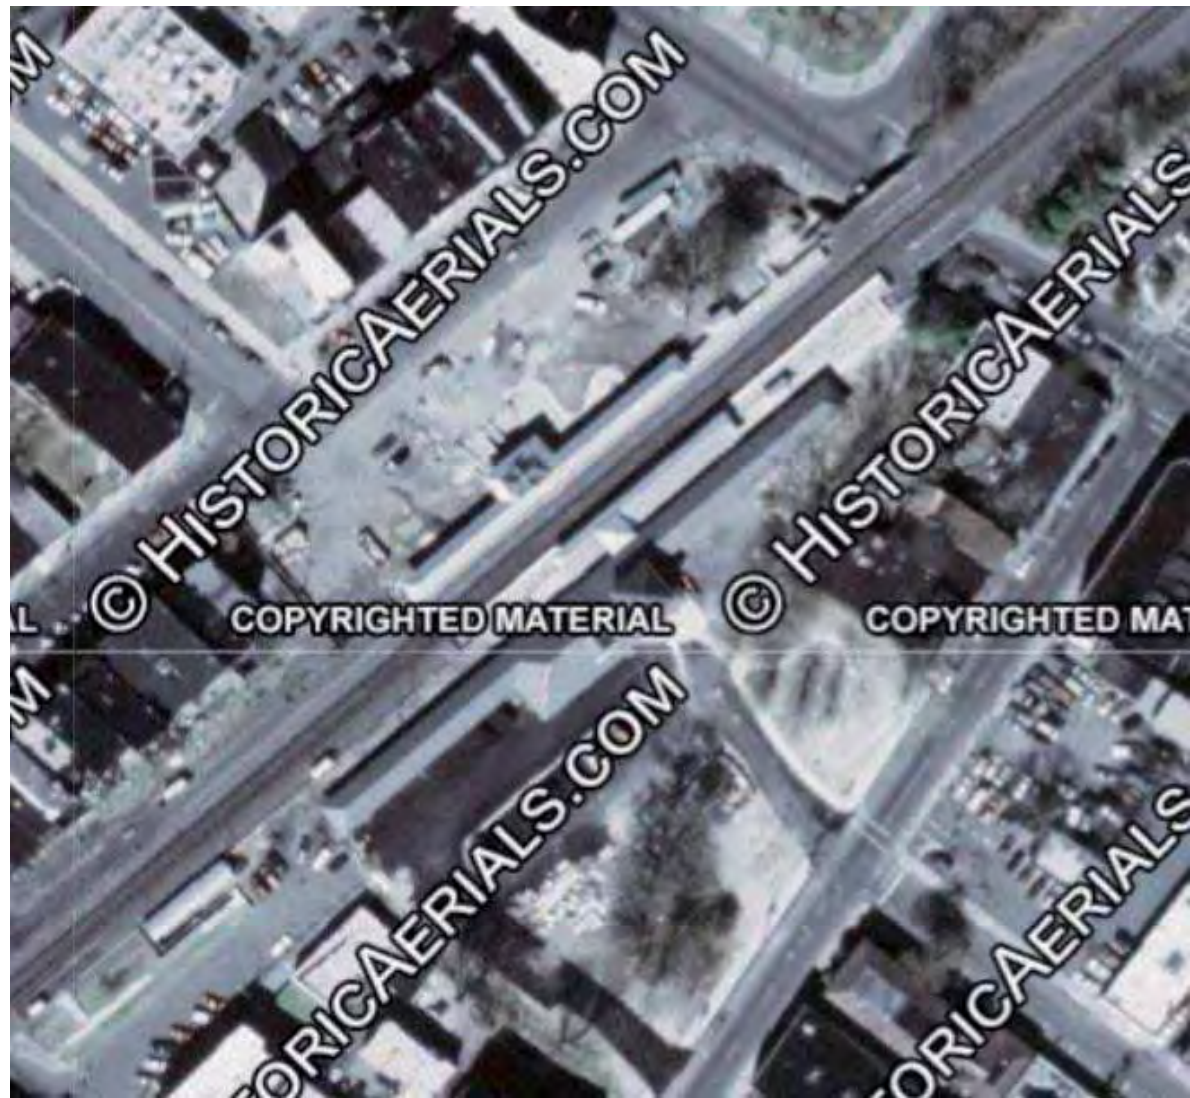
This 2002 image⁵⁵ is in color (although not vibrant). Here for the first time the currently extant westbound station is evident, and the parking/landscape area in front appears to be still under construction. The eastbound station proper appears unchanged, although a new covered platform is visible adjacent to the tracks. The center landscaped area south of the eastbound station appears to be under construction. No leaves are seen on the trees.

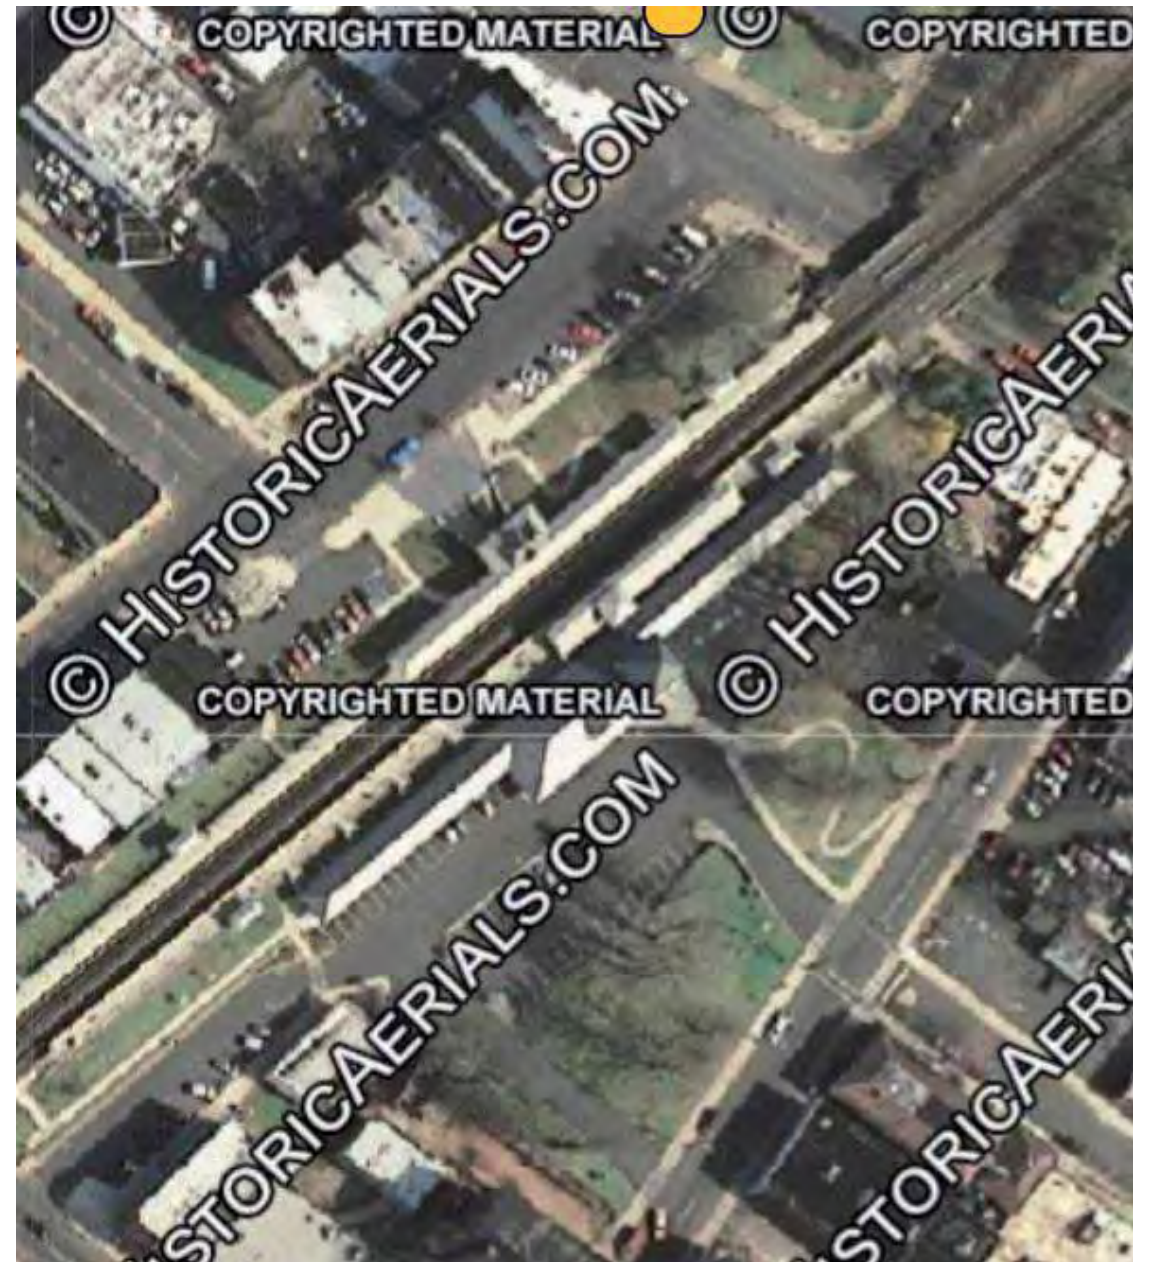
This 2007 image⁵⁶ shows the completed alterations to the station complex. The parking areas are clearly seen, as are the various sidewalks. No leaves are seen on the trees.

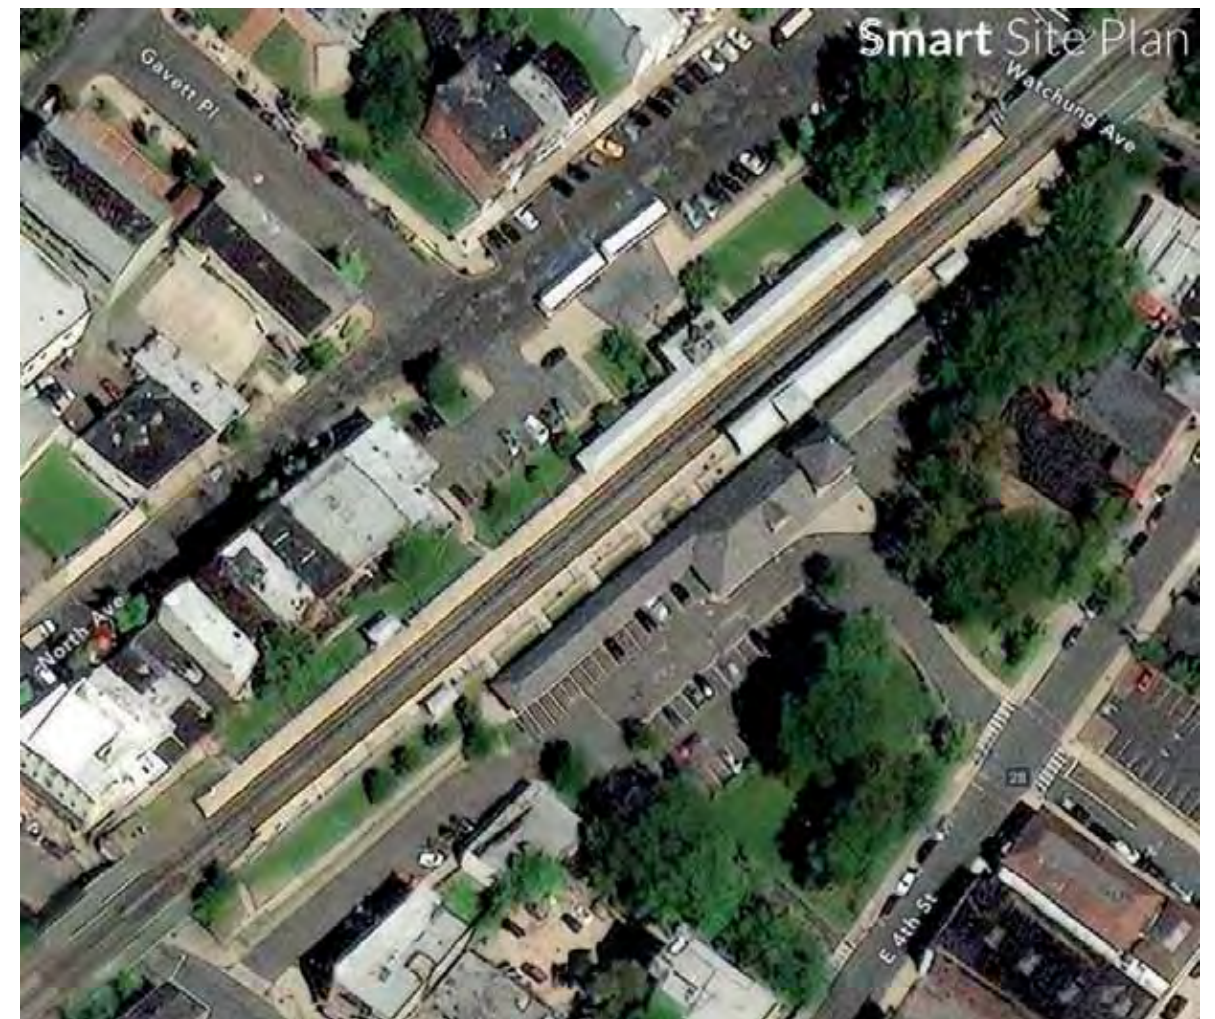
This 2019 image⁵⁸ shows the station complex in vibrant color. The parking areas are clearly seen, as are the various trees.

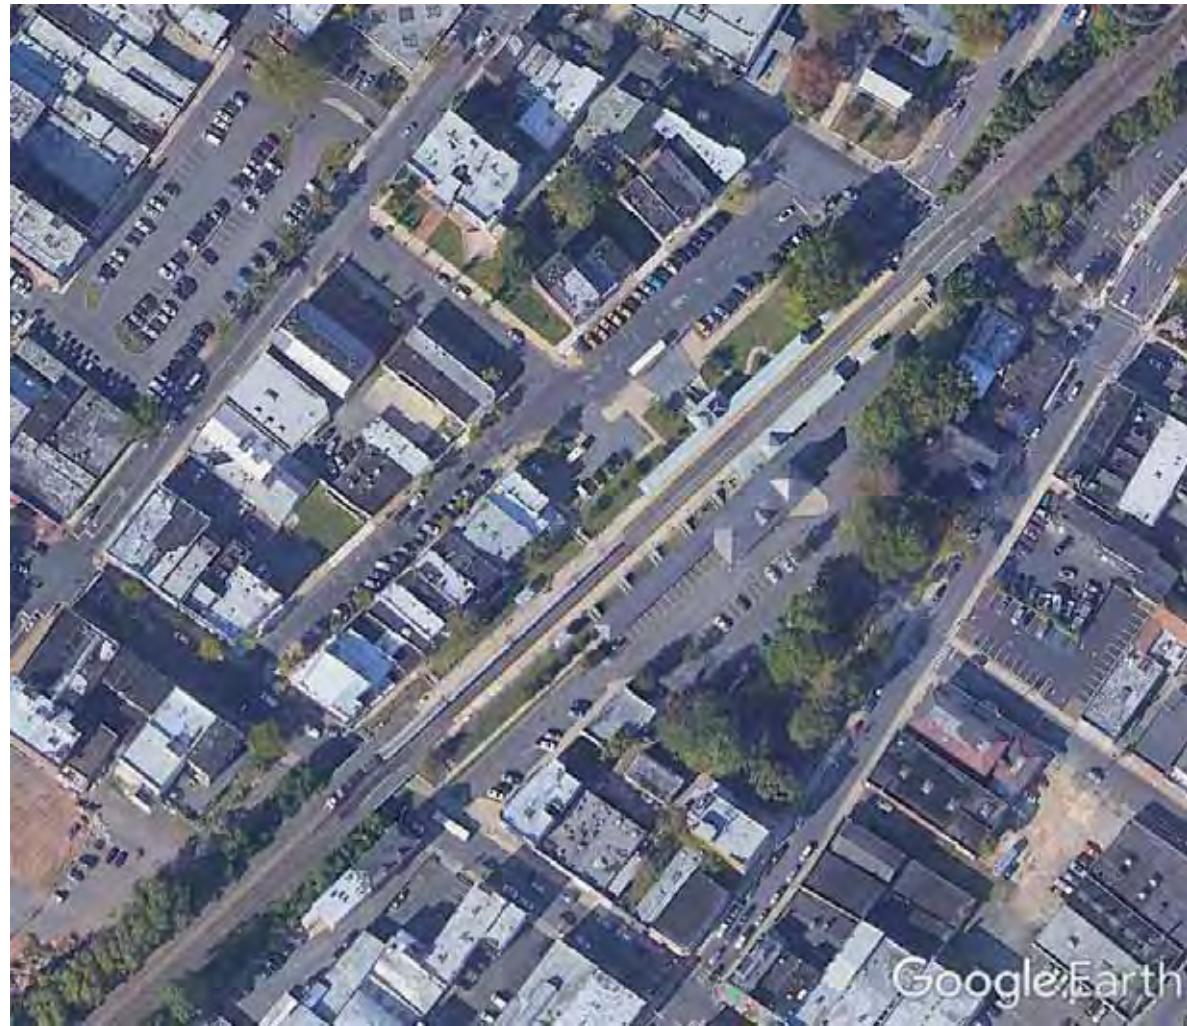
This 2020 image⁵⁹ shows the station complex in it's near extant condition.

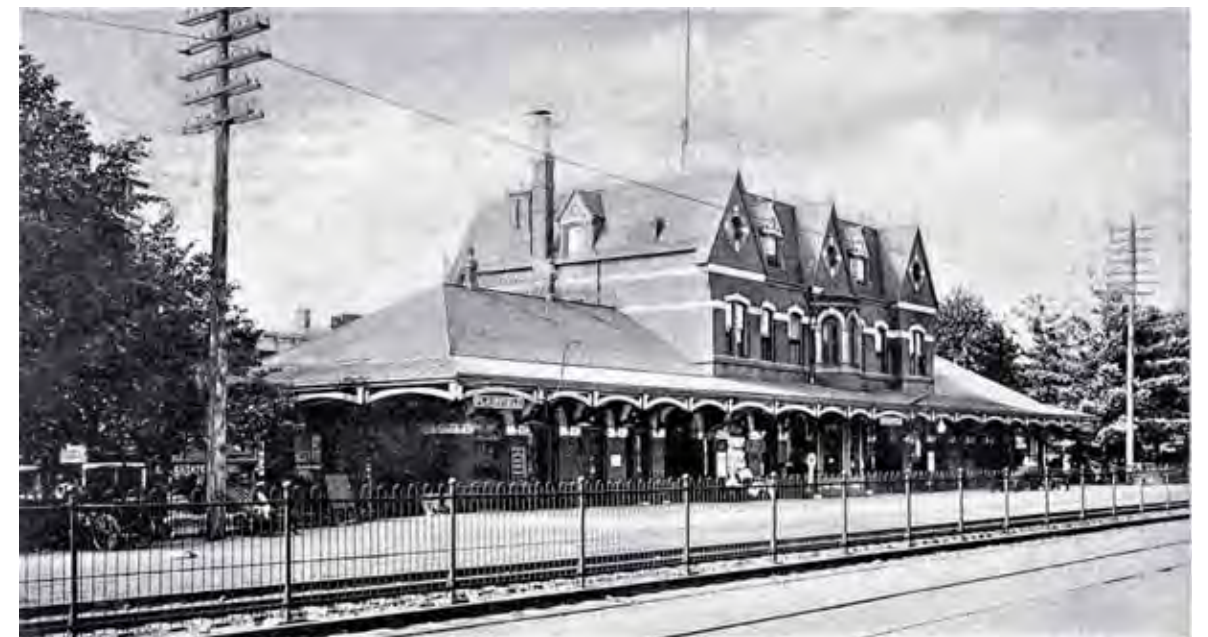
This image is said to be from 1906-07 and presents a clear picture with detail of the structure.

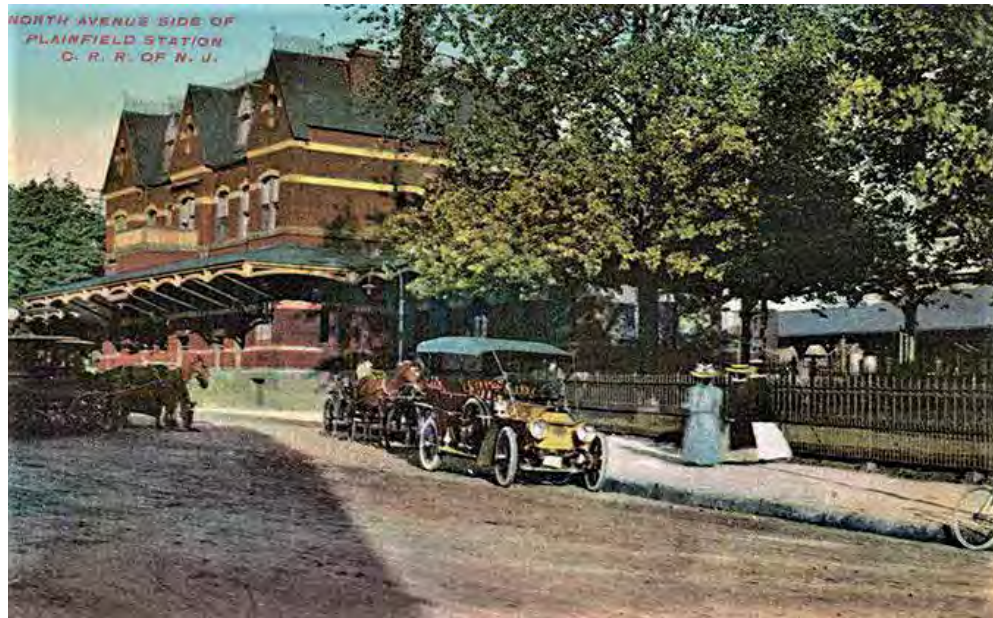
This post card image said to be from 1909. Here we see the station, an unpaved street, curbing, sidewalks, fencing by the park, and mature trees. In addition, note the street light.

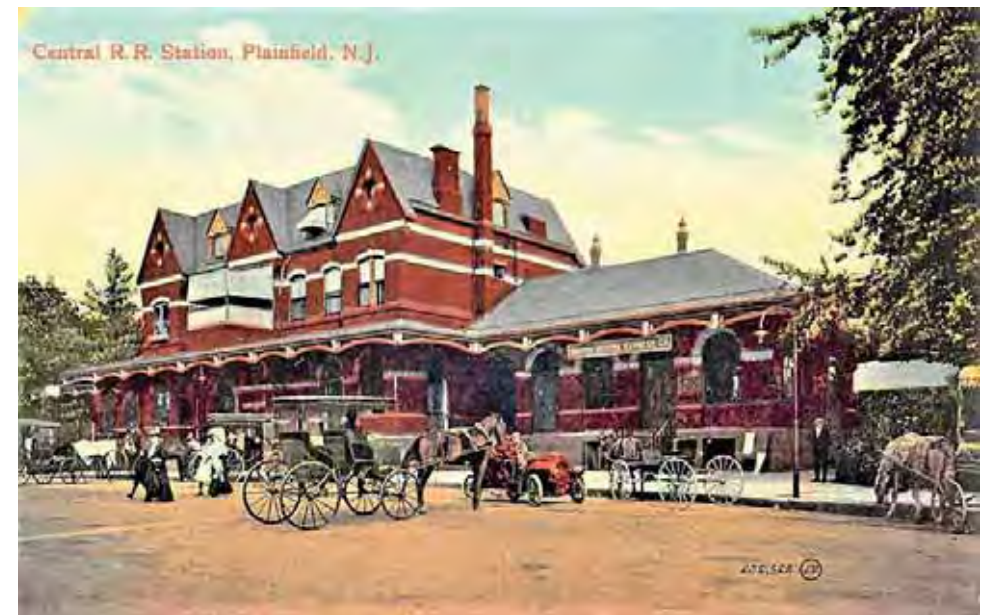
This post card image said to be from 1915 shows a busy front of the station. Note the unpaved road, sidewalk (possibly concrete), lamp post, mature trees.

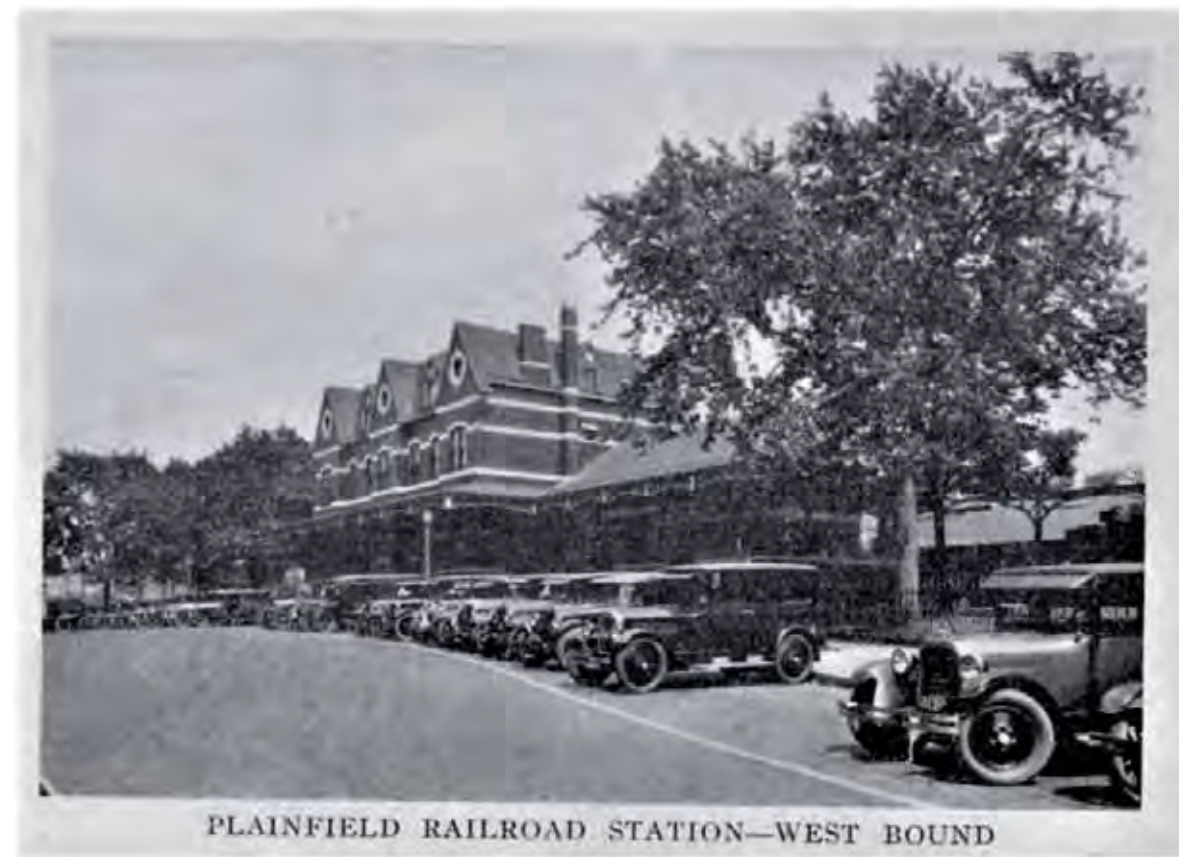
This image is from the 1926 Courier News *Plainfield and Vicinity in Pictures* book. Note the balcony is no longer evident on the front of the station. The iron fencing by the park remains unchanged. New streetlights are present, and the road is now paved.

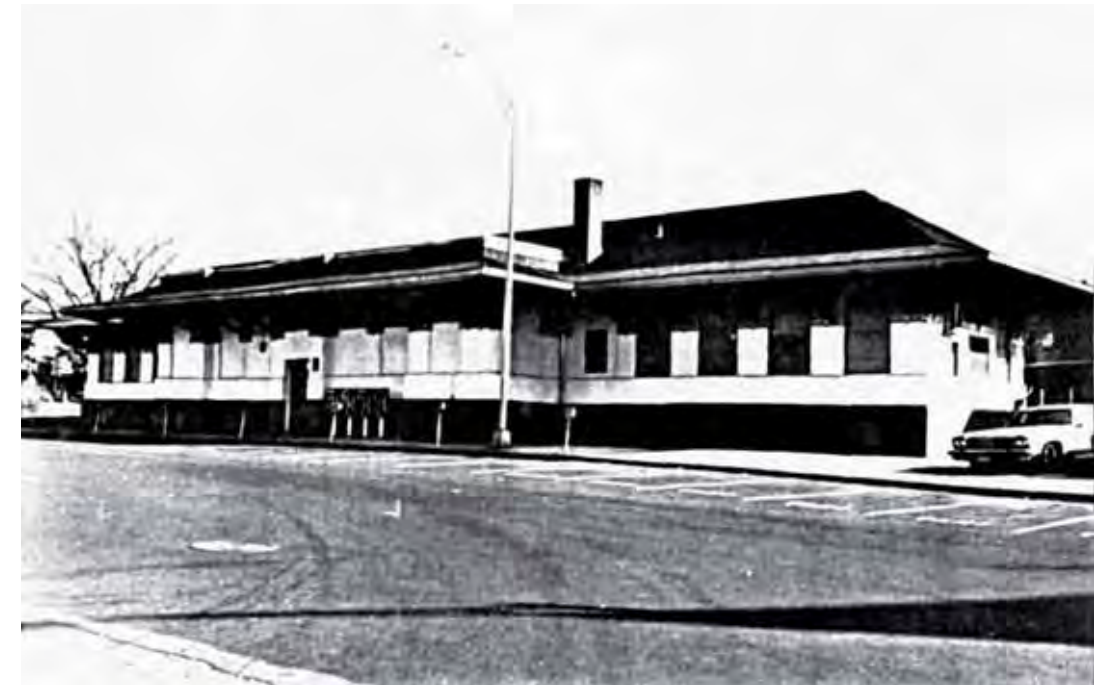
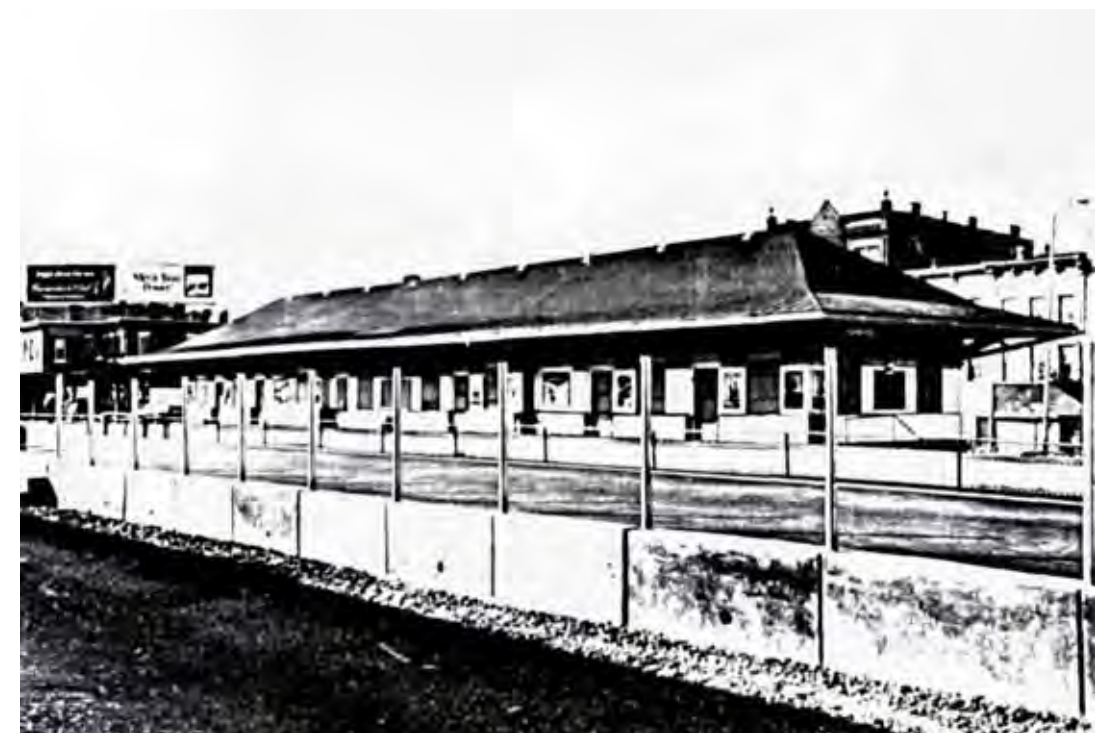
These two circa 1984 images show both sides of the station (front above, trackside below), and the destruction caused by uncaring alterations in a quest for modernization.

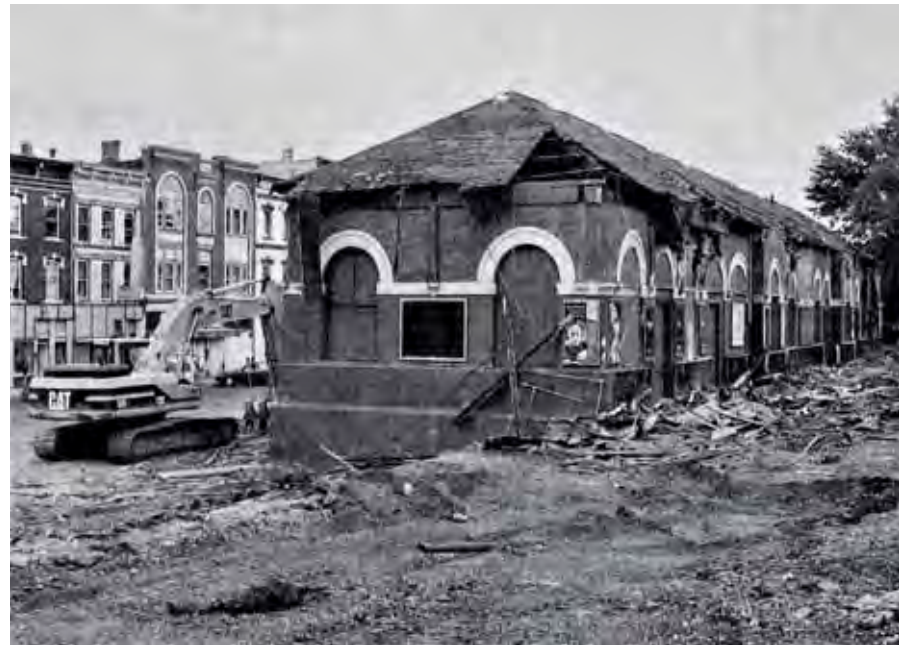
This *Courier News* photo from August 2000 documents the demolition work.

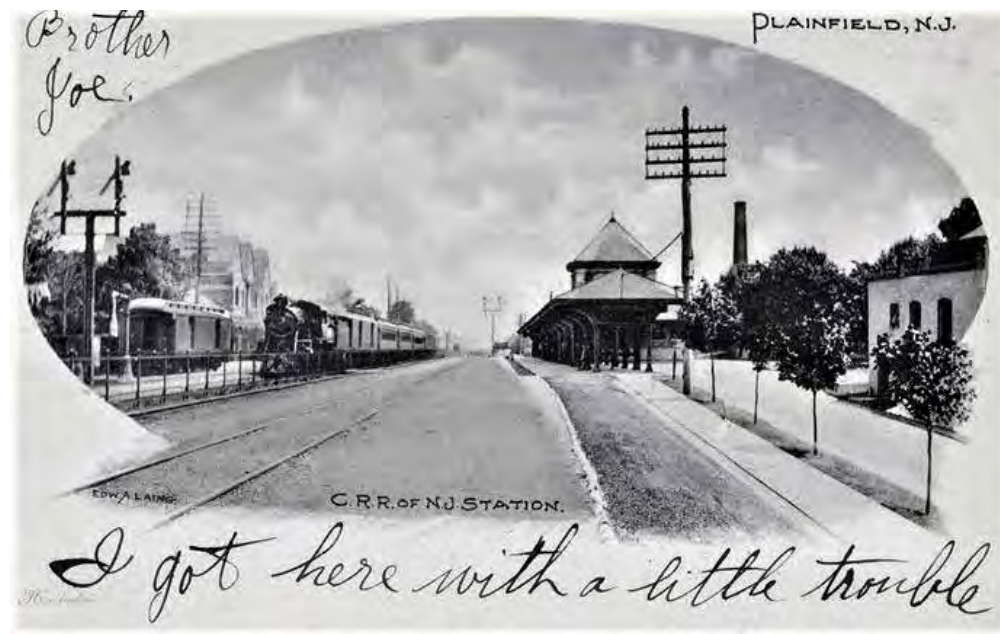
This 1906 photograph by Edward A. Laing gives a good view of the Eastbound station platform, an apparent concrete sidewalk, and imature trees.

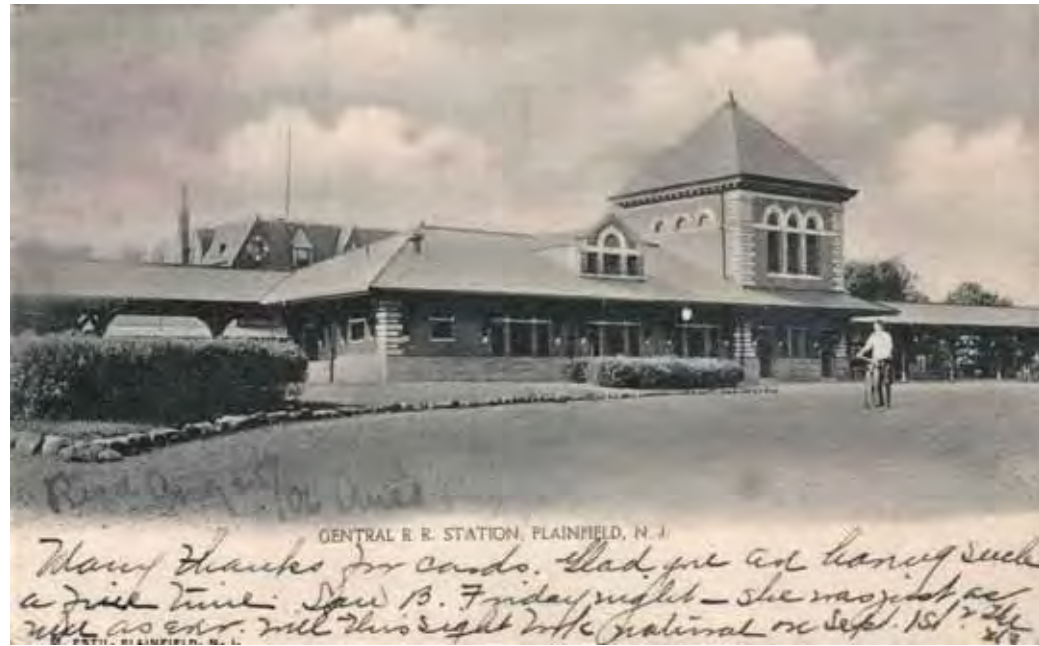
This 1906 postcard image of the station shows the unpaved roadway, curbing of stones, and some bushes.

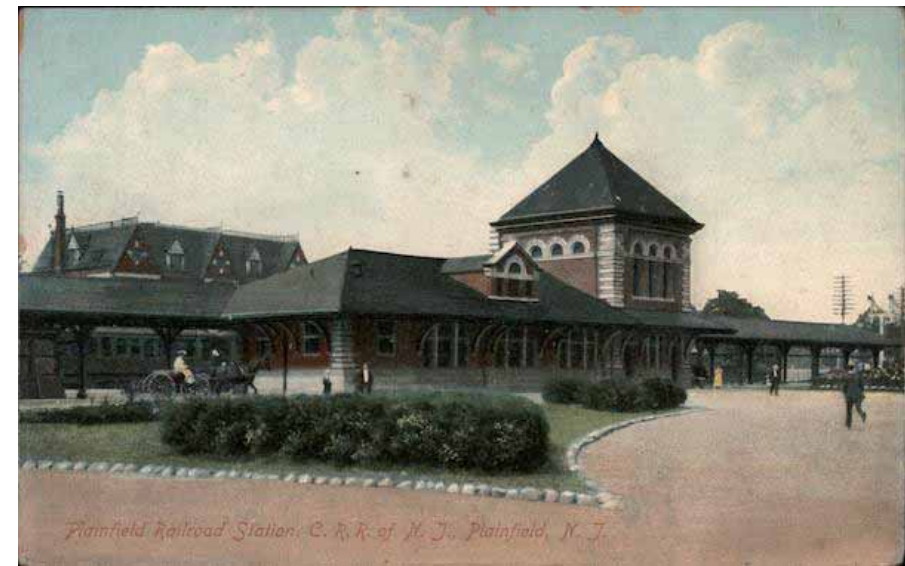
This circa 1906 postcard image gives a wide view of the south side of the station. Note the stones used as curbing.

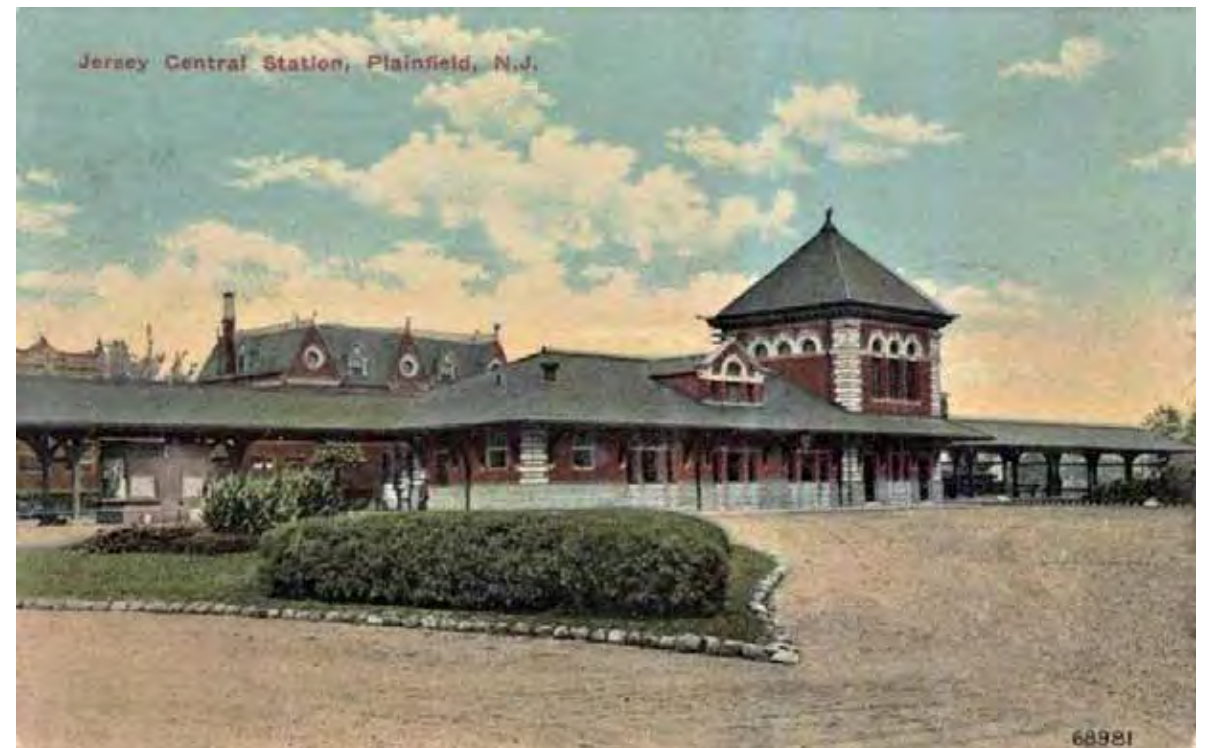
In this 1907 postcard view carriage ruts are visible in the drives (proving it was dirt). The news stand is visible on the platform. A greater variety of plantings are visible. No lighting is evident.

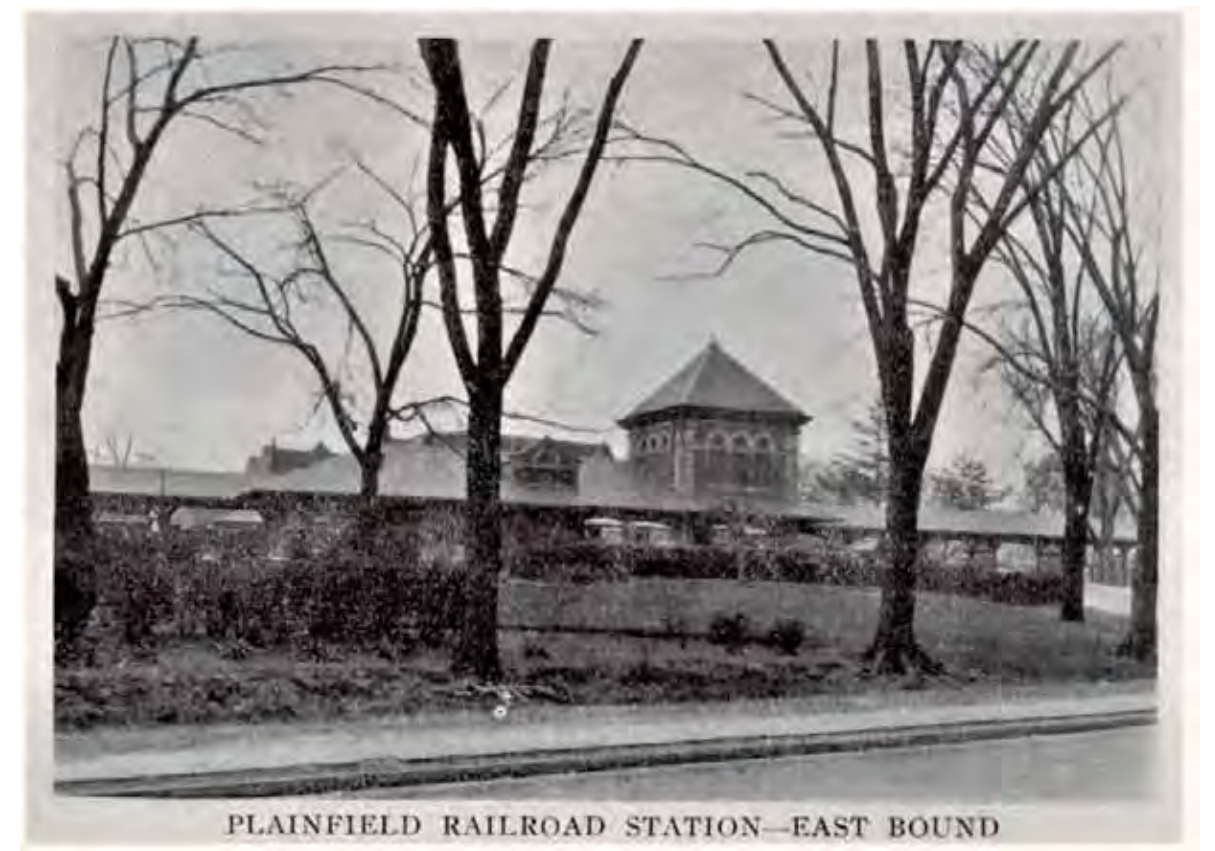
This image is from the 1926 Courier News *Plainfield and Vicinity in Pictures* book gives a good view of the park area along East Fourth Street. Note the paved street, concrete sidewalk and curbing, and the cars parked head facing the park area.

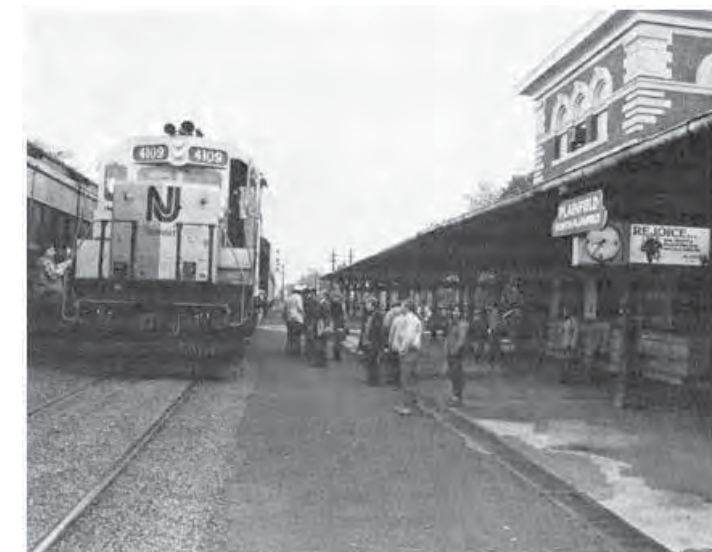
This circa 1980s photo possibly shows an rail excursion run of some type (note the vintage car to the left of the locomotive). Note the tracks near the platform were removed, and the pavement.

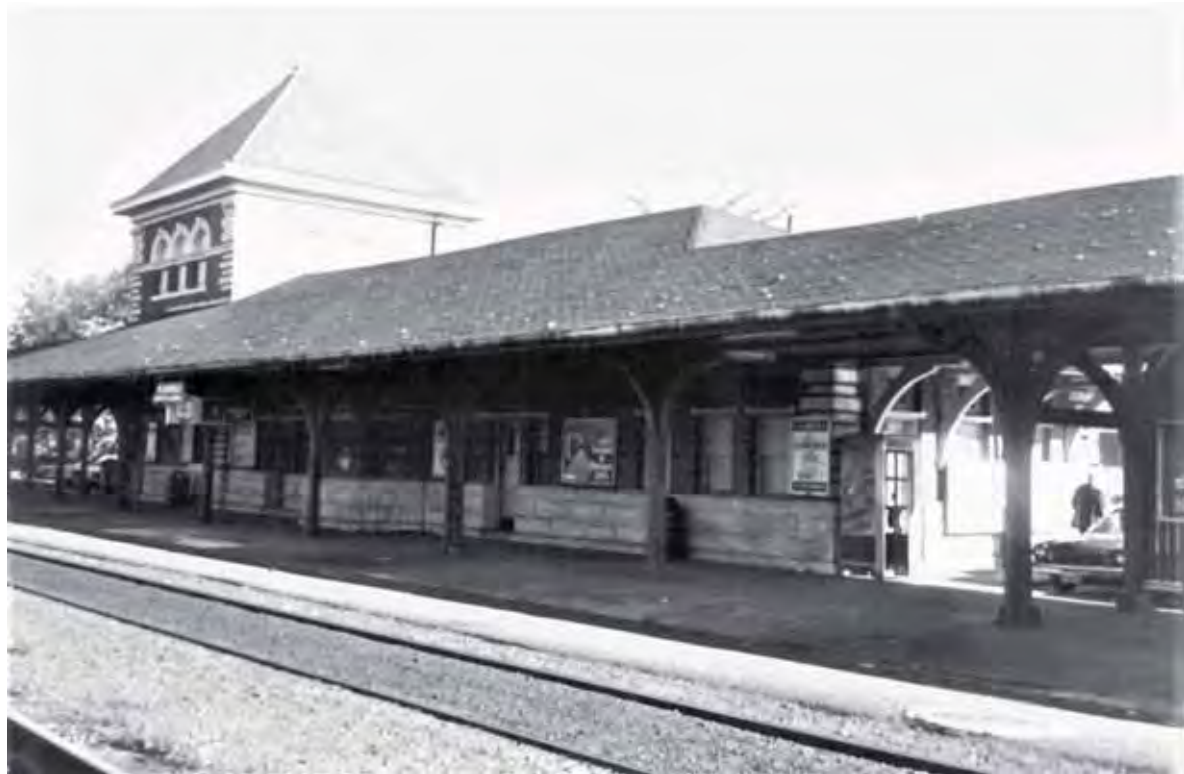
This 1984 image provides good detail of the track side of the station.
