NORTH AVENUE STREETSCAPE AND PEDESTRIAN MALL
HPO Project #21-1463-2 North Avenue Commercial Historic District
Plainfield, Union Co., New Jersey

North Avenue Streetscape and Pedestrian Mall
Schematic Design

The Plainfield Railroad Station Plainfield, NJ

AN HISTORICAL INVESTIGATION

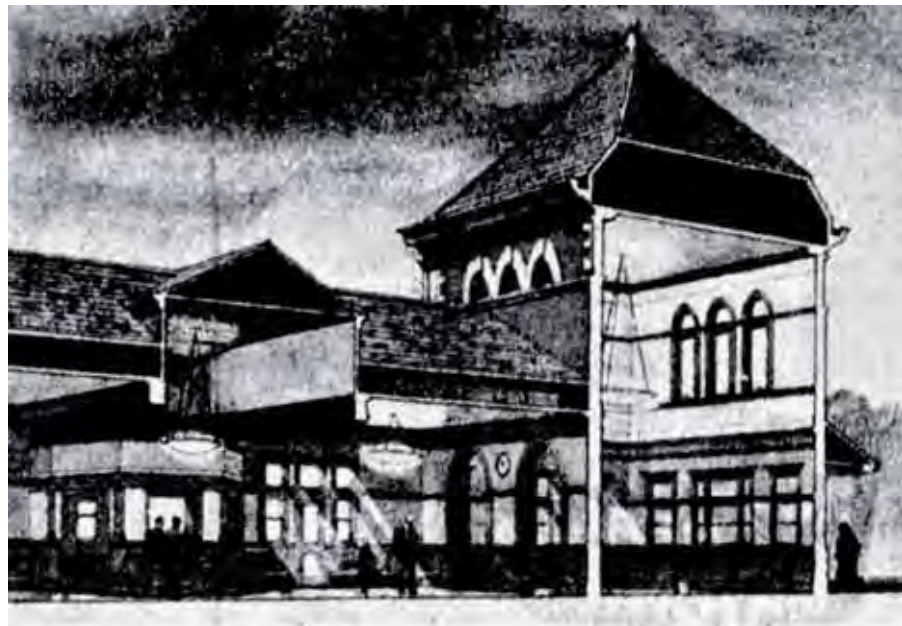
This rendering from 2000 shows some of the proposed changes to the station.
