PRELIMINARY INVESTIGATION FOR AREA IN NEED OF REDEVELOPMENT DETERMINATION WEST END INDUSTRIAL CORRIDOR

CITY OF PLAINFIELD NEW JERSEY

West End Industrial Corridor Area in Need of Redevelopment Preliminary Investigation - Non-Condemnation

City of Plainfield, Union County, New Jersey

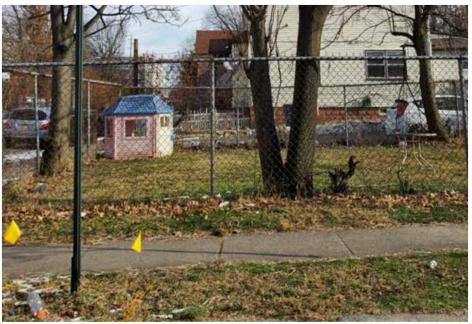
The property is vacant with a chain-link fence surrounding the property. It appears that the occupants of Lot 34 are utilizing this property as a yard. The property is deficient in several zoning regulations for single-family dwelling of the R-4 Moderate Density Residential District including minimum lot size (7,500 square feet) and minimum lot width (50 feet).

• Criteria "C": The property has been vacant for more than 10 consecutive years. Because the property does not conform to several of the required zoning regulations, it is not likely that it would be redeveloped through the instrumentality of private capital.

Although Criteria "C" is satisfied, it is not recommended that Block 116, Lot 1 should not be designated as an "area in need of redevelopment" because no other adjacent lots qualify.

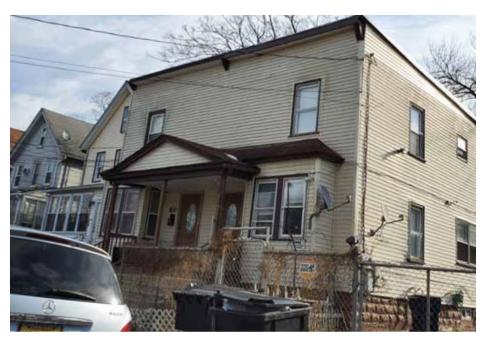
• [NONE]

Based on these existing conditions, Block 116, Lot 2 should not be designated as an "area in need of redevelopment."

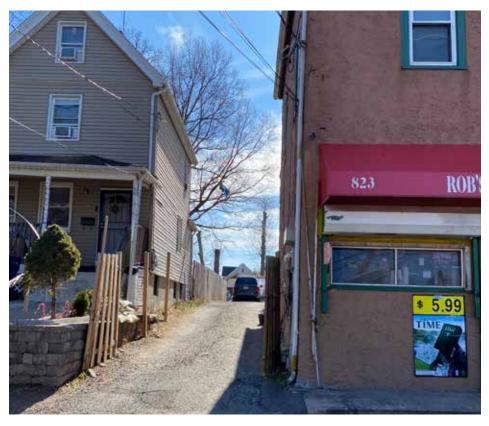
821 SOUTH SECOND STREET (BLOCK 116, LOT 8) PROPERTY EVALUATION

• Section 3: Effective redevelopment cannot occur without the inclusion of this property. With a "flag" portion of Lot 7 abutting this site at its rear, it is necessary to include this lot as an "area in need of redevelopment" in order to cohesively redevelop this portion of Block 116.

Based on these existing conditions and satisfied LRHL criteria, Block 116, Lot 8 should be designated as an "area in need of redevelopment."

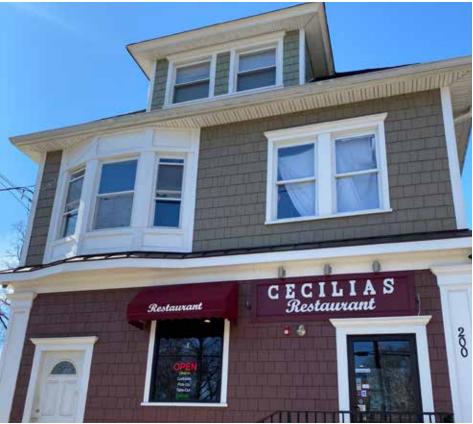
The property is deficient in several zoning regulations for singlefamily dwelling of the R-4 Moderate Density Residential District including minimum lot size (7,500 square feet) and minimum lot width (50 feet). Mixed-use buildings are not a permitted principal use in the R-4 District. This building also does not abide by the setback requirements of the R-4 District.

• **Criteria "G"**: The property is located within the City's designated Urban Enterprise Zone.

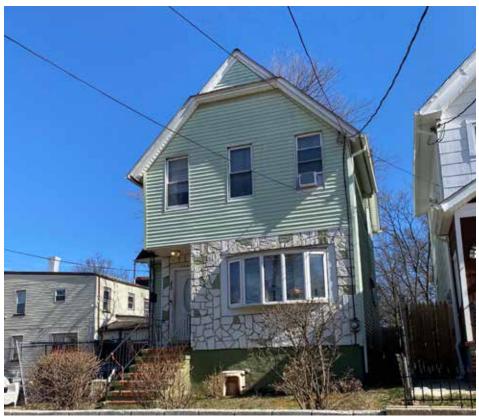
Besides the residential dwelling standing on the property, there are other site improvements present, including an asphalt driveway, cinder block retaining wall, concrete walkway, brick steps and railing. It appears occupants of this property utilize Block 116, Lot 1 as their yard. A chain-link fence also surrounds the perimeter of this property.

The property is deficient in several zoning regulations for singlefamily dwelling of the R-4 Moderate Density Residential District including minimum lot size (7,500 square feet) and minimum lot width (50 feet).

Based on these existing conditions, Block 116, Lot 34 should not be designated as an "area in need of redevelopment."

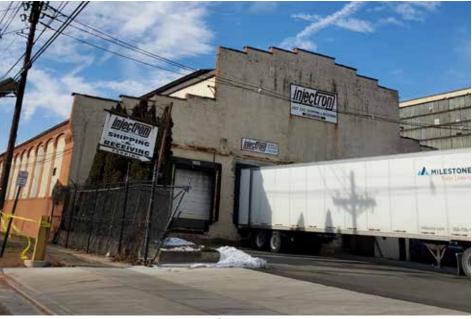
• **Criteria "D"**: One of the site's loading areas is setback into the building approximately 85 feet. The facility has a 0-foot front yard setback along South Second Street except at this curb cut and loading area. This creates potential hazardous conflicts between trucks unloading and motorists and pedestrians along South

Second Street. The majority of the site is covered with impervious coverage, which can contribute to stormwater management issues such as runoff onto adjacent properties. Exterior deterioration was observed, including peeling paint, rust, graffiti and barbed wire fencing along a portion of the property. Window openings were not visible preventing adequate light for work conditions. Current operations within this facility are obsolete for modern industrial needs. This is evidenced by the building's age, expansive and obsolete layout, and the narrow curb cuts which make commercial truck access difficult. The parking areas at the easternmost and westernmost ends of the site are enclosed with chain-link fences that contain barbed wire at the top, which is banned in the City. Cumulatively, these conditions are detrimental to the public health, safety and general welfare of the community.

• **Criteria** "G": The property is located within the City's designated Urban Enterprise Zone.

Based on these existing conditions and the satisfied LRHL criteria, Block 117, Lot 1.01 & C0001 should be designated as an "area in need of redevelopment."

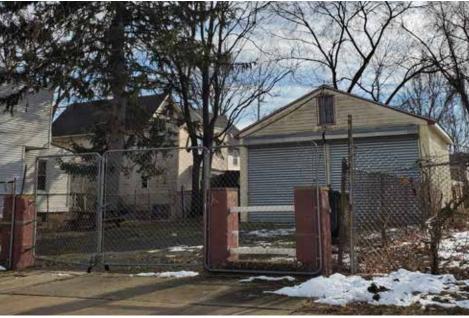
• **Criteria** "D": The site is in need of maintenance as there is vegetation overgrown exposed wires, and debris present on the property. Dirt and soot were visible on the building. The chain-link fence showed signs of rusting and deterioration. To that

end, cumulatively, this lack of maintenance demonstrates that the current commercial use is not active. These physical conditions present detriments to the public health, safety, and general welfare of the community.

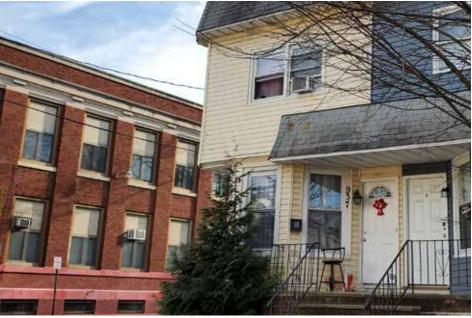
Besides the residential dwelling standing on the property, there are other site improvements present, including concrete steps and a metal railing. An asphalt parking area is accessible via the site's Prescott Place frontage. During the time of the site visit, there were structural deficiencies present on the building, including missing shingles on the roof and paint chipping at the base of the building.

The property is deficient in several zoning regulations for singlefamily dwellings in the R-4 Moderate Density Residential District including minimum lot size (7,500 square feet) and minimum lot width (50 feet).

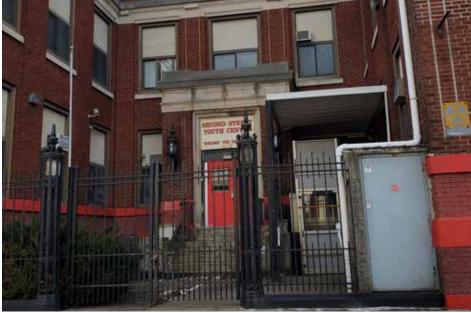
During the time of the site investigation, numerous deficiencies were observed in the building's interior. Exposed electrical wires were present throughout many of the rooms. Stained tiles hung from the ceiling and the walls within the facility and peeling paint covered the walls. Kitchen equipment was removed and only part of the kitchen facility was still intact. Debris was also found scattered in parts of the building and on the premises in general, which invites pests. Based on these observations, it appears the property has not been maintained. These building and site issues pose hazardous conditions to the health, safety, and general welfare of the community.

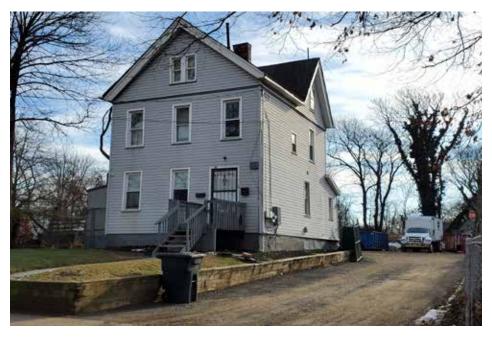
In addition to the residential dwelling standing on the property, other site improvements present were a concrete walkway, wooden retaining wall, and wooden steps and railing. A wide gravel driveway provides access to a large parking area within the rear yard of the site. Within this rear parking area, multiple trailers were stored as well as other structures, including an accessory shed. A contracting business appears to be active on the property. A chain-link fence was present along the easterly and westerly property lines and gate openings enclosed the rear yard.

Although home occupations is a permitted accessory use in the R-4 District, the contracting business onsite is not a permitted use per the regulations of home occupations in the Land Use Ordinance (Section 17:9-33).

• **Criteria** "D": Trucks and trailers stored in the rear yard in association with the contracting business. The presence and use of these commercial vehicles and outdoor storage demonstrate detrimental conditions the public health, safety, and general welfare of the community, especially with a multi-family residential property abutting the site along its southerly property line.

Based on these existing conditions and satisfied LRHL criteria, Block 131, Lot 18 should be designated as an "area in need of redevelopment."

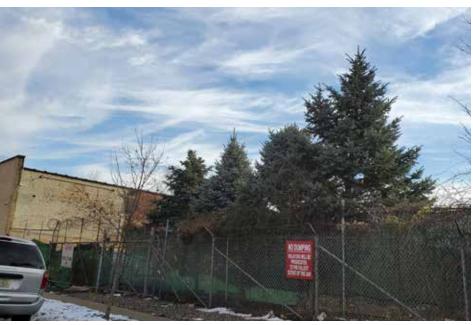
• **Criteria "D"**: The site is in need of maintenance and presents perilous conditions. The presence of barbed wire, which is banned in the City, and multiple curb cuts can be hazardous to pedestrians,

which is banned in the City. The excessive impervious coverage of the parking area can lead to stormwater management issues and runoff onto adjacent properties. Cumulatively, the conditions of this property are detrimental to the public health, safety and general welfare of the community.

Based on these existing conditions and satisfied LRHL criteria, Block 131, Lot 19 should not be designated as an "area in need of redevelopment."

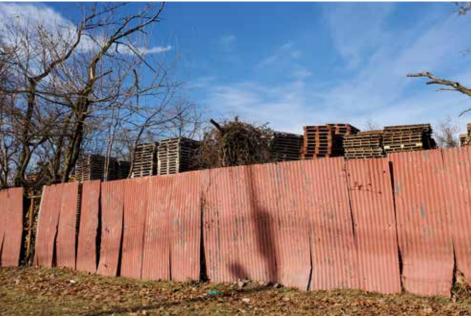
Numerous buildings and structures are standing on the property. A hanger on the property shows signs of rust and need for maintenance. A brick and cement wall lines a large portion of the frontages along Clinton Avenue and continues along the eastern portion of South Second Street. A red metal fence also lines the site along South Second Street at its westerly portion. The fence is in need of maintenance as the paint is peeling and damaged.

There are three curb cuts present along the property's South Second Street frontage. At the northerly curb cut, there is a chainlink gate that contains barbed wire at the top. Additionally, there is a metal frame structure that was utilized with an older gate, which is no longer present.

Multiple buildings and structures show signs of deterioration with peeling paint and rust.

Many pallets are stored in haphazard arrangements giving the appearance of litter as opposed to materials being actively used by the business.

• Criteria "A": Several buildings onsite are no longer conducive for living or working conditions. Buildings at the site's northerly end are aged and windows are missing.

• Criteria "D": The arrangements of buildings and structures in association with the industrial use of the property are no longer conducive to modern industrial and manufacturing needs. Many of the pallets stacked and stored on the property are not covered and are vulnerable to damage from events such as storms and fires. To that end, the obsolete layout is detrimental to the public health, safety and general welfare the community. Although there are two curb cut present on the site, it appears the southerly curb cut is primarily used. Based on the expansive vastness of the site, this could be problematic in the event of emergency vehicles accessing the site at portions that are away from this curb cut and vehicular access point.

Based on these existing conditions and satisfied LRHL criteria, Block 137, Lot 1 should be designated as an "area in need of redevelopment."

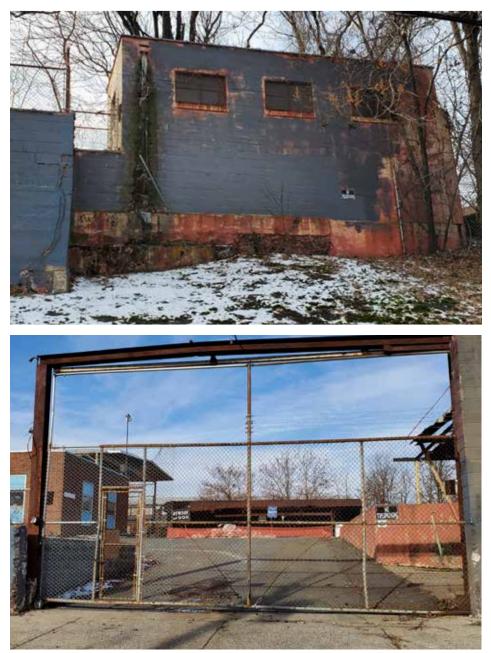
1600-1612 SOUTH SECOND STREET (BLOCK 137, LOT 2) PROPERTY EVALUATION

use, which was a state-operated vehicle inspection facility. It has not been occupied since this facility vacated in 2018. To that end, the layout of the site is obsolete. The property's conditions are an eyesore. These conditions are detrimental to the public health, safety, and general welfare the community.

Based on these existing conditions and satisfied LRHL criteria, Block 137, Lot 2 should not be designated as an "area in need of redevelopment."

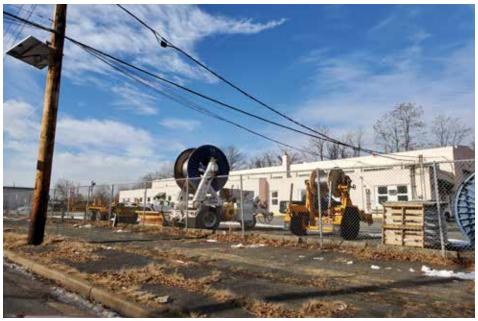
- **Criteria** "B": The commercial property has been vacant for over two consecutive years.
- Criteria "D": The site is no longer conducive to its former

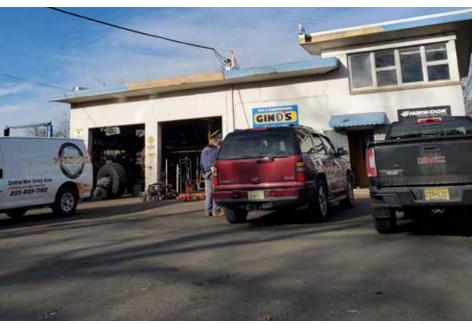
• **Criteria "D"**: The existing arrangement of the site is deleterious. The majority of the site is covered with impervious surfaces, which can negatively impact stormwater management and lead to runoff onto adjacent properties. Deterioration is present on the site, especially rust on the freestanding sign, which demonstrates signs of neglect. The chain-link fence contains barbed wire at its top, which is banned in the City and is also hazardous

to the public. Tires were haphazardly stored along the northerly property line. Overall, the site's conditions are detrimental to public health, safety, and general welfare of the community.

Based on these existing conditions and satisfied LRHL criteria, Block 137, Lot 3 should not be designated as an "area in need of redevelopment."

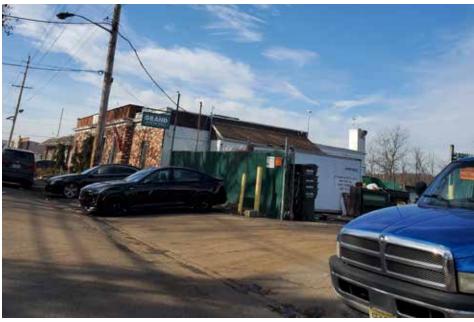
• **Criteria "D"**: The existing arrangement of the site is faulty. The 6-bay garage is positioned close to the frontage of the property, which restricts access of the vehicles accessing the bays. Numerous vehicles were also parked on the site's sidewalk and

these conditions pose hazards to the pedestrians and motorists. The parking area in the rear, where the sanitation service business vehicles and equipment are stored, do not have delineated spaces or areas for storage and directional arrows are also absent. This lack of necessary infrastructure can create vehicular conflicts.

Based on these existing conditions and satisfied LRHL criteria, Block 137, Lot 4 should not be designated as an "area in need of redevelopment."

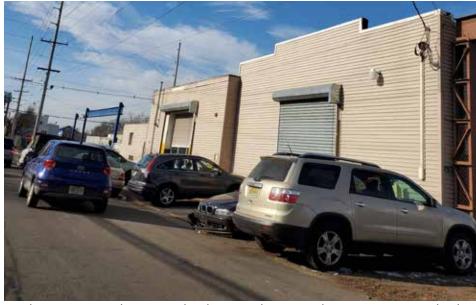
Criteria "D": With many vehicles parked on the site's South Second Street frontage, the abundance of curb cuts and parked vehicles creates conflicts. This especially has impacts on

pedestrians as these parked cars obstruct their access. Vehicles exiting the site are also subject to dangerous conditions as these parked cars block sight distances. Vehicles parked at the rear of the property are parked in a haphazard arrangement. A portion of the chain-link fence contains barbed wire, which is banned in the City and is a safety hazard to the community. Two large overhang structures previously used in operation of the gated entrances along South Second Street no longer serve this purpose and to that end, are obsolete and could restrict large vehicles from safely accessing the site. Overall, the existing arrangement of the site is deleterious.

Based on these existing conditions and satisfied LRHL criteria, Block 137, Lot 5 should not be designated as an "area in need of redevelopment."

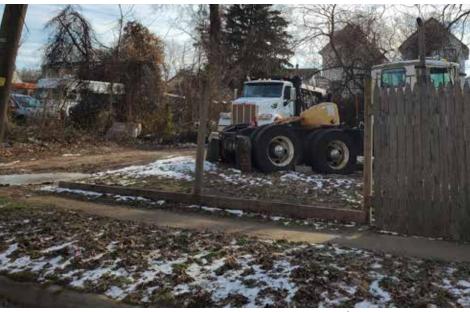
• Criteria "D": The vehicles are parked haphazardly on the

property. Additionally, adequate parking areas for these vehicles (i.e., driveways) are absent from the site. The apparent stalled construction of the building on the property could lure nefarious activity. Multiple zoning violations have also been issued to this property the City. To that end, the existing conditions of the lot are detrimental to the public health, safety and general welfare of the community.

This site was previously designated as an "area in need of redevelopment" as set forth in the "Citywide In Need of Redevelopment Study of City-Owned, Foreclosure and Bankrupt Properties", which was adopted by City Council on September 13, 1999. Based on the previous designation of this property, Block 138, Lot 2.01 does not need to be designated as an "area in need of redevelopment" as a part of this study as the condition of the property remains unchanged.

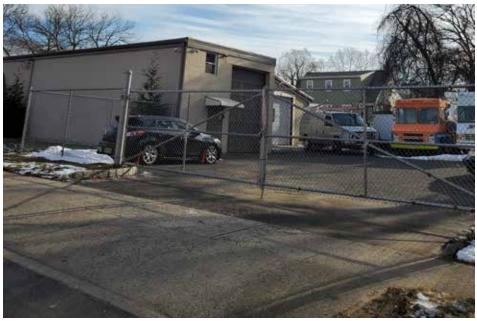
• **Criteria** "D": The abundance of vehicles parked on site demonstrates detriments to the public health, safety and general welfare of the community as some of these vehicles partially block access to the site, which can lead to issues especially when accessing the site in the event of an emergency. Additionally, these parking spaces were not delineated which is necessary for proper vehicular

circulation and safety.

Based on these existing conditions and satisfied LRHL criteria, Block 138, Lot 3 should be designated as an "area in need of redevelopment."

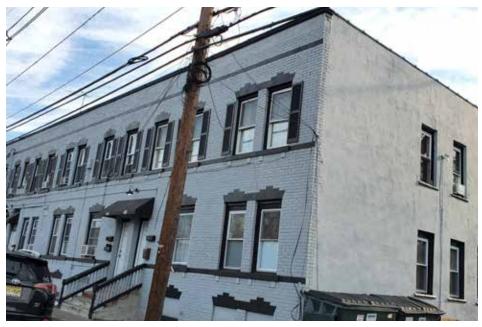
1301-1315 SOUTH SECOND STREET (BLOCK 140, LOT 6 & 6X) PROPERTY EVALUATION

Besides the mixed-use building, other site improvements onsite include an asphalt driveway at the westerly end of the property with a curb cut providing access from South Second Street. Refuse containers are also located at the westerly driveway. At the easterly corner of the site, there is a concrete covered area which extends into the dead-end portion of Evona Avenue. Although partially off-site, this concrete-covered area restricts access to the building and site from South Second Street, especially in the event of an

emergency.

Based on these existing conditions, Block 140, Lot 6 & 6X should not be designated as an "area in need of redevelopment."

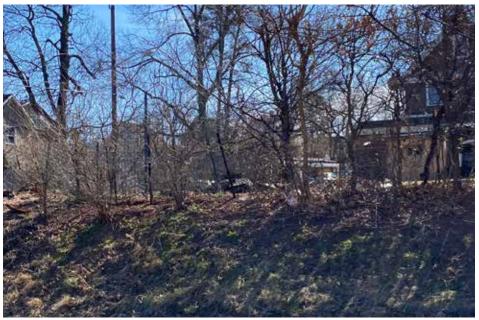
The property is deficient in zoning regulations for single-family dwellings in the R-4 Moderate Density Residential District including minimum lot size (7,500 square feet) or two-family dwelling (10,000 square feet).

• **Criteria "C"**: The property has been vacant for over 10 consecutive years.

Although LRHL criteria is satisfied, it is recommended that Block 148, Lot 6 should not be designated as an "area in need of redevelopment" because no other adjacent lots also qualify.

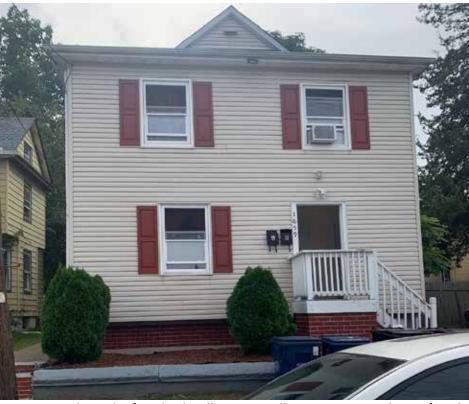
• **Criteria** "D": The three-family dwelling standing on the property is not a permitted use in the R-4 District. With a lot size of 3,000 square feet, this lot significantly undersized to accommodate

a permitted single-family dwelling as well as a permitted two-family dwelling. Based on these conditions, this demonstrates physical overcrowding on the site. To that end, the lot is detrimental to the public health, safety and general welfare of the community

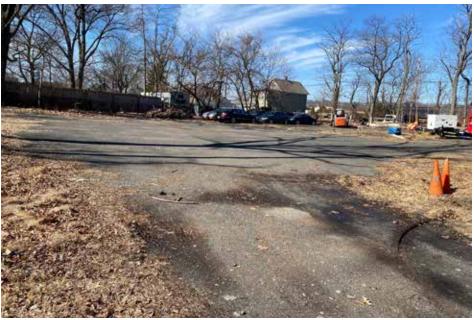
• Criteria "D": The existing permitted use is not permitted in R-4 District. Vehicular access via Willever Street can be disruptive to residences along this street as commercial vehicles are stored on this lot. Lot 5 must be utilized in order to access the site from South Second Street. The equipment and materials stored on the property are not covered properly or secured in a storage

structure. Because of the nature of these conditions, the property is detrimental to the public health, safety and general welfare of the community

Based on these existing conditions and satisfied LRHL criteria, Block 152, Lot 6 should be designated as an "area in need of redevelopment."

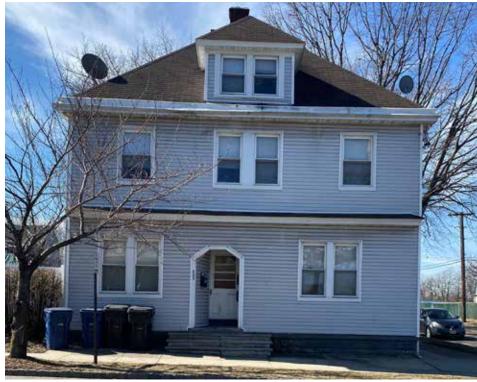
Besides the two-family dwelling onsite, other site improvements include a stone steps stone steps and walkway, white board fence, and wooden and metal railings. An unpaved driveway with vehicular access along South Second Street leads to a one-story, two-car accessory garage. A detached shed is also present in the rear yard.

The property is deficient in zoning regulations for single-family dwelling of the R-4 Moderate Density Residential District including minimum lot size (7,500 square feet).

Based on these existing conditions and satisfied LRHL criteria, Block 153, Lot 1 should be designated as an "area in need of redevelopment."

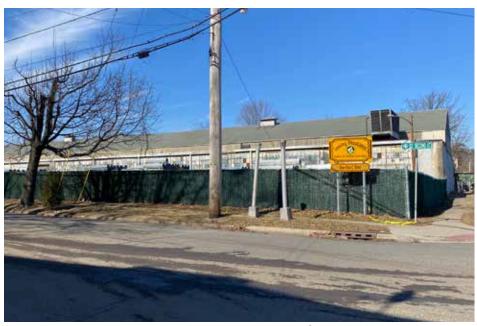
• **Criteria** "D": Building deficiencies were observed including the presence of rust and peeling paint. Supplies and equipment were stored outside the industrial facility. Outdoor storage can

lead to hazardous conditions, especially if the building needs to be accessed in the event of an emergency. The majority of the property is covered with impervious coverage, which can contribute to the heat island effect as well as stormwater management issues such as runoff onto adjacent properties. Truck loading and parking spaces were not clearly delineated, which are necessary for safe vehicular circulation. To that end, the dilapidation is detrimental to the public health, safety and general welfare of the community.

Based on these existing conditions and satisfied LRHL criteria, Block 154, Lot 1 should be designated as an "area in need of redevelopment."

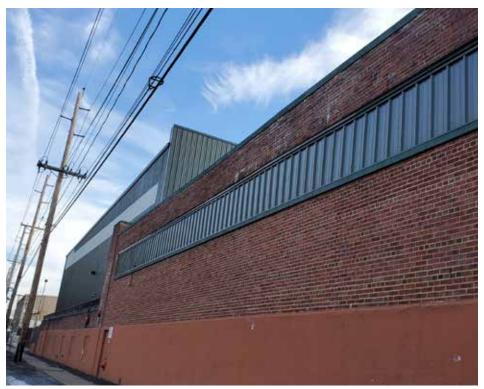
• Criteria "D": The site is almost completely covered with impervious coverage, with the building spanning the majority of the property. This can lead to stormwater management issues, such as runoff onto adjacent properties. There are essentially no windows present on the southerly and easterly building façades, which can impede adequate light and air. The building has a 0-foot front yard setback, which obstructs necessary sight lines for drivers of vehicles leaving the site and accessing West Front Street and

creates hazardous environment for both drivers and pedestrians. Overall, these existing physical conditions are detrimental to the public health, safety and general welfare of the community.

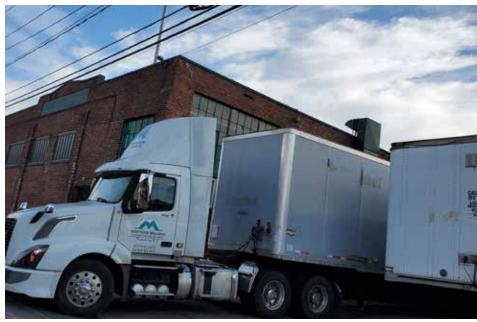
• Criteria "D": Essentially the entire site is covered with impervious coverage. The truck loading conditions are perilous as large trucks must back into the bays fronting West Front Street. This can be dangerous for motorists traveling along both directions

of West Front Street. Additionally, pedestrian conditions are hazardous, especially since the building has a 0-foot front yard setback north of the loading bays, which impedes the views of the truck drivers and pedestrians alike. Overall, these existing physical conditions are detrimental to the public health, safety and general welfare of the community.

Based on these existing conditions and satisfied LRHL criteria, Block 202, Lot 1.2 should be designated as an "area in need of redevelopment."

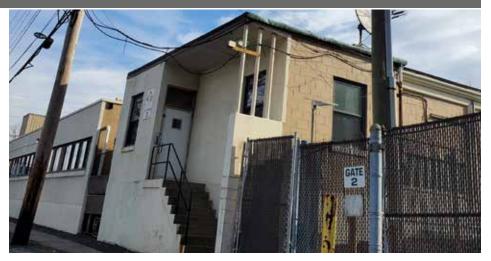
Besides the complex of commercial buildings standing on the property, other site improve-ments consist of surface parking, chainlink fences with gate openings and barbed wire at the top, and other structures and equipment associated with the establishment's operations. Ve-hicular access to the site is provided via curb cuts along West Front Street and Rock Avenue. Other metal bars and poles are also present at the property's frontage.

Criteria "D": The site, in general, is not conducive to modern industrial uses and needs. Operations are spread out in numerous buildings rather than concentrated and consolidated in one building. To that end, a faulty arrangement and obsolete design are present due to the separated, fragmented, and scattered nature of these existing buildings. With necessary loading and parking space delineation absent, and no clear circulation pattern (including directional arrows), this can cause dangerous conditions pertaining to internal vehicular circulation. The barbed wire fence, which is banned in the City, is perilous to the general welfare of the public. Other metal bars and poles attached to the dates along the site's frontages are rusting and are no longer serving a purpose. Lastly, the entire site is essentially covered with impervious coverage, which can lead to stormwater management issues and runoff onto adjacent properties. Cumulatively, these conditions poses as detriments to the public health, safety and general welfare of the community.

Based on these existing conditions and satisfied LRHL criteria, Block 202, Lot 1.02 should be designated as an "area in need of redevelopment

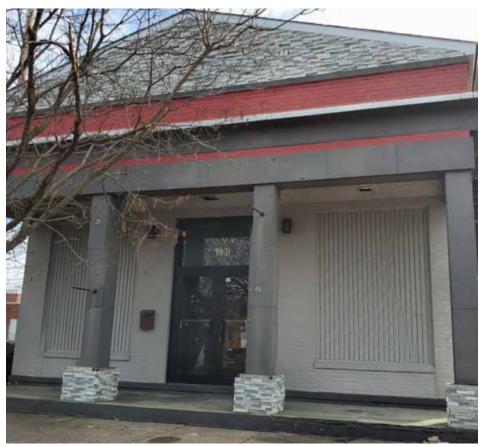
Besides the principal building on the property, other site improvements include an inactive freestanding sign, a drive-through structure that appears to have been formerly used in association with a bank and trailer. Vehicular access to the site is provided at curb cuts along both West Front Street and Clinton Avenue. A chain-link fence with gate is located at both curb cut entrances.

• **Criteria** "D": Multiple structures existing on the property are no longer in operation, including the freestanding sign and the drive-through teller structure, which appeared to be associated with a former bank. These defunct structures are not utilized by the existing occupant of the property, causing an obsolete layout of the site. The drive-through structure obstructs vehicular access traveling through the site from West Front Street to Clinton Avenue.

This circulation restriction can hinder public safety, especially in the case of an emergency. At the same time, at the rear of the property, there is no separation from Lot 2, which can cause vehicular conflicts. Taken together, these components arise to the property being detrimental to the public health, safety and general welfare of the community.

Based on these existing conditions and satisfied LRHL criteria, Block 202, Lot 1 should be designated as an "area in need of redevelopment."

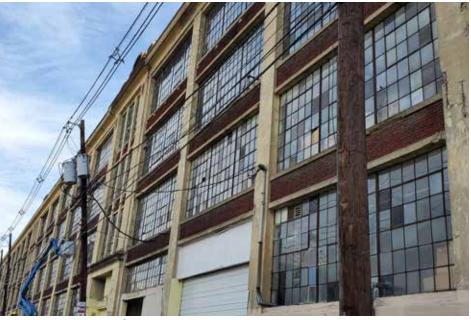
• Criteria "D": Deterioration present on the exterior of the

building. Some of the windows are broken or completely open with glass missing. Loading in rear which can be accessed via Clinton Avenue; however, trucks must travel though the rear of Lot 1 to access this loading area. There are other loading areas with gate access directly onto West Front Street. These loading areas are within a 0' front yard building setback, which can cause dangerous conditions for pedestrians and motorists alike. Overall, the lot has challenging access due to the vast building on the site. Lastly, the lot contains excessive land coverage as it is nearly completely impervious with building covering essentially the entire property, which can contribute to stormwater management issues and runoff onto adjacent properties. Cumulatively, these site conditions are detrimental to the public health, safety and general welfare of the community.

Based on these existing conditions and satisfied LRHL criteria, Block 210, Lot 2 should be designated as an "area in need of redevelopment."

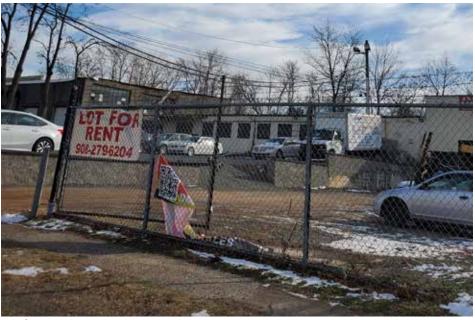
• Criteria "D": The site is essentially covered with impervious

surfaces. This can lead to negative impact such stormwater management, runoff onto adjacent properties, and contributing to the heat island effect. The barbed wire fence is prohibited in the City and can be perilous to pedestrians passing by. The site improvements are obsolete as the site has not been used as a used automobile sales establishment for numerous years. The ongoing vacancy of the property is problematic to adjacent property owners as it detracts their value. It is an eyesore as it is a gap in the buildup, industrial character of West Front Street. To that end, this dilapidation is detrimental to the public health, safety and general welfare of the community.

Based on these existing conditions and satisfied LRHL criteria, Block 210, Lot 3 should be designated as an "area in need of redevelopment."

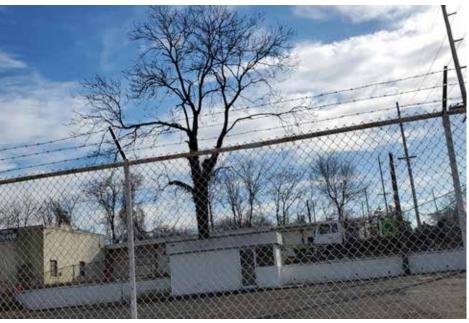
• Criteria "D": Vehicles stored on the site are parked and arranged in a haphazard fashion. Necessary infrastructure is missing, including a consistent paved surface and directional arrows displaying a clear circulation pattern. This can create conflicts among motorists and pedestrians. A portion of the site, particularly at its southwestern corner, is in need of maintenance as

there is overgrown vegetation present. The commercial building on the property contains rust and vegetation. Lastly, the lack of property maintenance is also evident from the delinquent tax payments, which demonstrates the property owner's disregard for the lot. Overall, these conditions are detrimental to public health, safety and general welfare of the community.

Based on these existing conditions and satisfied LRHL criteria, Block 210, Lot 4.01 should be designated as an "area in need of redevelopment."
