Area in Need of Redevelopment Investigation

TODD-South Study Condemnation
City of Plainfield, New Jersey

TODD-South Study

City of Plainfield, New Jersey

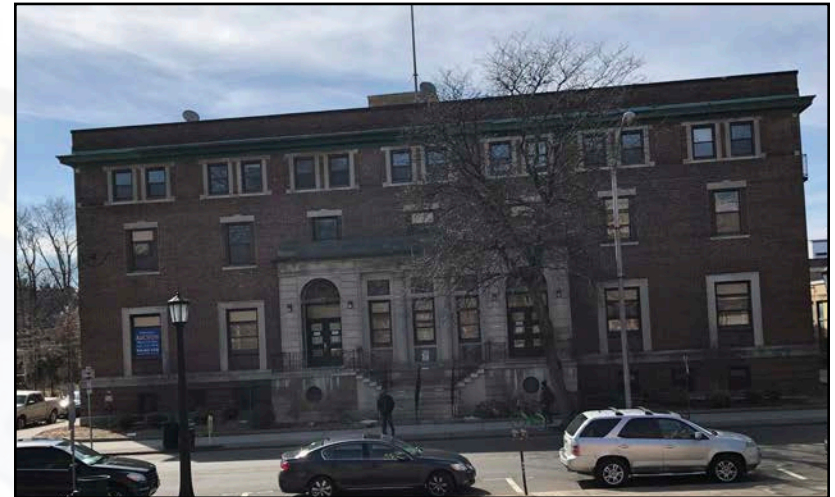
Property is vacant and currently up for auction. The property is listed as a contributing building to the Civic Historic District. The property has a low improvement ratio. Broken and boarded windows can be seen from E. 6th Street and Cleveland Avenue

Criteria B: The site is the location of the former YMCA. The site has been vacant for over a year and the windows on the ground floor are covered with boards from the interior. Historic buildings usually deteriorate and become structurally unstable if left vacant for an extended period of time which could result in the structure becoming untenable.

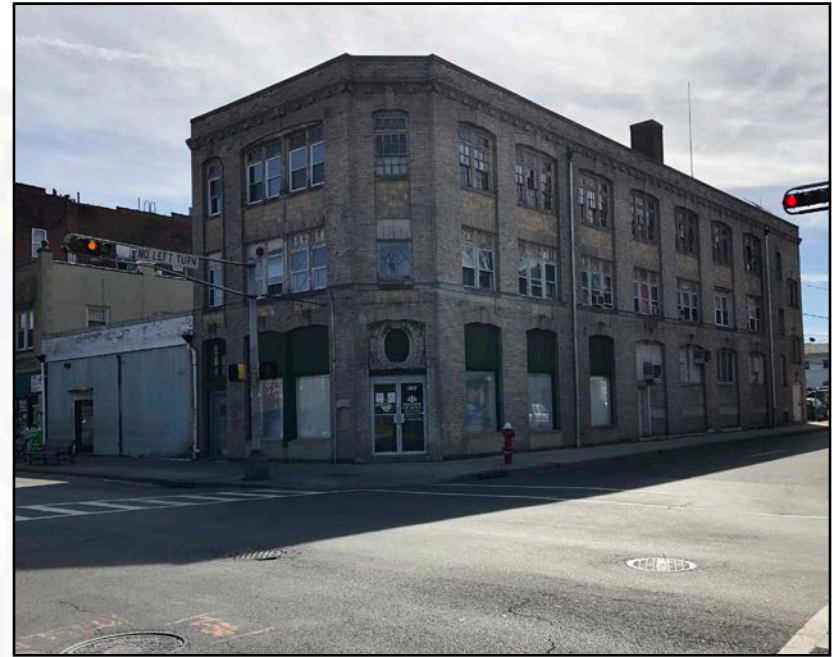
**TODD CENTRAL
BUSINESS ZONE****ADDRESS: 400-404 Watchung Avenue
BLOCK: 836 LOT: 1****PROPERTY DESCRIPTION**

Rectangular lot. Three story commercial building. Current use: office space. The lot size is 7,958 sq. ft. Built in 1910.

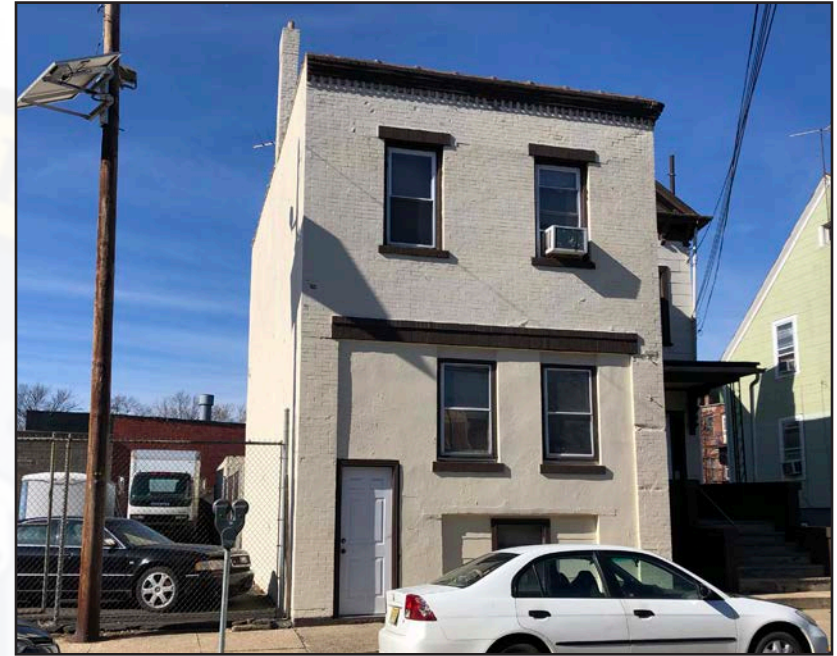
**TODD CLEVELAND
ARTS ZONE****ADDRESS: 143-145 E. 5th Street
BLOCK: 836 LOT: 9****PROPERTY DESCRIPTION**

Rectangular shaped lot. Residential structure with four units. Two story building. Built in 1906. The lot size is 4,438 sq ft.

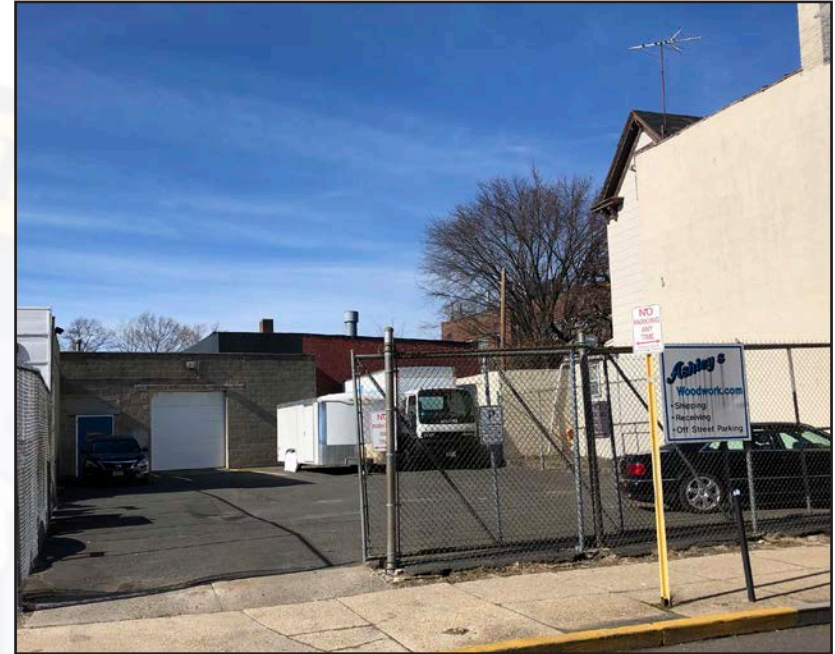
**TODD CLEVELAND
ARTS ZONE****ADDRESS: 131-137 E. 5th Street
BLOCK: 836 LOT: 11****PROPERTY DESCRIPTION**

Rectangular shaped parcel. One story commercial building. Current use: auto body. The lot size is 6,393 sq ft. Built in 1935.

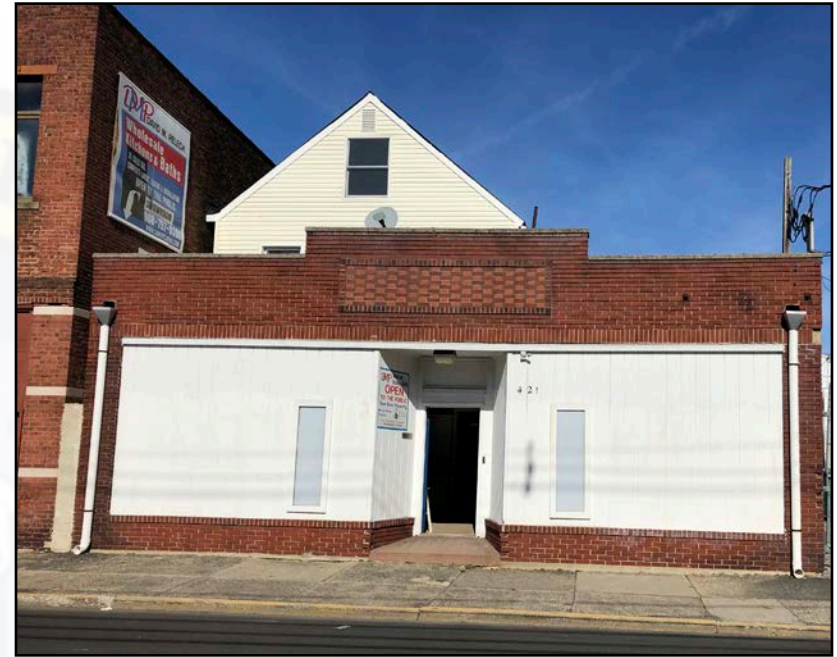
**TODD CLEVELAND
ARTS ZONE****ADDRESS: 417-419 Cleveland Avenue
BLOCK: 836 LOT: 13****PROPERTY DESCRIPTION**

Rectangular shaped parcel. Two story commercial building. Current use: temporary storage. The lot size is 7,501 sq. ft. Built in 1910.

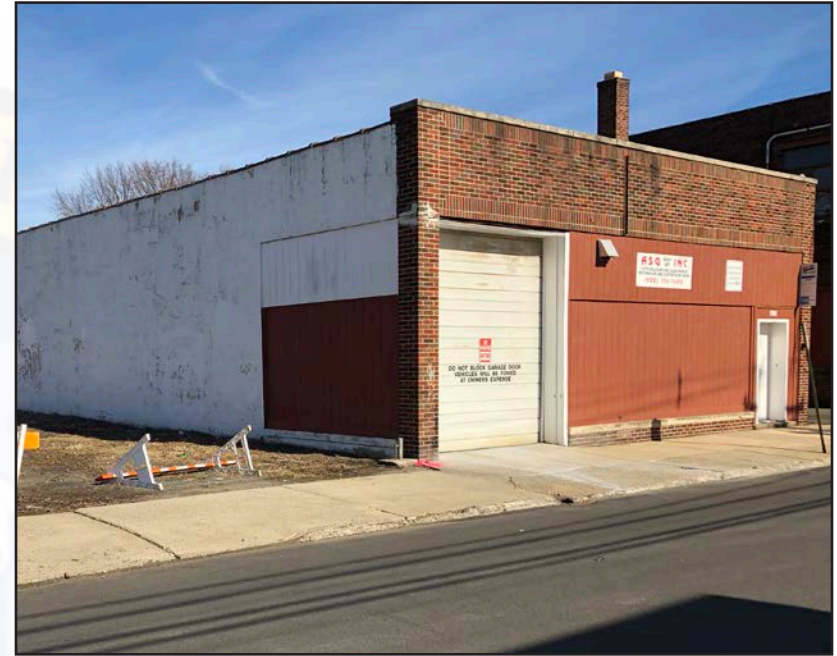
**TODD CLEVELAND
ARTS ZONE****ADDRESS: 413-415 Cleveland Avenue
BLOCK: 836 LOT: 14****PROPERTY DESCRIPTION**

Irregular shaped parcel. Two story commercial building. Current use: auto body. The lot size is 10,285 sq. ft. Built in 1910.

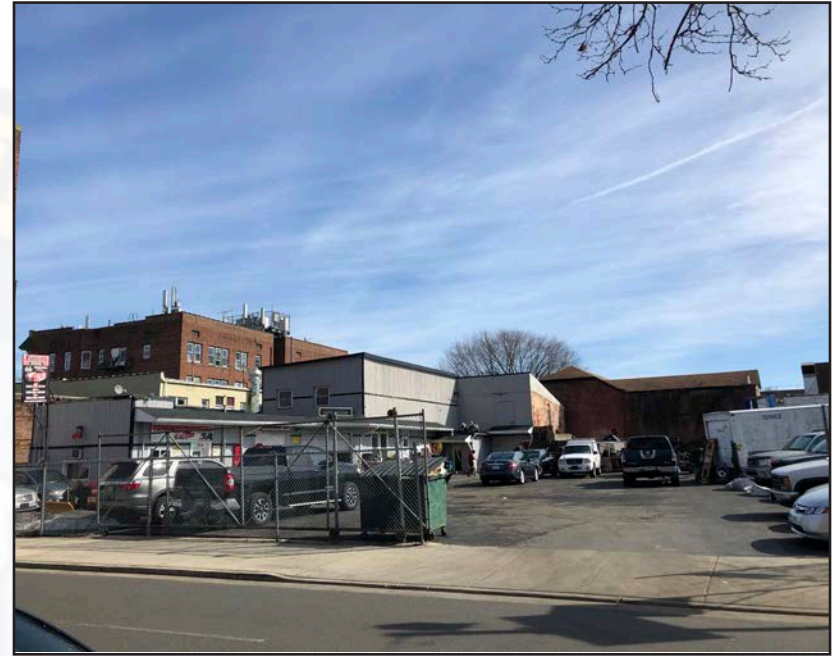
**TODD CLEVELAND
ARTS ZONE****ADDRESS: 140-144 E. 4th Street
BLOCK: 836 LOT: 17****PROPERTY DESCRIPTION**

Rectangular shaped lot. Paved lot. Current use: auto body shop. The lot size is 6,399 sq. ft sq. ft.

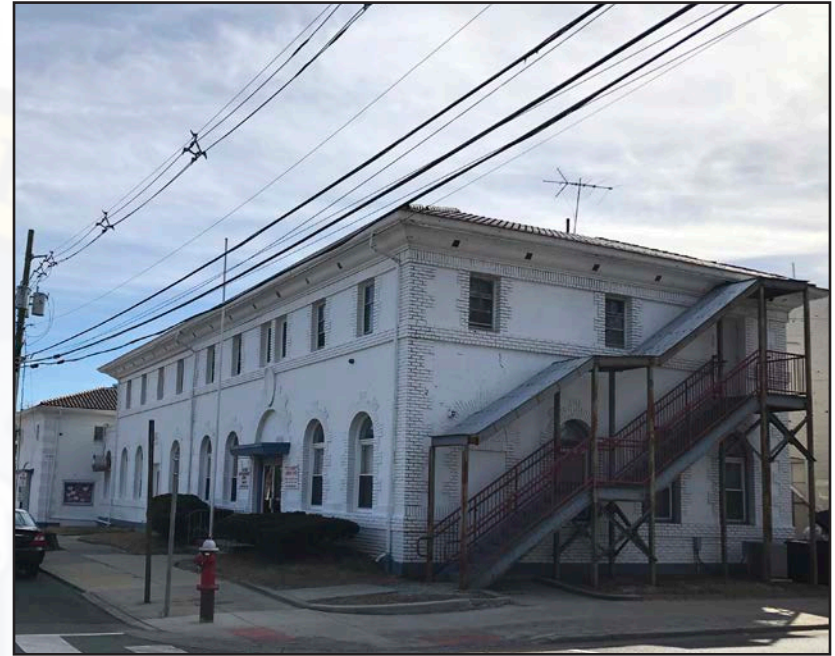
**TODD CLEVELAND
ARTS ZONE****ADDRESS: 400-410 Cleveland Avenue
BLOCK: 839 LOT: 1****PROPERTY DESCRIPTION**

Rectangular shaped lot. Two story commercial building. Current use: day care. The lot size is 8,015 sq. ft sq. ft.

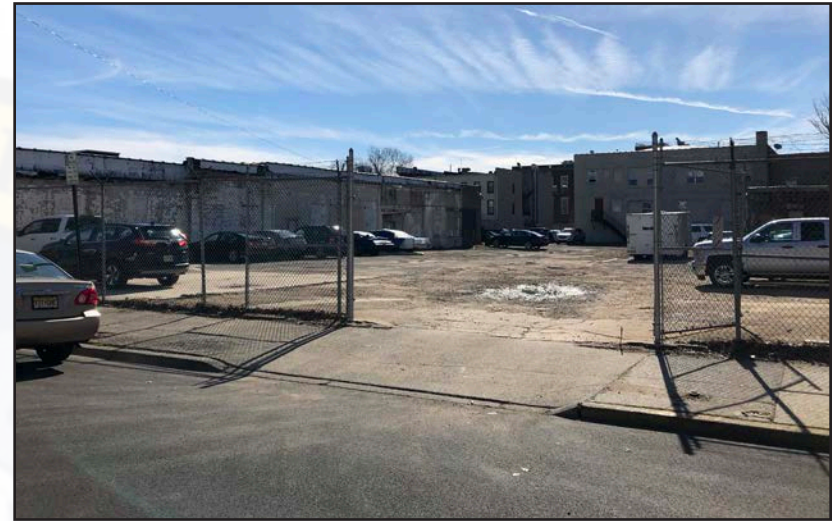
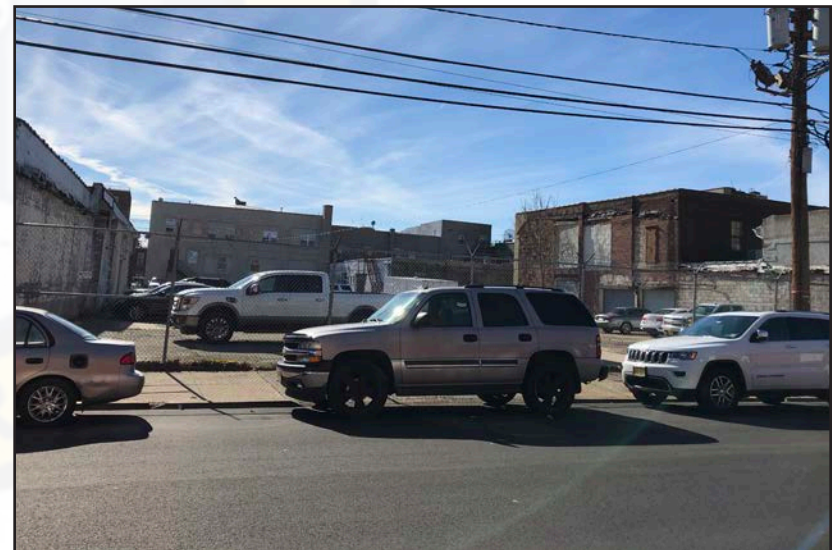
**TODD CLEVELAND
ARTS ZONE****ADDRESS: 412-414 Cleveland Avenue & 415-418 Cleveland Avenue
BLOCK: 839 LOT: 2 & 3****PROPERTY DESCRIPTION**

Rectangular shaped lots. Asphalt paved parcels. The lot sizes are 5,955 sq. ft and 6,883 sq. ft.

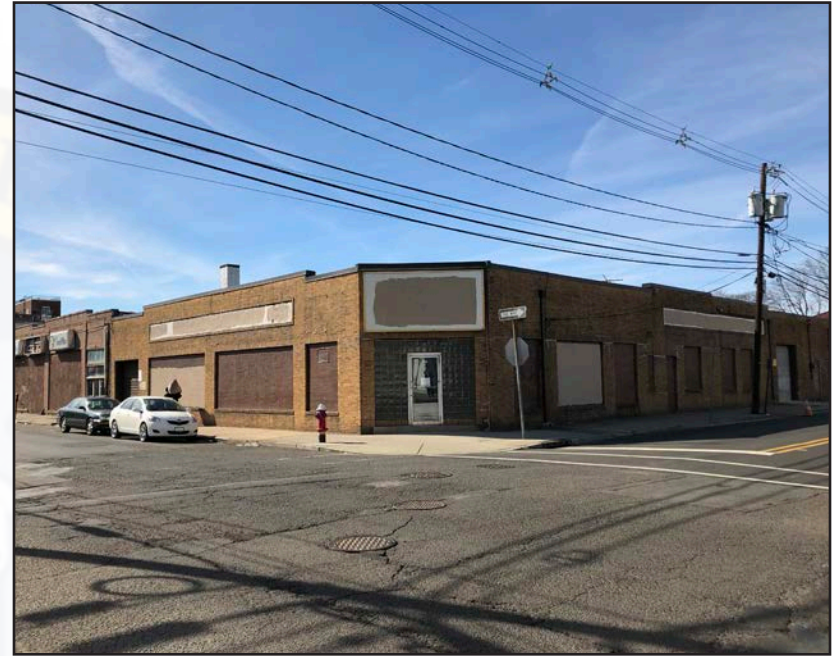
**TODD CLEVELAND
ARTS ZONE****ADDRESS: 123-129 E. 5th Street
BLOCK: 839 LOT: 4****PROPERTY DESCRIPTION**

Rectangular shaped lot. One story, commercial building. The lot size is 8,867 sq. ft. Built in 1940.

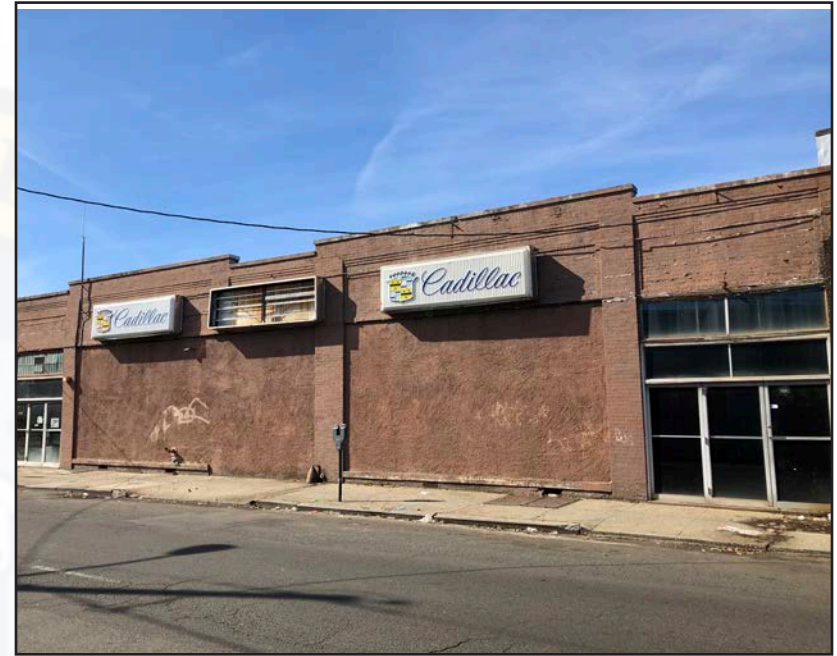
**TODD CLEVELAND
ARTS ZONE****ADDRESS: 115-117 E. 5th Street & 119-121 E. 5th Street
BLOCK: 839 LOT: 5 & 6****PROPERTY DESCRIPTION**

Rectangular shaped lots. One story, commercial building. The lot sizes are 4,432 and 6,033 sq. ft. Built in 1925.

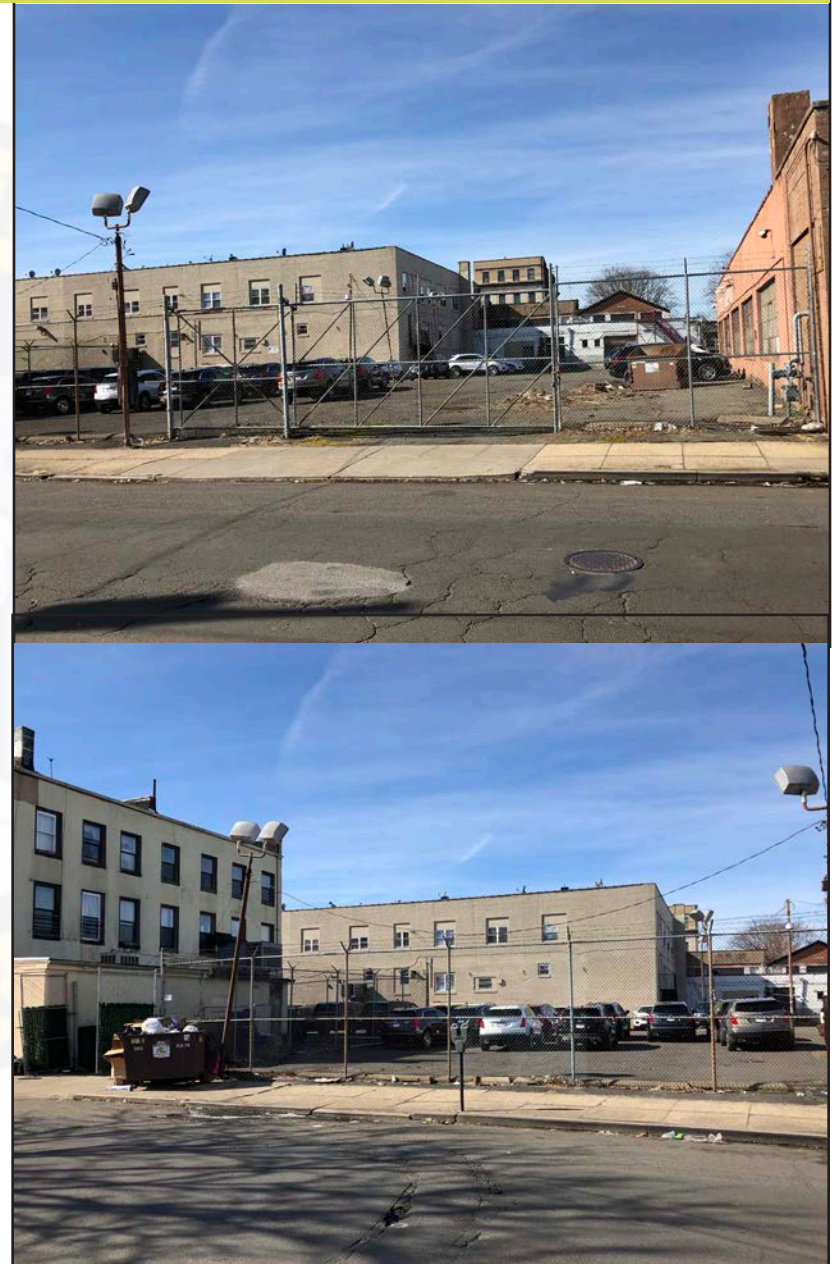
**TODD CLEVELAND
ARTS ZONE****ADDRESS: 111-113 E. 5th Street & 107-109 E. 5th Street
BLOCK: 839 LOT: 7 & 8****PROPERTY DESCRIPTION**

Rectangular shaped parcels. Asphalt Paving. Current use: inventory storage for car dealership. The lot sizes are 11,761 and 2,827 sq. ft.

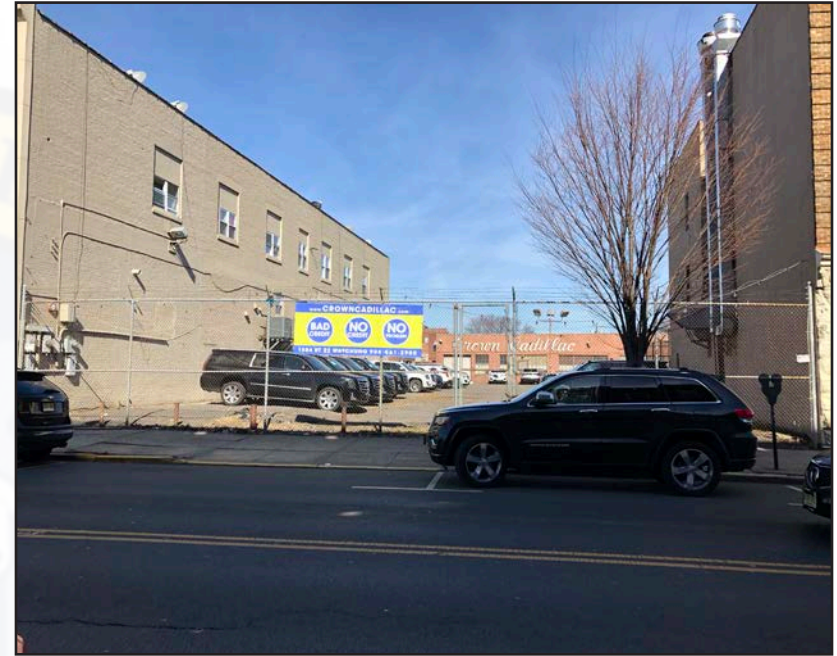
**TODD CENTRAL
BUSINESS ZONE****ADDRESS: 425-429 Park Avenue
BLOCK: 839 LOT: 11****PROPERTY DESCRIPTION**

Rectangular shaped parcel. Asphalt Paving, Inventory storage for car dealership. The lot size is 8,339 sq. ft.

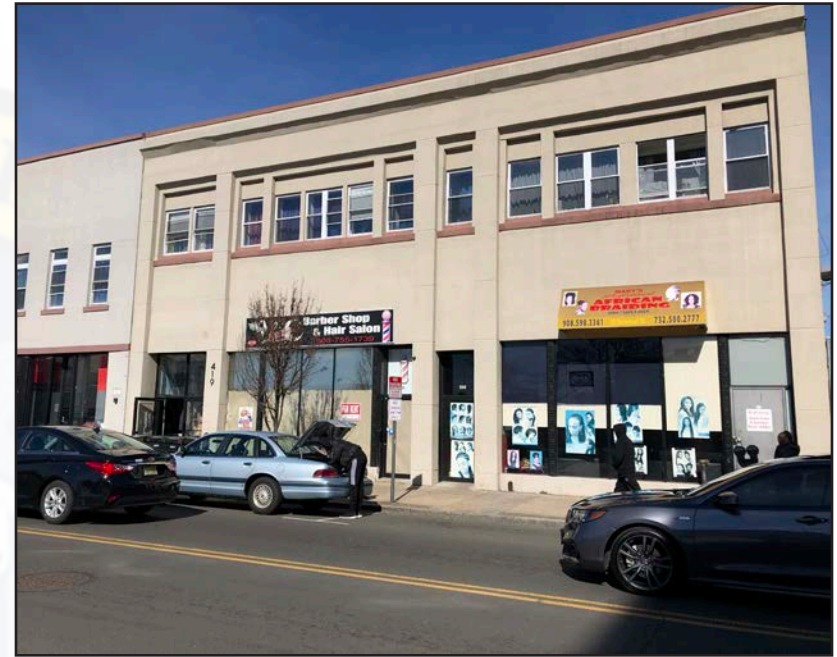
**TODD CENTRAL
BUSINESS ZONE****ADDRESS: 419-423 Park Avenue
BLOCK: 839 LOT: 12****PROPERTY DESCRIPTION**

Rectangular shaped parcel. Two story, commercial building with two storefronts and dwelling units above. The lot size is 8,735 sq. ft. Built in 1925.

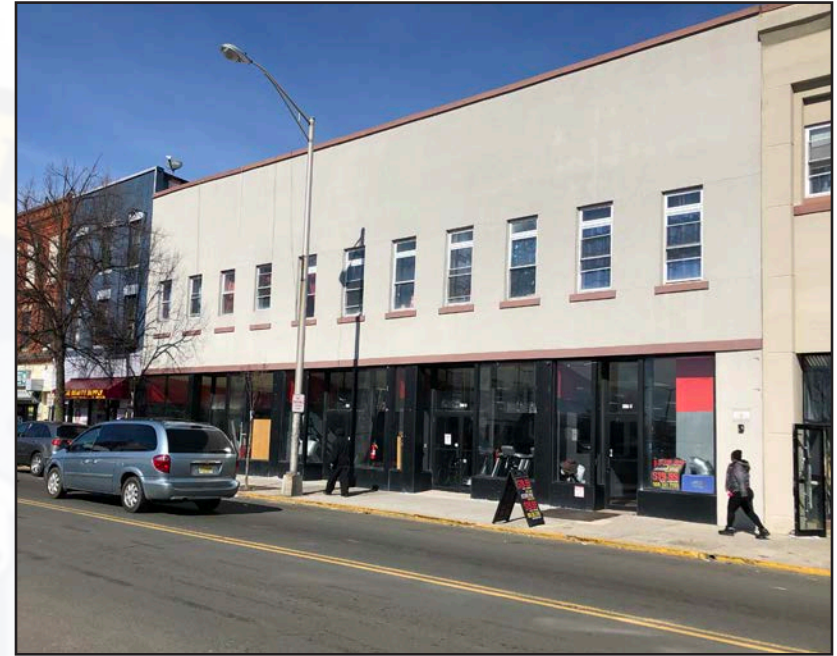
**TODD CENTRAL
BUSINESS ZONE****ADDRESS: 413-417 Park Avenue
BLOCK: 839 LOT: 13****PROPERTY DESCRIPTION**

Rectangular shaped parcel. Two story, commercial building with two storefronts with dwelling units. The lot size is 9,530 sq. ft. Built in 1925.

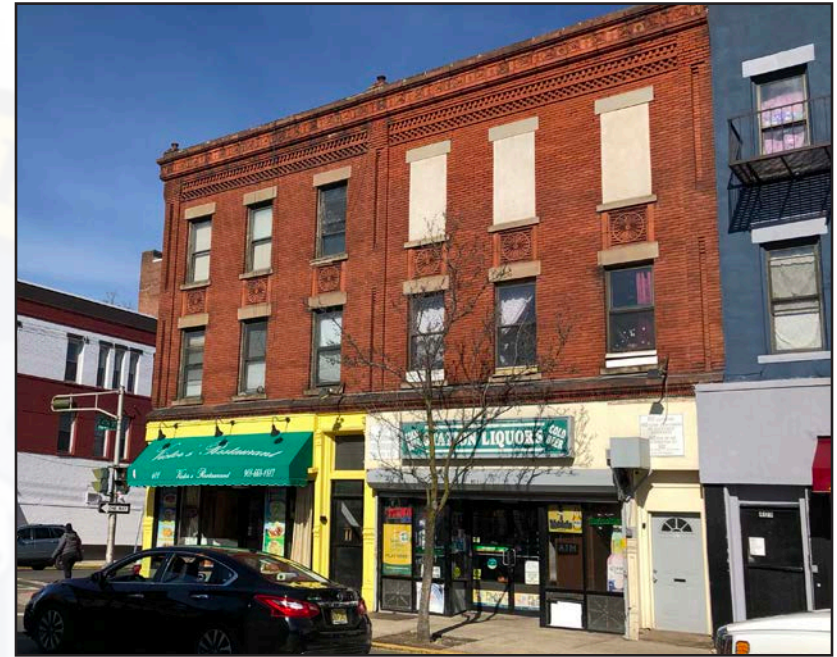
**TODD CENTRAL
BUSINESS ZONE****ADDRESS: 405-407 Park Avenue
BLOCK: 839 LOT: 15****PROPERTY DESCRIPTION**

Rectangular shaped parcel. Three story, mixed use building with one storefront and two dwelling units on the upper floors. The lot size is 1,732 sq. ft. Built in 1910.

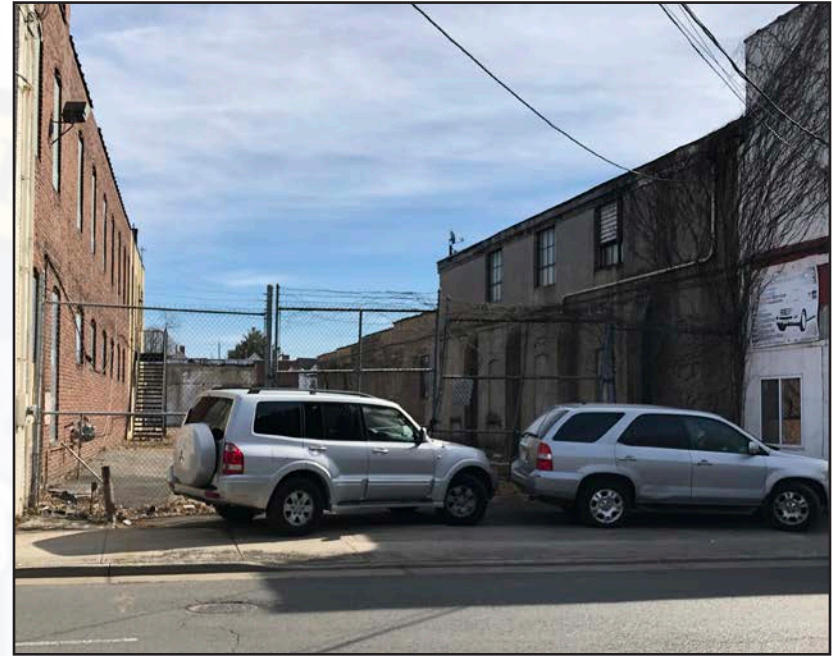
**TODD CLEVELAND
ARTS ZONE****ADDRESS: 120-122 E. 4th Street
BLOCK: 839 LOT: 19****PROPERTY DESCRIPTION**

Irregular shaped parcel. Asphalt paved lot. The lot size is 5,858 sq. ft.

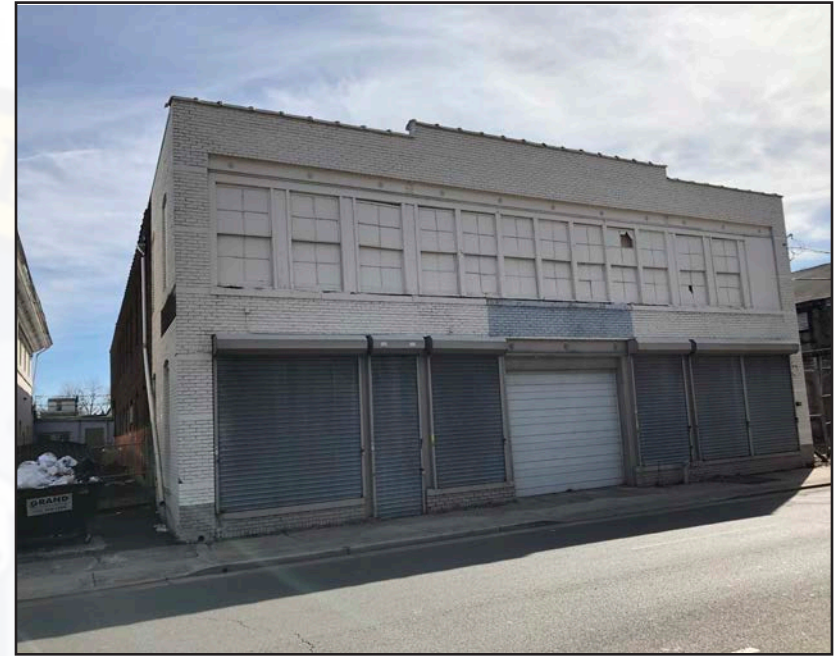
**TODD CLEVELAND
ARTS ZONE****ADDRESS: 124-128 E. 4th Street
BLOCK: 839 LOT: 20****PROPERTY DESCRIPTION**

Rectangular shaped parcel. Two story commercial building. The lot size is 7,810 sq. ft.

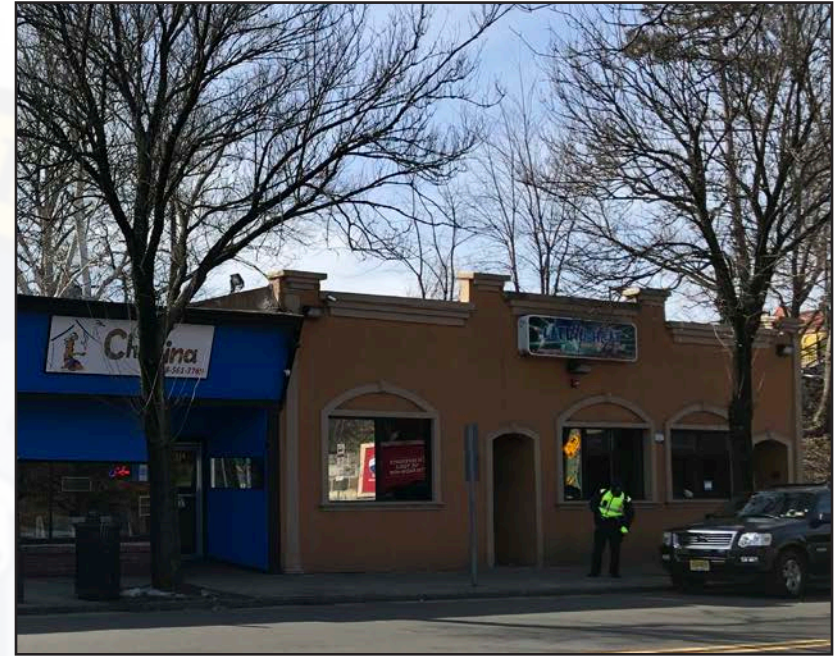
**TODD CENTRAL
BUSINESS ZONE****ADDRESS: 306-312 Watchung Avenue
BLOCK: 840 LOT: 1****PROPERTY DESCRIPTION**

Flagged shaped parcel. One story, commercial building. Current use: night club. The lot size is 6,528 sq. ft. Built in 1915.

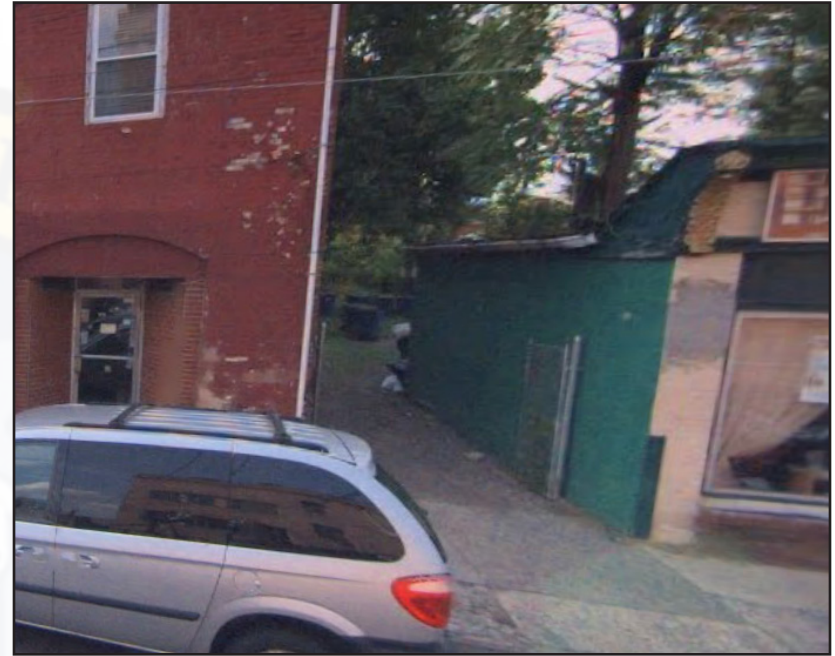
**TODD CENTRAL
BUSINESS ZONE****ADDRESS: 153 E. 4th Street
BLOCK: 840 LOT: 4****PROPERTY DESCRIPTION**

Rectangular shaped parcel. Vacant land. The lot size is 888 sq. ft.

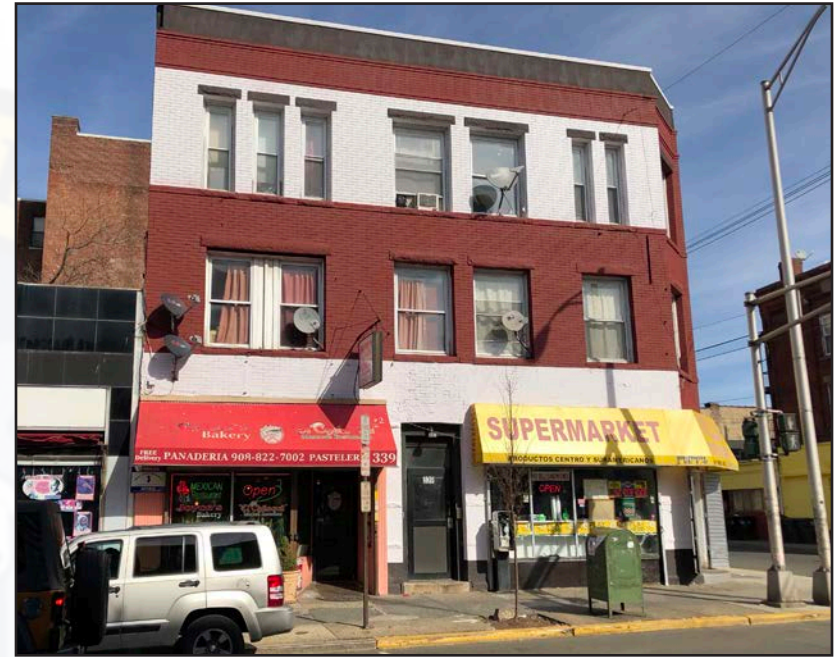
**TODD CENTRAL
BUSINESS ZONE****ADDRESS: 337-341 Park Avenue
BLOCK: 840 LOT: 9****PROPERTY DESCRIPTION**

Rectangular shaped parcel. Three story, mixed use building with two storefronts and six units. The lot size is 4,230 sq. ft. Built in 1900.

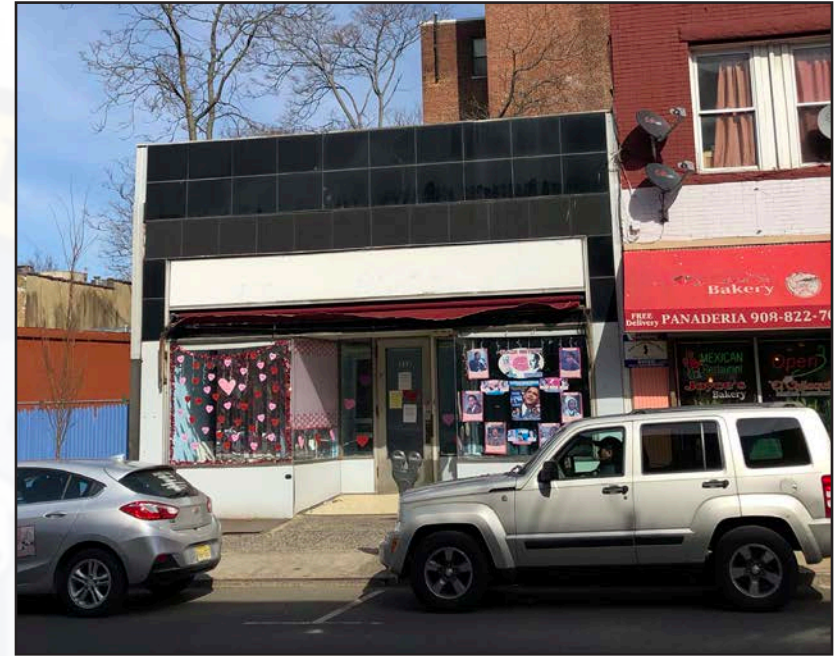
**TODD CENTRAL
BUSINESS ZONE****ADDRESS: 331-335 Park Avenue
BLOCK: 840 LOT: 10****PROPERTY DESCRIPTION**

Rectangular shaped parcel. One story, commercial building. The lot size is 2,500 sq. ft. Built in 1901.

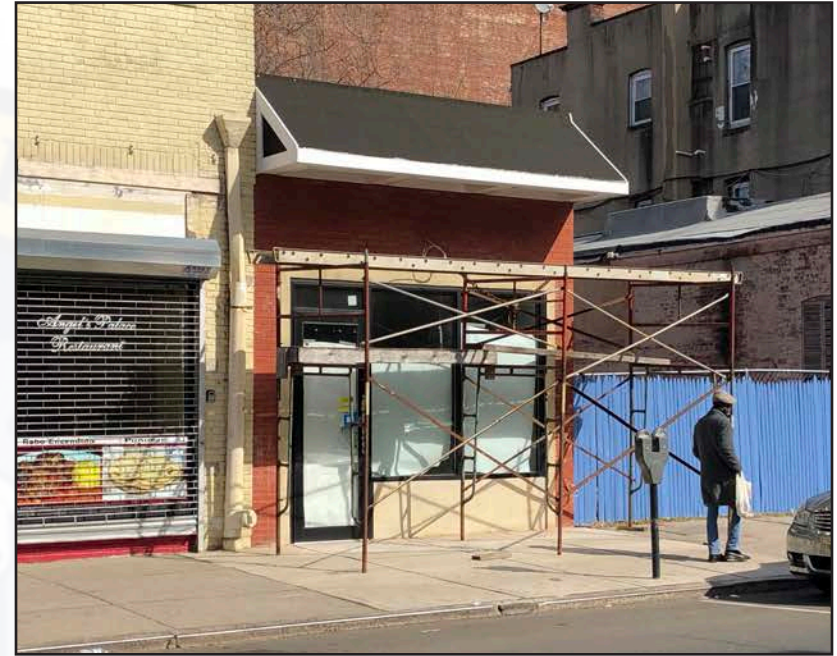
**TODD CENTRAL
BUSINESS ZONE****ADDRESS: 325-327 Park Avenue
BLOCK: 840 LOT: 12****PROPERTY DESCRIPTION**

Rectangular shaped parcel. One story, commercial building. The lot size is 1,644 sq. ft. Built in 1954.

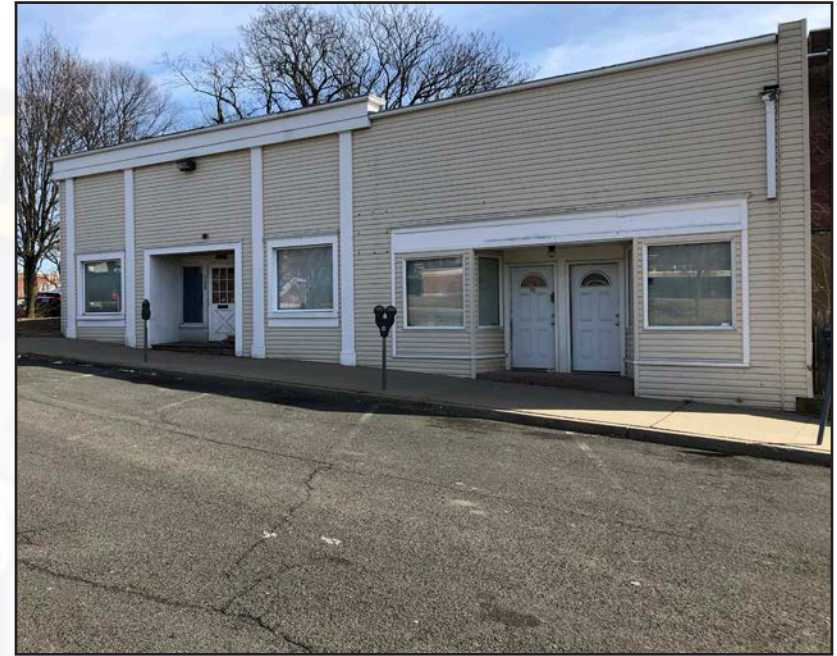
**TODD CENTRAL
BUSINESS ZONE****ADDRESS: 116-124 Depot Park
BLOCK: 840 LOT: 14****PROPERTY DESCRIPTION**

Irregular shaped parcel. One story building. The lot size is 3,100 sq. ft. Built in 1920.

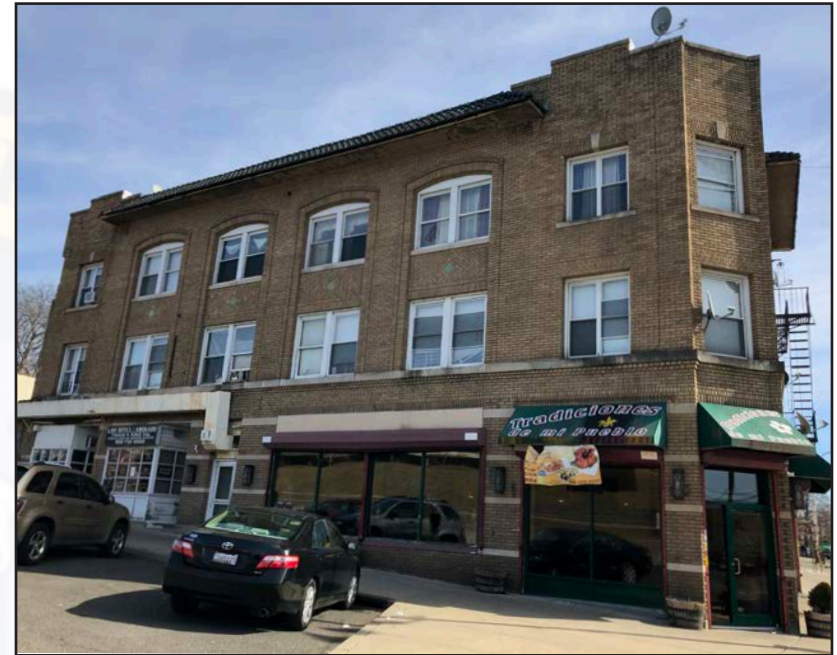
**TODD CENTRAL
BUSINESS ZONE****ADDRESS: 307-313 Park Avenue
BLOCK: 840 LOT: 15.01****PROPERTY DESCRIPTION**

Rectangular shaped parcel. Three story, mixed use building with four storefronts and twelve dwelling units. The lot size is 5,416 sq. ft. Built in 1910.
