HALSTEAD & ASSOCIATES
Environmental / Biological Consultants

Date: June 12, 2008

RE: Wetland Issues and Wetland Areas on the Project Site
Rockwell Pond - Selma Development Project (Fresno County, CA)

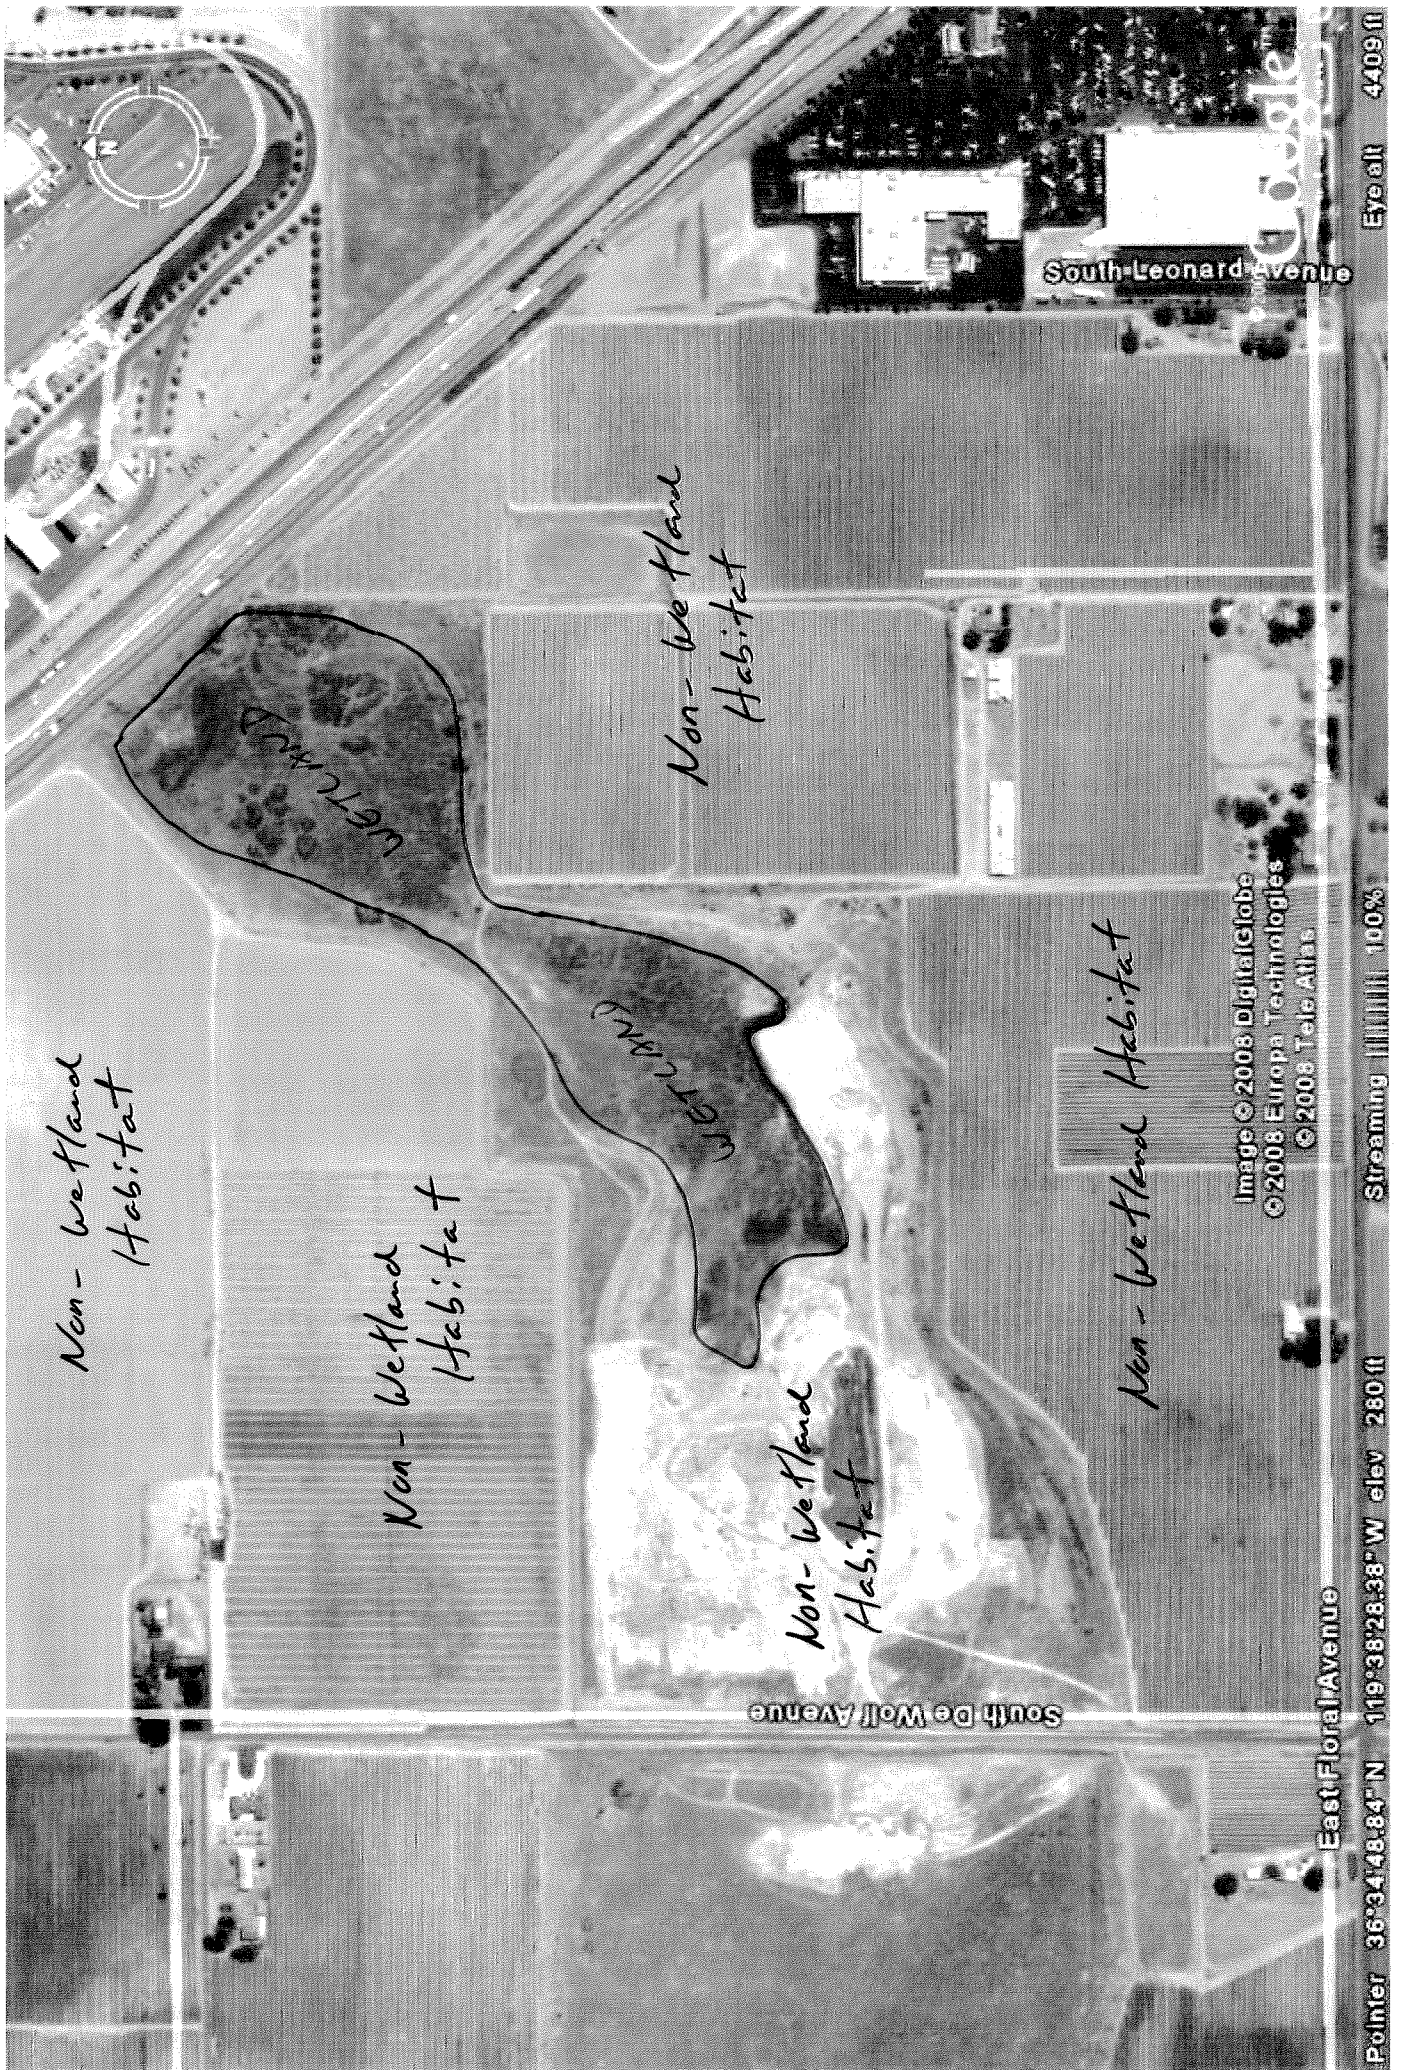
As shown on the attached map, the ponds near Highway 99 would meet the criteria of wetland. They have wetland vegetation such as bullrush and rush, evidence of water inundation, and wetland soil indicators are present. Any dredge, fill, or discharge to the ponds by the project would require consultation with the Corps, extensive paperwork, and obtaining a 404 Permit. We suggest that impacts to the wetland ponds be avoided by the project so that extensive permitting is not necessary.

As shown on the attached map, the agricultural areas on the project site and the pond near De Wolf Avenue are not wetlands. The pond along De Wolf Avenue has mostly upland vegetation from its upper bank to its bed. A few sparse patches of wetland plants such as bullrush and rush occur around the upper perimeter; however, this is an insufficient amount to meet the wetland vegetation criteria. The soil is sandy and no wetland soil indicators are present. Also, indicators of inundation are vague. In our opinion, this pond would not meet the criteria of wetland.

Non-Wetland
Habitat

Wetland
