53 SPRING STREET WETLAND DELINEATION

SOIL SCIENTIST REPORT

Client Ref: 141.21387.00001

**53 Spring Street
Southington, Connecticut
Wetland Delineation
Soil Scientist Report**

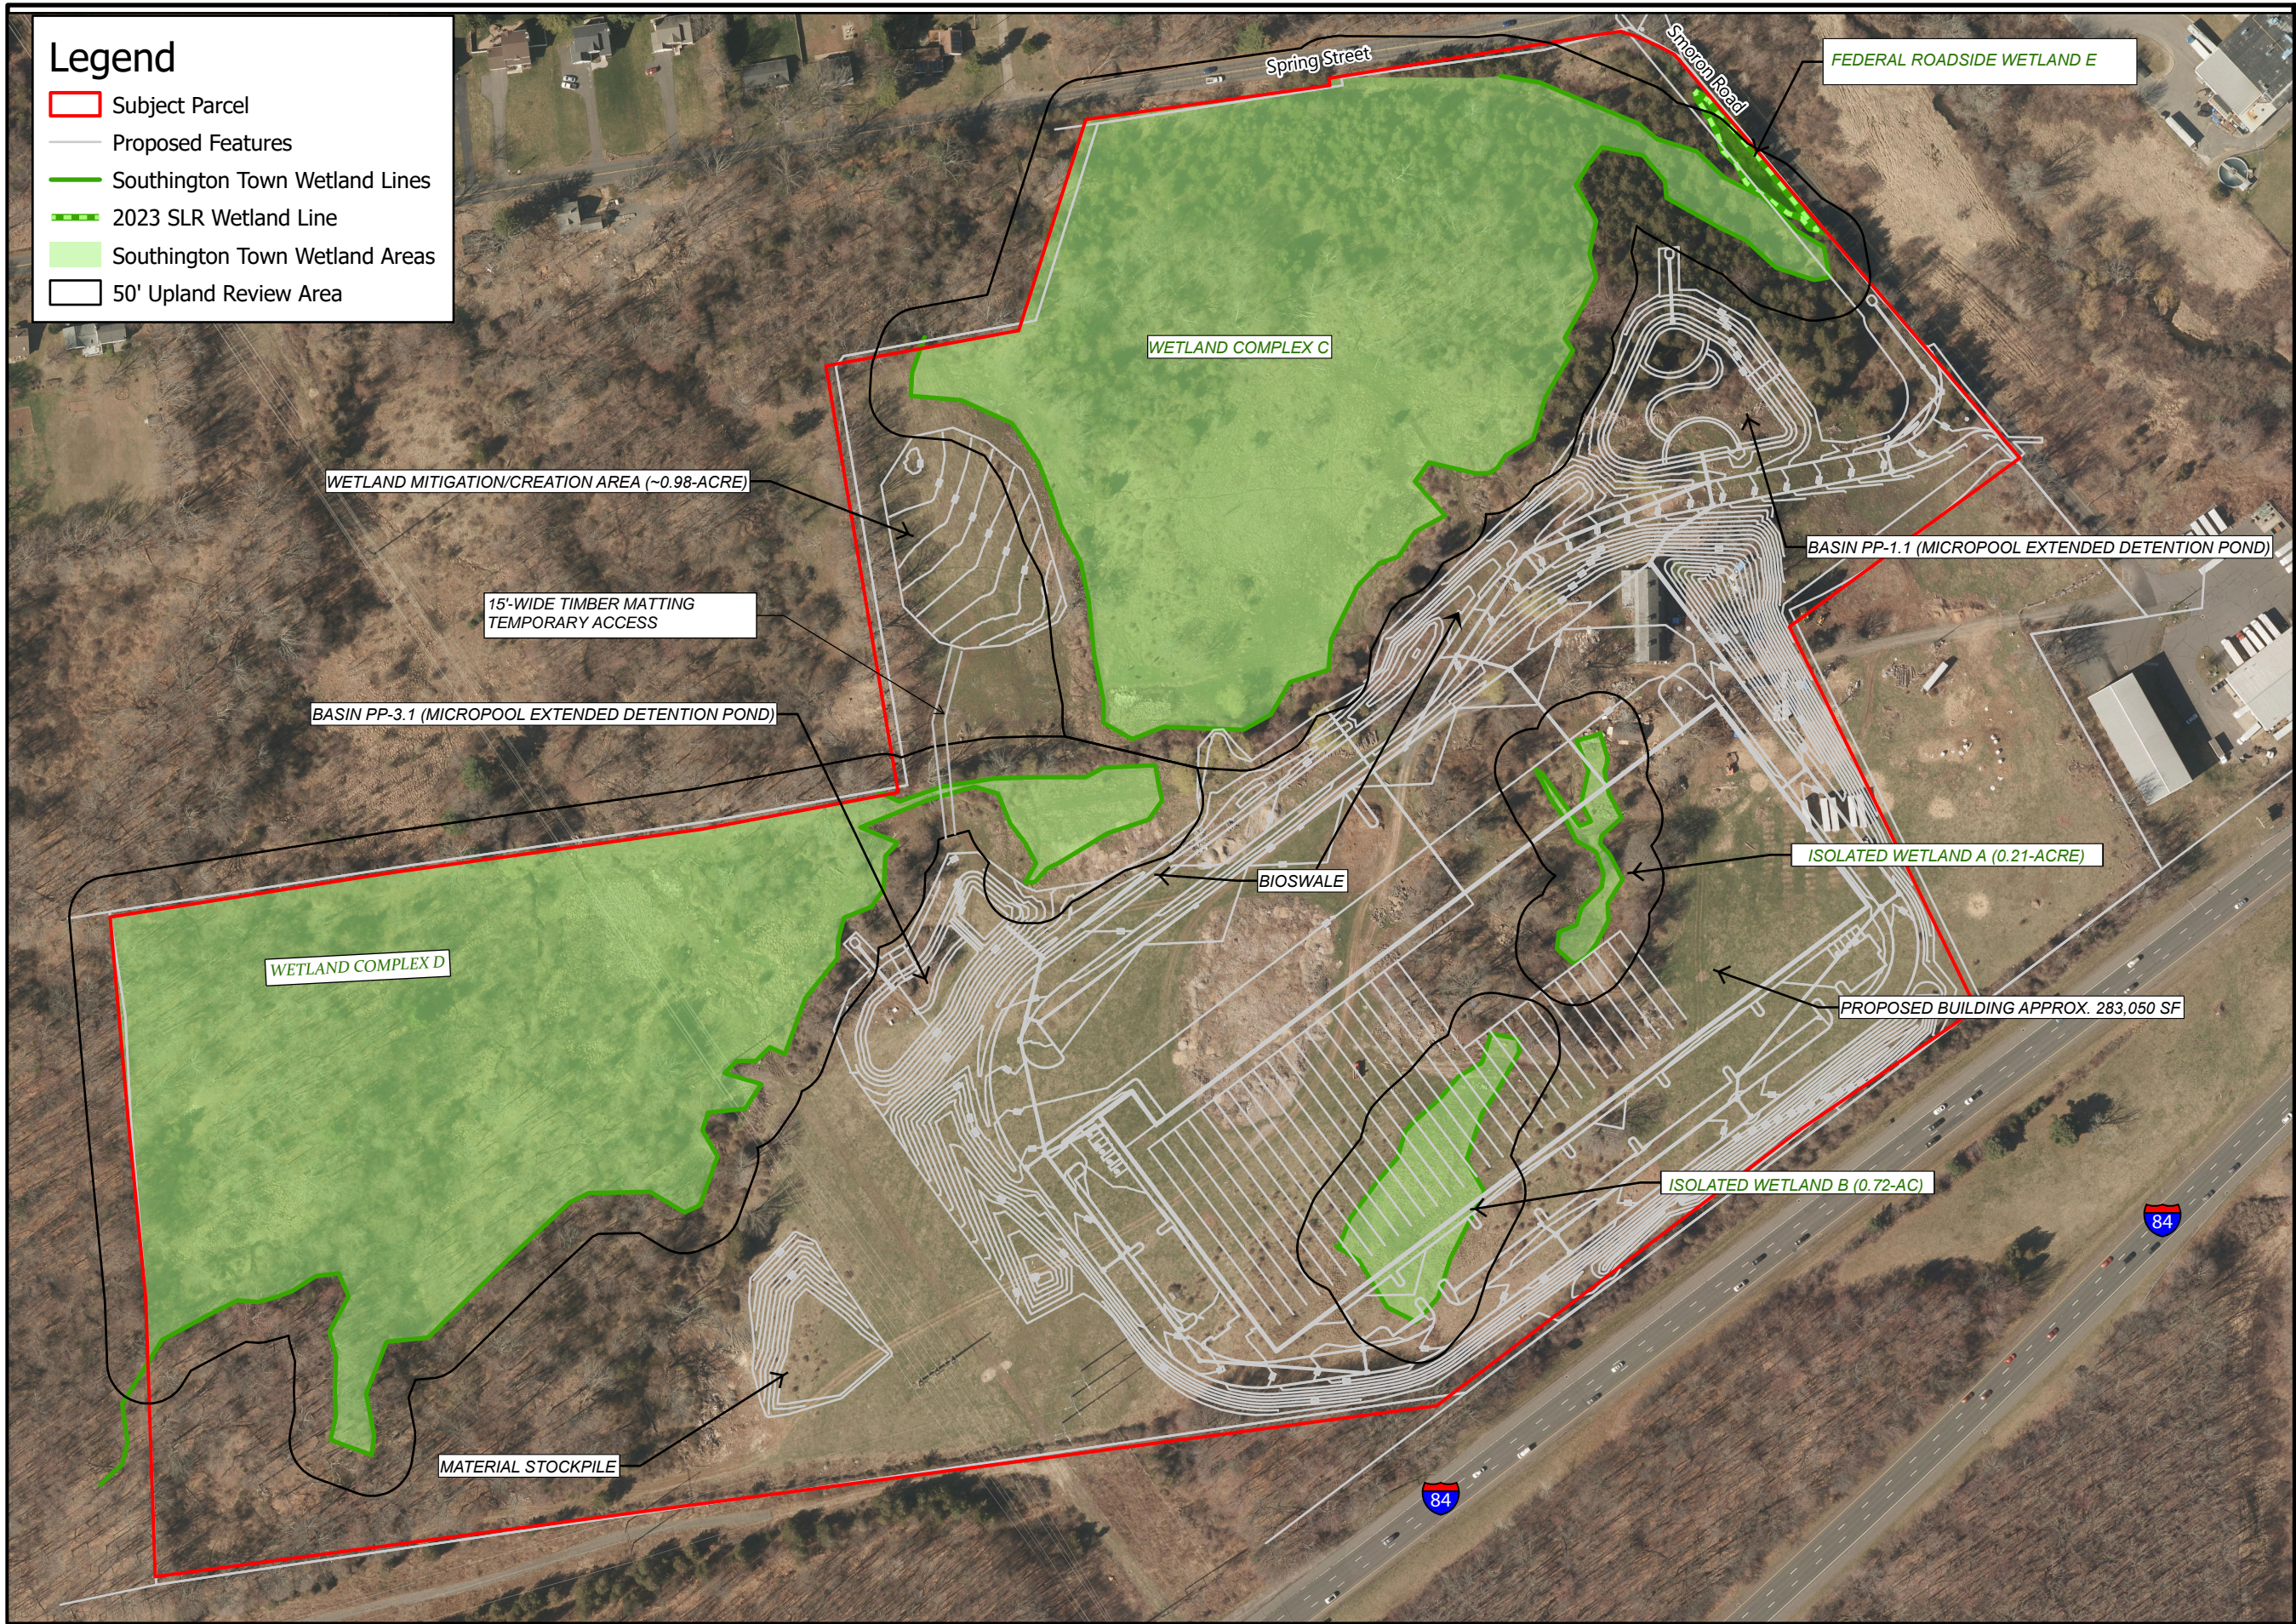
PROPOSED CONDITIONS
PROPOSED DEVELOPMENT
JOHNSON DEVELOPMENT ASSOCIATES, INC.
53 SPRING STREET
SOUTHINGTON, CONNECTICUT

To compensate for the proposed filling of two state-regulated wetlands totaling 0.93 acres, SLR has designed an approximately 1.0-acre wetland mitigation area for a 1:1 creation to impact ratio. The wetland mitigation plans were prepared based on field investigations and baseline conditions established during design development and regulatory permitting. The proposed mitigation area will be located within the northern portion of the 53 Spring Street parcel, north of the proposed development and west of Wetland Complex C. The area is within a former agriculture field that is predominantly vegetated with upland herbaceous and nonnative woody species. A comprehensive native species planting plan has been developed to replicate the vegetative composition of both the adjacent federal wetland and those wetlands that will be filled as part of this development. The complete mitigation plan is described in further detail in Appendix E, and all grading, planting tables, and details are depicted on sheet C-707 of the project site plans.

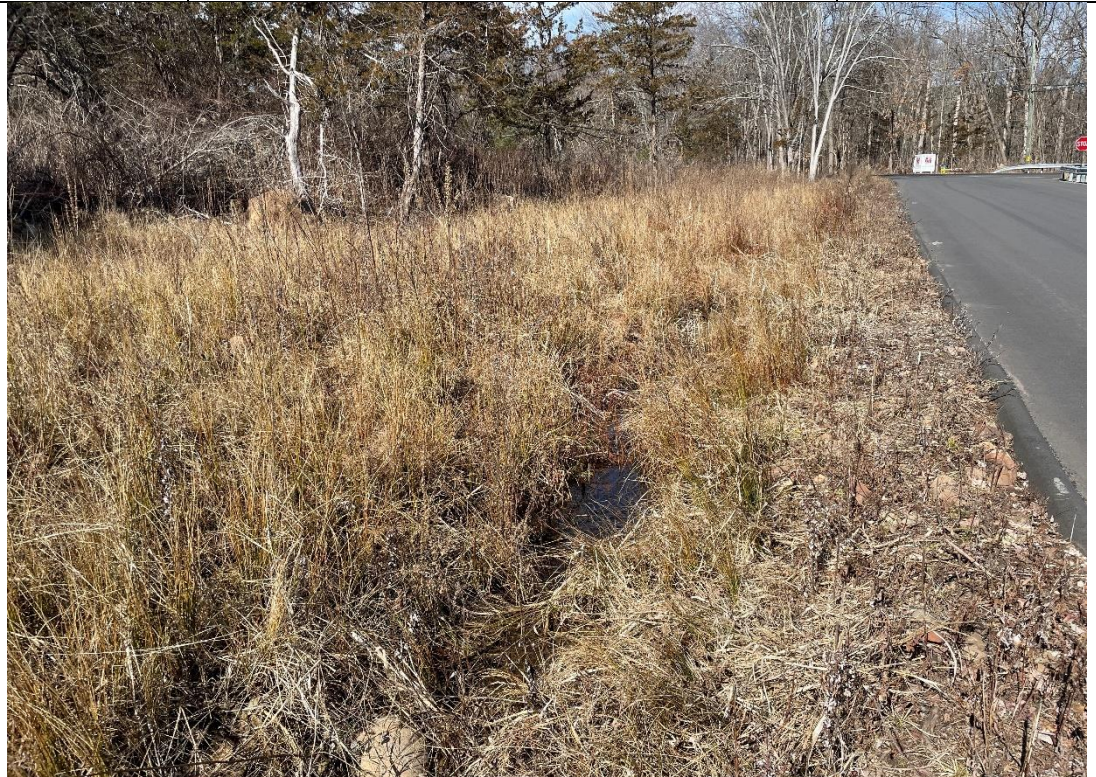
Direction Photo Taken:
North

Description:
Emergent/wet meadow fringe wetland located west of Smoron Road and delineated in March 2023 by SLR wetland scientists. Photo looking towards Spring Street in the background.

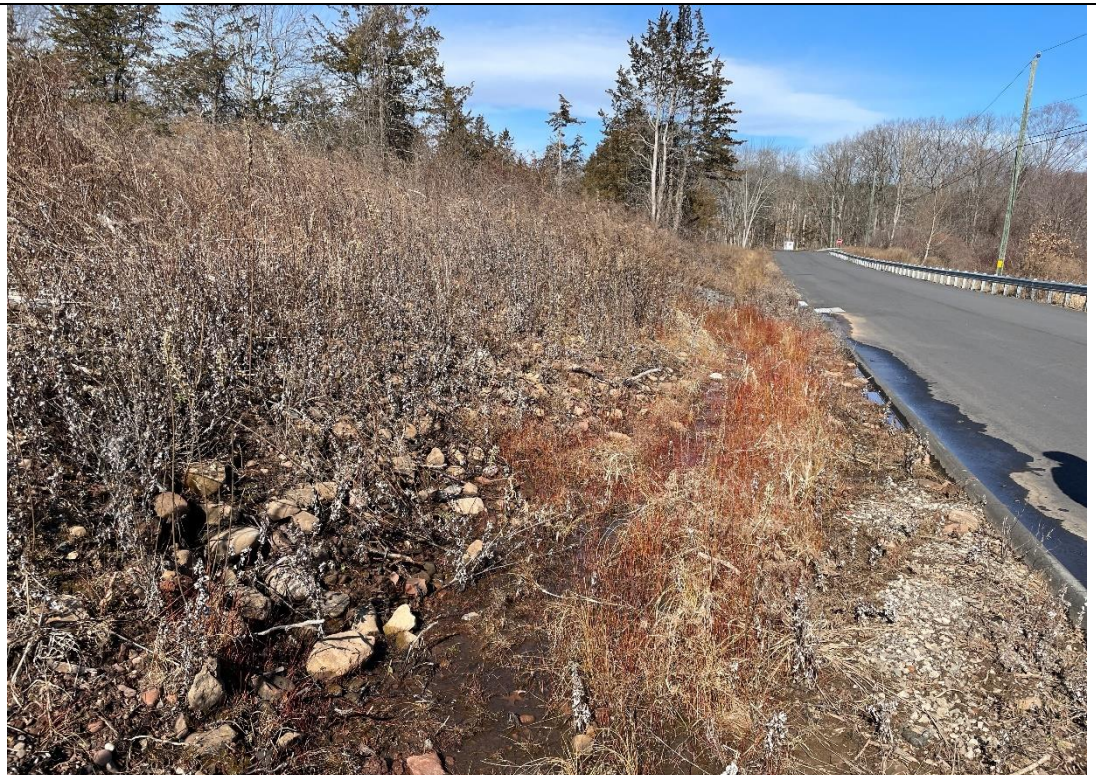
Photo No.
2

Description:
Surface swale/drainage ditch feature west of Smoron Road and south (outside) of delineated wetland area.

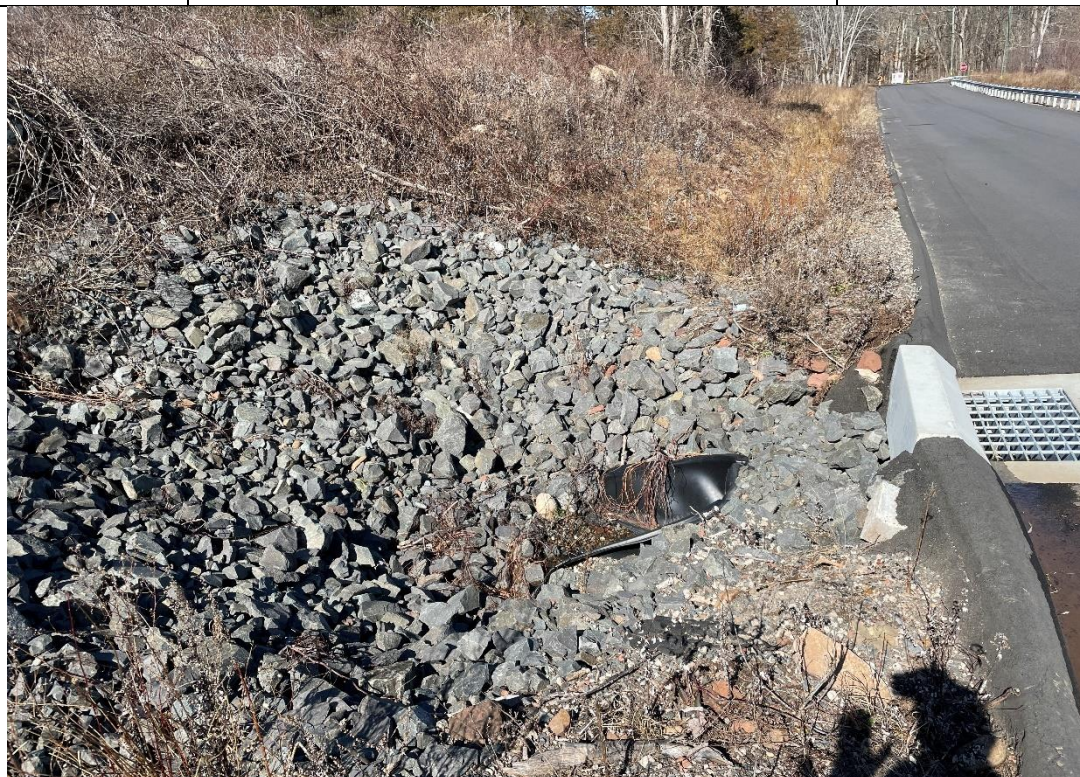
Stormwater outfall and riprap plunge pool located west of Smoron Road and between upland surface swale to the south and SLR delineated fringe wetland area to the north.

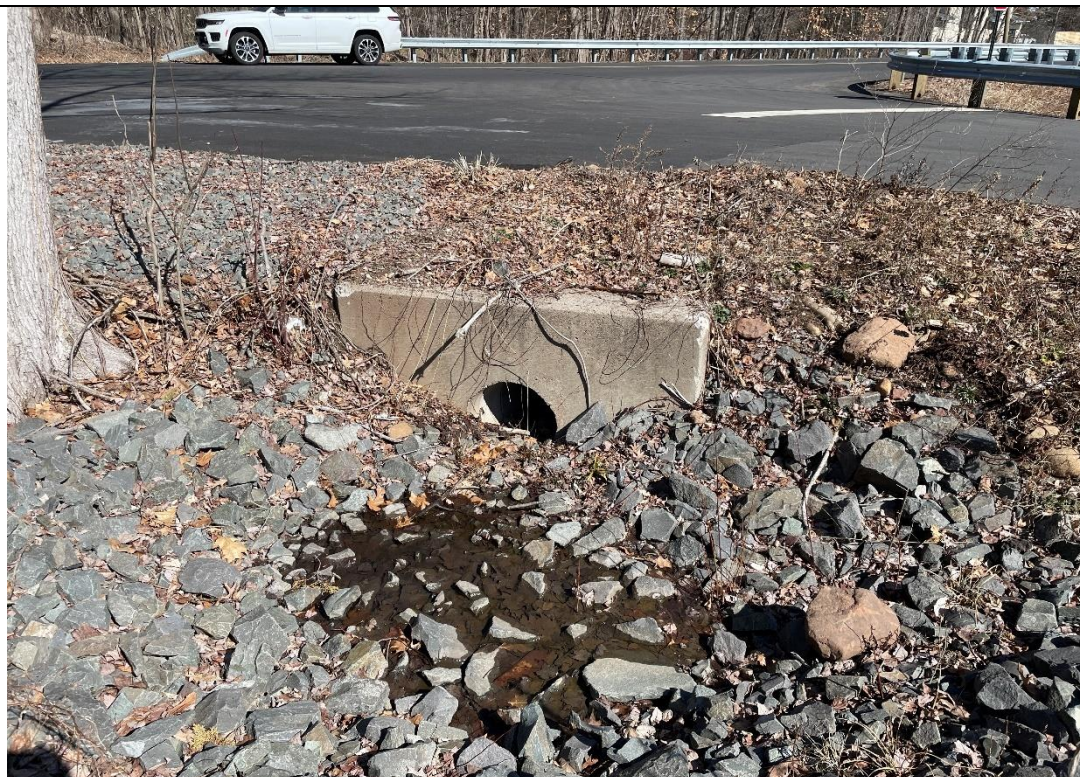
4

Northernmost stormwater outfall and riprap plunge pool located west of Smoron Road and south of Spring Street.

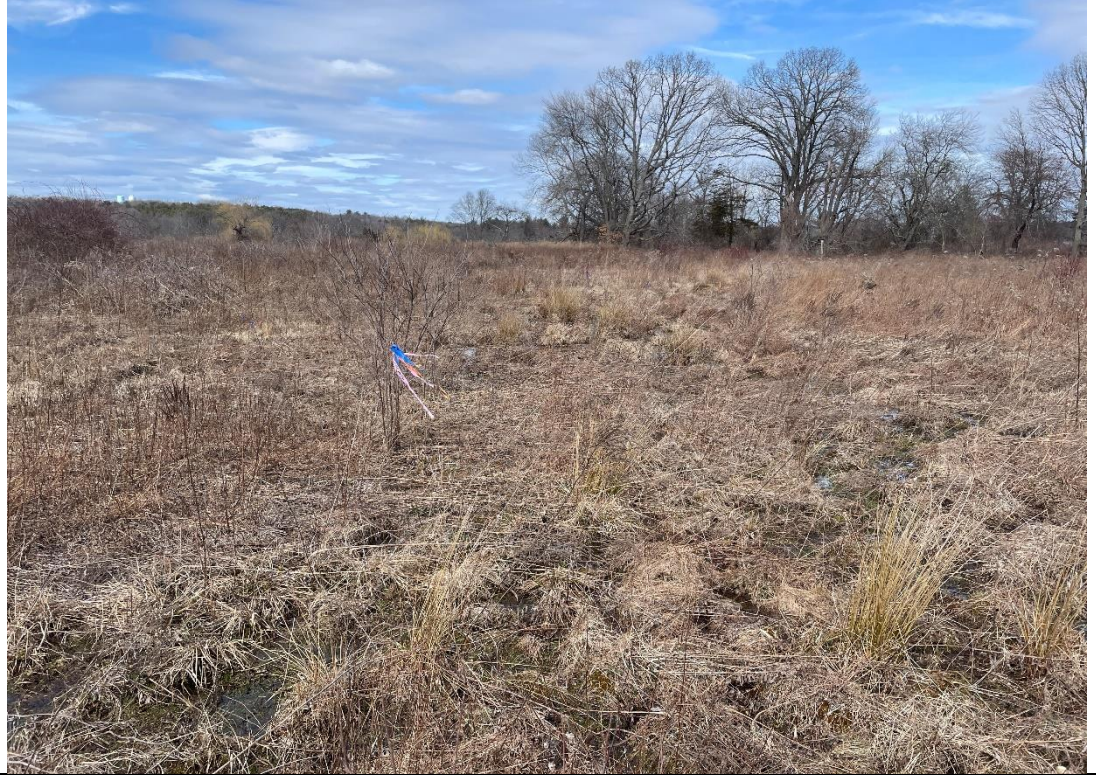
Description:
Northern portion of open, isolated wet meadow wetland located near southern property boundary with I-84.

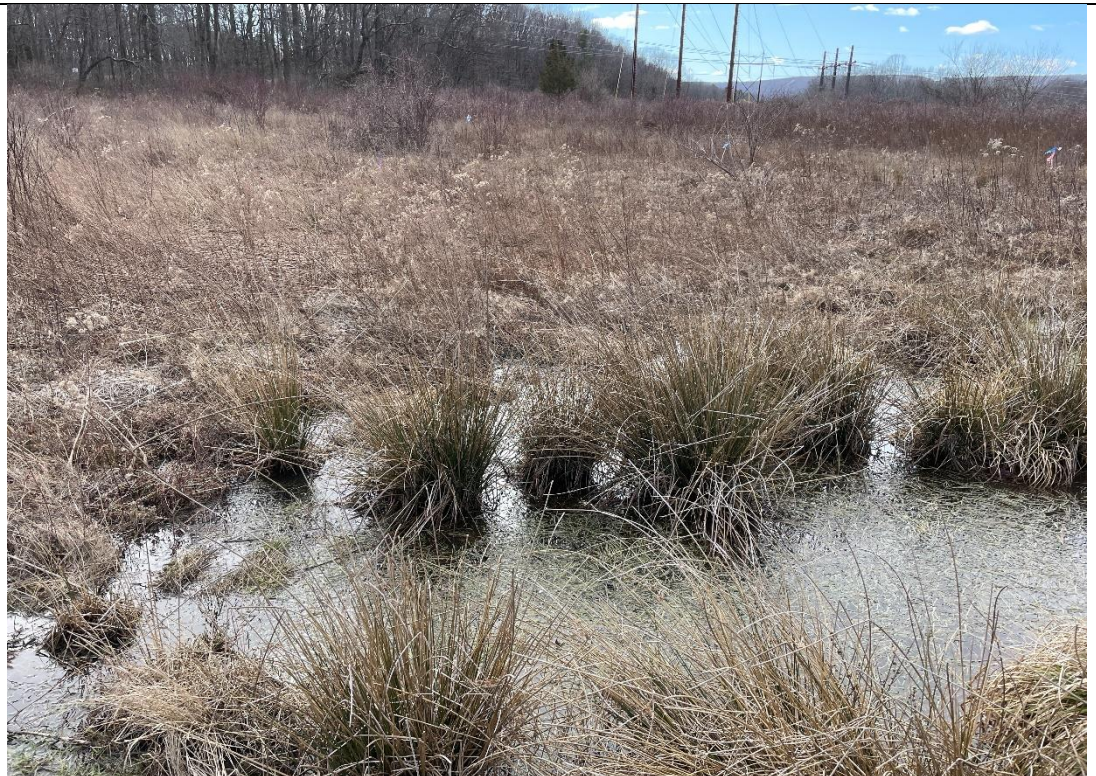
Photo No.
10

Description:
Approximately 900 SF pond with 2 to 6 inches of standing water in southern portion of southern wet meadow wetland. Wooded corridor north of I-84 and transmission corridor poles can be seen in background.

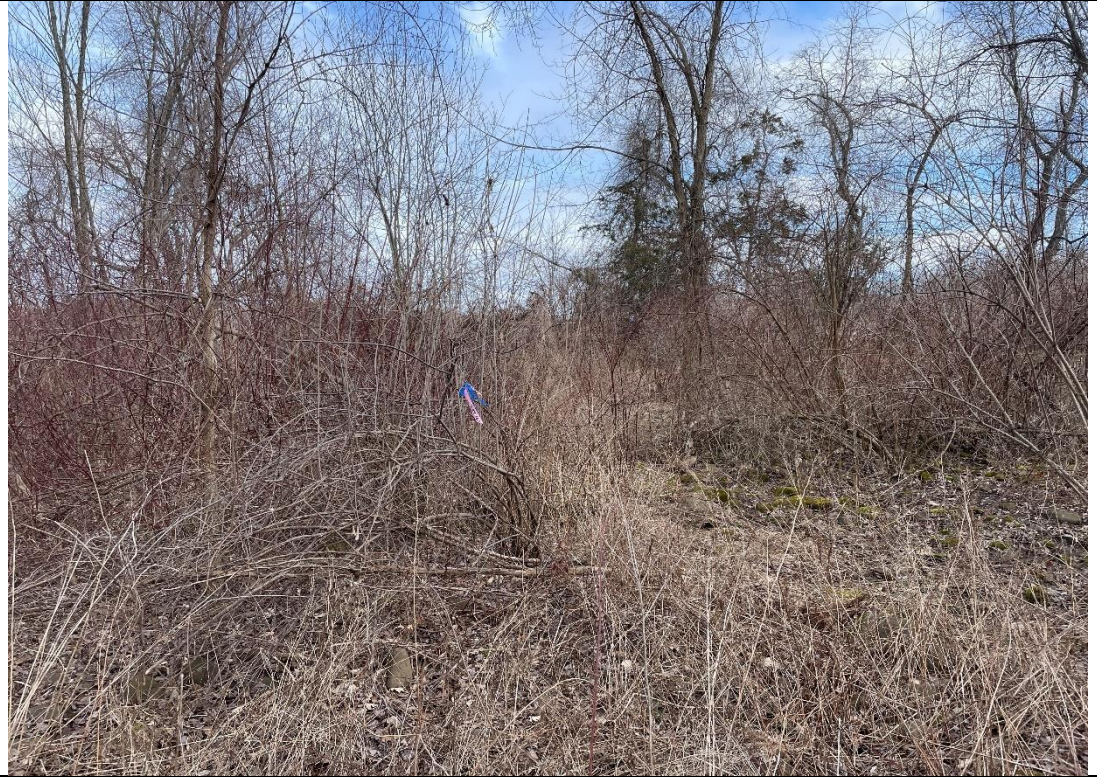
Description:
Southern portion of isolated scrub shrub wetland with sparse tree canopy. Northern of two wetland areas to be directly impacted by proposed project.

The isolated state wetlands to be filled, Wetland A and Wetland B, are described in detail within the above soil report's existing conditions section. In summary, these two wetlands possess varying levels of the required hydrology, soils, and vegetation to qualify as wetlands; however, they lack hydrologic (i.e., nexus) connection to any federally regulated waterway or wetland. Therefore, these wetlands fall under the jurisdiction of Connecticut (i.e., local commission), but not the United States Army Corps of Engineers (USACE). Although a lack of hydrologic connectivity does not necessarily reduce the value of a wetland, the existing isolated state wetlands on site are constrained by size, topographic position, disturbance (i.e., mowing), and prevalence of invasive vegetation, which considerably limits their functions and values. Using the USACE *Highway Methodology Workbook Supplement*, SLR found that the functions and values provided by these two wetlands are limited to groundwater discharge and some nutrient removal¹.

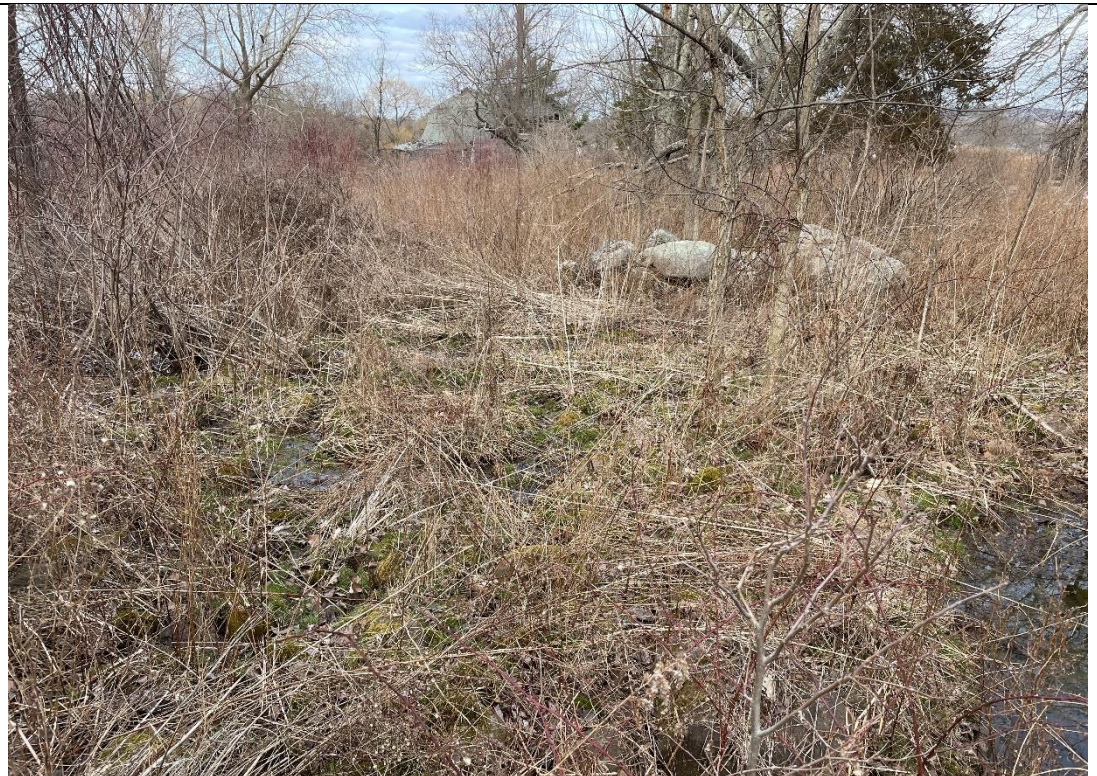
Photo No.
12

Description:
Northern portion of isolated scrub shrub wetland with areas of standing water and one of several boulder clusters. Old barn and some large trees can be seen in background.

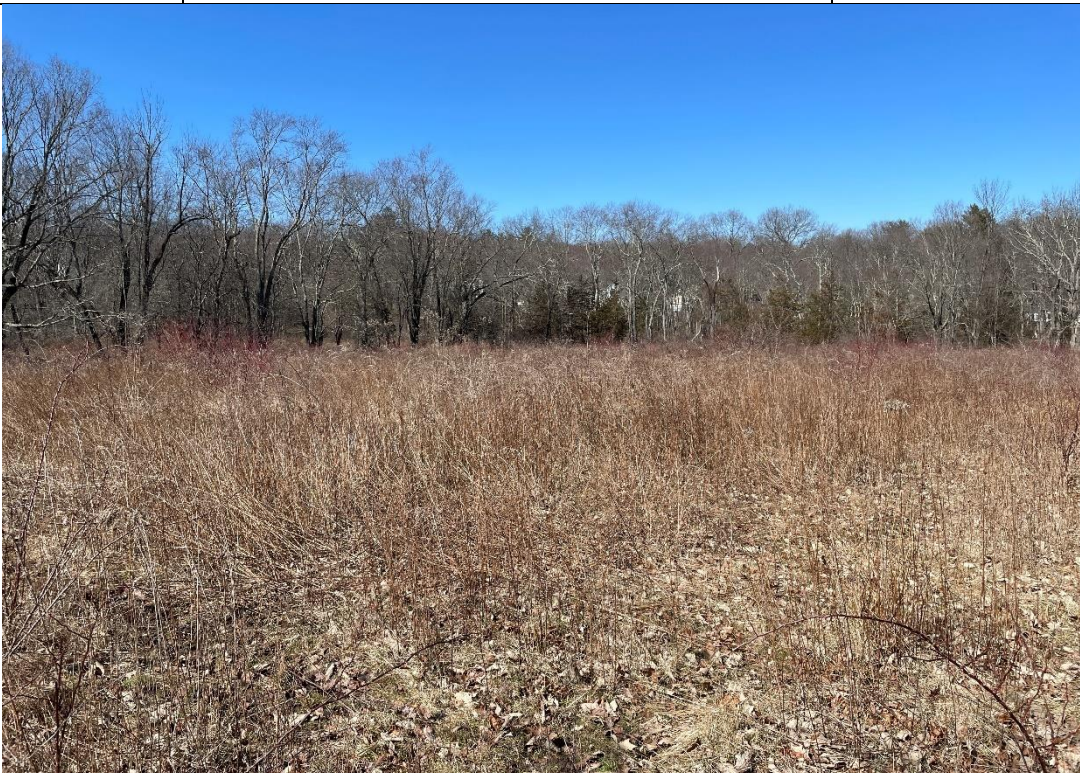
Direction Photo Taken: North			
Description: Proposed wetland mitigation area: former farm field west of central wetland area consisting of upland herbaceous and invasive shrub vegetation.

The location of the proposed wetland mitigation was chosen due to its relative distance from the proposed development, proximity to large, onsite federal wetlands, and the opportunity to replace an upland, monoculture field with a diverse wetland, significantly increasing the ecological value of this portion of the site. The adjacent wetland, described in the soil report as the western portion of Federal Wetland C, is classified as an old field/wet meadow wetland that was also formerly used for agricultural purposes and contains two farm ponds/emergent cattail marsh areas in the southernmost portion of the wetland complex. The vegetation is comprised of herbaceous hydrophytes and low-statured wetland shrubs, while the topography of this area slopes to the south, similar to the mitigation area to the west. As such, the mitigation area was designed to reflect and mimic the existing wetland vegetative community structure and habitat.

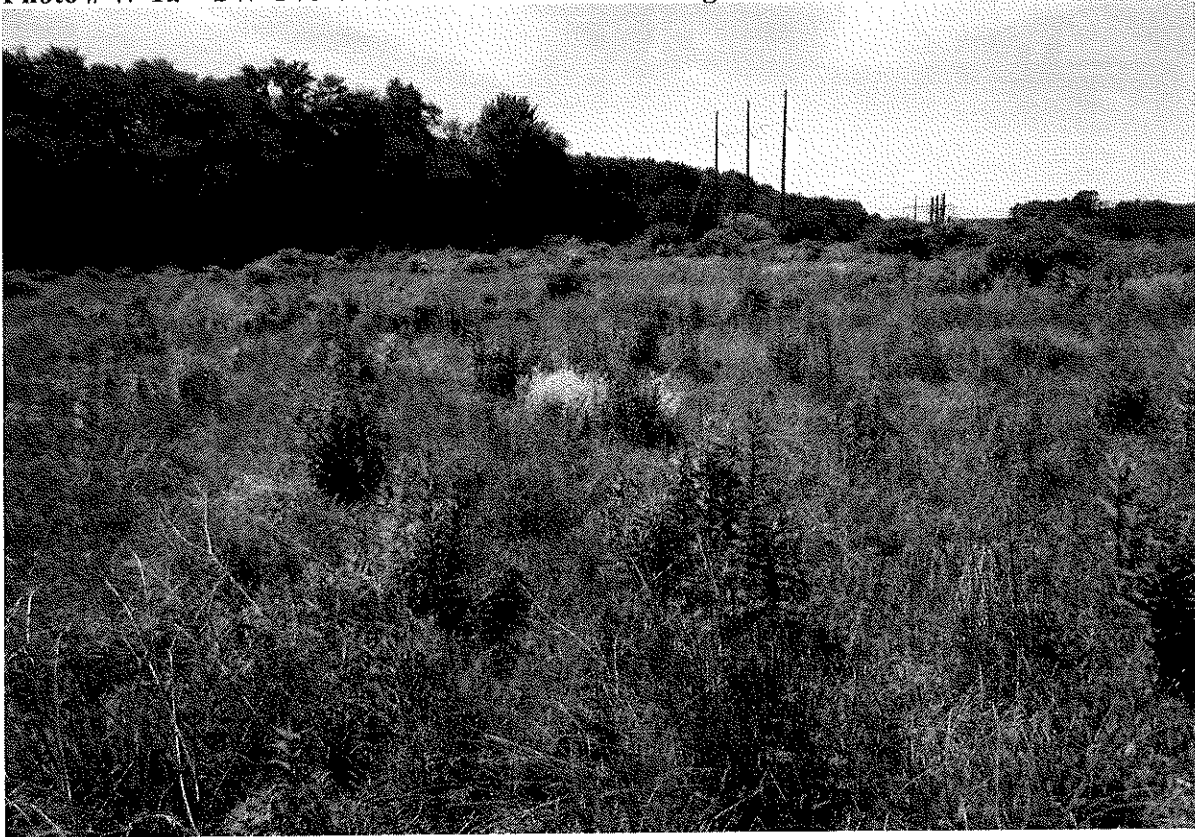
Photo # W-1a - SW Overview of Wetland W-1 looking towards Transmission Lines

This wetland shown in the photos on page 3 is becoming overgrown with Multiflora Rose along its outer edges and in numerous slightly elevated low mounds. Smartweed, Sedges, Rushes, and Goldenrods dominate the very dense herbaceous strata. Scattered Elderberry shrubs are scattered within the wetland limits. No other tree or shrub species were observed within the defined wetland limits.
