TRINITY RIVER AUTHORITY 2008 BASIN HIGHLIGHTS REPORT

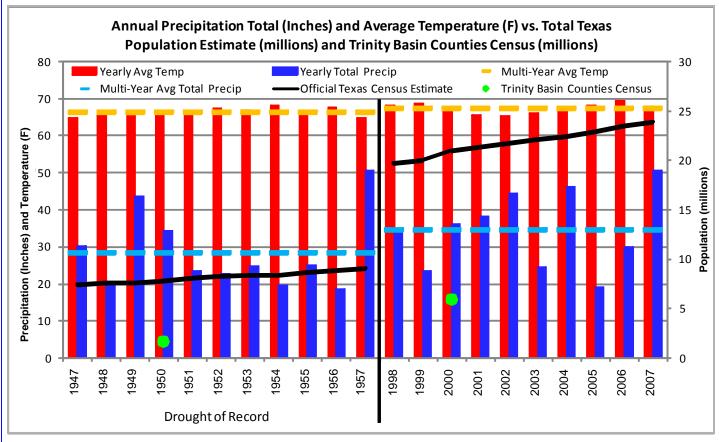
> water shortages. The graph on the following page compares the most recent ten year period to the drought of record from 1947 to 1957. The temperature and precipitation values are taken from a continuous NOAA dataset that has been collecting data from a gage currently located at Dallas/Fort Worth International Airport. During the drought of record, this gage was located at Fort Worth Meacham Airport and later moved to the **Greater Southwest International** Airport. It is interesting to note that the average total precipitation for the most recent ten year period is approximately six inches greater than during the drought of record.

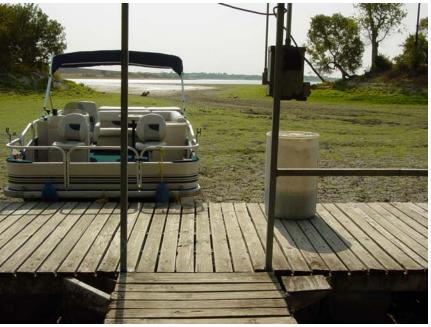
Dry marina on Lake Benbrook—August 23, 2006.

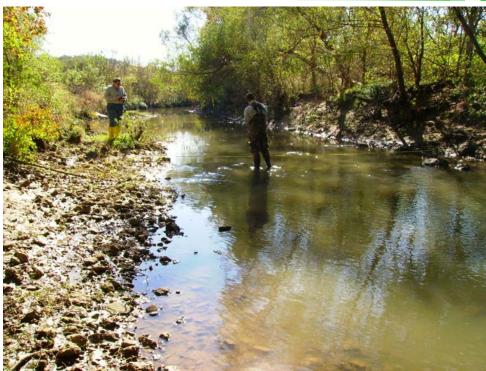
Flow measurement at Village Creek and IH-30 in Arlington—November 27, 2007.

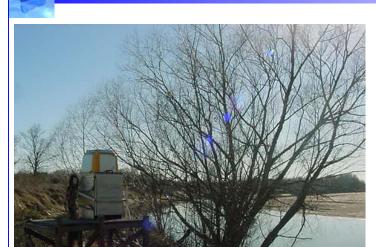
Continuous monitoring station on the Trinity River at Liberty.
