# Trinity River Authority Clean Rivers Program

## 2013 Basin Highlights Report

### Watershed Characterizations for the West Fork, Clear Fork, Village Creek, and Mountain Creek Subwatersheds

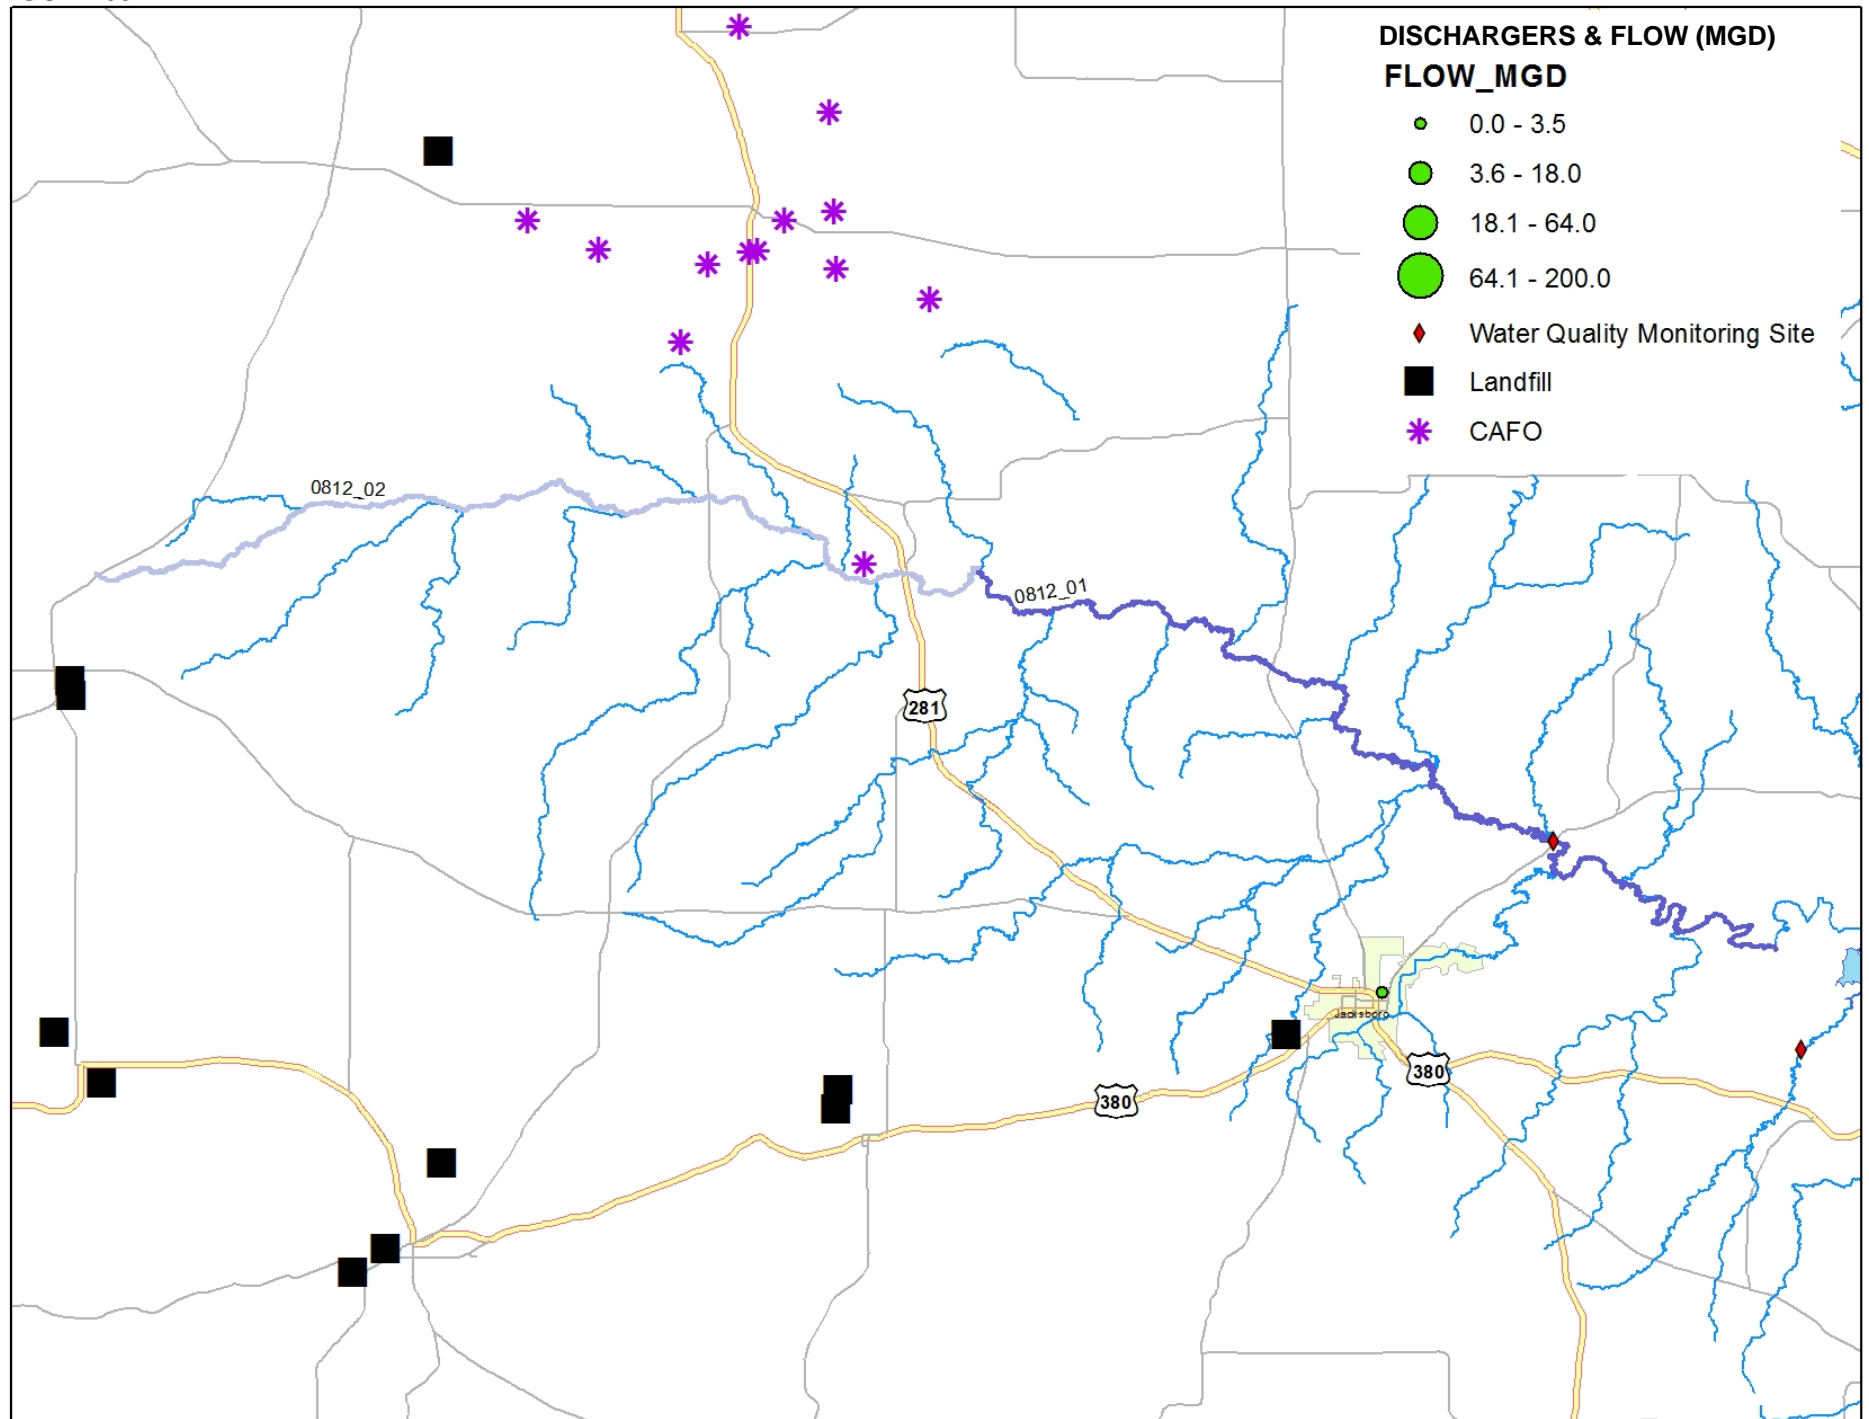
FIGURE 0812.1

Figure 0812.1 shows the locations of assessment units, monitoring stations, dischargers, landfills, and confined animal feeding operations (CAFOs). Table 0812.1 lists the stations being monitored in fiscal year 2013 as well as the parameters being collected and the frequency of sampling.

This segment is largely rural with rangeland dominating the land use. There are smaller areas of cropland, pastures, and forest interspersed throughout the segment. The upper portion of the watershed drains the Broken Red Plains while the remainder flows through the Western Cross Timbers. A few of the tributaries drain the Carbonate Cross Timbers. See Figures 0812.2 to 0812.4 for land covers, soil regions, and vegetative provinces in this segment. There is one small discharger in this segment as well as two confined animal feeding operations (CAFOs) and one landfill. The locations of these can be seen in Figure 0812.1.

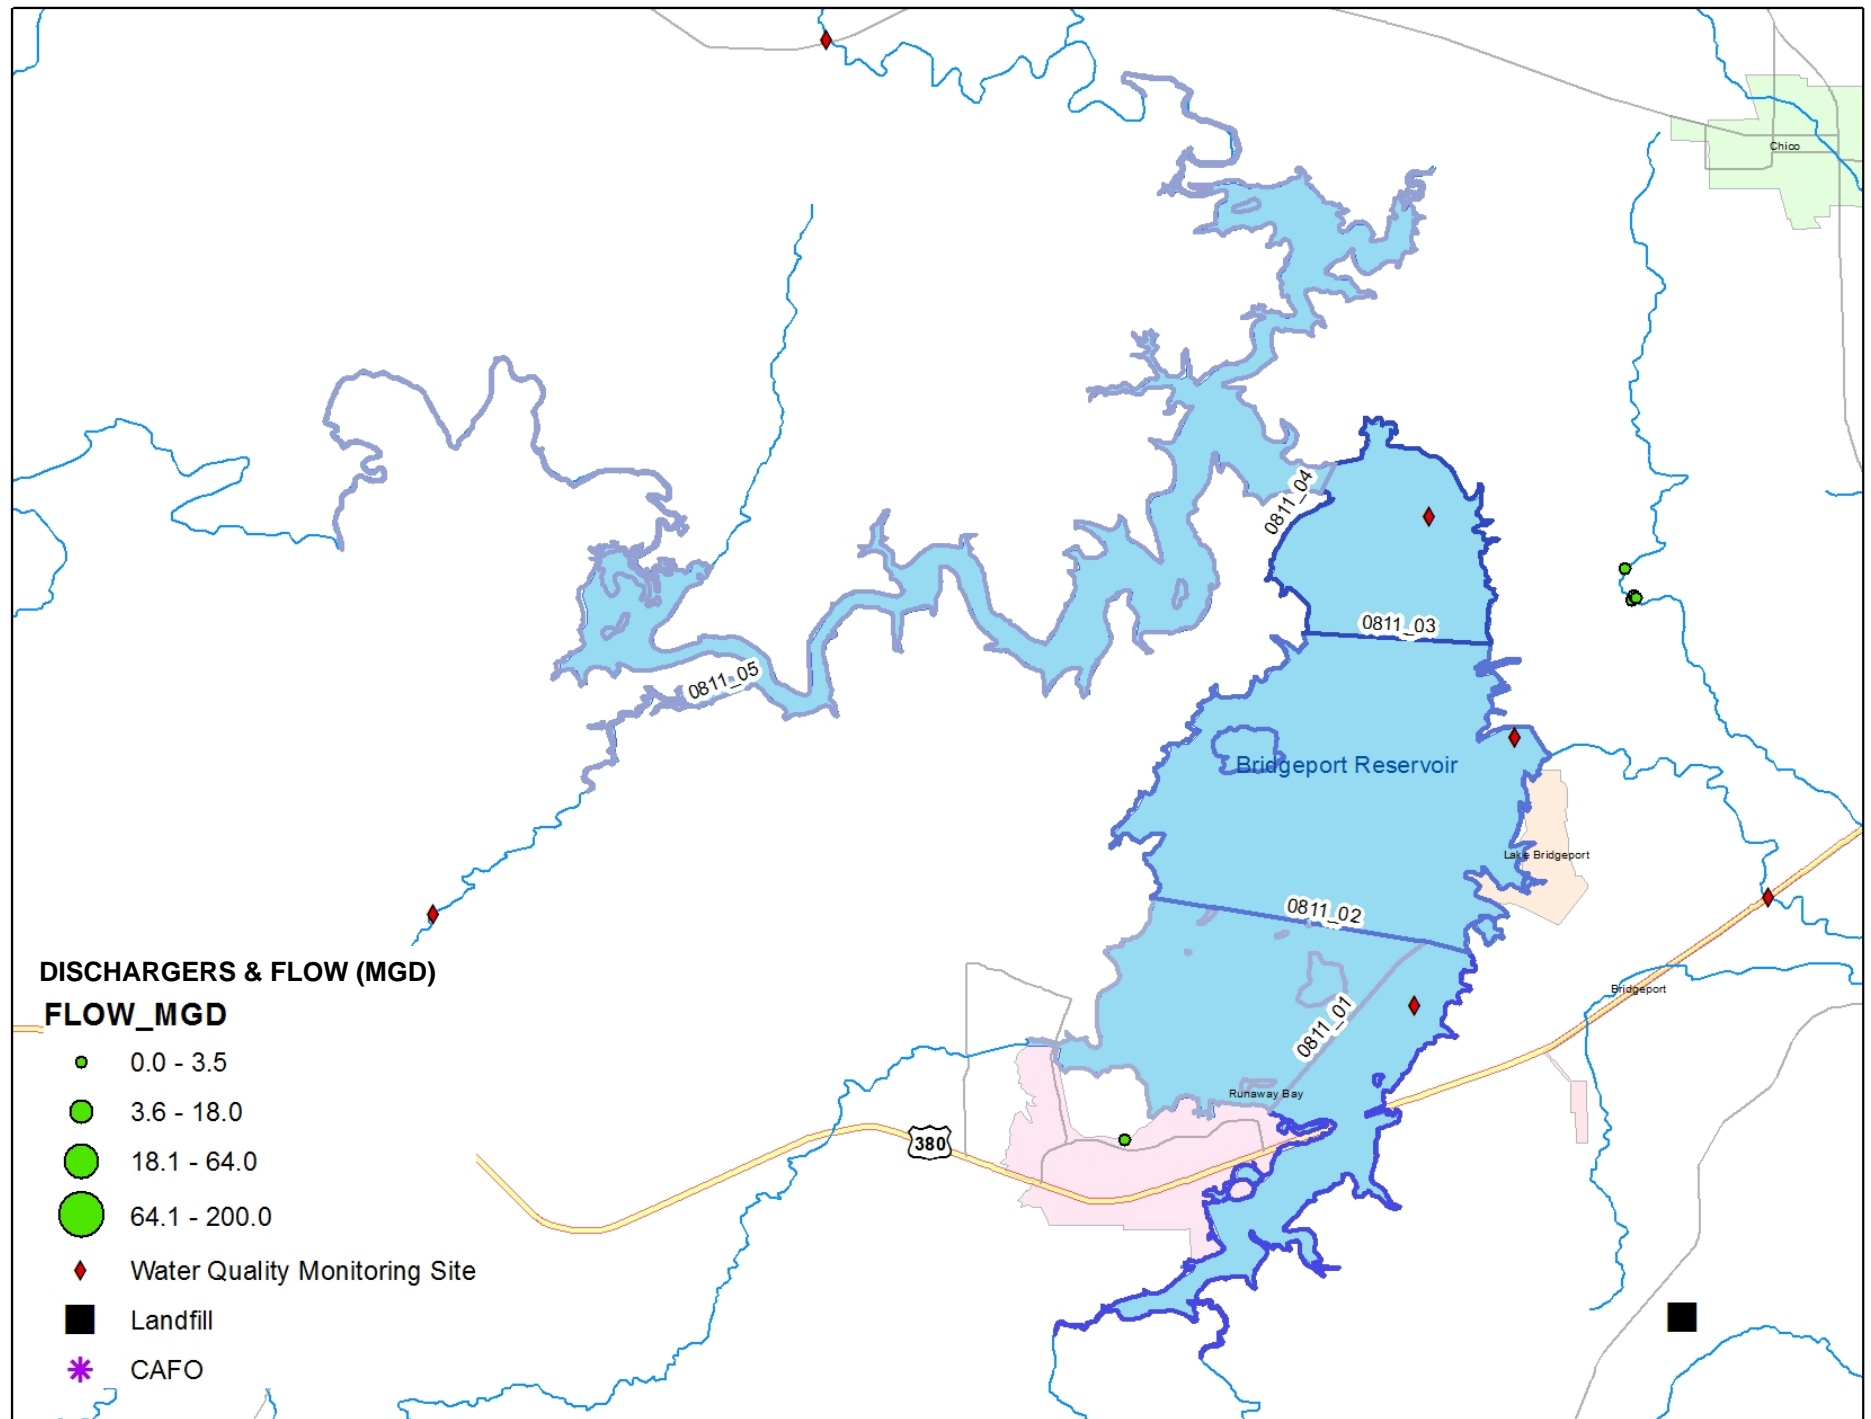
FIGURE 0811.1

Figure 0811.1 shows the locations of assessment units, monitoring stations, dischargers, landfills, and confined animal feeding operations (CAFOs). Table 0811.1 lists the stations being monitored in fiscal year 2013 as well as the parameters and the frequency of sampling.
