Acknowledgements

Contents

Each year, the local planning agencies produce a Basin Highlights Report which summarizes the CRP activities in their basin. This report may include information on events effecting water quality, a summary of water quality data, and an overview of public outreach activities and special projects. Every fifth year, a greatly expanded Basin Summary Report provides a detailed analysis of water quality data and potential sources, as well as offering recommendations for future basin activities. All past reports are available on TRA's website at http://www.trinityra.org/default.asp?contentID=97.

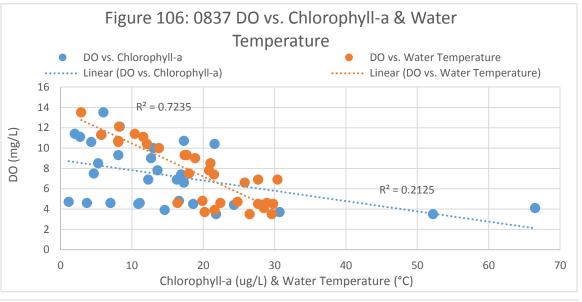
This stream had concerns for chlorophylla as identified by the 2014 IR. As shown in Figure 107, concentrations frequently exceed the screening level. As discussed in the 2015 Basin Summary Report, chlorophylla was fairly well correlated with TKN. Based on the rural nature of the watershed, it is believed that livestock and agricultural fertilizers are contributing nitrogen to the stream. This, in conjunction with the low flows in the stream, may be providing algal populations with the nutrients and residence times needed to increase.
