# LiDAR Acquisition and Flow Assessment for the Middle Trinity River

For: Trinity and San Jacinto Rivers and Galveston Bay Stakeholder Committee through the Texas Water Development Board

Final Report – October 15, 2015

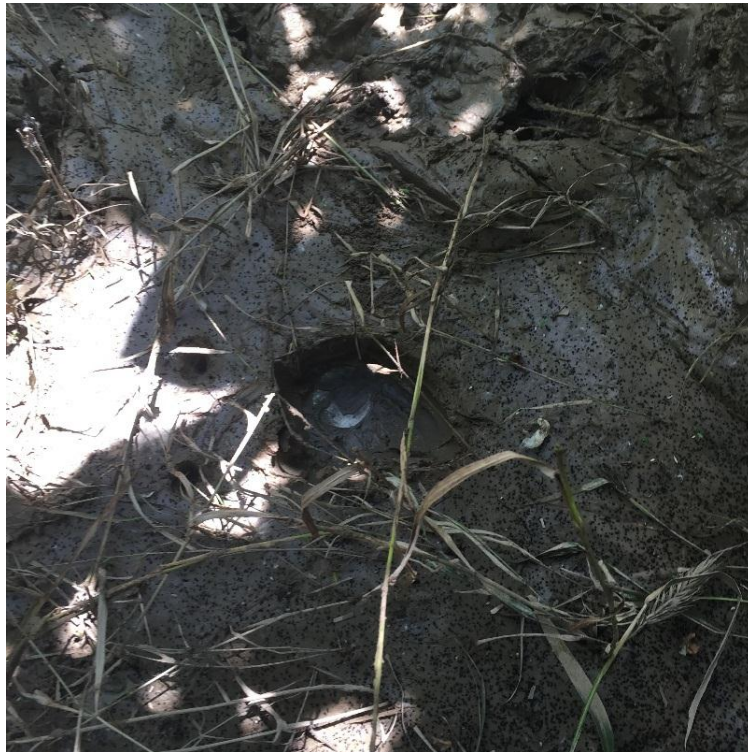
Figure 12. Deposition on top of a benchmark at 080444.

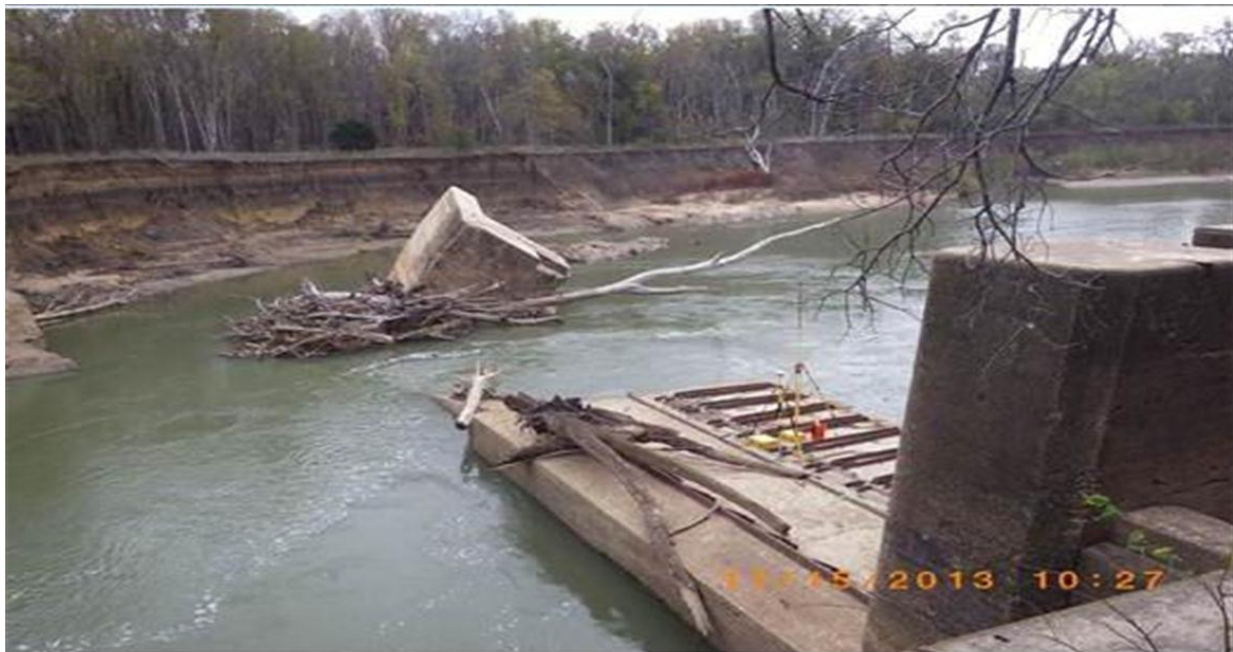
Figure 23. Photograph showing the river flanking the historic lock structure. Downstream is towards the right.

Significant changes in the channel were observed and are expected to continue as the system adjusts to the recent slope changes caused by the failure of the relic USACE Lock 3 structure located between Cross-sections 4 and 5 within this site (Figure 23).

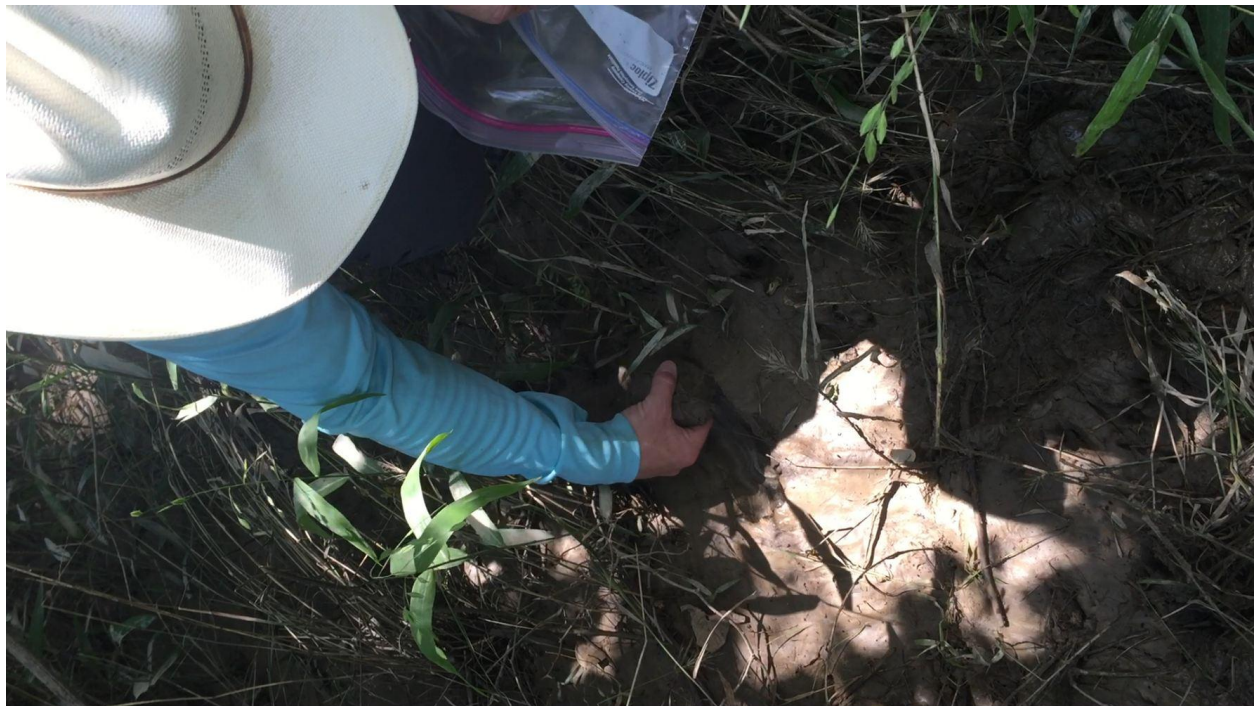
Figure 53. TRA staff collection sand and clay from on top of benchmark at 080444 Cross-section 4, left bank.

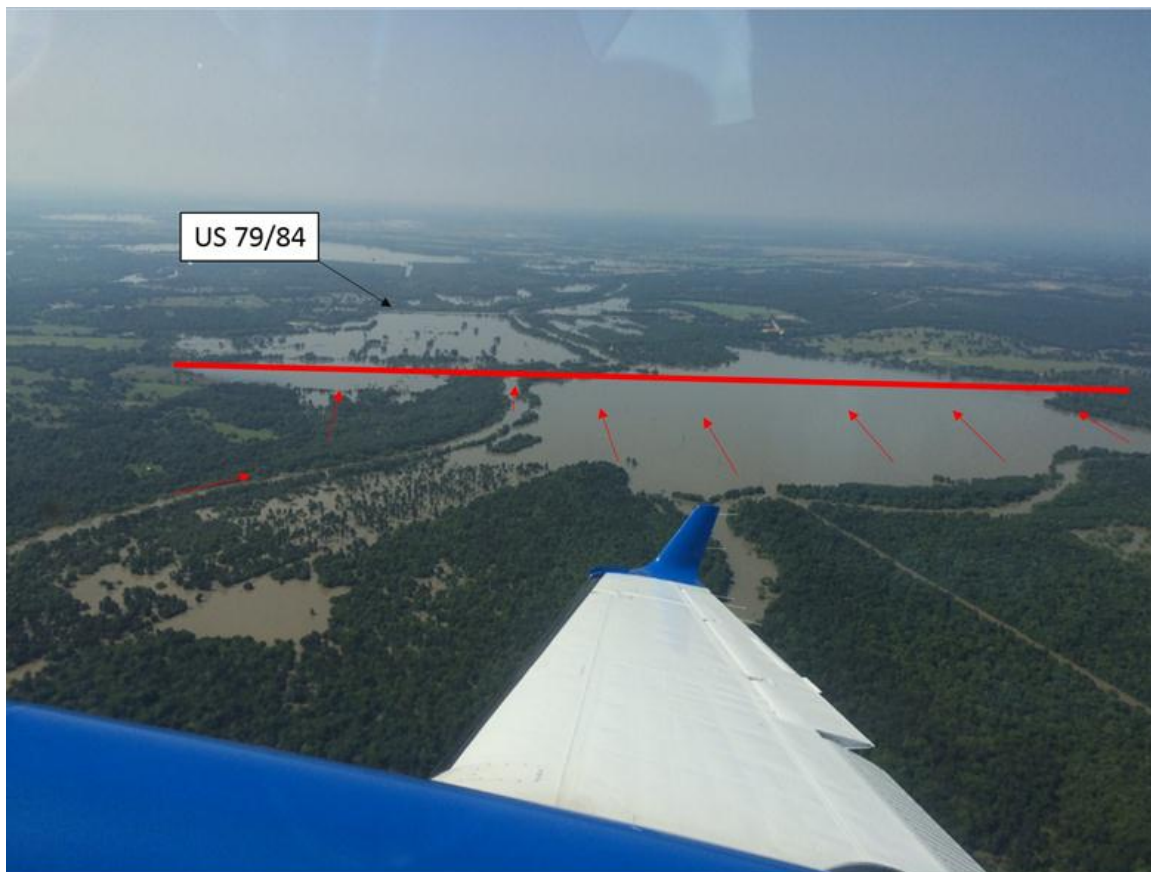
Figure 86. 080295 – Overbank flow condition and velocity direction, at same cross-section. The river reach under the airplane wing is experiencing reverse flow; the reach behind the wing is experiencing transverse flow.

This site was unique in that predominant flow direction was transverse or slightly reverse to the direction of typical river channel flows, predominantly overtopping the right bank to flow southward through a large agriculture area (Figure 85). Flow generally bypassed the meander bend and riffle at Cross-section 3. Channel flow appeared to slow considerably and reverse at the confluence with Keechi Creek, creating a large backwater area upstream of the confluence. However, flow in the down-channel direction was observed in the Trinity River channel downstream of Keechi Creek. An attempt to collect an extended discharge cross-section across the inundated agriculture field and the Trinity River channel accounted for the majority of the flow within this part of the Trinity River (Figure 86).
