2020 White Rock Creek *E. coli* Data Report

Trinity River Authority of Texas

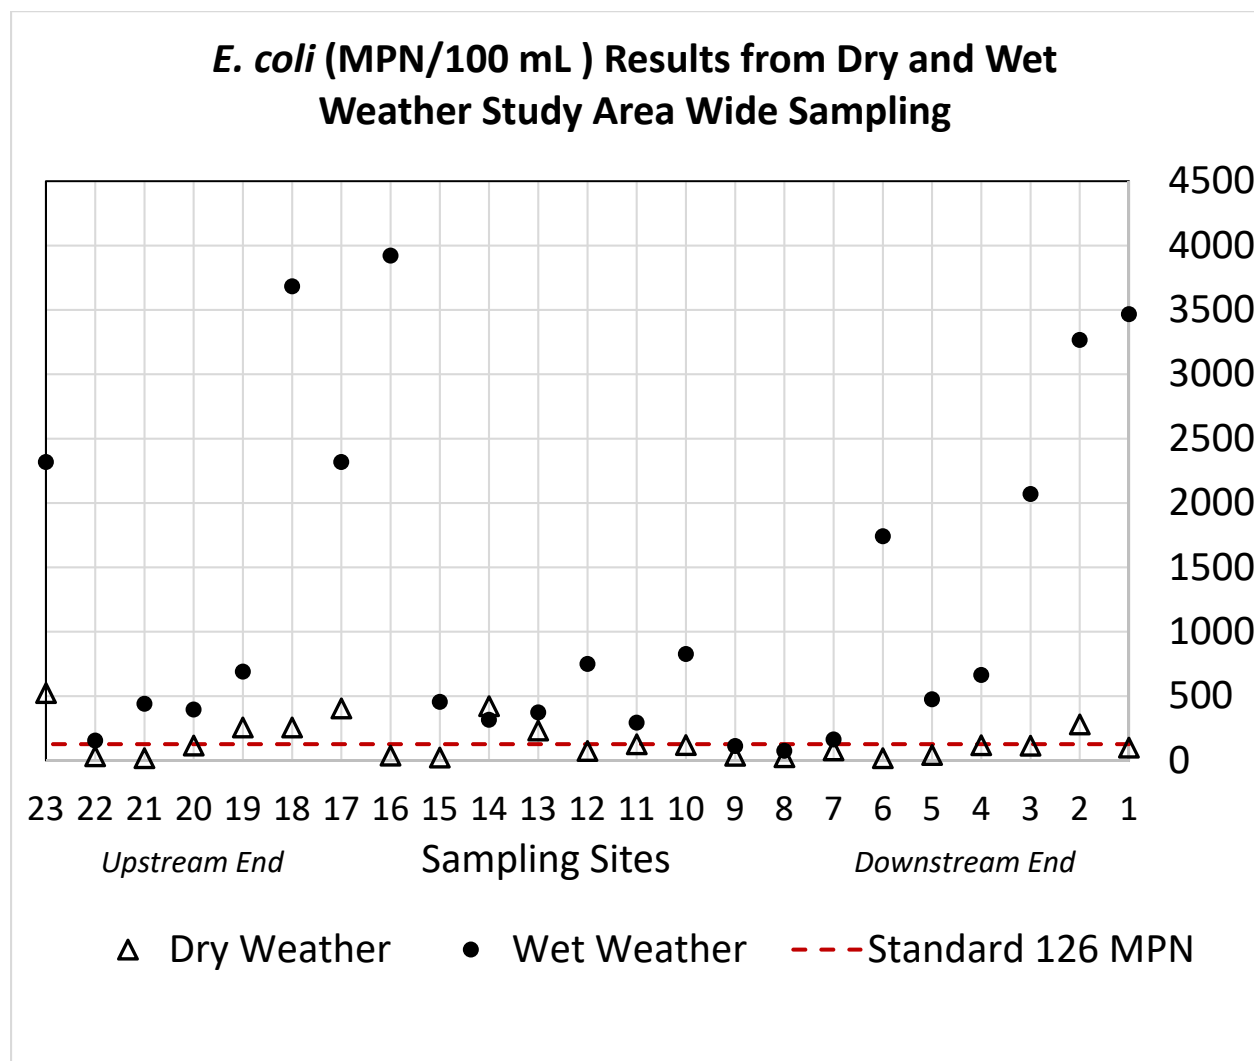
Figure 2. Comparison of *E. coli* Results Between the Coarse-scale Wet and Dry Sampling Events.

The *E. coli* geomean for the for the Dry-weather study area-wide sampling event was 91.36 MPN/100 mL, which is below the 126 MPN/100 mL standard, with 7 of 23 sites exceeding. For Wet-weather study area-wide sampling, the geomean was 696 MPN/100 mL with 21 of the 23 samples exceeding the standard. These values indicate that there are likely both point and non-point sources of *E. coli* affecting the water quality in White Rock Creek (Figure 2 & Figure 3)

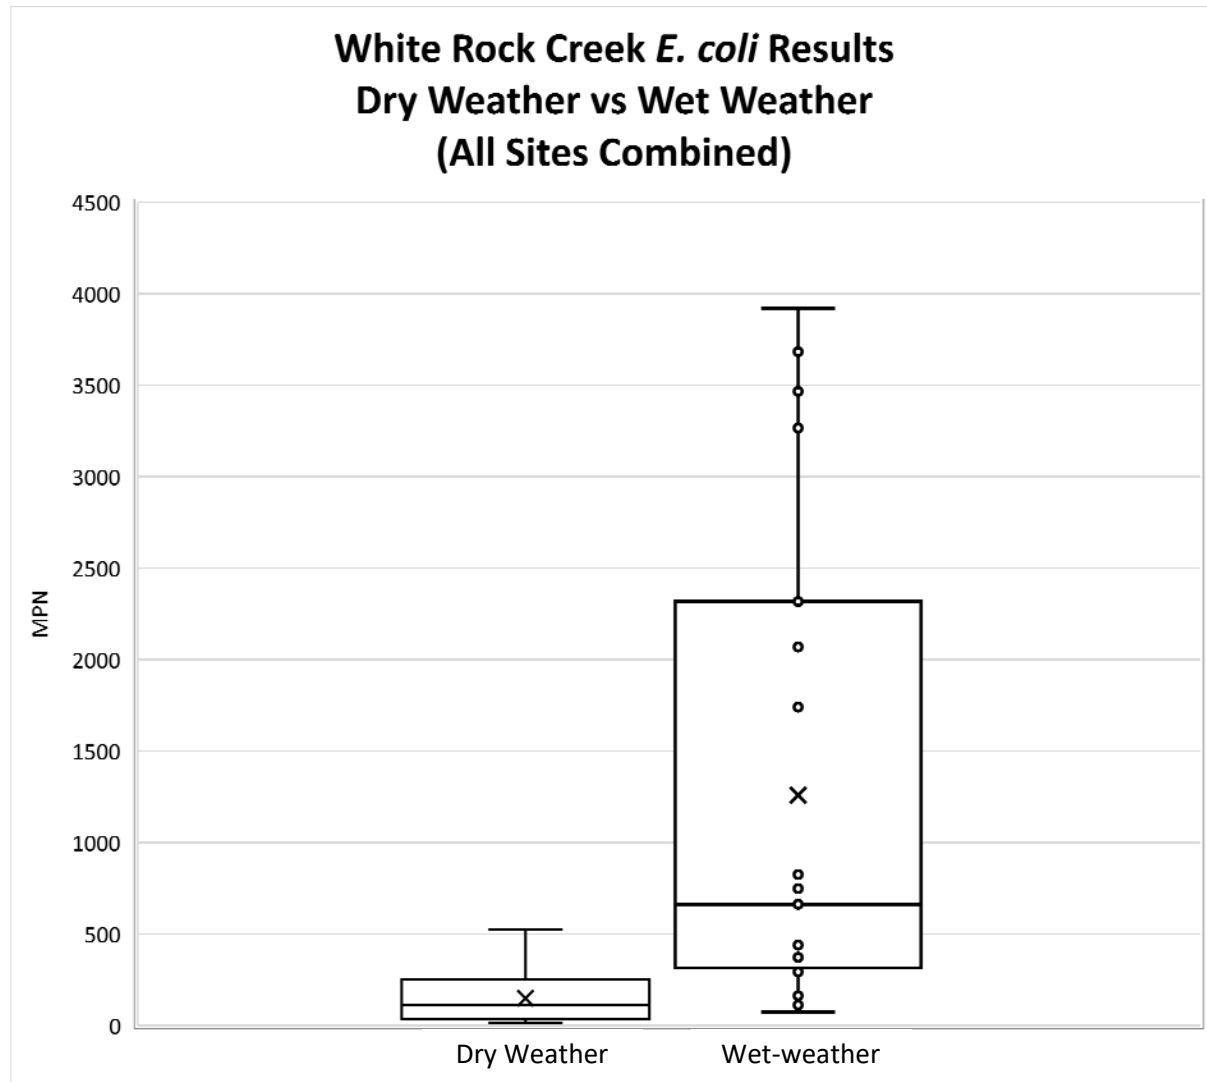
Figure 3. Boxplot of Coarse-scale Dry-weather and Wet Weather samples.

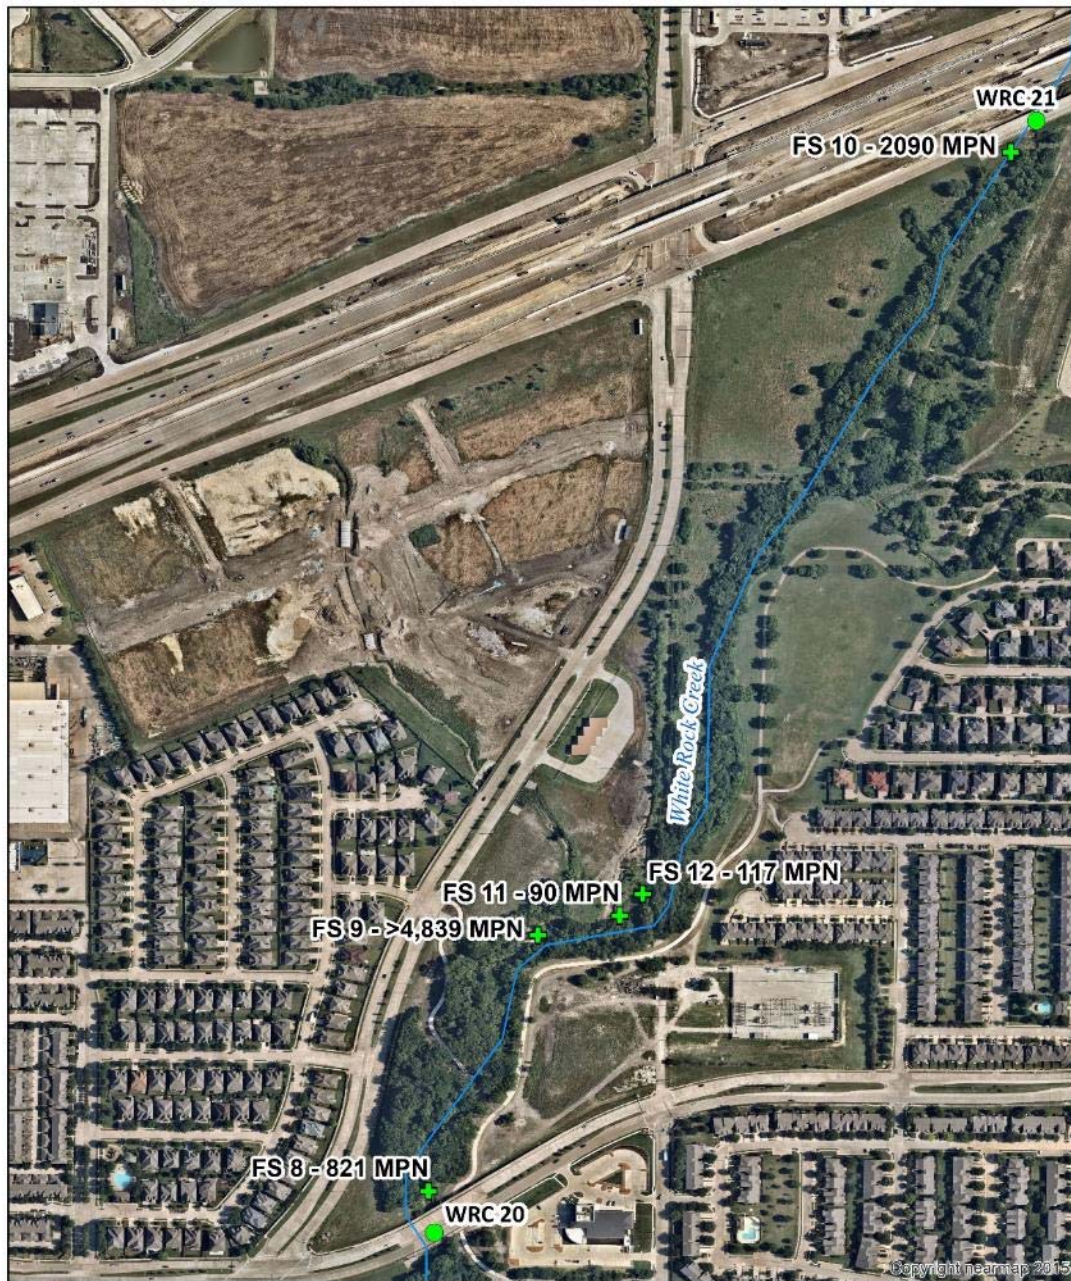
Figure 5 Map showing reach 20-21 Dry-weather, Fine-scale *E. coli* Results.

TRA staff walked the stream reach between sites 20 and 21 and the results are shown in Table 2 and the map in Figure 5. The most upstream sampling site showed a high *E. coli* value of 2,092 MPN/100 mL, but that number dropped to 117 MPN/100 mL and 90 MPN/100 mL at the next two sampling sites. The next sample was taken just downstream of a creek confluence that came in from the northwest. This sample result was very large, >4,839 MPN/100 mL, indicating that this watershed is contributing quite a bit of *E. coli* at low flows (Figure 6). At the downstream boundary, the *E. coli* was down to 821.

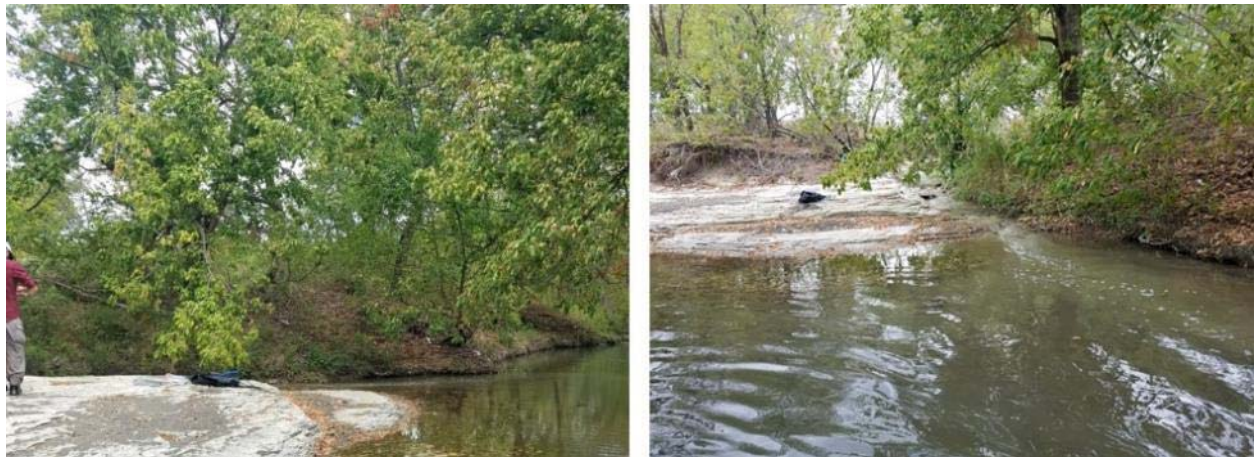
Figure 6. Two photographs showing the inflow location from the tributary just upstream of FS 9 ($> 4,839$ MPN/100 mL *E. coli*).

Analysis of aerial imagery showed that between August 1 and October 17, the watershed that drains the land upstream of the creek confluence where the extremely high *E. coli* value (>4,839 MPN/100 mL) was reported was converted from pasture into a major, active construction site (Figure 7). It is likely that runoff from the construction site is the cause for the *E. coli* loadings. This information was shared with the City of Plano. There were no other notable changes between the sites to any of the other water quality parameters collected.

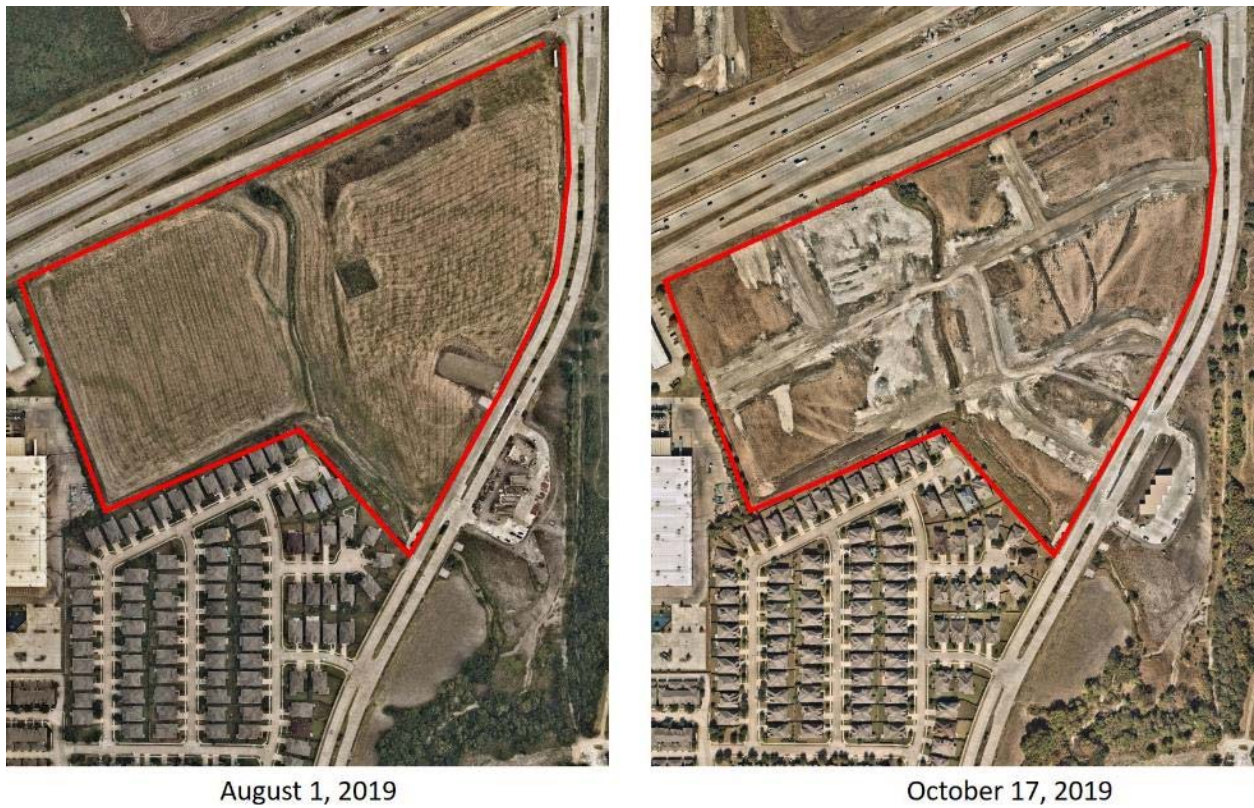
Figure 7. Comparison of two aerial images taken before and after the conversion of pastureland to a large construction site (NearMap, 2020).

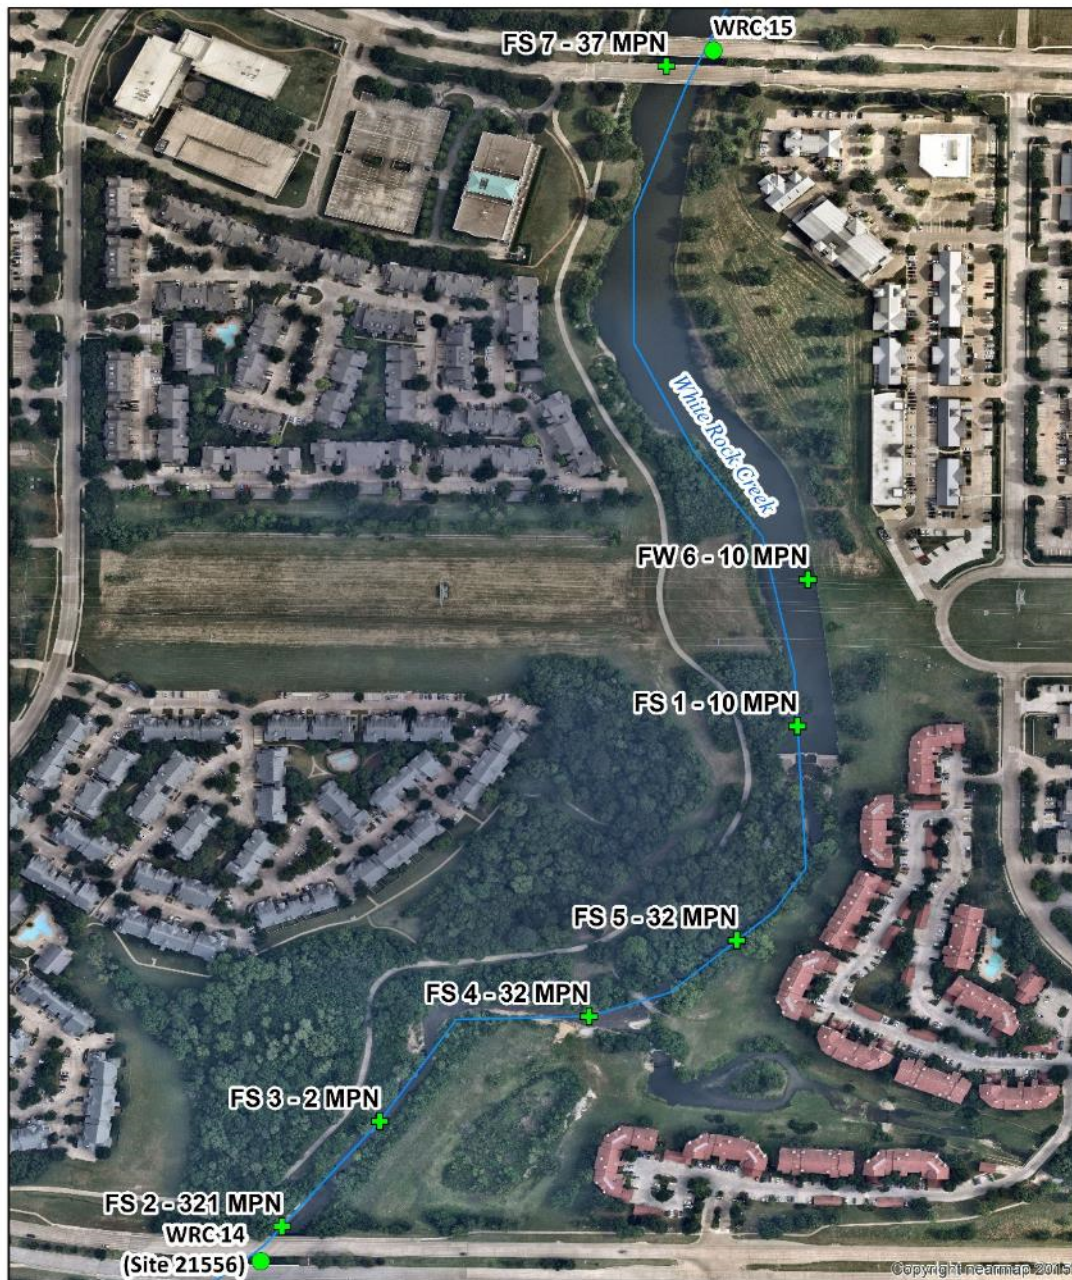
Figure 8. Aerial Imagery showing Reach 14-15 Dry-Weather, Fine-scale *E. coli* Results.

TRA staff walked the stream reach between sites 14 and 15 and selected seven sites for targeted sampling. The sites are described and the *E. coli* results are shown in Table 3 and the map in Figure 8. No notable inputs of *E. coli* were identified and all of the results were far below the 126 MPN/100 mL standard, except for the downstream site (WRC DRY FS2) which showed 321 MPN/100 mL. No potential outfalls or source locations were observed; it is likely the bridge facilitates the direct input of *E. coli* either through wildlife or anthropogenic sources. Previous studies have shown that birds nesting under bridges can be a driver of *E. coli* loadings in the Dallas/Fort Worth area (Pendergrass, Huack, & McFarland, 2013).

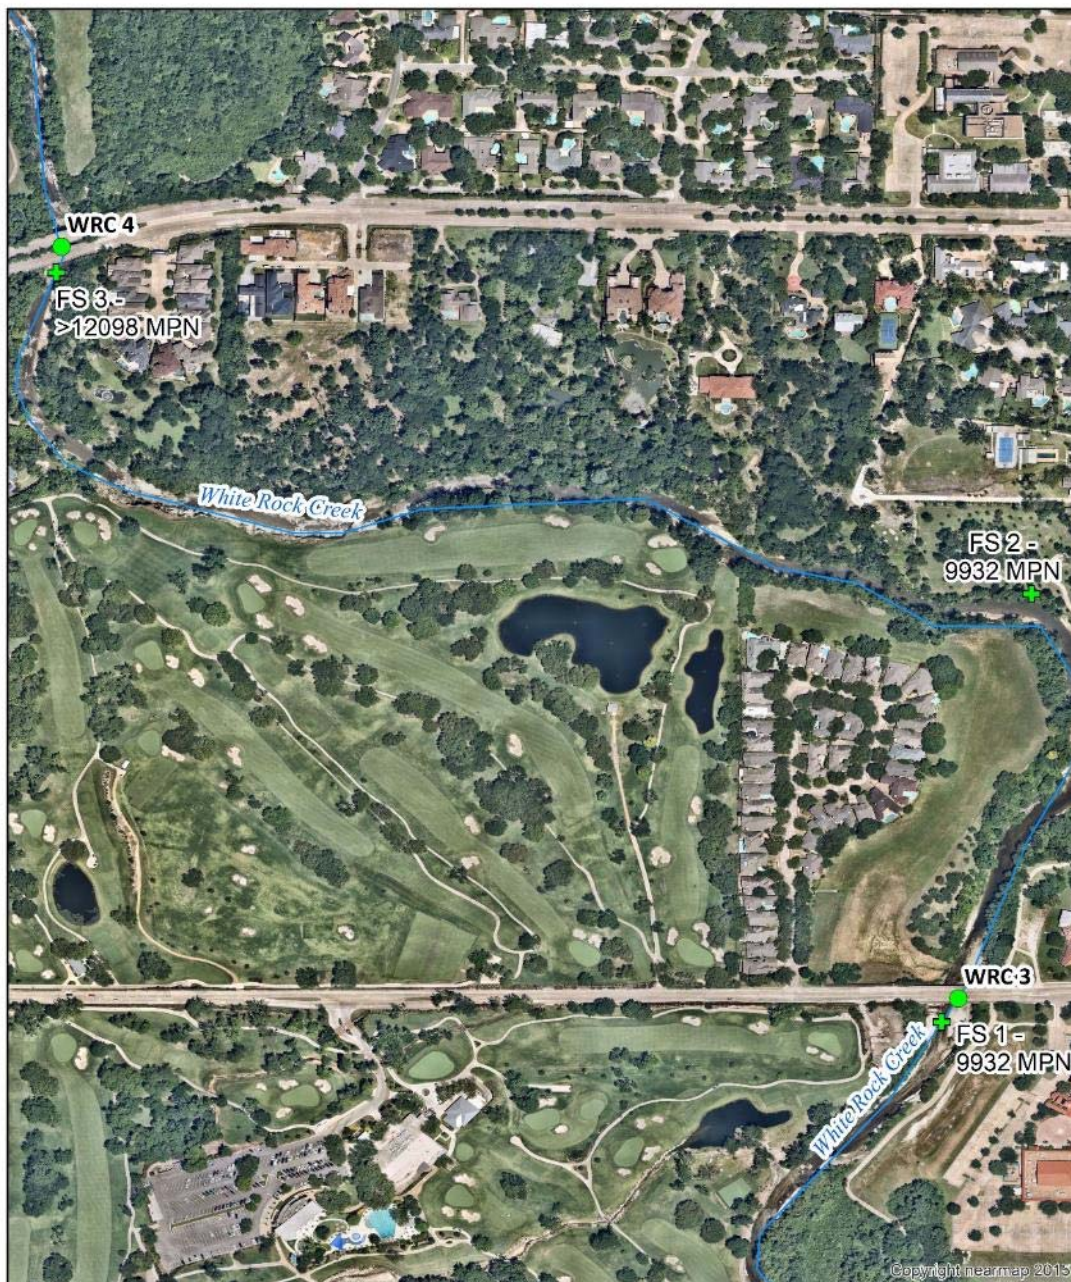
Figure 9. Aerial image showing the results from reach 3-4 wet-weather, fine-scale sampling.

The required threshold for targeted wet-weather sampling was met for three reaches between sites 18-19, 6-8³, and 3-4 (Figure 1) and the data are shown in Table 4 and the aerial images displayed in Figure 9, Figure 10, and Figure 11.

All of the results were far above the standard and no discernable pattern or sources of inputs could be determined. In short, *E. coli* was ubiquitous throughout the system and in all three cases, the upstream value for *E. coli* was higher than the downstream indicating a *reduction* throughout the reach. Two of the three reaches bracketed golf courses, but looking at the entire study area, there are an additional four reaches that contain all or part of a golf course, and they did not meet the criteria for fine-scale analysis.

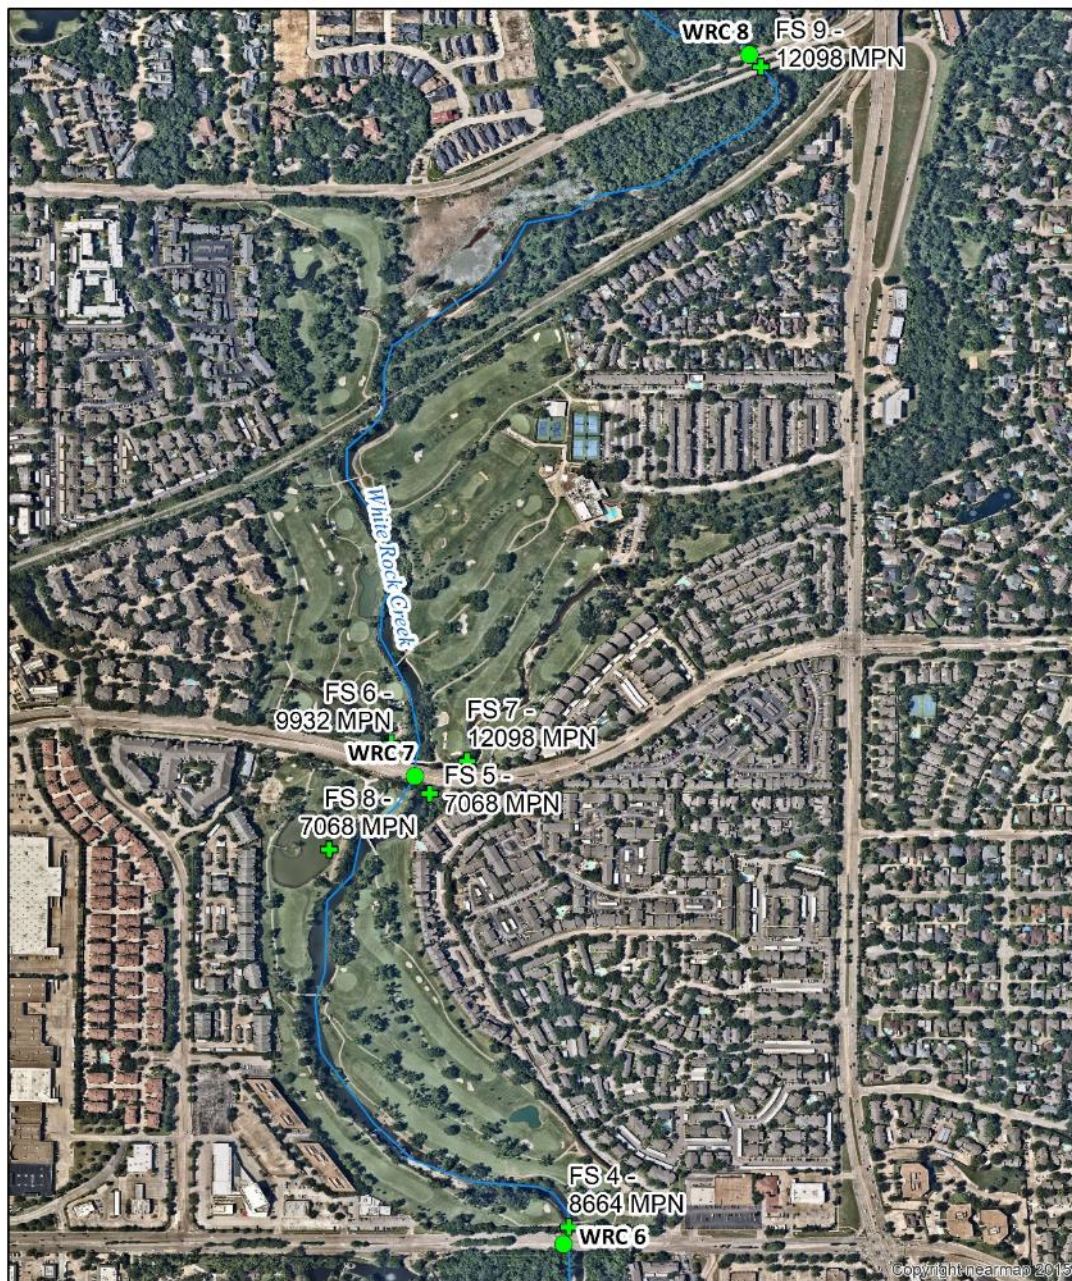
Figure 10. Aerial image showing the results from reach 6-8 wet-weather, fine-scale sampling.

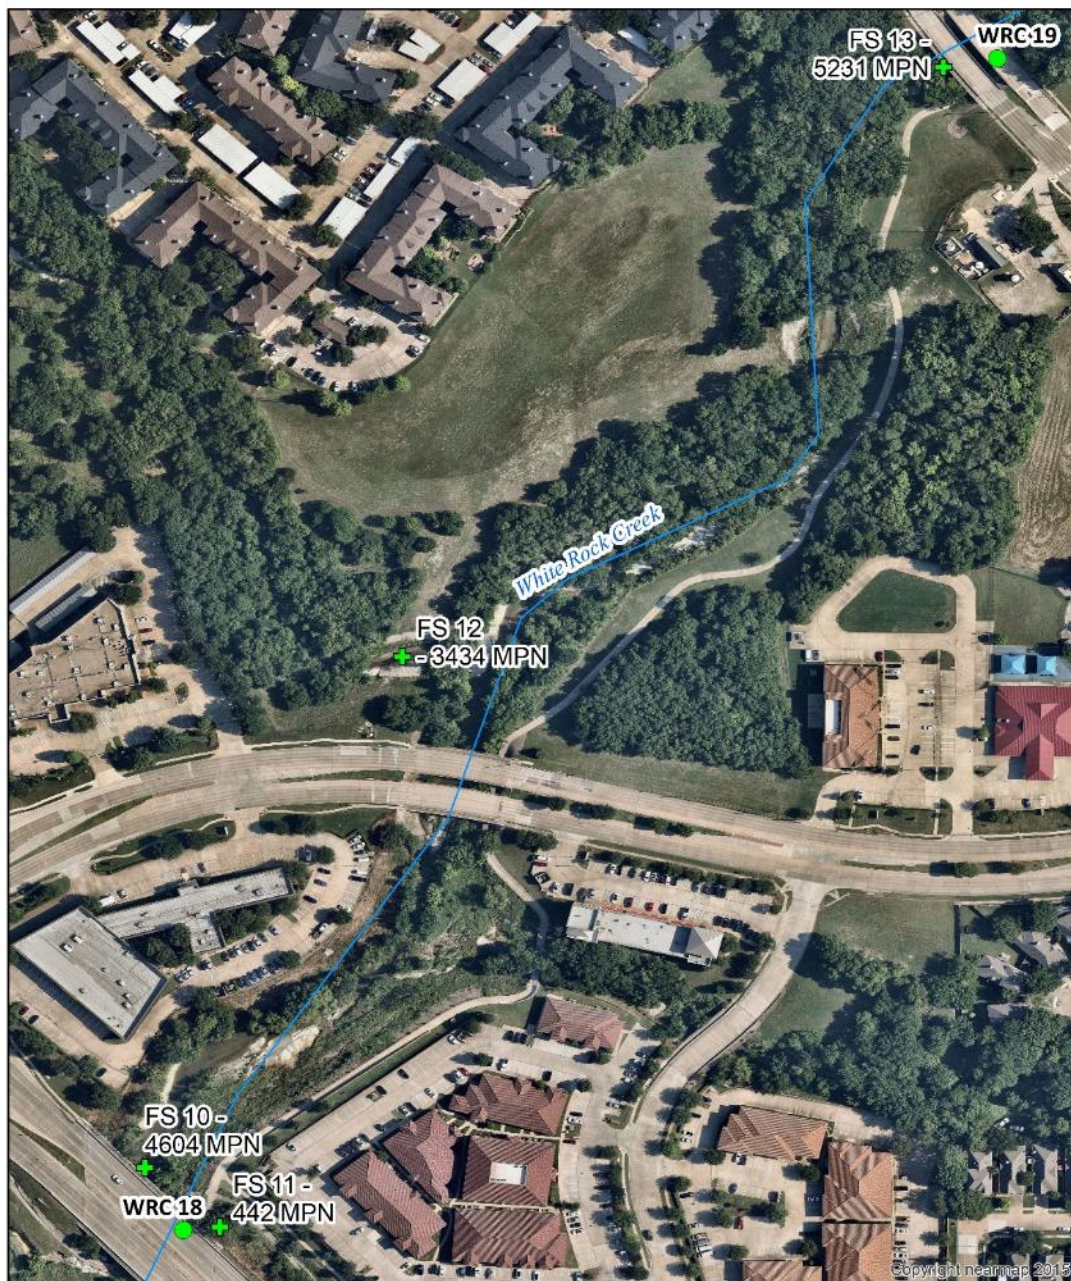
Figure 11. Aerial image showing the results from reach 18-19 wet-weather, fine-scale sampling.
