# Village Creek-Lake Arlington Watershed Protection

Trinity River Authority

September 22, 2016

# Stormwater Green Infrastructure: Evaluation, Performance and Modeling

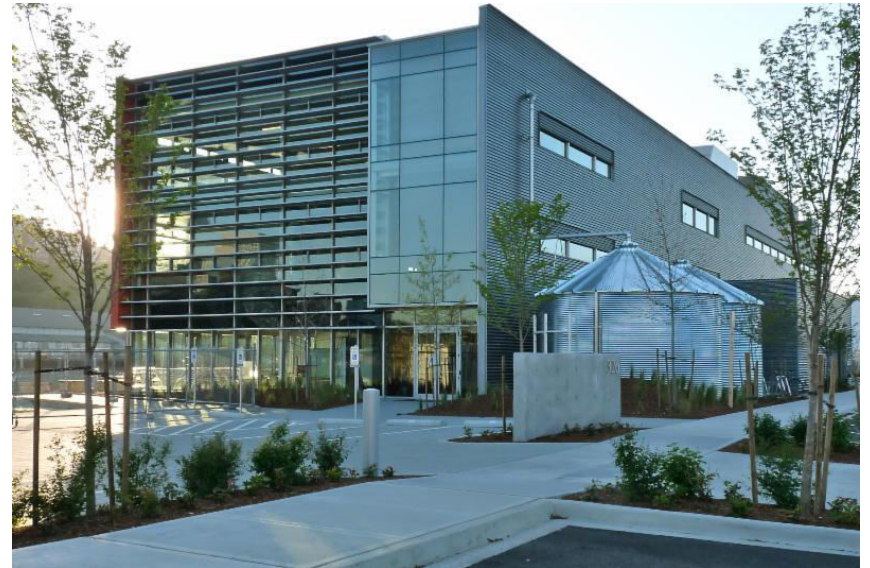
# What is Rainwater Harvesting?

- **Rainwater Harvesting** is the capture, diversion, storage and distribution of rainwater for later use or as stormwater mitigation
- **Why Rainwater Harvesting**
  - Reduces flooding, erosion, and contamination of surface water
  - Slowly release stormwater back into stream or use for irrigation

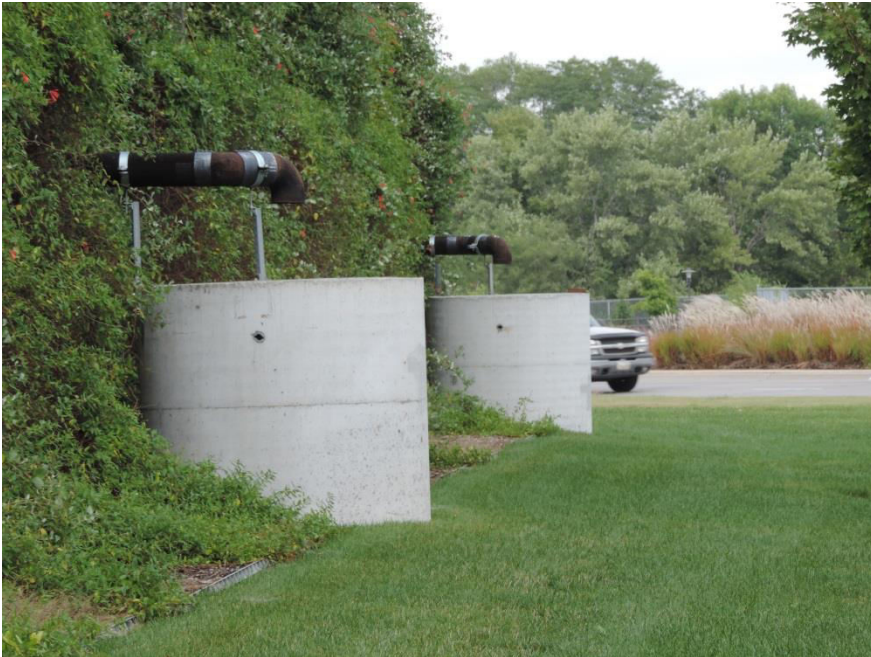
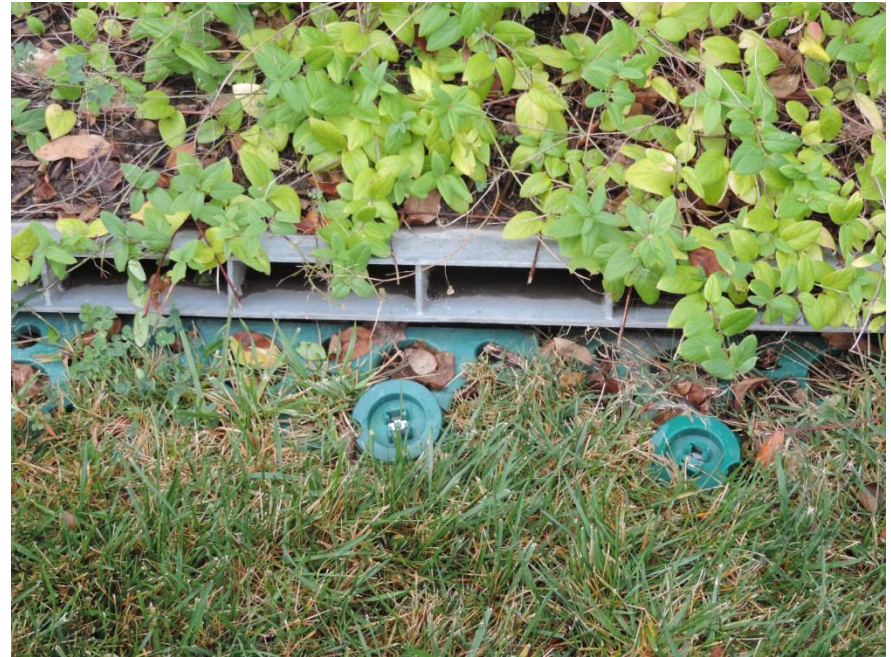
# How Much Rainwater Can I Collect?

- .6 gallons for every square foot roof per 1" rainfall
- 20,000 sq. foot roof X 1" rain = 12,000 gal. water
- 12,000 gal. X 32" rainfall per year = 384,000 gal/yr

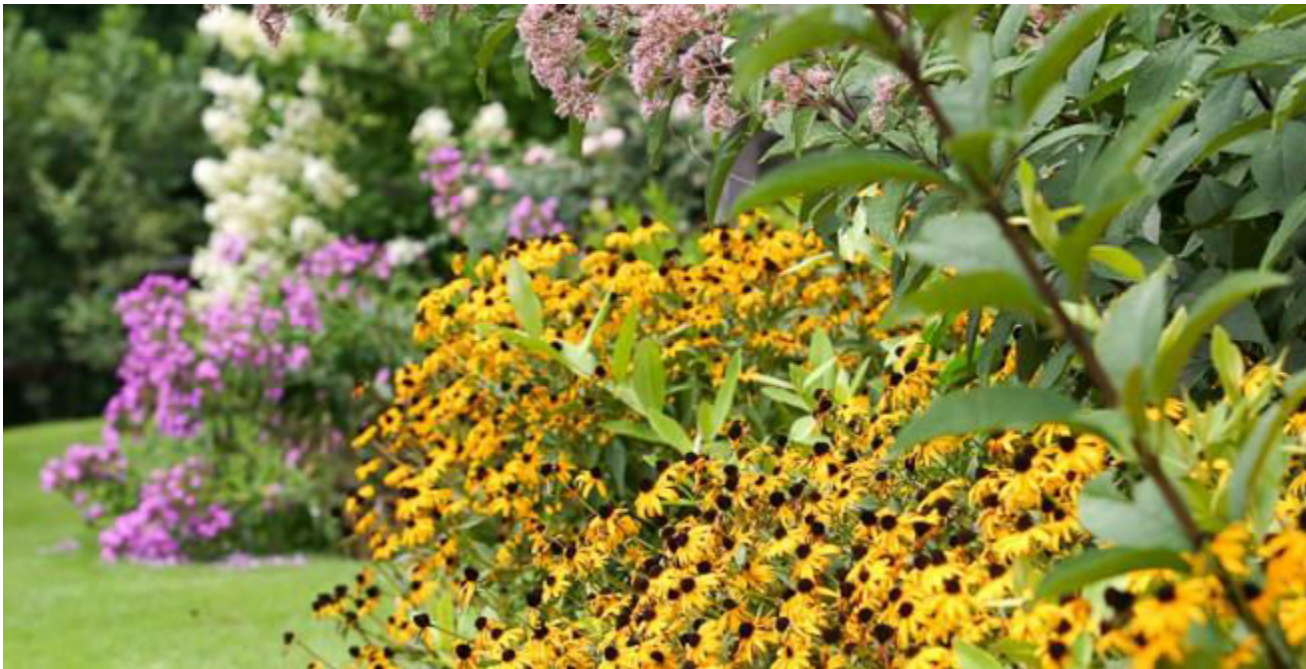
# Calculate Irrigation Requirements for Irrigation

Requirements (gal) =  $ET \text{ (in)} \times \text{Plant Coefficient} \times 0.623 \times \text{Irrigated Area (sq ft)}$

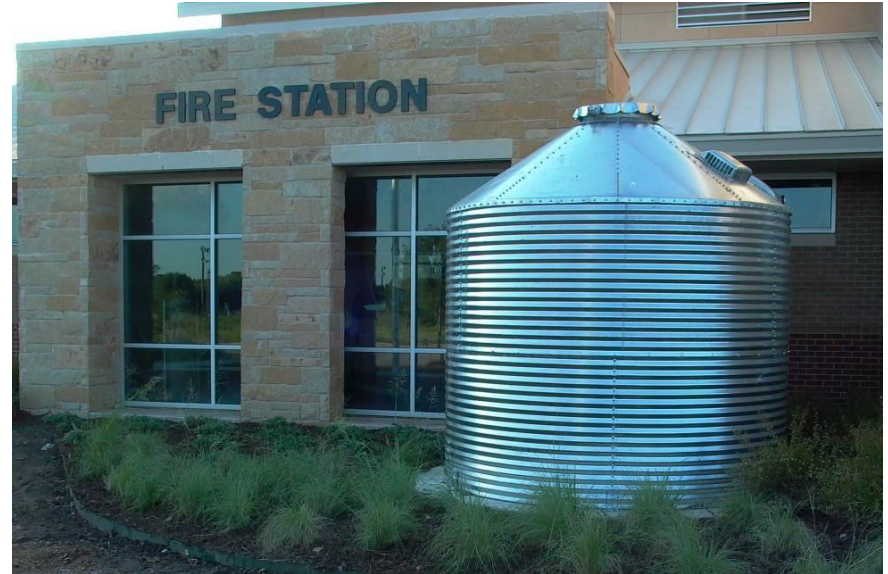
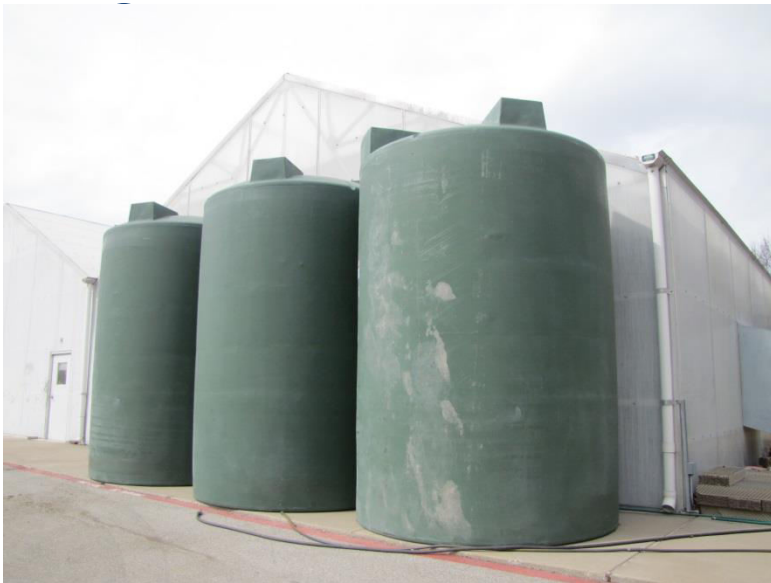
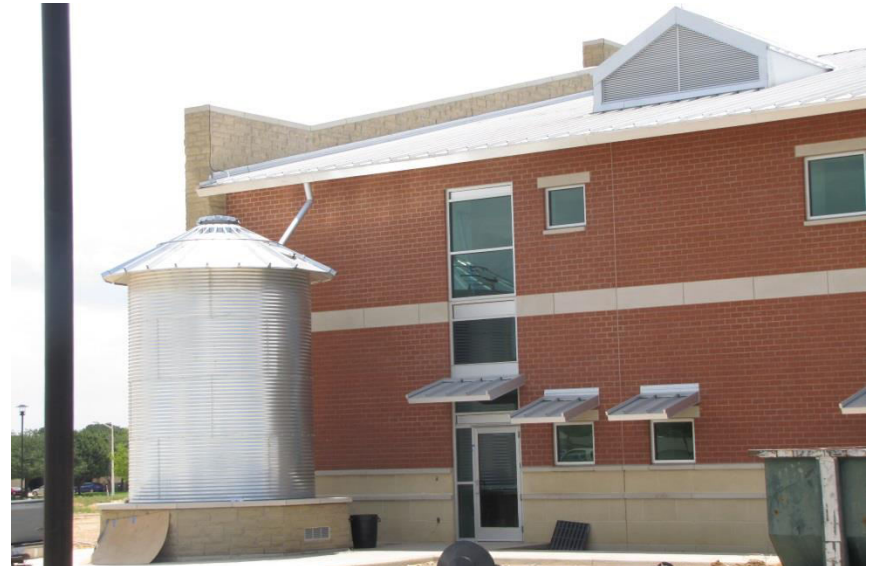
# Rainwater Harvesting System

## Storage

- Containers may be made of polyethylene, fiberglass, wood, concrete, or metal
- underground or above-ground

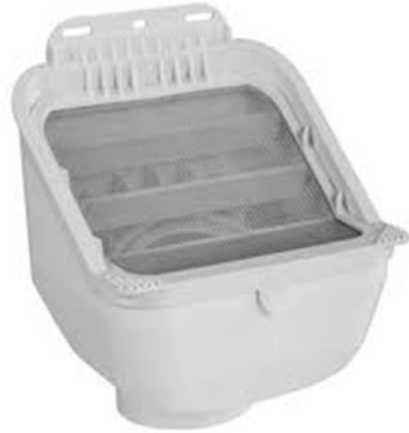
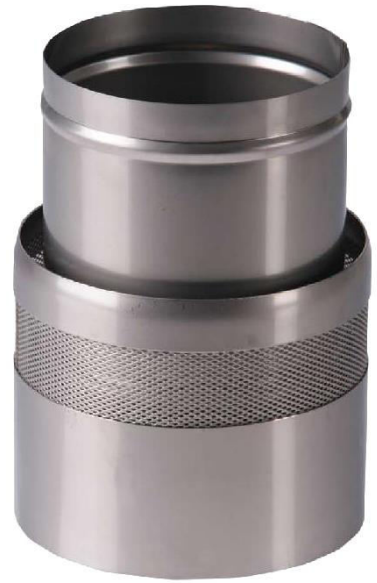
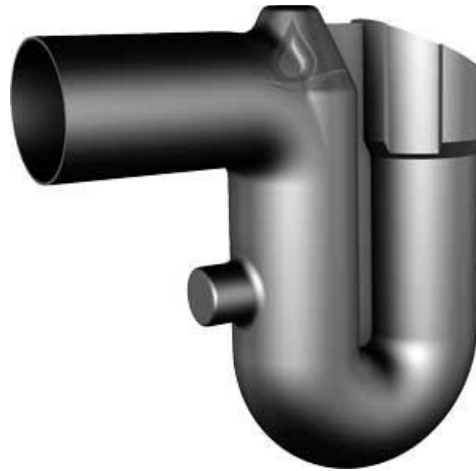
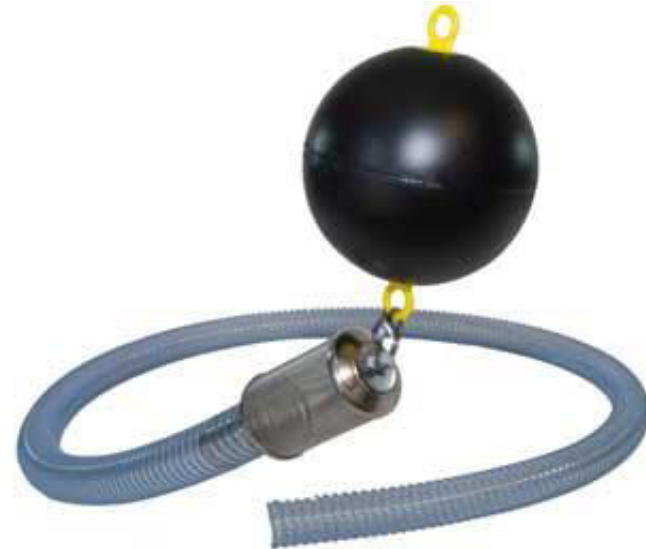
# Components

- **Leaf filter**
- **Calming Inlet**
  - Keep Sediment Layer From Being Disturbed
- **Overflow Siphon**
  - Creates Vacuum
  - Skims Floating Debris
- **Floating Intake/Extractor**
  - Acts As Intake/Suction For Pump
  - Only Takes The Cleanest Water From The Tank

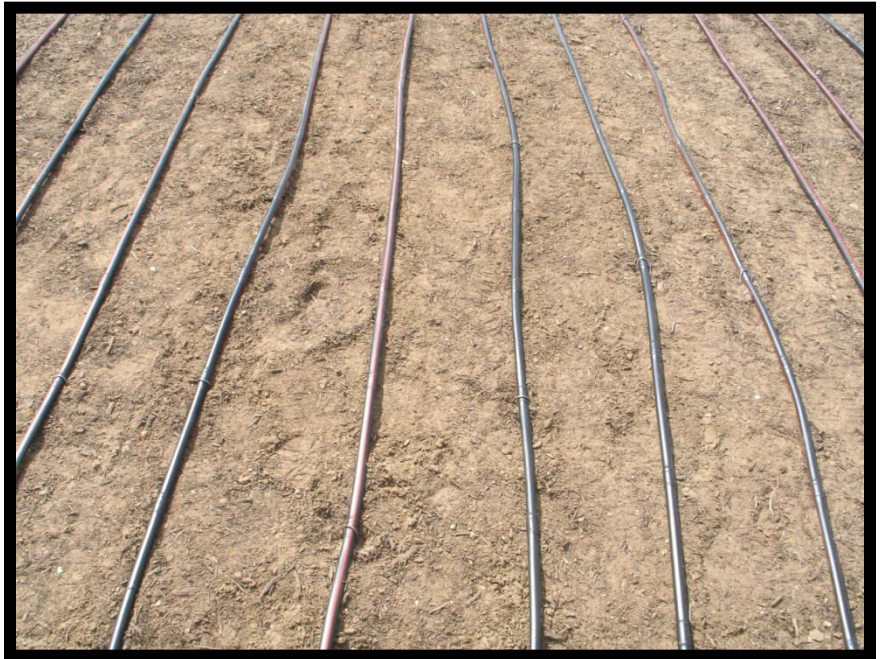
# Rainwater Harvesting System

- Distributes water to plants from storage containers
- Use garden hoses, soaker hose, or drip system
- Use pump either electric or solar powered
- If the system is integrated with municipal supply, install a backflow preventer double check valve with an “air gap” or other approved backflow device

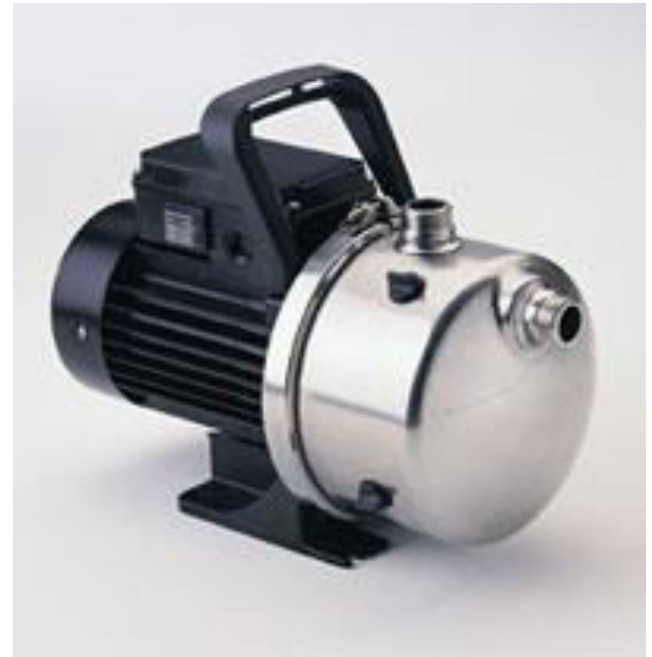
# Pump and Pressure Tank

- Shallow well pump
- Pressure tank
- On-Demand Pump

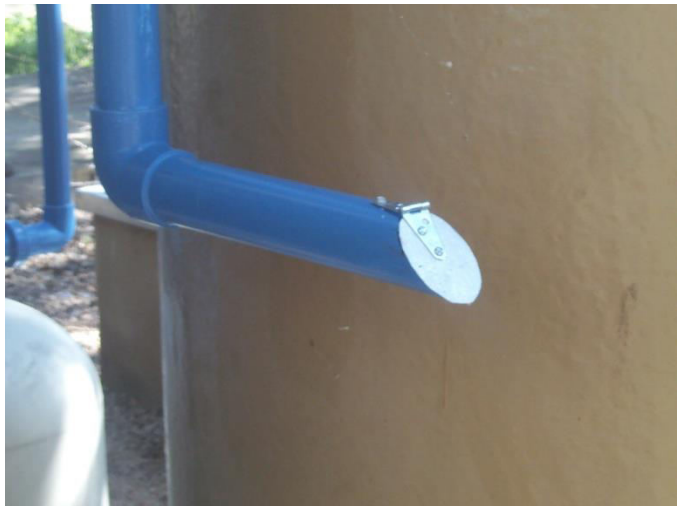
# Overflow Pipe

The overflow allows water to run out of the tank when it is full rather than backing up into the gutter
