Trinity River Authority Clean Rivers Program 2022 Basin Highlights Report

**Watershed Characterizations for Water Bodies with Fish
Consumption and Recreation Use Impairments and Concerns**

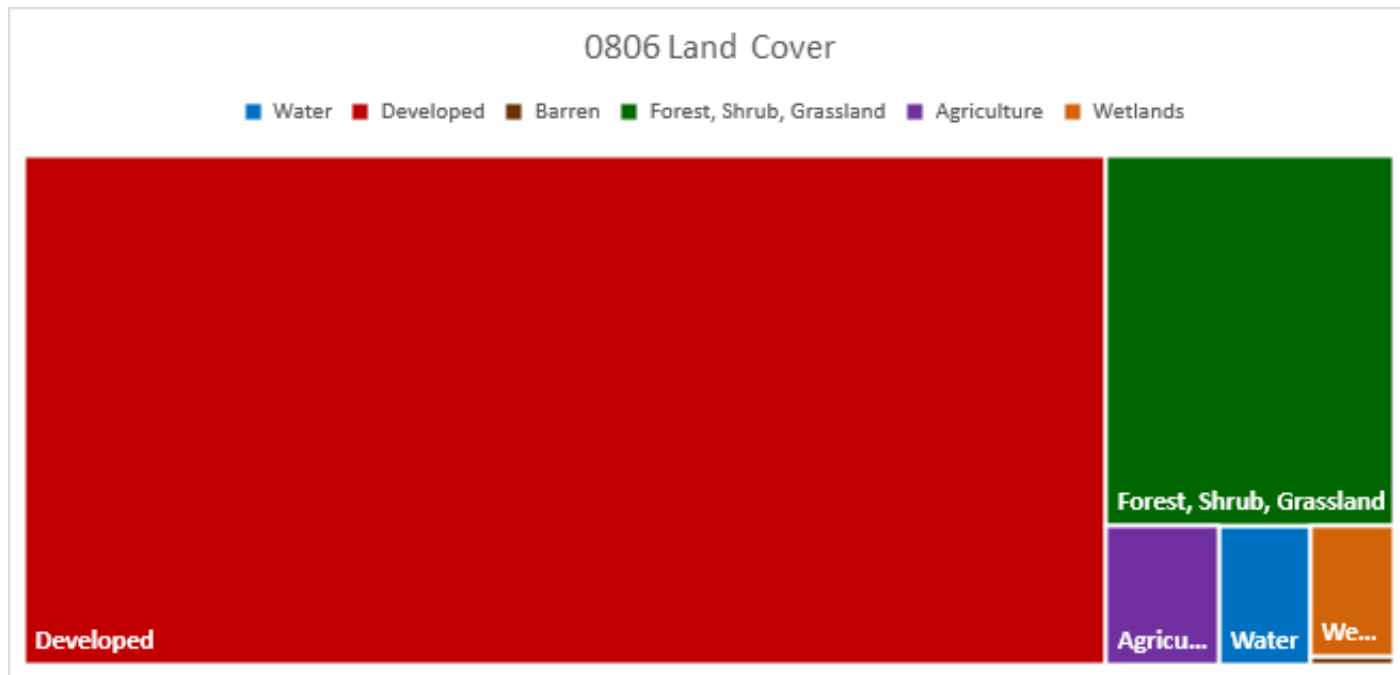
A majority of the segment is heavily developed by the cities of White Settlement, Fort Worth, Haltom City, and Arlington. There are some forested areas directly adjacent to the river. This segment begins in the Grand Prairie and ends in the Eastern Cross Timbers ecoregion.

Figure 20: 0806 relative land cover totals.

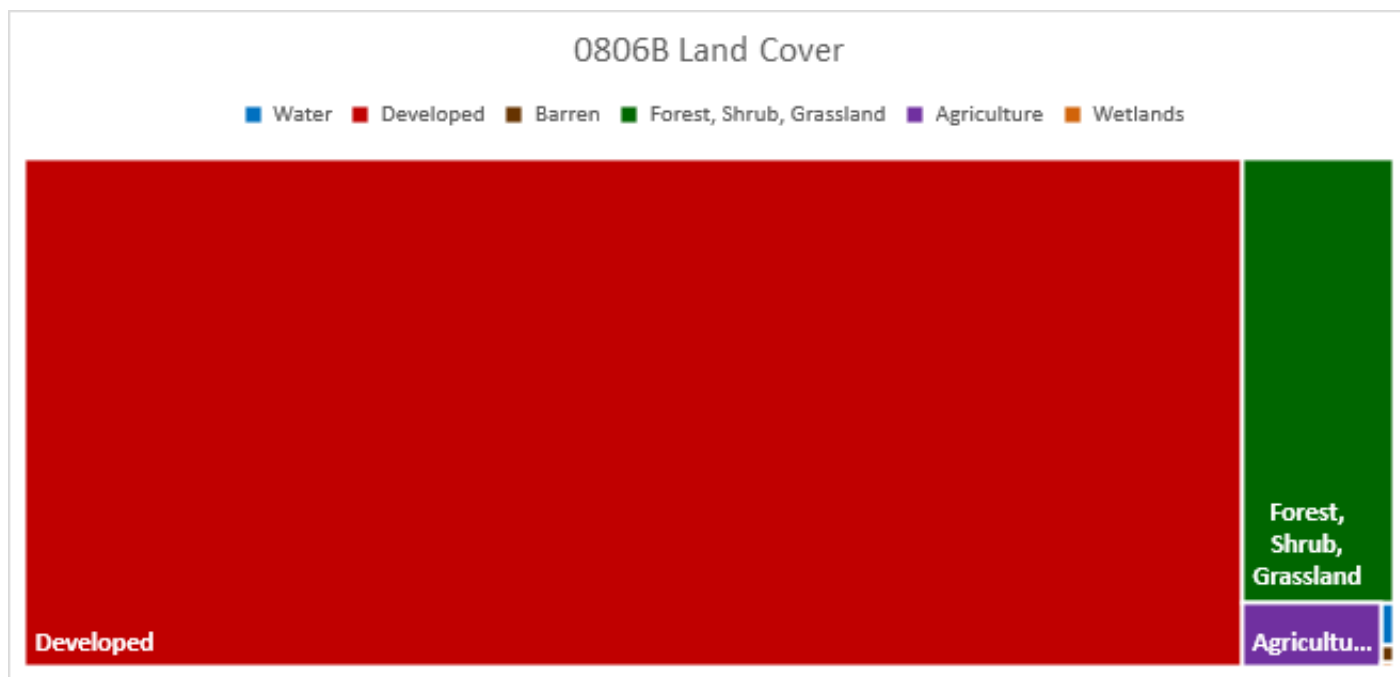
The watershed is developed and lies within the Grand Prairie ecoregion.

Figure 24: 0806B relative land cover totals.

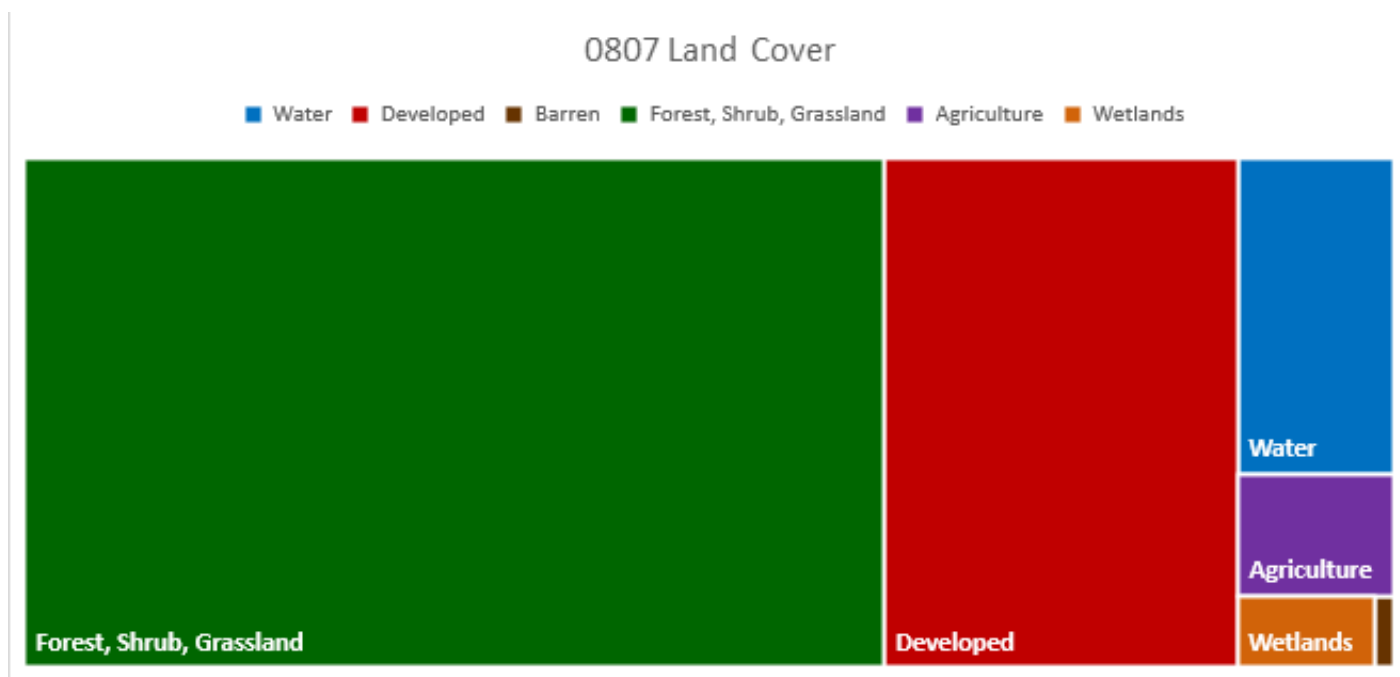
Figure 26: 0807 relative land cover totals.

The watershed for Lake Worth is highly urbanized to the south and east with the remainder being mostly forested areas with some grassland and pastures. The majority of the watershed and reservoir is located in the Grand Prairie ecoregion with the west side of the watershed draining the Western Cross Timbers. Lake Worth has been noted as being eutrophic by the [TCEQ Trophic Classification of Texas Reservoirs](#) report.

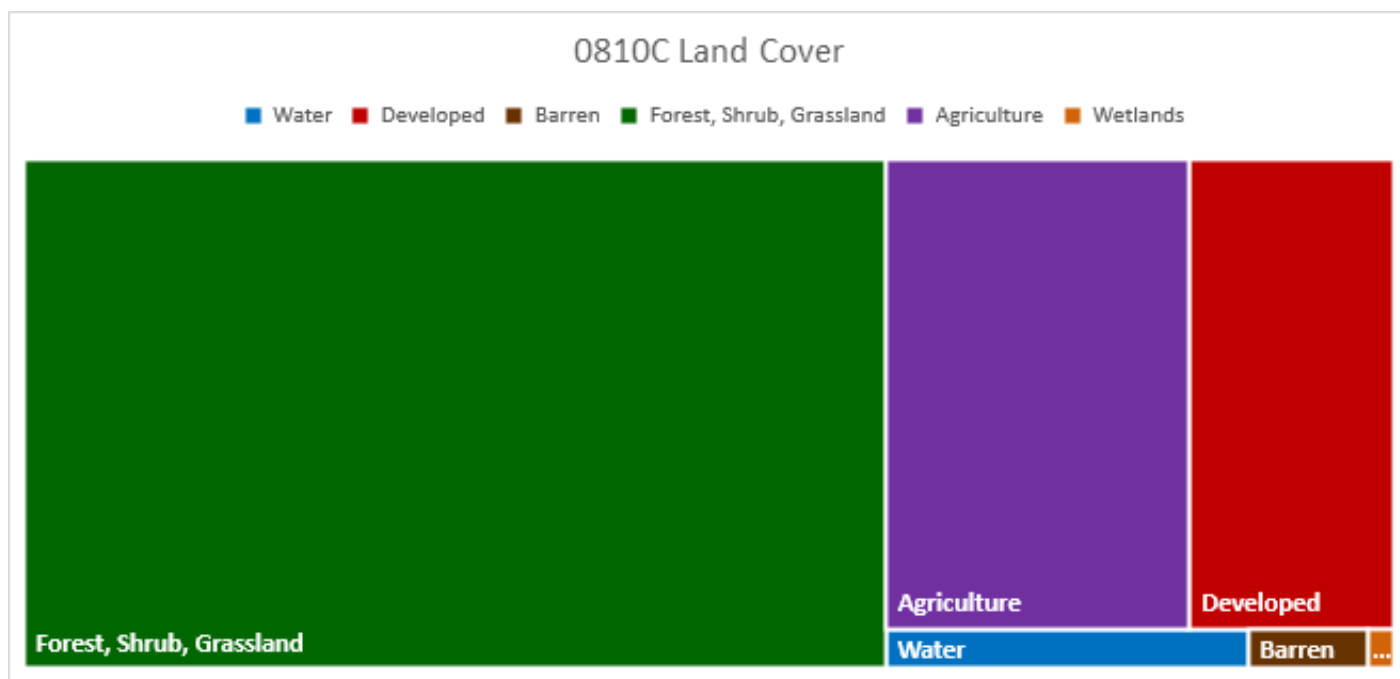
The headwaters lie in the Grand Prairie ecoregion and flows into the Western Cross Timbers. The stream begins in the City of Decatur and then travels through rural areas consisting largely of pasture, hay, and crop lands before joining the West Fork Trinity River.

Figure 87: 0810C relative land cover totals.

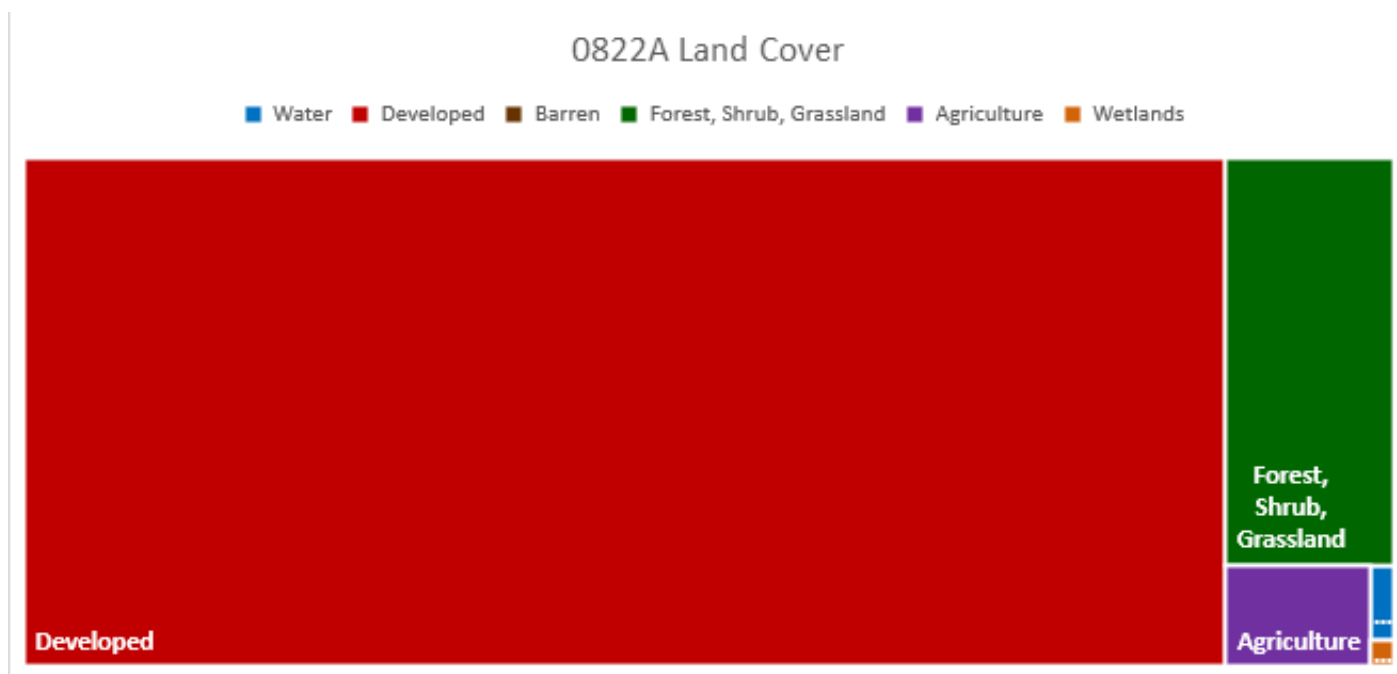
The watershed is heavily developed; beginning at Dallas-Fort Worth International Airport and flowing through the City of Irving. It lies within the Northern Blackland Prairie ecoregion.

Figure 131: 0822AB relative land cover totals.

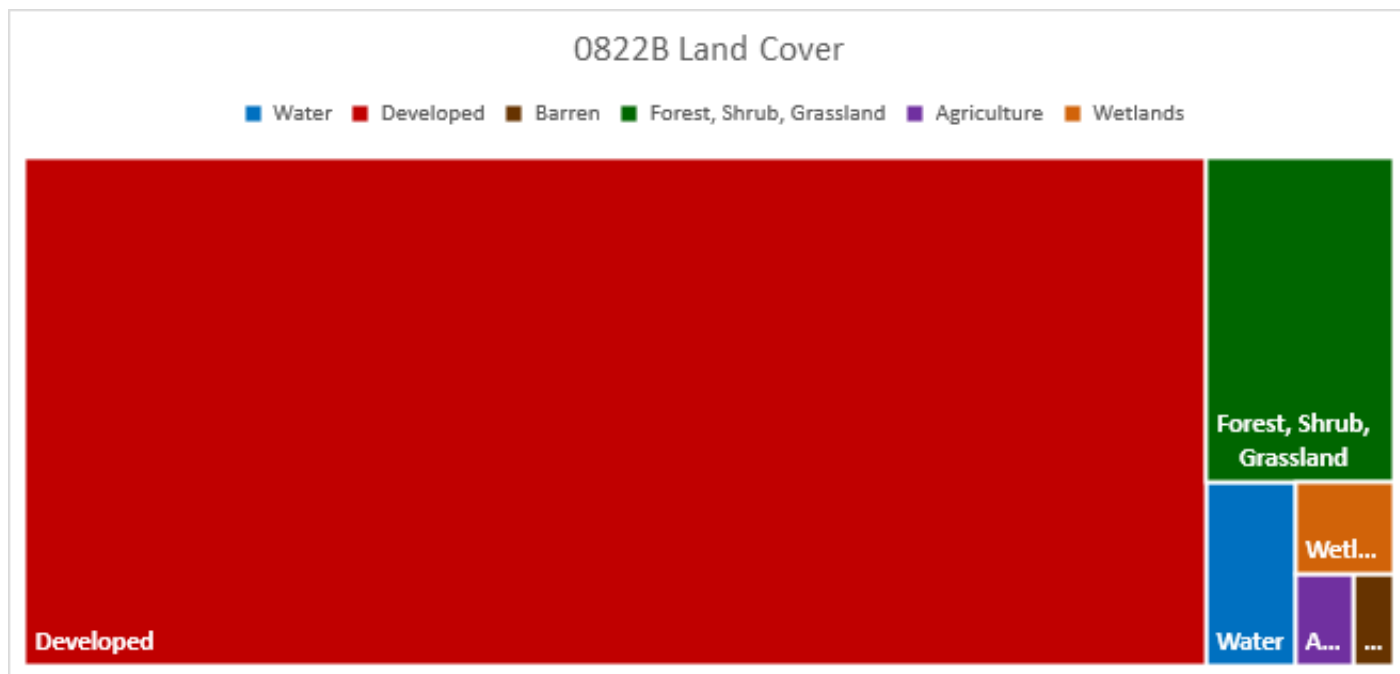
The watershed is heavily developed with the airport at its headwaters and flowing through the City of Coppell. It lies within the Northern Blackland Prairie ecoregion.

Figure 133: 0822B relative land cover totals.

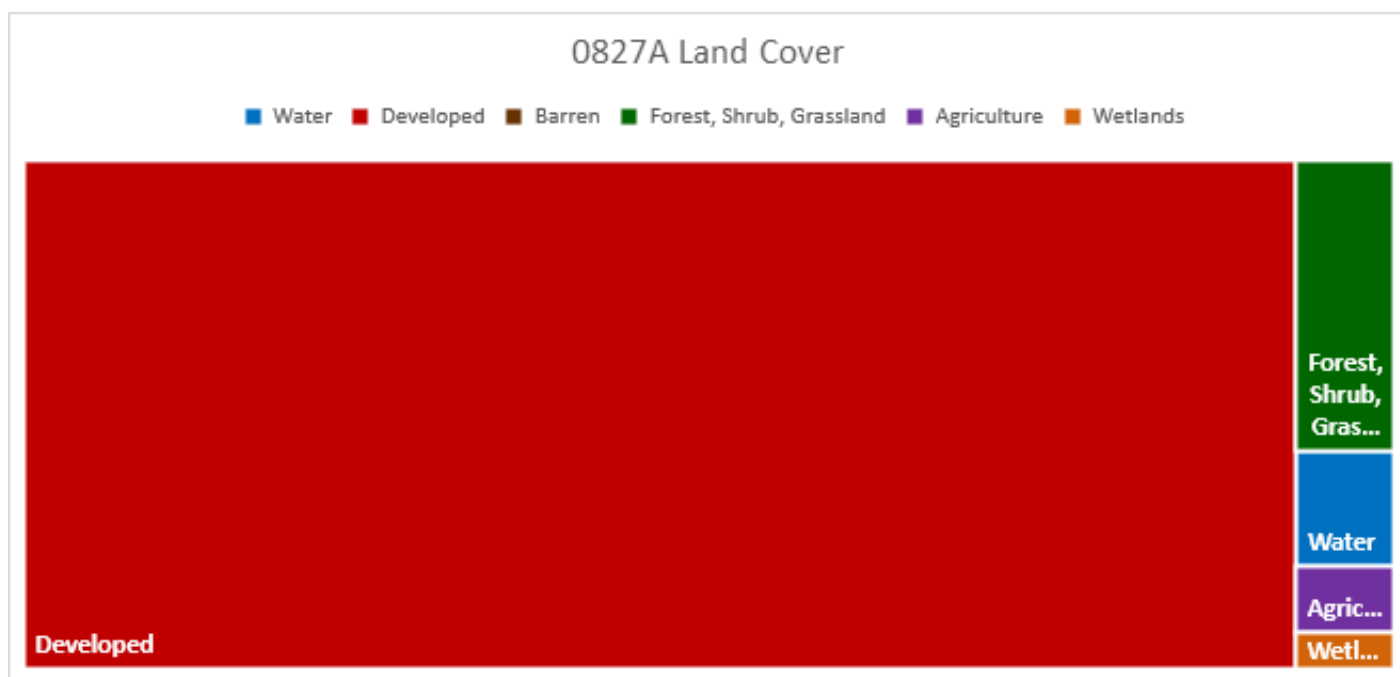
The watershed is heavily developed with some small wooded riparian areas and lies within the Northern Blackland Prairie ecoregion.

Figure 144: 0827A relative land cover totals.

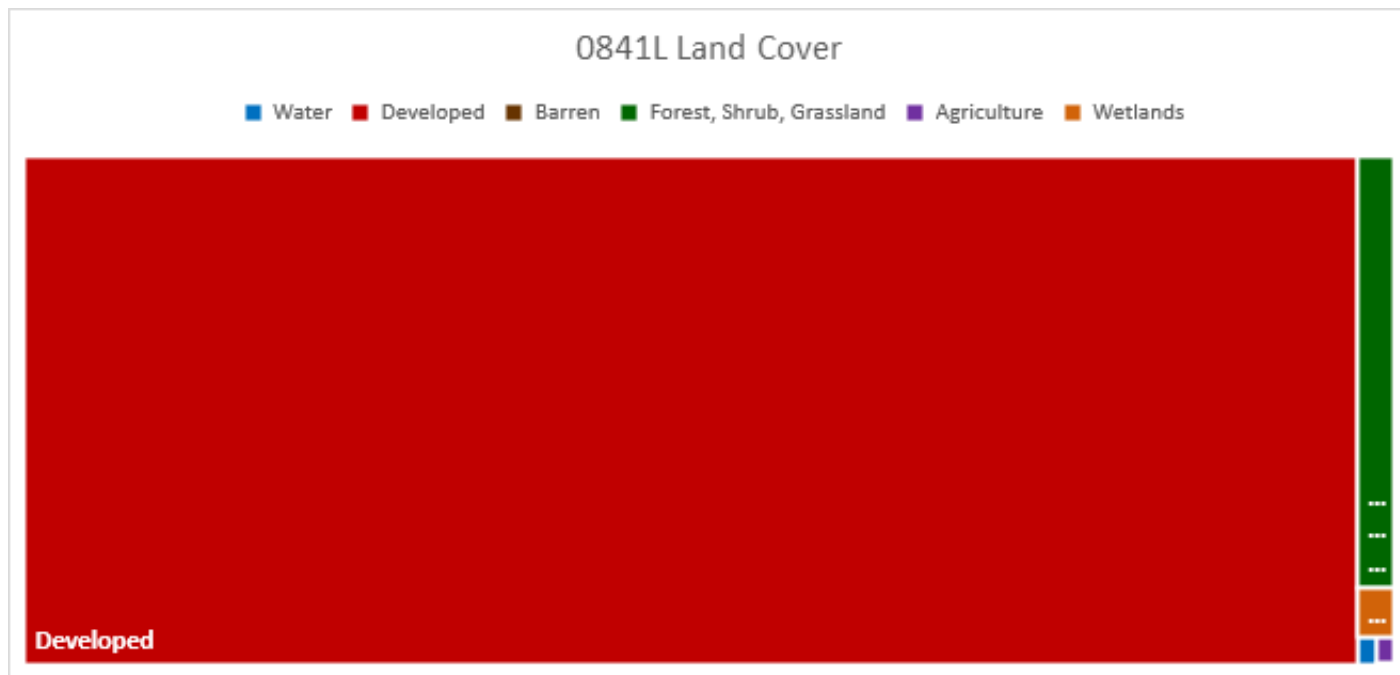
The watershed is heavily developed and flows through the Eastern Cross Timbers and Northern Blackland Prairie ecoregions.

Figure 173: 0841L relative land cover totals.

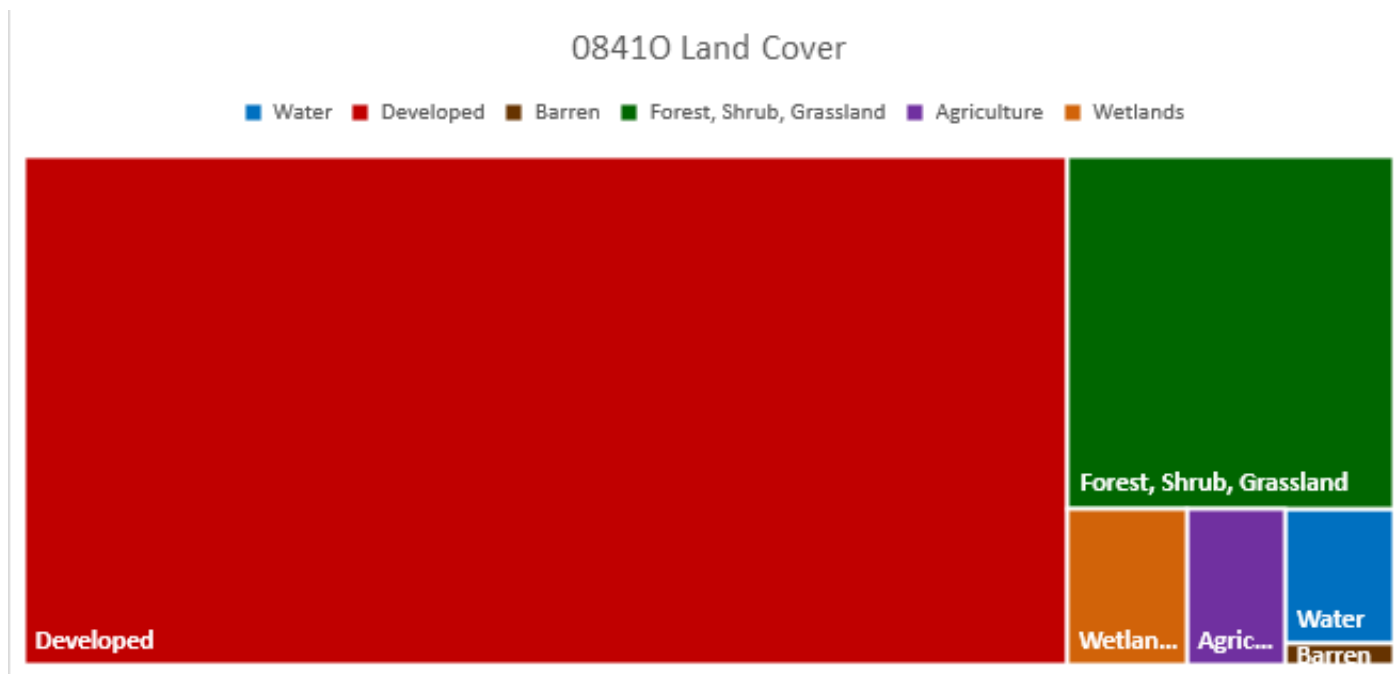
Figure 181: 08410 relative land cover totals.

The watershed is heavily developed with some wooded and wetland riparian areas and lies within the Northern Blackland Prairie ecoregion.

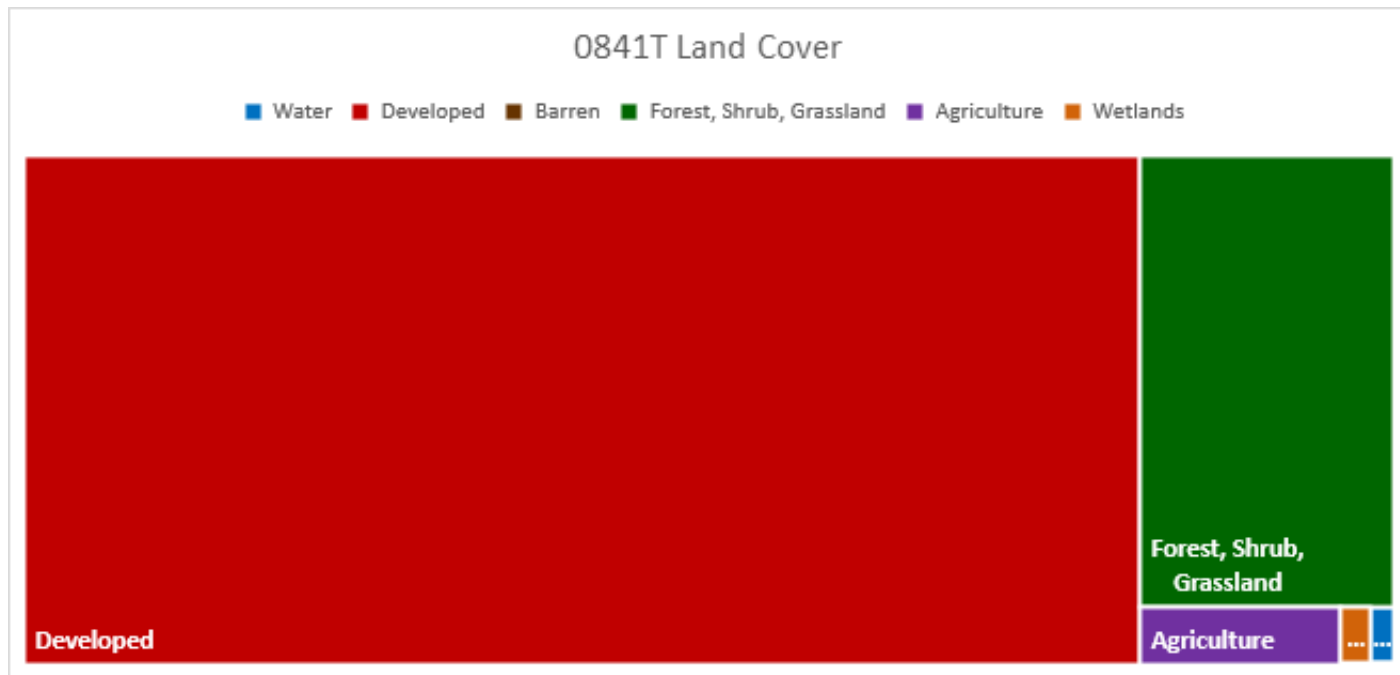
Figure 190: 0841T relative land cover totals.

Although the watershed is developed, the area directly adjacent to the stream is wooded with some grass and pasture land. The watershed lies within the Eastern Cross Timbers.
