Trinity River Authority Clean Rivers Program 2021 Basin Highlights Report

2021 Basin Highlights Report

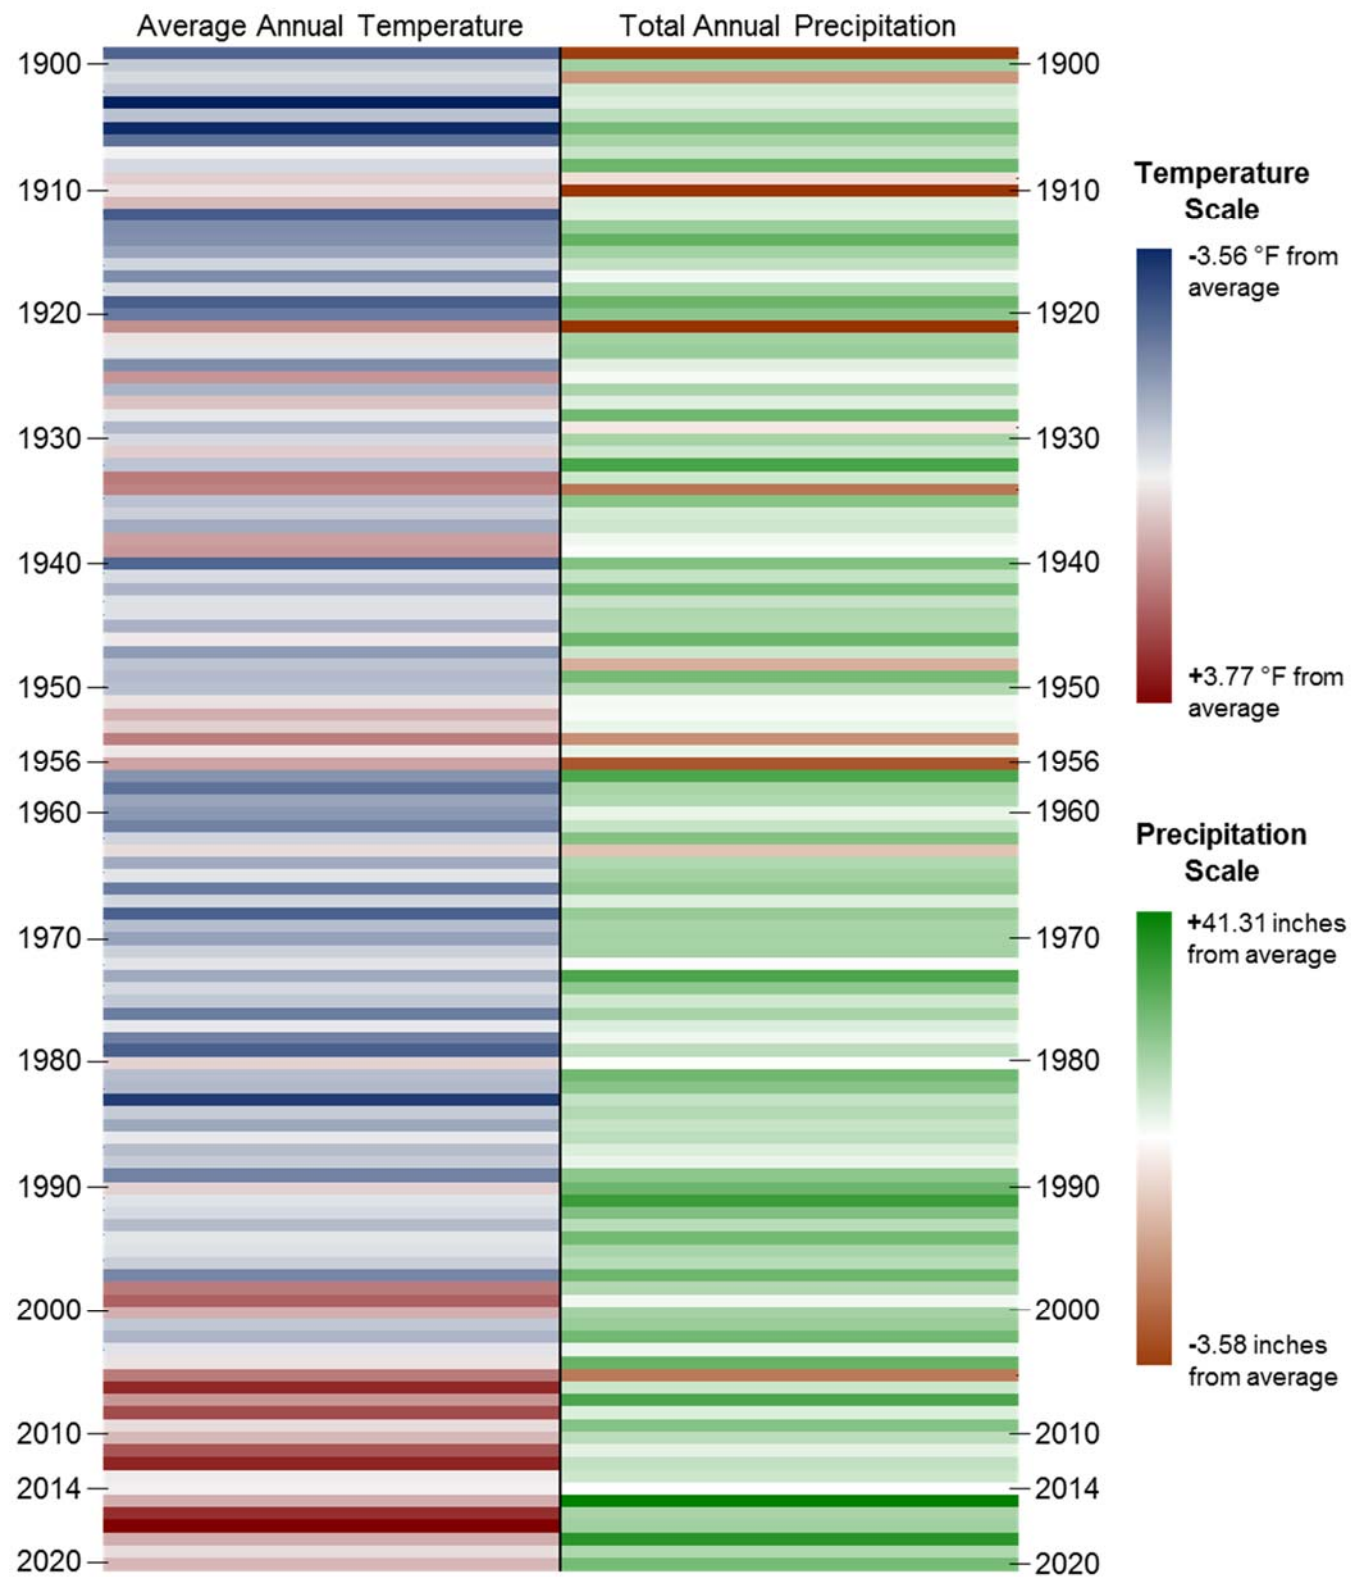
Figure 3: Temperature and Precipitation Differences from 1950-1957 Drought of Record

Difference From 1950-1957 Drought of Record

The drought of record in Texas has generally been accepted as being a period between October 1950 and February 1957¹ based on the Palmer Drought Severity Index. This drought is used for water planning in the state. The most recent drought extended from August 2010 to October 2014. Based on NOAA data from a continuously operating weather station currently located at DFW International Airport, the 2010's drought was hotter than the drought of record. However, there was slightly more precipitation during the most recent drought. **Figure 1** **Figure 3** shows a gradient scale comparison of climate data from the Dallas weather station. For temperatures, blue shades are years that were cooler than the average temperature during the drought of record and red shades are warmer years; darker blue and darker red shades being the coolest and warmest years, respectively. For precipitation totals, brown shades were drier than the drought of record and green shades were wetter with the darkest brown and darkest green being the driest and wettest years, respectively. As shown in **Figure 3**, the last 17 years have been consistently warmer than the 1950s drought. Although, precipitation totals have generally been higher than those seen during the 1950s drought, the most recent drought was observed to have effects on water quality as discussed in the [TRA 2020 Basin Summary Report](#). Decreased precipitation, along with warmer temperatures and its associated increase in evaporation, increased concentrations of pollutants in water bodies. The effects of drought are compounded by ever-increasing populations and their demands on existing water supplies. In response to the recent drought, the Texas Water Development Board has required that all state water planning regions provide drought response plans. Additionally, water providers must now notify TCEQ when they have less than 180 days of water supply available¹.

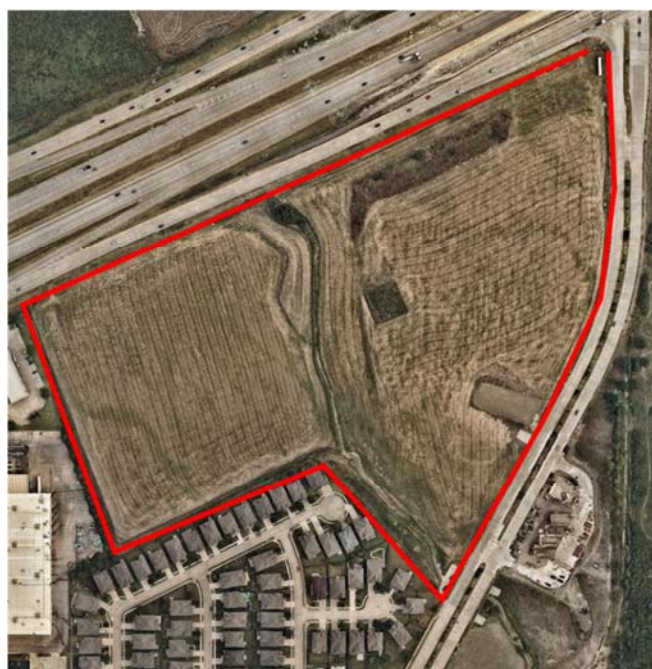
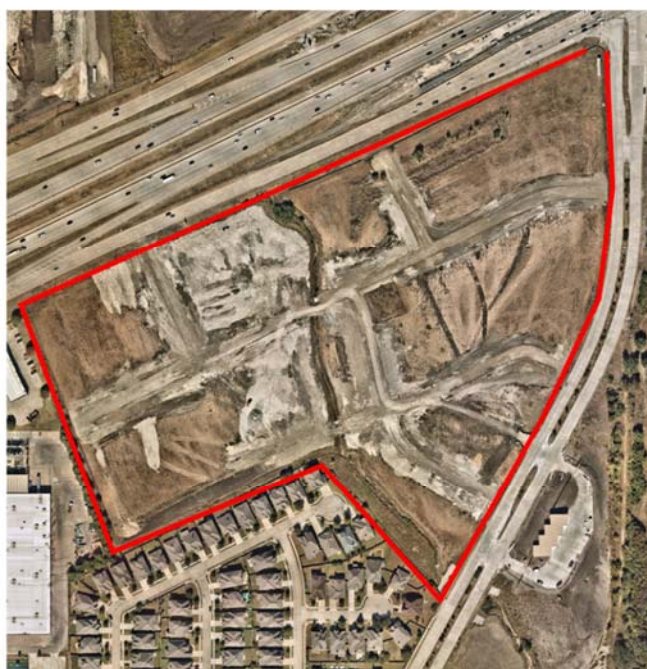
Figure 4: Comparison of two aerial images taken before and after the conversion of pastureland to a large construction site (NearMap, 2020)

August 1, 2019

October 17, 2019

In 2019, TRA began a study to learn more about the bacteria levels in this stream. A study was developed based on samples collected at multiple bridge crossings upstream of the TRA monitoring station 20289 (White Rock Creek at IH635 service road in Dallas). The first part of the study consisted of samples collected at 23 bridges from IH635 in Dallas to College Parkway in Frisco during dry weather conditions on July 16, 2019. Based on the results of this sampling, two reaches were identified for fine-scale sampling where there were the two highest relative percent differences and an order of magnitude increase in *E. coli* concentrations from an upstream bridge to the next bridge downstream. These reaches were sampled on October 10, 2019. The reaches were walked and additional *E. coli* samples were collected in various locations that appeared to be potential *E. coli* inputs. This sampling found that a small tributary entering White Rock Creek downstream of SH 121 may have contributed *E. coli*. The land surrounding the tributary immediately upstream of its confluence had been an agricultural field during the July 2019 samples and had transitioned to a residential construction area by the October 2019 samples (see **Figure 4**). It is believed that the disturbed sediments in the agricultural field and then the construction site may have contributed to the elevated *E. coli* concentrations seen in this reach.

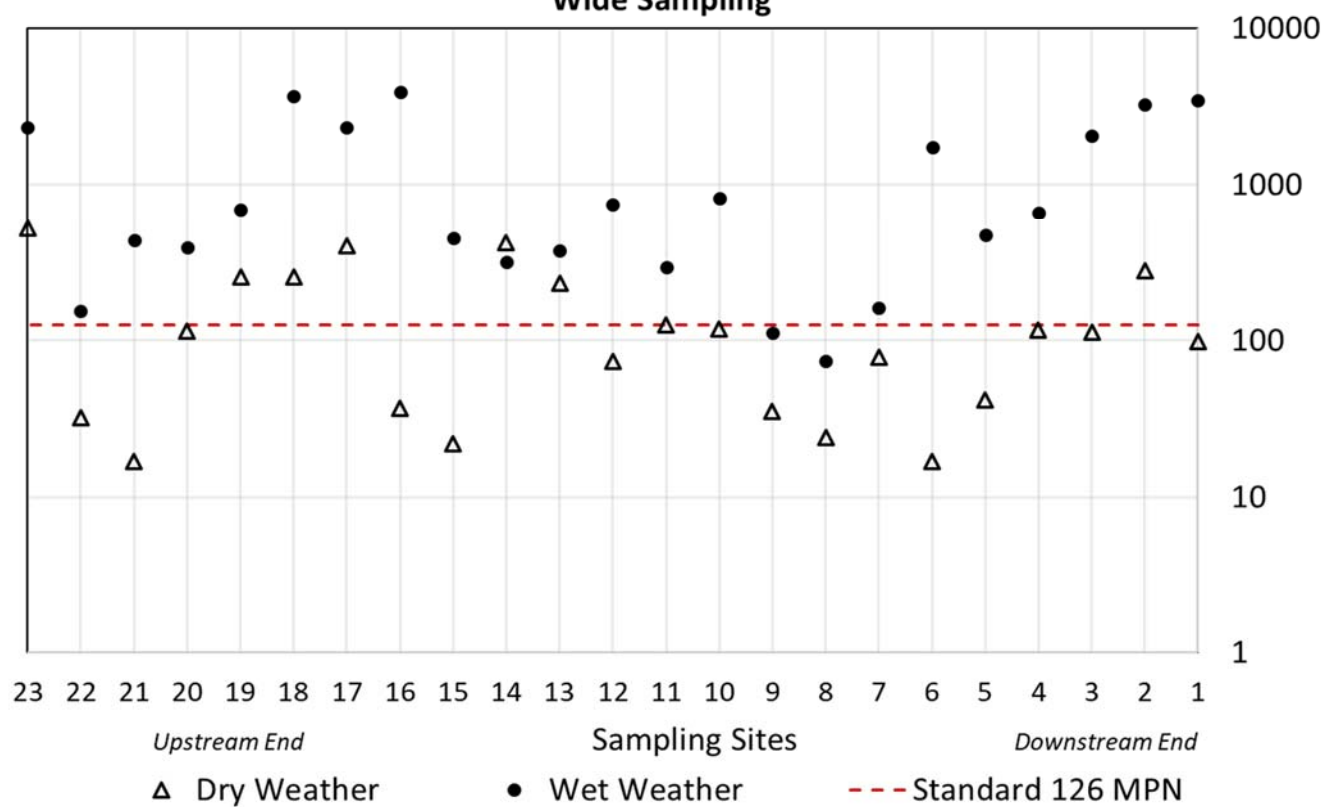
Figure 5: Comparison of *E. coli* Results Between the Coarse-scale Wet and Dry Sampling Events

It is interesting to note that the measured *E. coli* levels from the dry weather and wet weather sampling followed the same patterns although with vastly different concentrations as shown in **Figure 5**. This pattern appears to be a function of the changes in land uses and the presence of riparian buffer zones throughout the watershed.

***E. coli* (MPN/100 mL) Results from Dry and Wet Weather Study Area Wide Sampling**

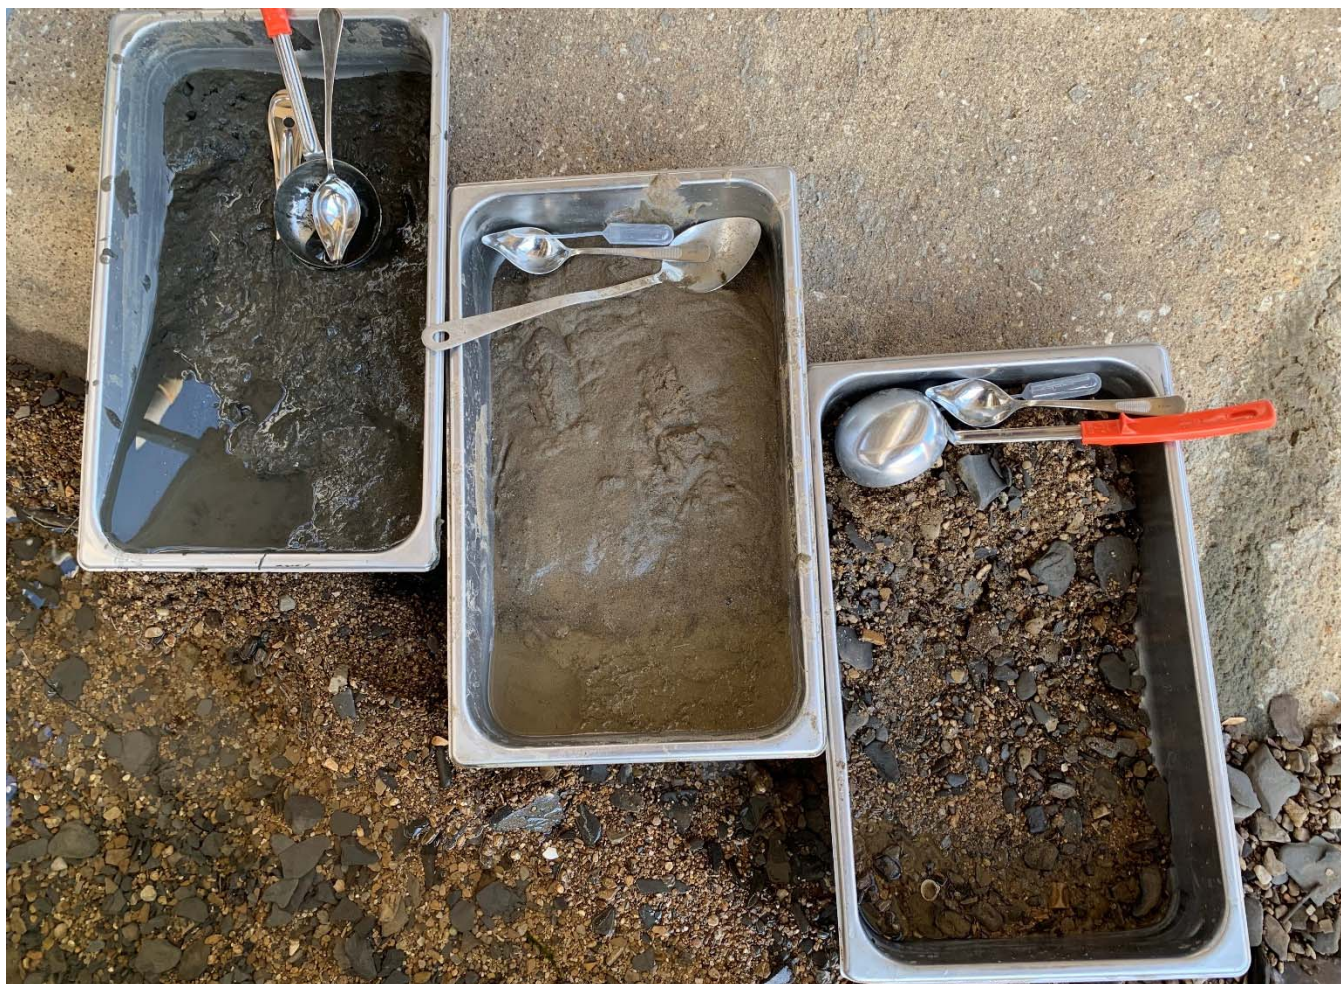
Figure 7: Sub-area Sediment Samples for Phase 2 Sediment *E. coli*

Phase 2 sampling was designed to remove any differences across watersheds from the resultant data. Samples are being collected from a roughly 6,500 square foot area to exclude any confounding factors such as shading, upstream contributions, and general water chemistry. Within this 6,500 square foot area are sub-areas that are predominately fines, sands, or gravels (see **Figure 7**). Samples are being collected from these three subareas. Since sampling has only just begun, results are limited and sediment analyses are not yet available. Based upon the pre/post-disturbance water column *E. coli* samples and the sediment concentrations, it appears that disturbance of fine sediments has the greatest impact on water column concentrations as shown in **Table 5**.
