ROAD SAFETY AUDITS

COURTHOUSE HIGHWAY AND FOURSQUARE
ROAD / SCOTTS FACTORY ROAD
SMITHFIELD, VIRGINIA

July 2024

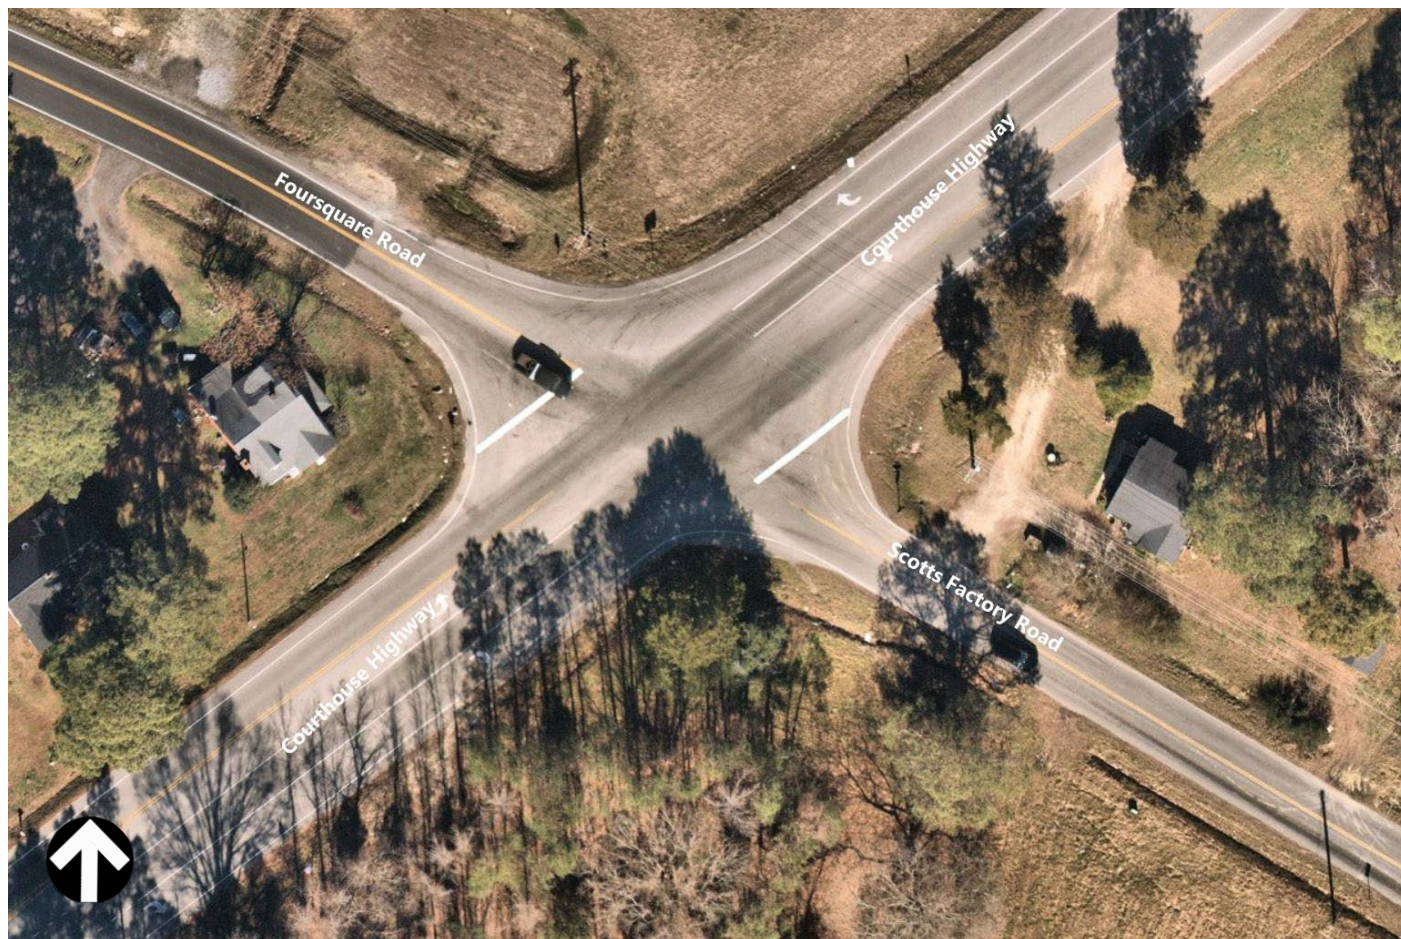
Figure 1. Overview of Study Area

The study area consists of the intersection of Courthouse Highway (Route 258) and Foursquare Road/Scotts Factory Road (Route 620), situated in Isle of Wight County, Virginia. For the purposes of this report, Foursquare Road/Scotts Factory Road is oriented northwest-southeast but is referred to as an east-west road, while Courthouse Highway is oriented southwest-northeast but will be referred to as a north-south road. An overview of the study area is shown in Figure 1.

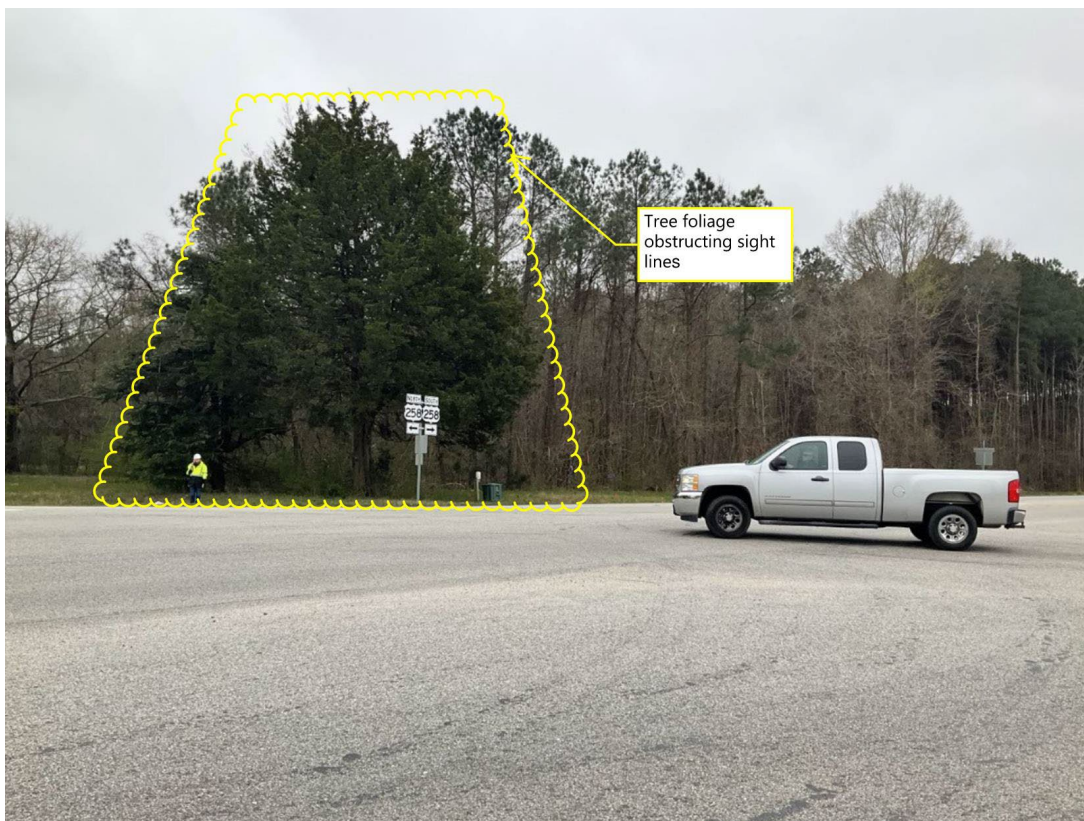
Figure 9. Tree foliage obstructing sight lines between through vehicles on Scotts Factory Road and turning vehicles on Courthouse Highway

As shown in Figure 9, the view of vehicles traveling westbound from Scotts Factory Road is obstructed by tree foliage especially in the summer and fall months when the trees bear the most leaves. The prevalence of foliage during the late spring through early fall months, which can significantly impact sight lines, may be a contributing factor for the higher frequency of crashes recorded from May through November within the analysis period.

Potential Safety Treatment(s): Landscape maintenance/Foliage Trimming, Pavement marking improvements, Geometric improvements

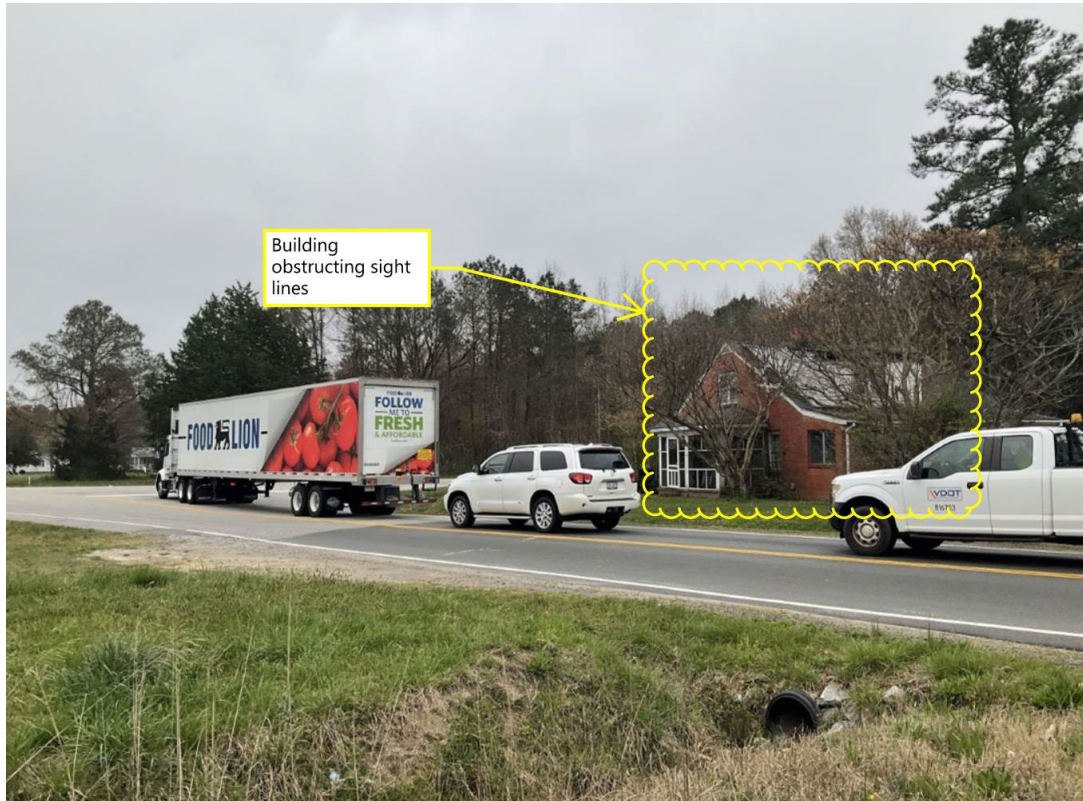
Figure 10. Building obstructing sight lines between turning vehicles on Foursquare Road and Courthouse Highway

Similar to the impact of foliage on sight lines, the residence on the southwest corner obstructs sight lines between northbound traveling drivers on Courthouse Highway and vehicles waiting at the stop line on eastbound Foursquare Road as shown Figure 10.

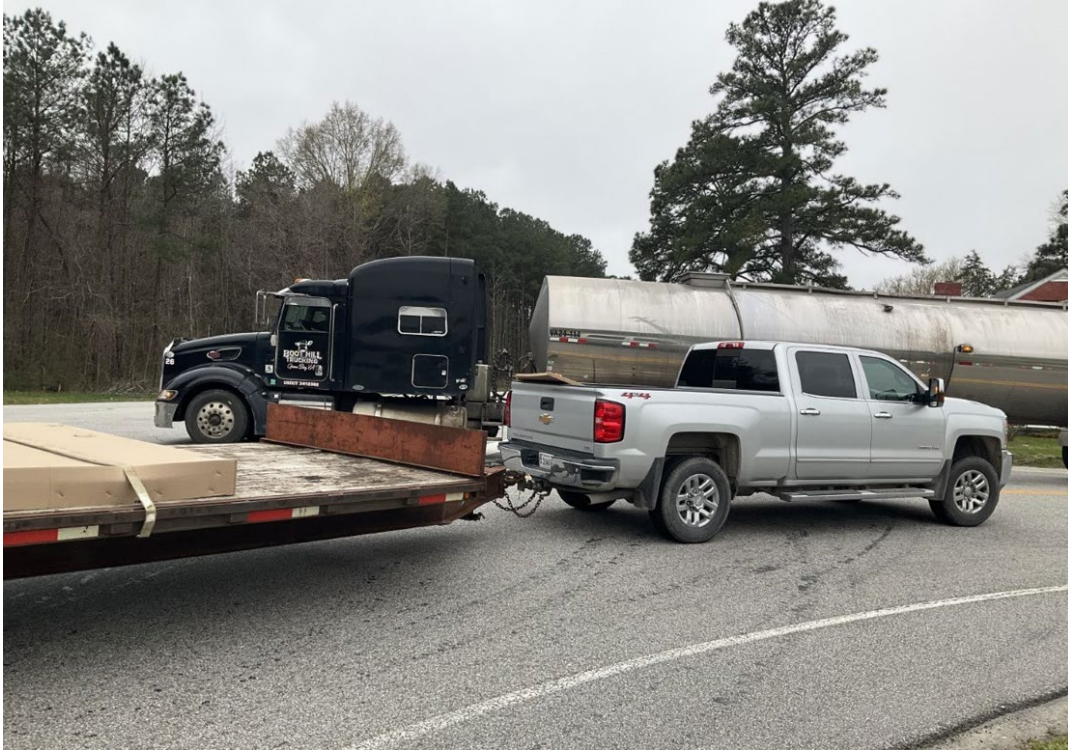
Figure 11. Turning Movement showing Truck Turning Restrictions

While there are sufficient turning radii at the intersection, it was observed that vehicles turning left onto northbound Courthouse Highway were positioned at the stop line, close to the centerline. Vehicles positioned close to the centerline made the receiving side of Foursquare Road for right turns from southbound Courthouse Highway narrow and challenging for larger vehicles turning right to stay on the pavement. These turning challenges could potentially lead to safety challenges associated with heavy vehicle turning movements and if not properly managed, collisions. During the RSA, this situation was observed multiple times as shown in Figure 11.

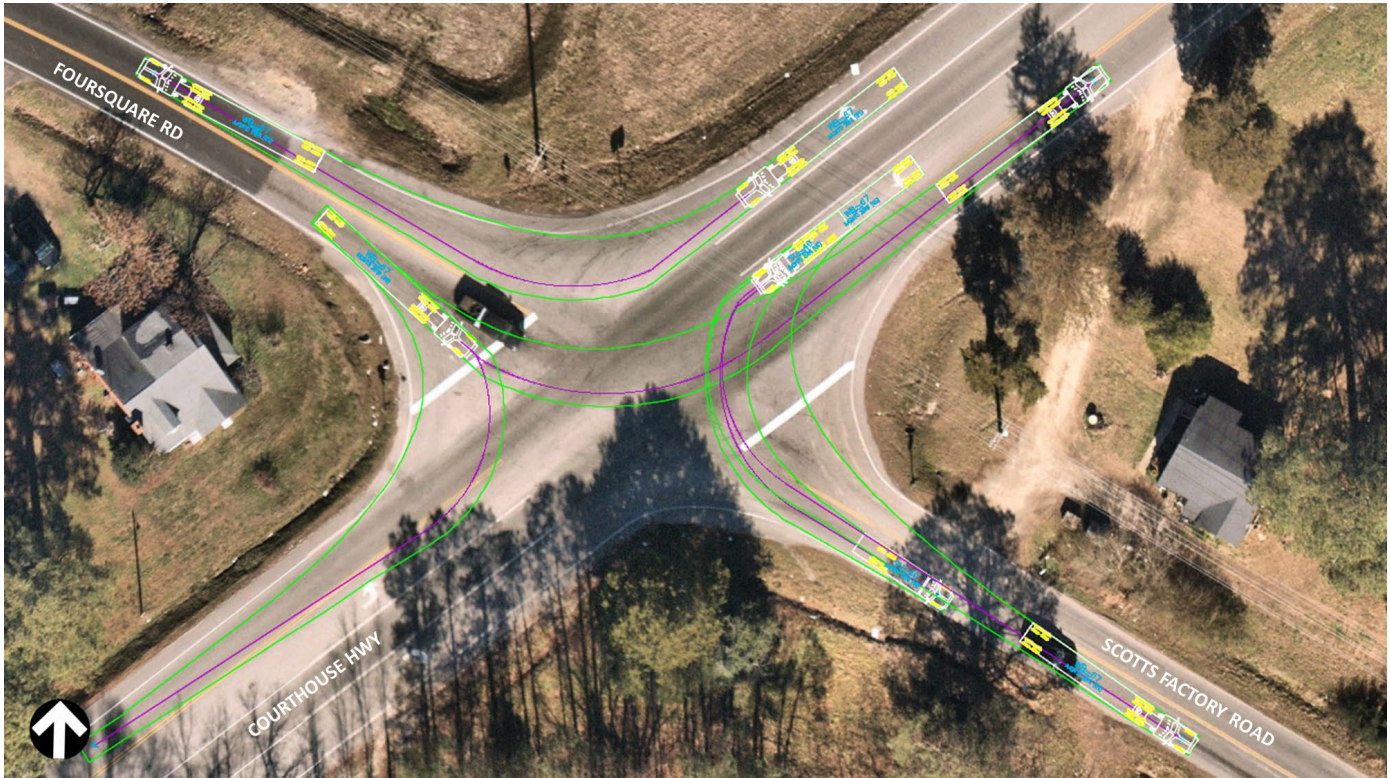
Figure 12. Turning Movement in AutoTurn on to and off of Foursquare Road

The potential conflicts that could result from the turning movements of heavy vehicles at the intersection from Courthouse Highway is represented in AutoTurn and shown in Figure 12. The figure below indicates the need for geometric improvements for turns on and off Foursquare Road due to the restricted pavement and lane width for right turns from Courthouse Highway onto Foursquare Road. Additionally, the current stop line placement of Scotts Factory Road conflicts slightly with a 40-foot single-unit truck but falls well within the path of a WB-67 freight truck. Given some of the sight distance limitations on the Scotts Factory Road approach (discussed in Section 4.1.1) to the intersection versus the likelihood of a large freight truck turning left onto Scotts Factory Road, it may be more beneficial to keep the stop line at its current placement.

Moreover, it should be noted that drivers on the eastbound approach tend to position their vehicles close to the double yellow line to increase their sight distance around the house in the southwest corner of the intersection, as shown in Figure 12. This behavior results in vehicles being positioned closer to the turning conflict being discussed.

It should also be noted that the over-tracking of the southbound left turn across the Scotts Factory Road stop line is less of a concern than the over-tracking and pavement deterioration resulting from the southbound right turn onto Foursquare Road. This is because there are far fewer potential conflicts resulting from heavy vehicles turning left onto Scotts Factory Road while a driver is waiting to turn left onto Courthouse Highway or continue through on Foursquare Road. The predominant movement from Scotts Factory Road involves right turns onto northbound Courthouse Highway. Additionally, the heavy vehicle volumes are significantly less on Scotts Factory Road than they are on Foursquare Road. The Scotts Factory Road approach would need to be widened to fully accommodate both the southbound left turn and the westbound left turn or through movement. This pavement widening would require right-of-way acquisition, stormwater management, and utility relocation. Given the low volumes and infrequent heavy vehicle conflicts on the Scotts Factory Road approach, the safety benefits may not exceed the high costs and high impacts associated with widening the pavement.

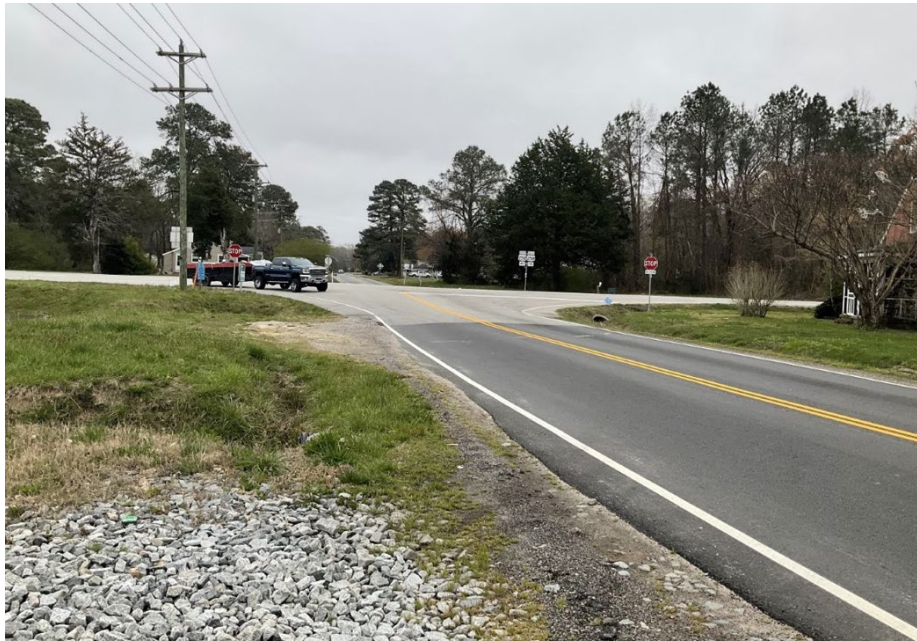
Figure 13. Pavement markings and stop signs without retroreflective element.

While the predominant lighting condition for crashes observed at the intersection have been daylight, a proactive approach to safety considers the potential for crashes during dark hours (with the approaches not lighted). The sign retroreflective for the stop ahead warning sign and stop sign on Foursquare Road as observed during the field visit has degraded, which can make sign visibility difficult in nighttime conditions. However, the stop signs have been replaced since the RSA was conducted as part of the VDOT Fatal Crash Review.

Potential Safety Treatment(s): Replace stop signs and stop ahead warning signs, upgrade stop signs to LED

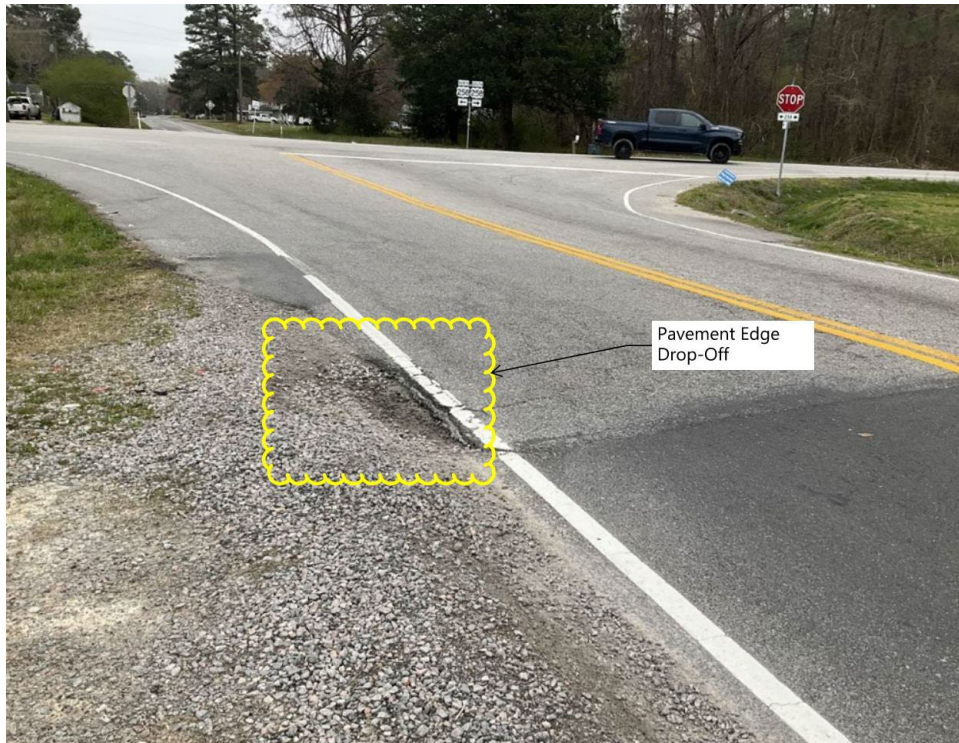
Figure 14. Pavement defects and gravel deposition on Foursquare Road

Pavement defects and gravel deposition can be found along the study area as seen in Figure 14. These features can pose property damage risks to drivers entering and exiting Foursquare Road, may cause drivers to abruptly slow or stop while exiting Foursquare Road, or drivers may lose traction while exiting the road. This presents a potentially hazardous situation, where drivers on the receiving side of the intersection can lose control of their vehicles and completely depart the roadway.

Potential Safety Treatment(s): Pavement marking improvements, Geometric improvements.

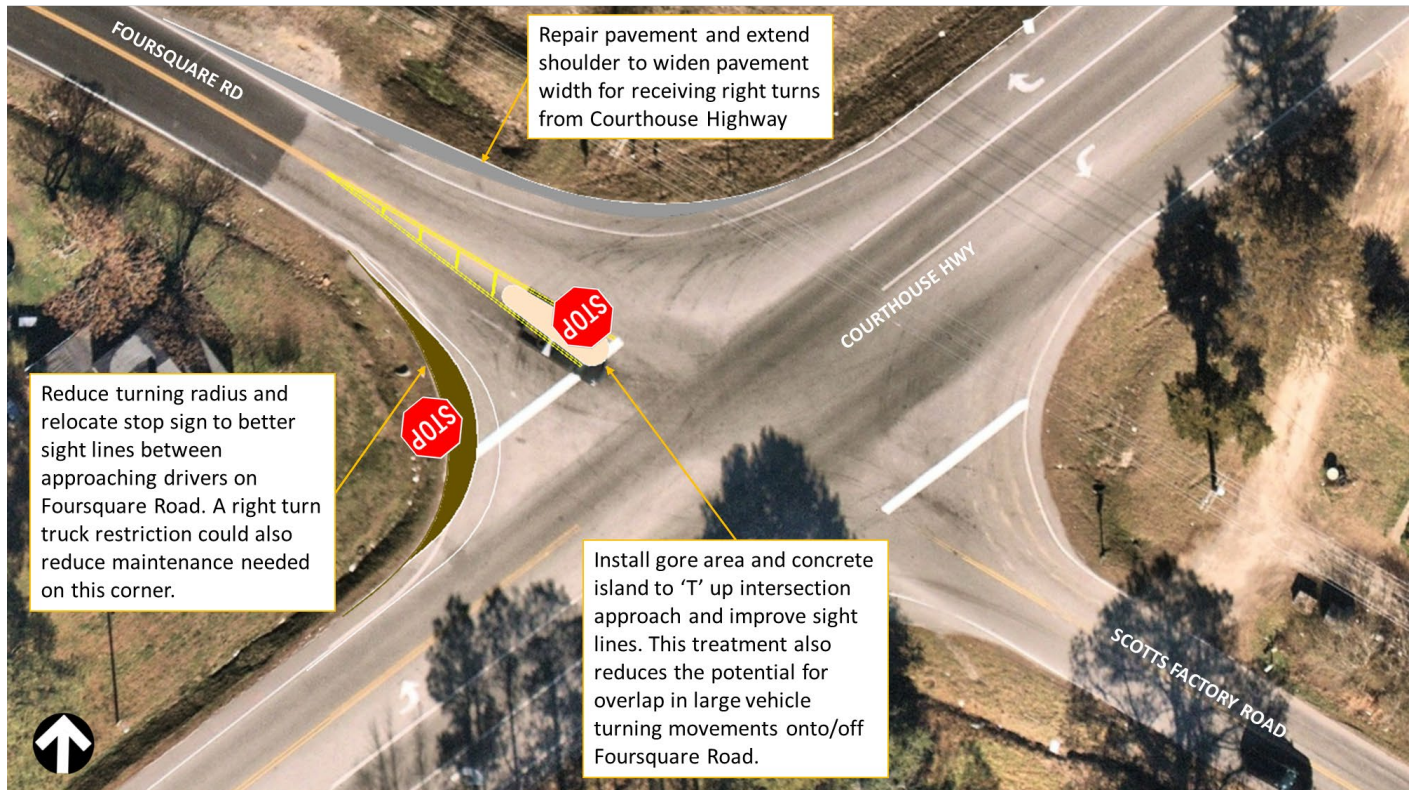
Figure 15. High-level concept showing stop sign visibility improvements

configuration and turning movement of the intersection in relocating the stop sign. Numerous studies have underscored effectiveness of stop sign visibility enhancements in reducing the incidence of intersection-related crashes.⁶ A concept depicting potential improvements to intersection geometry for stop sign visibility improvements is shown in Figure 15.

Stop sign visibility enhancements at the intersection of Courthouse Highway and Foursquare Road/Scotts Factory Road include potentially reducing the turning radius and relocating the stop sign to provide better sight lines between approaching drivers on Foursquare Road. This improvement may require a right-turn truck restriction to reduce the potential for the stop sign being knocked over and the maintenance needed on the reduced corner. Another potential improvement could include repairing the pavement on the corner where right-turning trucks are off tracking near the edge of pavement on the receiving lane of Foursquare Road. This improvement could allow trucks to turn with more distance from the centerline where other large vehicles may be waiting to turn onto northbound Courthouse Highway. This improvement could then be paired with the new gore area and concrete island to help 'T' up the Foursquare Road approach to improve sight lines. During the RSA field visit, drivers who were familiar with the intersection were positioning their

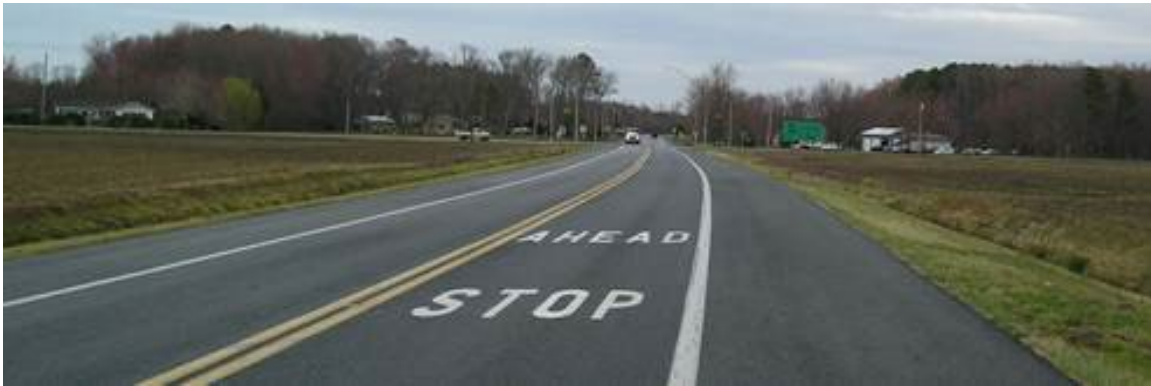
Figure 16. Example stop ahead pavement markings according to FHWA, Gross et al. (2008)

As shown in Figure 16, this added measure introduces an essential safety layer, emphasizing the need to stop, thereby enhancing the overall road safety at the intersection. This precautionary notification mitigates the risk of sudden stops or the likelihood of not stopping in time, crucial for enhancing driver awareness, especially for those unfamiliar with the area or who travel it infrequently. A 2015 study conducted on rural roads across the U.S. found that the implementation of stop ahead pavement markings contributed to a potential crash reduction of 66 percent for all crashes and a potential decrease in fatal and injury crashes of 69 percent.¹¹ Lane widths on both approaches are typically 11 feet and the word message "AHEAD" with 8-foot lettering is roughly 10.5 feet, meaning that the pavement word marking would fit in the existing lane width. If installed on both approaches, the stop ahead pavement markings should be installed adjacent to the stop ahead warning signs located 570 feet in advance of the stop on Foursquare Road, and 425 feet in advance of the stop on Scotts Factory Road.

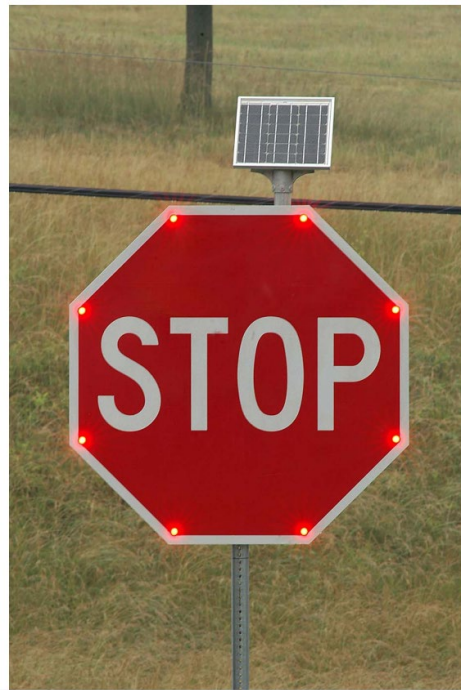
Figure 17. Example LED Stop Sign (Source: FHWA)

In addition to other stop sign conspicuity enhancements, light-emitting diode (LED) stop signs can command attention of both local and non-local drivers. The installation of an LED stop sign can have a potential angle crash reduction of 42 percent.¹² If Tier 1 countermeasures for stop sign conspicuity improvements do not adequately increase driver awareness of the stop control on the Foursquare Road approach to Courthouse Highway, an LED stop sign could supplement the existing countermeasures. Stop sign visibility and compliance on the Scotts Factory Road approach are good and have significantly fewer crashes than the Foursquare Road approach, meaning that LED stop signs may be better suited on the Foursquare Road approach. On the Foursquare Road approach, the LED sign could replace either the stop sign on the southwest corner (adjacent to the approach lane) or the two stop signs on both sides of the approach.

Given the identified challenge of stop control visibility, the installation of LED stop sign can be implemented to help with stop sign conspicuity. LED stop signs are equipped with small bright lights around the edges of the sign, enhancing the visibility of the stop sign significantly as shown in Figure 17. These signs are more noticeable to drivers, especially at night or in low-visibility conditions, thereby helping in better recognition and compliance with the stop control at the intersection. One potential downside to consider is that light

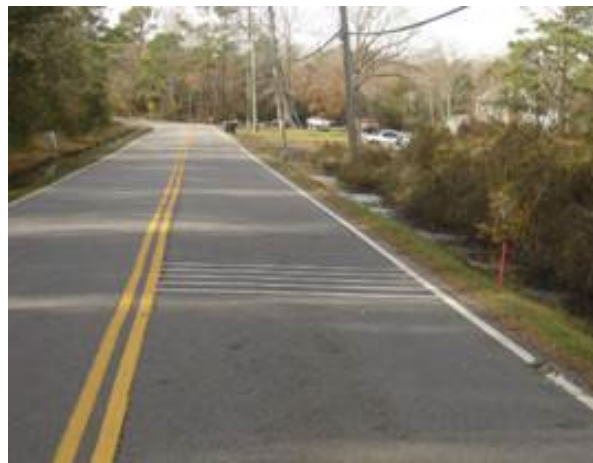
Figure 18. Example Rumble Strips (Source: FHWA)

In terms of composition, the rumble strips are typically placed in closely arrayed groups across the roadway as shown in Figure 18. Transverse rumble strips can be integrated in a variety of methods. For this location, epoxy strips on the existing pavement surface are recommended. Together with the “Stop Ahead” warning signage, these pavement markings provide a tactile and audible warning to drivers, reinforcing their awareness of an impending stop. While studies show that transverse rumble strips have a potential to increase total crashes by 7 percent, the crash reduction potential for fatal and injury crashes is 9 percent,

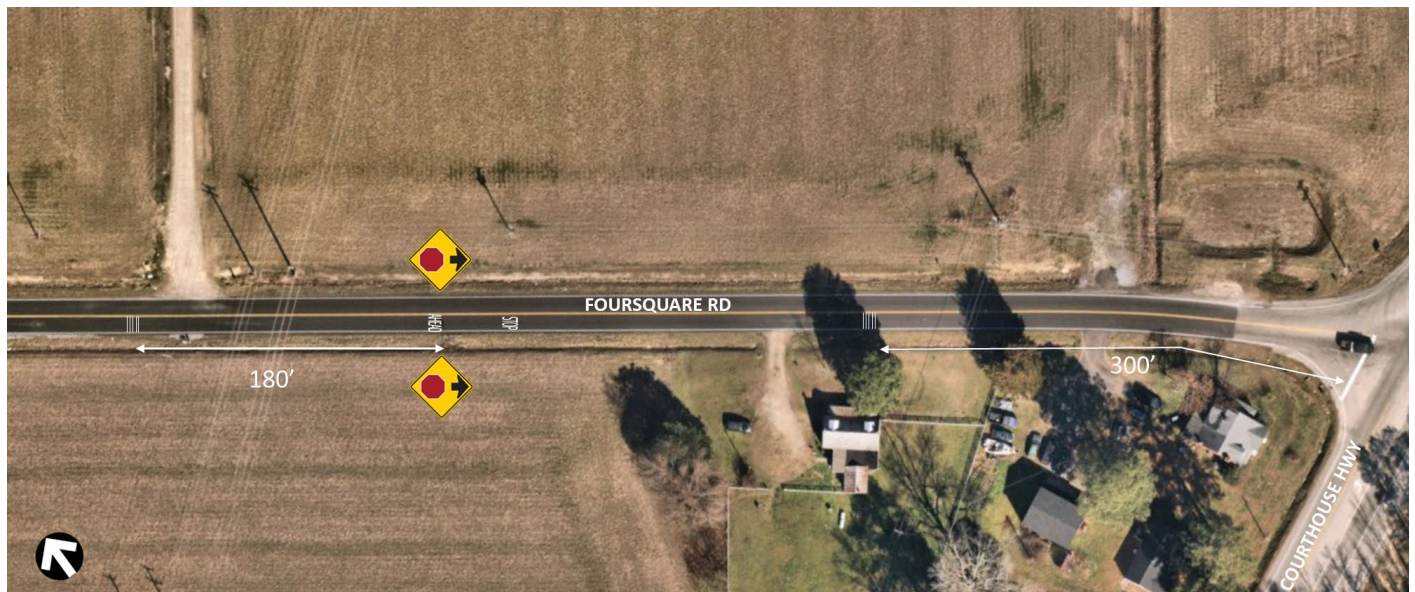
Figure 19. Overview of transverse rumble strip placement on Foursquare Road approach.

The placement of the first set of transverse rumble strips on the Foursquare Road approach would be at the point of perception of the stop ahead warning sign, 180' in advance of the sign. The other set should be placed roughly 300 feet before the stop sign itself, per best practices identified by the Virginia Transportation Research Council.¹⁴ However, given the residence on the southwest corner of the intersection (shown in Figure 19), placing the rumble strips 300 feet before the stop may not be possible given the noise generated when vehicles drive over them. Alternatively, the first set of rumble strips could be installed at a distance of 400 feet and the second set at 180 feet in advance of the in advance of the stop ahead warning signs (W3-1). Best practices on the placement and spacing of transverse rumble strips for stop-controlled intersections varies significantly among states.¹⁵

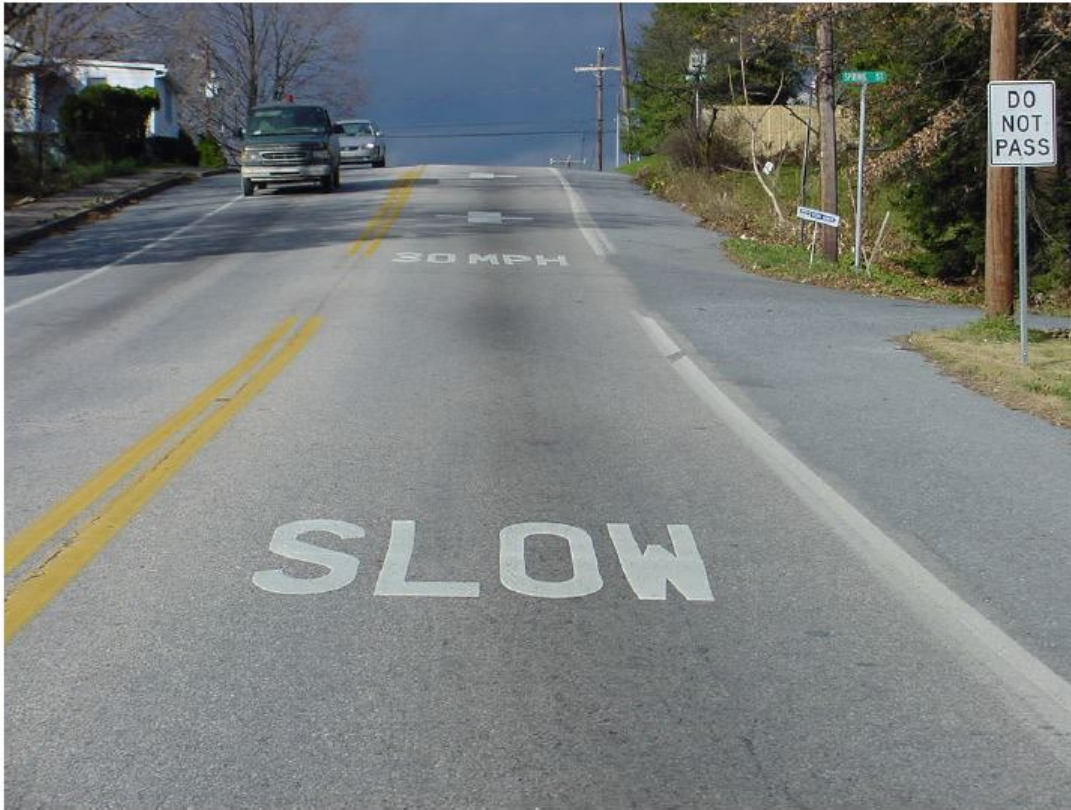
Figure 20. Supplemental Intersection Pavement Markings, Torbic et al. (2015)

As shown in Figure 20, these pavement markings are generally arranged in sets and strategically placed along the driver's direction of travel for optimal visibility. The first set of these markings typically carries a warning message instructing drivers to slow down to the speed limit of the roadway, for instance, "SLOW, 45 MPH". This initial set of pavement markings provides an essential alert for drivers along Courthouse Highway, encouraging them to adjust their speed to react to potential turning movements at the upcoming intersection. The second set of markings, located closer to the intersection, provides a symbolic depiction of the intersection's configuration. With the four-legged intersection, the pavement markings would show the intersecting roads as a cross symbol.

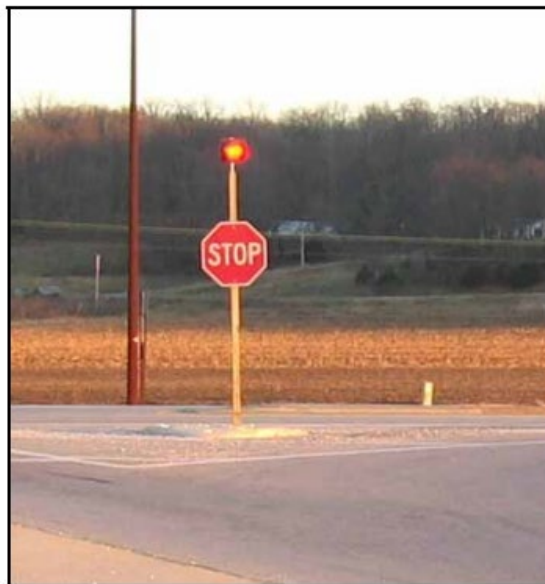
Figure 21. Example Stop Sign Flashing Beacons, Srinivasan et al. (2008)

Along Foursquare Road, a non-actuated (stop sign flashing beacon) warning system could be installed at the intersection as a cost-effective safety improvement. These can be posted above the stop signs and constantly flashing as shown in . This can lead to crash reductions of about 5 percent for all crashes and 10 percent for fatal and injury crashes.¹⁸ Given the similarity in purpose between the flashing beacon and the flashing LED sign, only one of these countermeasures should be selected. While crash reduction potential is higher for the flashing LED sign than the beacon, implementation needs should be considered in the ultimate selection of the countermeasures.
