PHASE I
ENVIRONMENTAL SITE ASSESSMENT REPORT

Former Mystic Oral School for the Deaf
Groton, Connecticut

June 2013

LOUREIRO ENGINEERING ASSOCIATES, INC.
100 Northwest Drive
Plainville, Connecticut 06062

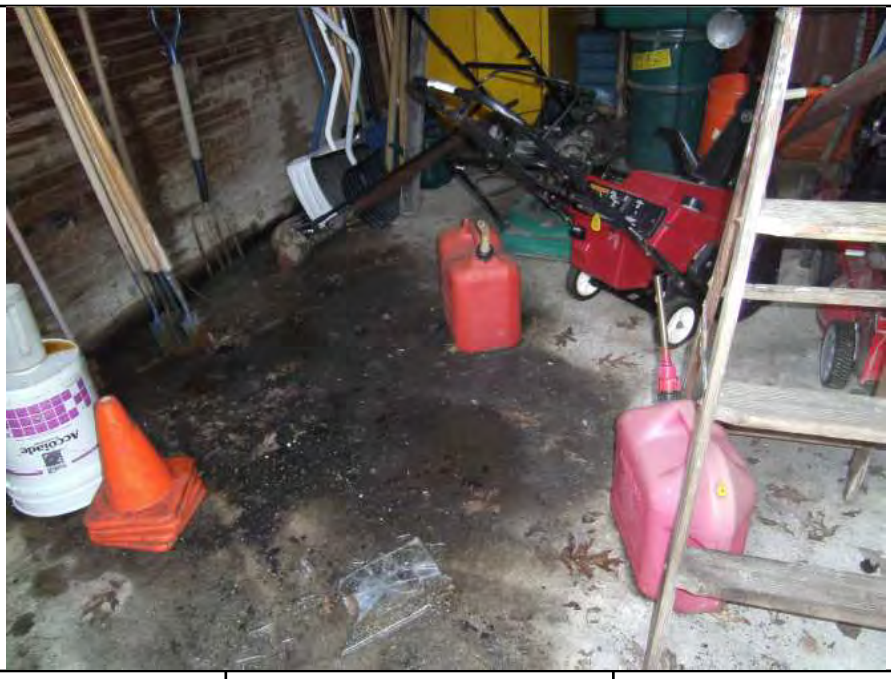
Date	Viewpoint	View Direction	Description
1/17/2013	Wood Shed	Down	Stained Concrete

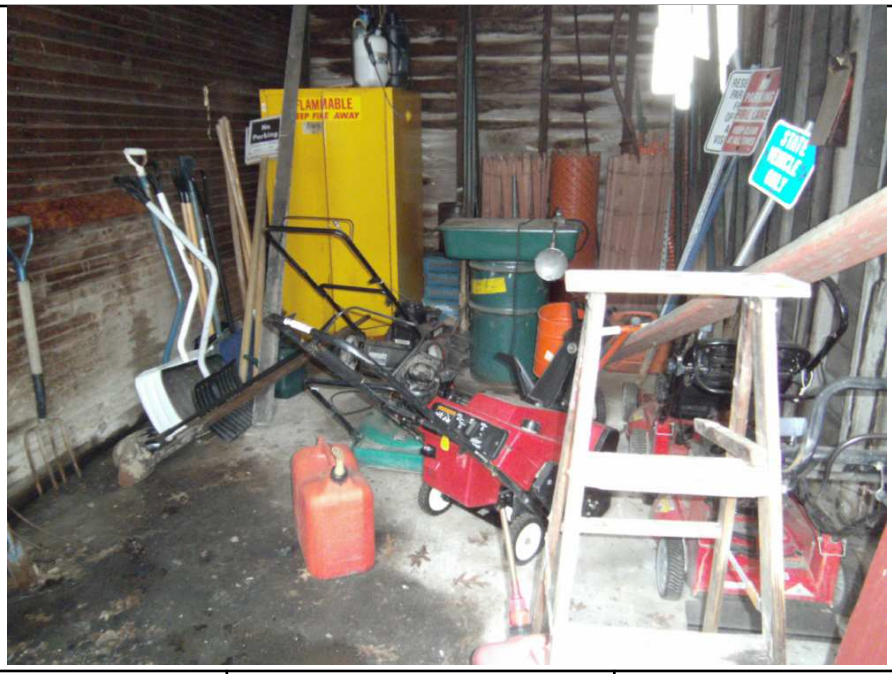
Date	Viewpoint	View Direction	Description
1/17/2013	Wood Shed	North	Stained Concrete

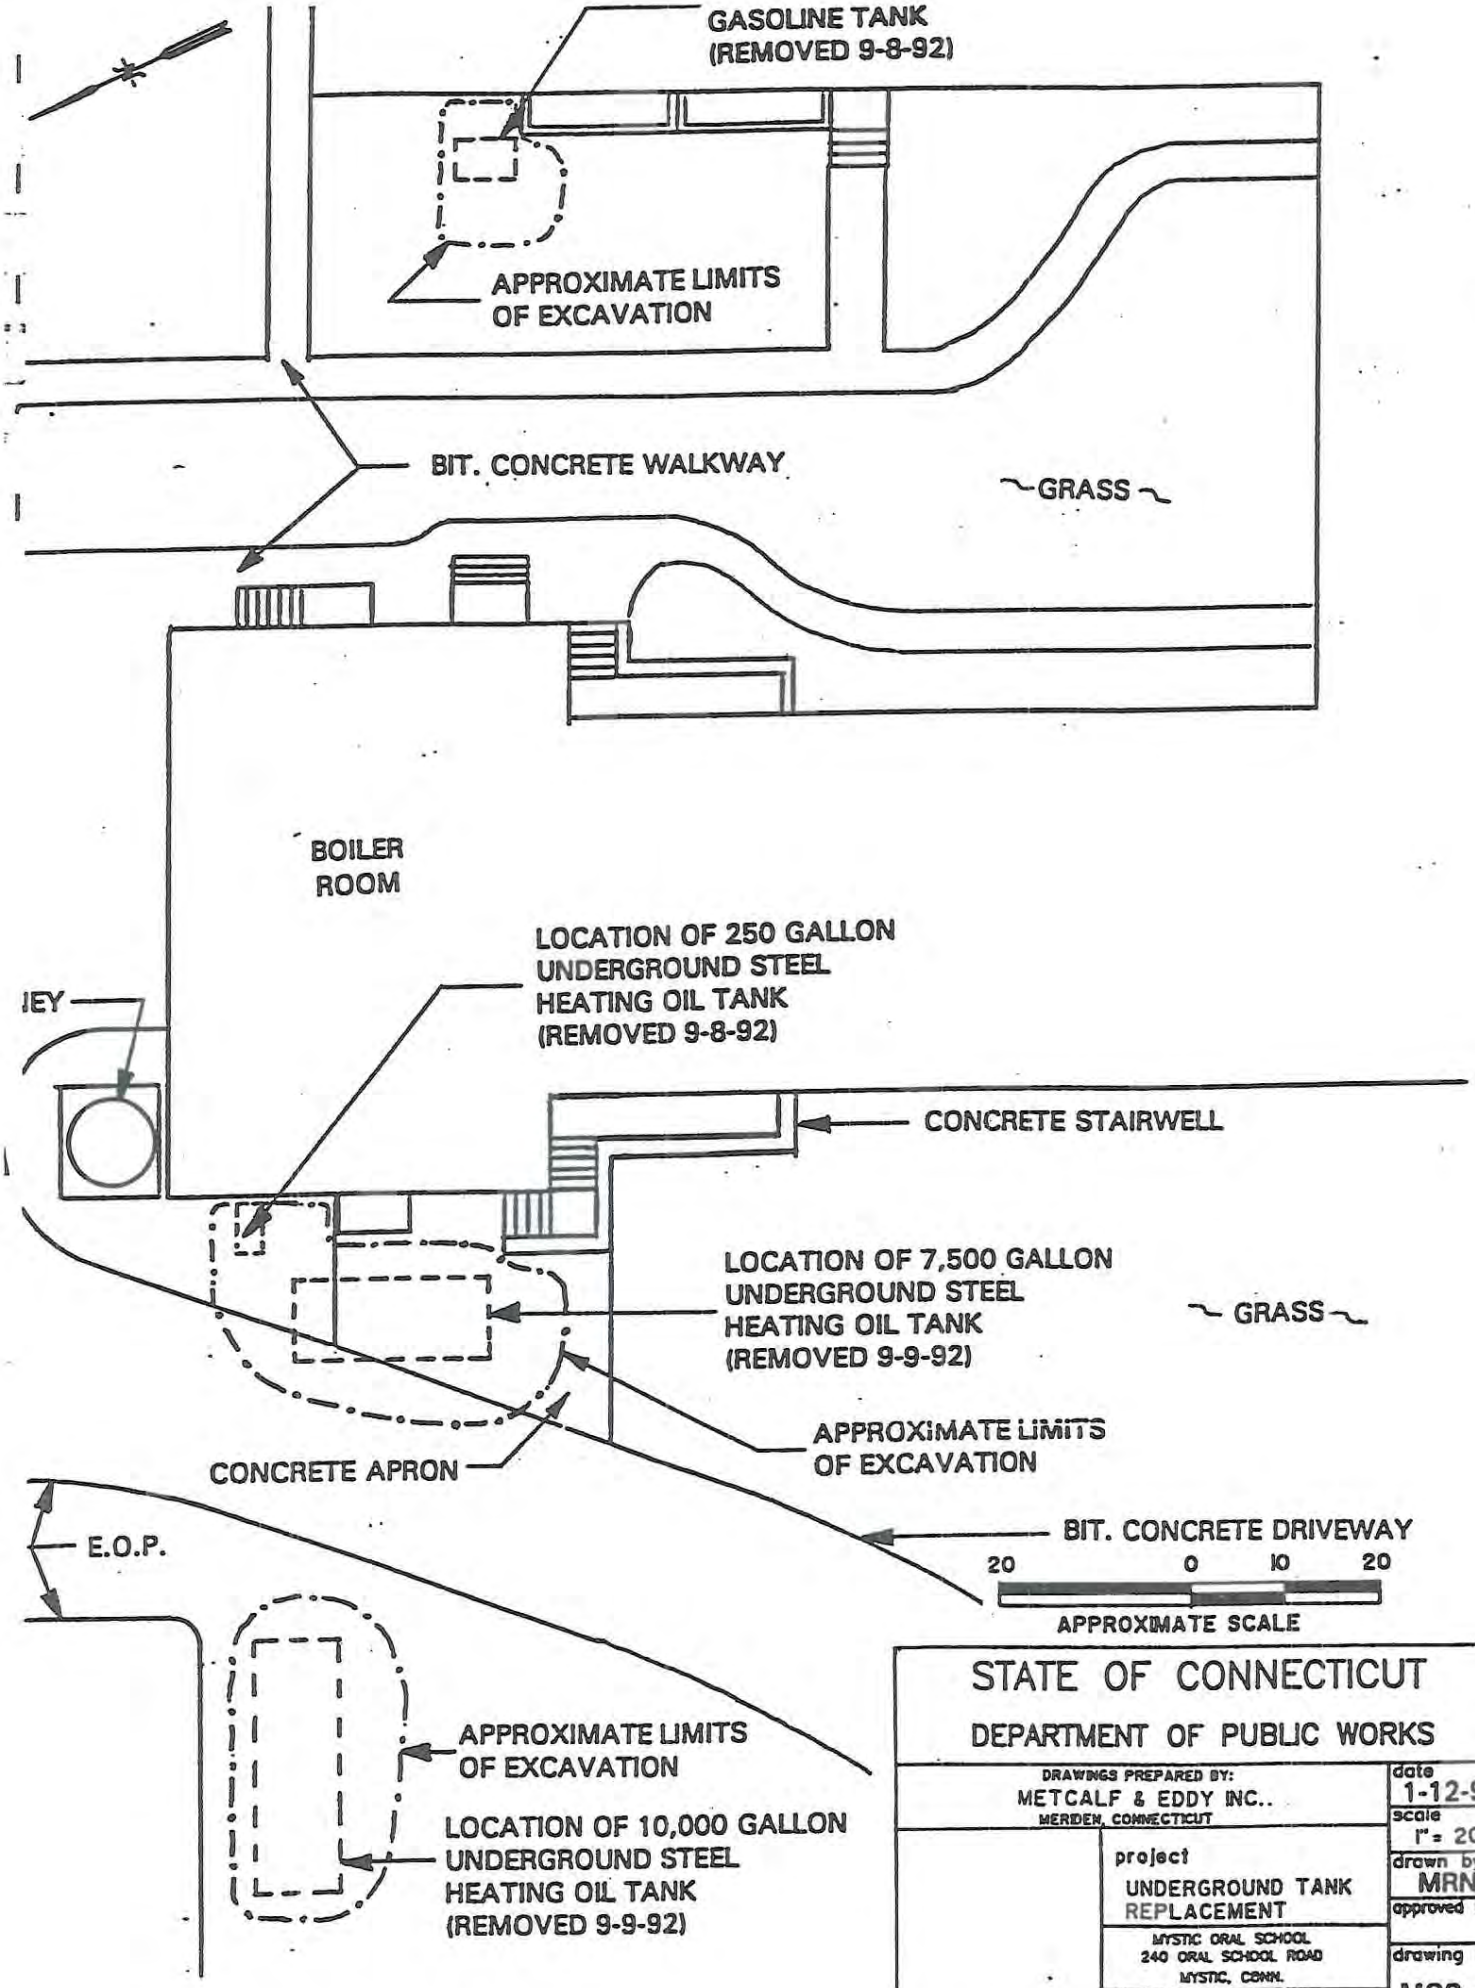
BI-2A-760-A12

GASOLINE TANK
(REMOVED 9-8-92)
APPROXIMATE LIMITS
OF EXCAVATION
BIT. CONCRETE WALKWAY
GRASS
BOILER
ROOM
LOCATION OF 250 GALLON
UNDERGROUND STEEL
HEATING OIL TANK
(REMOVED 9-8-92)
IEY
CONCRETE STAIRWELL
LOCATION OF 7,500 GALLON
UNDERGROUND STEEL
HEATING OIL TANK
(REMOVED 9-9-92)
GRASS
APPROXIMATE LIMITS
OF EXCAVATION
CONCRETE APRON
BIT. CONCRETE DRIVEWAY
E.O.P.
20 0 10 20
APPROXIMATE SCALE
APPROXIMATE LIMITS
OF EXCAVATION
LOCATION OF 10,000 GALLON
UNDERGROUND STEEL
HEATING OIL TANK
(REMOVED 9-9-92)
STATE OF CONNECTICUT
DEPARTMENT OF PUBLIC WORKS
DRAWINGS PREPARED BY:
METCALF & EDDY INC..
MERIDEN, CONNECTICUT
date 1-12-93
scale 1" = 20'
project
UNDERGROUND TANK
REPLACEMENT
drawn by MRN
approved by
MYSTIC ORAL SCHOOL
240 ORAL SCHOOL ROAD
MYSTIC, CONN.
drawing no.
MOS - 1
project no. 81-28-760A-12
RM-16945

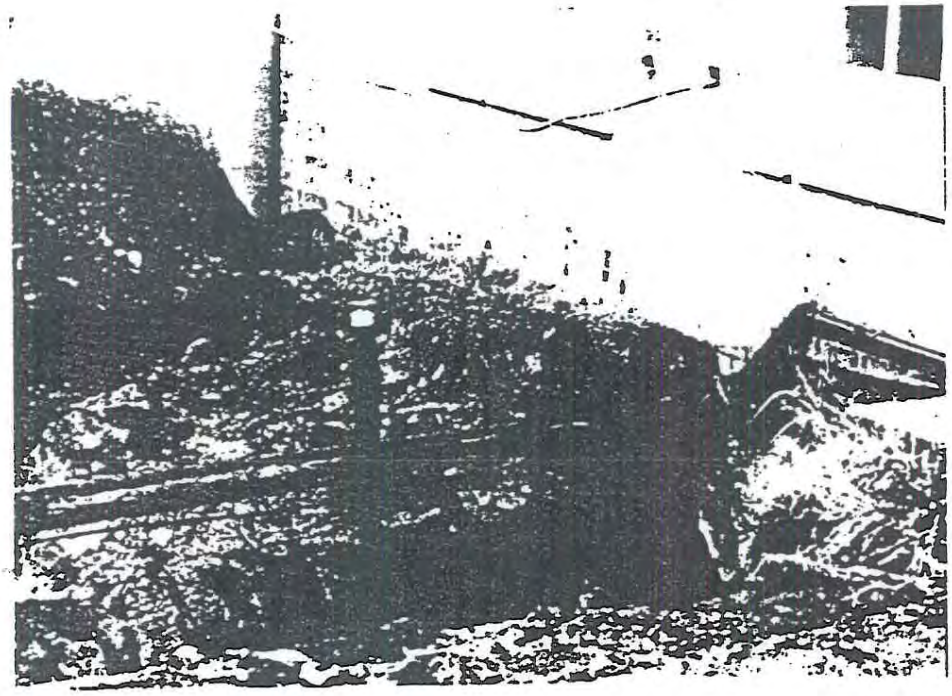
Top of 275 gallon heating oil tank with overburden soil removed. Note the extent of surficial corrosion on tank.

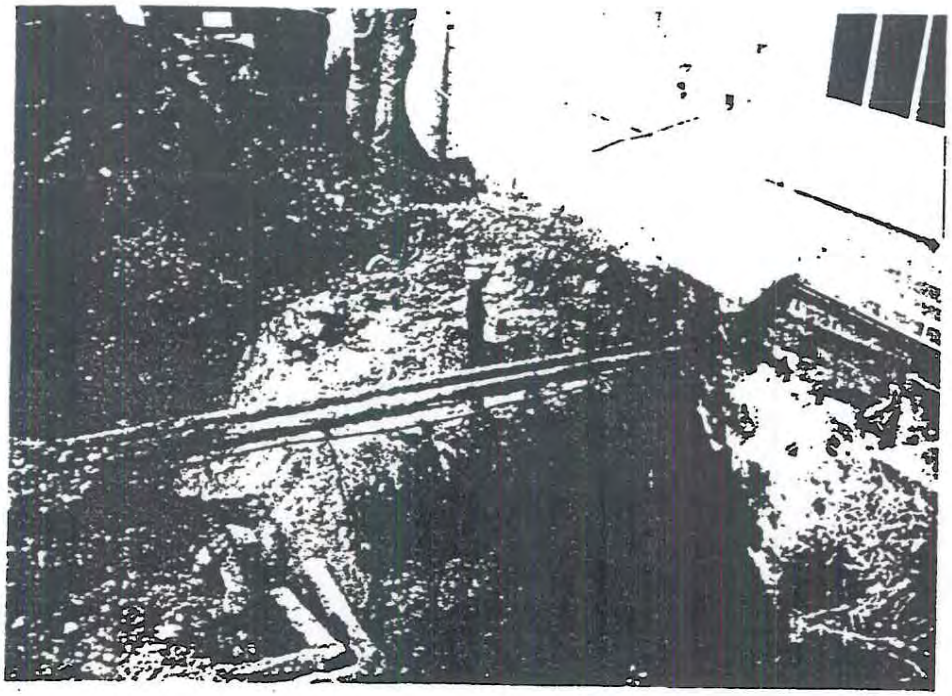
View of 275 gallon heating oil tank from south end of excavation.

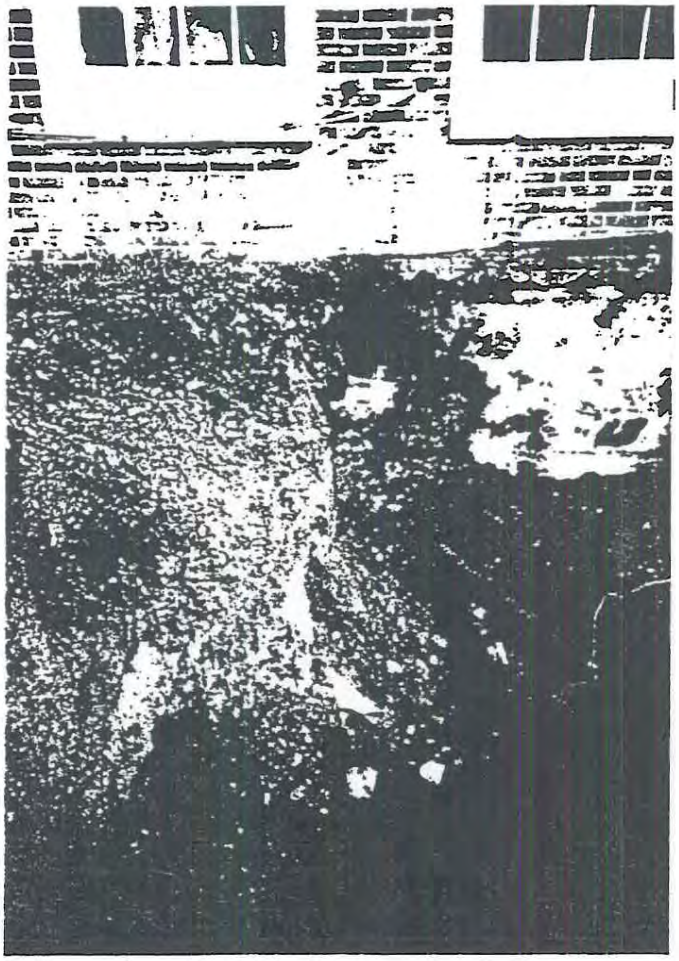
View of tank grave from west vantage point immediately after the 275 gallon heating oil tank was removed.

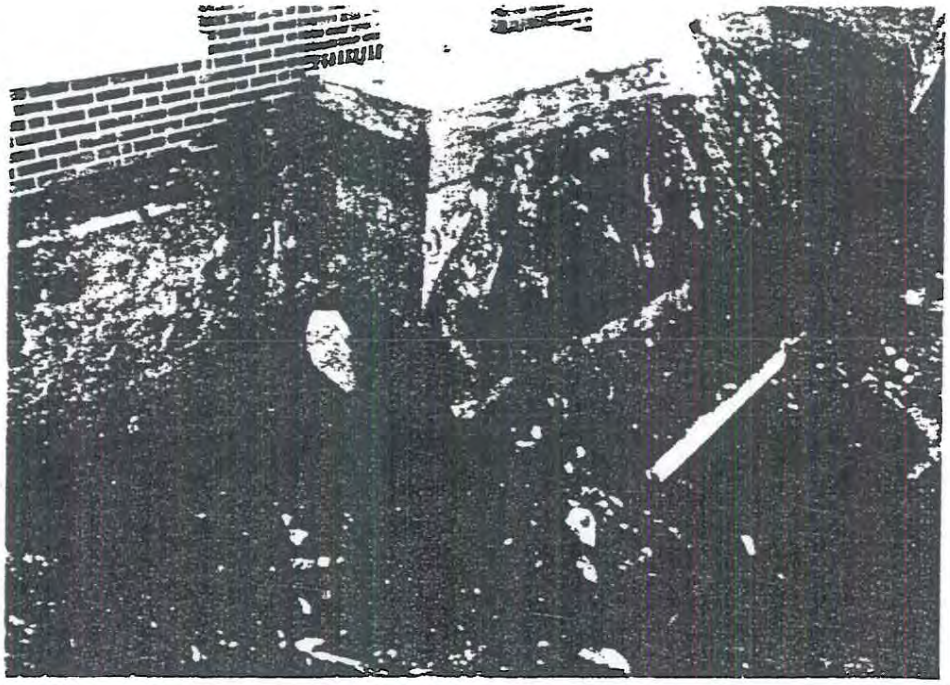
Heating oil tank excavation (left portion of photo) after initial removal of heating oil contaminated soil.

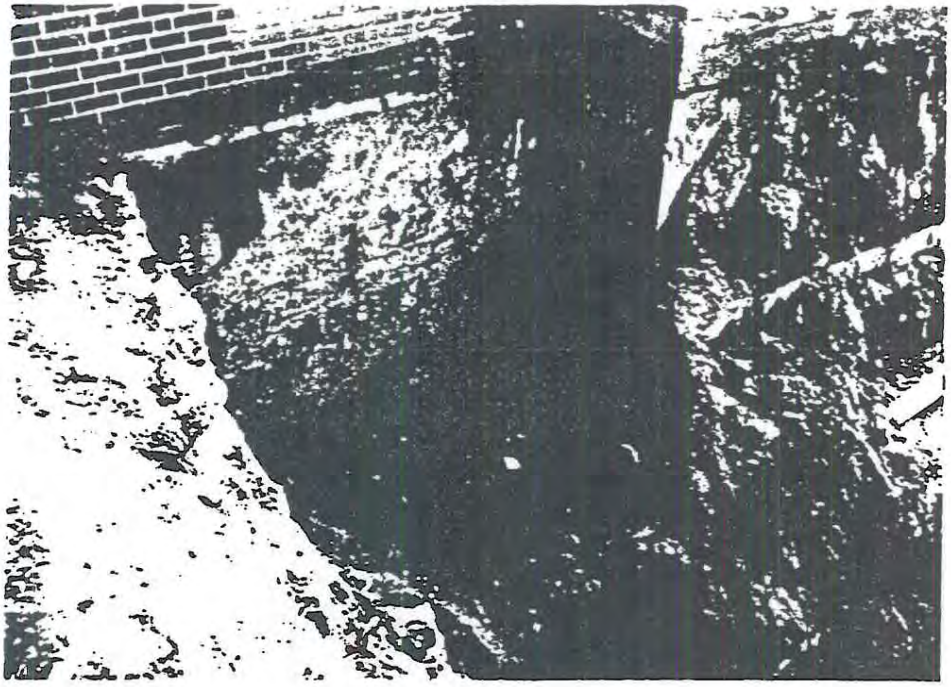
Heating oil tank excavation after removal of remaining contaminated soil.

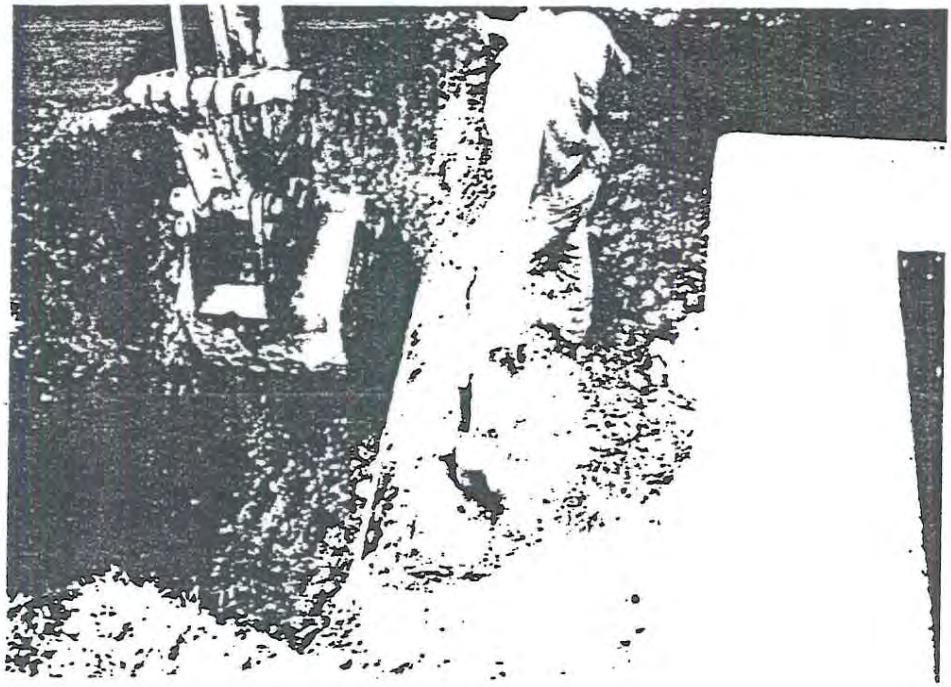
Contractor removing soil from along the north side of the gasoline tank. Note extensive surficial corrosion on tank.

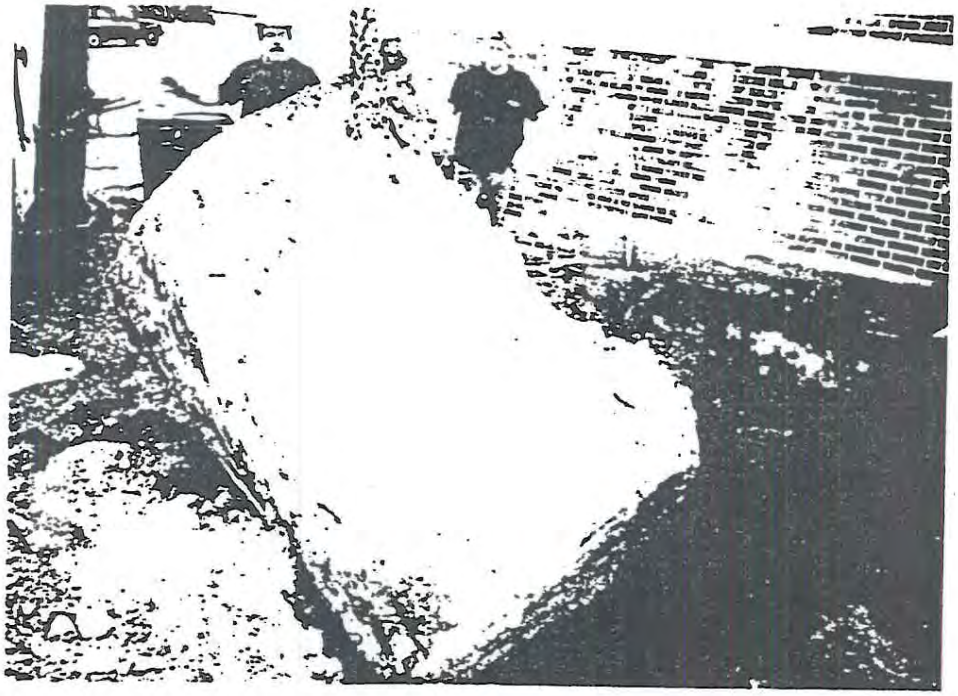
Removal of 500 gallon gasoline tank from excavation. Inspection of tank concluded no rust hole or breaches present.

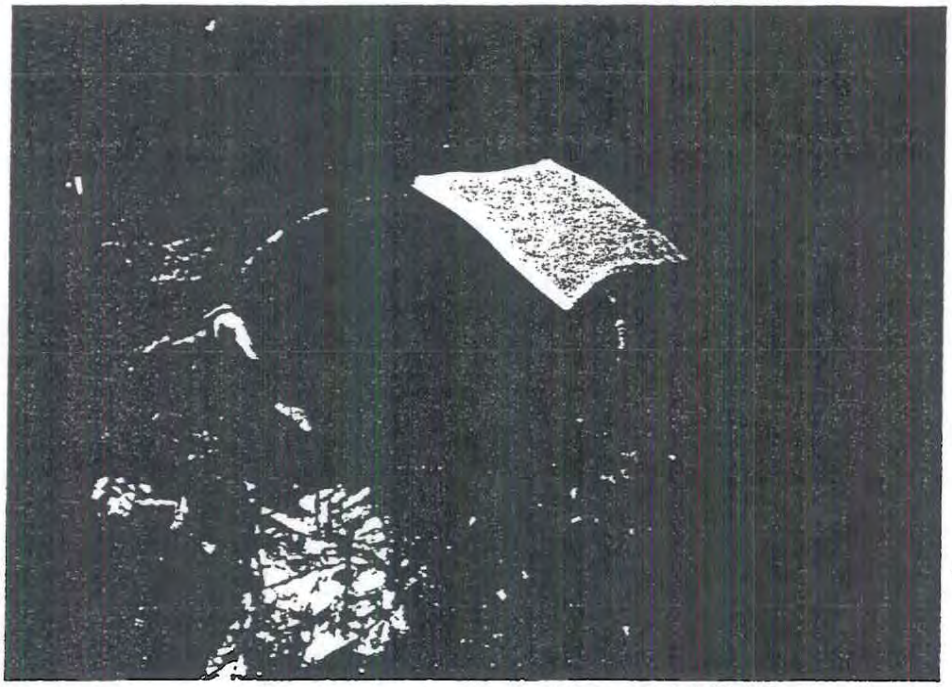
Photo of piping/valve sump accessible through 24" manway. Much of the contaminated soil removed from this tank grave was attributed to spills within the manway.

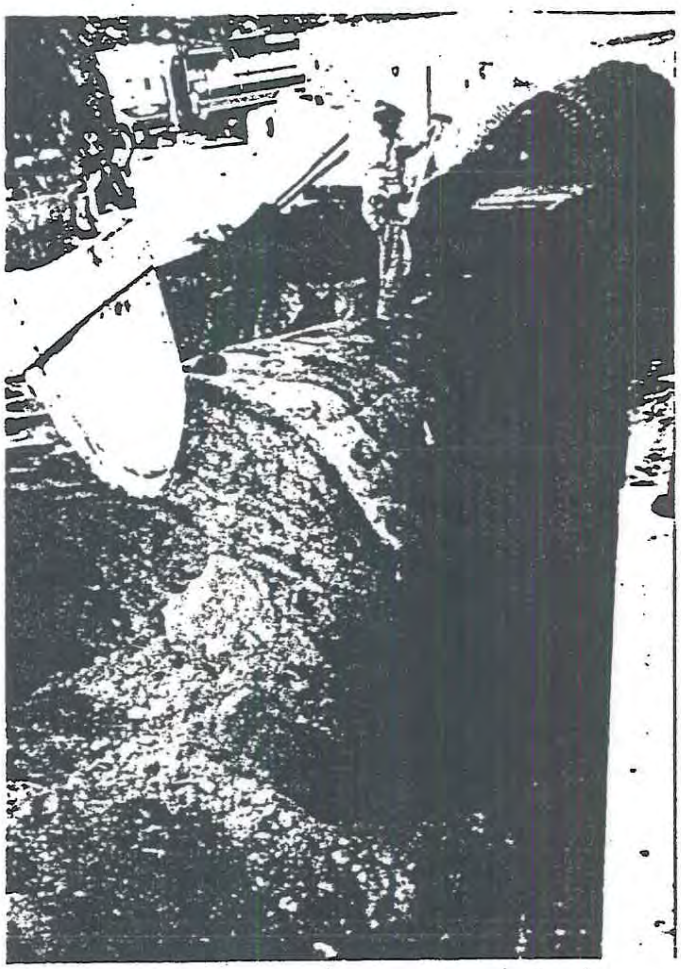
Photo of 7,500 gallon heating oil tank from the south side of the excavation. Note concrete piping sump and contaminated soil at far end of tank.

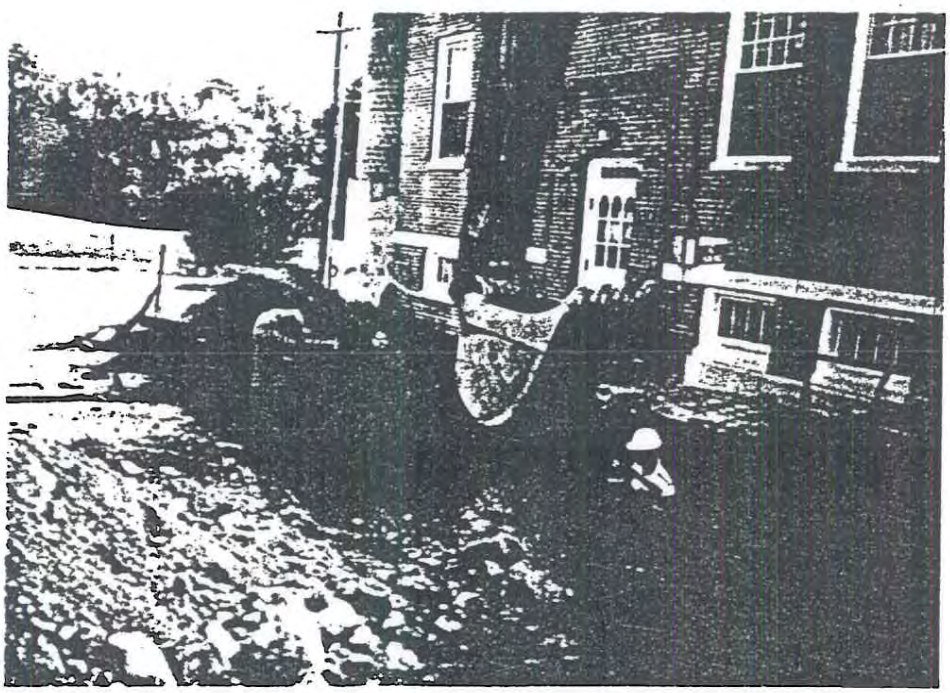
Loacation of 7,500 gallon heating oil tank installation with relation to steam generation building.

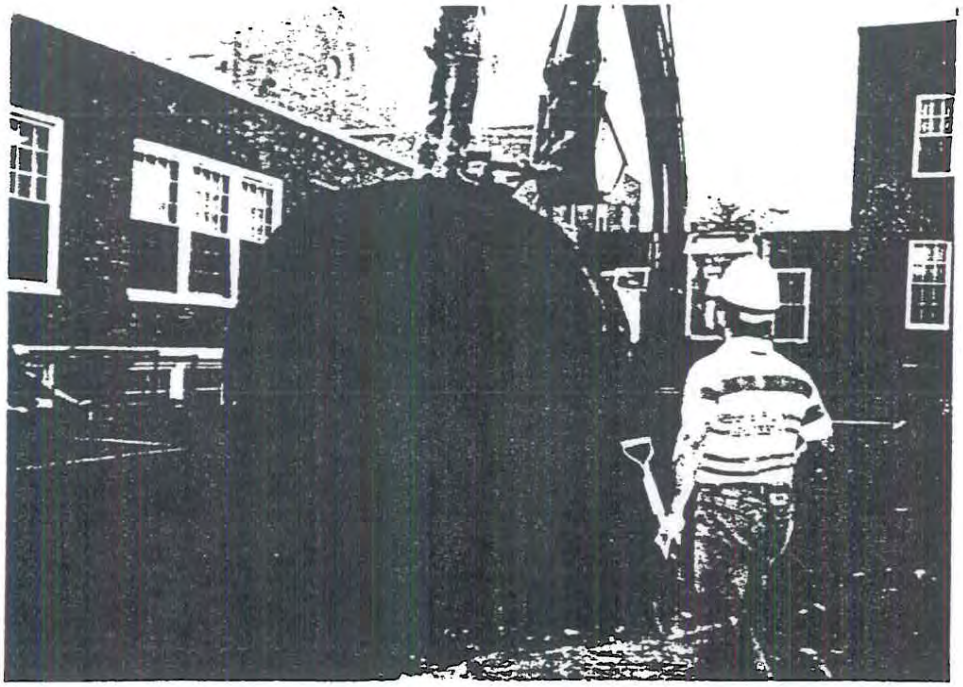
Removal of 7,500 gallon heating oil tank from tank grave.

The 7,500 gallon heating oil tank on ground next to the tank grave. Note surficial corrosion over most of the tank exterior.

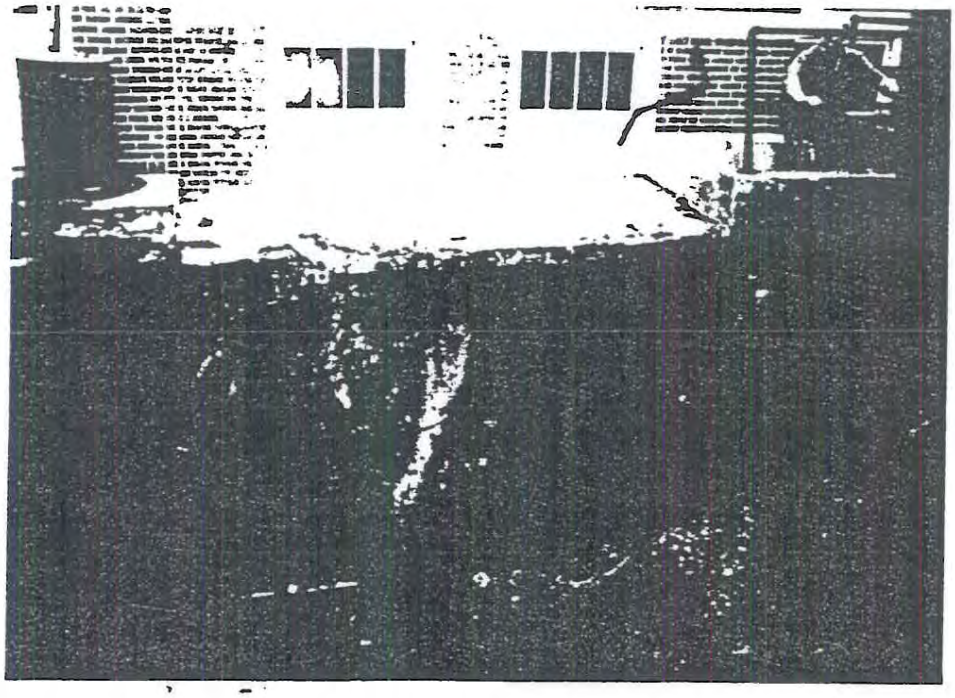
Photo of undermined concrete sidewalk adjacent to buiding.
Note broken clay pipe in lower left hand corner of photo.

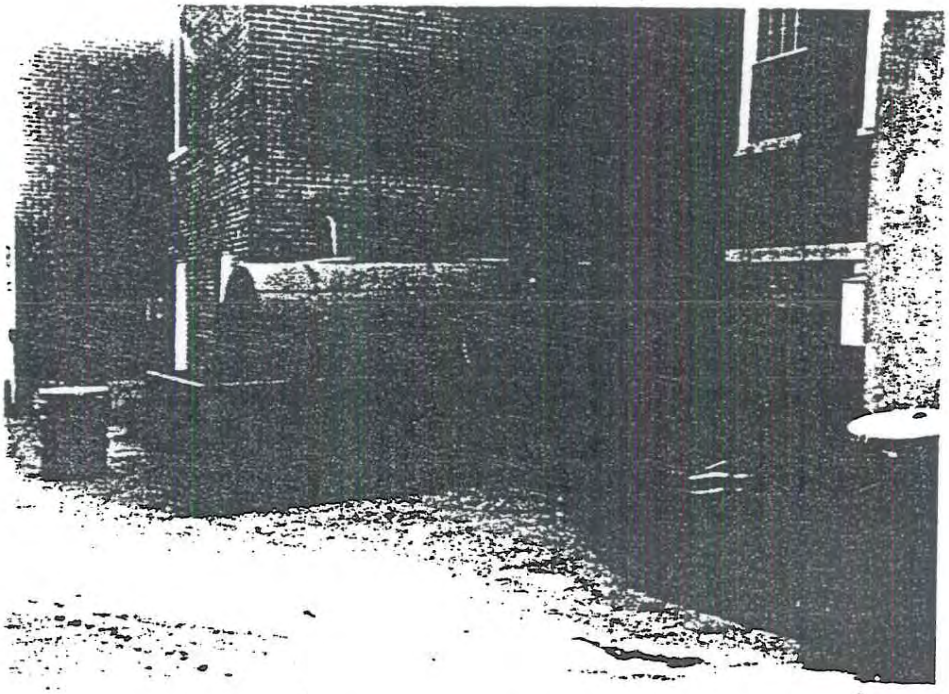
Temporary above ground heating oil tank to provide facility with fuel until the new tanks are installed.

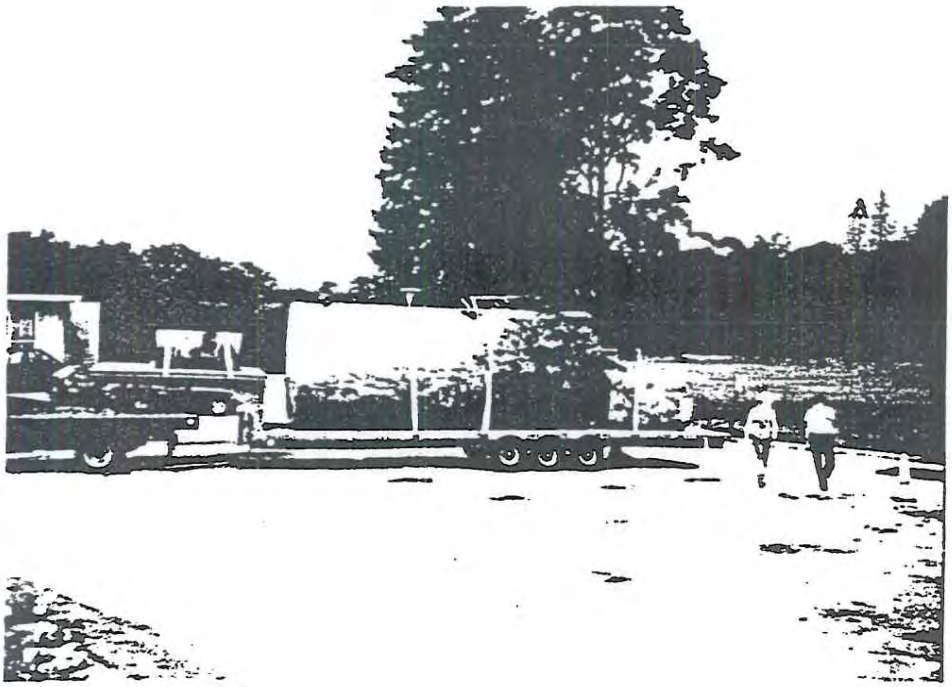
The 275 gallon heating oil tank, 7,500 gallon heating oil tank and the 500 gallon heating oil tank on trailer for delivery to disposal facility.

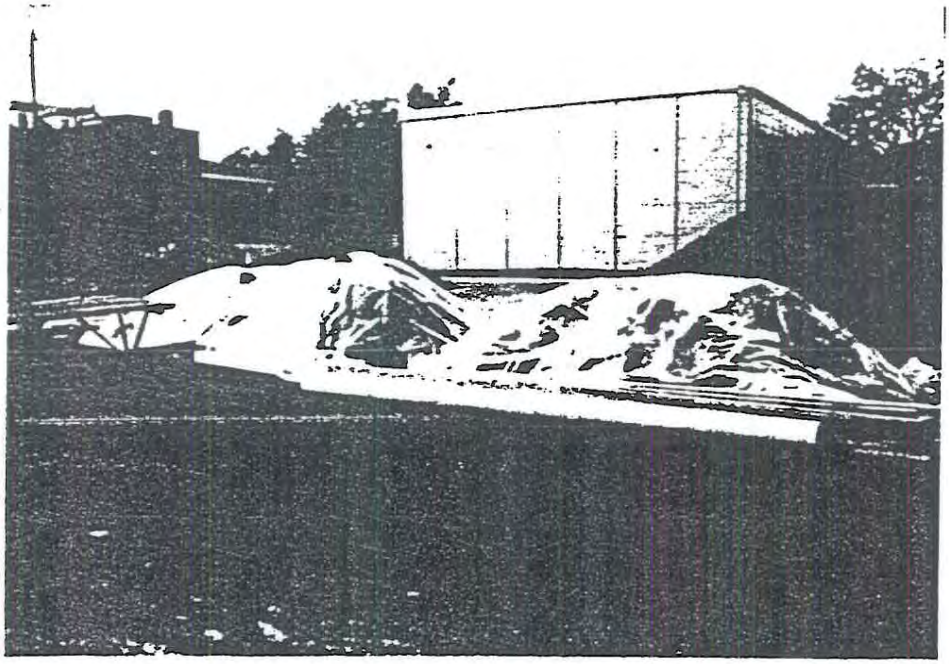
Staged contaminated soil resulting from remediation activities conducted within the 275 gallon and 7,500 gallon heating oil tank graves.

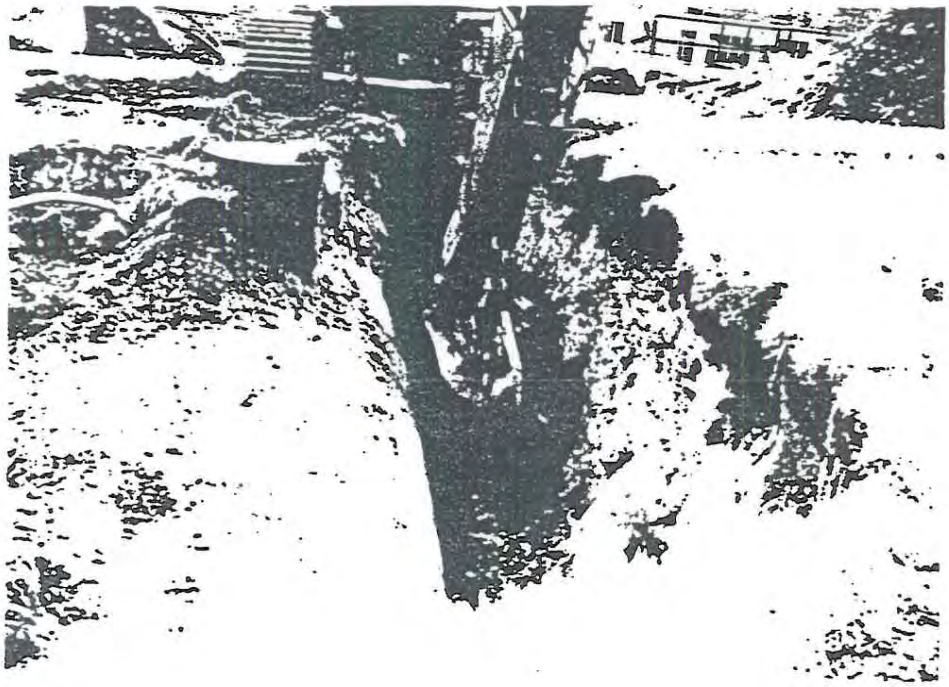
Excavation of soil from the along the south side of tank.

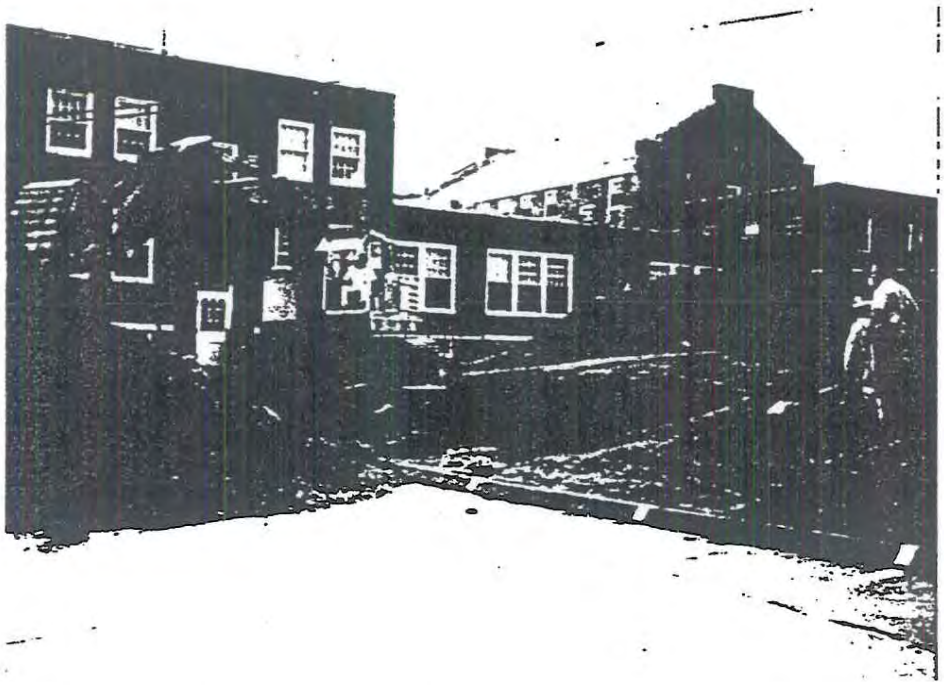
Contractor bailing clean soil from the 10,000 gallon heating oil tank grave to the north side of the excavation.

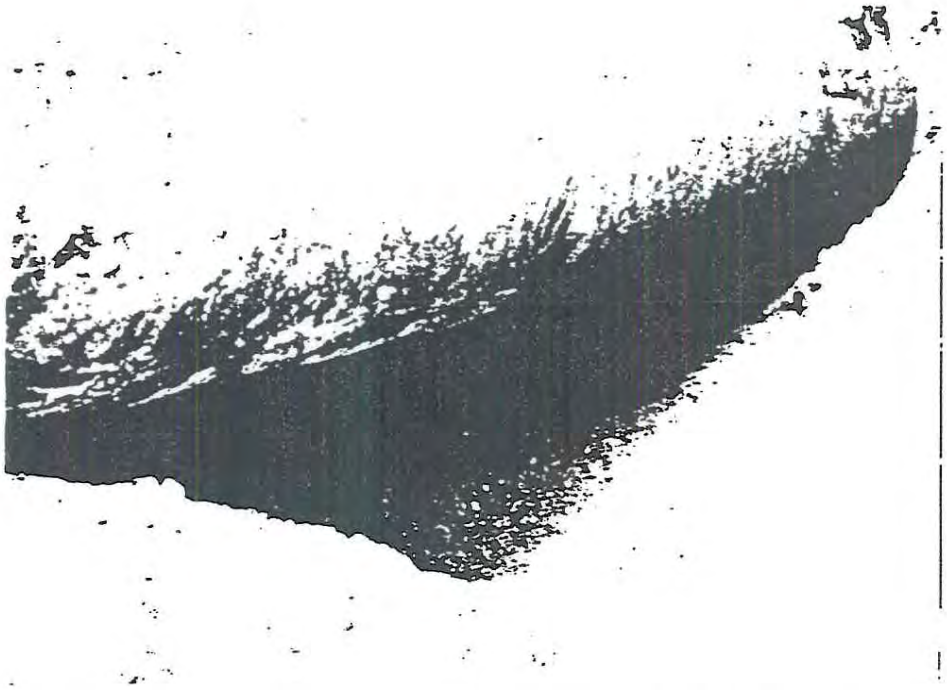
Another photo of bottom of the tank and tank grave at time of 10,000 gallon heating oil tank removal.

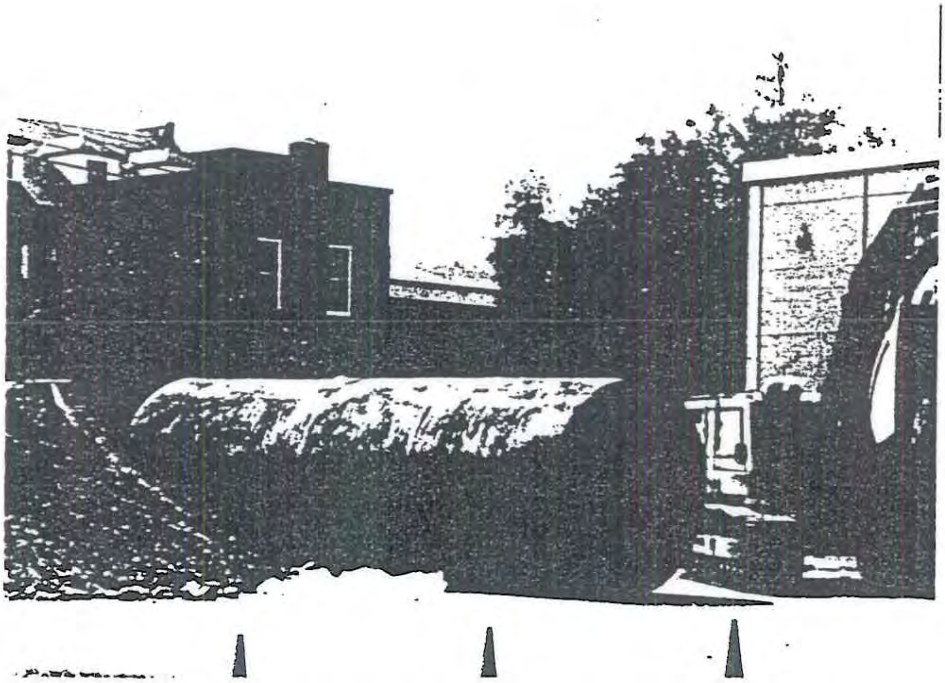
Removed 10,000 gallon heating oil tank positioned on bituminous asphalt to the north of the tank grave.

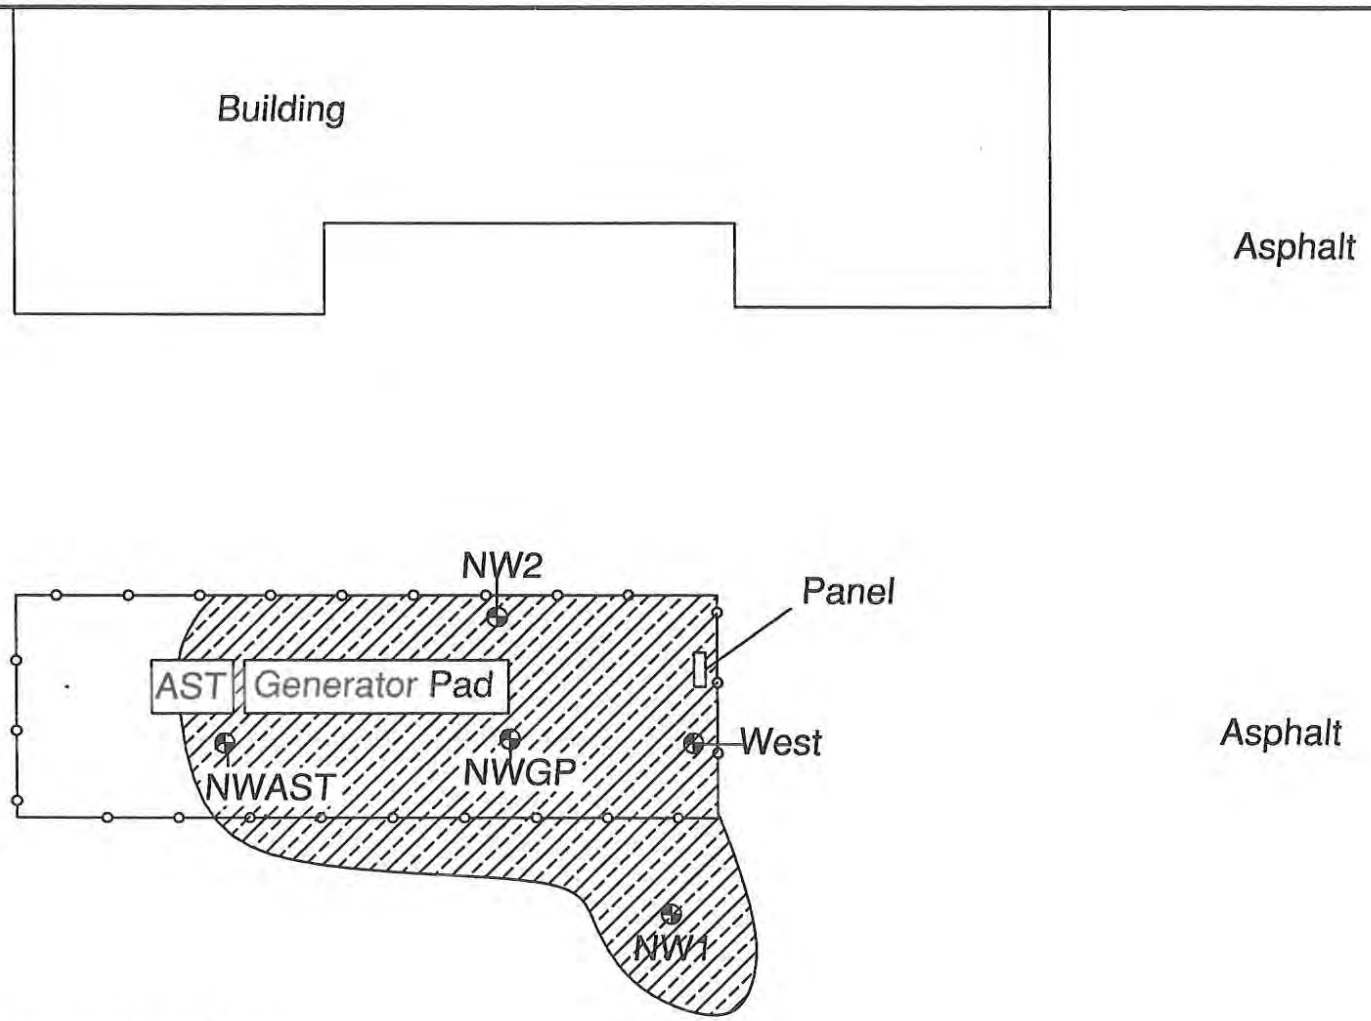
Excavation Area:
Approxmately 21' wide x 14' long

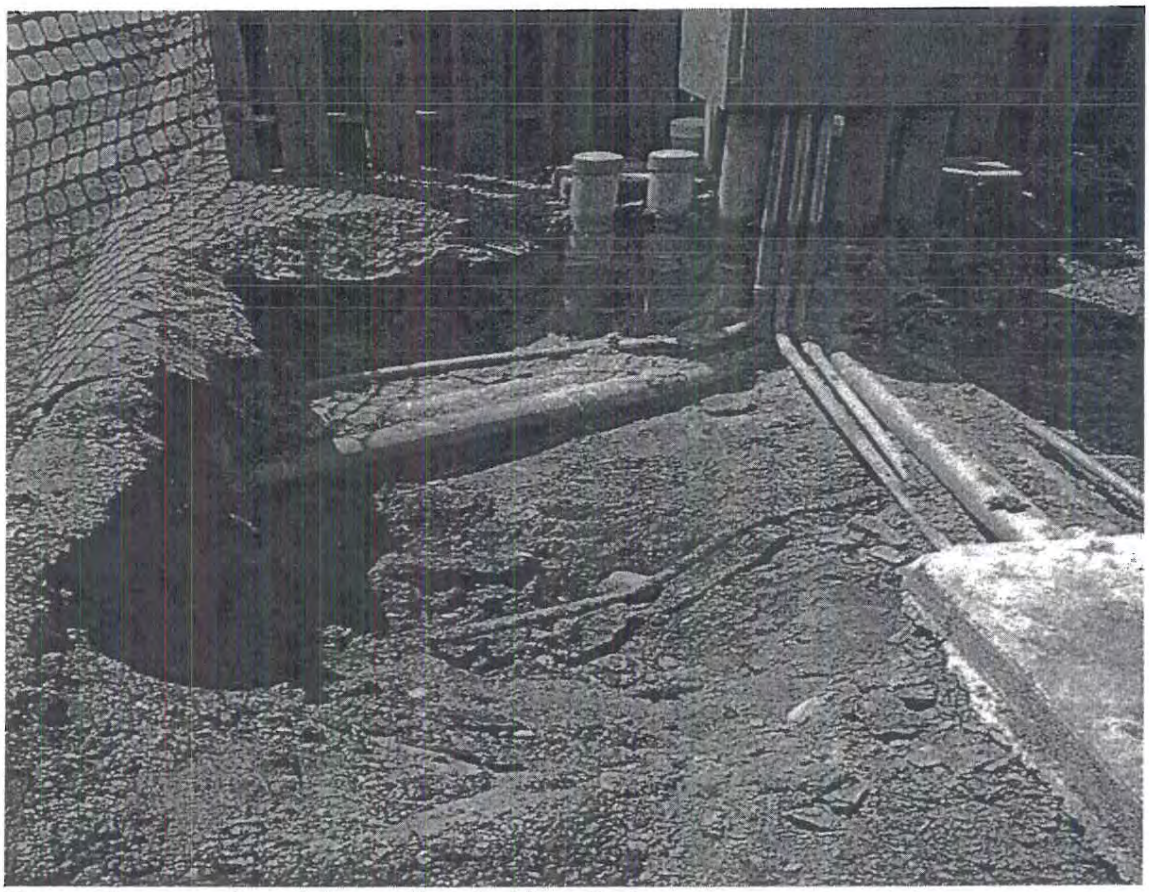
Excavation around conduits-northwest sidewall view.

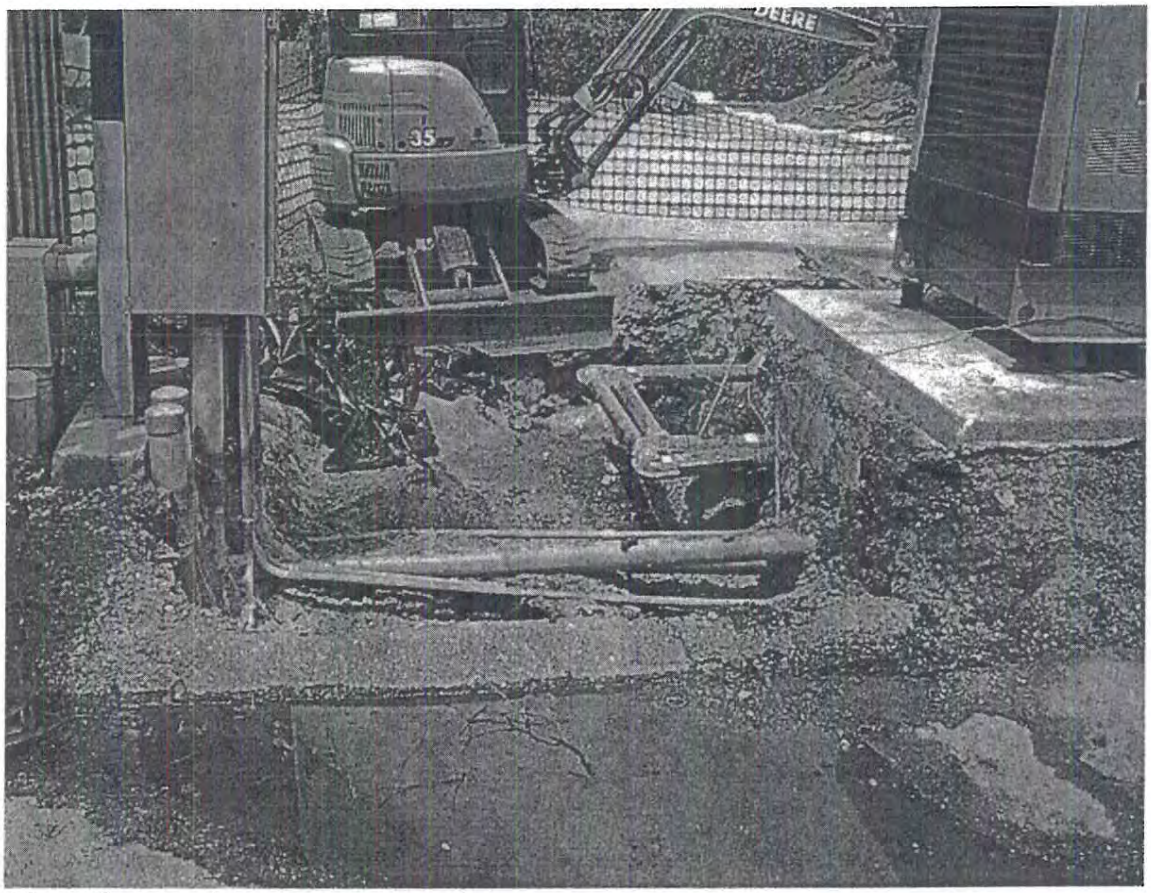
View of excavation area.

Compaction of Excavation Area

Backfill and Compaction of Excavated Area

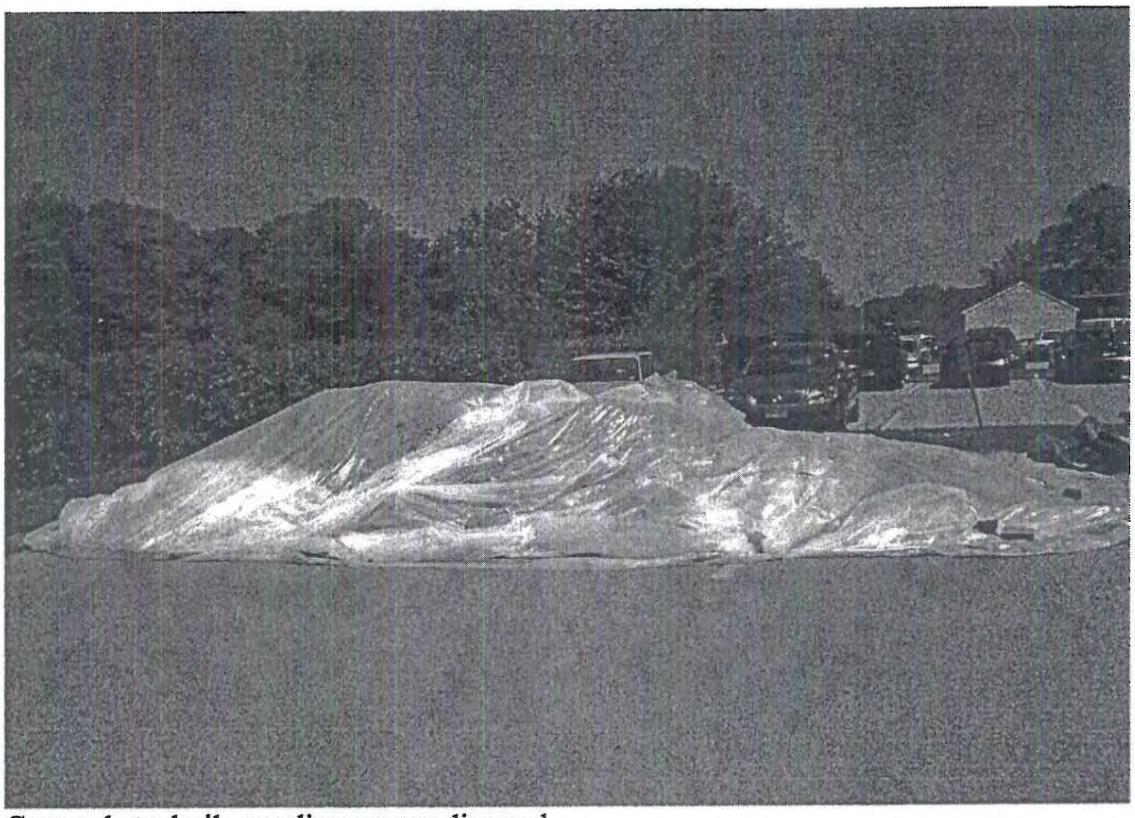
Covered stockpile pending proper disposal.

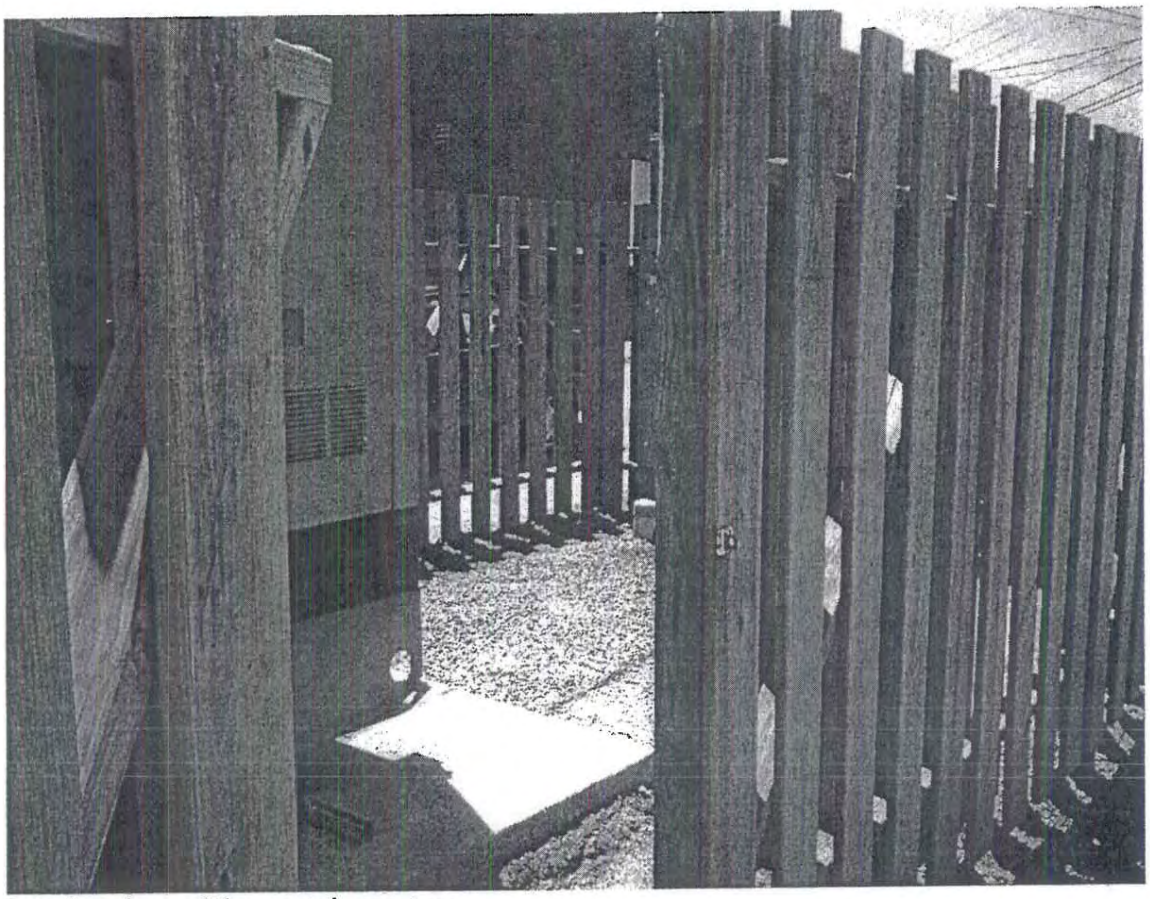
Interior view of the containment area.
