PHASE I
ENVIRONMENTAL SITE ASSESSMENT REPORT

Former Mystic Oral School for the Deaf
Groton, Connecticut

June 2013

LOUREIRO ENGINEERING ASSOCIATES, INC.
100 Northwest Drive
Plainville, Connecticut 06062

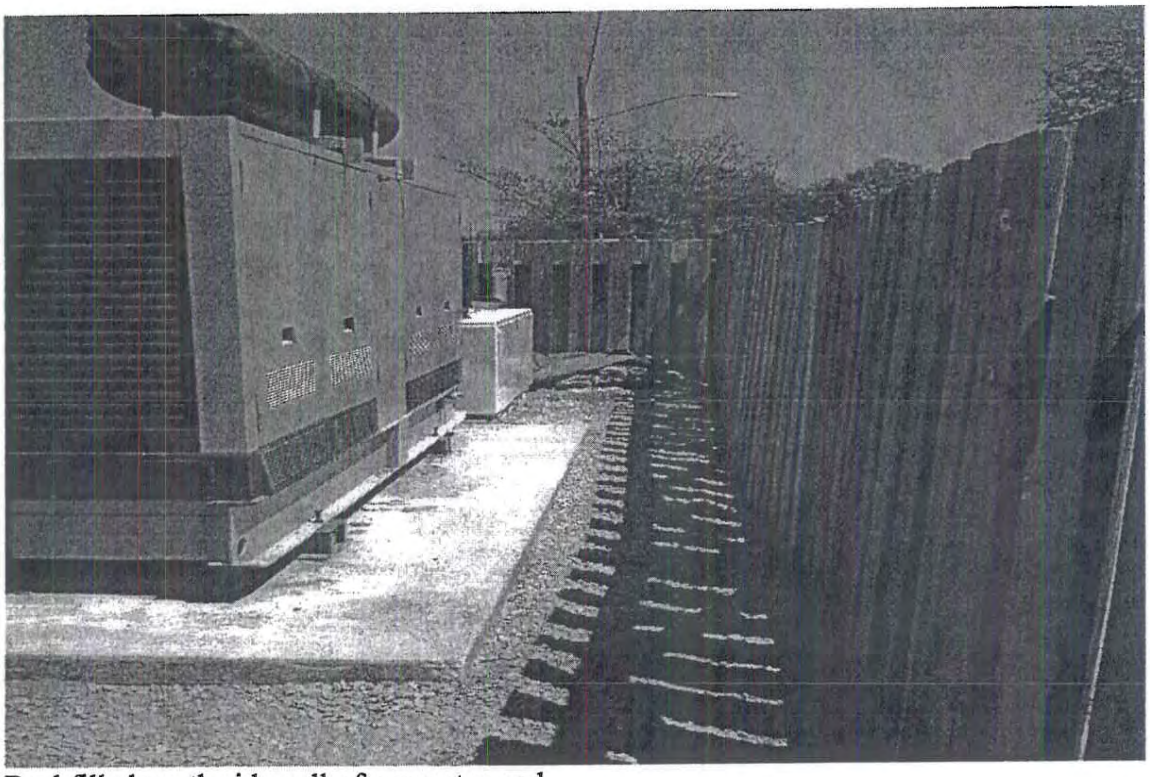
Backfilled south sidewall of generator pad.

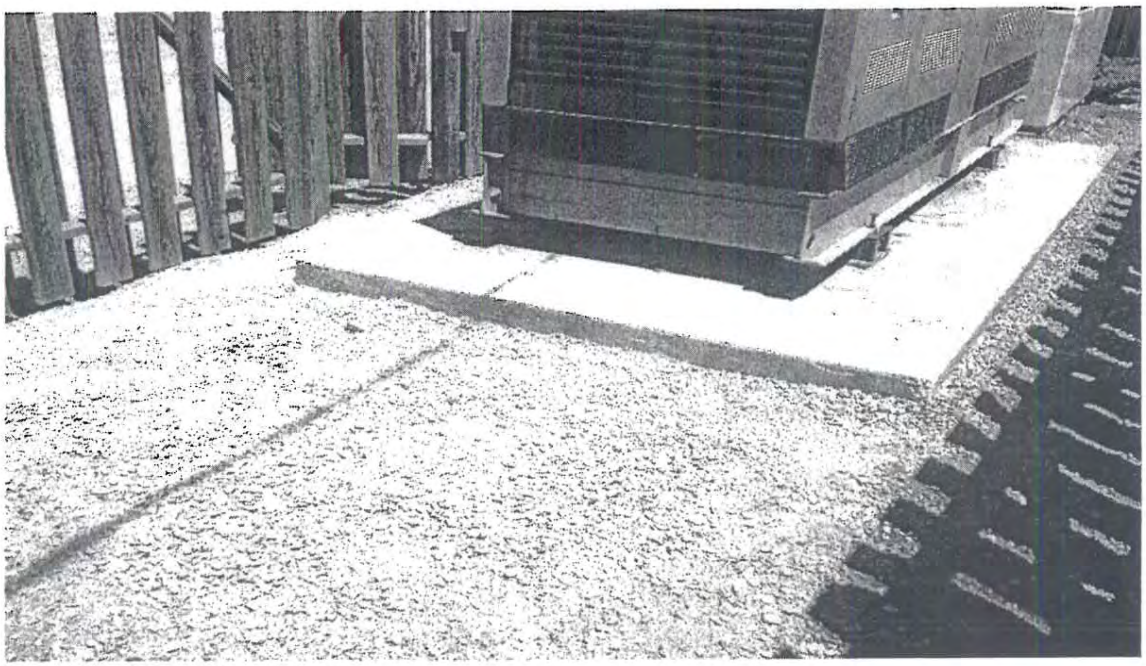
Backfilled containment area.

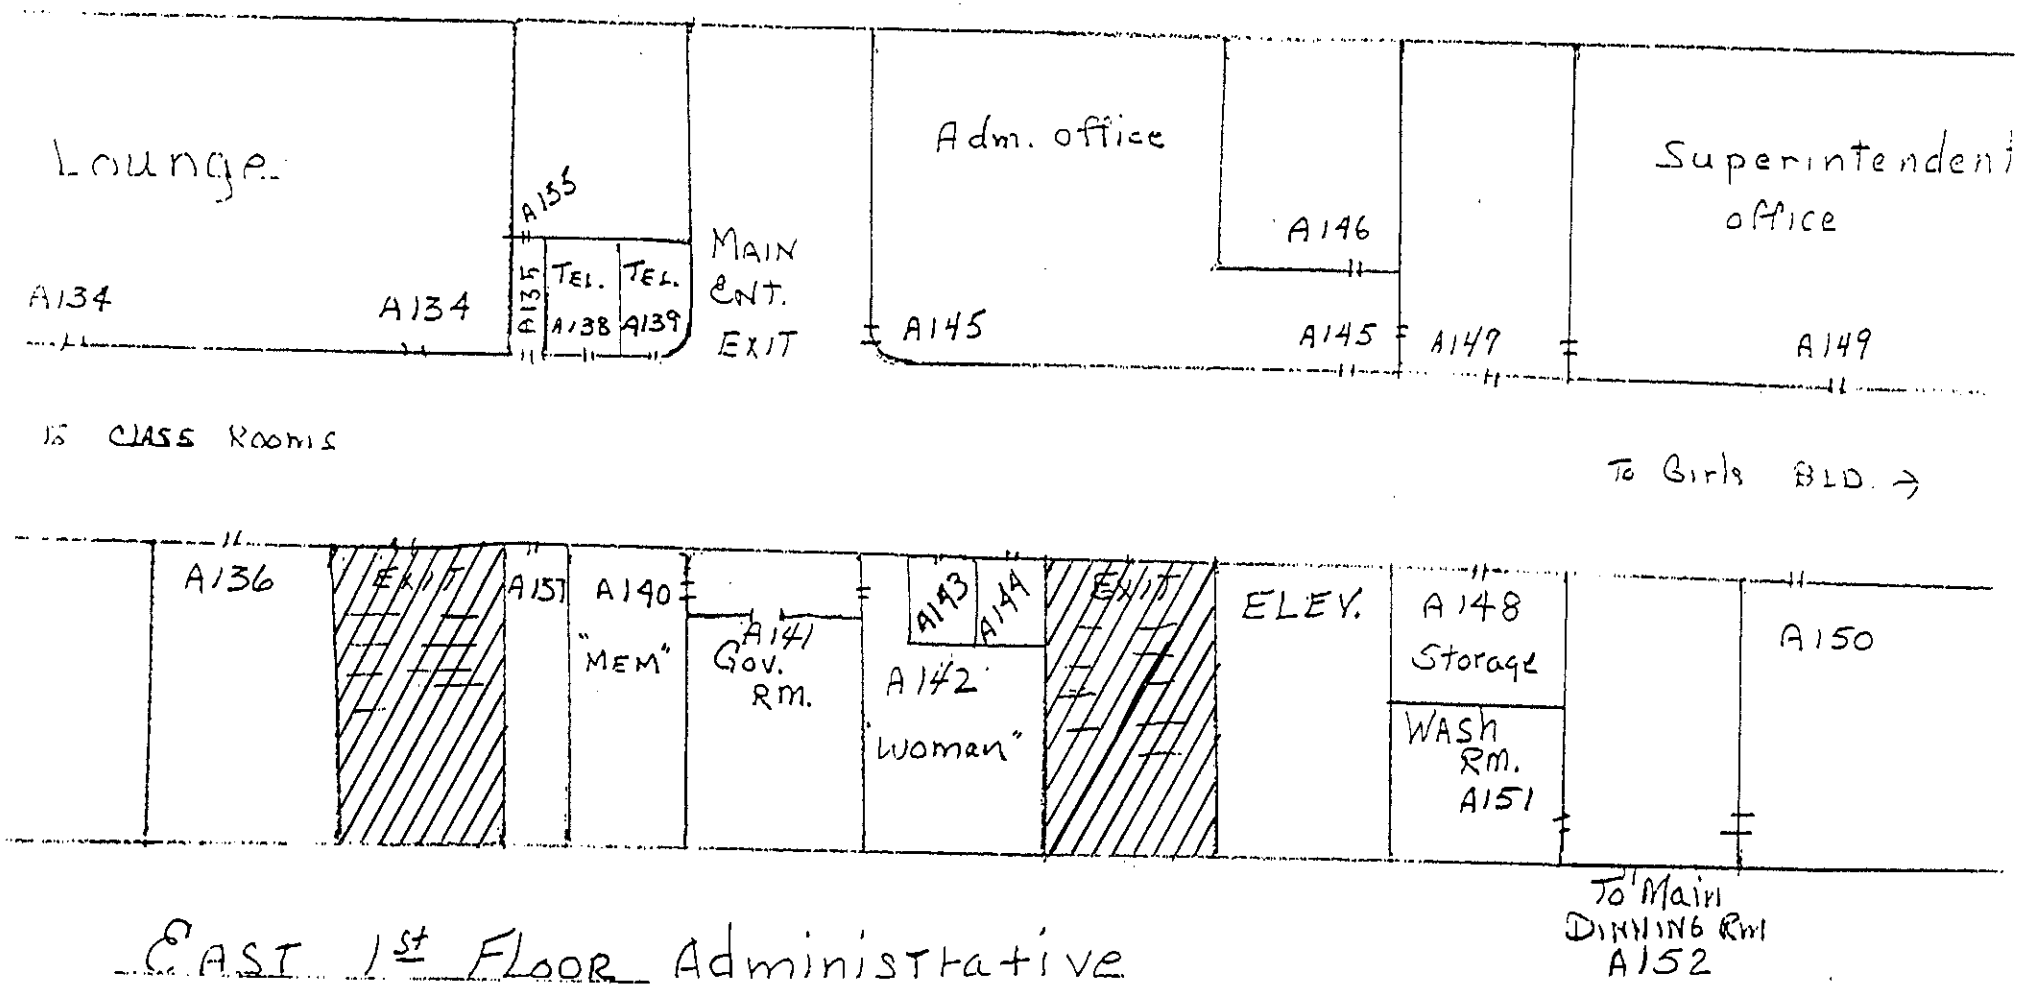
ADMINISTRATION/GIRL'S BLDG

A136+ A137 STAIRS { ~352 SF FLOOR TILE + MASTIC
1ST FLOOR LANDING, ENTRANCE LANDING + BSMT LANDING
