**Agenda Item 3**  
**335 Robinson Drive**  
**Revisions to Previously Approved Plans**

## STAFF REPORT AND RECOMMENDATION

| SUBJECT: | <b>335 Robinson Drive</b> – Revisions to Previously Approved Plans |

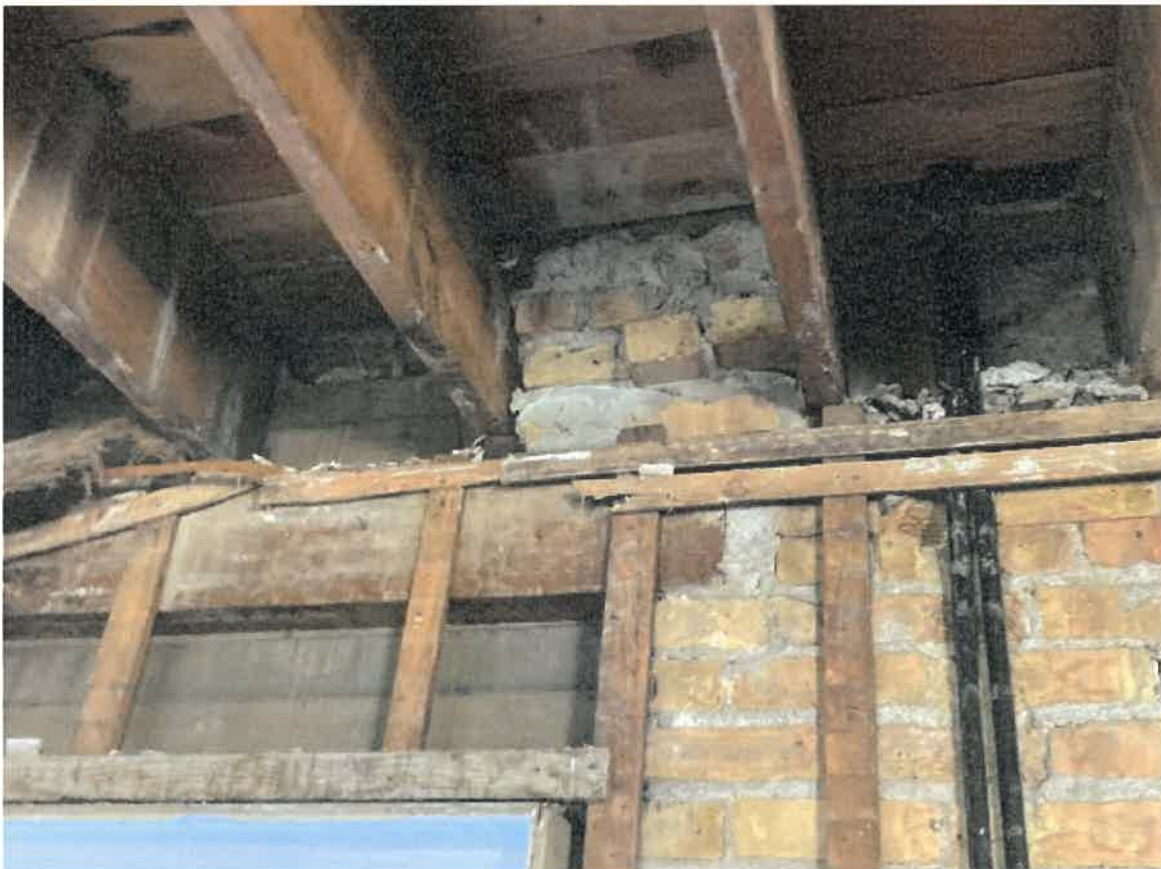
Photo 1: South Wing (First Floor) – Timber window header & second floor wood joists pocketed into 3-wythe brick masonry bearing wall.

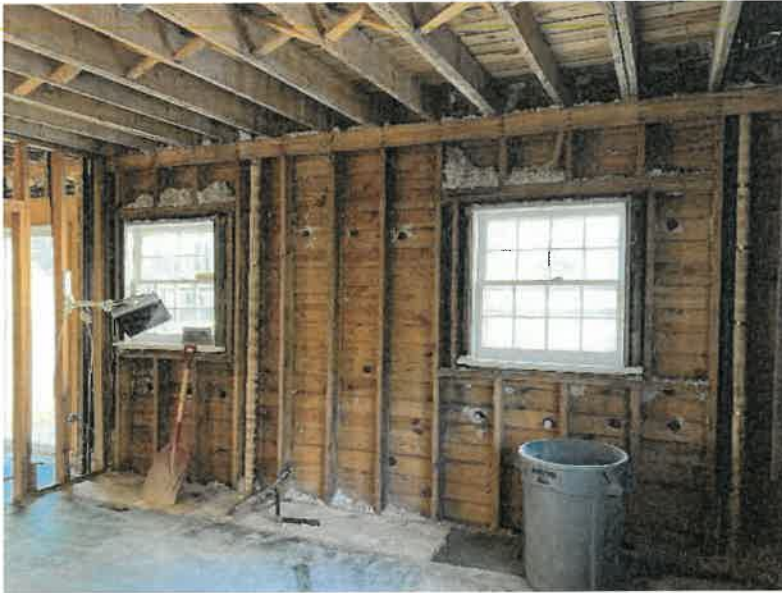
Photo 10: North Wing (First Floor) – Balloon framing at west wall.

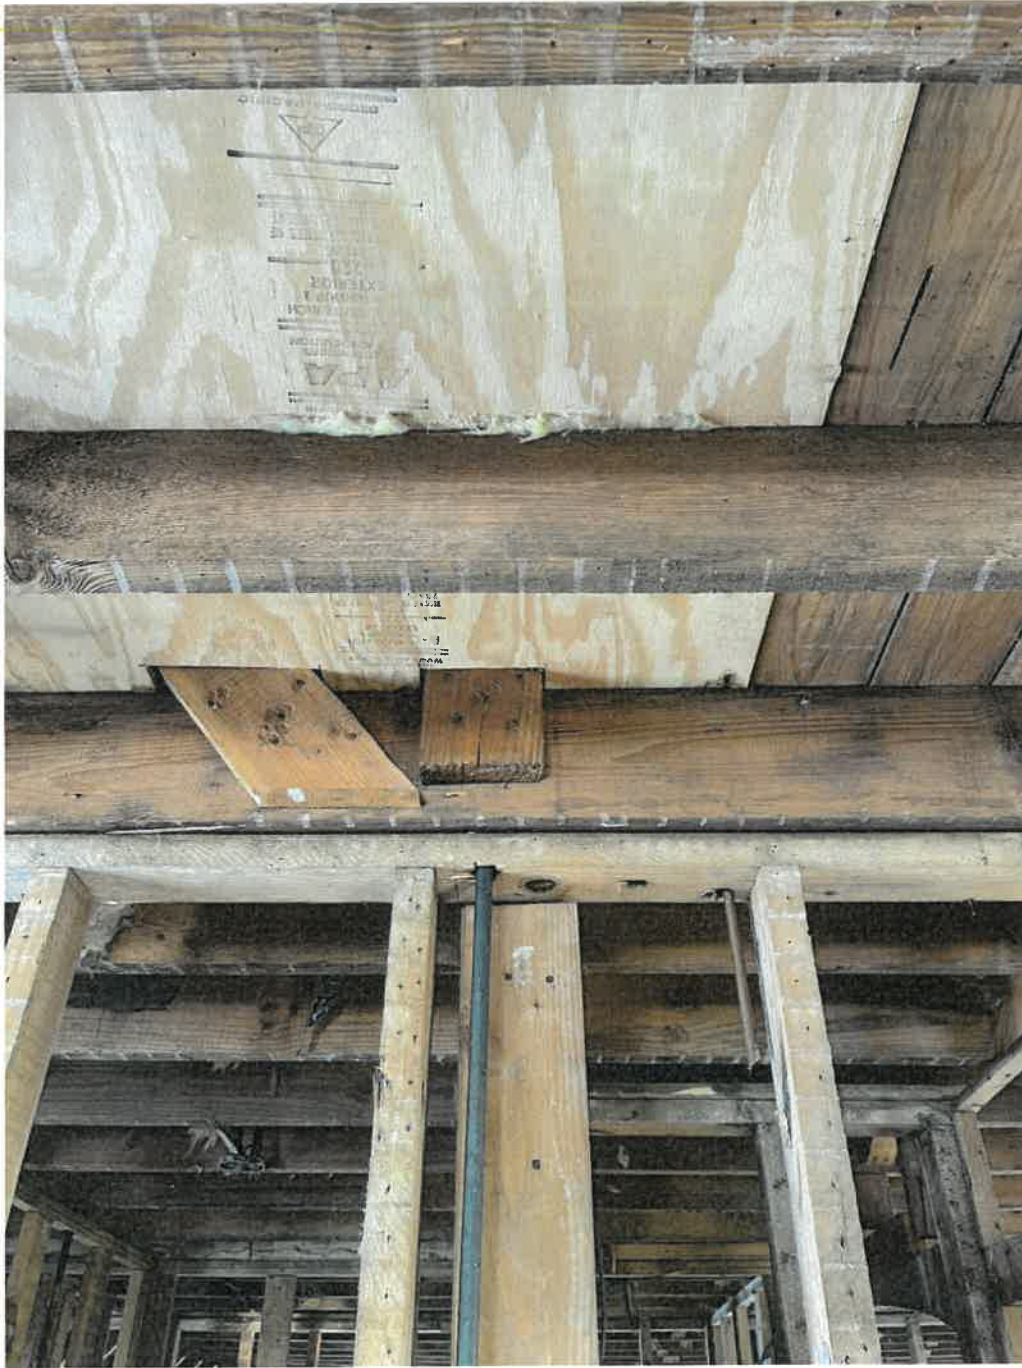
Photo 22A: South Wing (Second Floor) – Detail of 1 of 2 tie rods through wall framing connected through to roof framing with carpenter built timber truss/beam at ceiling framing with 1x4 vertical and diagonal members connecting to roof framing. Structural reinforcement of floor, ceiling and roof framing required.

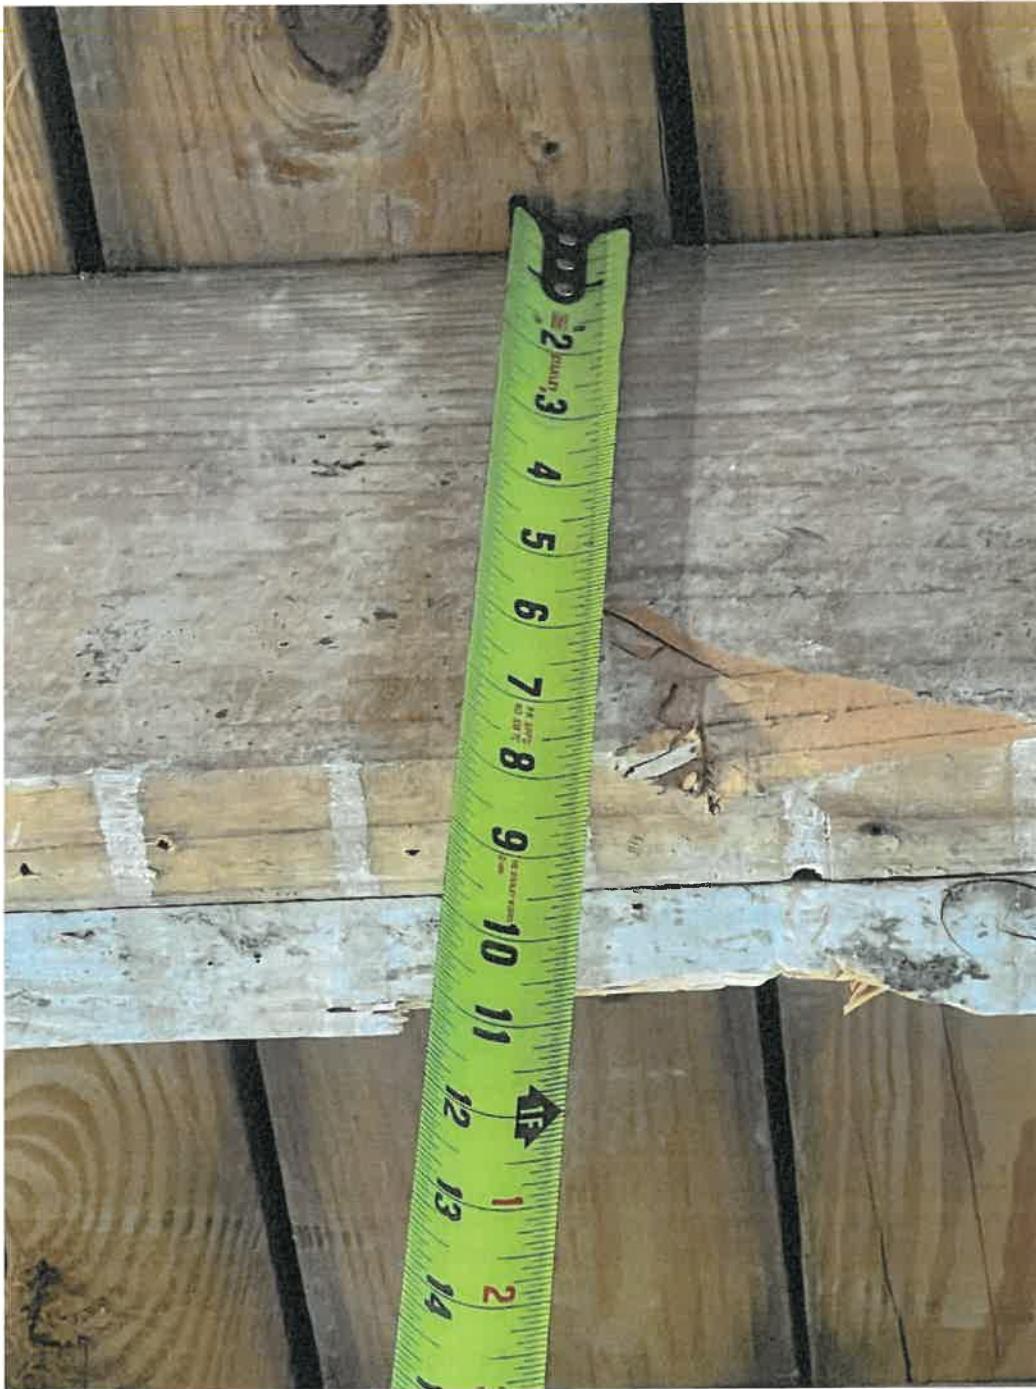
Photo 24A: North/East Wing (First Floor) – Second floor wood floor framing appears undersized (2x8 depth). Floor system is bouncy and significantly not level with 3" +/- dip in floor. Structural reinforcement of floor framing required.

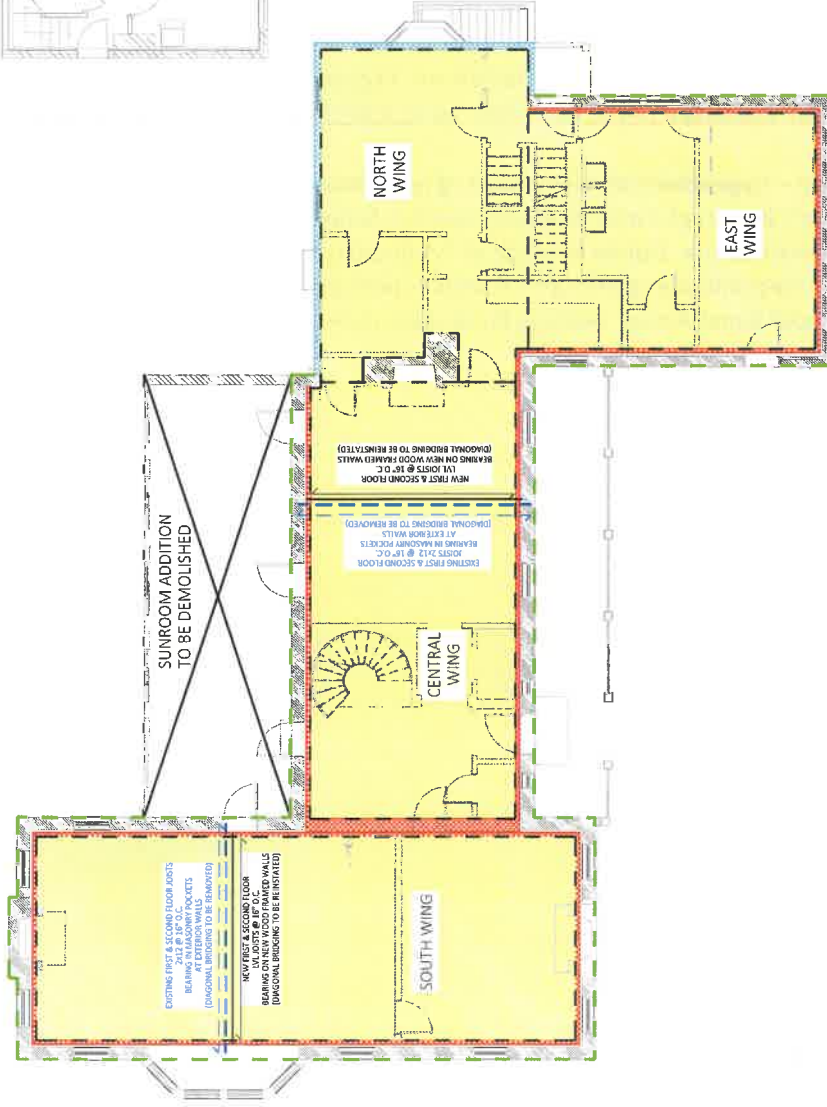
EXISTING FIRST FLOOR PLAN - STRUCTURAL REINFORCEMENT OVERLAY PLAN

INDICATES EXISTING MASONRY  
WALLS THAT WILL REQUIRE  
ADDITIONAL REINFORCEMENT  
TACKLING AND REPAIRS
