# Neighborhood Condition Survey:

## Housing and Infrastructure Conditions Analysis

Neighborhoods: East Lake Park, Habitat &  
Mickens Harper - Dade City, FL

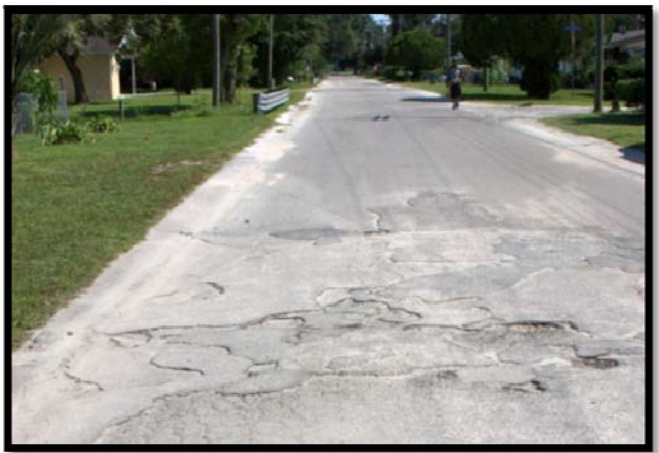
Wilson St. Looking South

Wilson St. by canal  
Drainage Issue & Pot Holes

The street conditions within Habitat and Mickens Harper are all in “Good” or “Average” condition. However 36% of East Lake’s roads are in poor condition with Wilson St. needing the most repairs. Railroad Ave. needs paving to be consistent with other roads within the neighborhoods and reduce its continued maintenance costs. At the East end of Taylor Ave. there is a round-about that services two parcels that is unpaved. All the streets that cross the canal except Summer Lake Rd have railing where the canal subsides under the road.

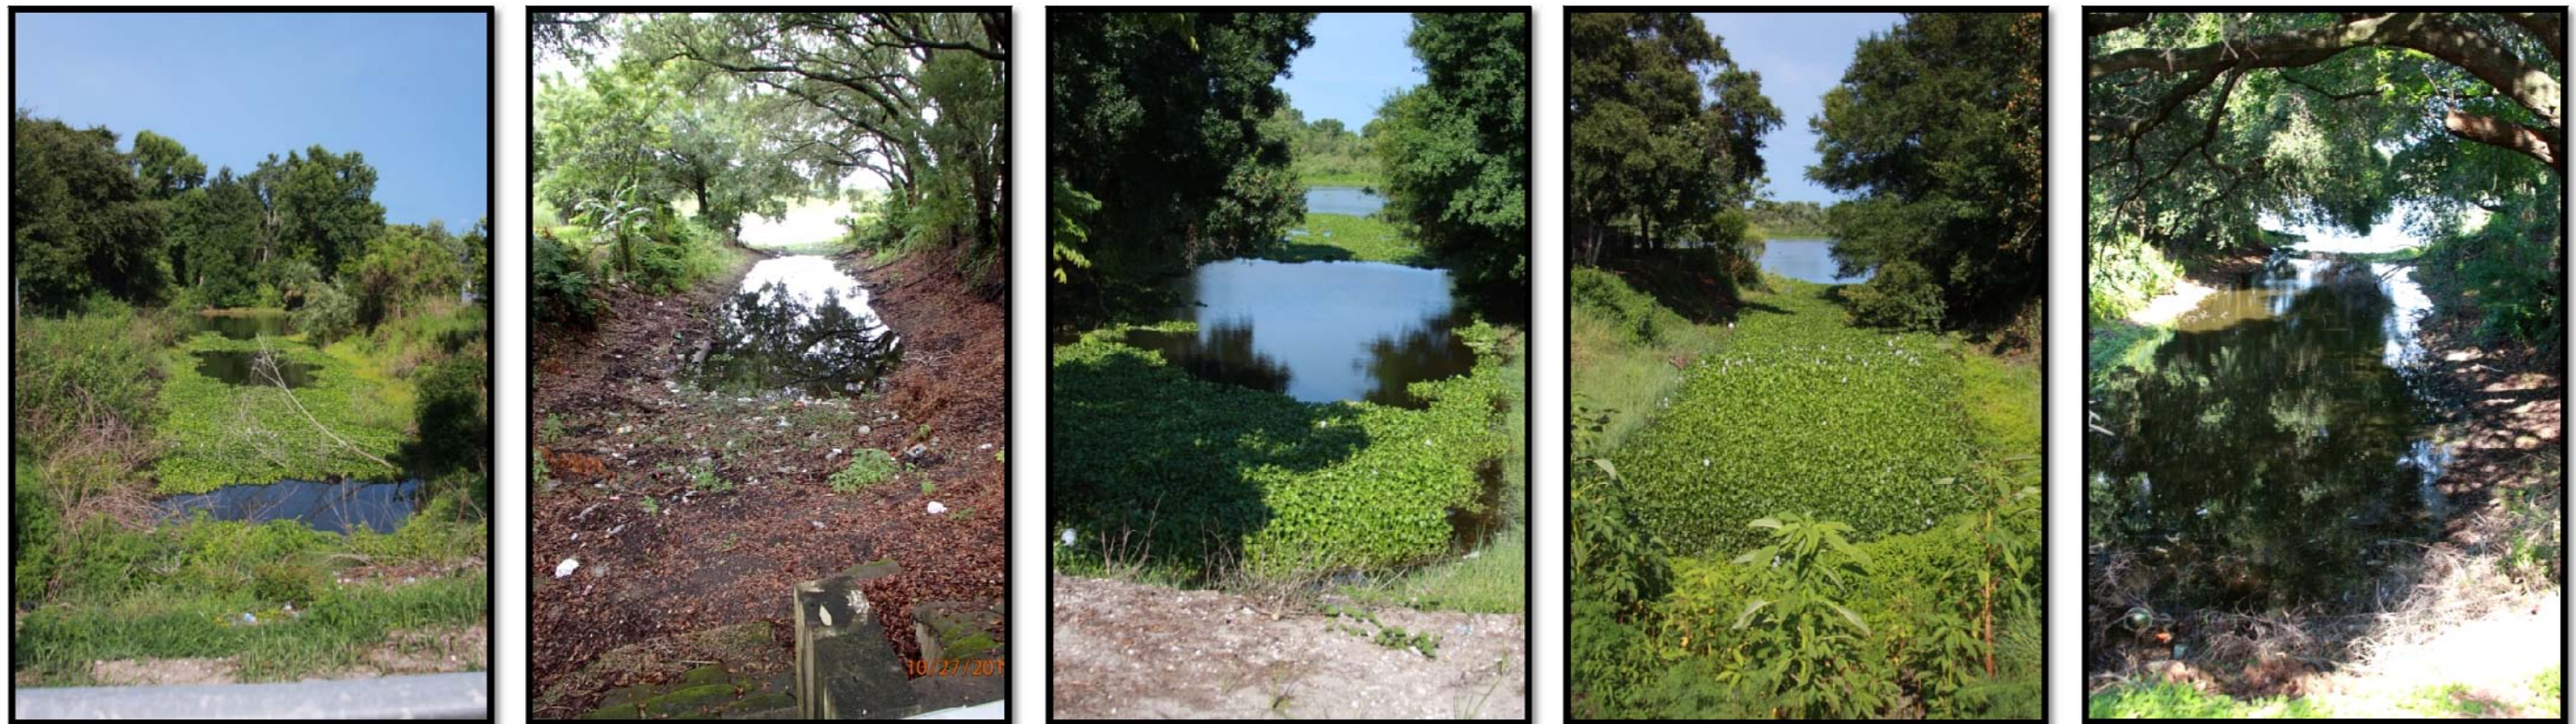
The East Canals in the East Lake neighborhood are located on the East side of Wilson Street. Each of the canals had natural borders that gently sloped up level to residential yards. Water levels were low during site visits. Debris was visible both in the water and along the shore at each of the six East Canals. Dumping of household garbage was prevalent in all canals. Water quality test and removal of debris are recommended due to the large amount of dumping in the waterways.

*Above are the East Canals Connected to Shadow Lake taken from Wilson St.*

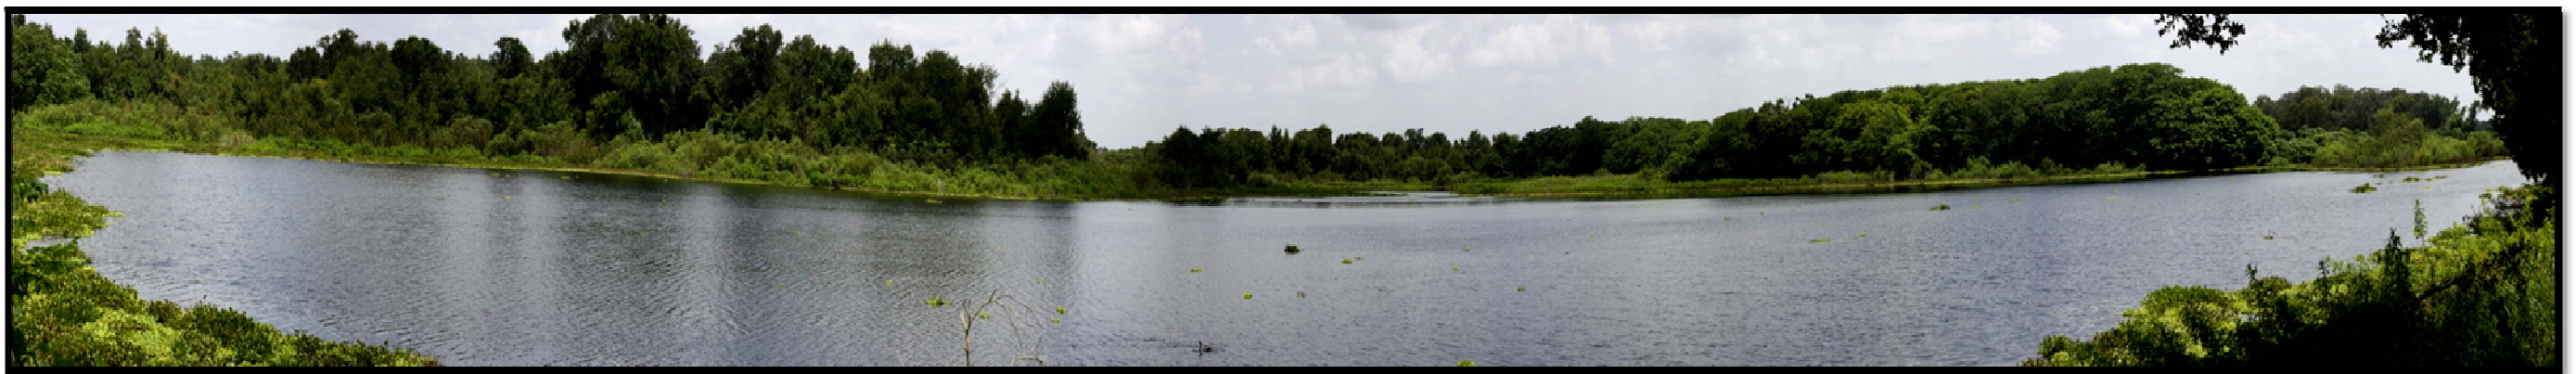
There is however still an issue to the North of Shadow Lake that is outside of the study area where dumping is an issue. Additionally, Shadow Lake has dealt with duckweed and is currently being inundated with water cabbage along its North bank.

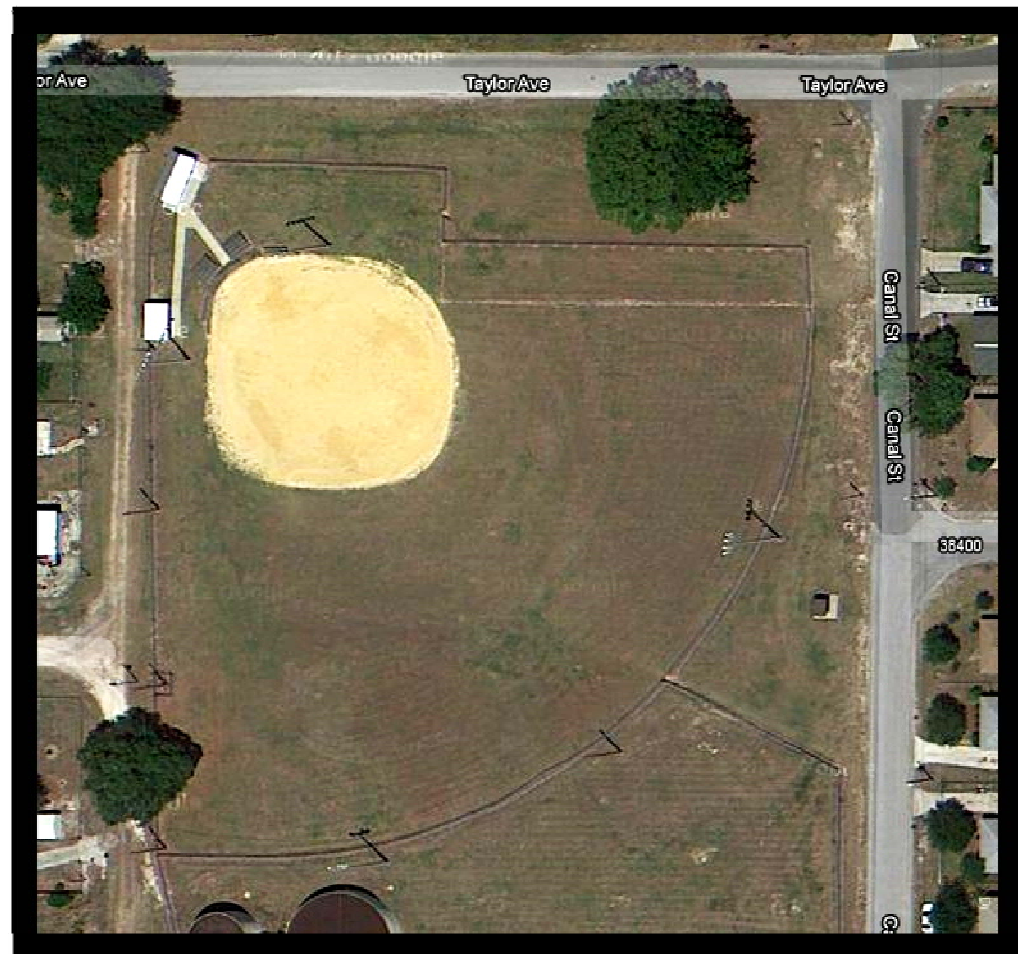
Dade City – James Irvin Baseball Field - Retrieved from Google Maps:

The baseball field sod was well trimmed at the time of the study. There was no debris on or around the field. The structures were observed to be in good repair. The field however is in need of maintenance. The baseball diamond as you can see from this google image needed to be defined. Grass is growing up through the sand through the baseball diamond. The baseball diamond was also unmarked and in need of edging.

Graffiti was observed on the light post and the covered bench located on the East side of the field along Canal Street. Private property issues may arise due to a private parcel located at the North East edge of this park on the corner of Taylor Avenue and Canal Street. The Habitat for Humanity charity currently owns the land that sits on the edge of the baseball field.

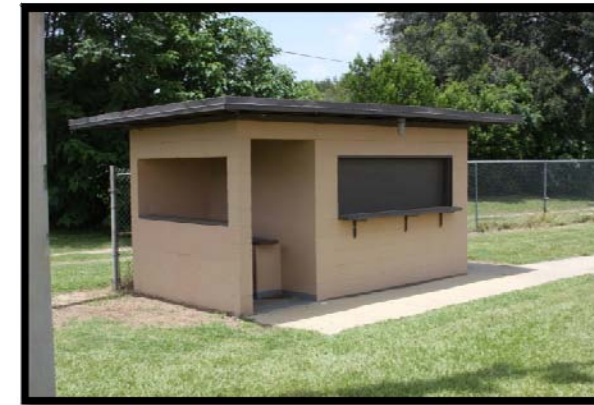
**Concession Stand**  
In Good Repair

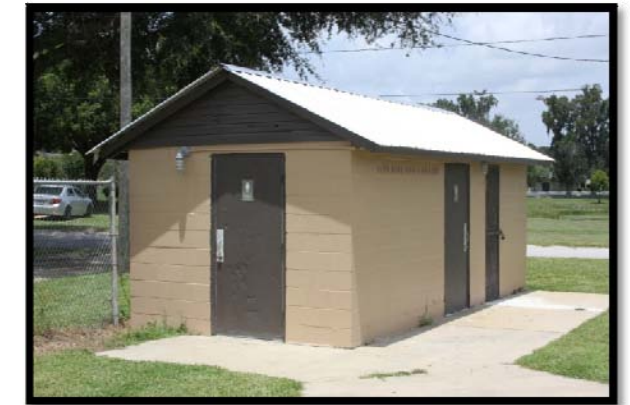
**Public Bathroom**  
In Good Repair.
