# Building and Site Assessment

Charter Township of Delta

April 23, 2020

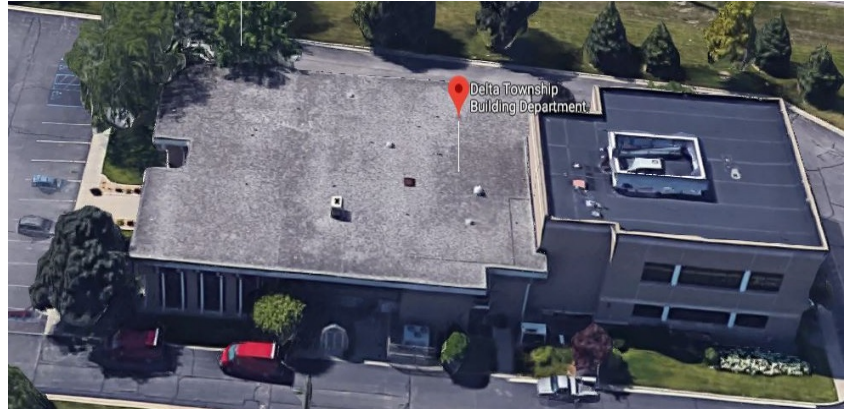
The Administration Building was originally constructed in 1969 with an addition in 2000. The overall square footage is 21,173; the original building is two stories and the addition consists of three stories including the basement. The primary structural system is masonry bearing wall for the original building and steel frame for the addition. The exterior elevations are clad in a combination of face brick and aggregate panel. The roof system is a single ply membrane that is ballasted at the original building and fully adhered at the addition. The building is generally in good shape, but with dated finishes. The facility received an overall score of **75** out of 100, which is **satisfactory**.

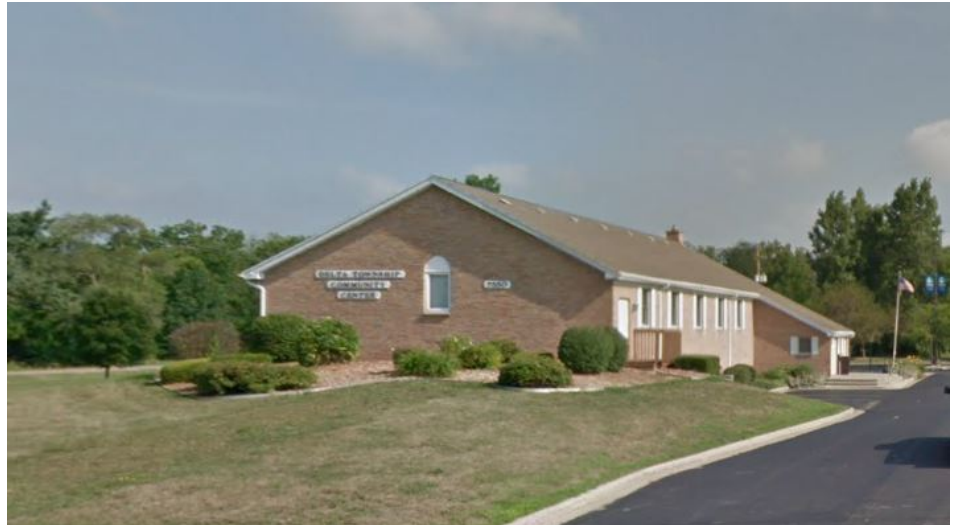
The Drolett Community Center was originally constructed in 1971 as a church with a small addition in 1996. It is a 6,900 sq. ft. in size and is two stories with the basement level located half way in the ground. The exterior elevations are face brick. The roof system asphalt

shingles. The building is generally unoccupied and is generally in good shape, but with dated finishes. The facility received a score of **61**, which is **borderline**.

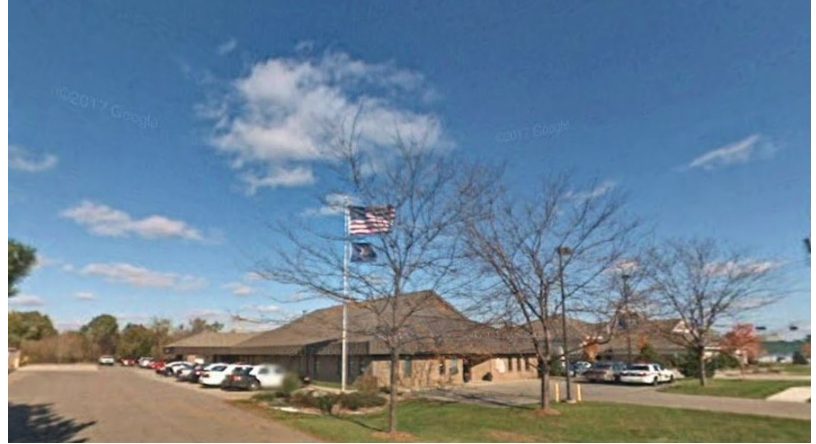
The Sheriff Substation was originally constructed in 1982 and an addition in 1991, with an interior renovation in 2013. The building is 7,120 sq. ft. in size and is one story. The primary structural system is wood stud bearing wall for all portions of the building. The exterior elevations are primarily face brick. The roof is clad in architectural standing seam metal with the north portion clad in asphalt shingles. The building is generally used for business use with offices and supporting when used it can hold appropriately 30 occupants. The facility received a score of **58**, which is

**Borderline.**

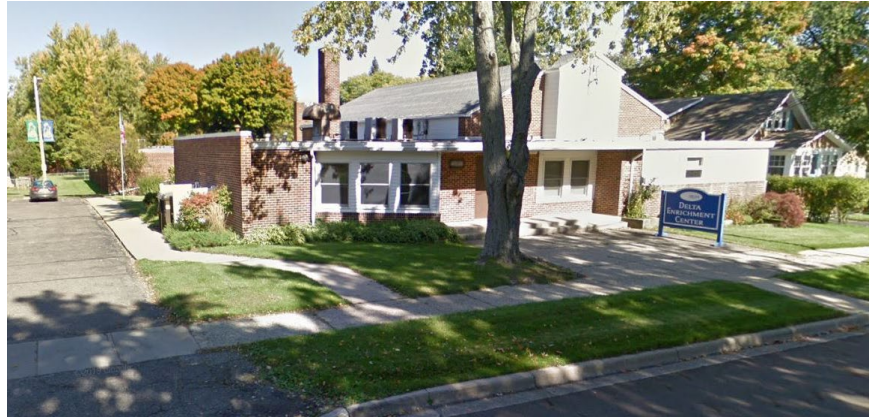
The Enrichment Center was originally constructed in 1939 as a school and in 1955, a six-classroom addition was added. In 1981, some of the school was partially demolished and renovated for use as the township library with some minor renovation in 2008 to support the new

use as a community center. It is a 14,100 sq. ft. in size and is one story. The primary structural system is bearing wall masonry. The exterior elevations are face brick with vinyl siding on stud infills at areas that were previously large windows. The building is used often during the week and weekend as a community center. The building is showing its age especially since portions are 80 years and 64 years old. The facility received a score of **49**, which is **Poor**.

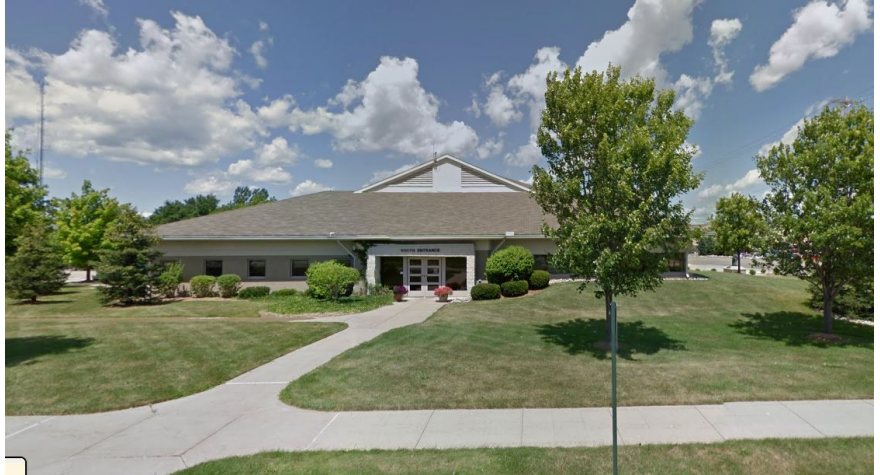
Fire Station No. 1 was originally constructed in 2002. It is a 25,520 sq. ft. in size and is one story with storage mezzanines on either side of the apparatus bay. The primary structural system is bearing wall masonry and steel stud bearing wall. The exterior elevations a combination of masonry low and synthetic stucco high.

Windows are a prefinished aluminum storefront system. The roof system is high slope clad in asphalt shingles. The building primary use has always been a fire station. The building can sleep 10 firefighters. It is generally not open to the public. The building looks like a 17-year-old building but well maintained. The facility received a score of **77**, which is **Satisfactory**.

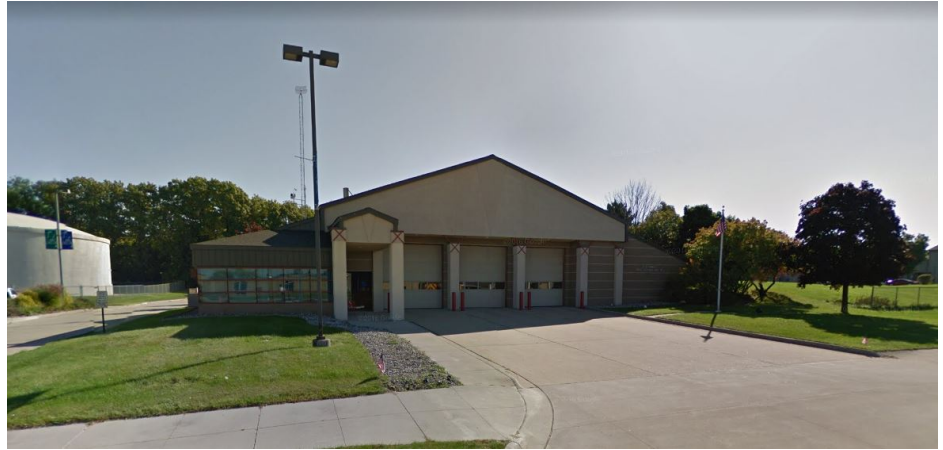
Fire Station No. 3 originally constructed in 1991. It is 11,280 sq. ft. in size and is one story with storage mezzanines on either side of the apparatus bay. The primary structural system is bearing wall masonry. The exterior elevations were originally decorative CMU, but

upgraded to face brick. Synthetic stucco used on the exterior above bay doors and at the entry. Windows are a prefinished aluminum storefront system. The roof system is high slope and clad in architectural metal standing seam. The building's primary use has always been a fire station. The building can sleep 10 firefighters. It is generally not open to the public. The building looks like a 28-year-old building but well maintained. The facility received a score of **71**, which is **Satisfactory**.
