POTTER COMMUNITY CENTER MASTER PLAN REPORT

PREPARED FOR
VILLAGE OF FAIRPORT

Dec. 8, 2011

LOMONACO ASSOCIATES

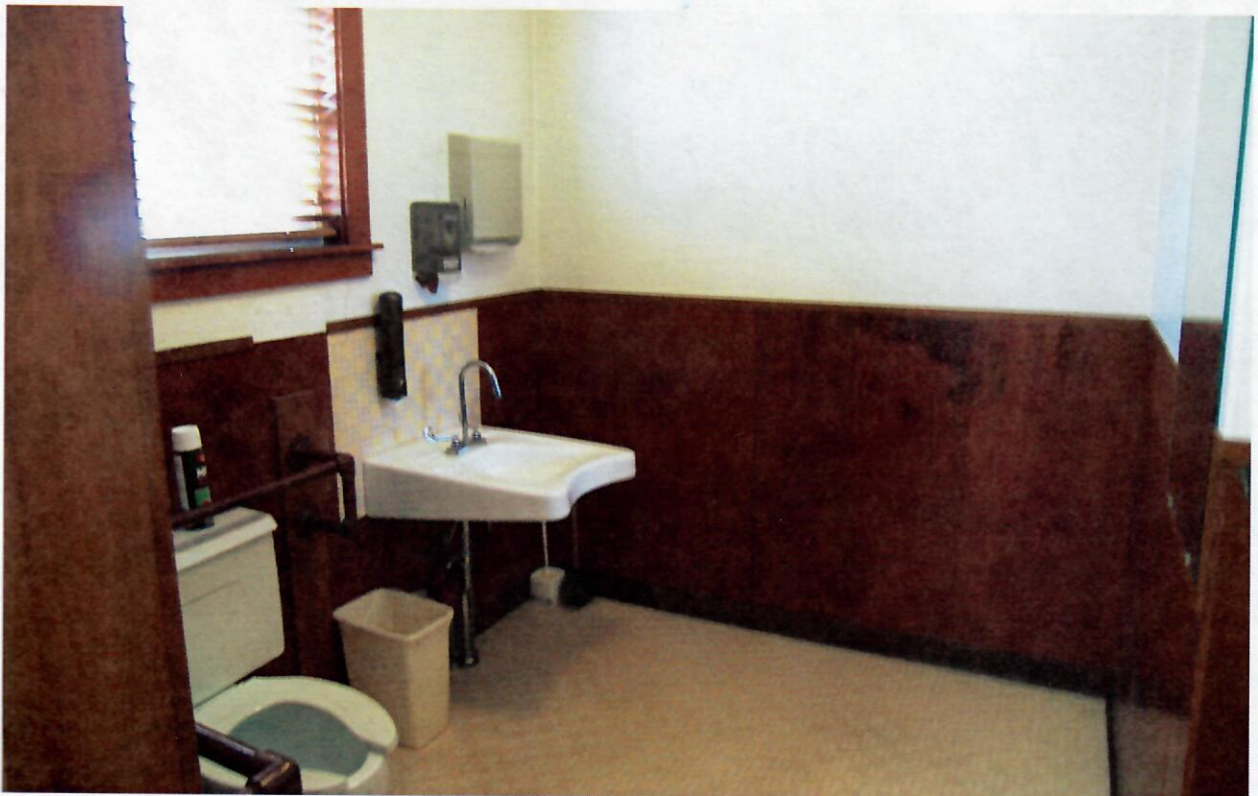
ATTIC WATER DAMAGE ABOVE / OUTDATED REST ROOMS BELOW

- Rest rooms should be updated with tile wainscot, new flooring and more handicap amenities.
- Address damaged drywall at beam and paint due to water infiltration.
- Reduce ceiling tile area and replace tiles that remain.
- Address wood floor which is aged and does not hold up to this kind of traffic and wear.
- Provide new finishes at damaged entryway due to water infiltration.
- Provide upgrade at kitchen floor.
