# City of Manassas Engineering Department Inspection Report

Project Name: Didlake Site Plan 2021-0014

Inspection Type: Inspection  
and Stage: Erosion\_Sediment\_Controls

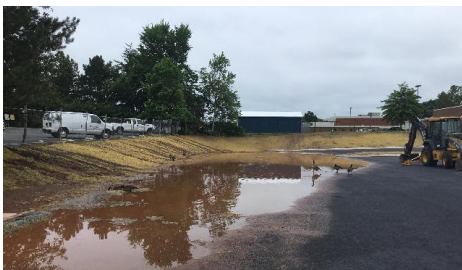
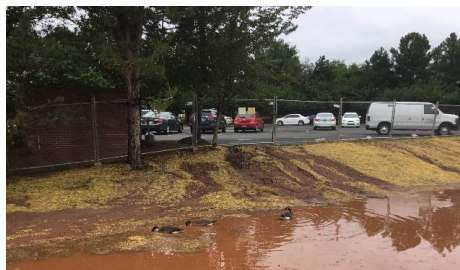
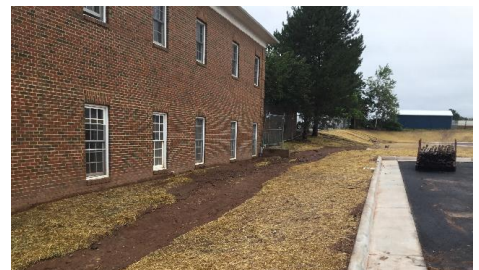
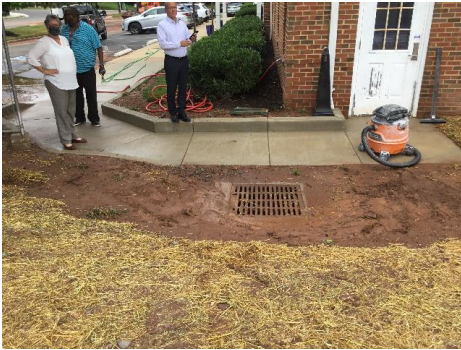
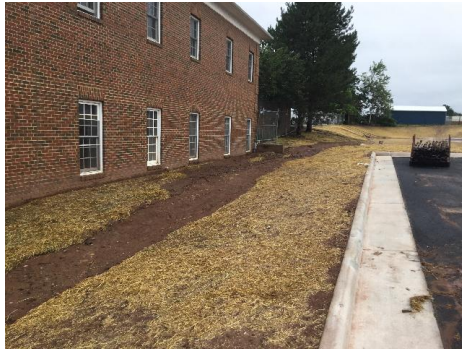
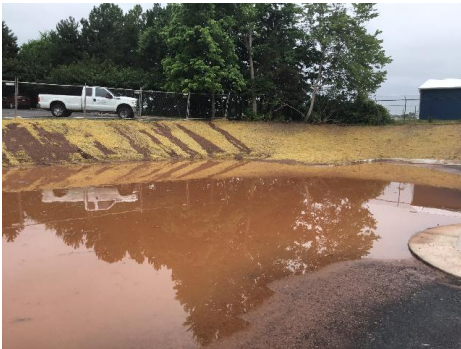
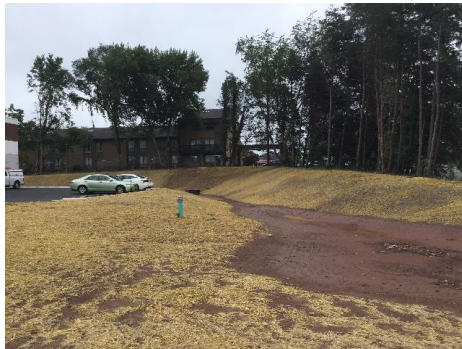
Deficiency #1 Temporary slope stabilization was not matted

ES Deficiency #1      3.36 Soil Stabilization Blankets and Matting   111-356

Corrective Action #1 Sod or installation of jute mesh on slopes of parking lot must be installed. Contractor is working on cleaning up and is actively making restoration repairs prior to my leaving the site.

Corrective Action Comments:      Contractor is actively making repairs and restoration while I was on site. Clean up is being performed.

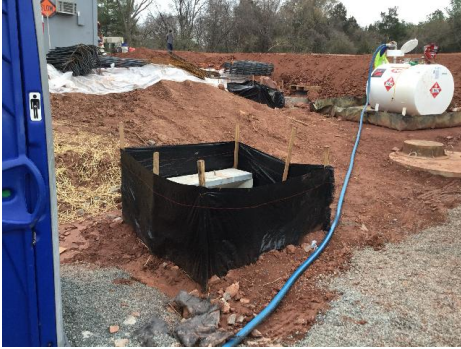
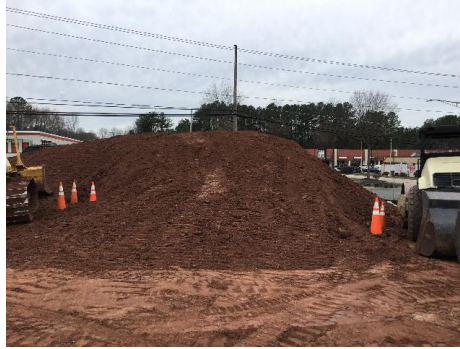
Deficiency #1 Inlet protection was installed incorrectly

ES Deficiency #1      3.07 Storm Drain Inlet Protection    111-3 1

Corrective Action #1 Install inlet protection as Shawn in approved plans in detail 307.1 inlet protection

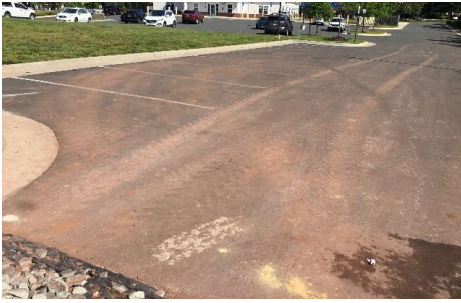
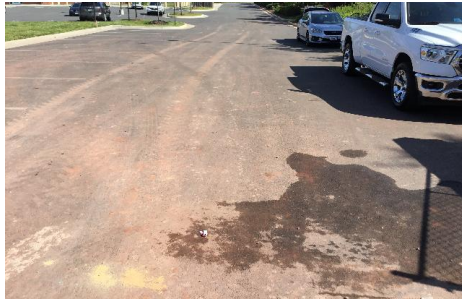
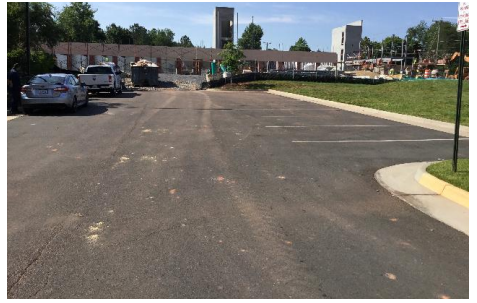
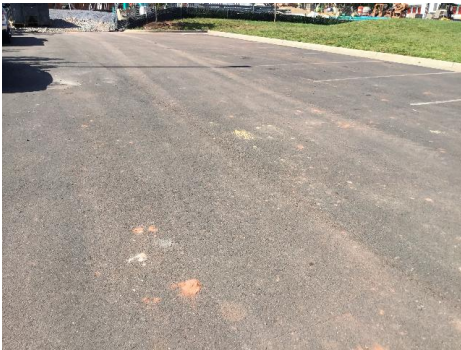
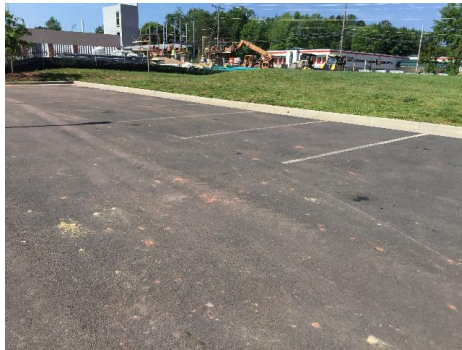
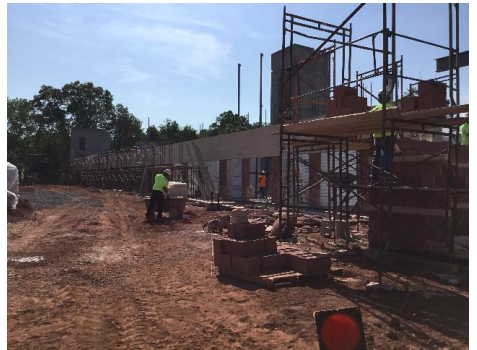
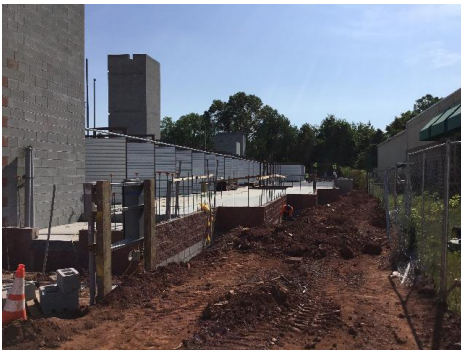
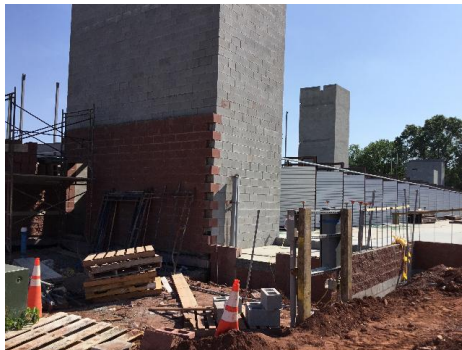
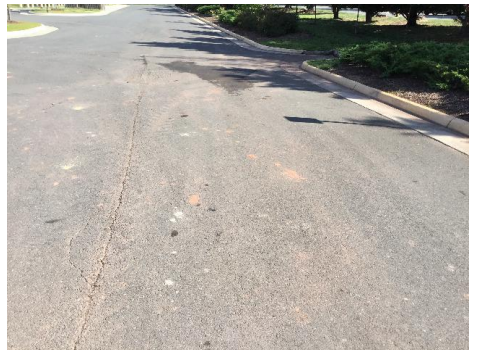
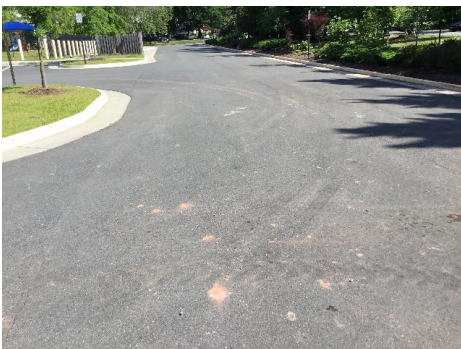
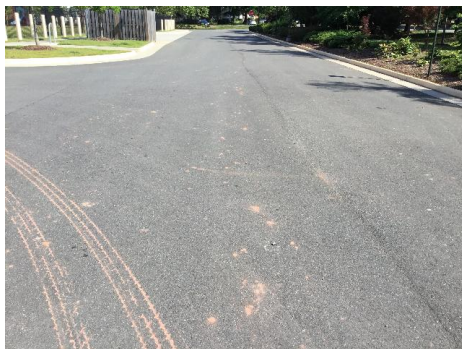
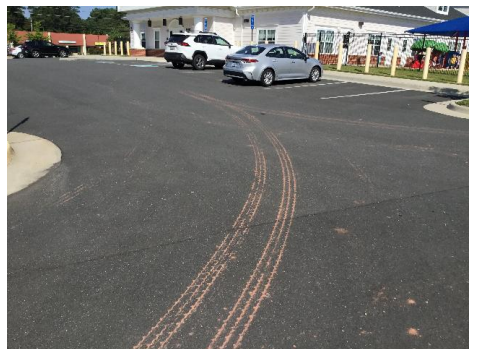
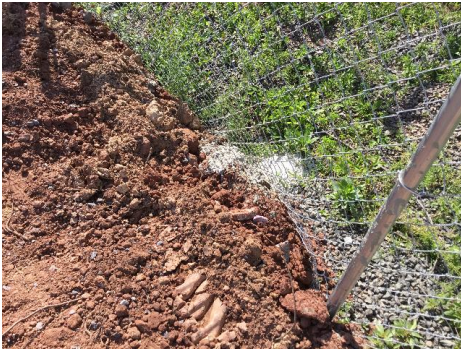
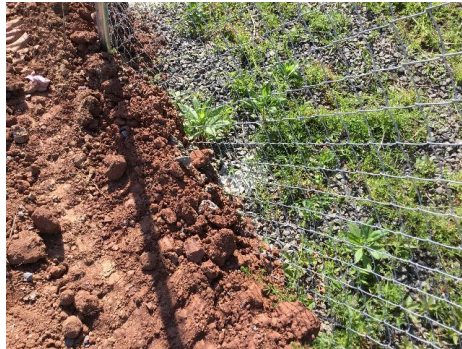
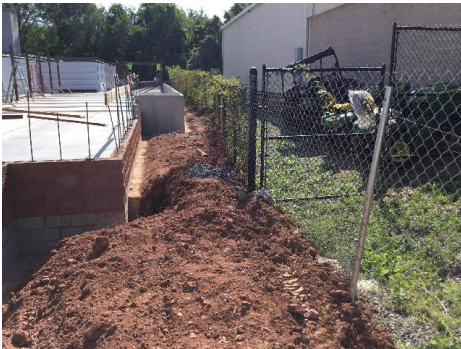
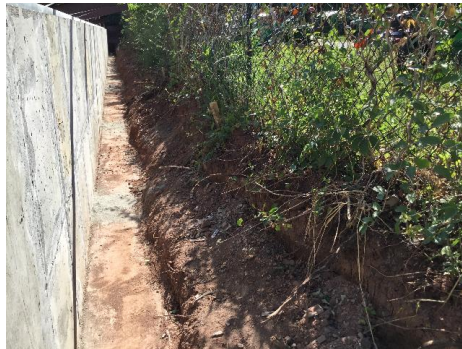
Deficiency #1 Mud tracking onto the road and Goddard School parking lot

- ES Deficiency #1 3.02 Construction Entrance 111-6
- ES Deficiency #2 3.39 Dust Control 111-414

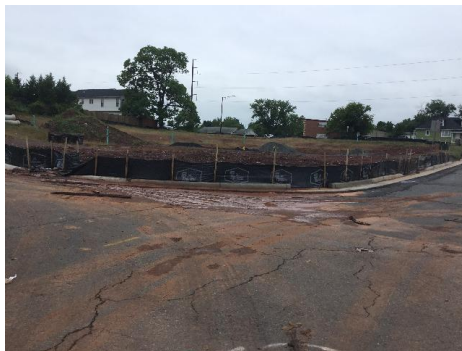
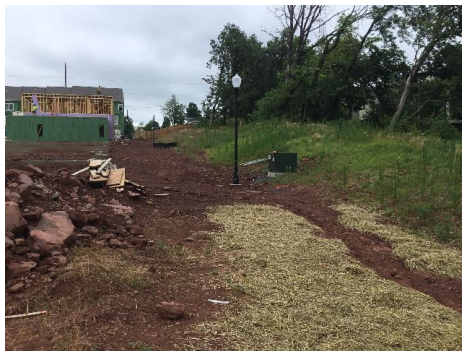
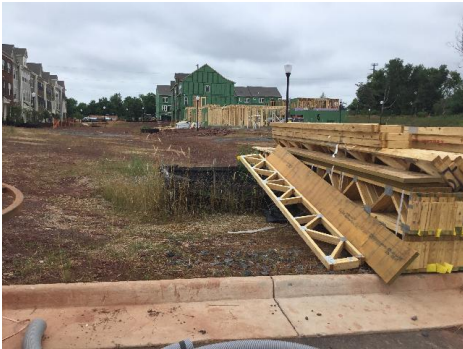
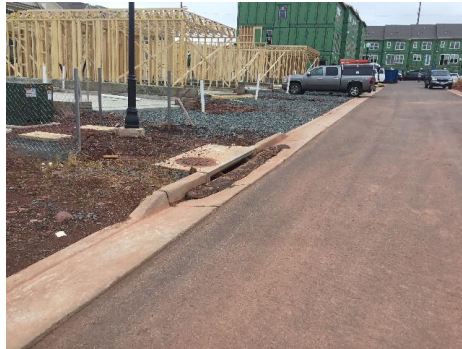
- Deficiency #1 Silt fence is down or blown out in multiple locations on site. Rear of project has blowouts that have breached next the stream.
- Corrective Action #1 Clean up silt in roadway on Jefferson St and on interior road of Barnes Loop. Replace or repair all silt fence and super silt fence that is down or blown out on the entire project.  
Concrete Washout is overflowing and in need of maintenance and repairs

- ES Deficiency #1 3.05 Silt Fence 111-19
- ES Deficiency #2 other
- ES Deficiency #2 Concrete Washout
- Other
- ES Deficiency #3 3.31 Temporary Seeding 111-284
- ES Deficiency #4 3.07 Storm Drain Inlet Protection 111-3 1

Additional Comments: RLD reports have not been reflected accurately as conditions on the project are evident that issues have been overlooked as part of RLD inspections.

- Corrective Action #2 Have Concrete Washout cleaned out and restored.
- Corrective Action #3 Multiple locations onsite where temporary stabilization has failed  
Have all areas on the project perimeter where temporary stabilization has failed and washed out repaired and restored to positive drainage and re-apply temporary stabilization  
Inlet protection on the project are in need of replacement or repair.

- Corrective Action #4 Replace or repair all inlet protection measures onsite as needed

Corrective Action Comments: Repairs and restorations must be completed by close of business 3pm July 13, 2022  
 Correct these deficiencies by: 7/13/2022 11:00:00 AM

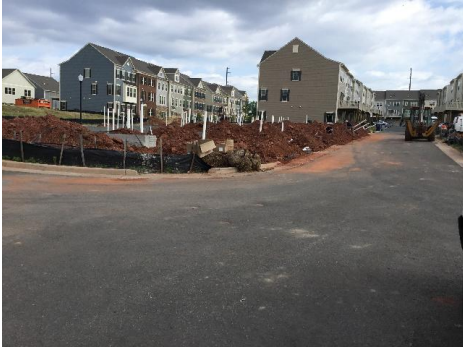
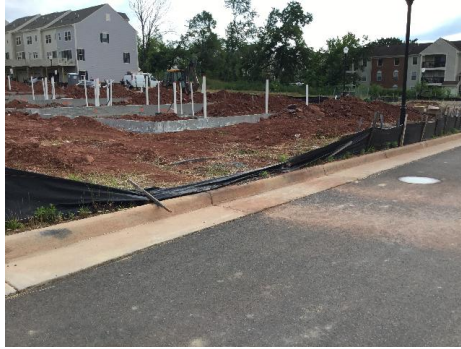
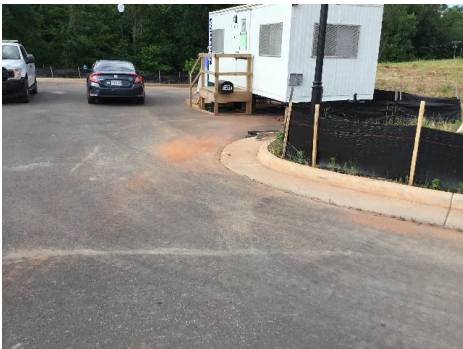
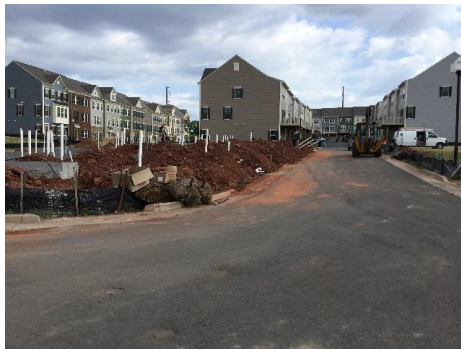
Deficiency #1 Parameter control (silt fence) has been removed, part of the dirt stock piles (resulted from building excavation activities) are placed beyond the limit of disturbance (on the gutter pan) and not stabilized.

ES Deficiency #1      3.05 Silt Fence 111-19

Corrective Action Comments:      The removal of the parameter control (silt fence) and having the dirt stock piles placed beyond the limit of disturbance caused the dirt (sediment) to leave the site during yesterday's storm event to the storm drainage structures in operation. I instructed the contractor yesterday and today to take all the necessary arrangements to have the dirt stock piles contained within the site and replace the parameter control as specified. I met the contractor on site and explained to him the deficiencies and corrective actions needed.

Corrective Action #1 All the parameter control (silt fence) should be restored, dirt stock piles are to be contained within the site and stabilized, according to the specs and drawings.

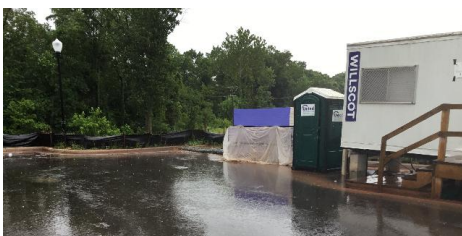
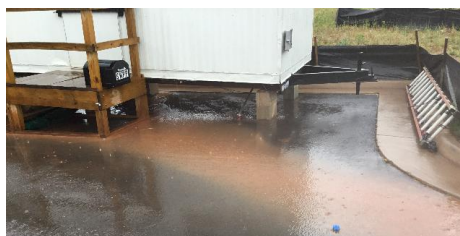
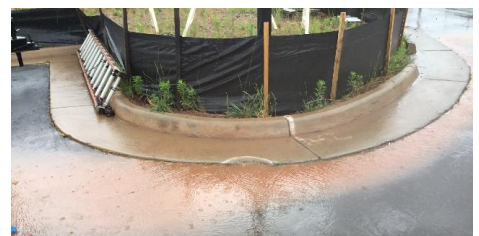
Deficiency #1 Silt fence has been removed from the limit of disturbance for lots #79-#85 while the drainage area is not stabilized.

ES Deficiency #1      3.05 Silt Fence 111-19

Corrective Action #1 The silt fence is to be restored as specified in the drawings and specs.

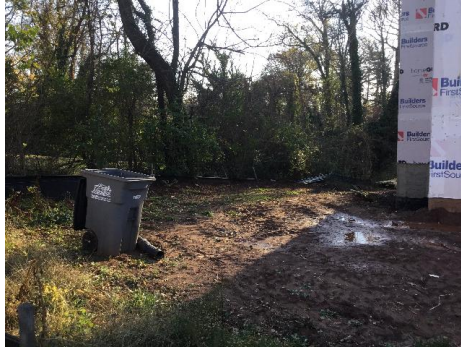
Deficiency #1 Silt fence has been damaged by contractor and is down in several locations.

ES Deficiency #1      3.05 Silt Fence 111-19

Corrective Action #1 Restore or replace silt fence that has been damaged or downed

Corrective Action Comments:      Restore or replace silt fence that has been damaged or downed on the site

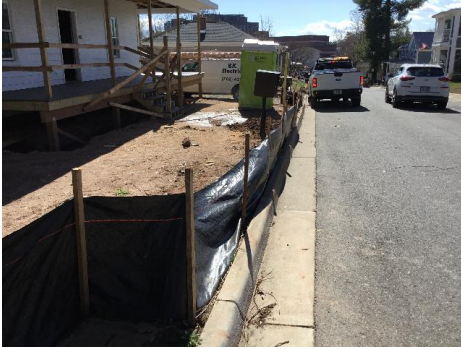
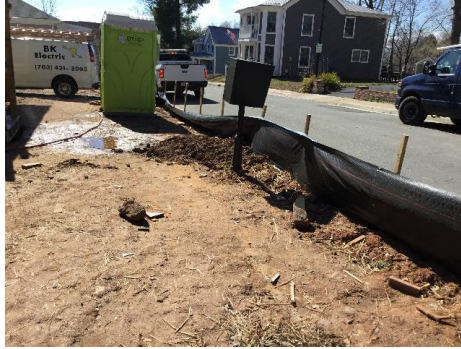
| Deficiency #1 | Silt fence is buried and broken in some locations around the site parameter in addition of having some Construction debris alongside the silt fence |

- ES Deficiency #1      3.05 Silt Fence   111-19  
ES Deficiency #2      3.02 Construction Entrance   111-6

| Corrective Action #2 | The contractor was instructed to have the construction area restored as specified in the drawing |

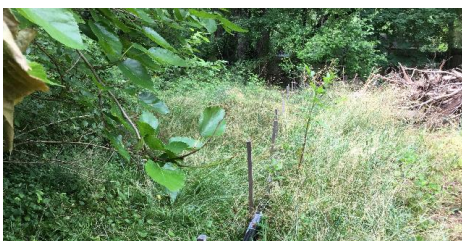
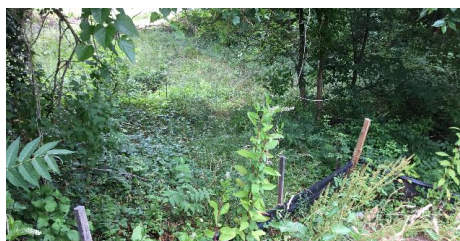
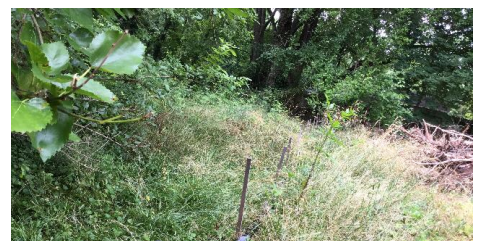
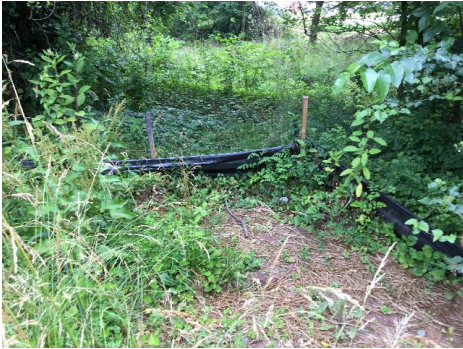
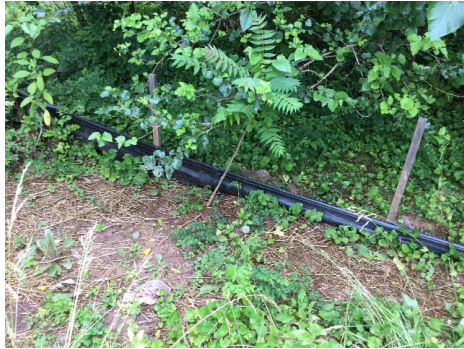
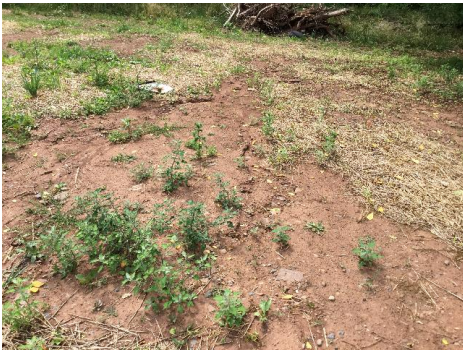
Deficiency #1 Silt fence is down at different locations within the site limit of disturbance.

ES Deficiency #1      3.05 Silt Fence 111-19

Additional Comments: The back yard needs to be stabilized as I observed signs of rill erosion and with having the silt fence down, the dirt will not be contained within the site.

Corrective Action #1 Silt fence to be restored according to the specs and drawings.

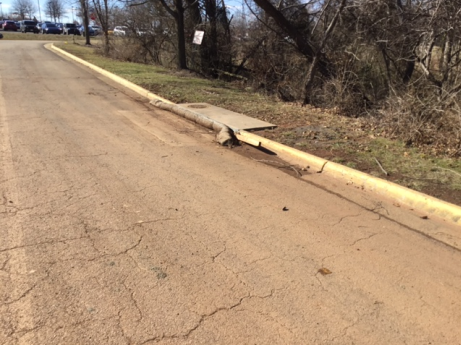
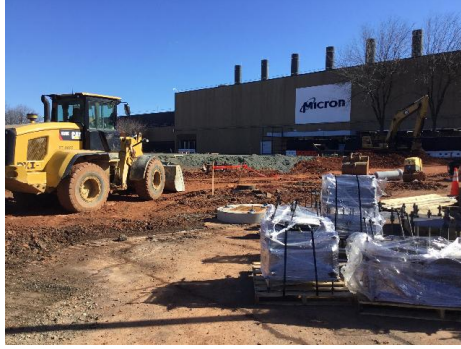
Deficiency #1 Inlet protection in need f maintenance

ES Deficiency #1      3.07 Storm Drain Inlet Protection    111-3 1

Corrective Action #1 Clean out sediment around inlet and and remove lumber and replace inlet protection device

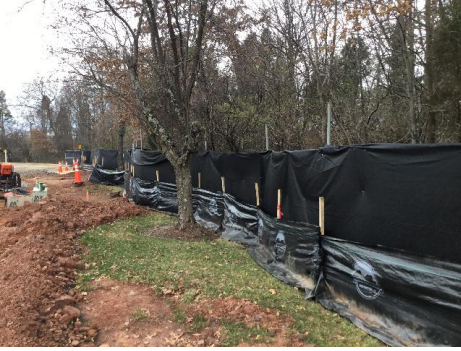
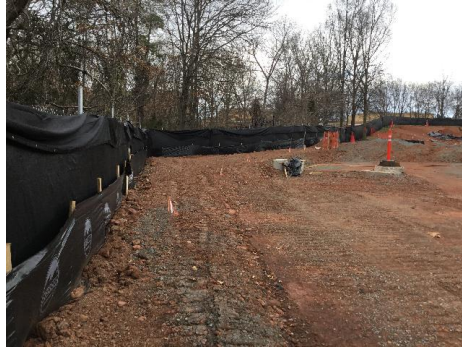
Deficiency #1 The silt fence has been relocated and is not entrenched as required.

- ES Deficiency #1      3.05 Silt Fence 111-19  
ES Deficiency #2      3.07 Storm Drain Inlet Protection 111-3 1

Corrective Action #2 Inlet protection should be installed as specified on approved E&S plans

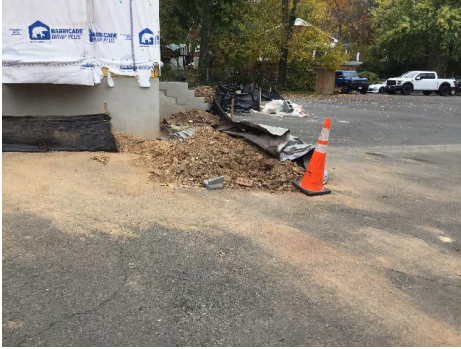
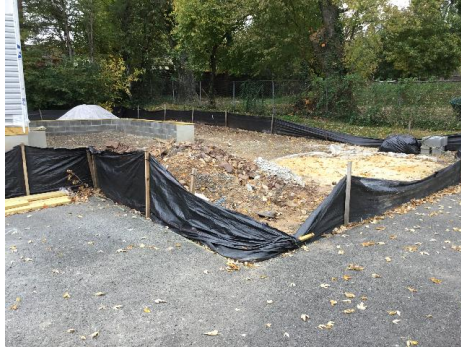
Deficiency #1 Silt fence has been removed and damaged in some locations around the perimeter of the building pad

ES Deficiency #1      3.05 Silt Fence 111-19

Corrective Action #1 Repair or replace the the downed or damaged silt fence

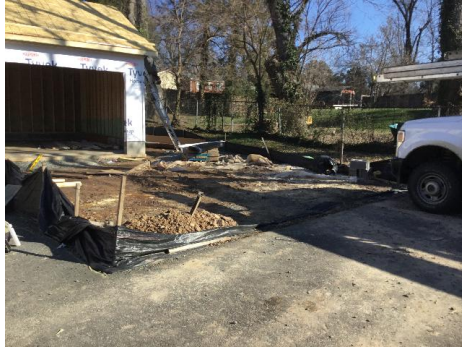
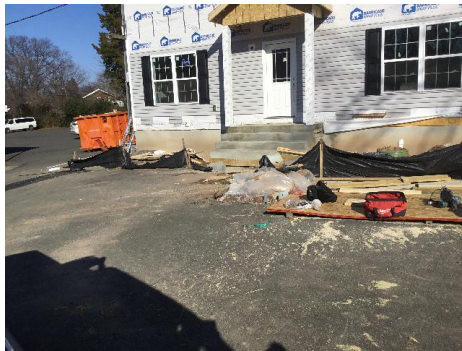
Deficiency #1 Silt fence has been removed or damaged

ES Deficiency #1      3.05 Silt Fence 111-19

Corrective Action #1 Repair or replace downed or damaged silt fence around perimeter of construction area

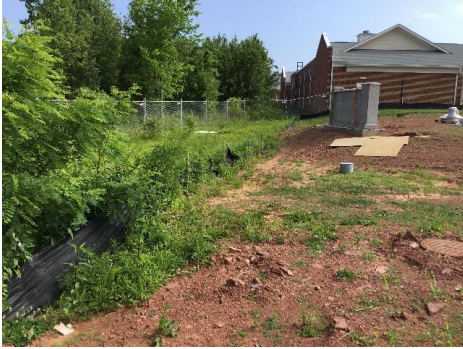
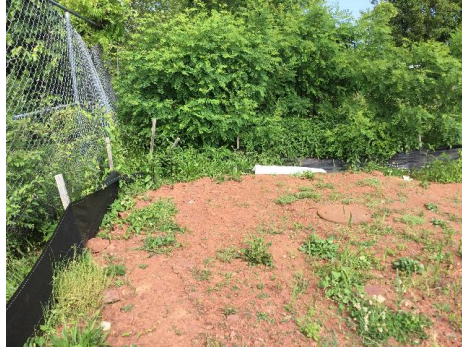
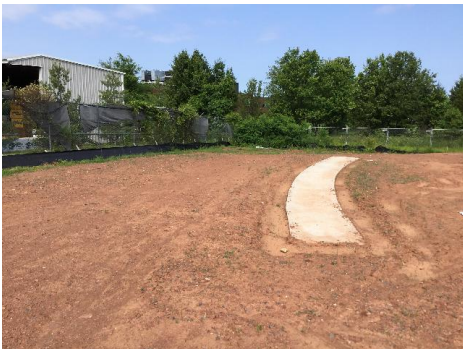
Deficiency #1 Silt fence is down at certain locations within the site especially between the site and the adjacent land (TM 101-01-00-45).

- ES Deficiency #1      3.05 Silt Fence   111-19  
ES Deficiency #2      3.31 Temporary Seeding   111-284

Corrective Action #2 To be stabilized according to the drawings sheets 6&4, and the specs.

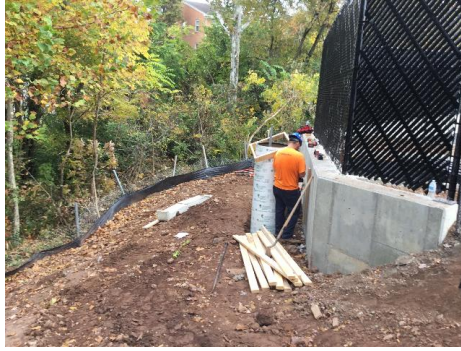
Deficiency #1	Super Silt Fence at rear LOD has been compromised and buried or damaged with excess spoils from excavation of underground storm facility
Corrective Action #1	Install temporary silt fence along rear perimeter LOD next to compromised super silt fence until final grading can be completed.

ES Deficiency #1      3.05 Silt Fence 111-19

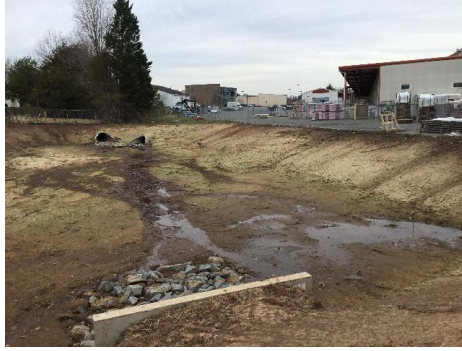
Deficiency #1 Slopes are not properly seeded and stabilized

Corrective Action #1 Repaired all erosion to slopes, apply stabilization matting and seeding

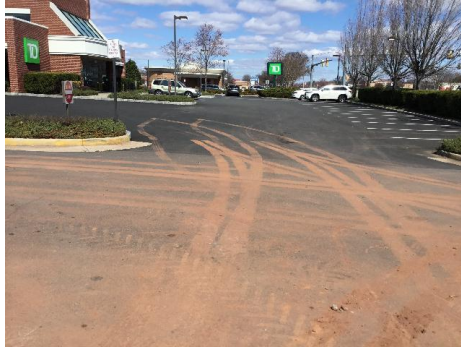
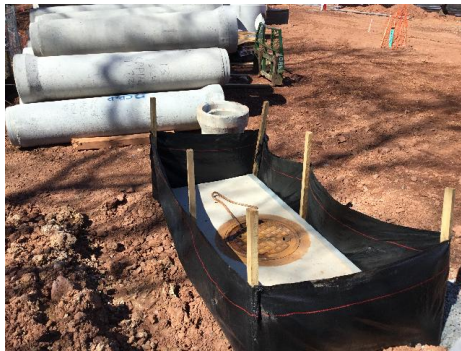
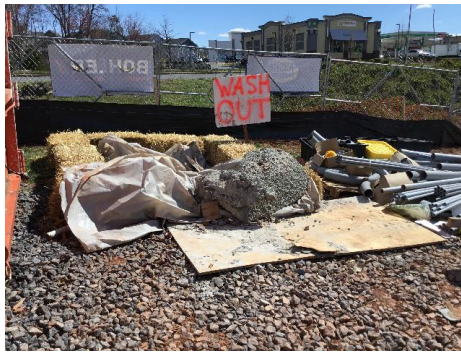
Deficiency #1 Construction entrance is not as specified and signs of sediment leaving the site were noticed on adjacent roads

- ES Deficiency #1 3.02 Construction Entrance 111-6  
ES Deficiency #2 3.08 Culvert Inlet Protection 111-46

Corrective Action #2 The inlet protection should be installed as specified in the drawings and specs

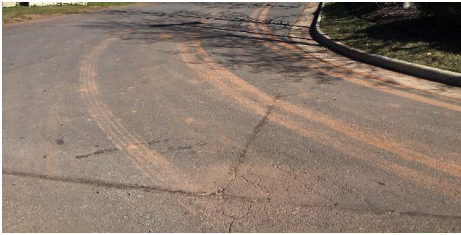
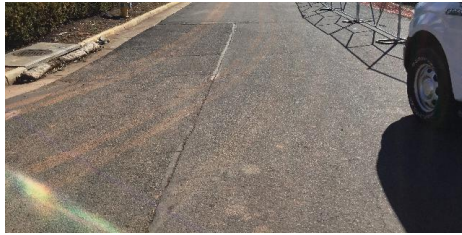
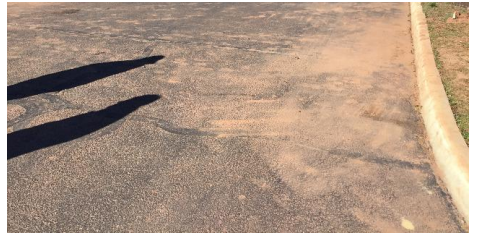
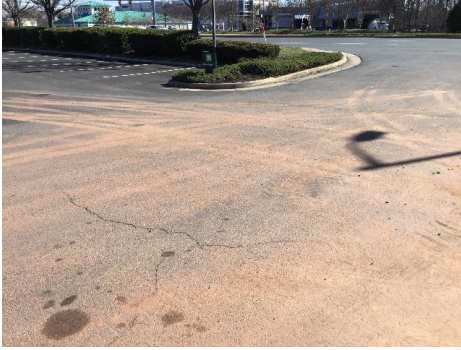
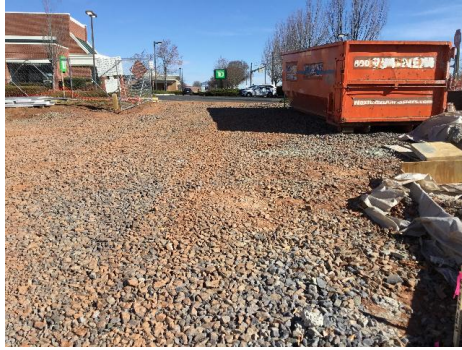
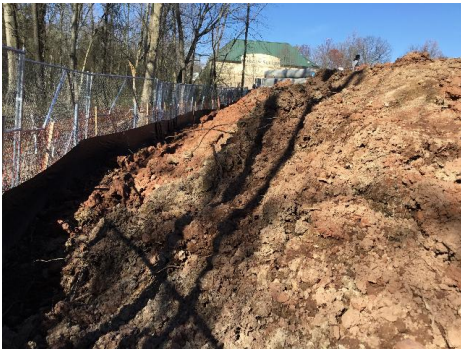
Deficiency #1 The construction entrance shows aggregate dissipation into the underlying soil and signs of trucks tracking were observed on the adjacent road

- ES Deficiency #1 3.02 Construction Entrance 111-6
- ES Deficiency #2 3.07 Storm Drain Inlet Protection 111-3 1

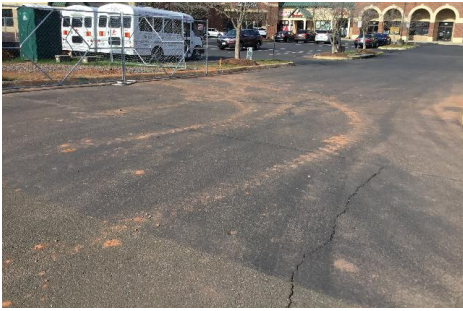
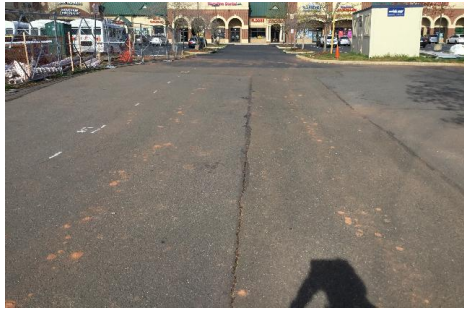
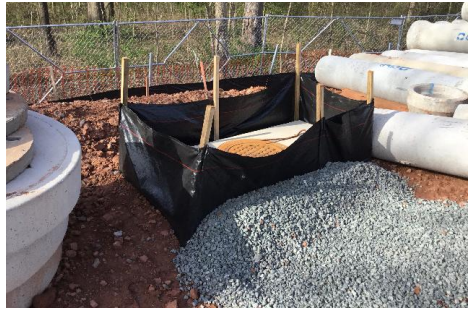
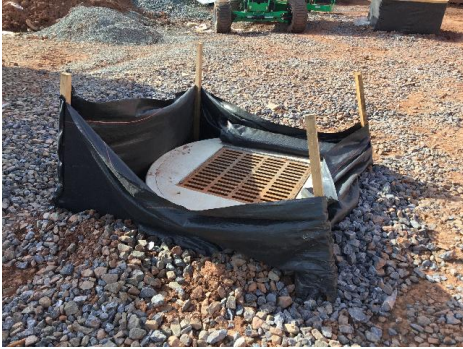
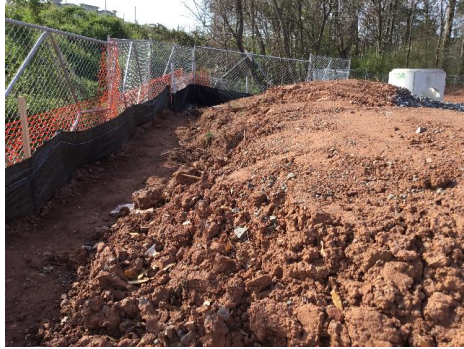
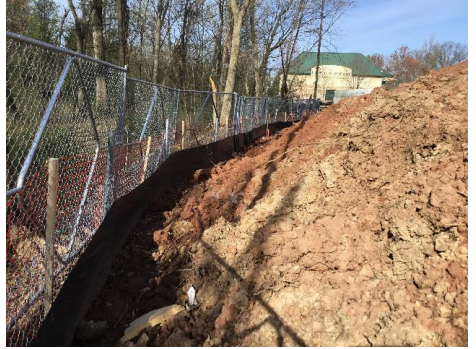
- Deficiency #1 Sediment tracking on the adjacent roadway.  
Corrective Action #1 Refreshing the construction entrance and installing wash rack as specified in the drawings and specs.
- The inlet protection is not installed as specified.  
Corrective Action #2 Install the inlet protection where needed according to the drawings and specs.
- Dirt stocks piles are not stabilized.  
Corrective Action #3 To stabilize the dirt stock piles on site as specified in the drawings and specs.

ES Deficiency #1	3.02 Construction Entrance 111-6
ES Deficiency #2	3.08 Culvert Inlet Protection 111-46
ES Deficiency #3	3.31 Temporary Seeding 111-284

Corrective Action Comments: The contractor was instructed to correct the above mentioned deficiencies according to the drawings and specs.
