**The Charter Township of Orion**  
**Space Allocation Study**  
October 2018

Orion Twp. Hall Facility  
Assessment  
Lake Orion, Michigan

# Mechanical & Electrical Condition Assessment

## REPORT ON BUILDING CONDITION SURVEY

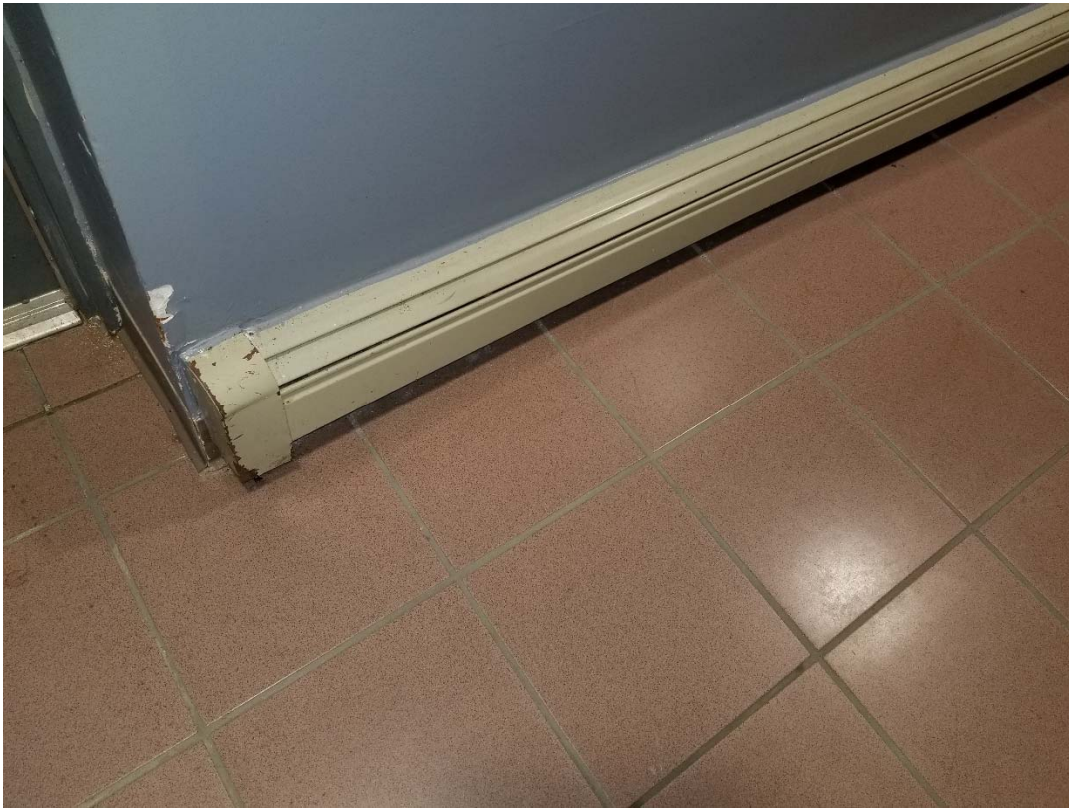
M3 Baseboard Fin Tube Radiation

Heating hot water supply and return piping is routed throughout the building to baseboard fin tube radiation and a ceiling mounted cabinet unit heater. (Refer to photo M6) There is also at least one electric cabinet unit heater serving an entrance. (Refer to photo M5) Some of the baseboard's cover is in fair to poor condition. (Refer to photos M3 & M4) Heating hot water is also supplied to a central heating and ventilation unit located in the same room as the boiler, Trane model MCCA017, manufactured in 2002, 16 years old. (Refer to photo M12) This unit appears to be in fair condition, though it is approaching the end of its useful life. (Coils 20-year useful life, and centrifugal fans 25-year useful life, per ASHRAE).

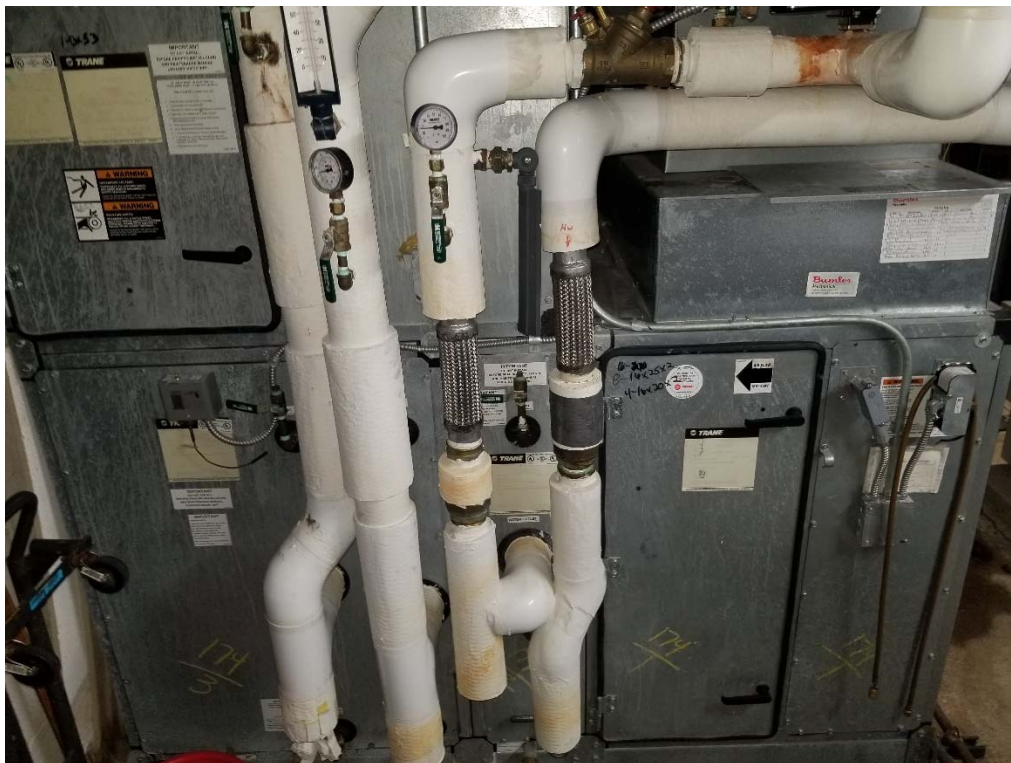
M12 Indoor Air Handling Unit

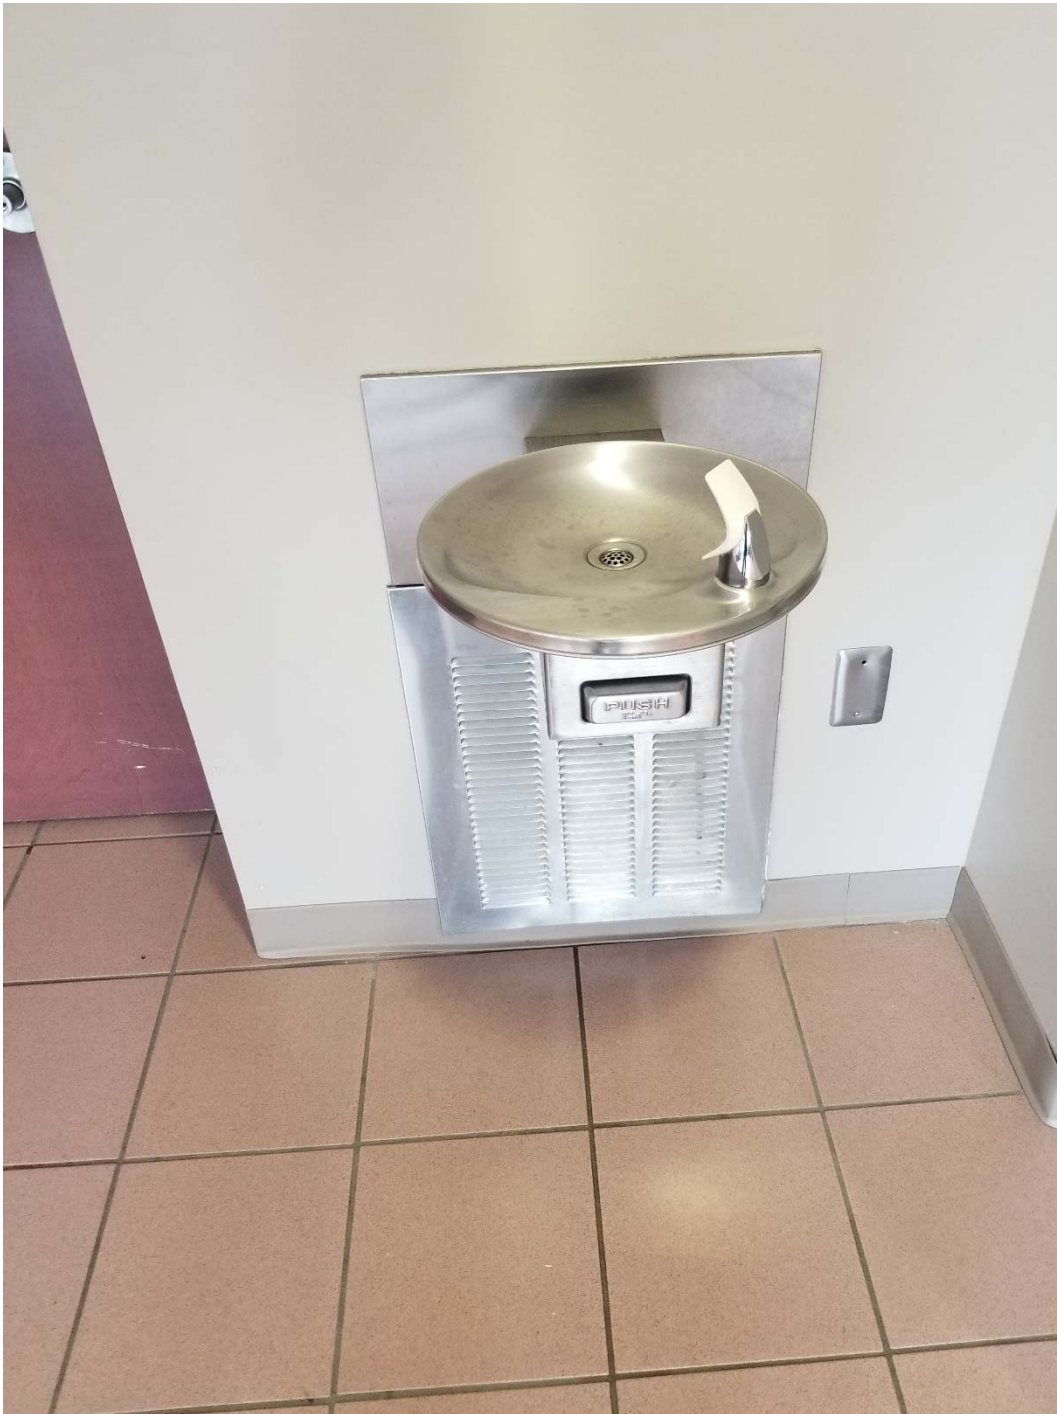
The plumbing fixtures appear to be original and in good condition. (Refer to photos P9, P13, P14 & P15) The lavs did not have the code required thermostatic mixing valve to prevent scalding. There was also a standalone hot and cold-water dispenser. (Refer to photo P10)

P9 Electric Water Cooler

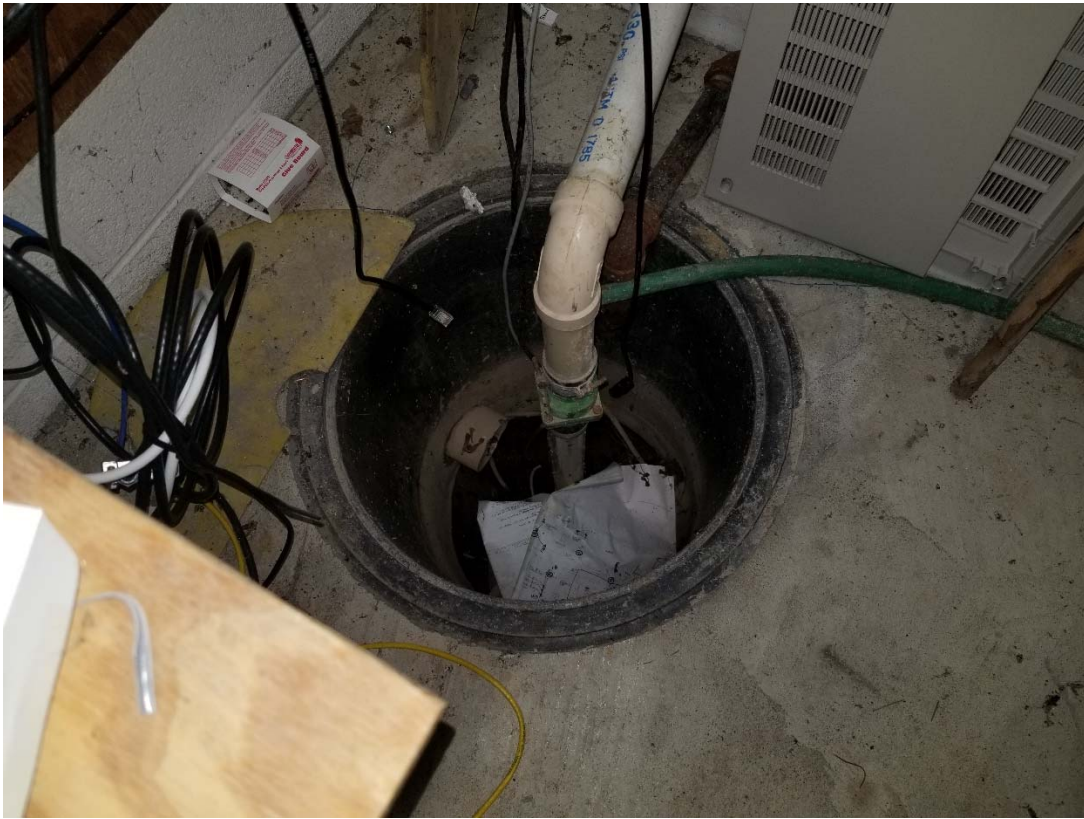
P11 Sump Pump (dry)

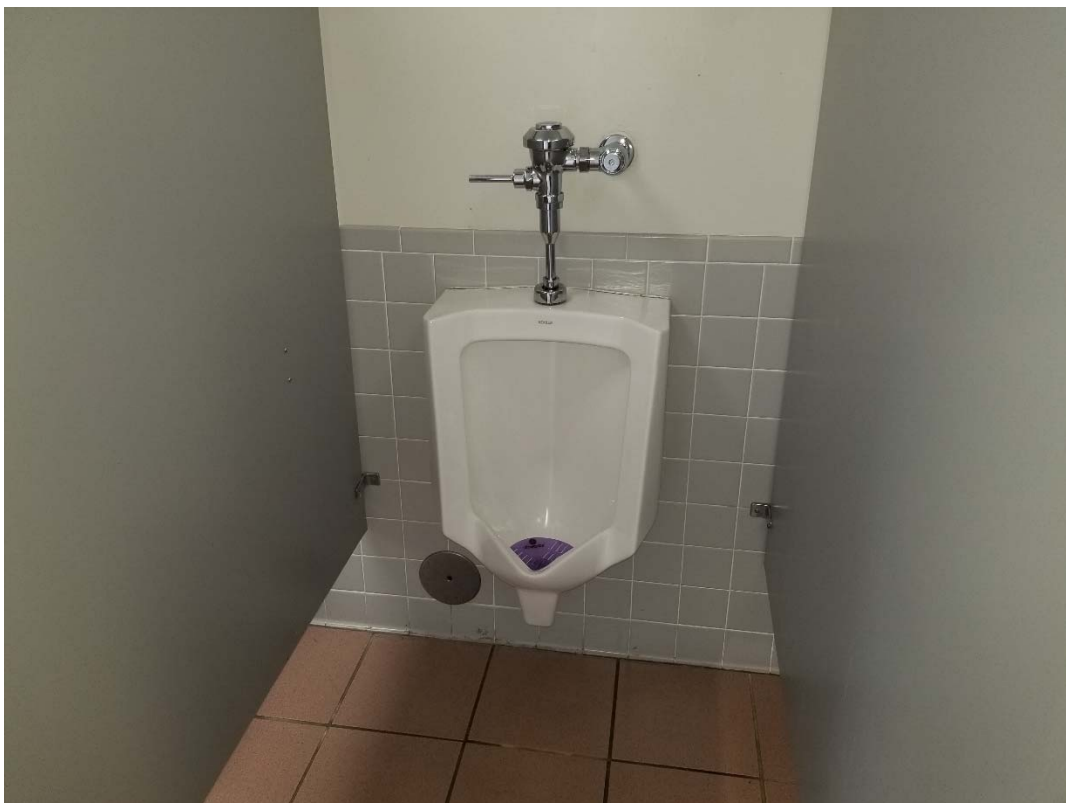
P14 Urinal

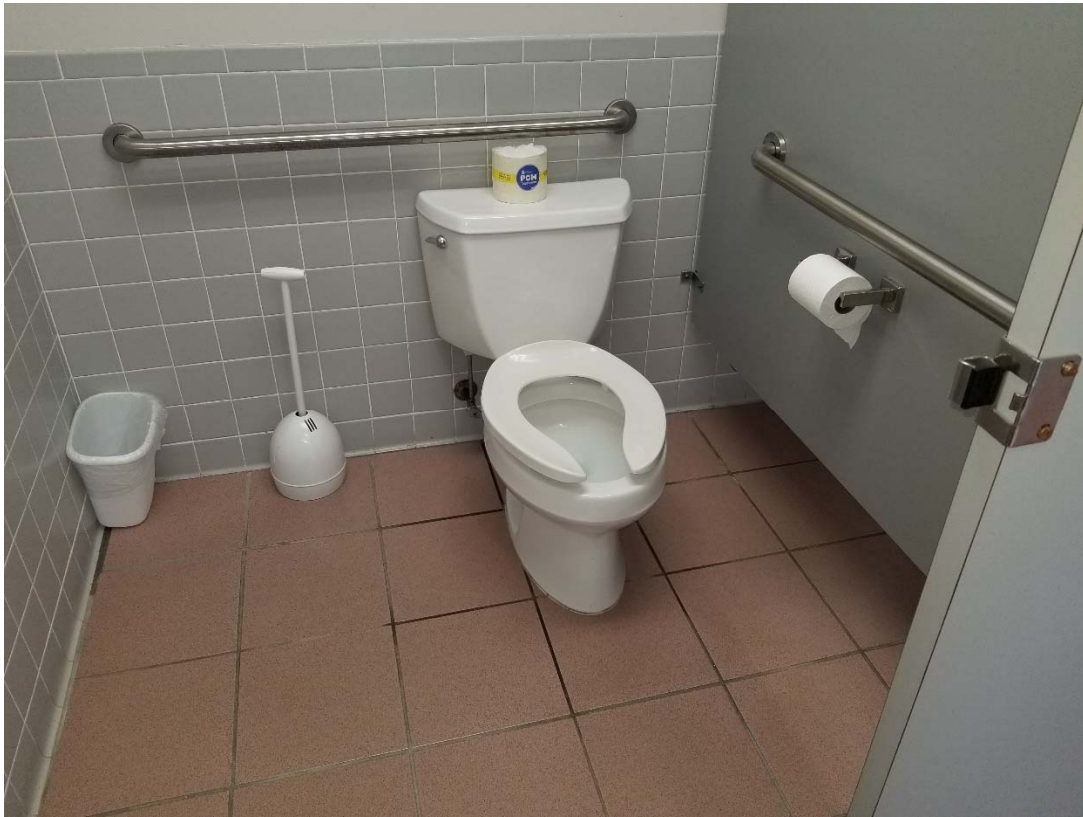
P15 Water Closet

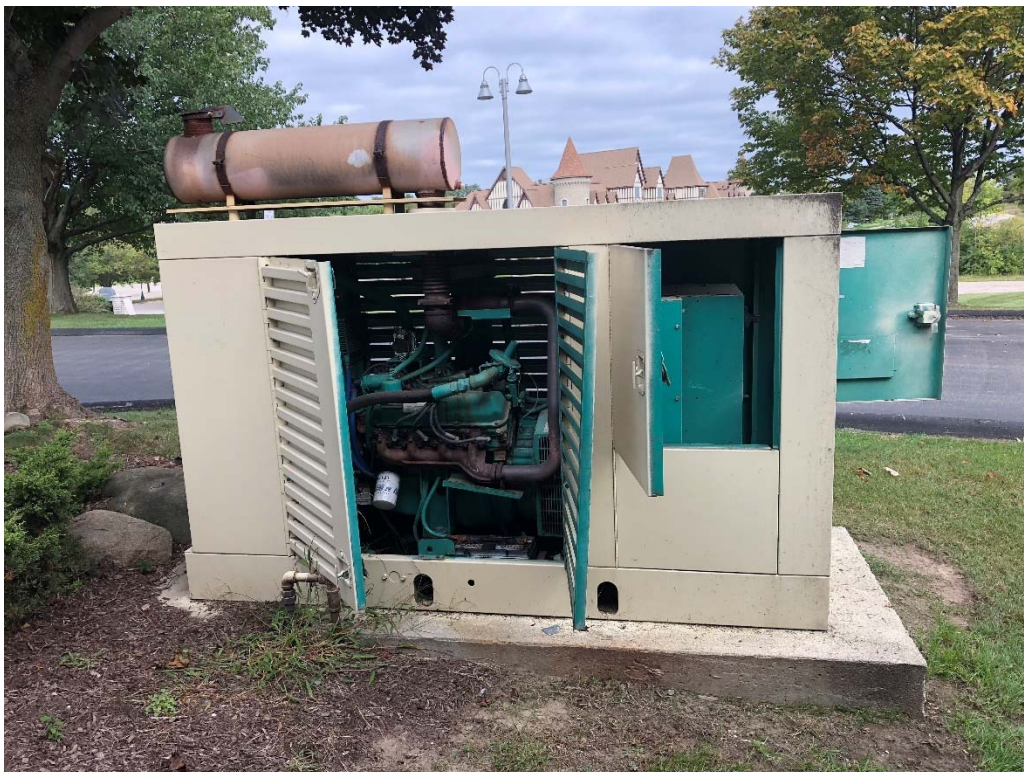
The building is currently equipped with a 100Kva 208/120v 3 phase 4 wire Natural Gas generator. The generator is located on the North side of the building, house in a sound attenuating enclosure, and is manufactured by “Onan/Cummins”. The generator was installed in 1996 with the new addition. It appears to be in good shape and in good working condition according to building owner **(See picture E4)**. The feeders from the generator enter the building underground to a 400A 3P automatic Transfer Switch (ATS) located in the main electrical room. The generator and the ATS are connected on the load side to distribution panel DP-SB (600A-208Y/120V 3 phase 4wire) which in turn feeds the entire original building distribution panel DP-2 (400A-208Y/120V 3 phase 4wire) along with the elevator and other HVAC units. The generator appears to be overloaded. **(See picture E5)**.

Picture E4 – Existing 100KW Generator

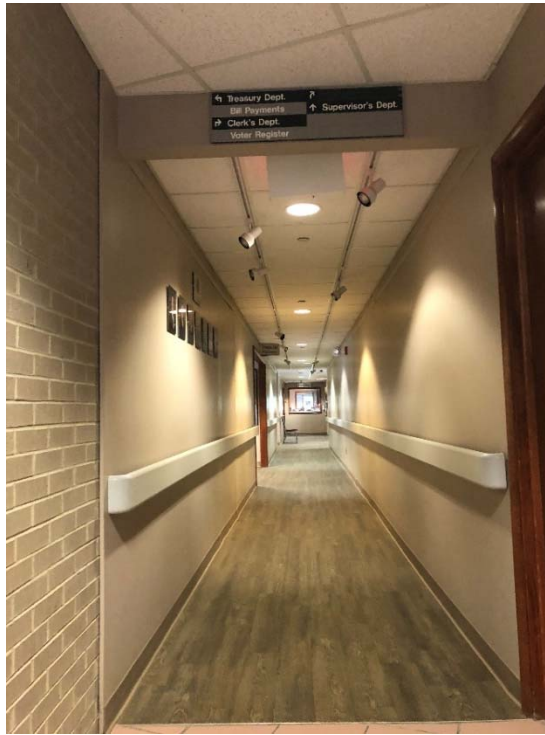
The lighting system appears to be in good working condition. However, it does not meet the current ASHRAE 90.1 2013 energy codes required by the state in case of any revisions or additions to the building.

The lighting system is fluorescent and does not meet today's energy codes, but it appears to be in good condition.

Picture E7 – Typical Corridor Lighting
