ALDRICH PUBLIC LIBRARY

FEASIBILITY STUDY

Issued: October 21, 2021

CROSSKEY ARCHITECTS, LLC
750 Main Street, Suite 150
Hartford, CT 06103

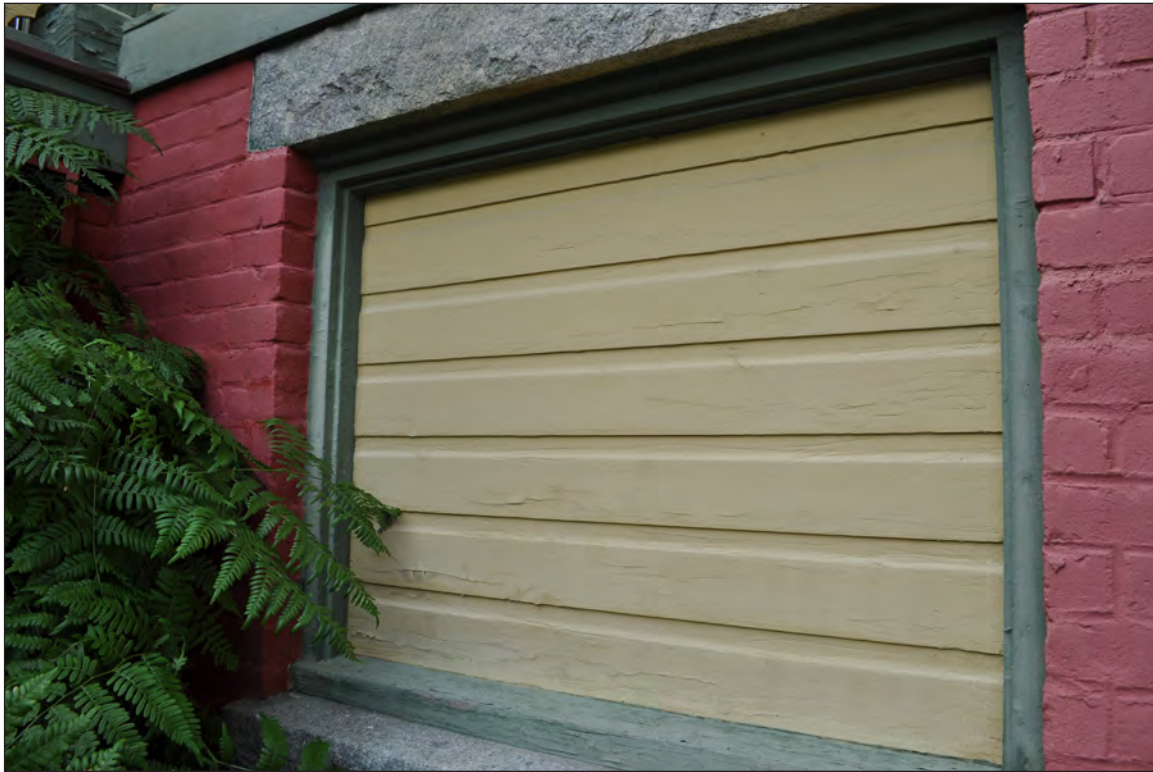
17. South elevation, infill of basement window, camera facing northwest.

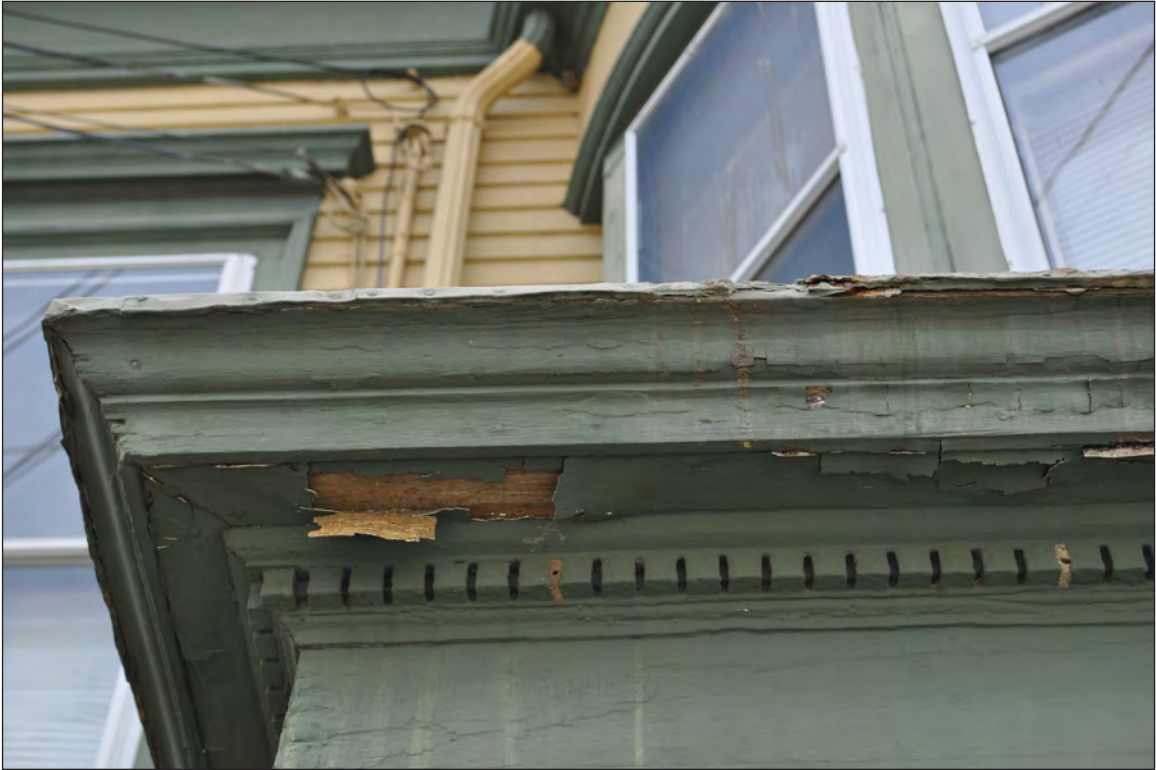
44. East elevation, underside of roof, camera facing southwest.
