Survey and Planning Grant

Application

The Aldrich Free Public Library Planning and Survey Grant Application 2022

**G. Long Term Preservation Plan/Conditions Assessment completed in
October 2021 by Crosskey Architects**

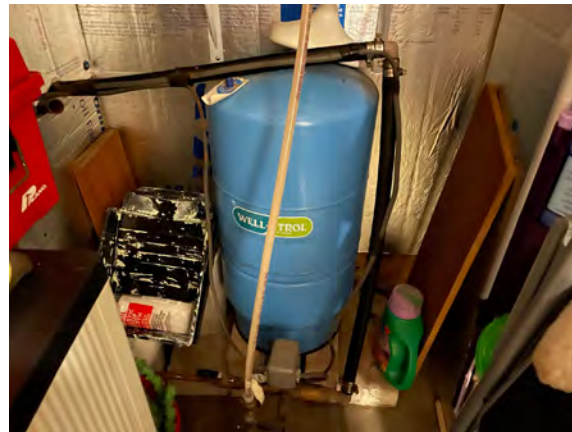
Figure 6 - Well-X-Trol Tank

The building is fed by a well on site with a “Wellxtrol” buffer tank in the basement. Piping appears in fair condition and may remain. The one bathroom lavatory is located in the basement and is not ADA accessible. The fixtures should be replaced with low flow fixtures at minimum. If the architectural section recommend an ADA accessible bathroom, accessible fixtures will be required. The lavatory hot water is generated by a point-of-use electric heater below the lav. This is in good condition and may remain.
