# PLAINFIELD HIGH SCHOOL ANNEX

PLAINFIELD, CONNECTICUT

## CONDITIONS ASSESSMENT AND FEASIBILITY STUDY

July 2019

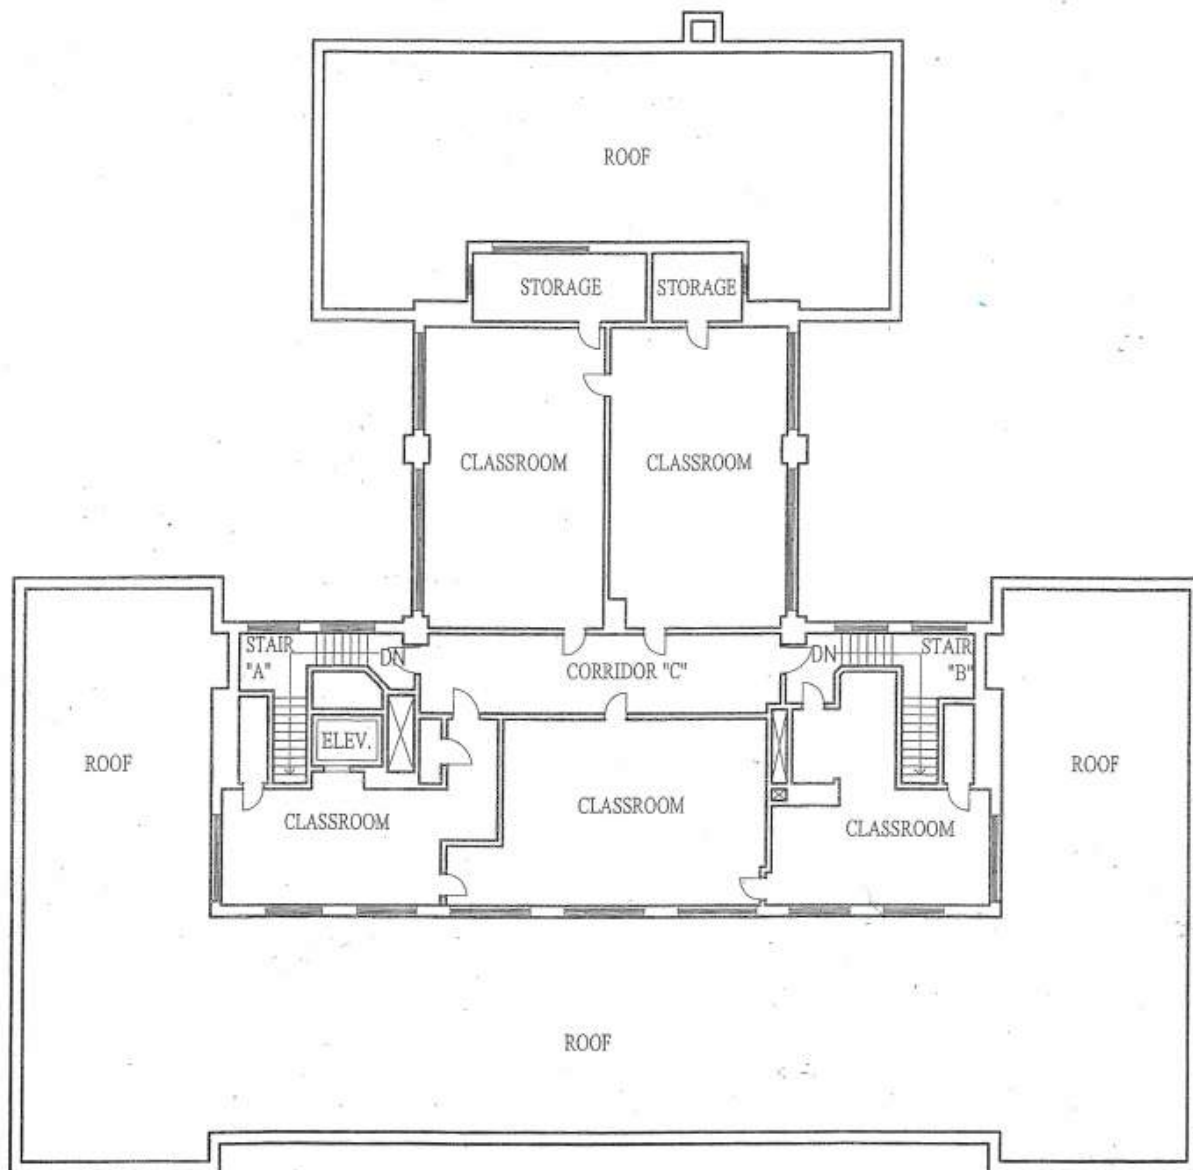
*Figure 3: Third Floor Plan. Possibly due to failure of the flat roof drainage over the classroom areas, a wood framed hipped roof system was added over the existing concrete slab roof.*

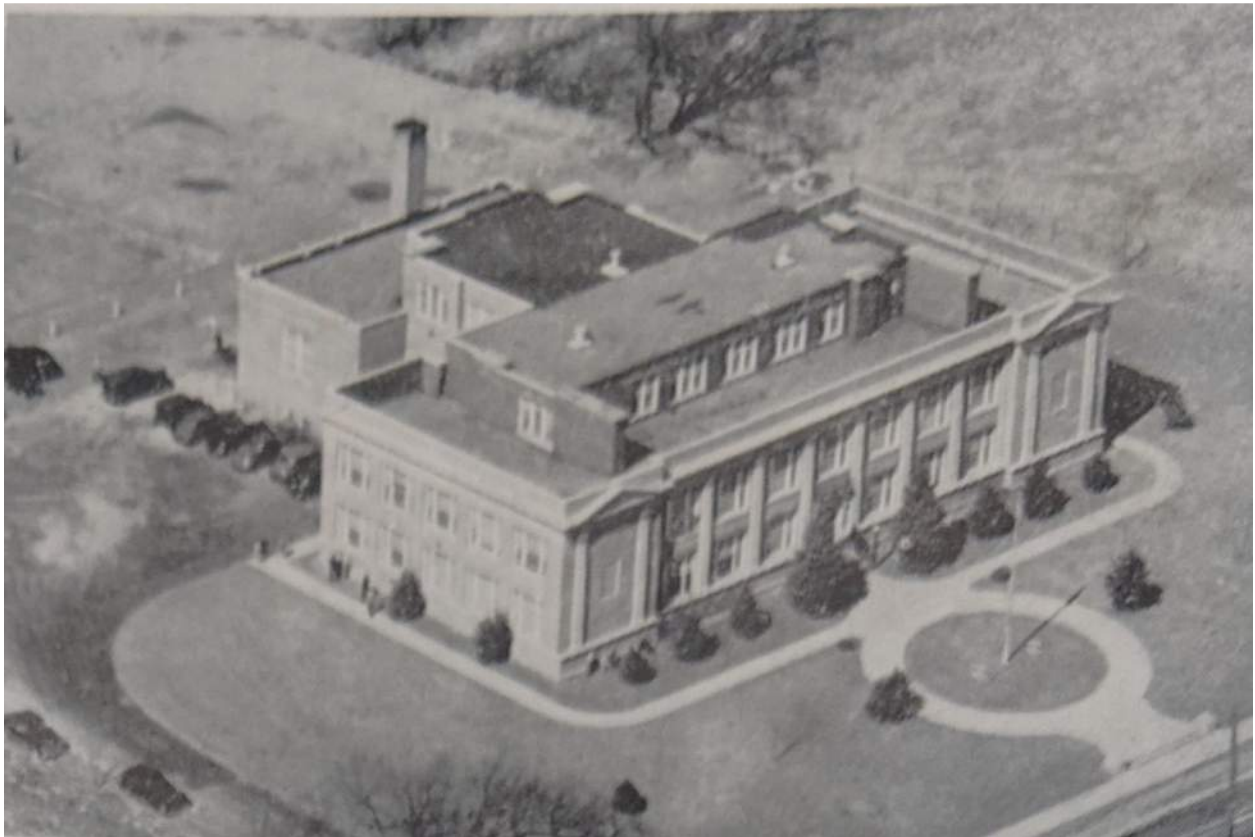
*Photo 7: The building is sited on a knoll facing Route 12 with open space surrounding the building. A formal lawn with a circular walk surrounding the flag pole is still in place. The building is symmetrical about an east/west axis. Original flat roofs of the third floor have been built over with hipped roof structure. The character defining parapet and pediments on the end pavilions have been removed.*

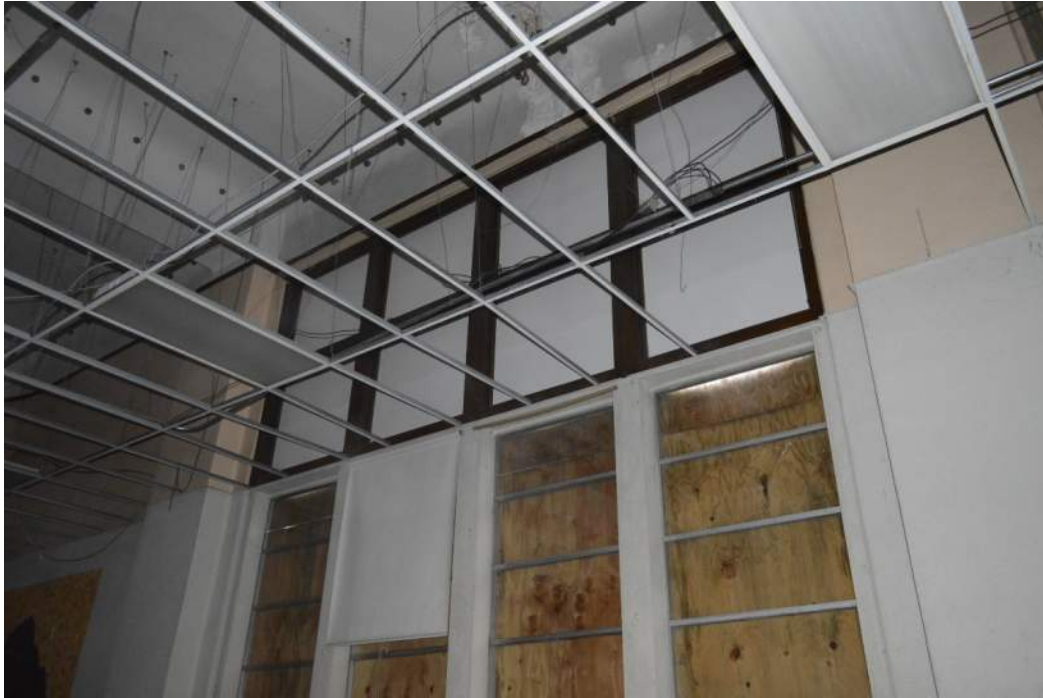
*Photo 10: The two-story Auditorium features a coffered ceiling with rows of electric lights around each coffer. Transom windows above the first-floor windows retain the original stained wood finish. The height of the space, the special ceiling treatment and the windows should be retained as they provide unique character to this space. Partitioned spaces within the room should be removed.*

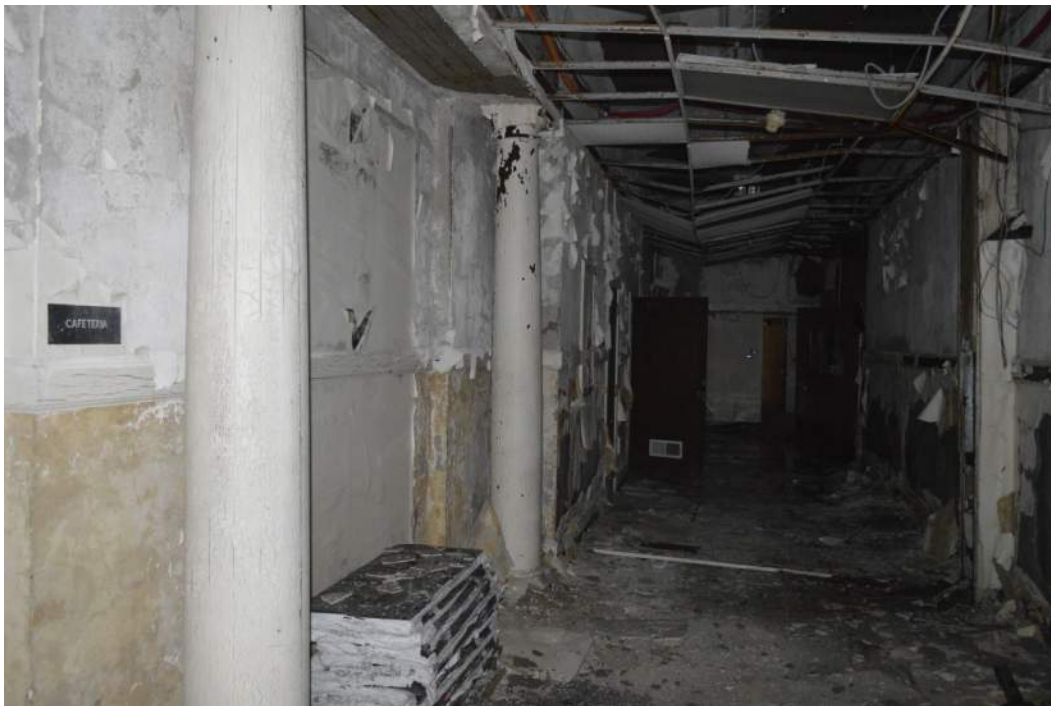
*Photo 11: The staved wood columns outside of the Auditorium in the main corridor should be salvaged and refinished. Originally three double door openings provided entrance to the Auditorium. The entrance between the columns in this photograph has been blocked off, interrupting the symmetry.*

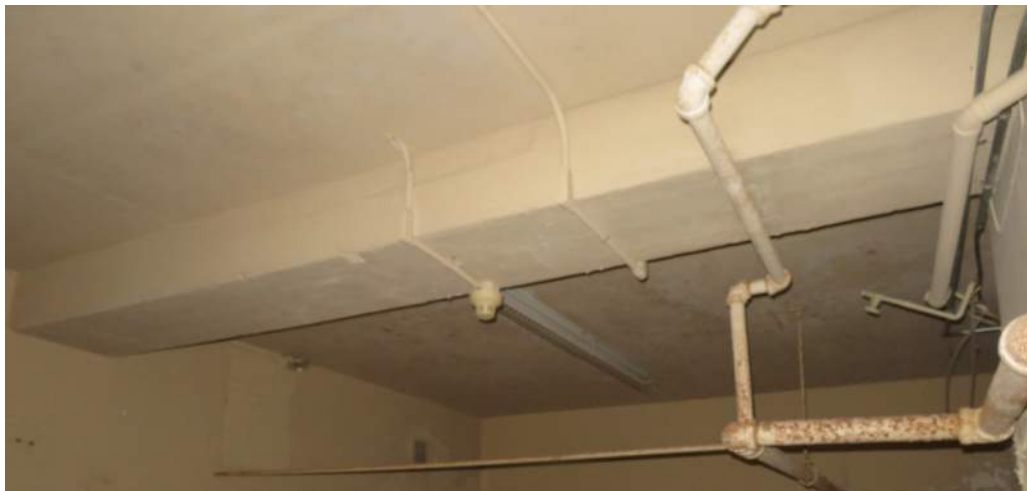
*Photo 19: First Floor Ribbed Slab and Beam Construction with Finishes below Gym/Stage*

Note that due to existence of finishes, as well as poor access due to debris, standing water in areas and accessibility of the crawlspace, the description and noted conditions need to be more fully investigated.

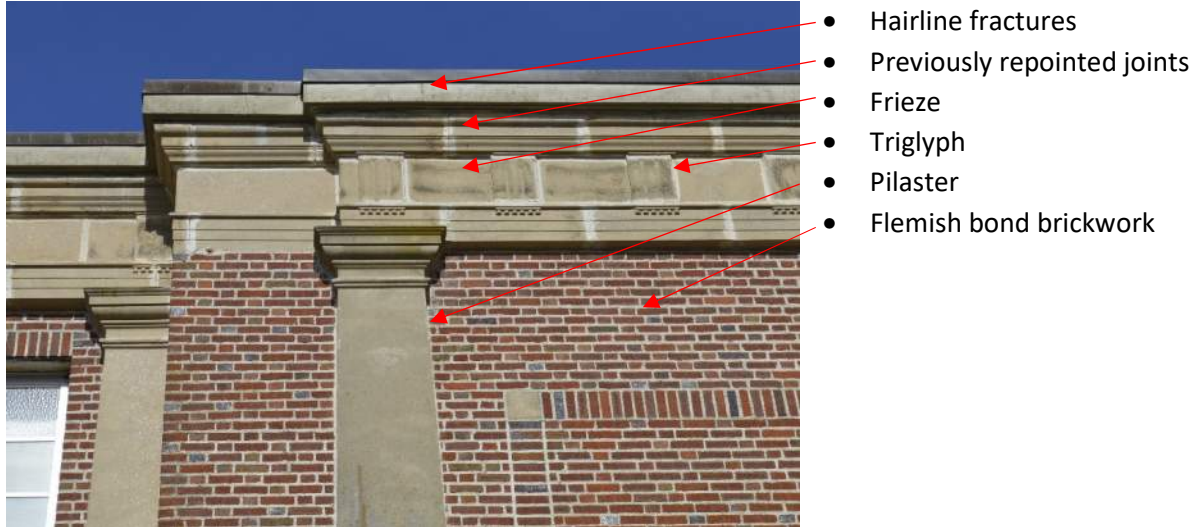
*Photo 24: A close up view of the top of the north pavilion.*

In general, the brick veneer is in good condition. The wire-cut brick of the front and side facades has not spalled as some of the smooth-faced brick of the rear elevation has. Mortar joints are for the most part in serviceable condition with localized exceptions. The cast concrete detailing is in fair condition. Past repointing of the frieze was poorly done and is quite visible. There are minor hairline cracks visible at the cap below the metal flashing.

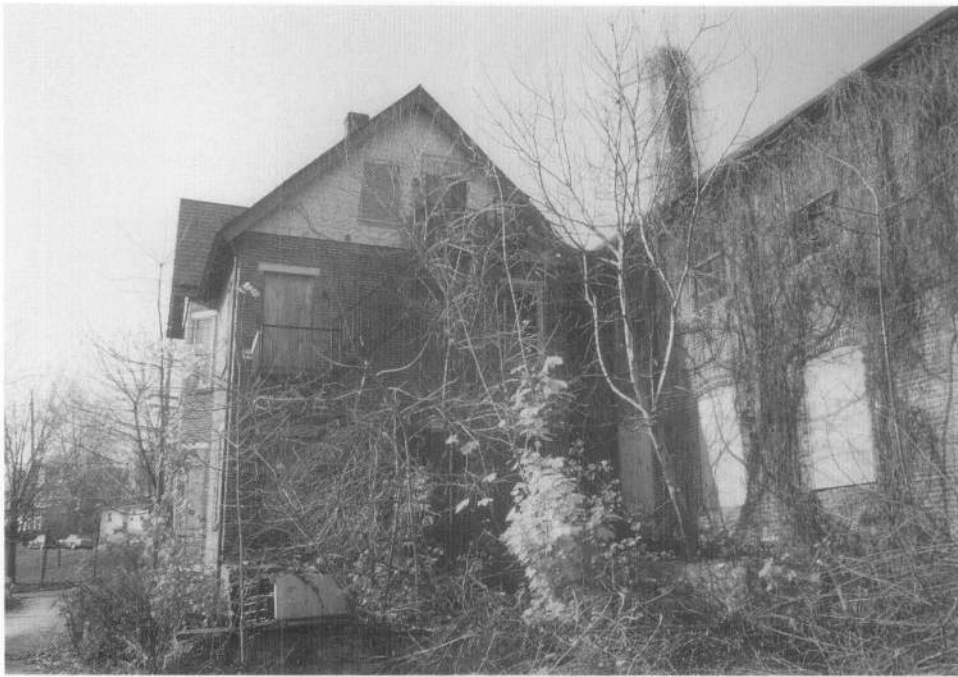
Figure 2. Improper treatment: Boarding up without adequate ventilation, lack of maintenance, and neglect of this property have accelerated deterioration. Photo; NPS file.

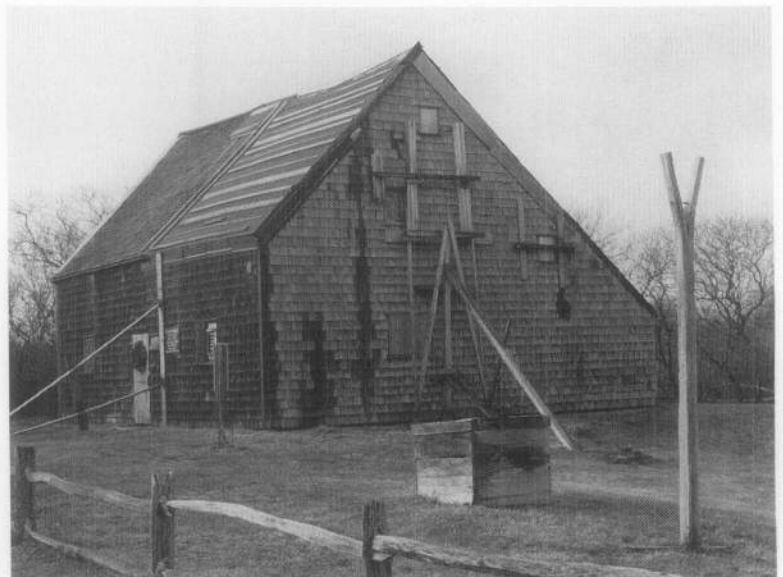
Figure 3. Buildings seriously damaged by storms or deterioration may need to be braced before architectural evaluations can be made. Jethro Coffin House. Photo: John Milner Architects.

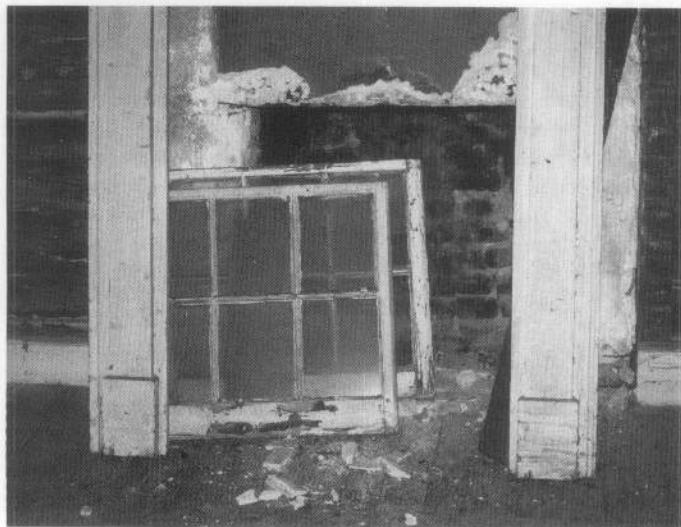
*Figure 5. Loose or detached elements should be identified, tagged and stored, preferably on site. Photo: NPS files.*

By understanding the history of the resource, significant elements, even though deteriorated, may be spared the trash pile. For that reason alone, any materials removed from the building or site as part of the stabilization effort should be carefully scrutinized and, if appearing historic, should be photographed, tagged with a number, inventoried, and safely stored, preferably in the building, for later retrieval (see fig. 5).

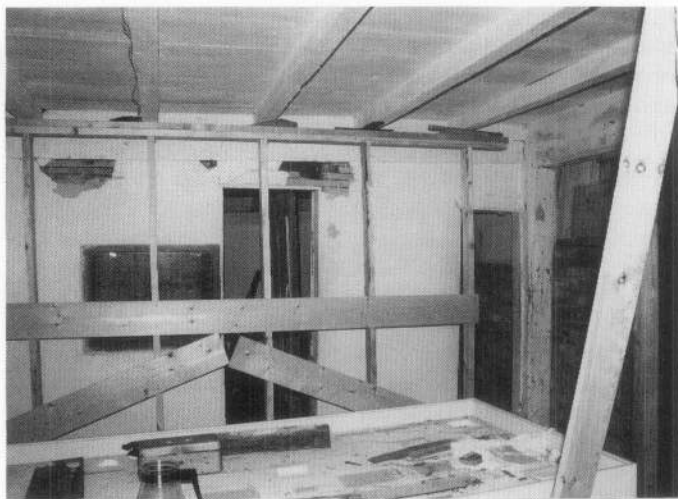
*Figure 6. Interior bracing which will last the duration of the mothballing will protect weakened structural members. Jethro Coffin House. Photo: John Milner Architects.*

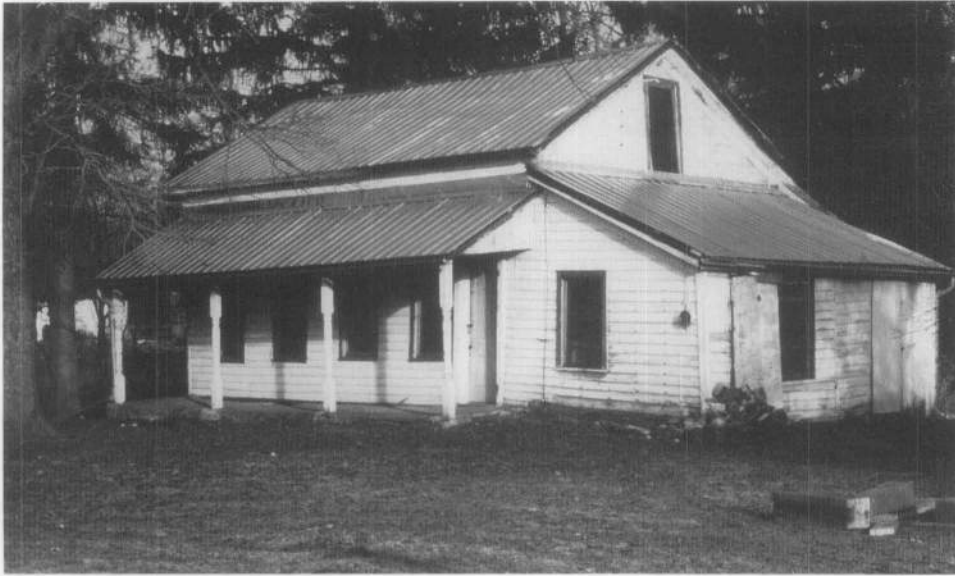
Figure 7. Non-historic materials are appropriate for mothballing projects when they are used to protect historic evidence remaining for future preservation. This lightweight aluminum channel frame and roofing covers the historic wooden shingle roof. Galvanized mesh panels secure the window openings from intrusion by raccoons and other unwanted guests. Photo: Williamsport Preservation Training Center, NPS.

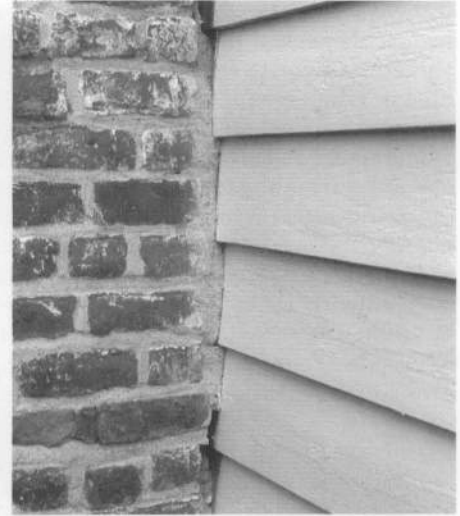
Figure 8. Appropriate mortar mixes should be used when masonry repairs are undertaken. In this case, a soft lime based mortar is used as an infill between the brick and wooden elements. When full repairs are made during the restoration phase, this soft mortar can easily be removed and missing bricks replaced.

For masonry repairs, appropriate preservation approaches are essential. For example, if repointing deteriorated brick chimneys or walls is necessary to prevent serious moisture penetration while the building is mothballed, the mortar should match the historic mortar in composition, color, and tooling. The use of hard portland cement mortars or vapor-impermeable waterproof coatings are not appropriate solutions as they can cause extensive damage and are not reversible treatments (see fig. 8).

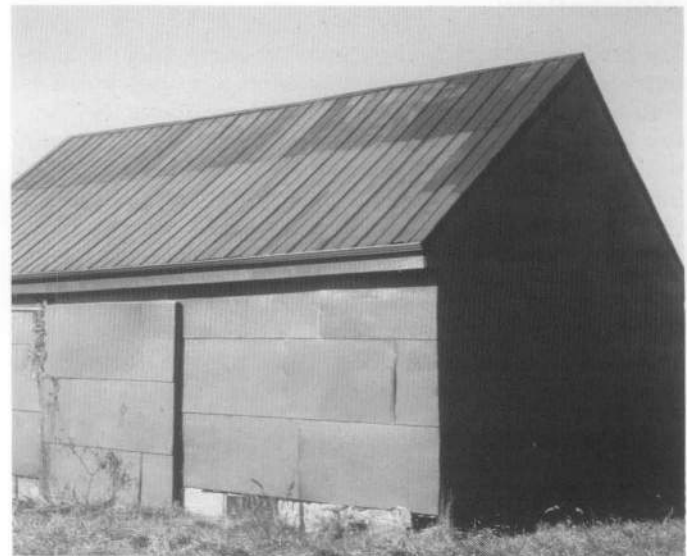
Figure 9. Severely deteriorated wooden siding on a farm building has been covered over with painted plywood panels as a temporary measure to eliminate moisture penetration to the interior. Foundation vents and loose floor boards allow air to circulate inside.

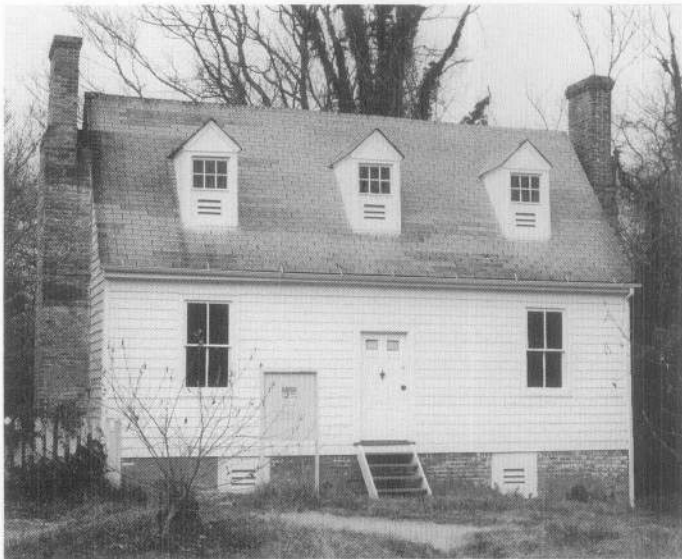
Figure 10. Regrading around the Booker Tenement at Colonial Williamsburg has protected the masonry foundation wall from excessive damp. This building has been successfully mothballed for over 10 years. Note the attic and basement vents, the temporary stairs, and the informative sign interpreting the history of this building.

If there are no significant landscape or exposed archeological elements around the foundation, consideration should be given to regrading the site if there is a documented drainage problem (see fig. 10). If building up the grade, use a fiber mesh membrane to separate the new soil from the old and slope the new soil 6 to 8 feet (200 cm-266 cm) away from the foundation making sure not to cover up the dampcourse layer or come into contact with skirting boards. To keep vegetation under control, put down a layer of 6 mil black polyethylene sheeting or fiber mesh matting covered with a 2"-4" (5-10 cm.) of washed gravel. If the building suffers a serious rising damp problem, it may be advisable to eliminate the plastic sheeting to avoid trapping ground moisture against foundations.

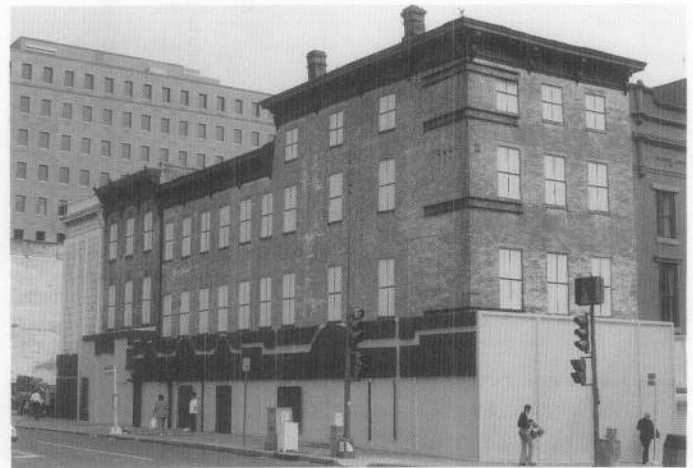
Figure 11. Urban buildings often need additional protection from unwanted entry and graffiti. This commercial building uses painted plywood panels to cover expansive glass storefronts and chain link fencing is applied on top of the panels. The upper windows on the street sides have been covered and painted to resemble 19th century sash. Photo: Thomas Jester, NPS.

Mothballed buildings are usually boarded up, particularly on the first floor and basement, to protect fragile glass windows from breaking and to reinforce entry points (see fig. 11). Infill materials for closing door and window openings include plywood, corrugated panels, metal grates, chain fencing, metal grills, and cinder or cement blocks (see fig. 12). The method of installation should not result in the destruction of the opening and all associated sash, doors, and frames should be protected or stored for future reuse.

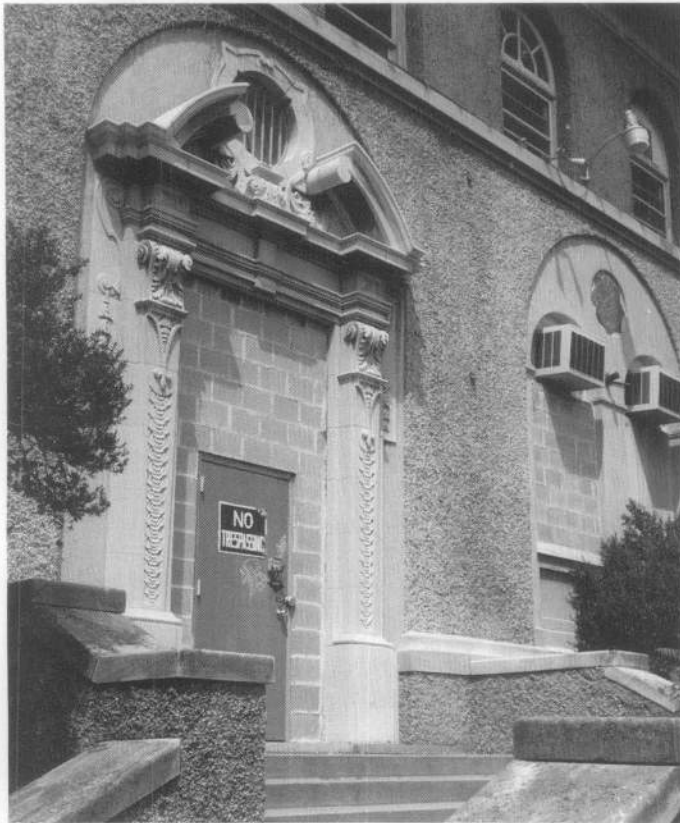
Figure 12. First floor openings have been filled with cinderblocks and doors, window sash and frames have been removed for safe keeping. Note the security light over the windows and the use of a security metal door with heavy duty locks. Photo: H. Ward Jandl, NPS.

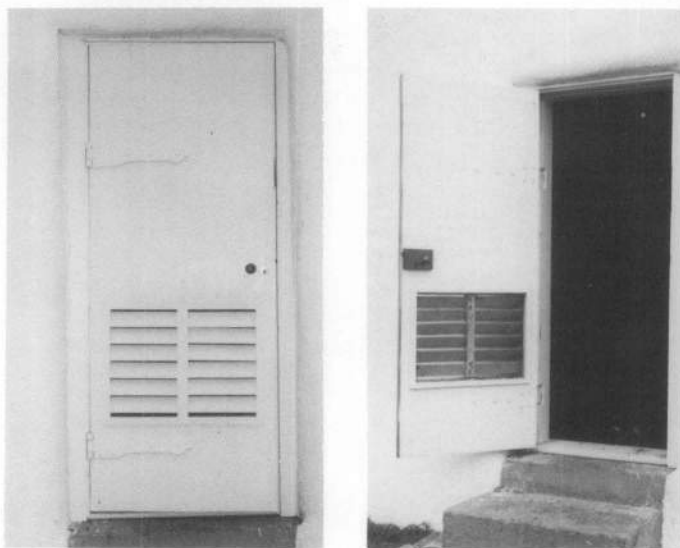
Figure 13. If historic doors would be damaged by adding extra locks, they should be removed and stored and new security doors added. At this lighthouse, the historic door has been replaced with a new door (seen both inside and outside) with an inset vent and new deadbolt locks. The heavy historic hinges have not been damaged. Photo: Williamsport Preservation Training Center, NPS.

Generally exterior doors are reinforced and provided with strong locks, but if weak historic doors would be damaged or disfigured by adding reinforcement or new locks, they may be removed temporarily and replaced with secure modern doors (see fig. 13). Alternatively, security gates in a new metal frame can be installed within existing door openings, much like a storm door, leaving the historic door in place. If plywood panels are installed over door openings, they should be screwed in place, as opposed to nailed, to avoid crowbar damage each time the panel is removed. This also reduces pounding vibrations from hammers and eliminates new nail holes each time the panel is replaced.

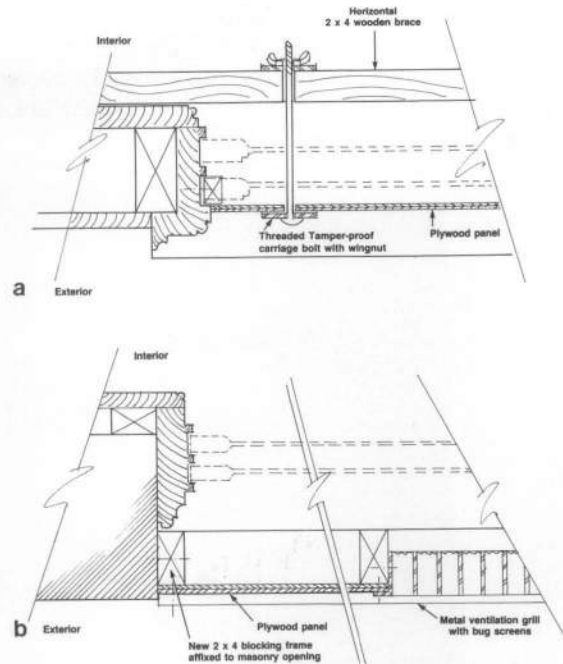
Figure 14. A: Plan detail showing plywood security panel anchored with carriage bolts through to the inside horizontal bracing, or strong backs. B: Plan detail showing section of plywood window panel attached to a new pressure treated wood frame set within the masonry opening. Ventilation should be included whenever possible or necessary.

There are a number of ways to set insert plywood panels into window openings to avoid damage to frame and sash (see fig. 14). One common method is to bring the upper and lower sash of a double hung unit to the mid-point of the opening and then to install pre-cut plywood panels using long carriage bolts anchored into horizontal wooden bracing, or strong backs, on the inside face of the window. Another means is to build new wooden blocking frames set into deeply recessed openings, for example in an industrial mill or warehouse, and then to affix the plywood panel to

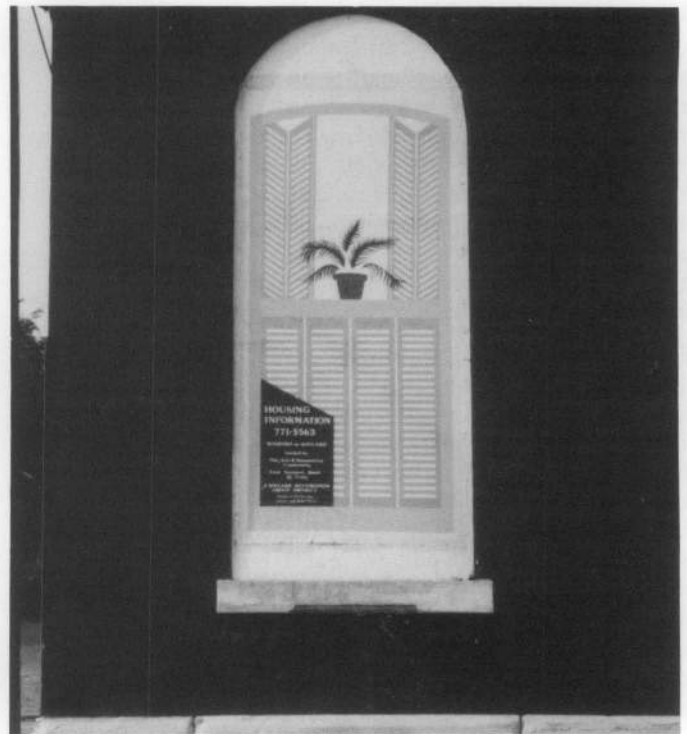
Figure 15. Painting trompe l'oeil scenes on plywood panels is a neighborhood friendly device. In addition, the small sign at the bottom left corner gives information for contacting the organization responsible for the care of the mothballed building. Photo: Lee H. Nelson, FAIA.

marine grade plywood. They should be painted to protect them from delamination and to provide a neater appearance. These panels may be painted to resemble operable windows or treated decoratively (see fig. 15). With extra attention to detail, the plywood panels can be

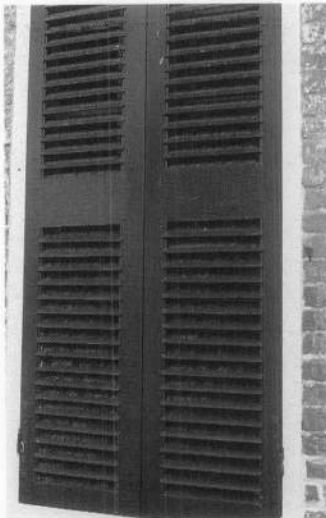
Figure 16. Historic louvered shutters make excellent security closures with passive ventilation.

If the building has shutters, simply close the shutters and secure them from the interior (see fig. 16). If the building had shutters historically, but they are missing, it may be appropriate to install new shutters, even in a modern material, and secure them in the closed position. Louvered shutters will help with interior ventilation if the sash are propped open behind the shutters.

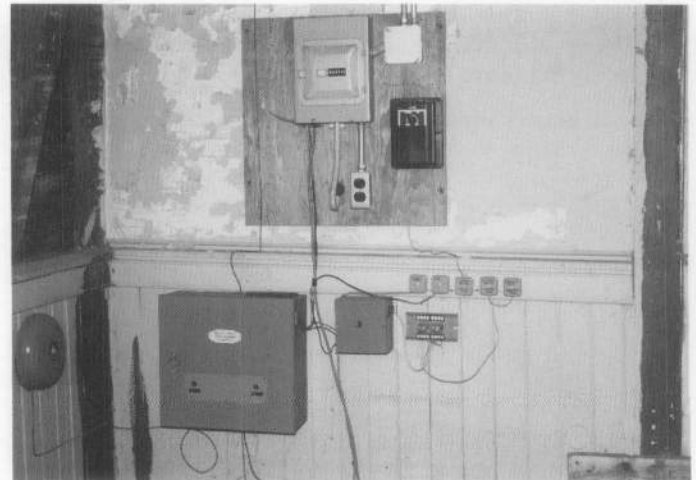
Figure 17. Security systems are very important for mothballed buildings if they are located where fire and security services are available. A temporary electric service with battery back-up has been installed in this building. Intrusion alarms and ionization smoke/fire detectors are wired directly to the nearby security service.

If at all possible, new temporary electric service should be provided to the building (see fig. 17). Generally a telephone

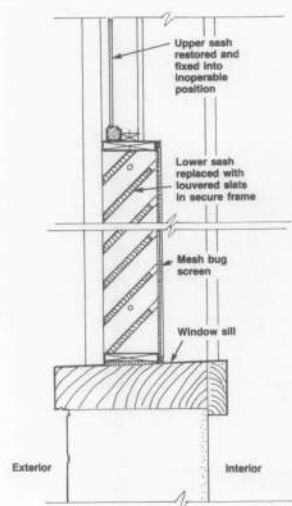
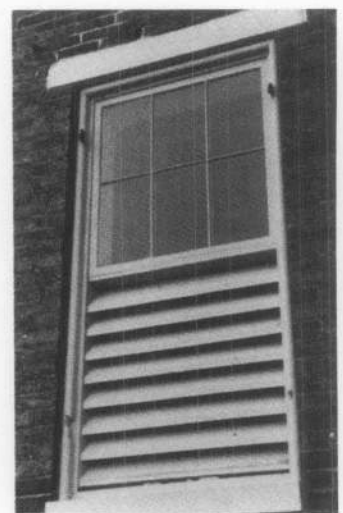
Figure 18. Heavy duty wooden slated louvers were custom fabricated to replace the deteriorated lower sash. The upper sash were rebuilt to retain the historic appearance and to allow light into this vacant historic building. Refer back to Fig. 1 for a view of the building. Photo: Charles E. Fisher, NPS. Drawing by Thomas Vitanza.

The type of ventilation should not undermine the security of the building. The most secure installations use custom-made grills well anchored to the window frame, often set in plywood security panels. Some vents are formed using heavy millwork louvers set into existing window openings (refer back to fig.18). For buildings where security is not a primary issue, where the interior is modest, and where there has been no heat for a long time, it may be possible to use lightweight galvanized metal grills in the window openings (refer back to fig.7). A cost effective grill can be made from the expanded metal mesh lath used by plasterers and installed so that the mesh fins shed rainwater to the exterior.
