ROAD SAFETY AUDIT

# **ROCHESTER ROAD CORRIDOR**

# **OAKLAND COUNTY**

FINAL REPORT

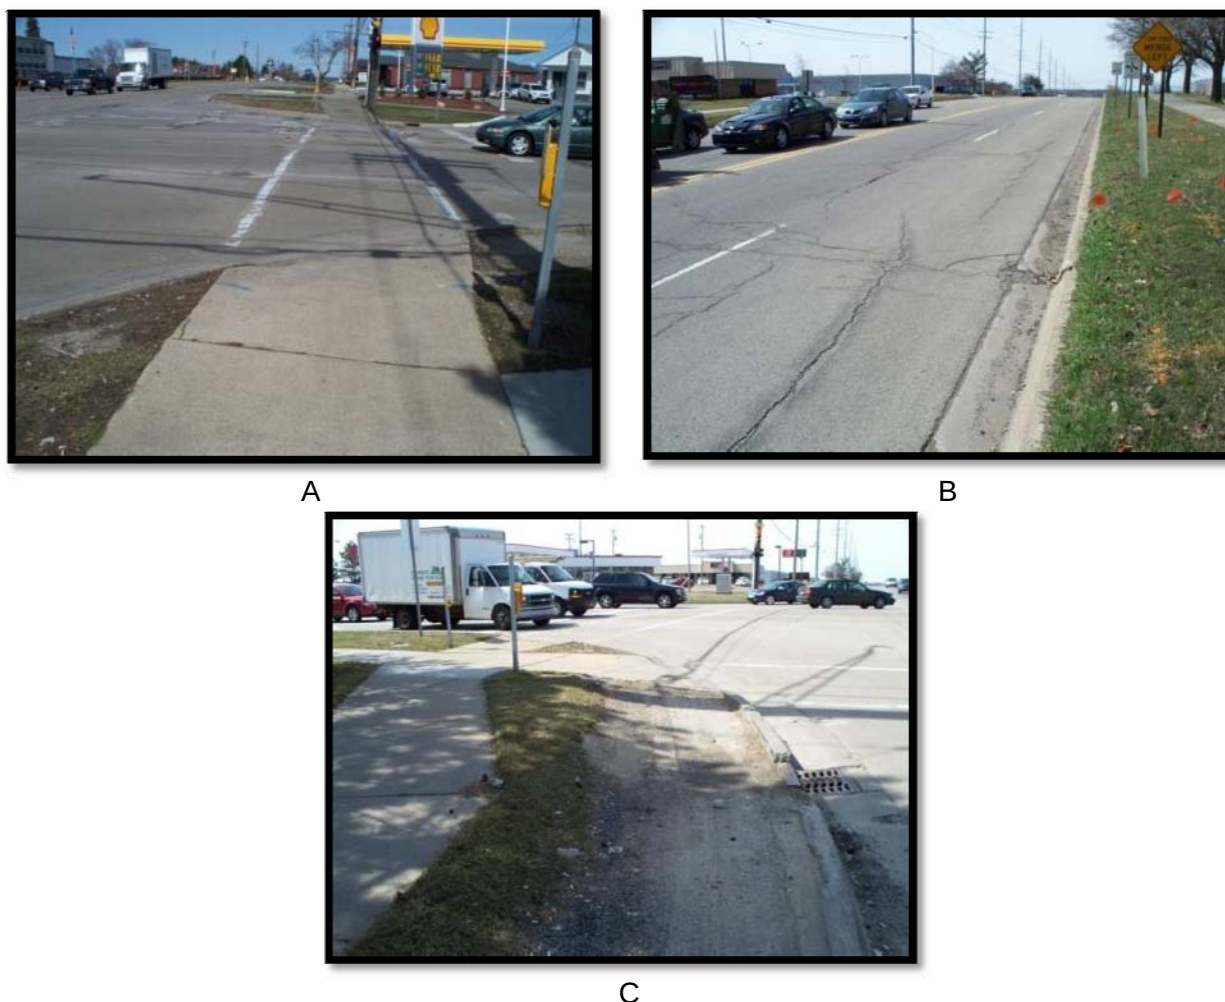
Figure 4-3 SITE OBSERVATION PHOTOGRAPHS: ROCHESTER ROAD AND AVON ROAD

- A. No truncated domes are provided on two of the four corners.*
- B. Crest vertical curves on both the north and east legs.*
- C. Grass-bare area on the southeast corner as a result of tires jumping the curb during southbound left-turn movements.*

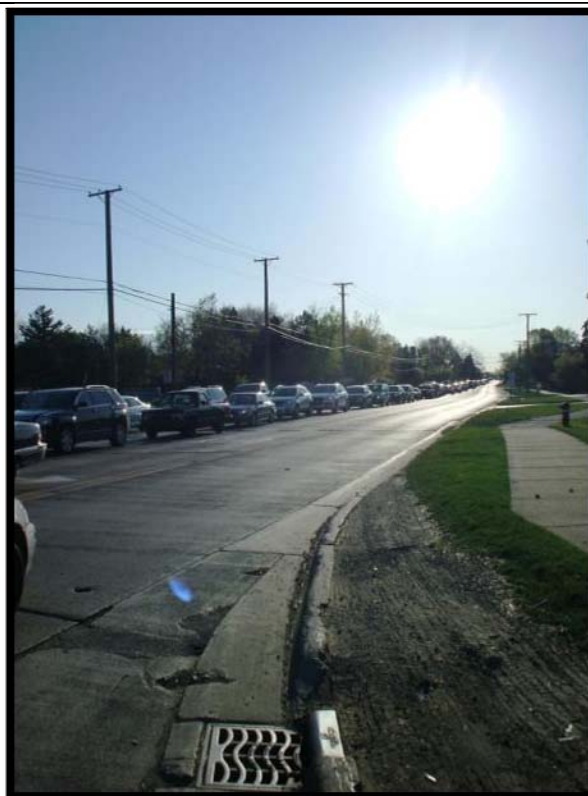
During the site visit, long queues were observed during both the morning and afternoon peak periods. During the A.M peak period (approximately 8:00 AM), westbound through traffic on Avon Road was found to consist in excess of 30 vehicles waiting in the queue. A long queue was observed in the eastbound through lane on Avon Road between 2:45 and 3:00 PM. This afternoon peak hour is likely a result of a number of local schools releasing around the same time. The long queues may have been worse than normal during the field review due to a detour resulting from construction on Hamlin Road. The long queues made it difficult for drivers to make left-turns out of the driveways both near the intersection as well as outside of the intersection's functional area. Long queues at intersections increase the risk of rear-end collisions and driver frustration, leading to red light running. Queuing may also lead to erratic movements as drivers attempt to merge into over-full lanes increasing the likelihood of sideswipe collisions.

*Westbound approach of Avon Road during the afternoon peak period*

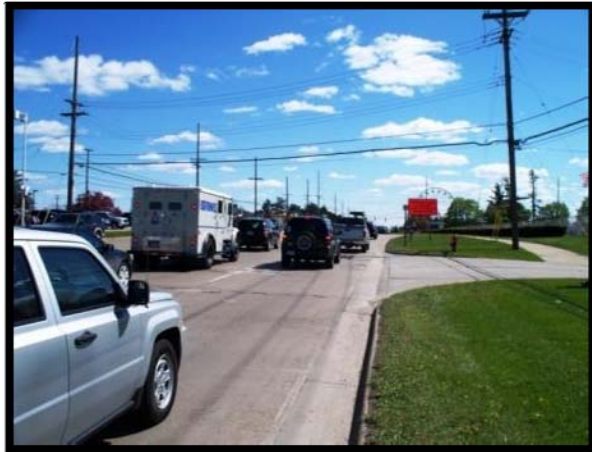
The signal visibility on the eastbound and southbound approaches is obstructed by the crest vertical curves resulting in limited stopping sight distance. As was stated in Issue 1, vehicles were observed queuing on several of the approaches during the field review. Vehicles stopped at the top of the crest vertical curve can block the view of the traffic signal for following vehicles. This issue is further aggravated when a taller vehicle such as a large SUV, truck or commercial van are waiting in the queue. Many of the rear end crashes are likely due to a driver's limited stopping sight distance due to the above listed complicating factors. Given the moderate truck volumes at this intersection, drivers may unwittingly follow taller vehicles into the intersection during the red phase. As a result, the obstructed signal visibility leads to an increased frequency in rear-end collisions and increases the risk for red light running.

*Poor signal visibility as a result of the crest vertical curve on the eastbound approach of Avon Road.*

It is also suggested that an advance warning flasher should be considered for the eastbound and southbound approaches of Rochester Road. The advance warning flasher should utilize the message "PREPARE TO STOP WHEN FLASHING." This advance dilemma zone warning device has been found to reduce traffic fatalities and injuries by 39 percent<sup>3</sup>. While some drivers may increase their speeds right when the device starts flashing, the majority of drivers have been found to be more aware of the signal. These devices can be installed either overhead or post mounted. Examples of the two types of mountings are shown below on the following page. Similar installations have been provided within Oakland County on northbound Telegraph (US-24) and 14 Mile Road and on northbound Northwestern Highway (M-10) at Inkster. In both of these cases, vertical curves limit the traffic signal visibility.

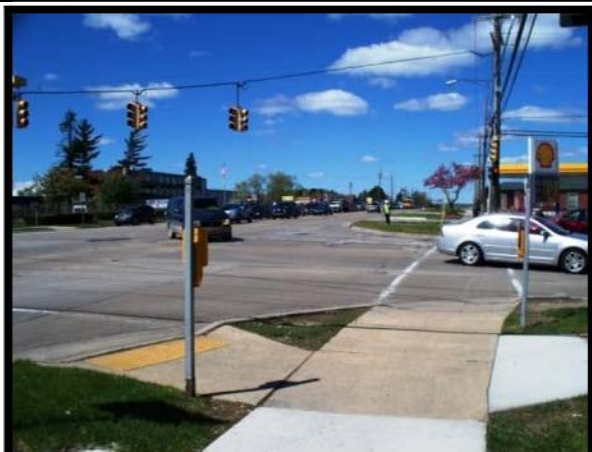
The southbound left-turn from Rochester Road to eastbound Avon Road is tight and drivers were observed having difficulty completing this maneuver. As a result of the tight left-turn radius, tire tracks and broken curbs were observed on the southeast corner of the intersection. It was noted during the site visit that vehicle tires were over-tracking over the curb. This tight turning radius increases the risk of sideswipe-opposing collisions.

*Tight turn radius from southbound Rochester Road to eastbound Avon Road.*

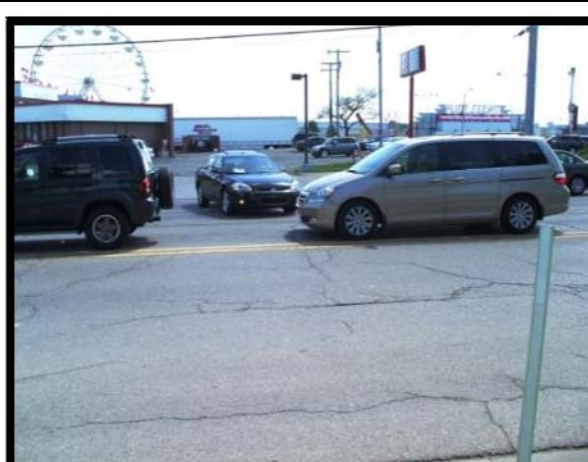
During the afternoon peak hour the eastbound through movement was observed blocking the Avon Road entrances to the Speedway gas station, Genisys Credit Union, and the Sears parking lot. Drivers in the Sears parking lot were observed attempting to both enter and pass through the queue. Drivers attempting making left-turns from the commercial driveways onto Avon Road also face limited intersection sight distance due to the vertical alignment. Driver's view of cross traffic is likely obstructed by the queued vehicles. Drivers who attempt to enter or pass through queues from the commercial driveways on Avon Road increase the risk of causing an angle crash or ancillary rear end crashes.

*Left-turning movement across traffic from Sears driveway.*

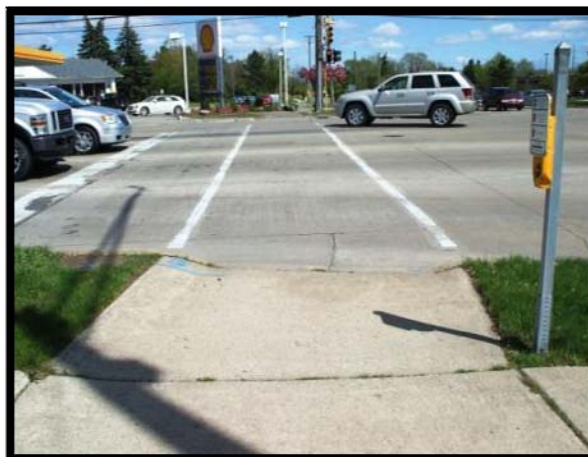
During the field review it was observed that accessible pedestrian signals, sidewalks and ramps had been provided on all approaches. The ramps on the north side of the intersection lacked the presence of a detectable warning surface. Blind pedestrians using a long cane need a detectable warning surface such as truncated domes to find the crossing. Given the increased likelihood of blind pedestrians at this intersection, complete pedestrian facilities are a necessity. Lack of fully accessible pedestrian facilities, increases the risk of a crash involving a blind pedestrian.

*Pedestrian crosswalk across the north leg of the intersection of Rochester Road.*

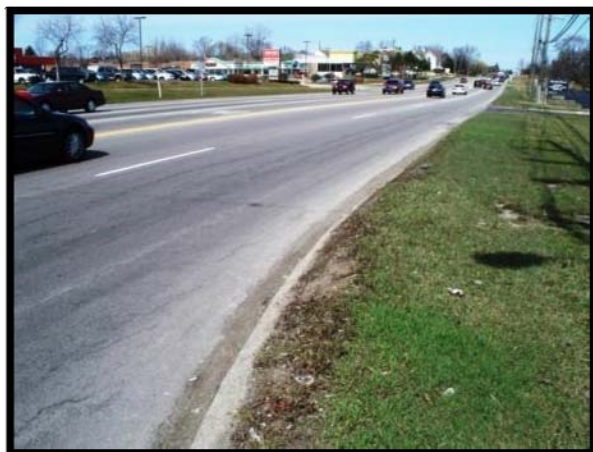
A

- A. Crest vertical curve on the north leg.*
- B. Significant volume of pedestrian and bicycle traffic.*

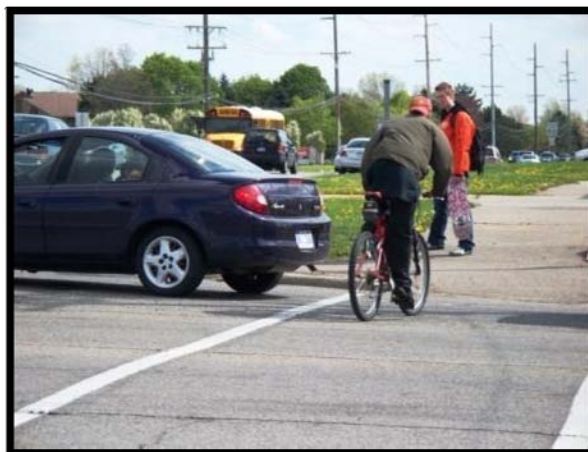
B

During the site visit, a moderate volume of non-motorized road users was observed travelling through the intersection. Several of the pedestrian connections were observed to be incomplete and not in compliance with current ADA standards. The northeast corner of the intersection has no pedestrian ramps or sidewalks. This was due to the fact that a building used to be located on the corner located within the public right-of-way. As a result, pathways and ramps were not provided within that corner even though pedestrian signals and crosswalks are provided. Additionally, several of the pedestrian ramps are quite steep and are not flush with the roadway surface. Collisions involving pedestrians are more likely to occur where pedestrian facilities are limited.

It is suggested that several upgrades to the existing pedestrian facilities are considered at this intersection. First, it is suggested that ramps and a level landing be provided on the northeast corner. Additionally, it is suggested that the other ramps be reviewed to determine whether they are too steep.

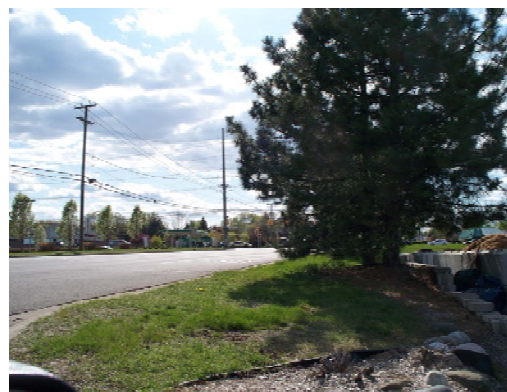
The crash data indicated a trend of angle crashes near the Bordine's driveway on the east leg of Hamlin. This was reviewed during the site visit and it was determined that the crashes were likely due to intersection sight distance obstructions at the driveway. Landscaping is present within the sight triangles and the driveway is on a steep vertical grade. As a result, vehicles attempting to make a left-turn out of this driveway have an obstructed view of cross traffic leading drivers to select insufficient gaps.

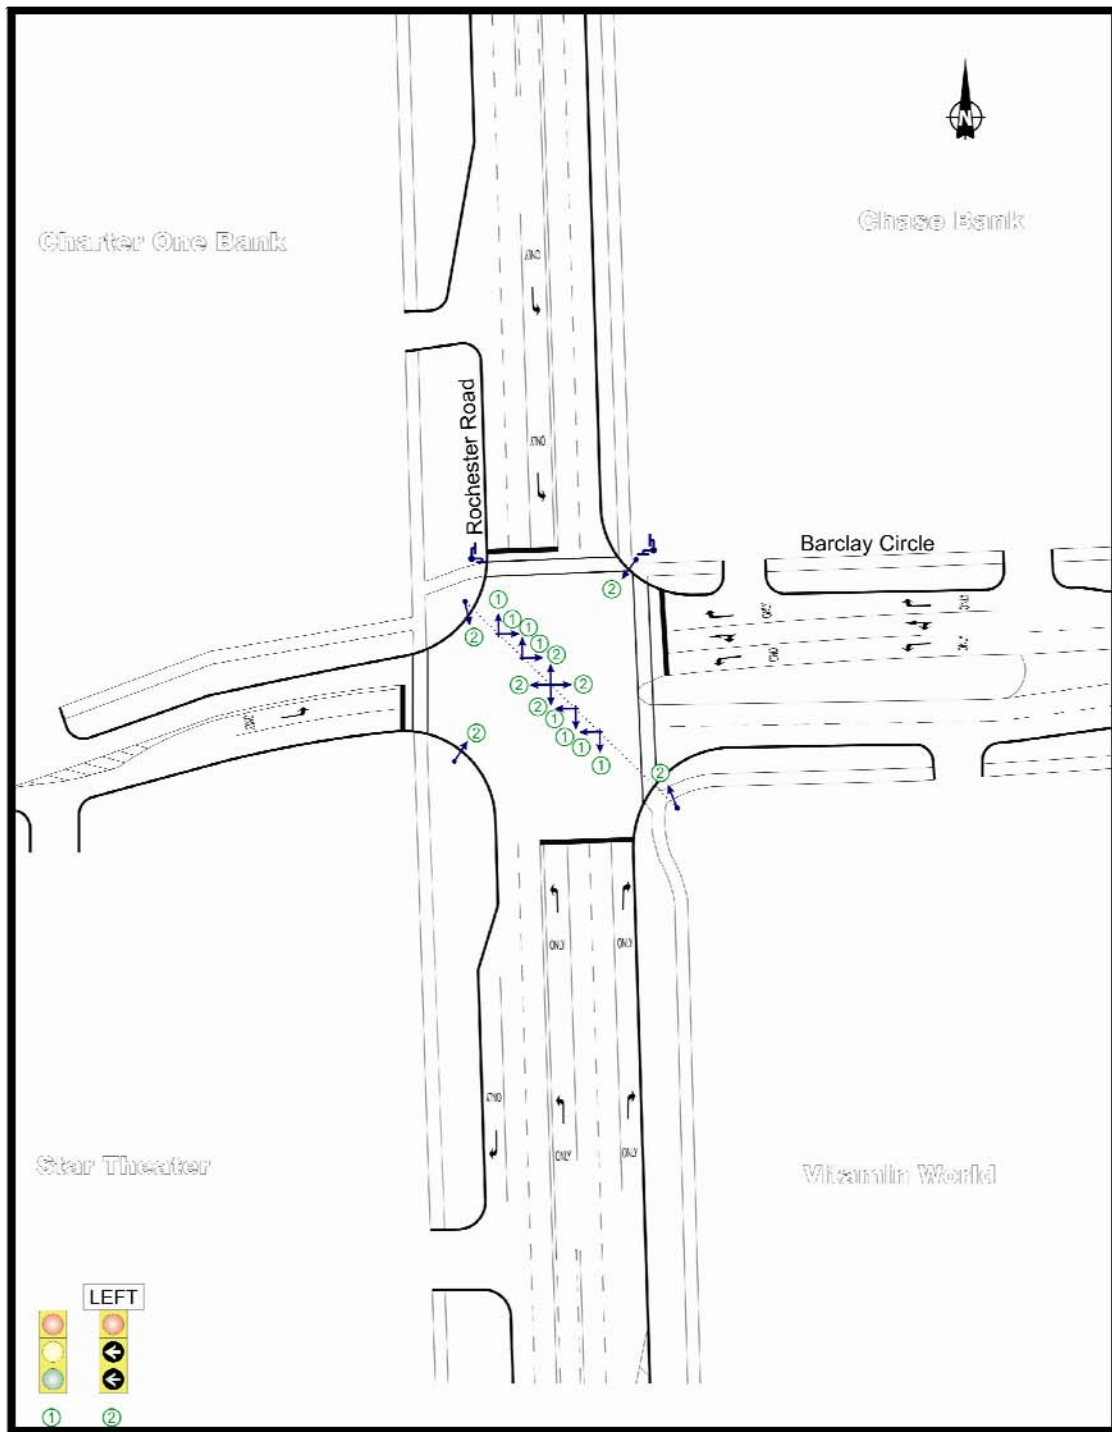
Figure 6-3 SIGNALS DIAGRAM: ROCHESTER ROAD AND BARCLAY CIRCLE/WABASH

The traffic signal display is shown schematically within **Figure 6-3**. Four signal heads are provided on each of the approaches including three overhead span wire signals and one far left post mounted signal. All signal heads have twelve inch lenses. There are no blackplates provided at this intersection.

The signals at this intersection are fully actuated and operate with protected permissive left-turn phasing on all approaches. The signals at this intersection are owned by MDOT and maintained by the Road Commission of Oakland County. These signals function as part of the FAST-TRAC system. Rochester Road has leading protected-only left-turn phases while Barclay/Wabash operates under split phasing. Under certain high demand conditions, southbound Rochester Road will operate with lead/lag protected-only phasing. Pedestrian signal heads and pushbuttons are provided for all crosswalks.

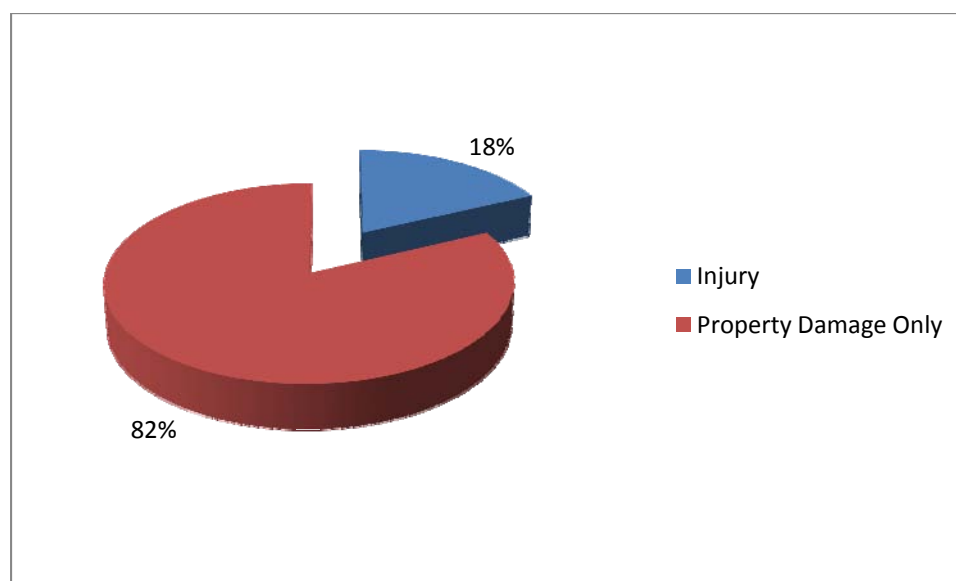
Figure 6-4 COLLISION SEVERITY DISTRIBUTION: ROCHESTER ROAD AND BARCLAY CIRCLE/WABASH

Crash data for the years of 2006 to 2008 were provided by MDOT and using the Office of Highway Safety Planning's website. Over the three years analyzed, 55 collisions were recorded at or near the intersection. As summarized in **Figure 6-4**, 18 percent of collisions resulted in at least one injury. The remainder of the collisions involved property damage only. No fatalities were reported during the study period.

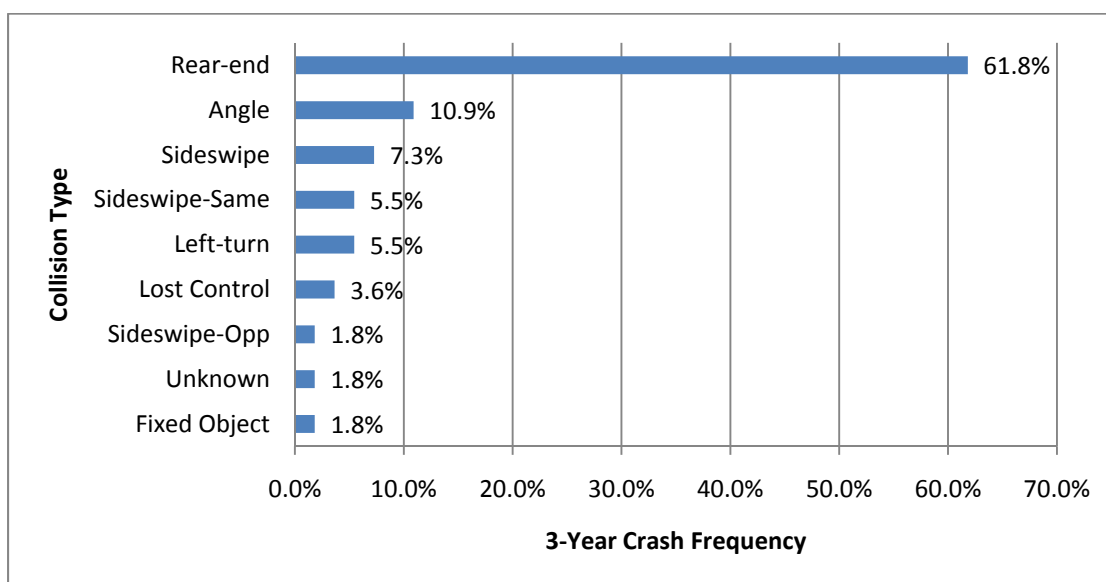
**Figure 6-5 COLLISION TYPE DISTRIBUTION: ROCHESTER ROAD AND BARCLAY CIRCLE/WABASH**

- Rear-end collisions predominated, accounting for 62 percent of all recorded collisions.
- Angle collisions accounted for eleven percent of the three-year total collisions.

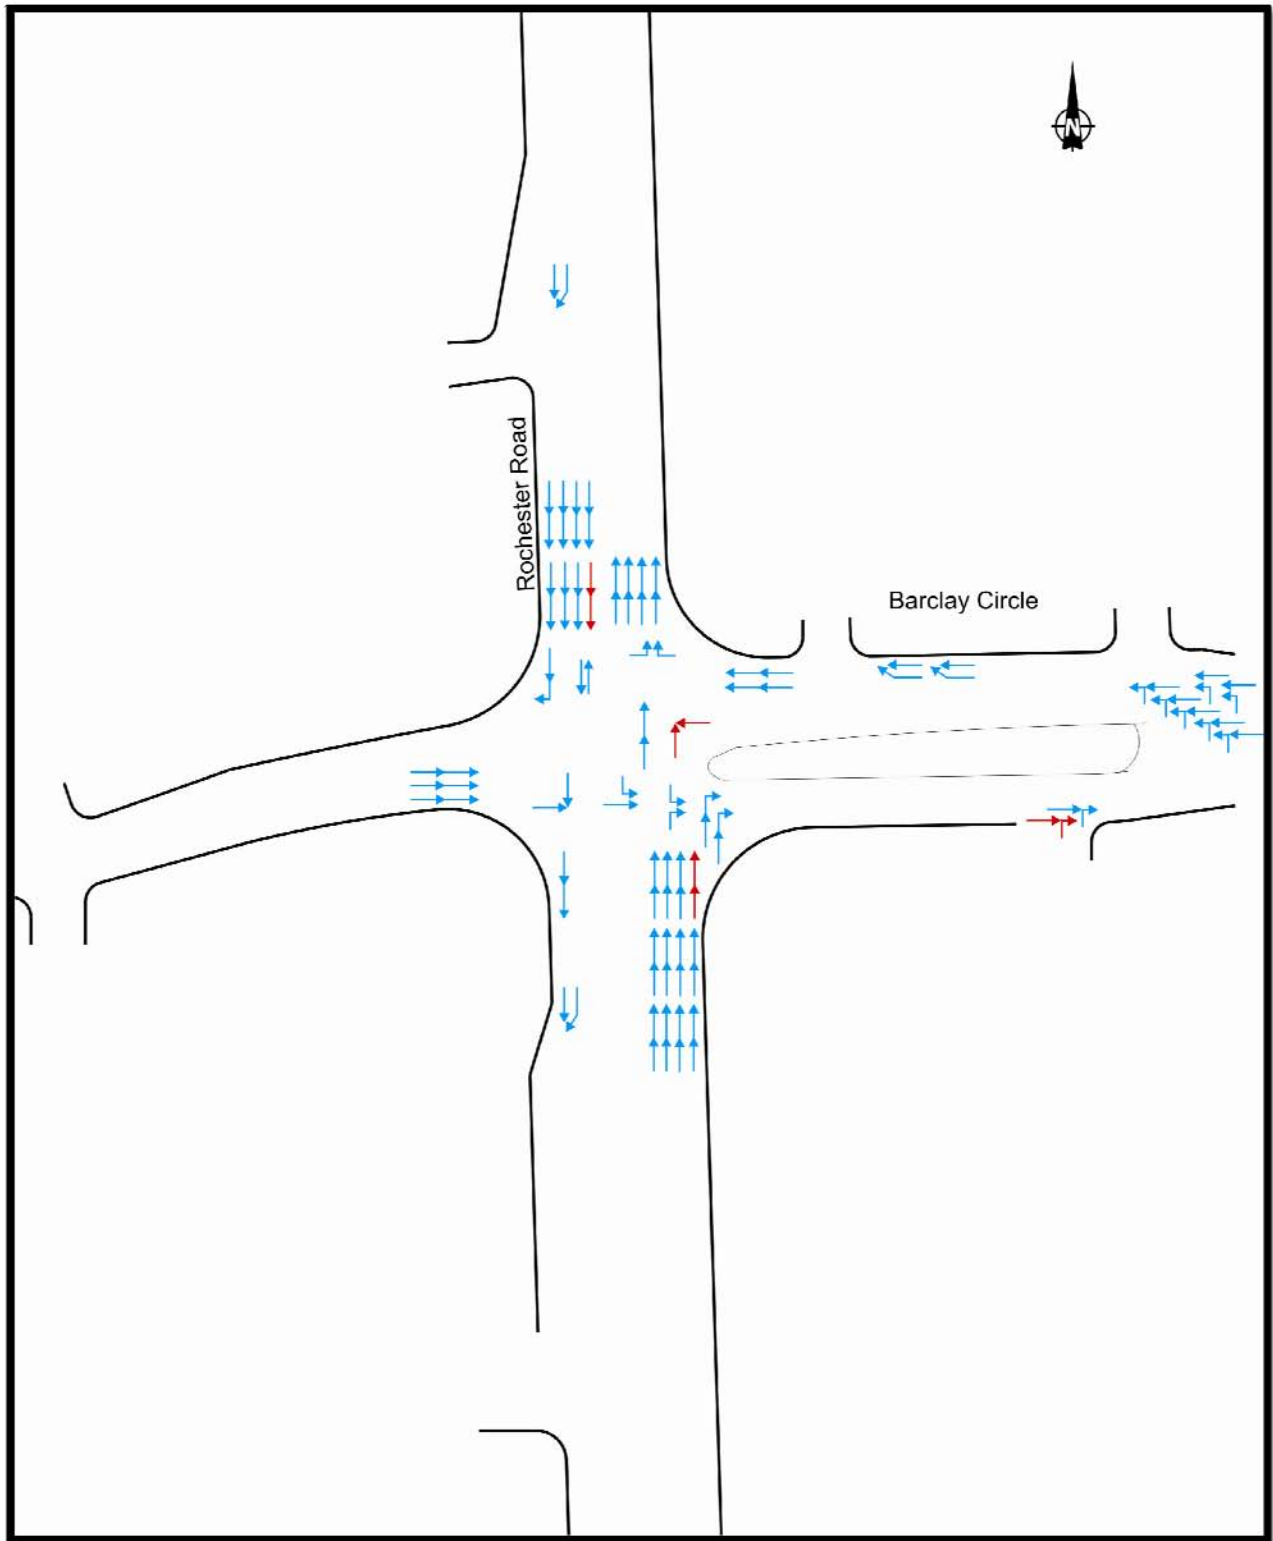
Figure 6-6 COLLISION DIAGRAM: ROCHESTER ROAD AND BARCLAY CIRCLE/WABASH

Collision type distribution is summarized in **Figure 6-5**, and a collision diagram is shown in **Figure 6-6**. The collision diagram illustrates crashes which UD-10 reports were available using [michigantrafficcrashfacts.org](http://michigantrafficcrashfacts.org). The following collision trends were observed:

- The highest frequency of collisions occurred during the months of June and July.
- Hourly distributions show a higher frequency of crashes between 1:00 and 2:00 PM.
- Twenty-six percent of collisions occurred under wet or winter conditions suggesting that road conditions may be a contributing factor to collisions.
- Approximately 71 percent of crashes occurred during daylight or lighted conditions, suggesting that lighting is likely not an issue at this intersection.

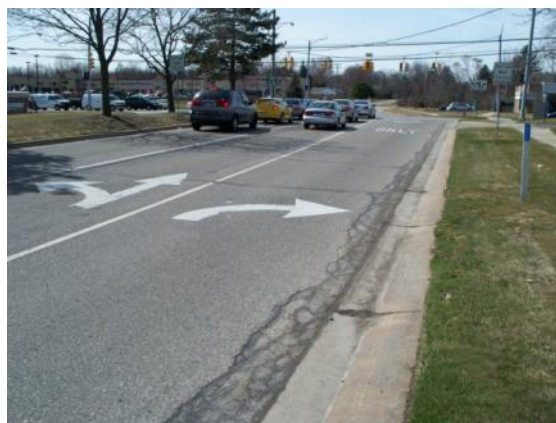
### Issue 1: Signal Display

The signal displays for westbound Barclay Circle at Rochester Road are not consistent with the current lane use. The signals currently do not display a left-turn arrow for the center through/left lane. This display leads to driver confusion and an underutilized center lane. This display increases the risk for angle crashes.

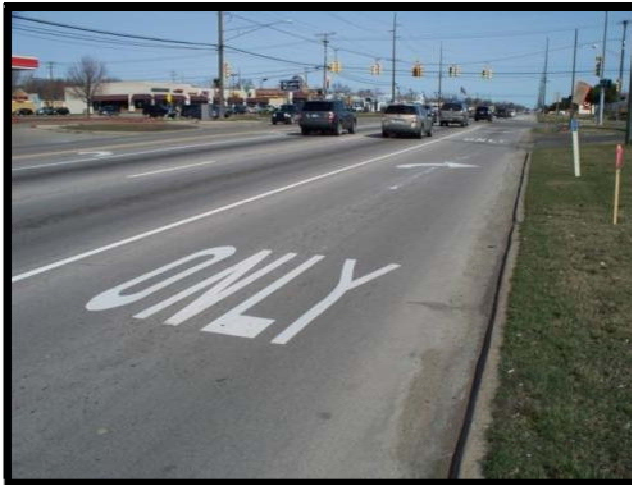
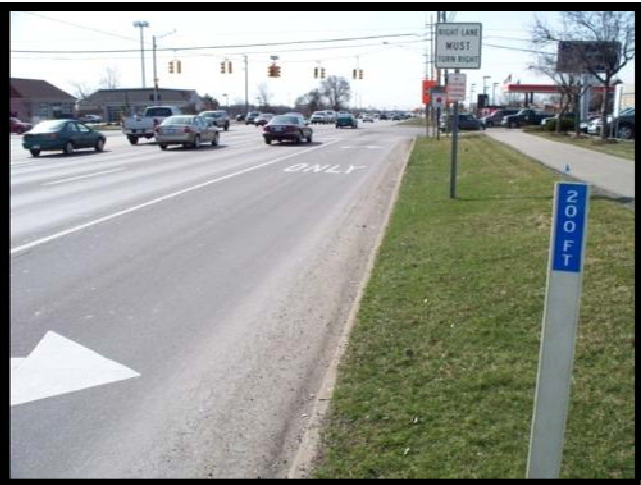
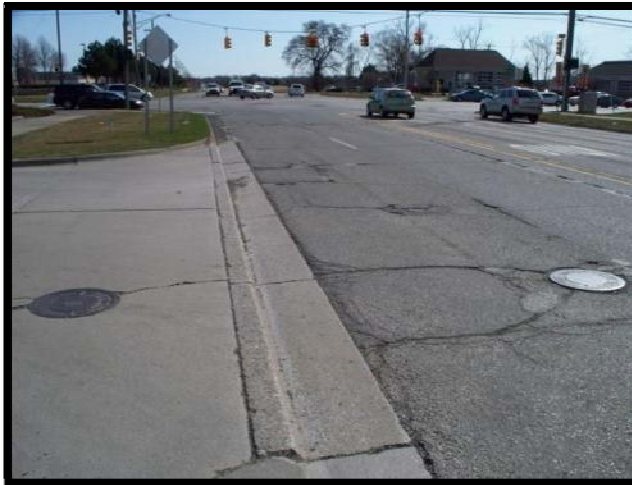
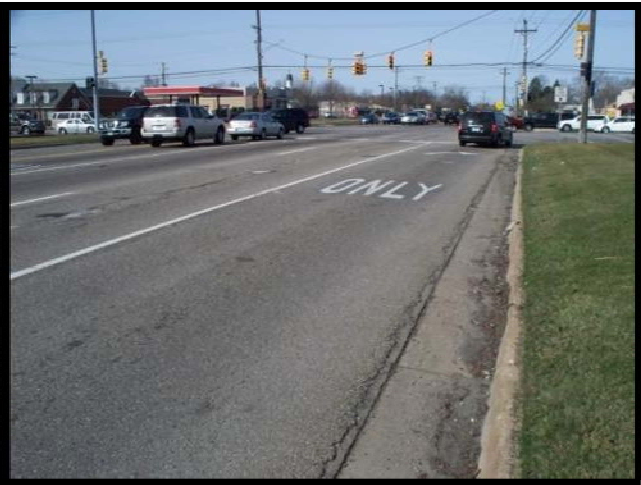
**Figure 7-2 SITE PHOTOGRAPHS: ROCHESTER ROAD AND AUBURN ROAD**

- *Some rutting is present.*
- *There is limited access management in this area.*
- *Red light running was observed on Rochester Road*

Moderate rutting is present on Rochester Road at the intersection with Auburn Road. Rutting often results in hydroplaning and loss of control under wet or icy conditions. This is justified as a contributing factor as Thirty-one percent of the crashes occurred in wet or icy conditions.

Consider resurfacing the existing pavement at this intersection to eliminate the pavement rutting. Additionally, consider installing a high friction treatment at this intersection to prevent hydroplaning and sliding during unfavorable weather conditions. The reduced potential for hydroplaning at this intersection may decrease the number of rear end and other crashes which occur at this intersection due to poor weather conditions. Additionally, resurfacing and a high friction treatment may result in a reduction in angle-type collisions occurring at the intersection due to drivers losing control.

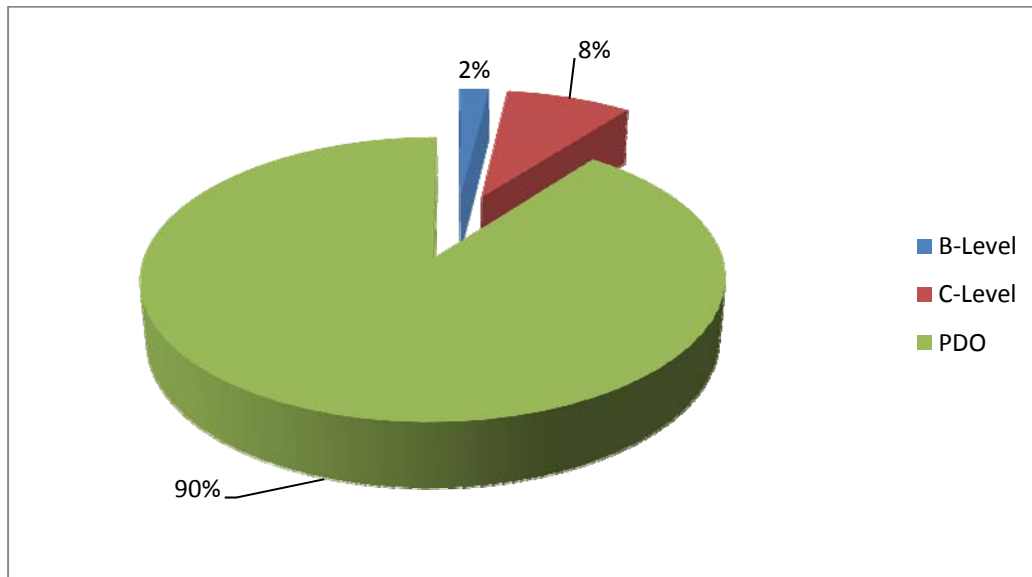
Figure 7-4 COLLISION SEVERITY DISTRIBUTION: ROCHESTER ROAD AND AUBURN ROAD

Crash data for the years of 2006 to 2008 were provided by MDOT and using the Office of Highway Safety Planning's website. Over the three years analyzed, 154 collisions were recorded at or near the intersection. As summarized in **Figure 7-4**, 10 percent of collisions resulted in at least one injury. The remainder of the collisions involved property damage only. No fatalities were reported during the study period.

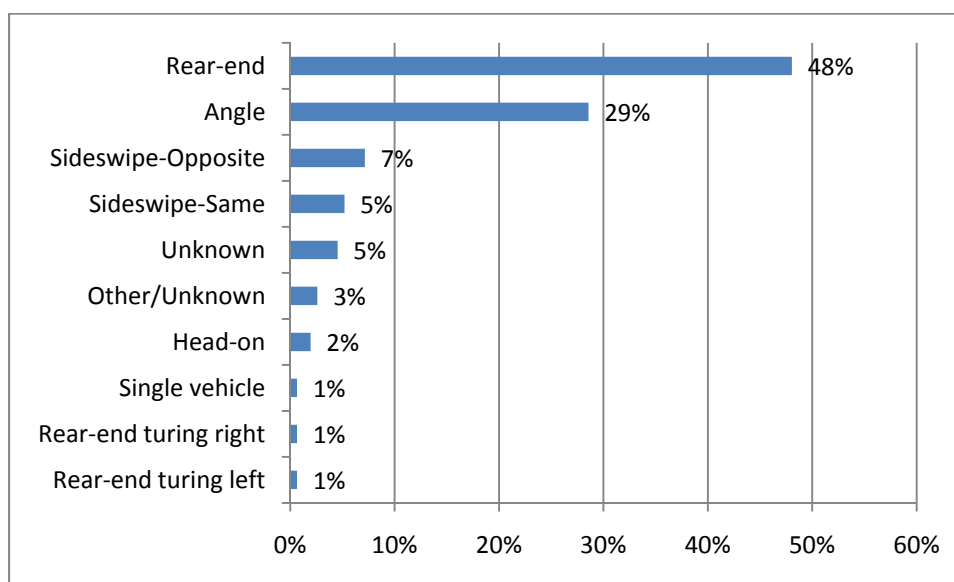
**Figure 7-5 COLLISION TYPE DISTRIBUTION: ROCHESTER ROAD AND AUBURN ROAD**

- Rear-end collisions predominated, accounting for 48 percent of all recorded collisions.
- Angle collisions accounted for 29 percent of the three-year total collisions.

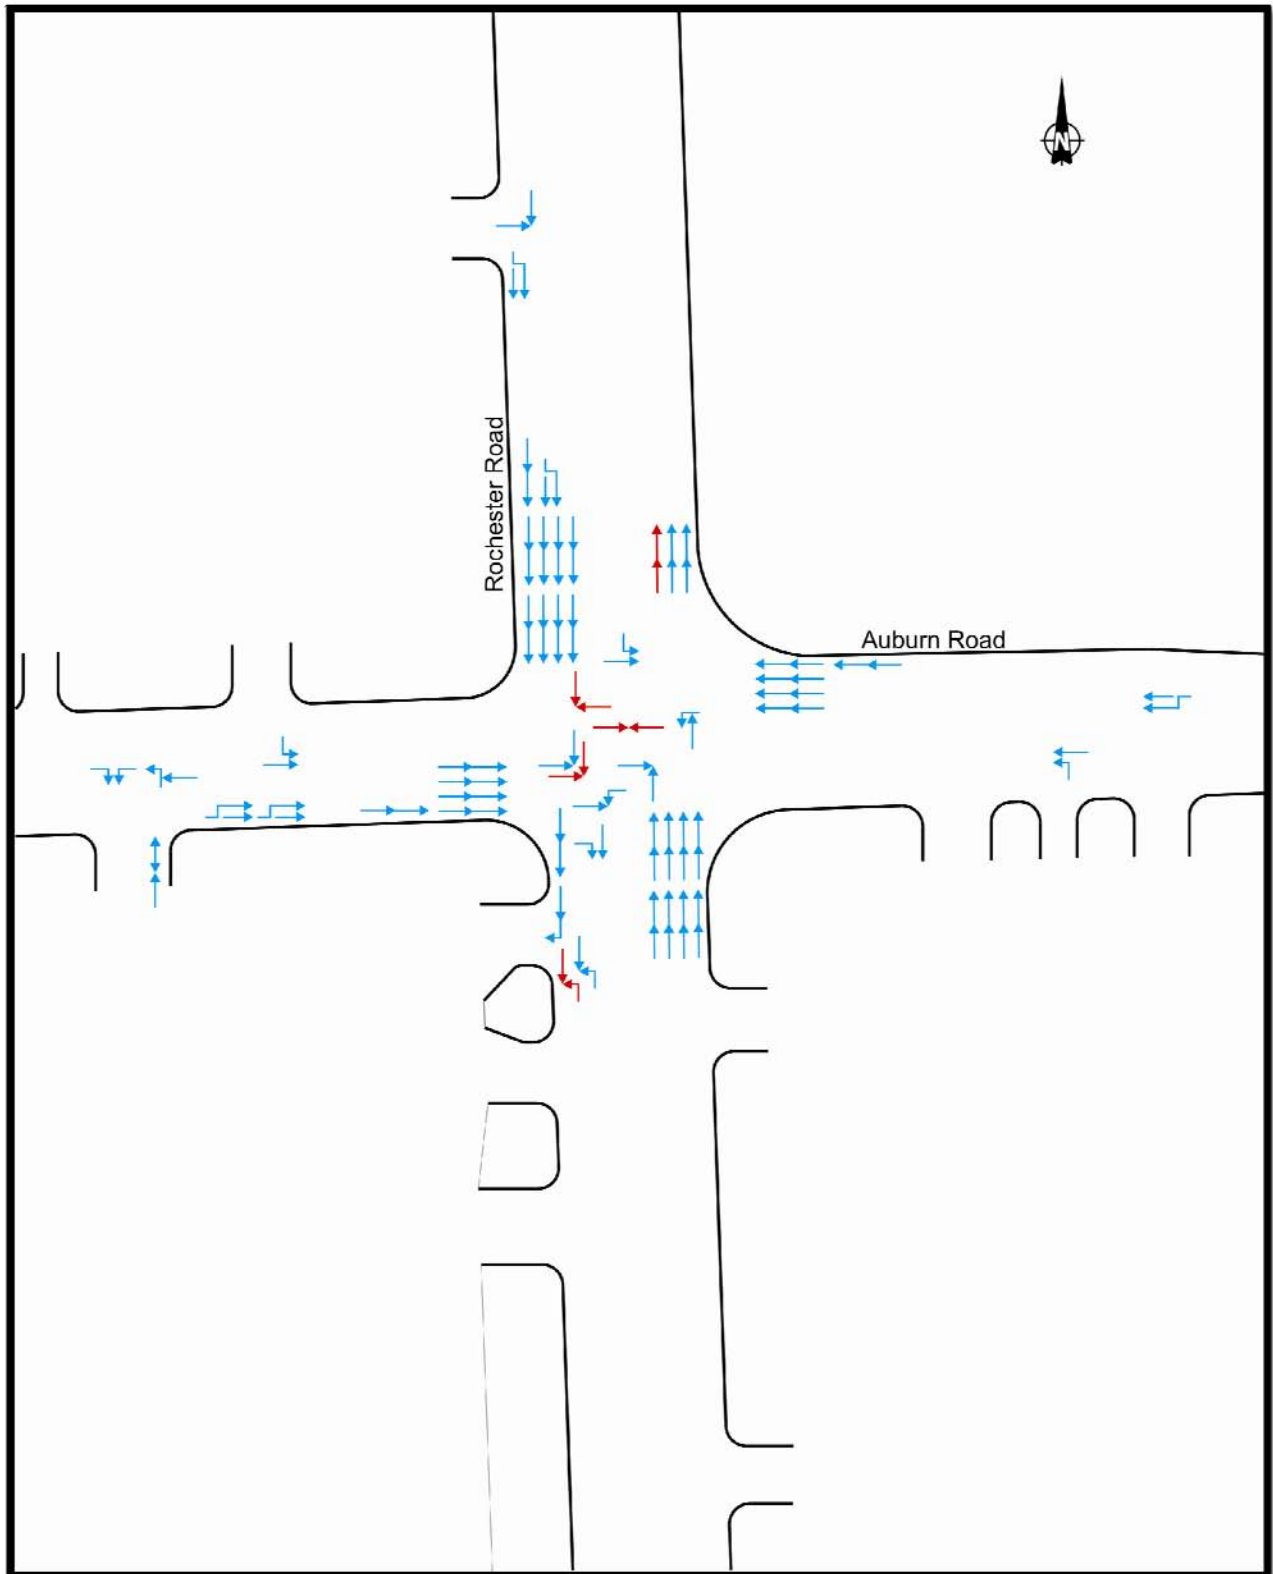
Figure 7-6 COLLISION DIAGRAM: ROCHESTER ROAD AND AUBURN ROAD

Collision type distribution is summarized in **Figure 7-5**, and a collision diagram is shown in **Figure 7-6**. The collision diagram illustrates crashes which UD-10 reports were available using [michigantrafficcrashfacts.org](http://michigantrafficcrashfacts.org). The following collision trends were observed:

- The highest frequency of collisions occurred during the month of December.
- Hourly distributions show a higher frequency of crashes between 2:00 and 3:00 PM, approximately when schools release.
- Thirty-one percent of collisions occurred under wet or winter conditions suggesting that road conditions may be a contributing factor to collisions.
- Approximately 80 percent of crashes occurred during daylight or lighted conditions, suggesting that lighting is likely not an issue at this intersection.

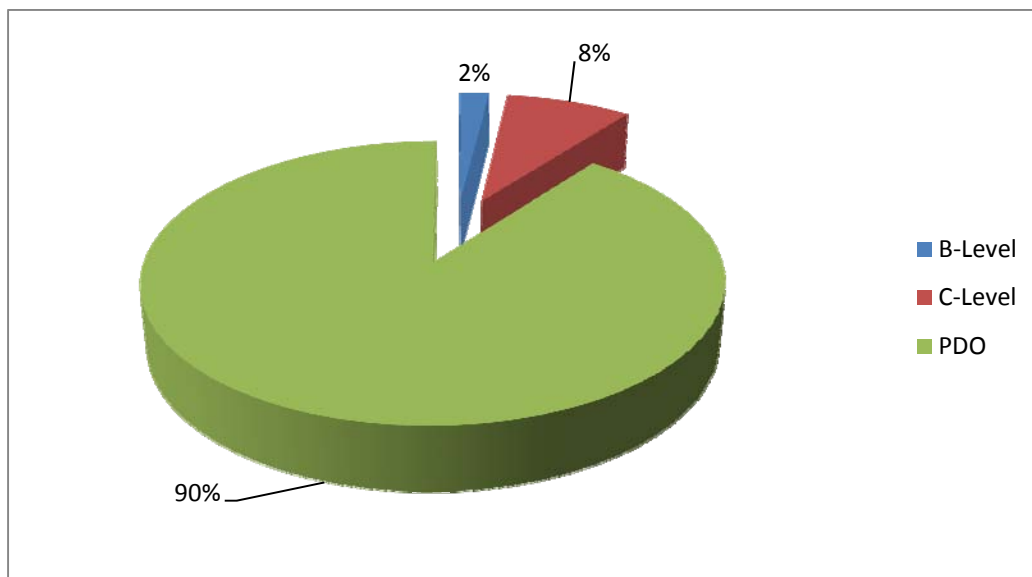
**Figure 8-5 COLLISION SEVERITY DISTRIBUTION: ROCHESTER ROAD AND MEIJER DRIVEWAYS**

Crash data for the years of 2006 to 2008 were provided by MDOT and the Office of Highway Safety Planning's website. Over the three years analyzed, 154 collisions were recorded at or near the intersection. As summarized in **Figure 8-5**, 10 percent of the collisions resulted in at least one injury. The remainder of the collisions involved property damage only. No fatalities were reported during the study period.

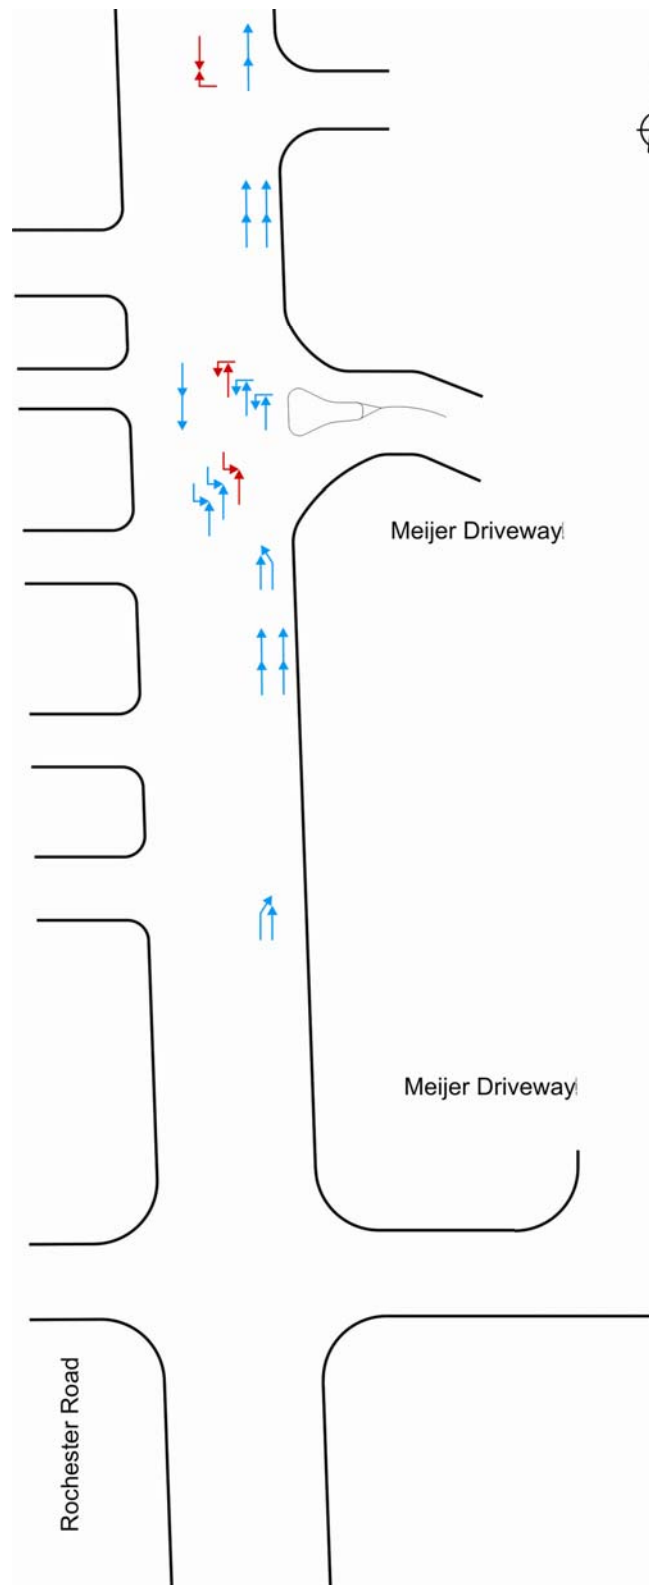
Figure 8-7 COLLISION DIAGRAM: ROCHESTER ROAD AND MEIJER DRIVEWAYS

Collision type distribution is summarized in **Figure 8-6**, and a collision diagram is shown in **Figure 8-7**. The collision diagram illustrates crashes in which UD-10's were available from [michigantrafficcrashfacts.org](http://michigantrafficcrashfacts.org). The following collision trends were observed:

- The highest frequency of collisions occurred during the month of December.
- Hourly distributions show a higher frequency of crashes between 2:00 and 3:00 pm, approximately when schools release.
- Thirty-one percent of collisions occurred under wet or winter conditions suggesting that road conditions may be a contributing factor to collisions.
- Approximately 80 percent of crashes occurred during daylight or lighted conditions, suggesting that lighting is likely not an issue at this intersection.

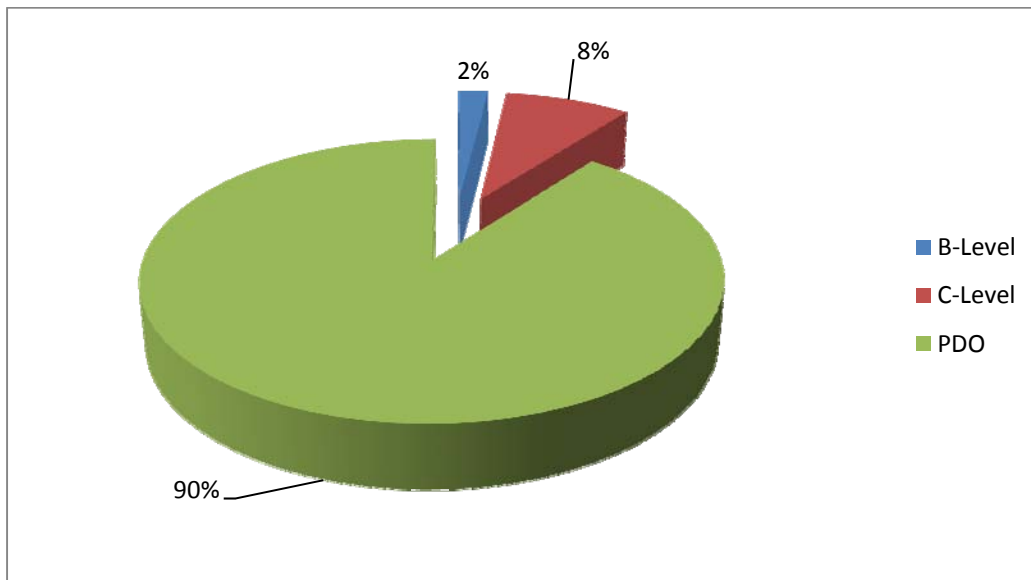
Figure 9-4 COLLISION SEVERITY DISTRIBUTION: ROCHESTER ROAD AND M-59 RAMPS

Crash data for the years of 2006 to 2008 were provided by MDOT and the Office of Highway Safety Planning's website. Over the three years analyzed, 154 collisions were recorded at or near the intersection. As summarized in **Figure 9-4**, 10% of collisions resulted in at least one injury. The remainder of the collisions involved property damage only. No fatalities were reported during the study period.

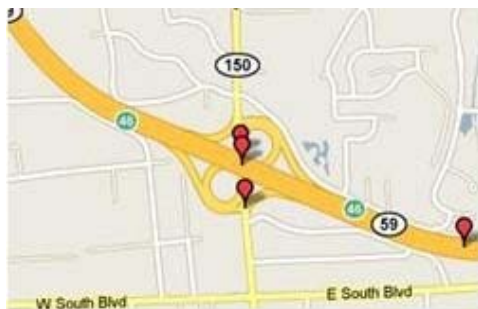
Source : [michigantrafficcrashfacts.org](http://michigantrafficcrashfacts.org)

- Rear-end collisions predominated, accounting for 48 percent of all recorded collisions.
- Angle collisions accounted for 29 percent of the 3-year total collisions.
- According to [michigantrafficcrashfacts.org](http://michigantrafficcrashfacts.org), three pedestrian crashes occurred between 2004 and 2008 within the limits of the interchange (right).

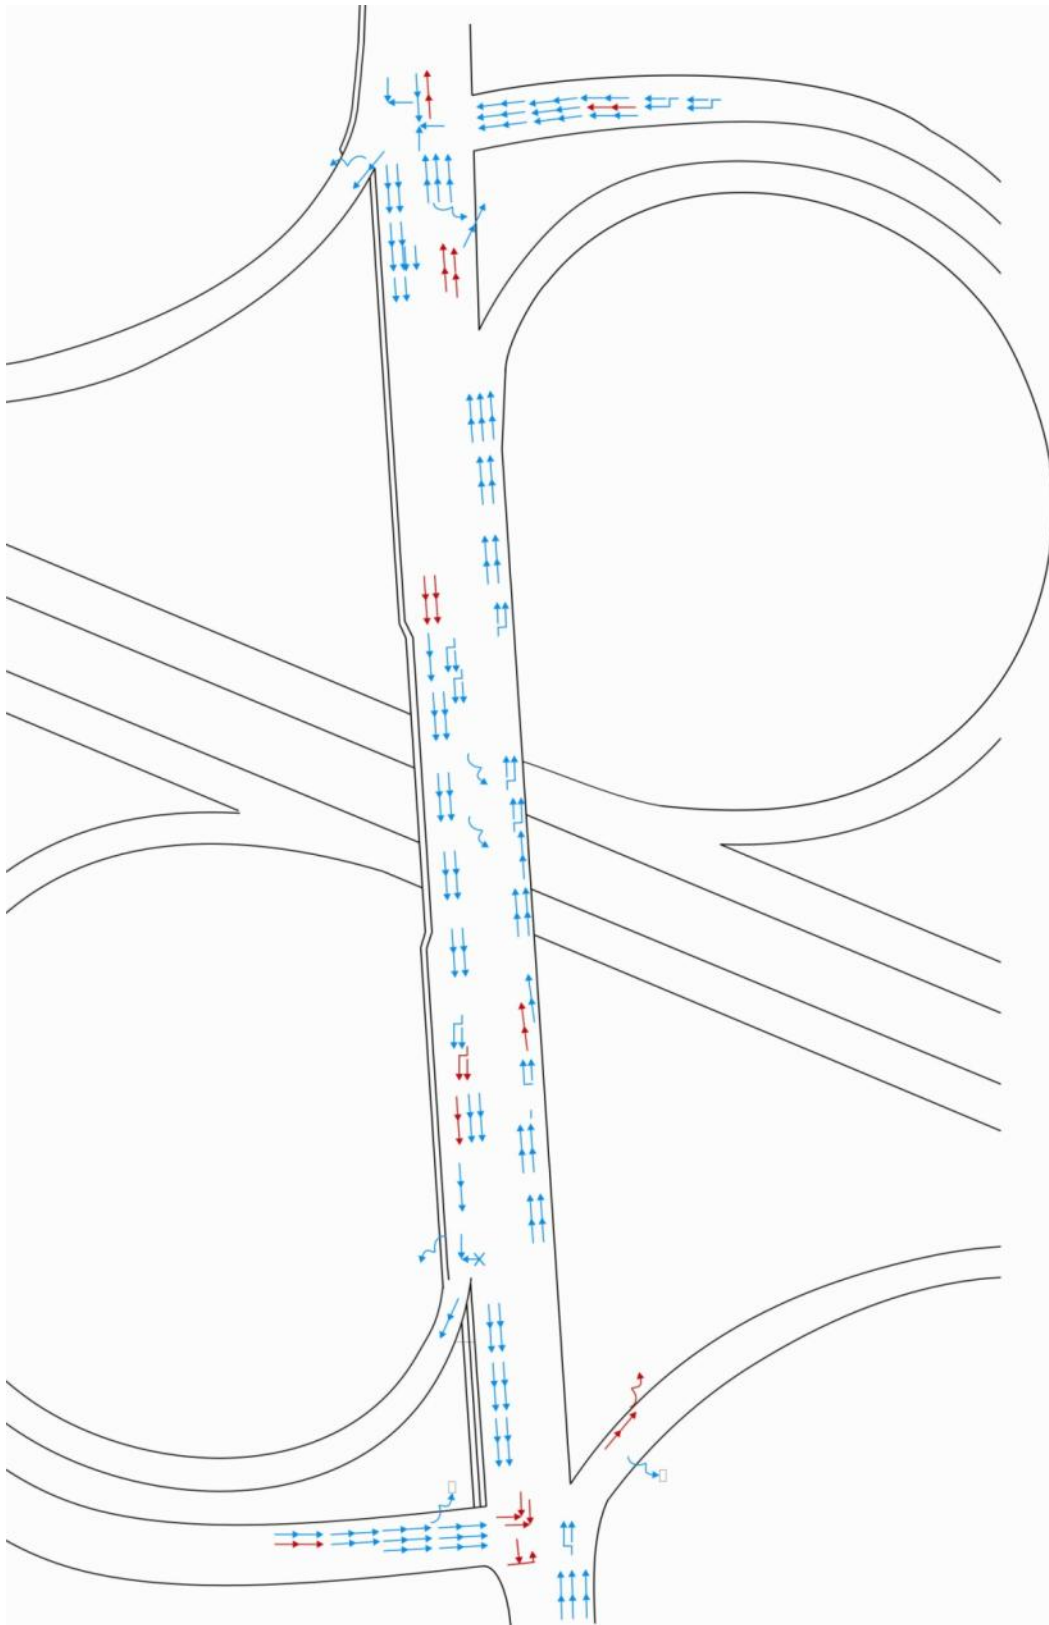
**Figure 9-6 COLLISIONS DIAGRAM: ROCHESTER ROAD AND M-59 RAMPS**

Collision type distribution is summarized in **Figure 9-5**. A collision diagram is provided in **Figure 9-6**. The collision diagram illustrates crashes which UD-10 reports were available using [michigantrafficcrashfacts.org](http://michigantrafficcrashfacts.org). The following collision trends were observed:

- The highest frequency of collisions occurred during the month of December.
- Hourly distributions show a higher frequency of crashes between 2:00 and 3:00 PM, approximately when schools release.
- Thirty-one percent of collisions occurred under wet or winter conditions suggesting that road conditions may be a contributing factor to collisions.
- Approximately 80 percent of crashes occurred during daylight or lighted conditions, suggesting that lighting is likely not an issue at this intersection.
