ROAD SAFETY AUDIT

# **ROCHESTER ROAD CORRIDOR**

# **OAKLAND COUNTY**

FINAL REPORT

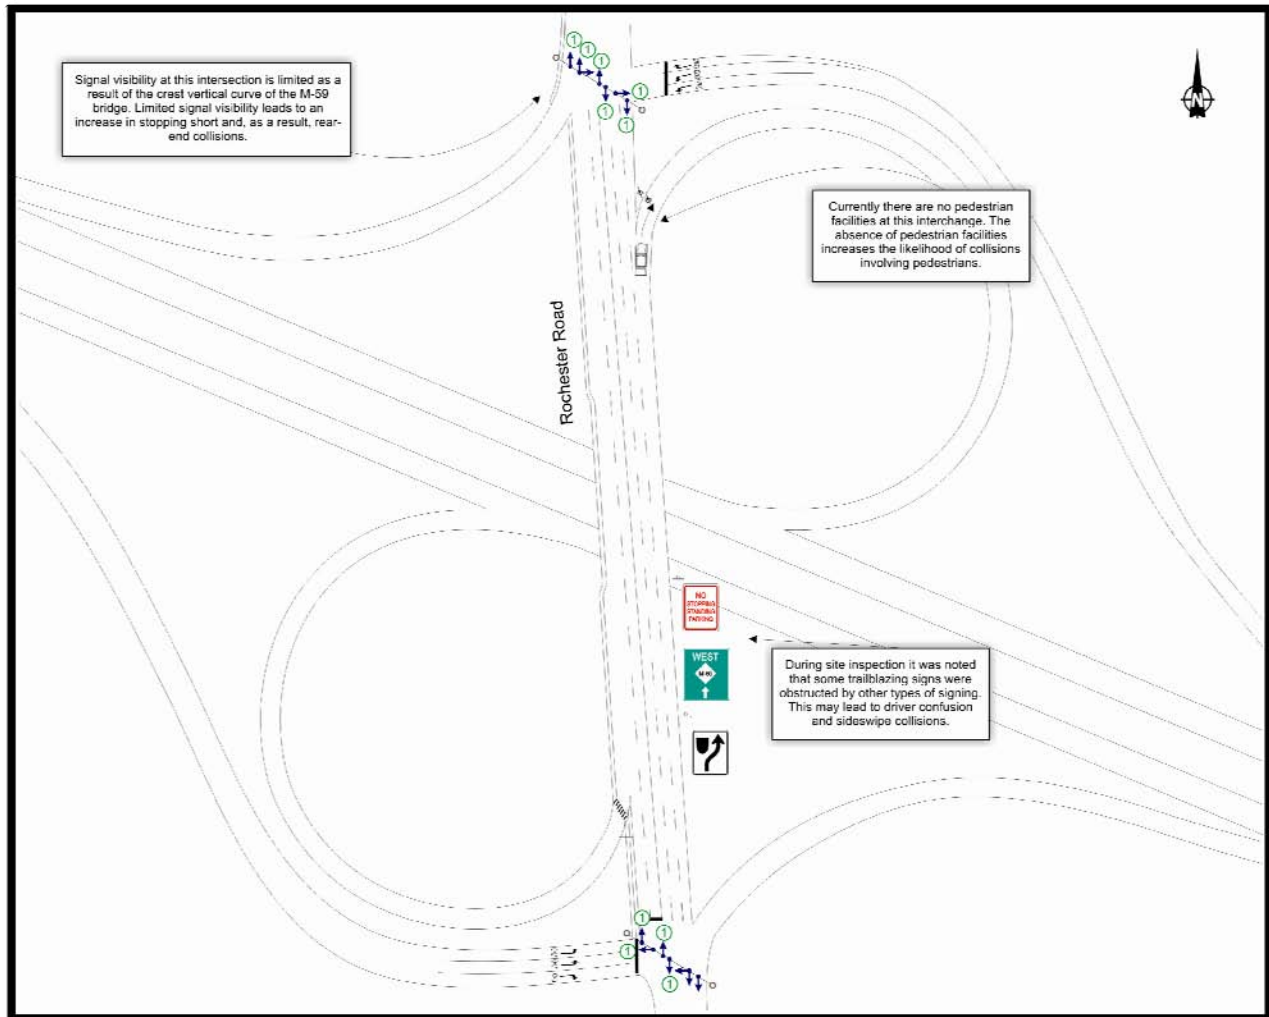
Figure 9-7 ISSUES DIAGRAM: ROCHESTER ROAD AND M-59 RAMPS

### *Issue 1: Signal Visibility*

The visibility of the ramp terminal traffic signals is limited for drivers on Rochester Road as they proceed over the bridge. This is due to the vertical crest curve of the bridge. The modernization of the signals from a diagonal span to a box span is expected to further complicate this issue as the signals will be located even further down the horizon for approaching drivers. The limited signal visibility may lead to an increased risk for rear-end and angle collisions.

### *Issue 2: Signing*

Several of the freeway guide signs on Rochester Road at the interchange are blocked by other signing. Limited visibility of guide signing within an interchange signing can result in driver confusion, leading to weaving, and other erratic movements.

### *Issue 3: Non-Motorized Facilities*

Currently, there are no non-motorized facilities within the interchange. During the site visit, numerous pedestrians were observed walking through the interchange on Rochester Road. Additionally, evidence of pedestrian use such as worn paths on both sides of Rochester Road indicated that this is likely a key link for pedestrians. Additionally, non-motorized pathways networks are located on both sides of the interchange and terminate as a pedestrian enters the functional area of the interchange. Three pedestrian crashes occurred within the interchange between 2004 and 2008. Risk for a pedestrian crash in this area is increased by the presence of continuous flow loop ramps as well as by the high speeds of vehicles traveling through the interchange. A lack of non-motorized facilities through the interchange increases the risk that additional serious pedestrian collisions will occur.

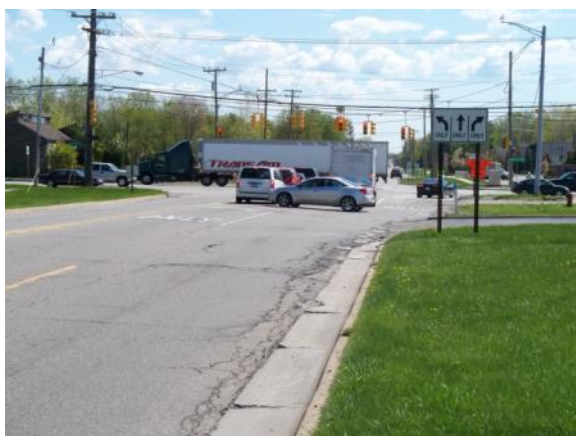
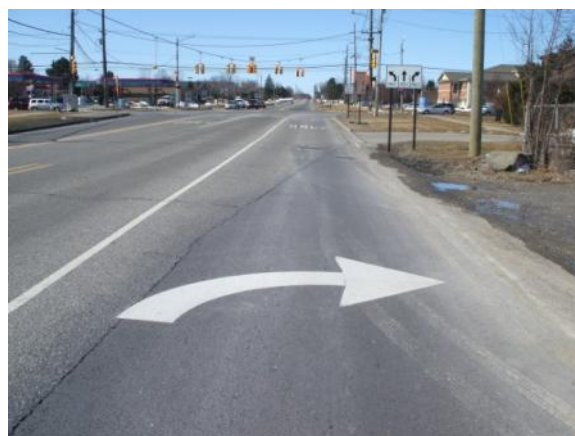
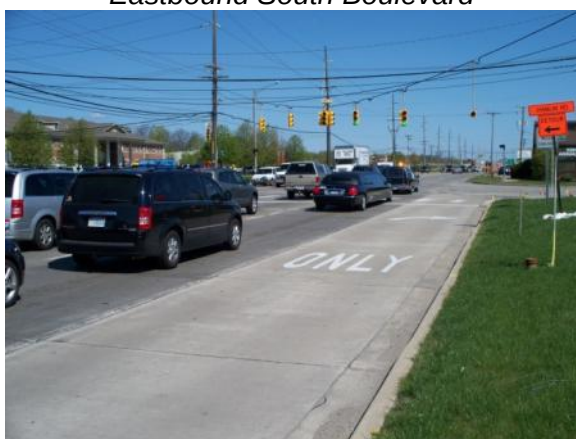
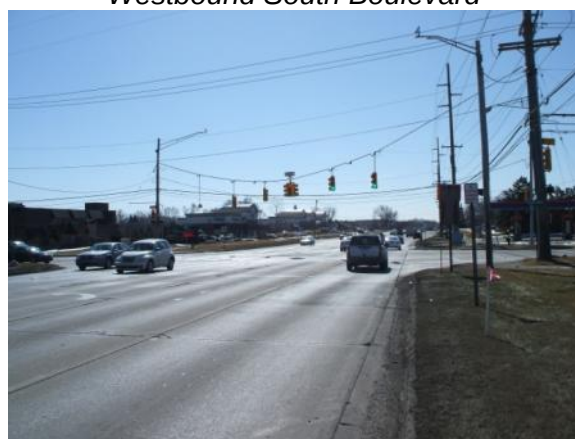
**Figure 10-2 SITE PHOTOGRAPHS: ROCHESTER ROAD AND SOUTH BOULEVARD**

- *Close proximity to the M-59/M-150 interchange.*
- *Some worn pavement markings.*

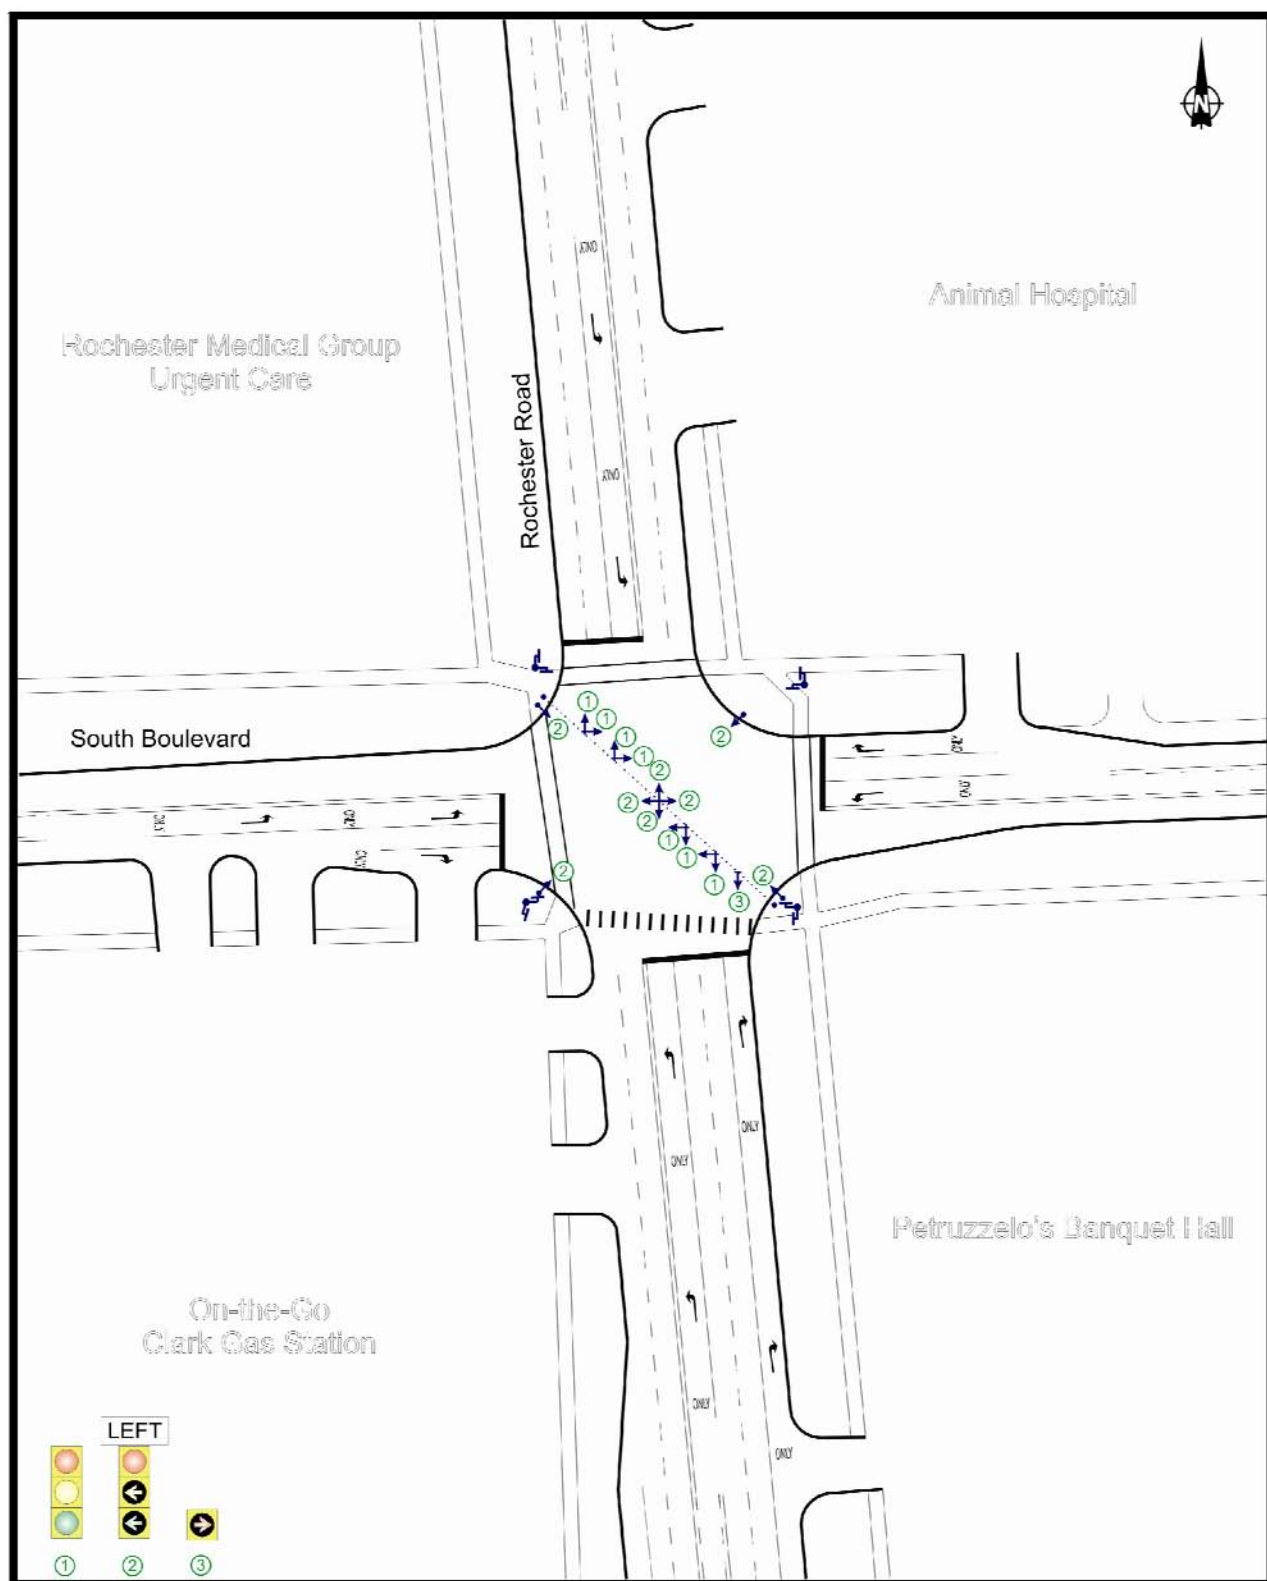
Figure 10-3 SIGNALS DIAGRAM: ROCHESTER ROAD AND SOUTH BOULEVARD

The traffic signal display is shown schematically within **Figure 10-3**. Four signal heads are provided on each of the approaches including three overhead span wire signals and one far left post mounted signal. All signal heads have twelve-inch lenses. There are no blackplates provided at this intersection. The signal operates with lagging permissive-protected left-turn phasing on all approaches. Pedestrian signal heads are provided for all crosswalks. The pedestrian signals are push-button actuated across all legs.

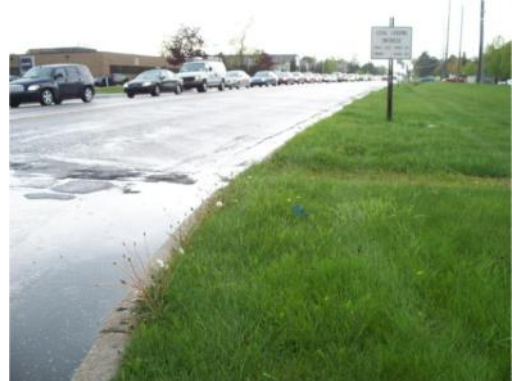
### *Issue 1: Wet Weather Conditions*

Based on the crash data analysis, this intersection has a drainage issue. During the site visit the RSA team noted drainage grates that appeared to be obstructed with debris. While on site, the RSA team viewed the intersection under moderate rain conditions and confirmed that the intersection was not draining well, resulting in hydroplaning and reduced stopping capacity. Poor drainage of an intersection leads to hydroplaning, loss of control, and an increase in rear-end collisions.

### *Mitigation Measure 1: Wet Weather Conditions*

It is suggested that the drainage be reviewed around the intersection. Once the intakes and the drainage structures are cleaned out, if the intersection continues to have standing water after rain storms, it is suggested that the intersection be repaved.
