# Van Buren Charter Township Wastewater Asset Management Plan

Project No. 171834  
December 16, 2020

**December 16, 2020**  
**Project No. 171834**  
**SAW Grant Project No. 1053-01**

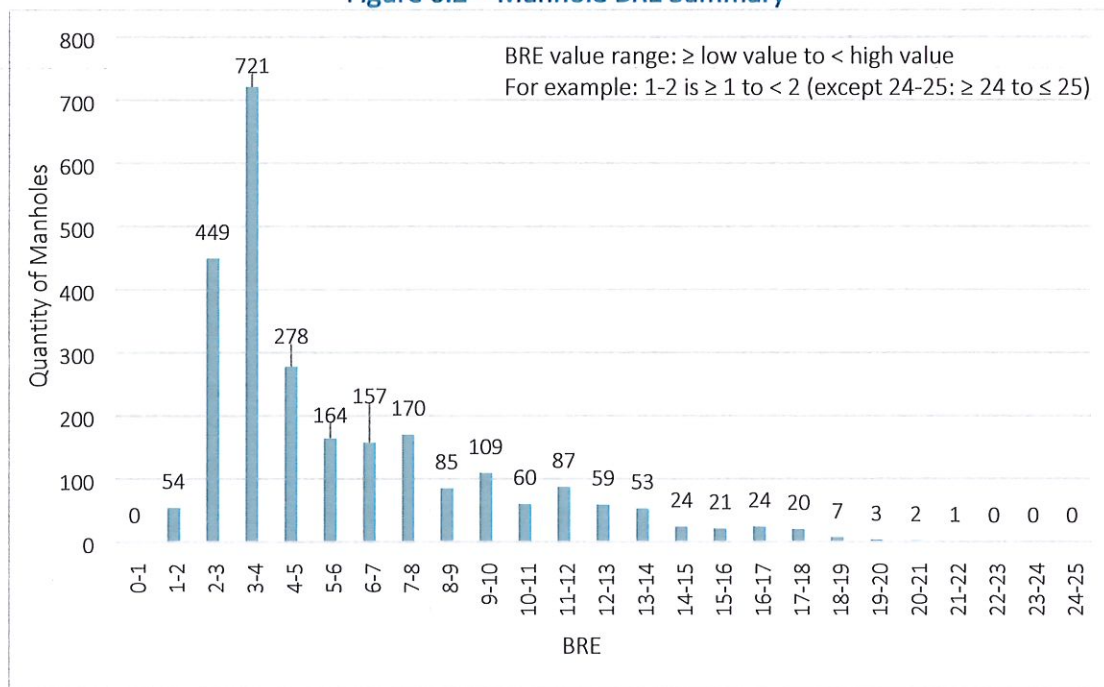
**Figure 6.2 – Manhole BRE Summary**

There were 57 manholes identified with BRE scores greater than or equal to 16.00. Of these manholes, 37 were inspected. The remaining 20 structures were not inspected. The POF for these 20 structures was calculated based only on expended useful life, and this, in combination with high COF scores, resulted in high BRE scores. These structures should be inspected to obtain a better understanding of their current conditions.
