# CITY OF EASTPOINTE

## WASTEWATER ASSET MANAGEMENT PLAN

**AEW Project No. 0145-0458  
MDEQ SAW Grant No. 1417-01**

**Anderson, Eckstein and Westrick, Inc.**

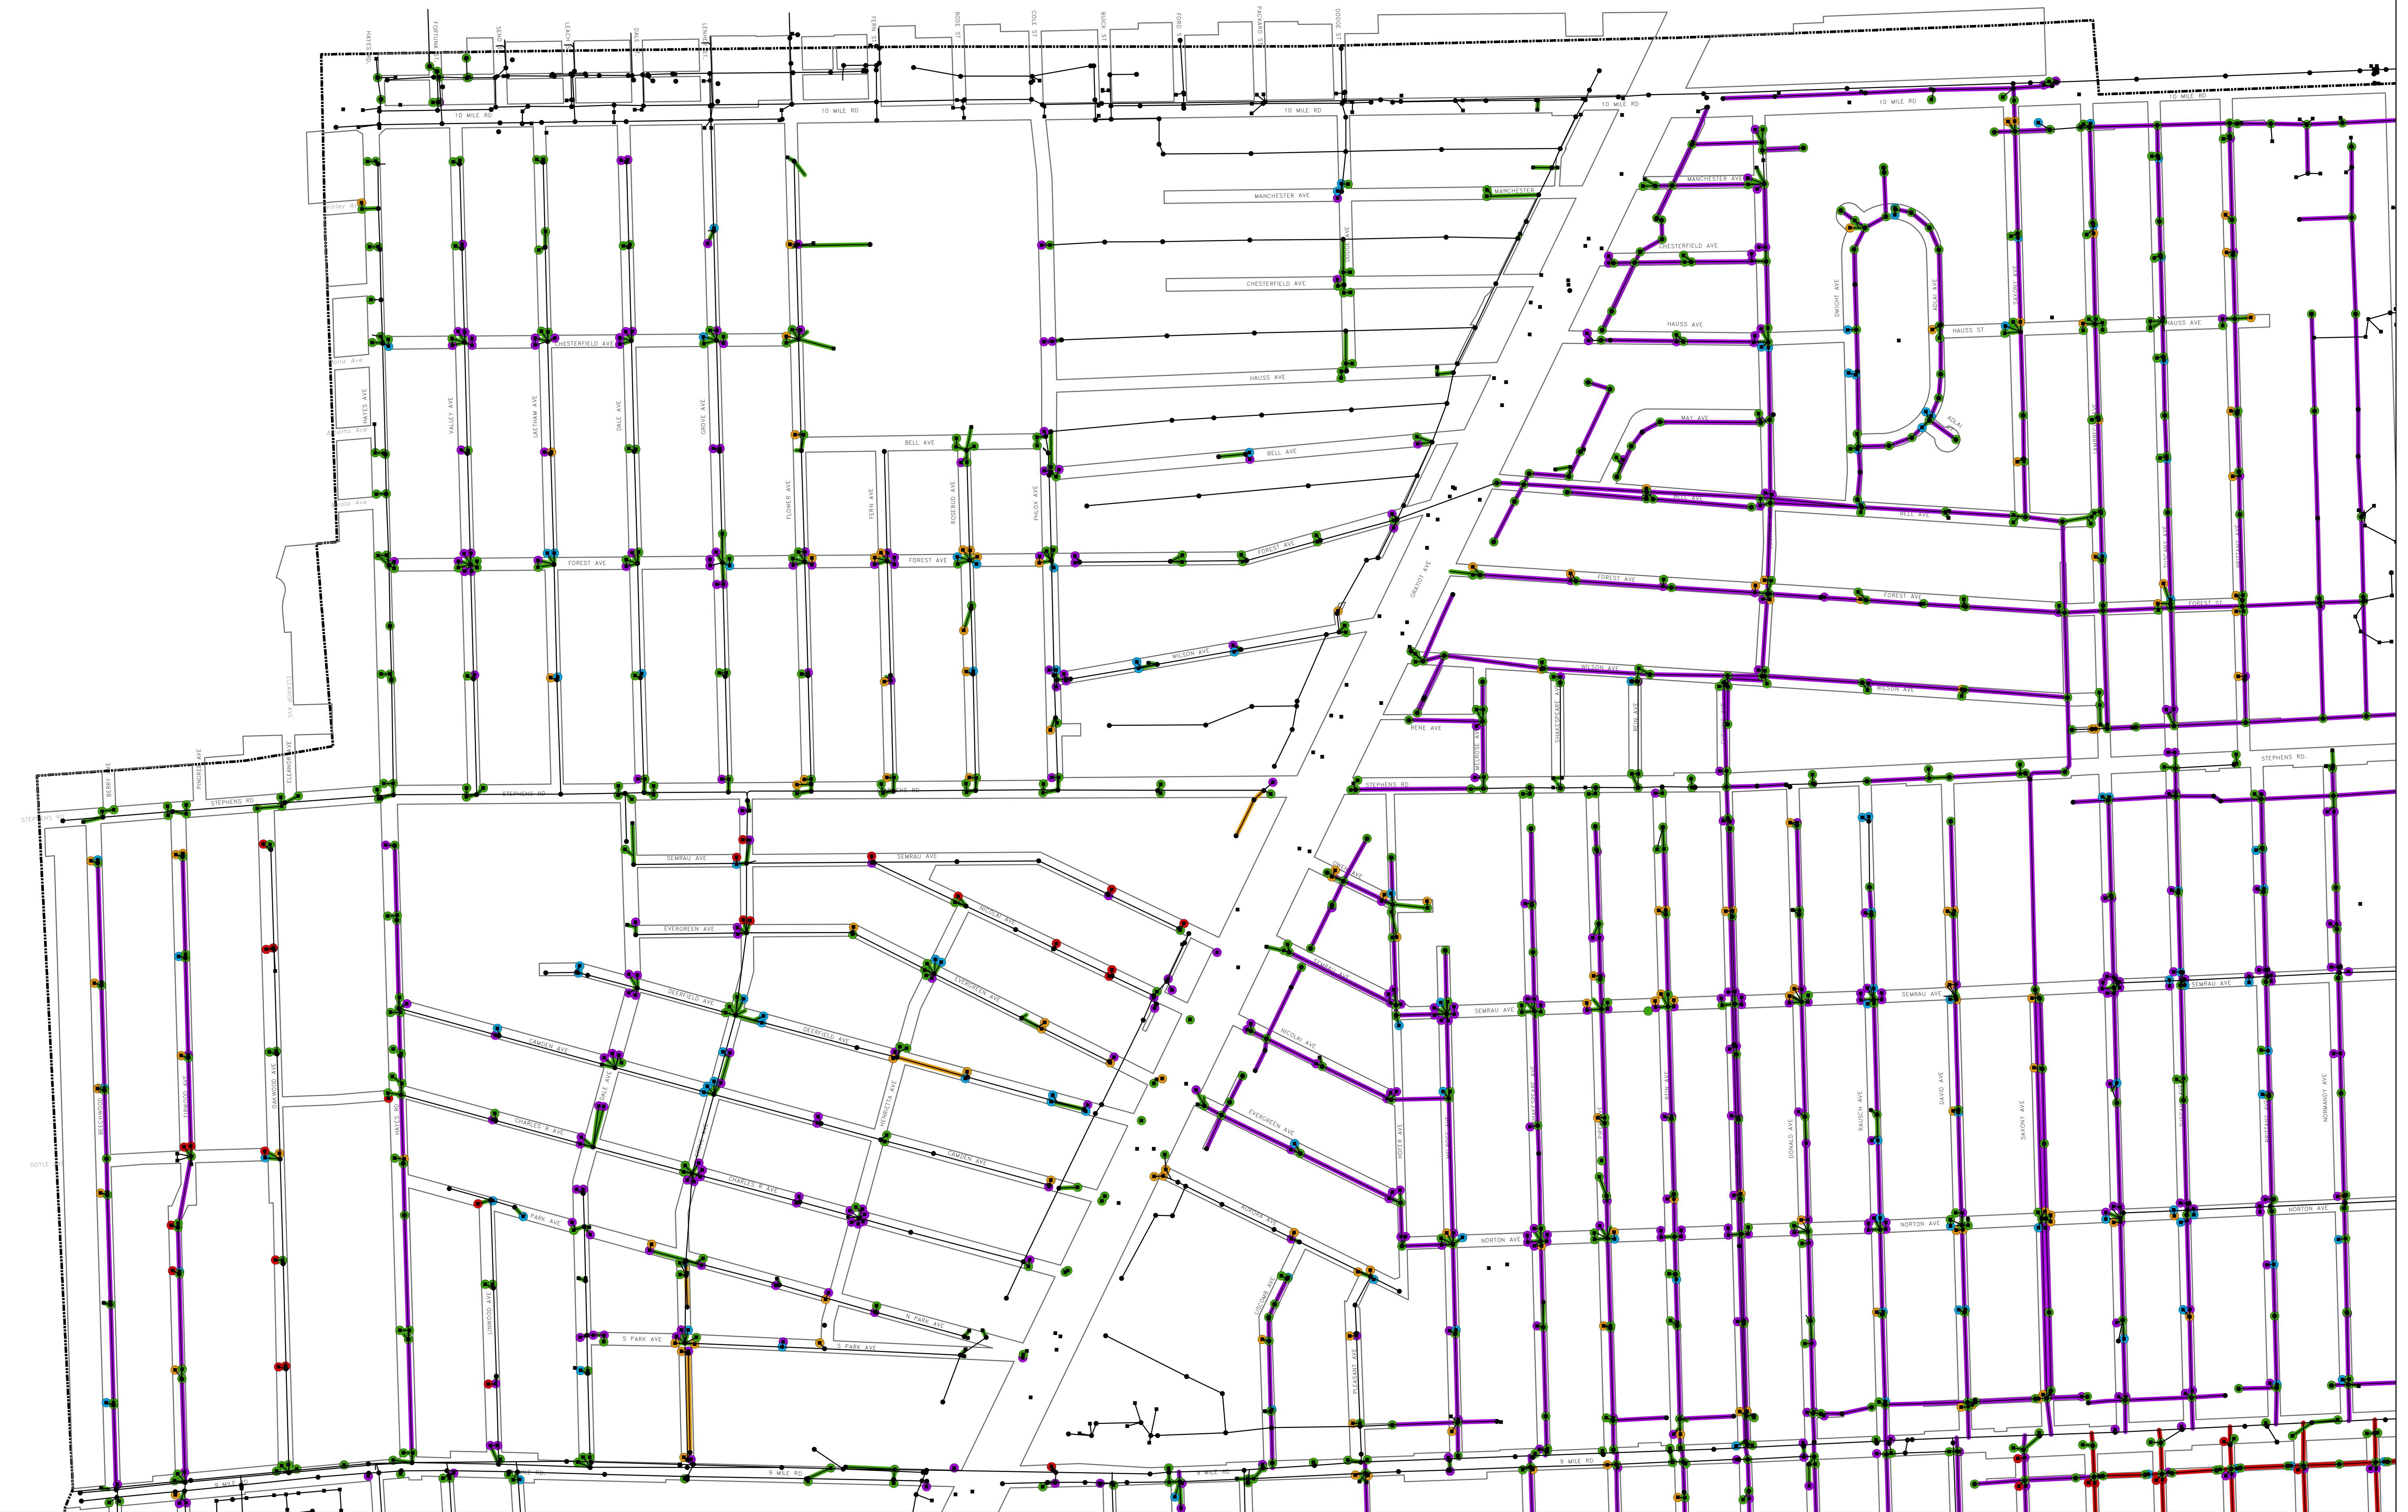
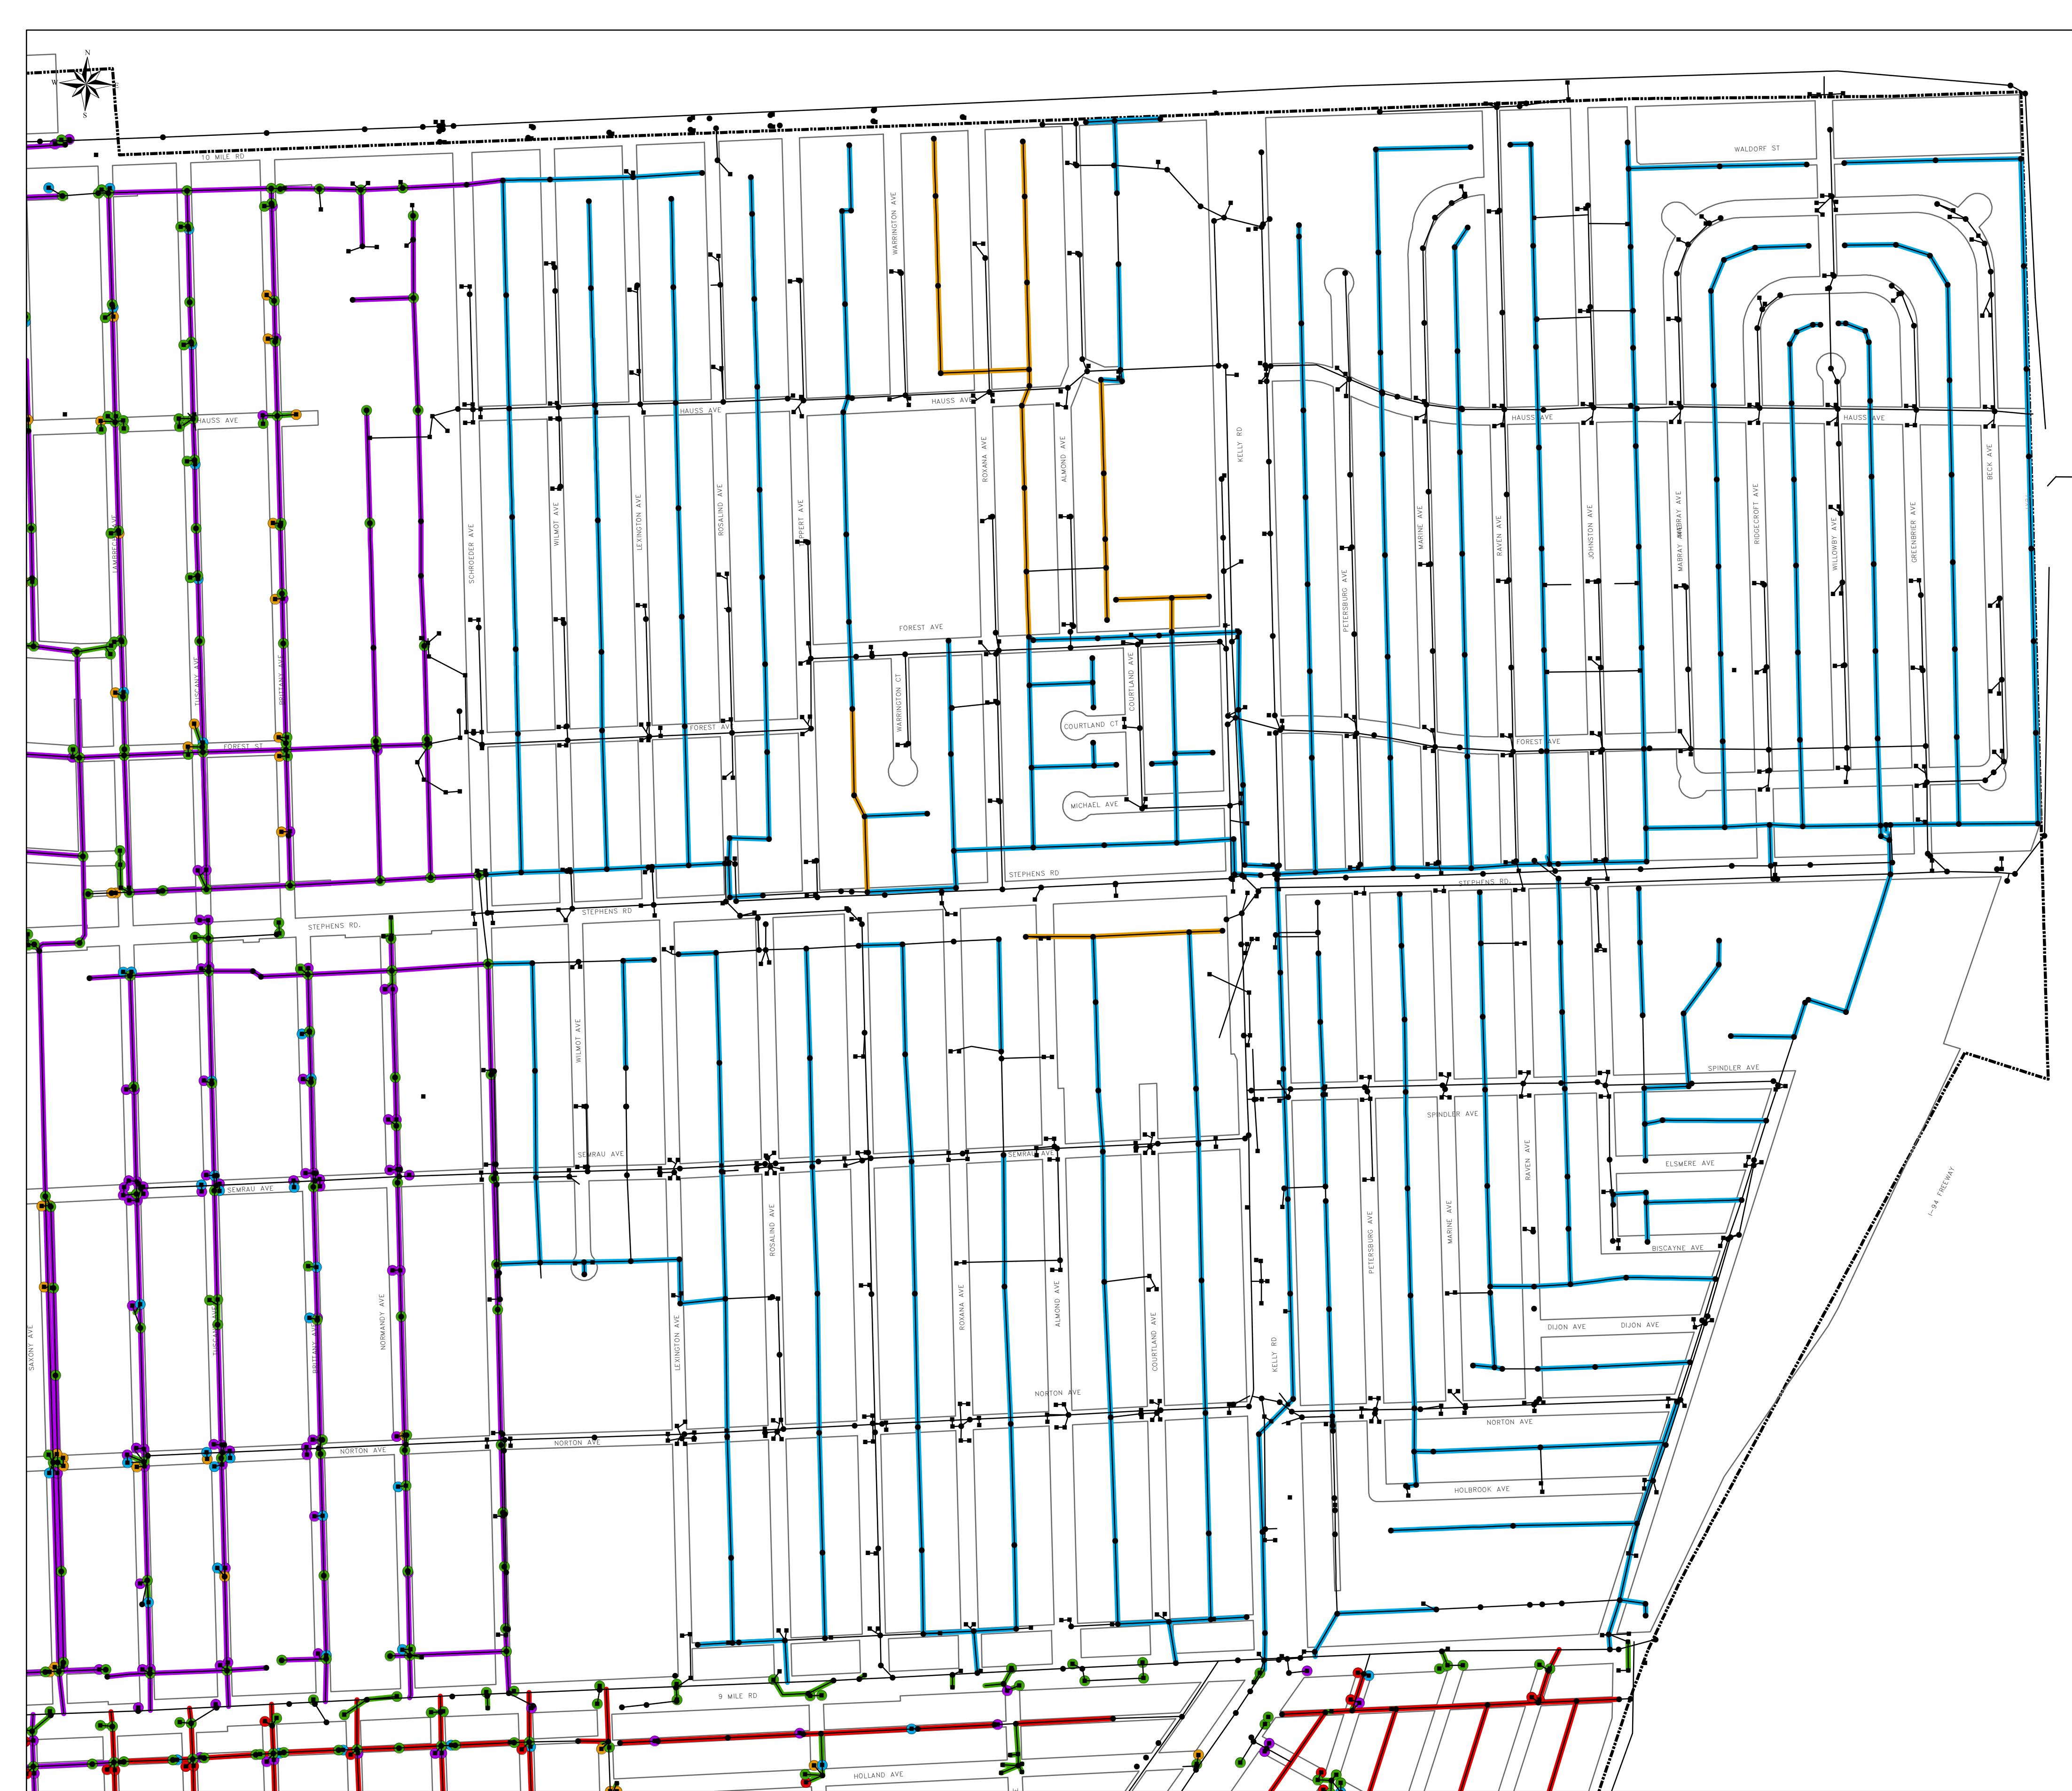
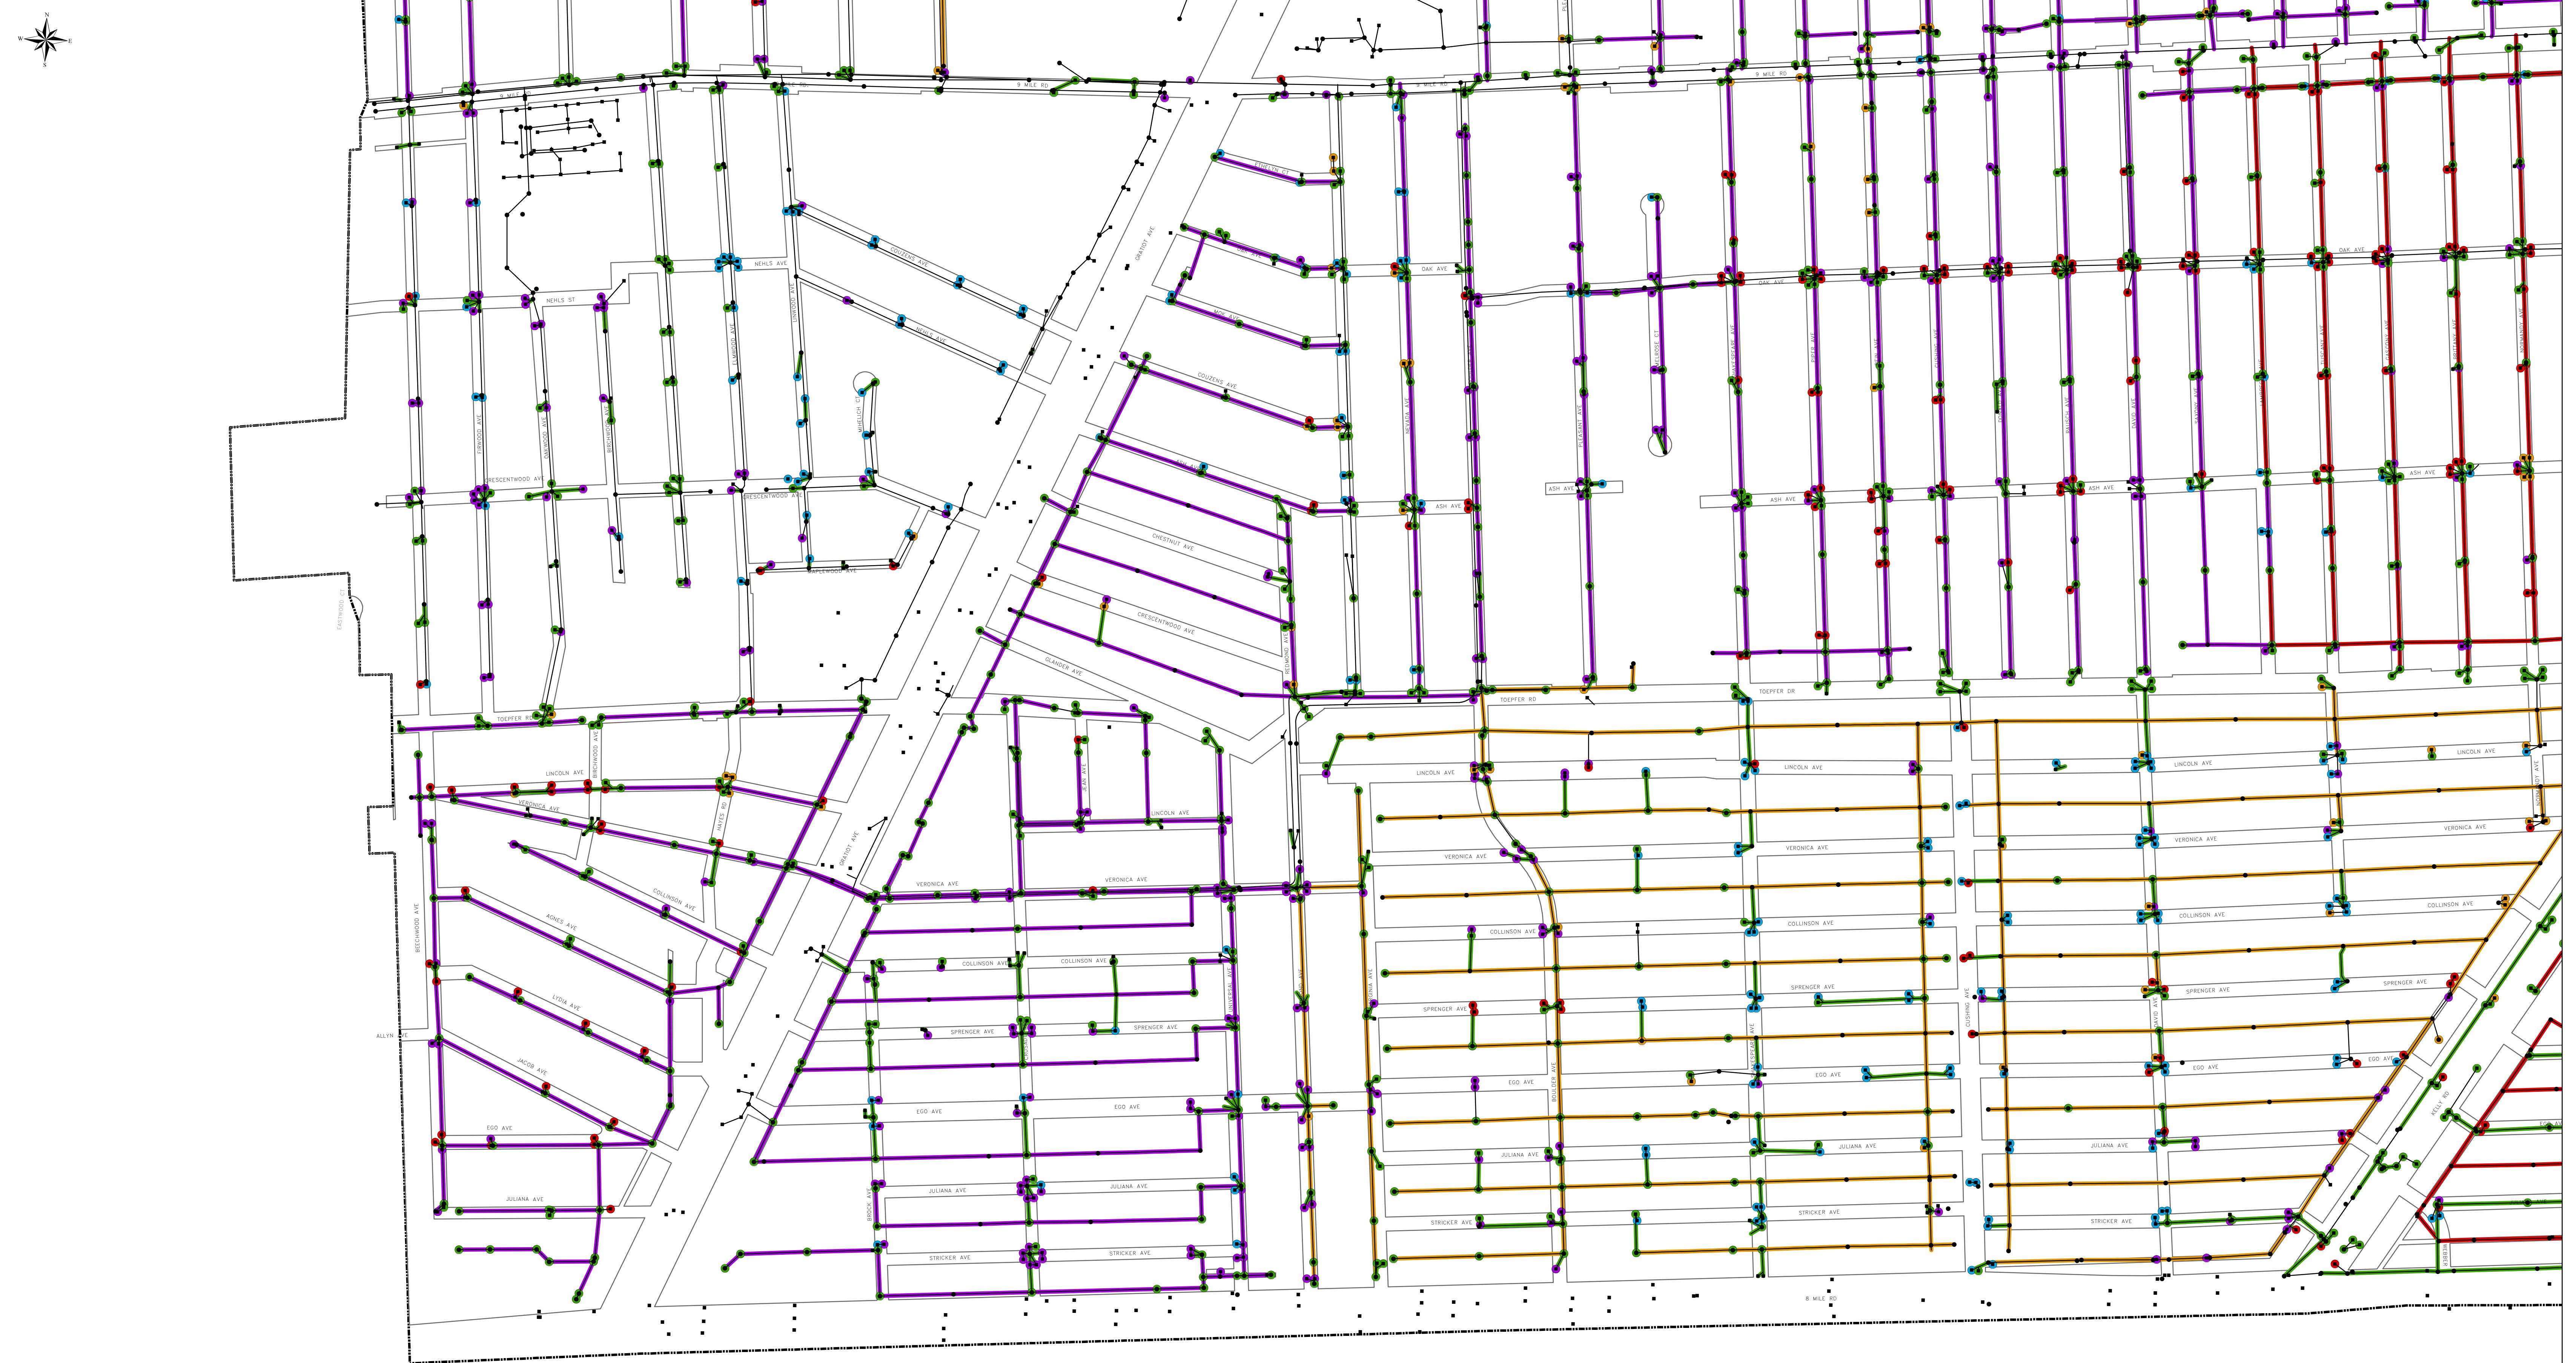
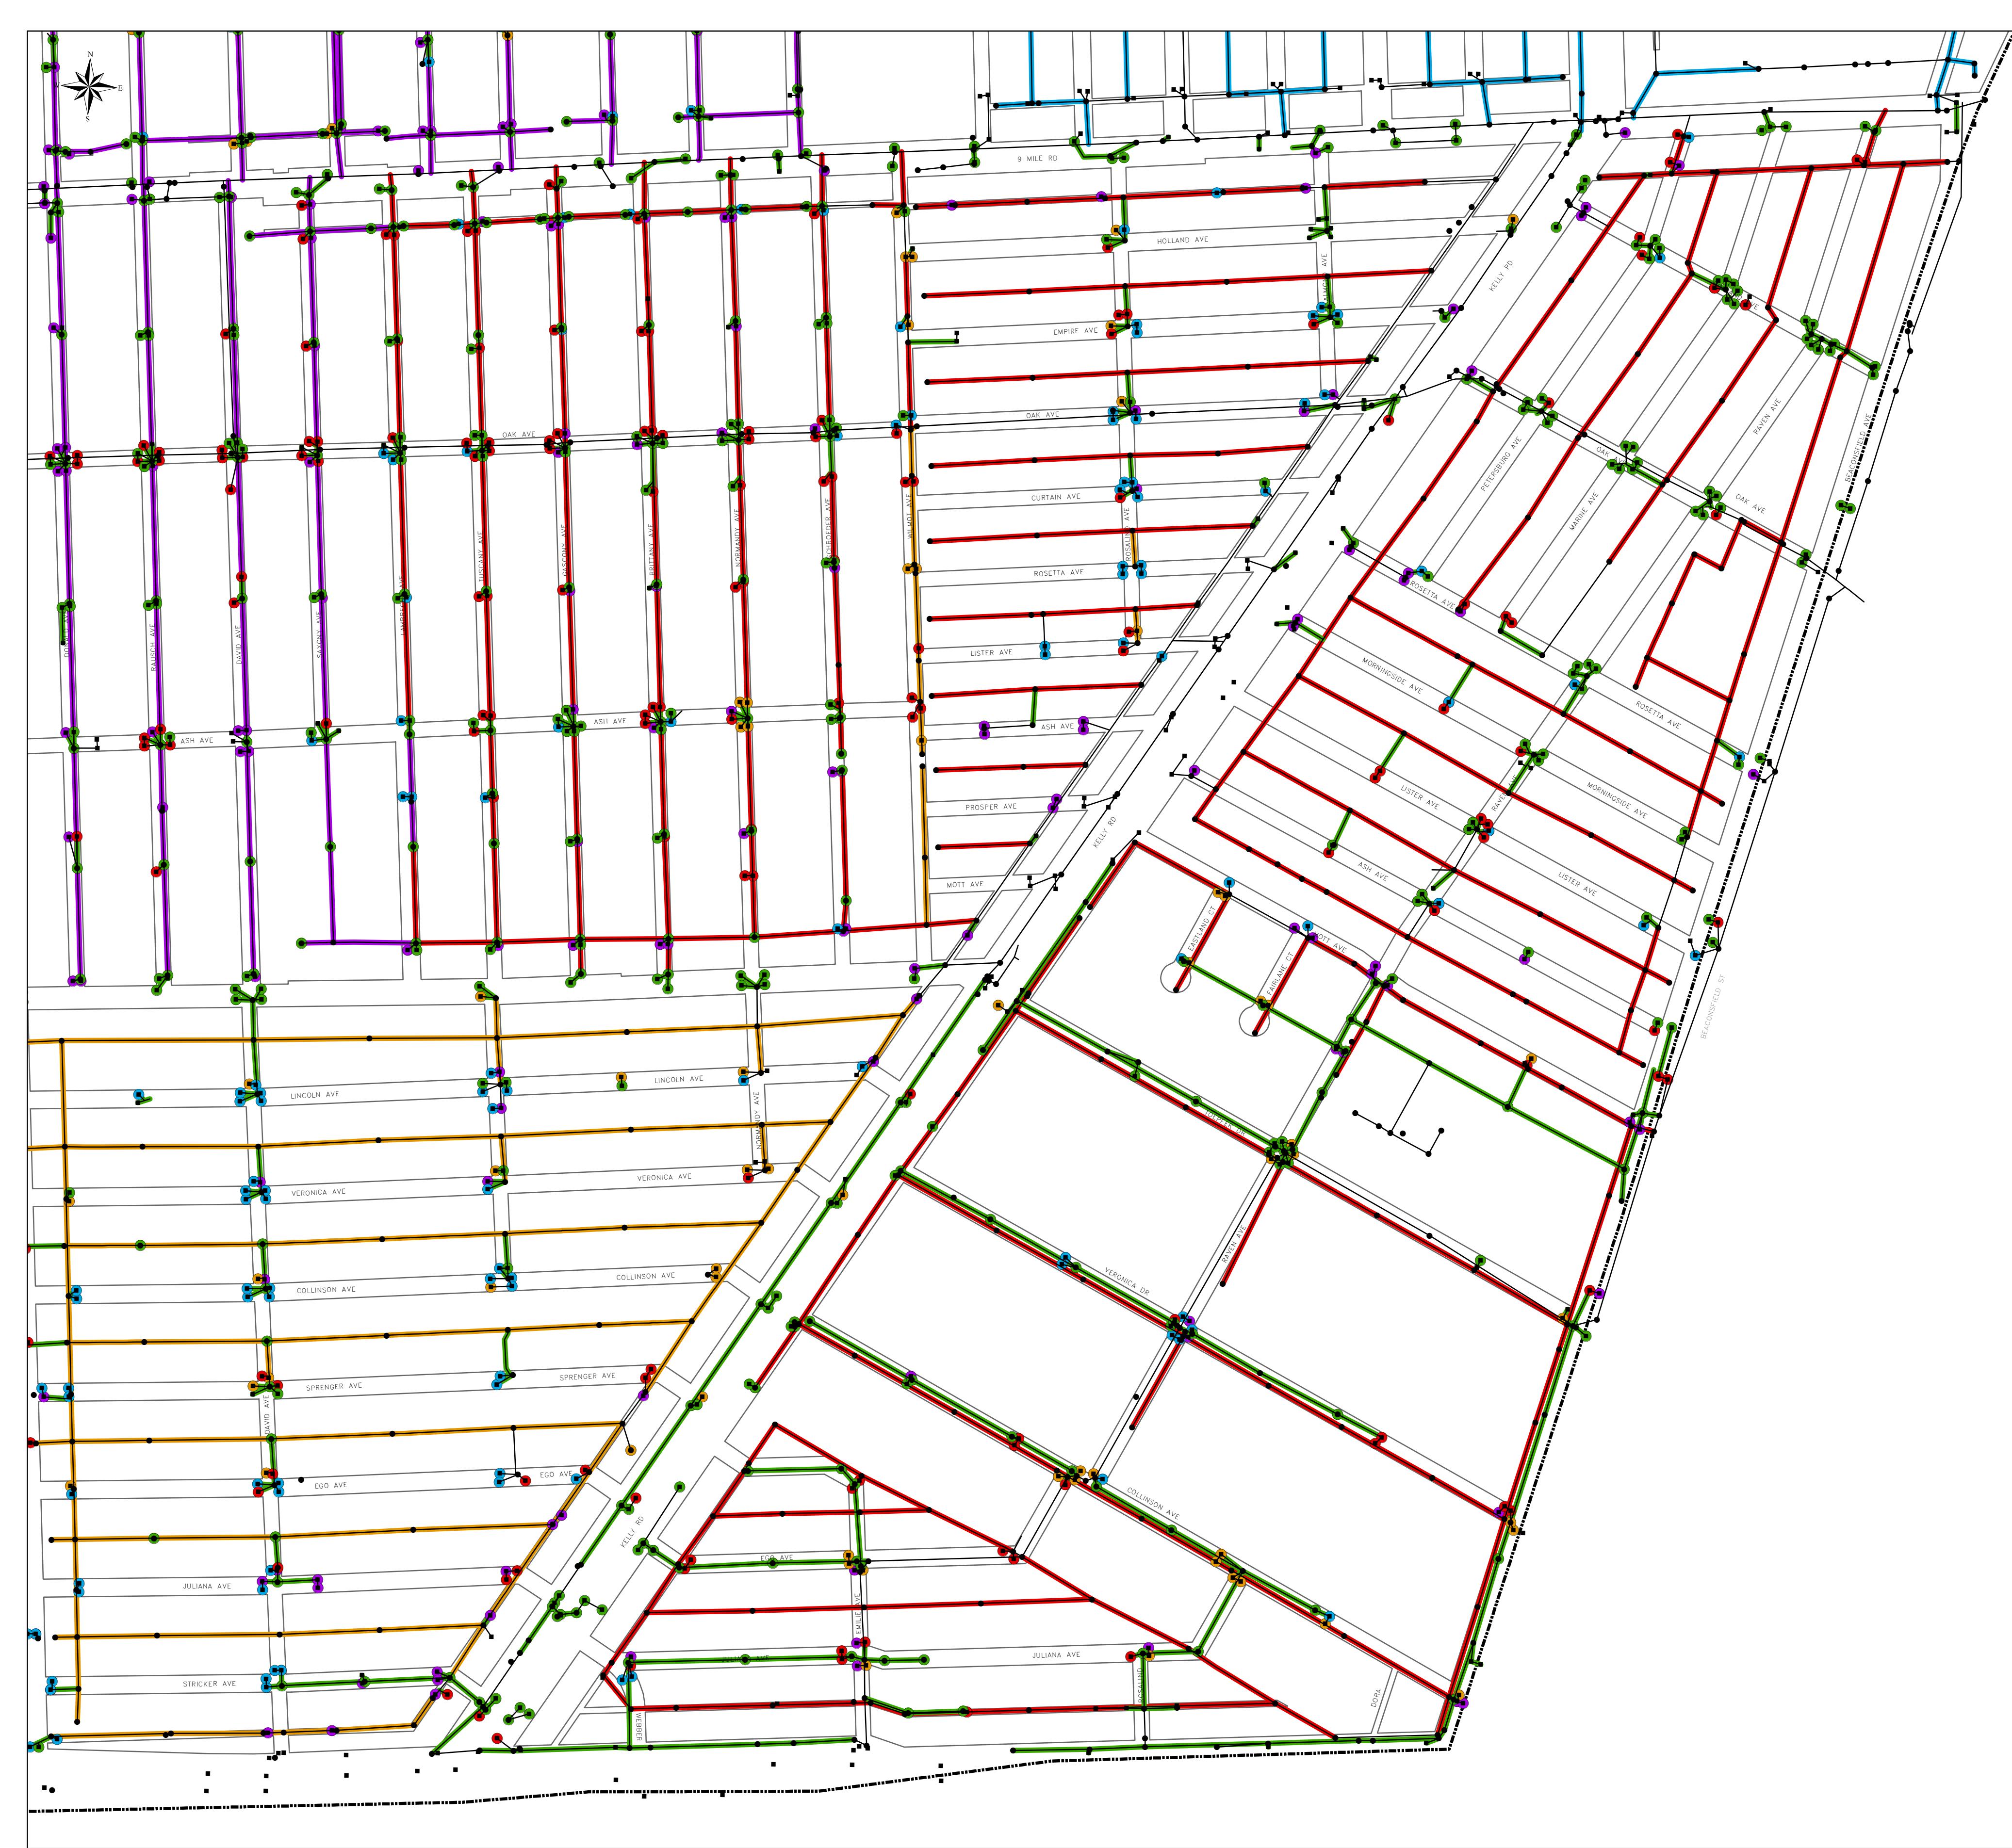
## Appendix A – Investigated Assets Maps

### **Year Investigated**

Year Investigated	
2016	2016
2015 - 2016	2015 - 2016
2013	2013
2011 - 2012	2011 - 2012
2007	2007

The subsequent sections will discuss how the condition assessment was performed, how the POF and COF were calculated, and the resulting criticality score for each asset. Location maps for the wastewater sewers and structures investigated can be found in Appendix A.
