# CITY OF EASTPOINTE

## WASTEWATER ASSET MANAGEMENT PLAN

**AEW Project No. 0145-0458  
MDEQ SAW Grant No. 1417-01**

**Anderson, Eckstein and Westrick, Inc.**

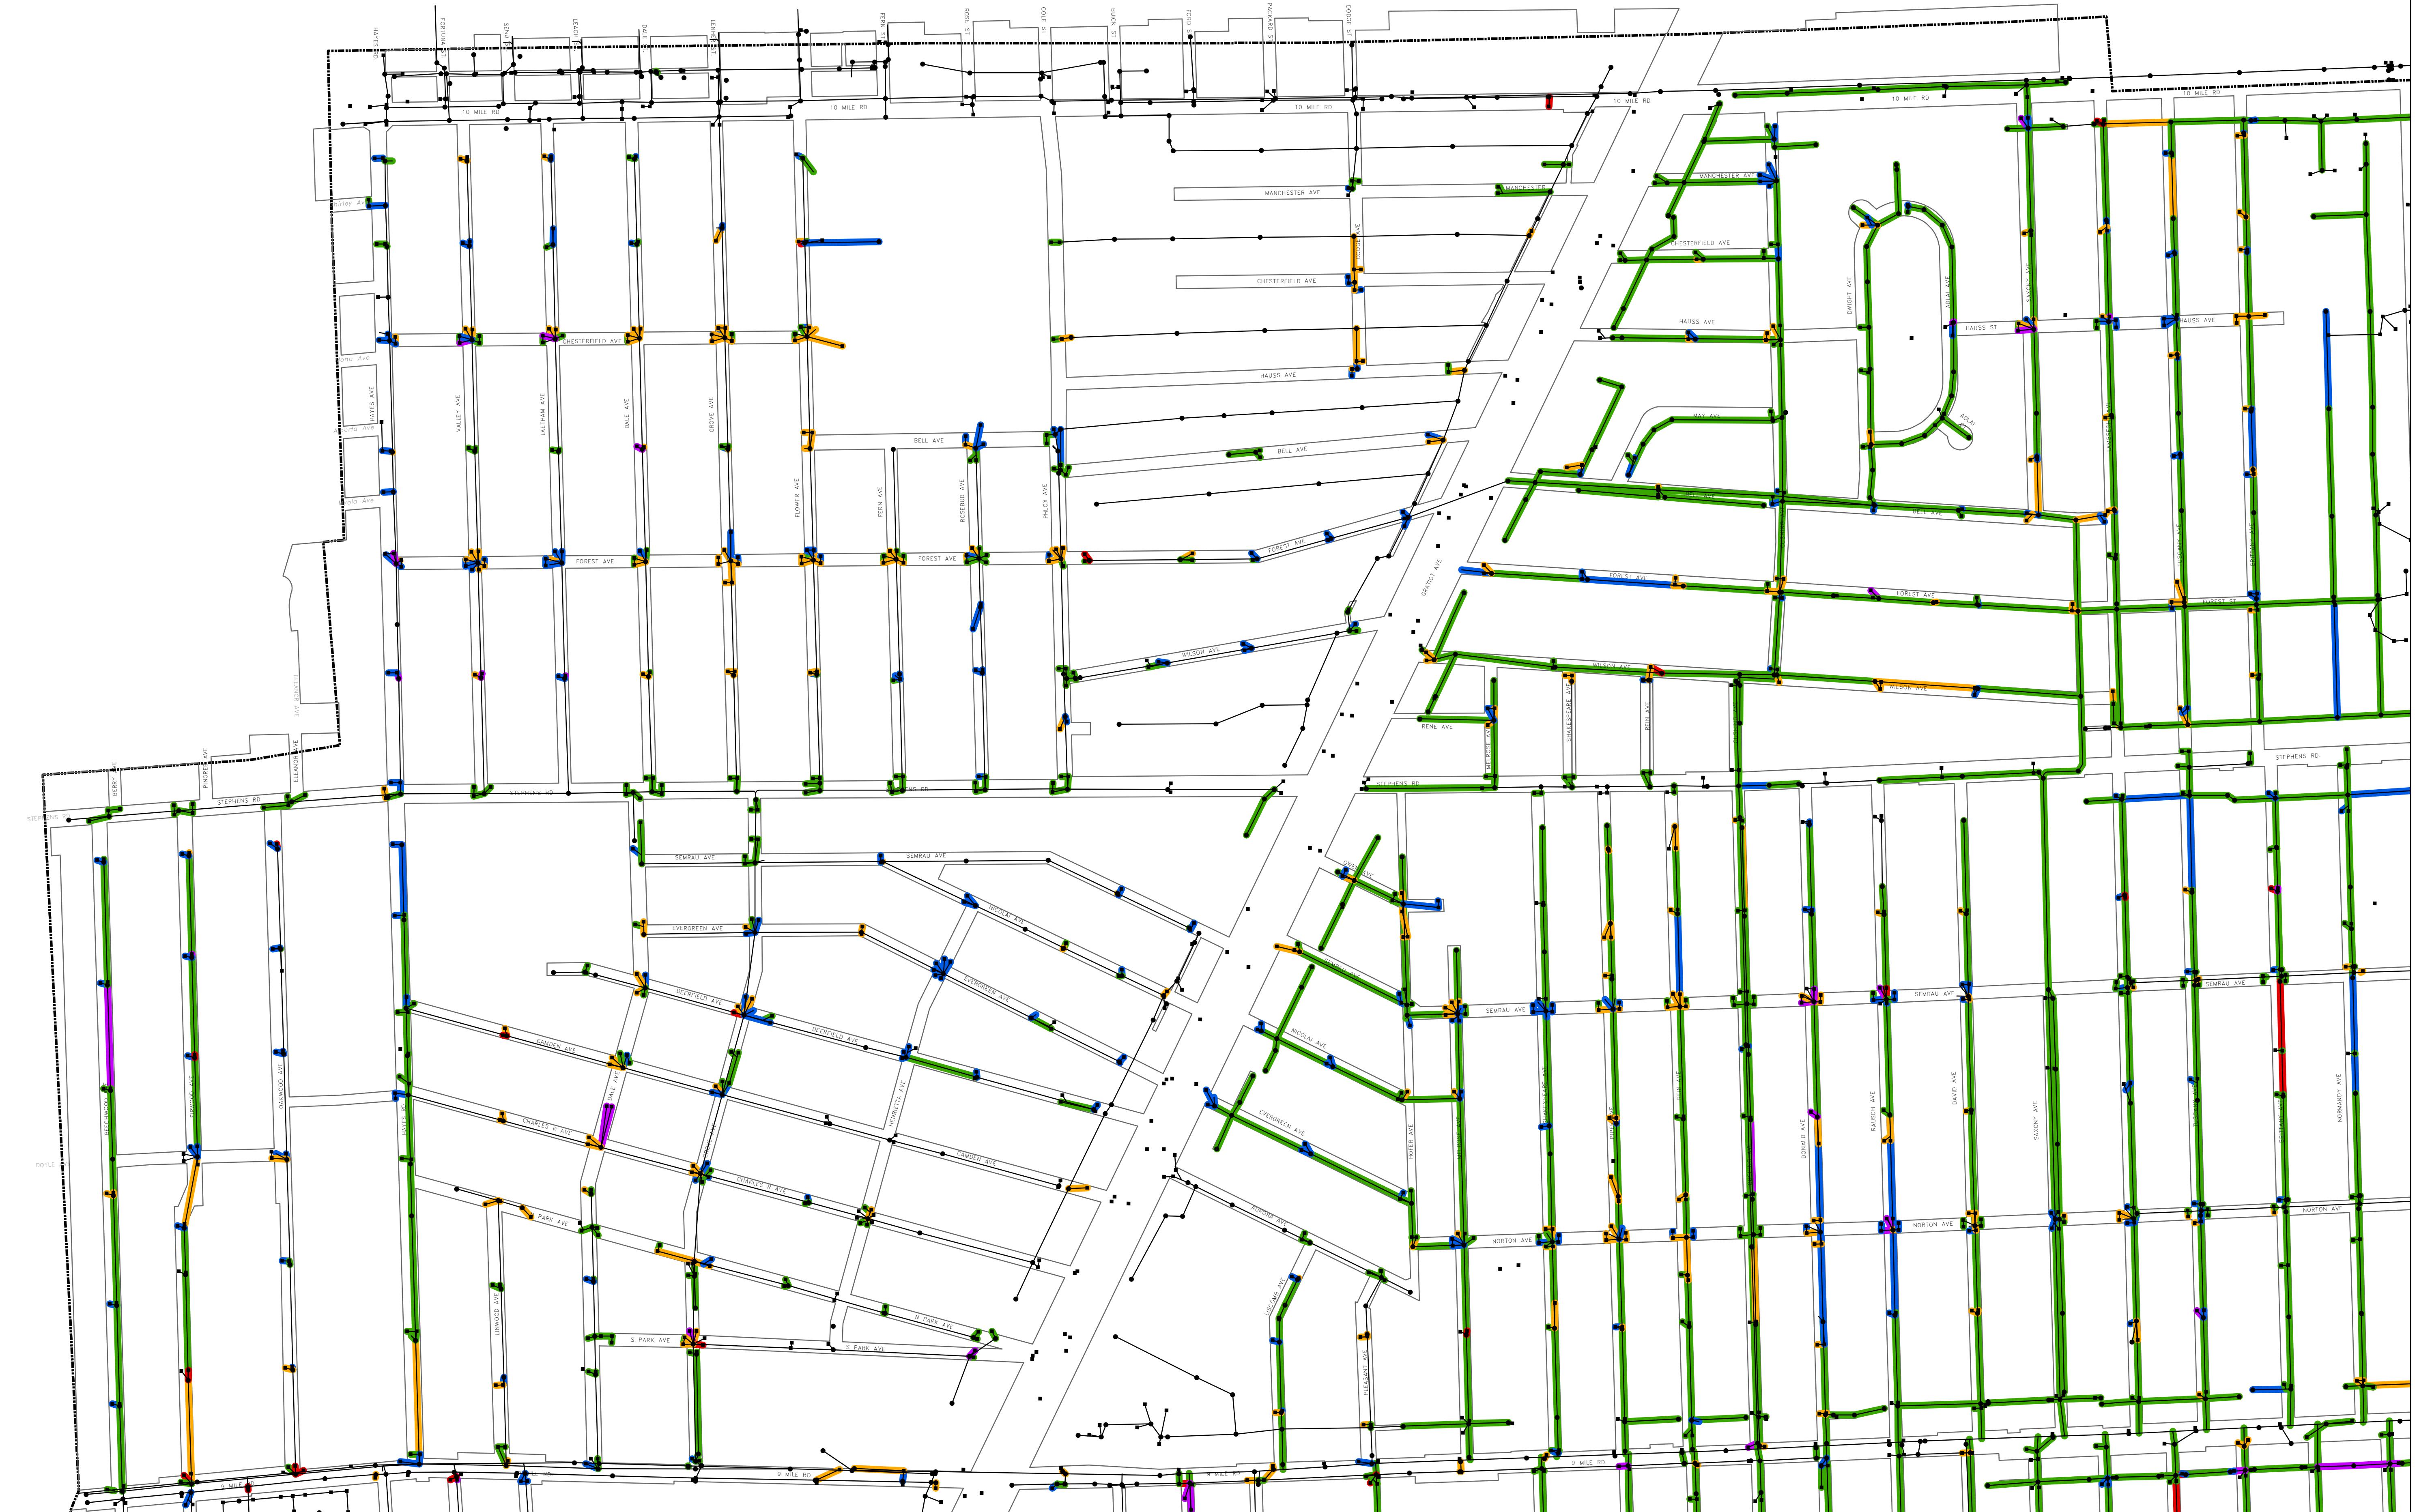
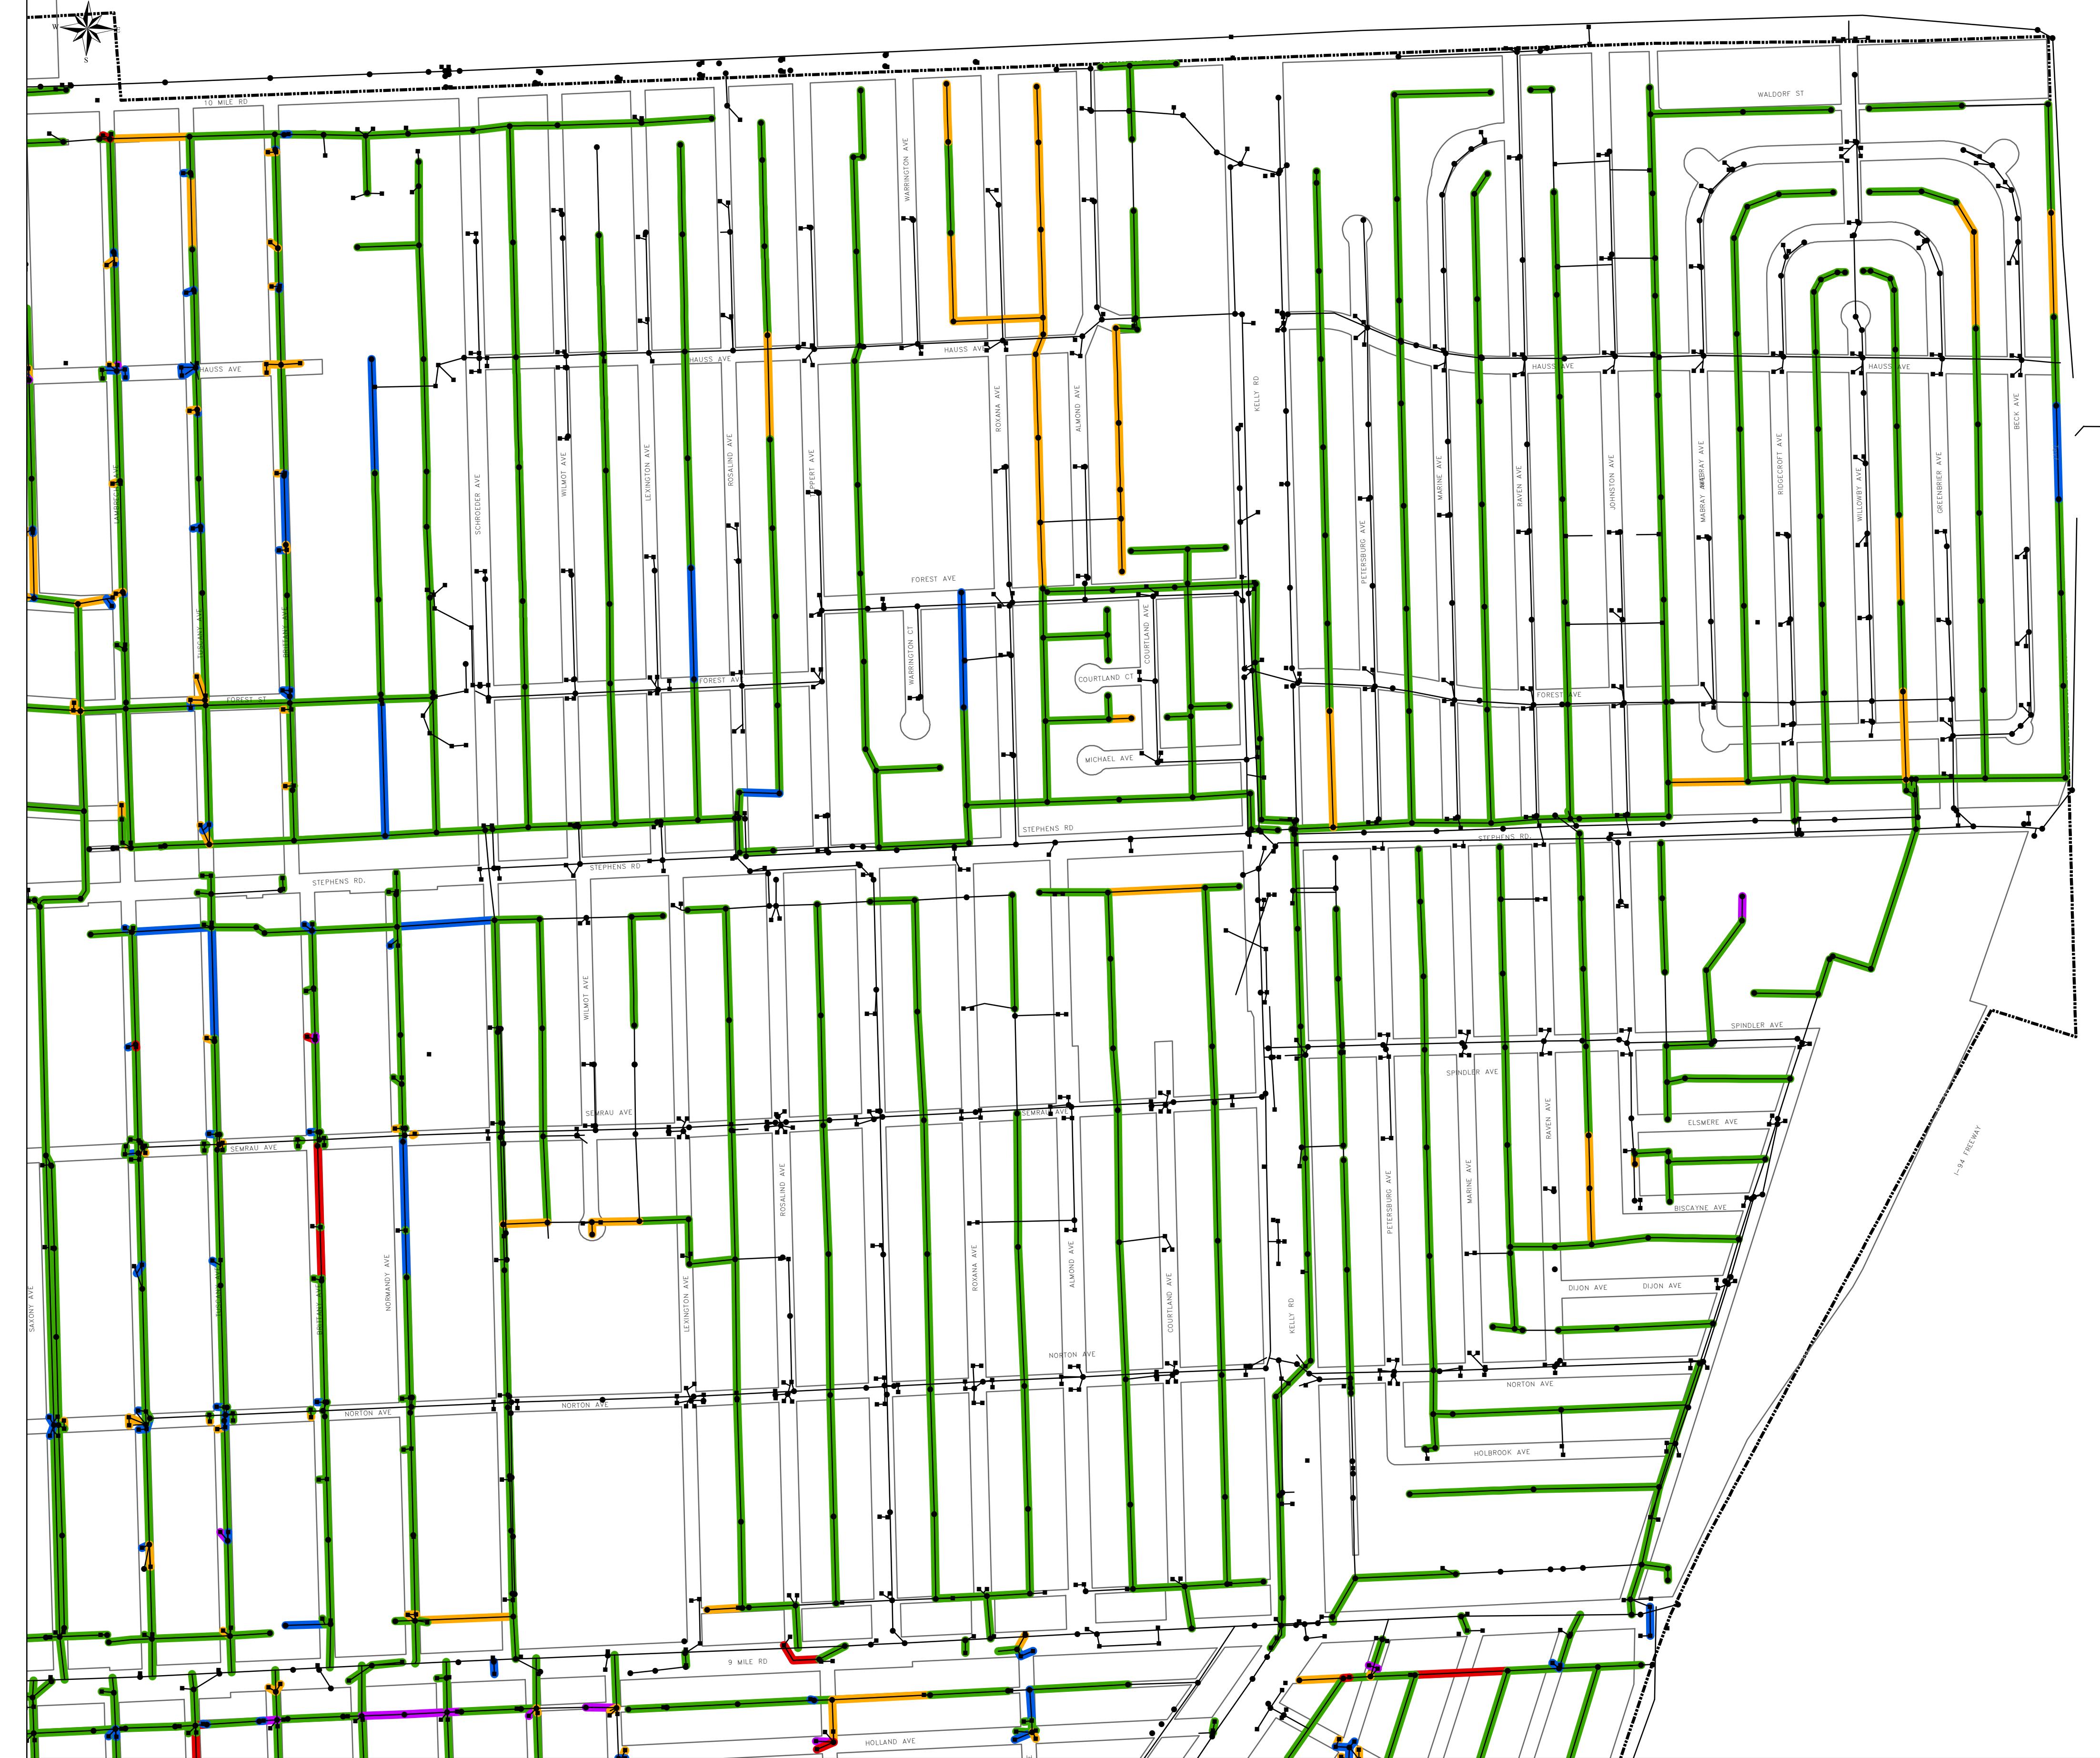
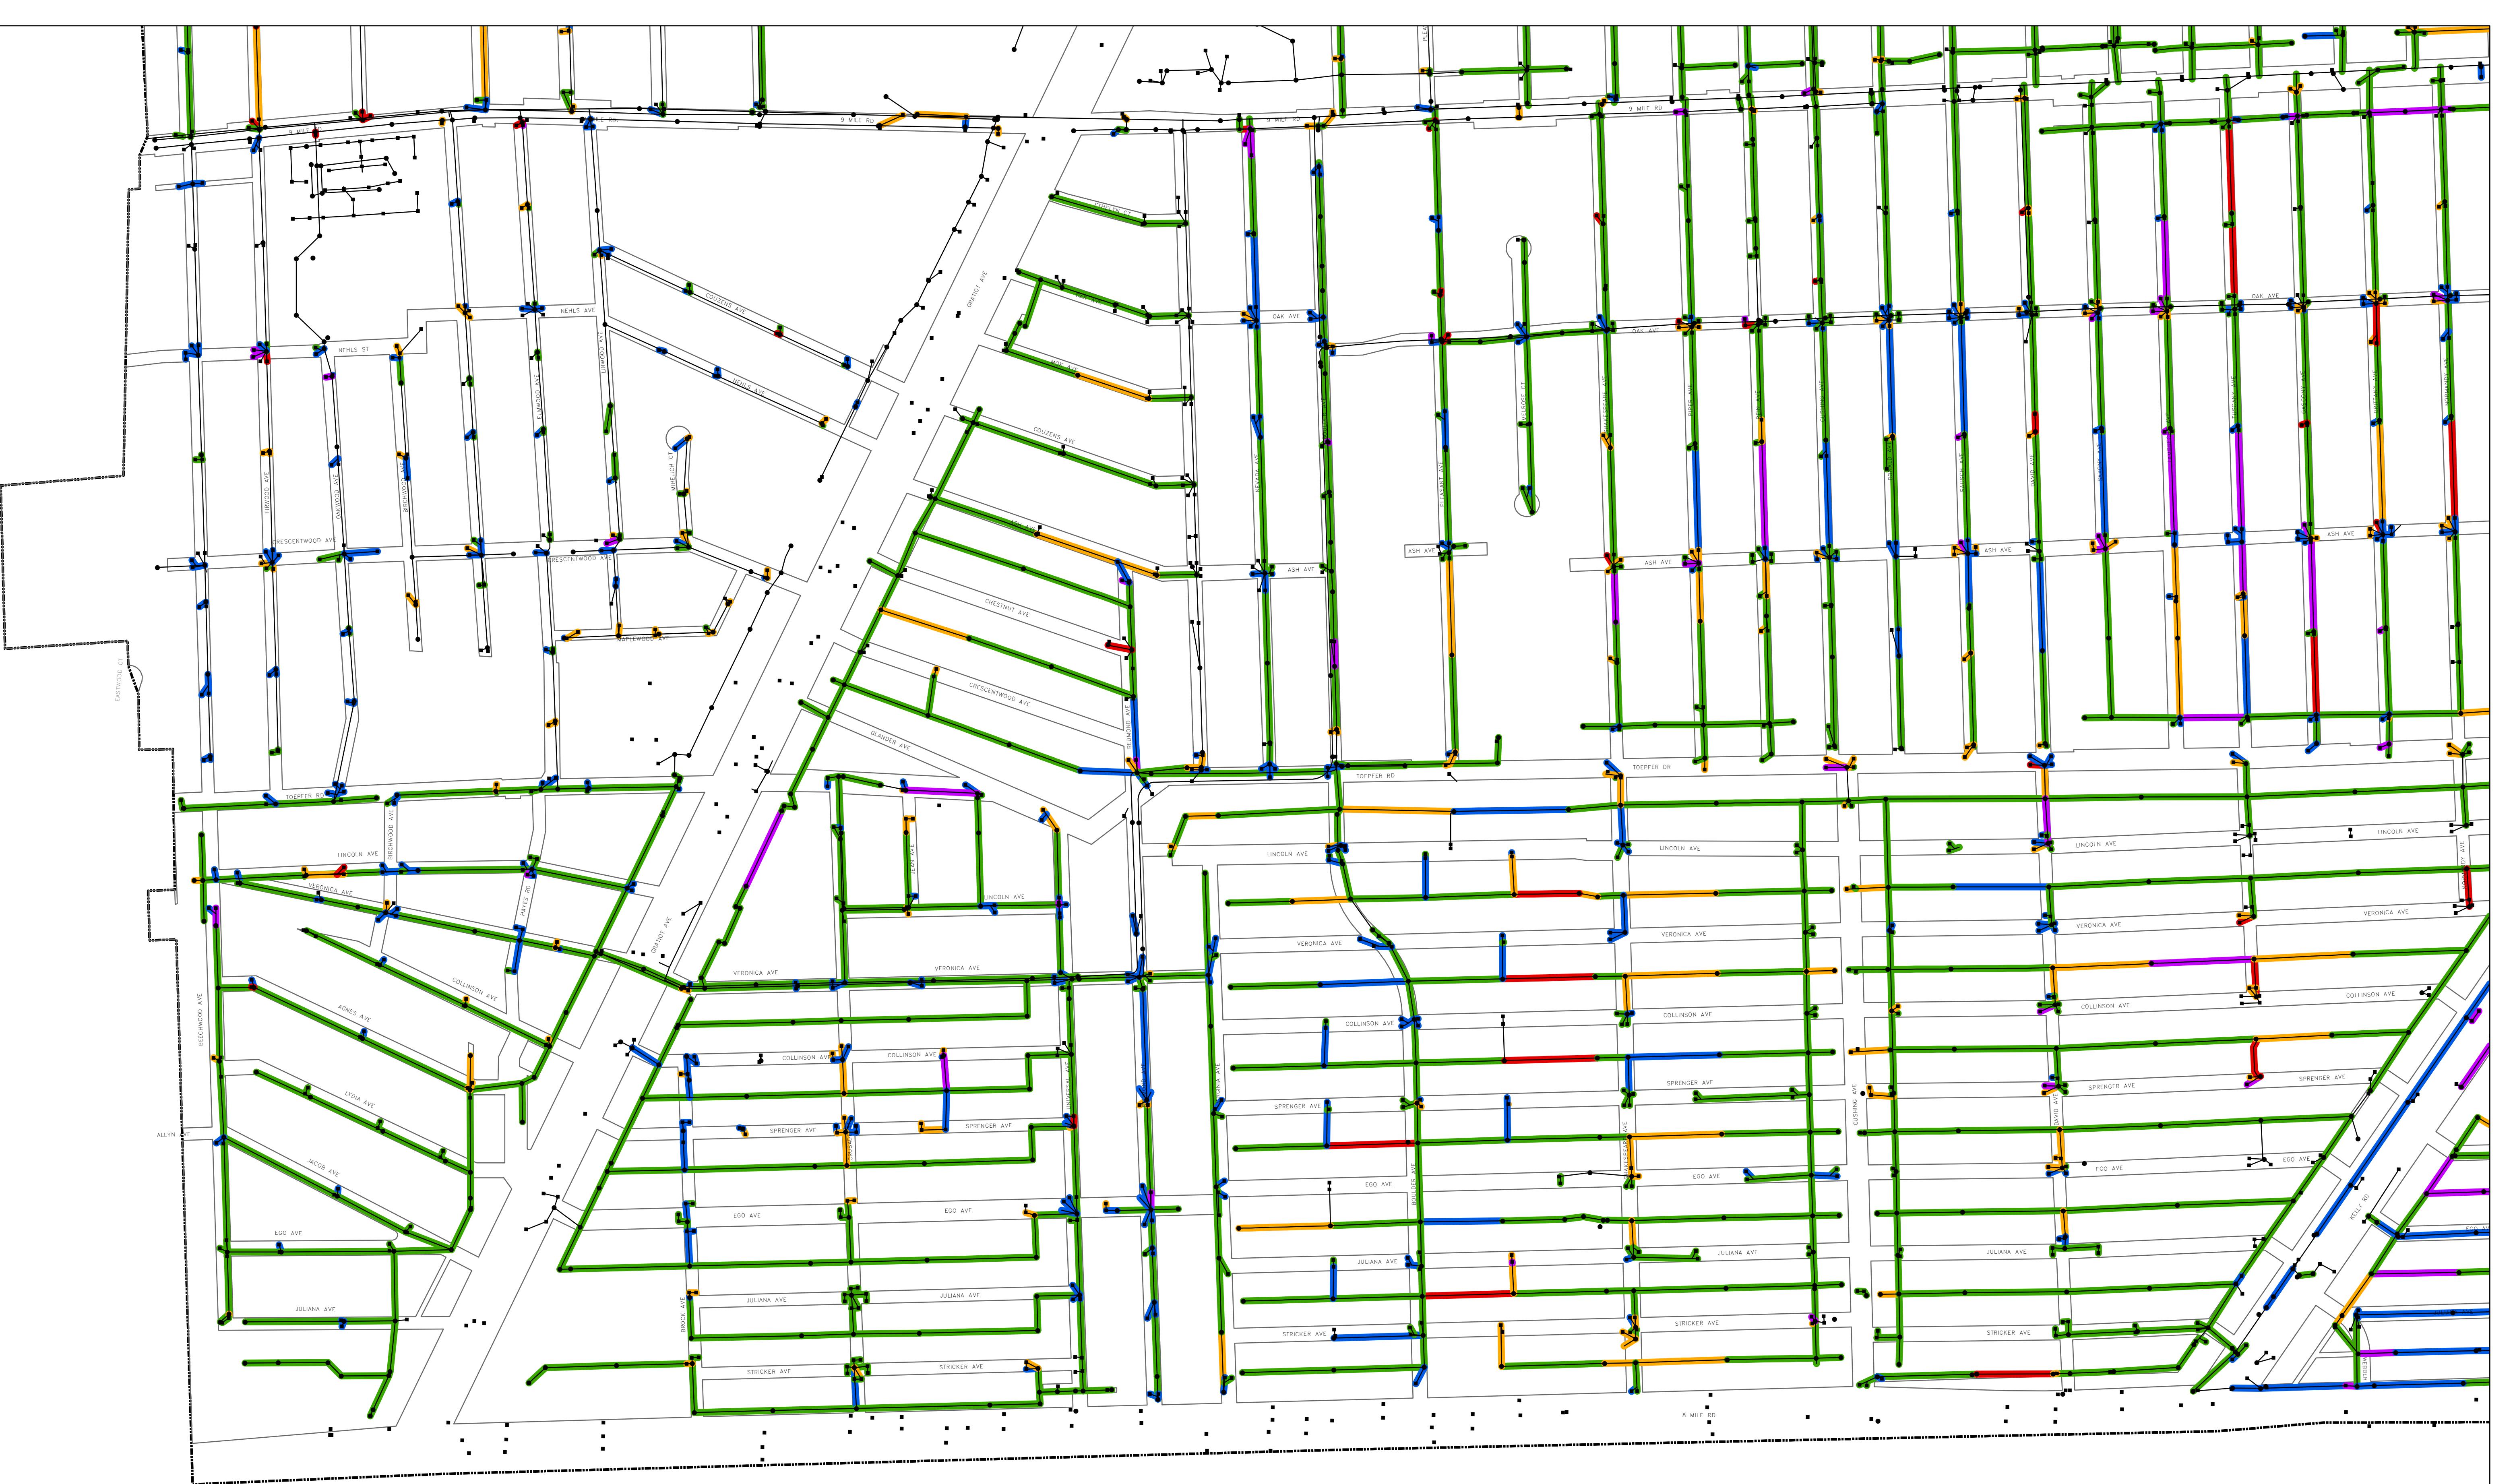
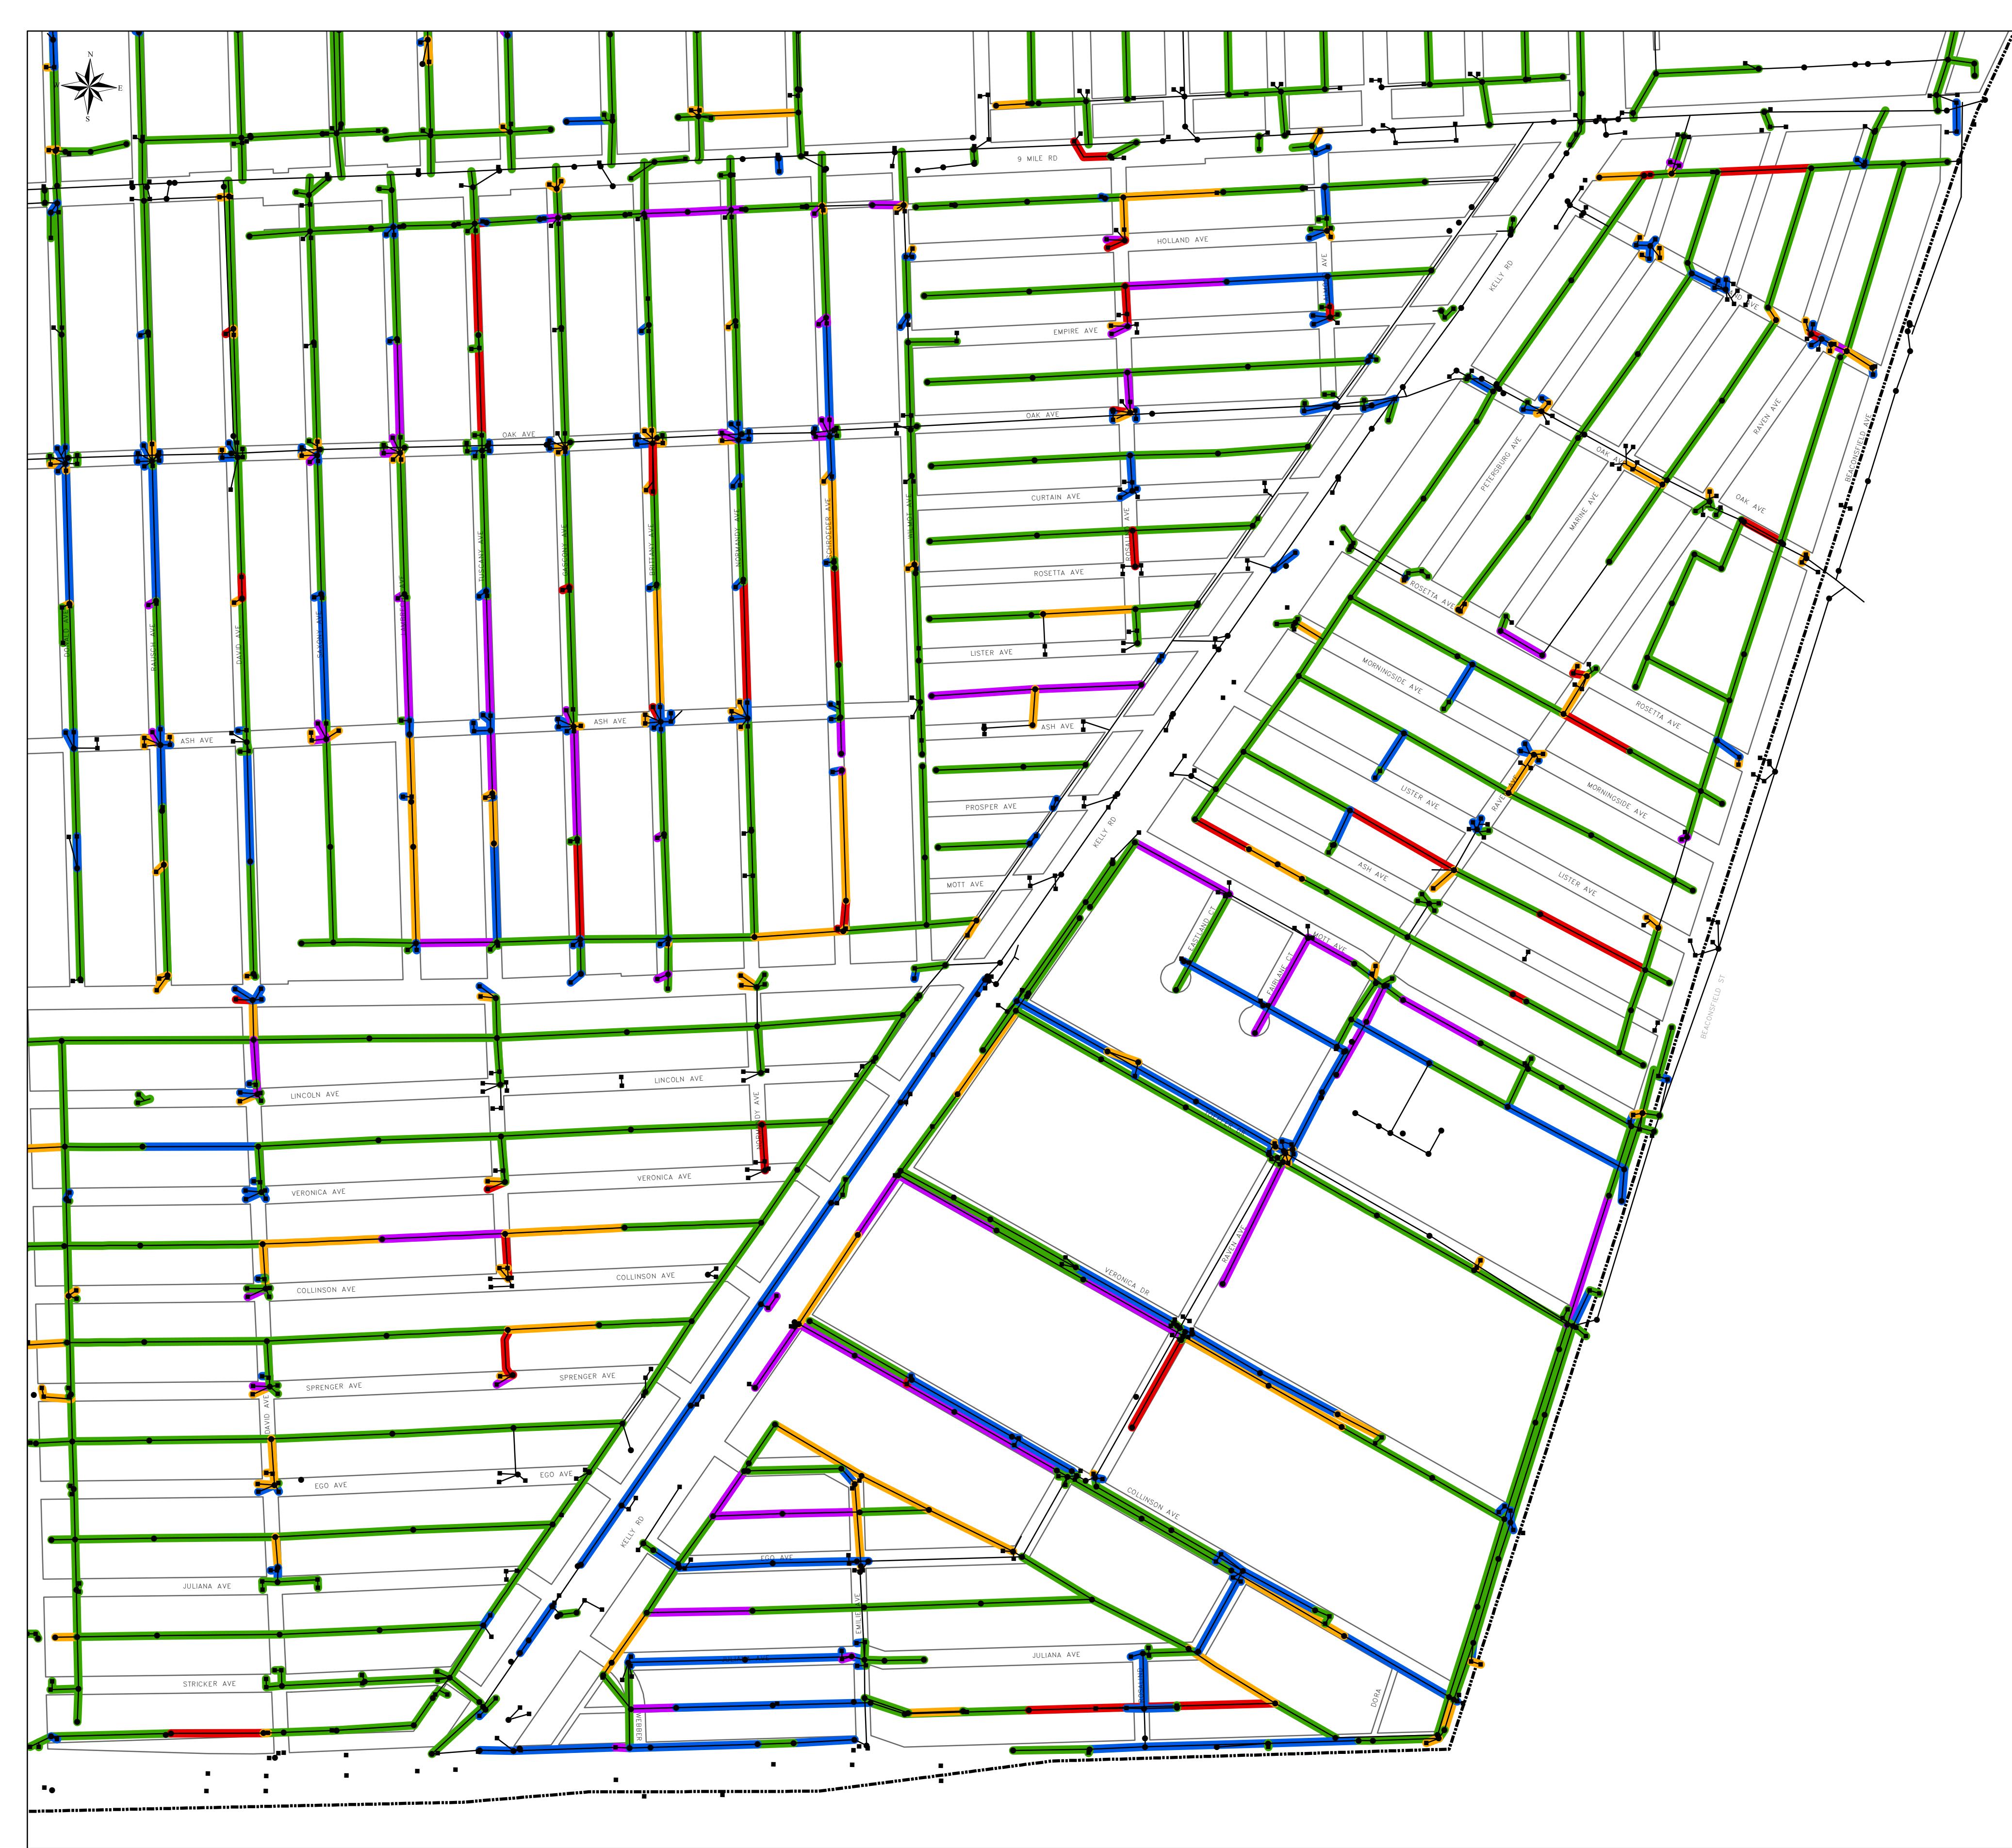
## Appendix B – Sewer PACP Ratings Maps

<b>PACP</b>	0.0 - 1.9
	2.0 - 2.9
	3.0 - 3.9
	4.0 - 4.9
	5.0

The City of Eastpointe currently owns over 134 miles of wastewater sewers ranging in size from 6 inches to 72 inches. A wastewater sewer is considered any sanitary or combined sewer as well as any storm sewer that outlets to a sanitary or combined structure or sewer. A condition assessment was completed for sewer lines through a CCTV investigation program. Table 1 shows the length of wastewater sewer televised (from 2007 to 2017) versus the amount of sewers in the entire City by diameter. The investigation generated a Pipeline Assessment Certification Program (PACP) rating for each segment of pipe. The PACP rating system assigns a 1 to 5 rating to each defect found in a pipe, whereby 1 indicates new or excellent condition and 5 indicates failure or imminent failure. Defects are divided into two categories, structural defects and operation and maintenance (O&M) defects. Structural defects include cracks, deformation, and pipe collapse while O&M defects include deposits, defective taps, and infiltration. Table 2 summarizes the proportional dissemination of the 515,104 feet of wastewater sewer lines televised. Based on the ratio of these findings, the dissemination for the 709,904 total feet of city owned wastewater sewer was projected and shown in Table 3. Maps depicting the location of the pipes and their assigned PACP scores can be found in Appendix B. Note: Sewers 72" and greater not include in report.
