# CITY OF EASTPOINTE

## WASTEWATER ASSET MANAGEMENT PLAN

**AEW Project No. 0145-0458  
MDEQ SAW Grant No. 1417-01**

**Anderson, Eckstein and Westrick, Inc.**

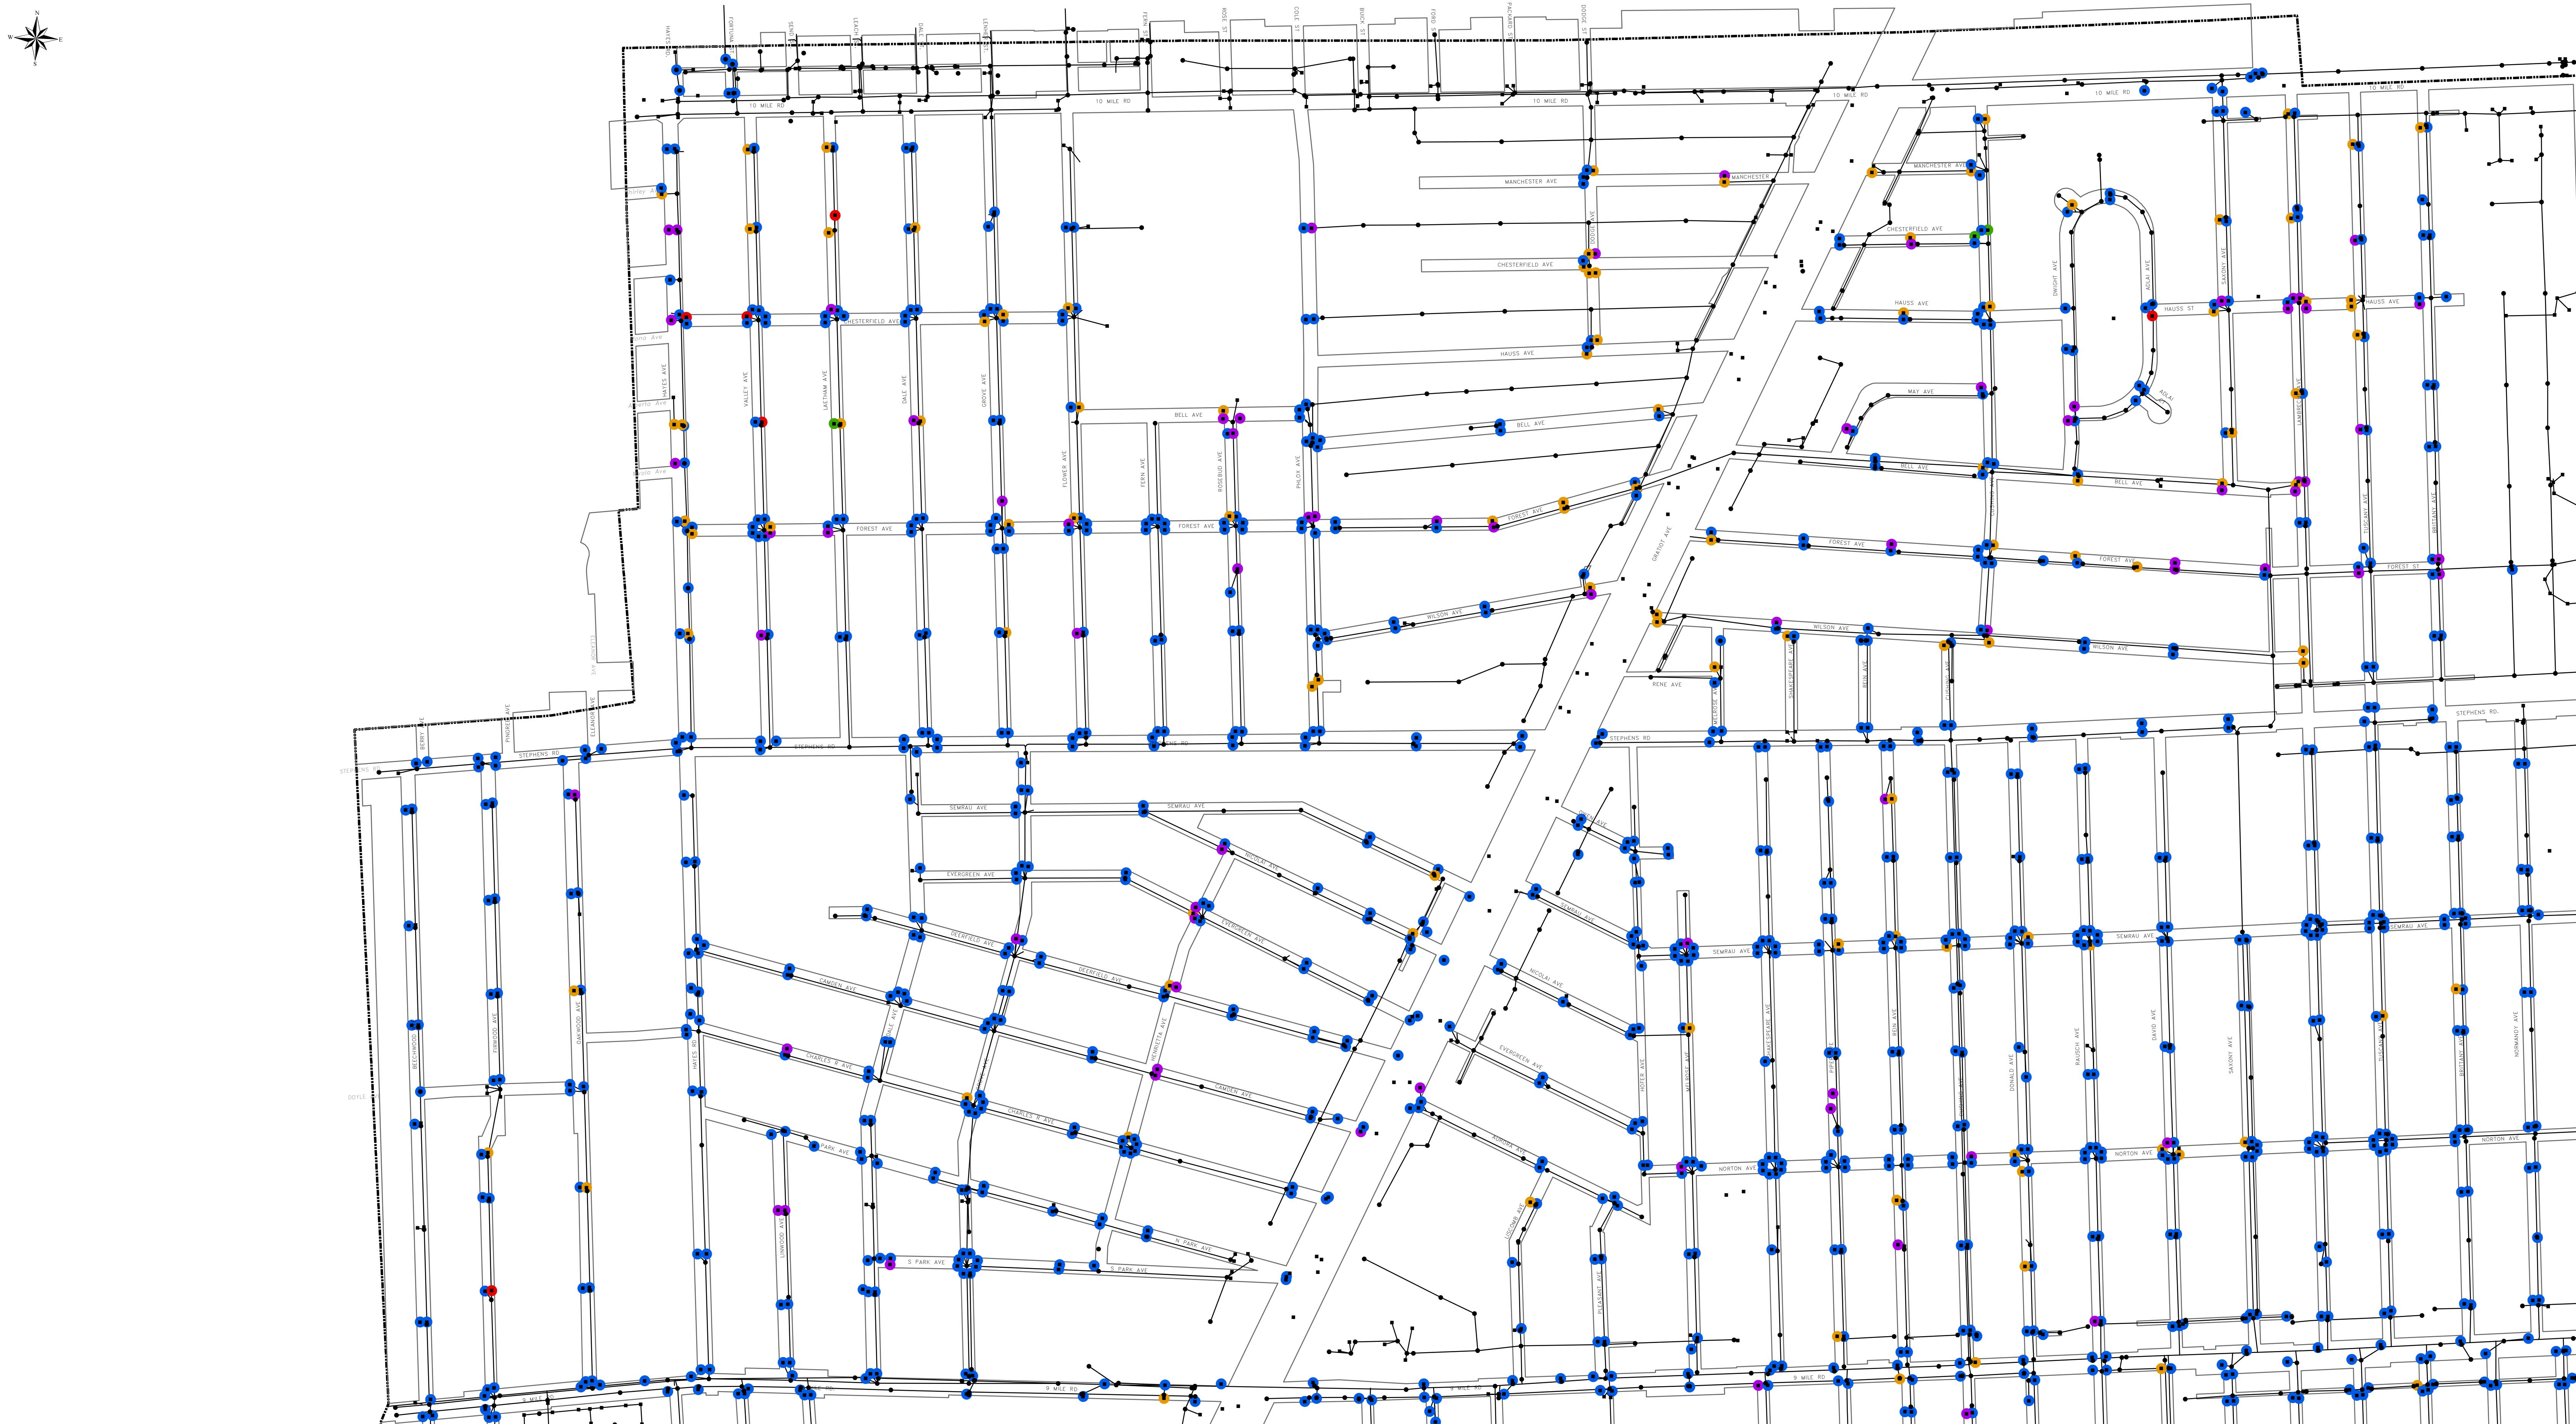
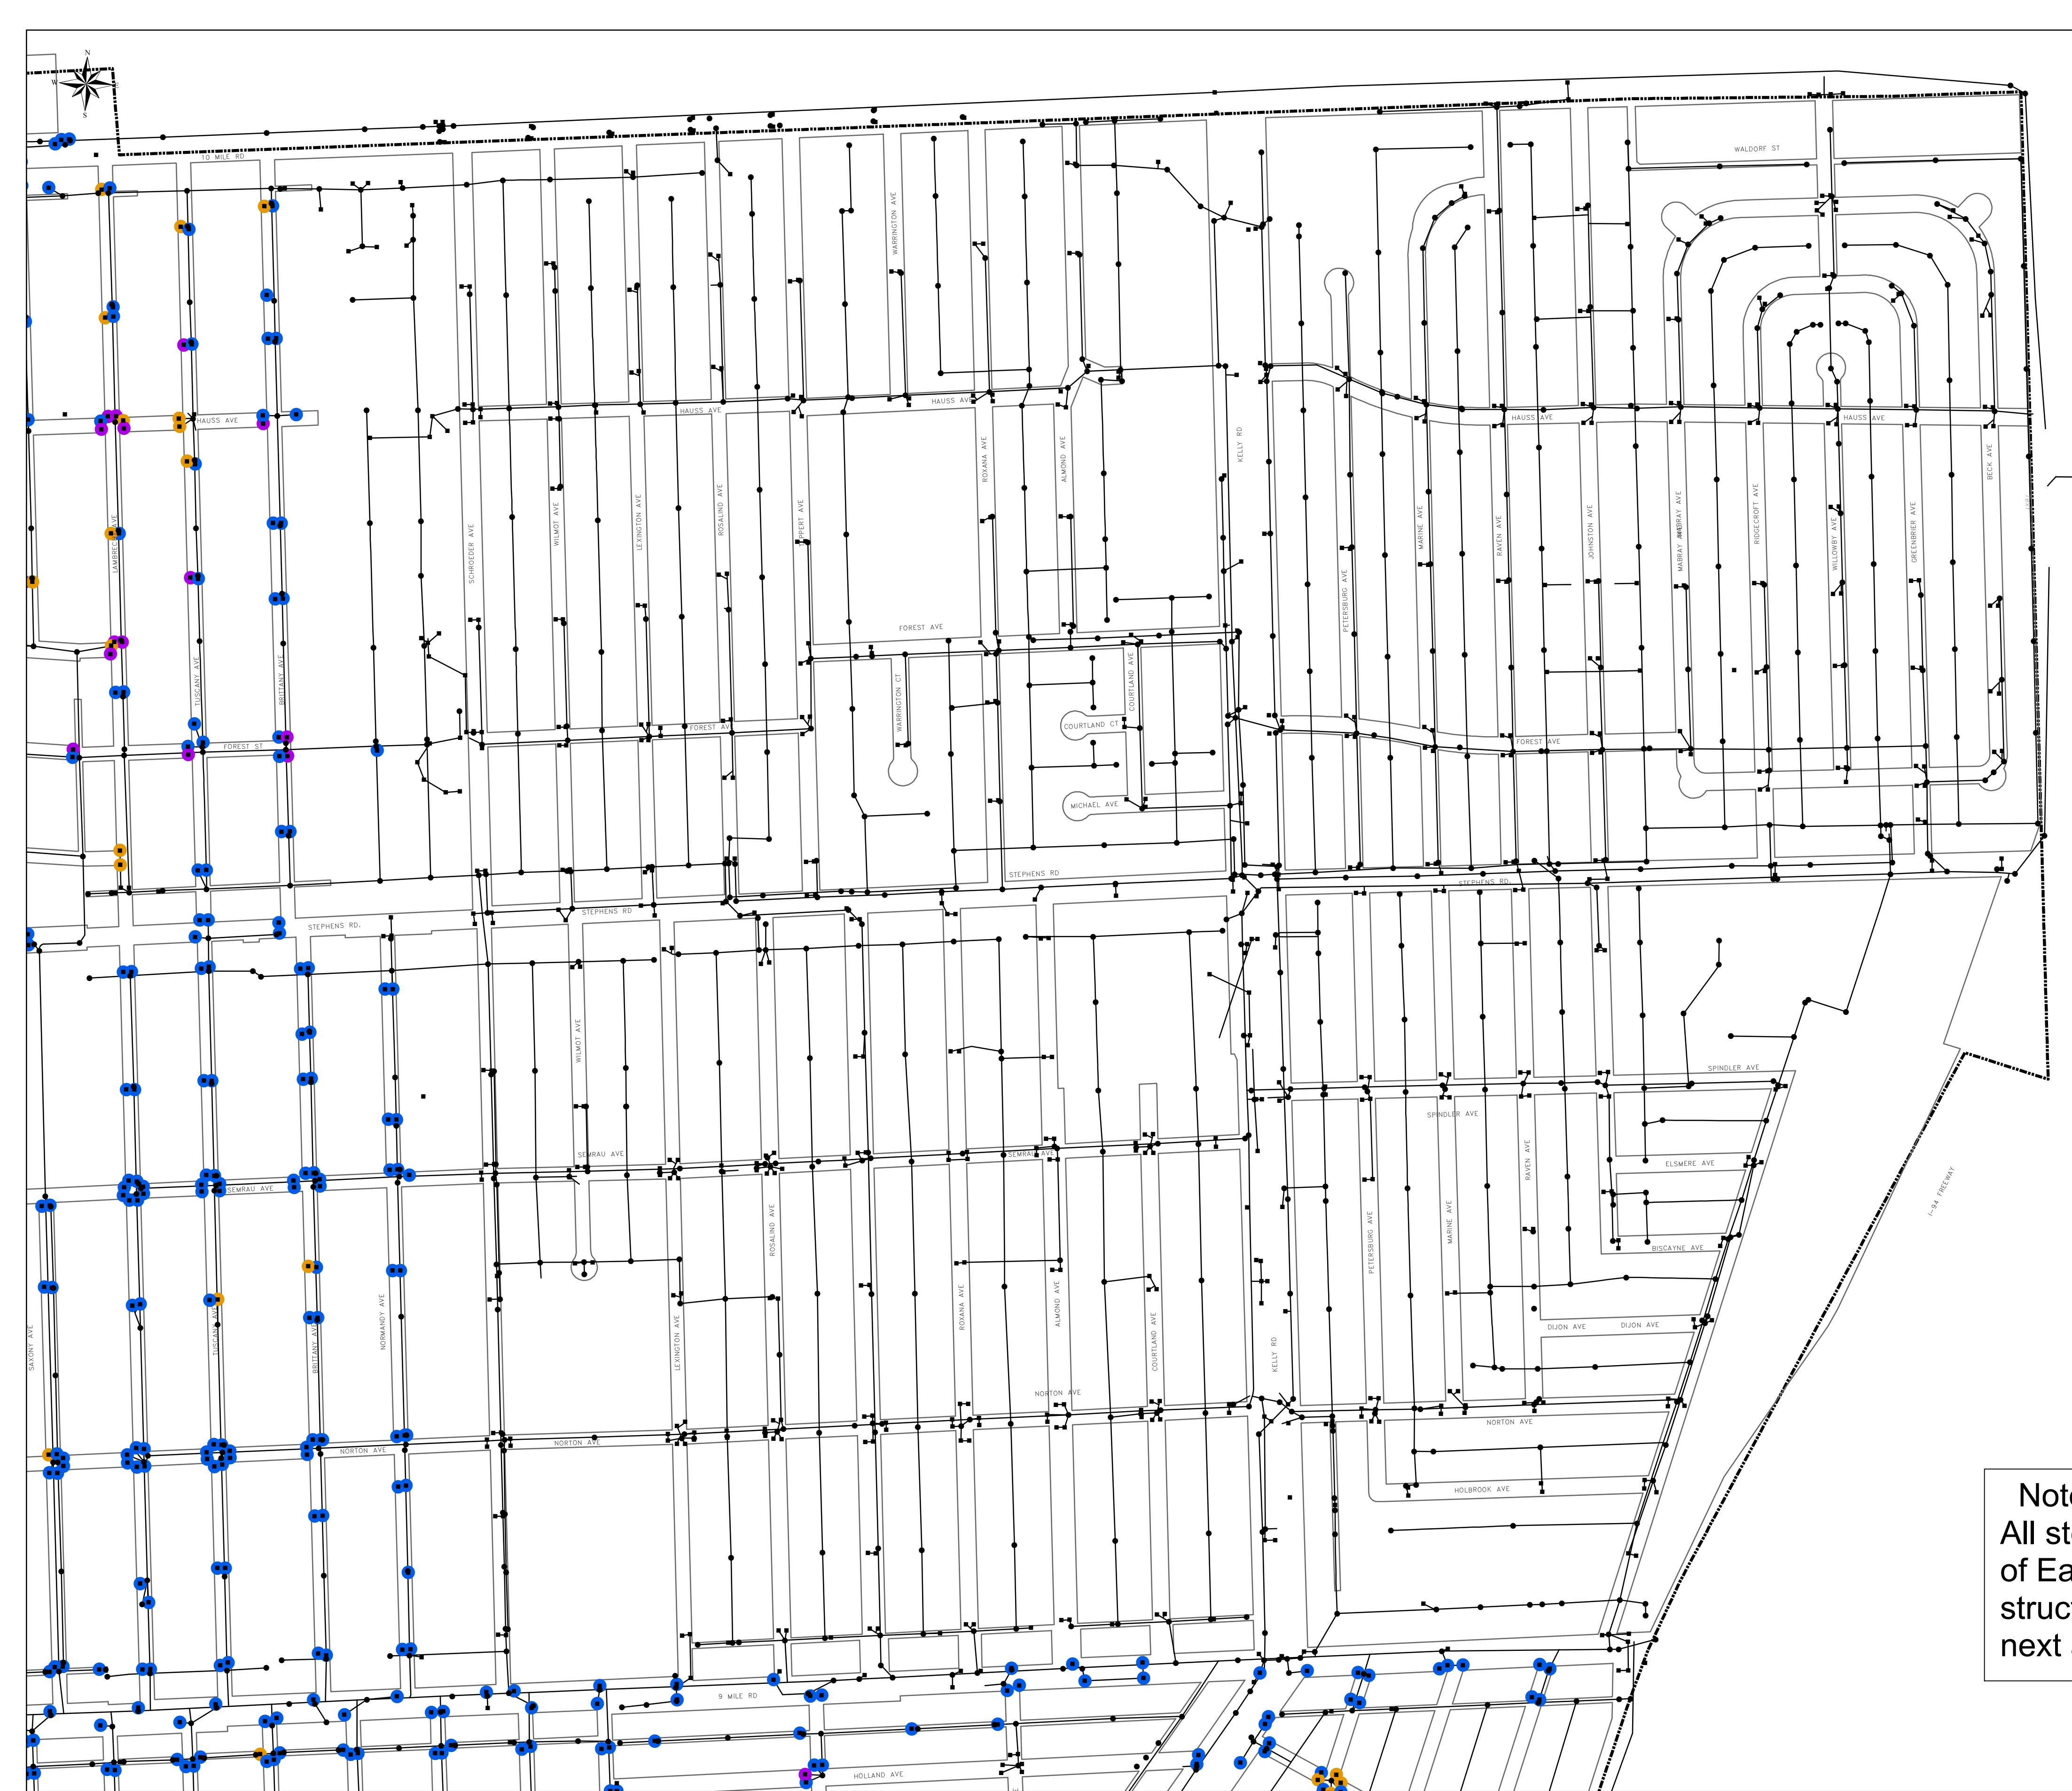
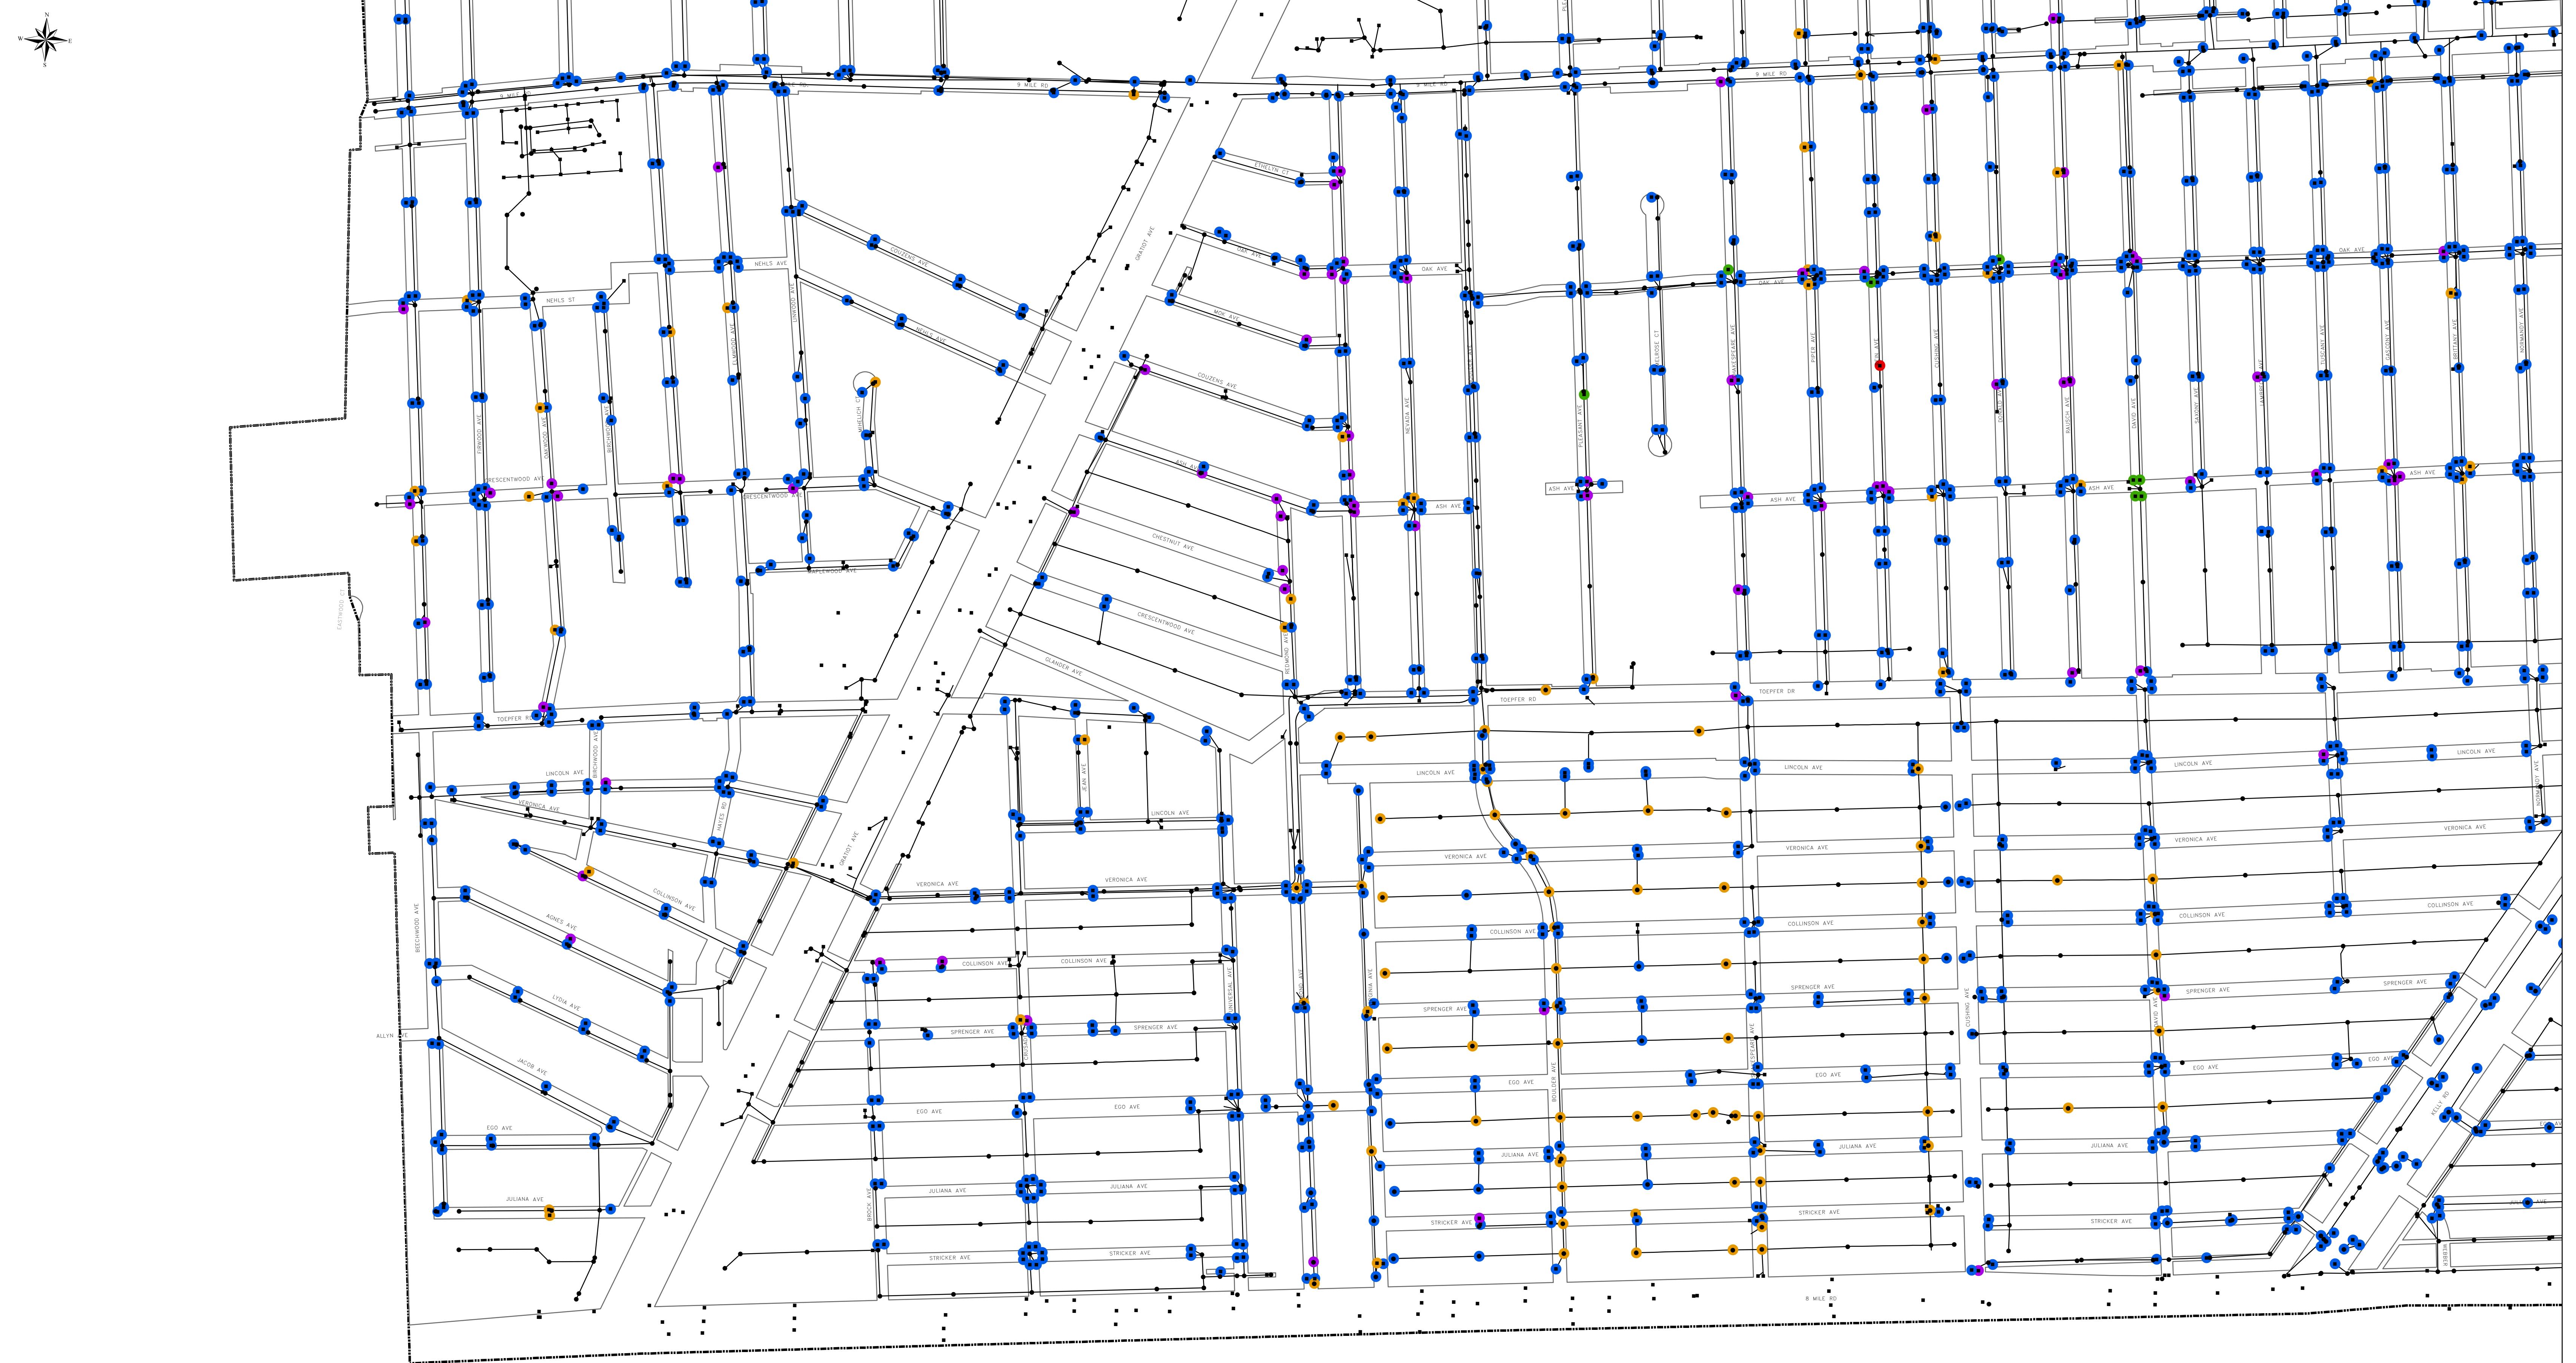
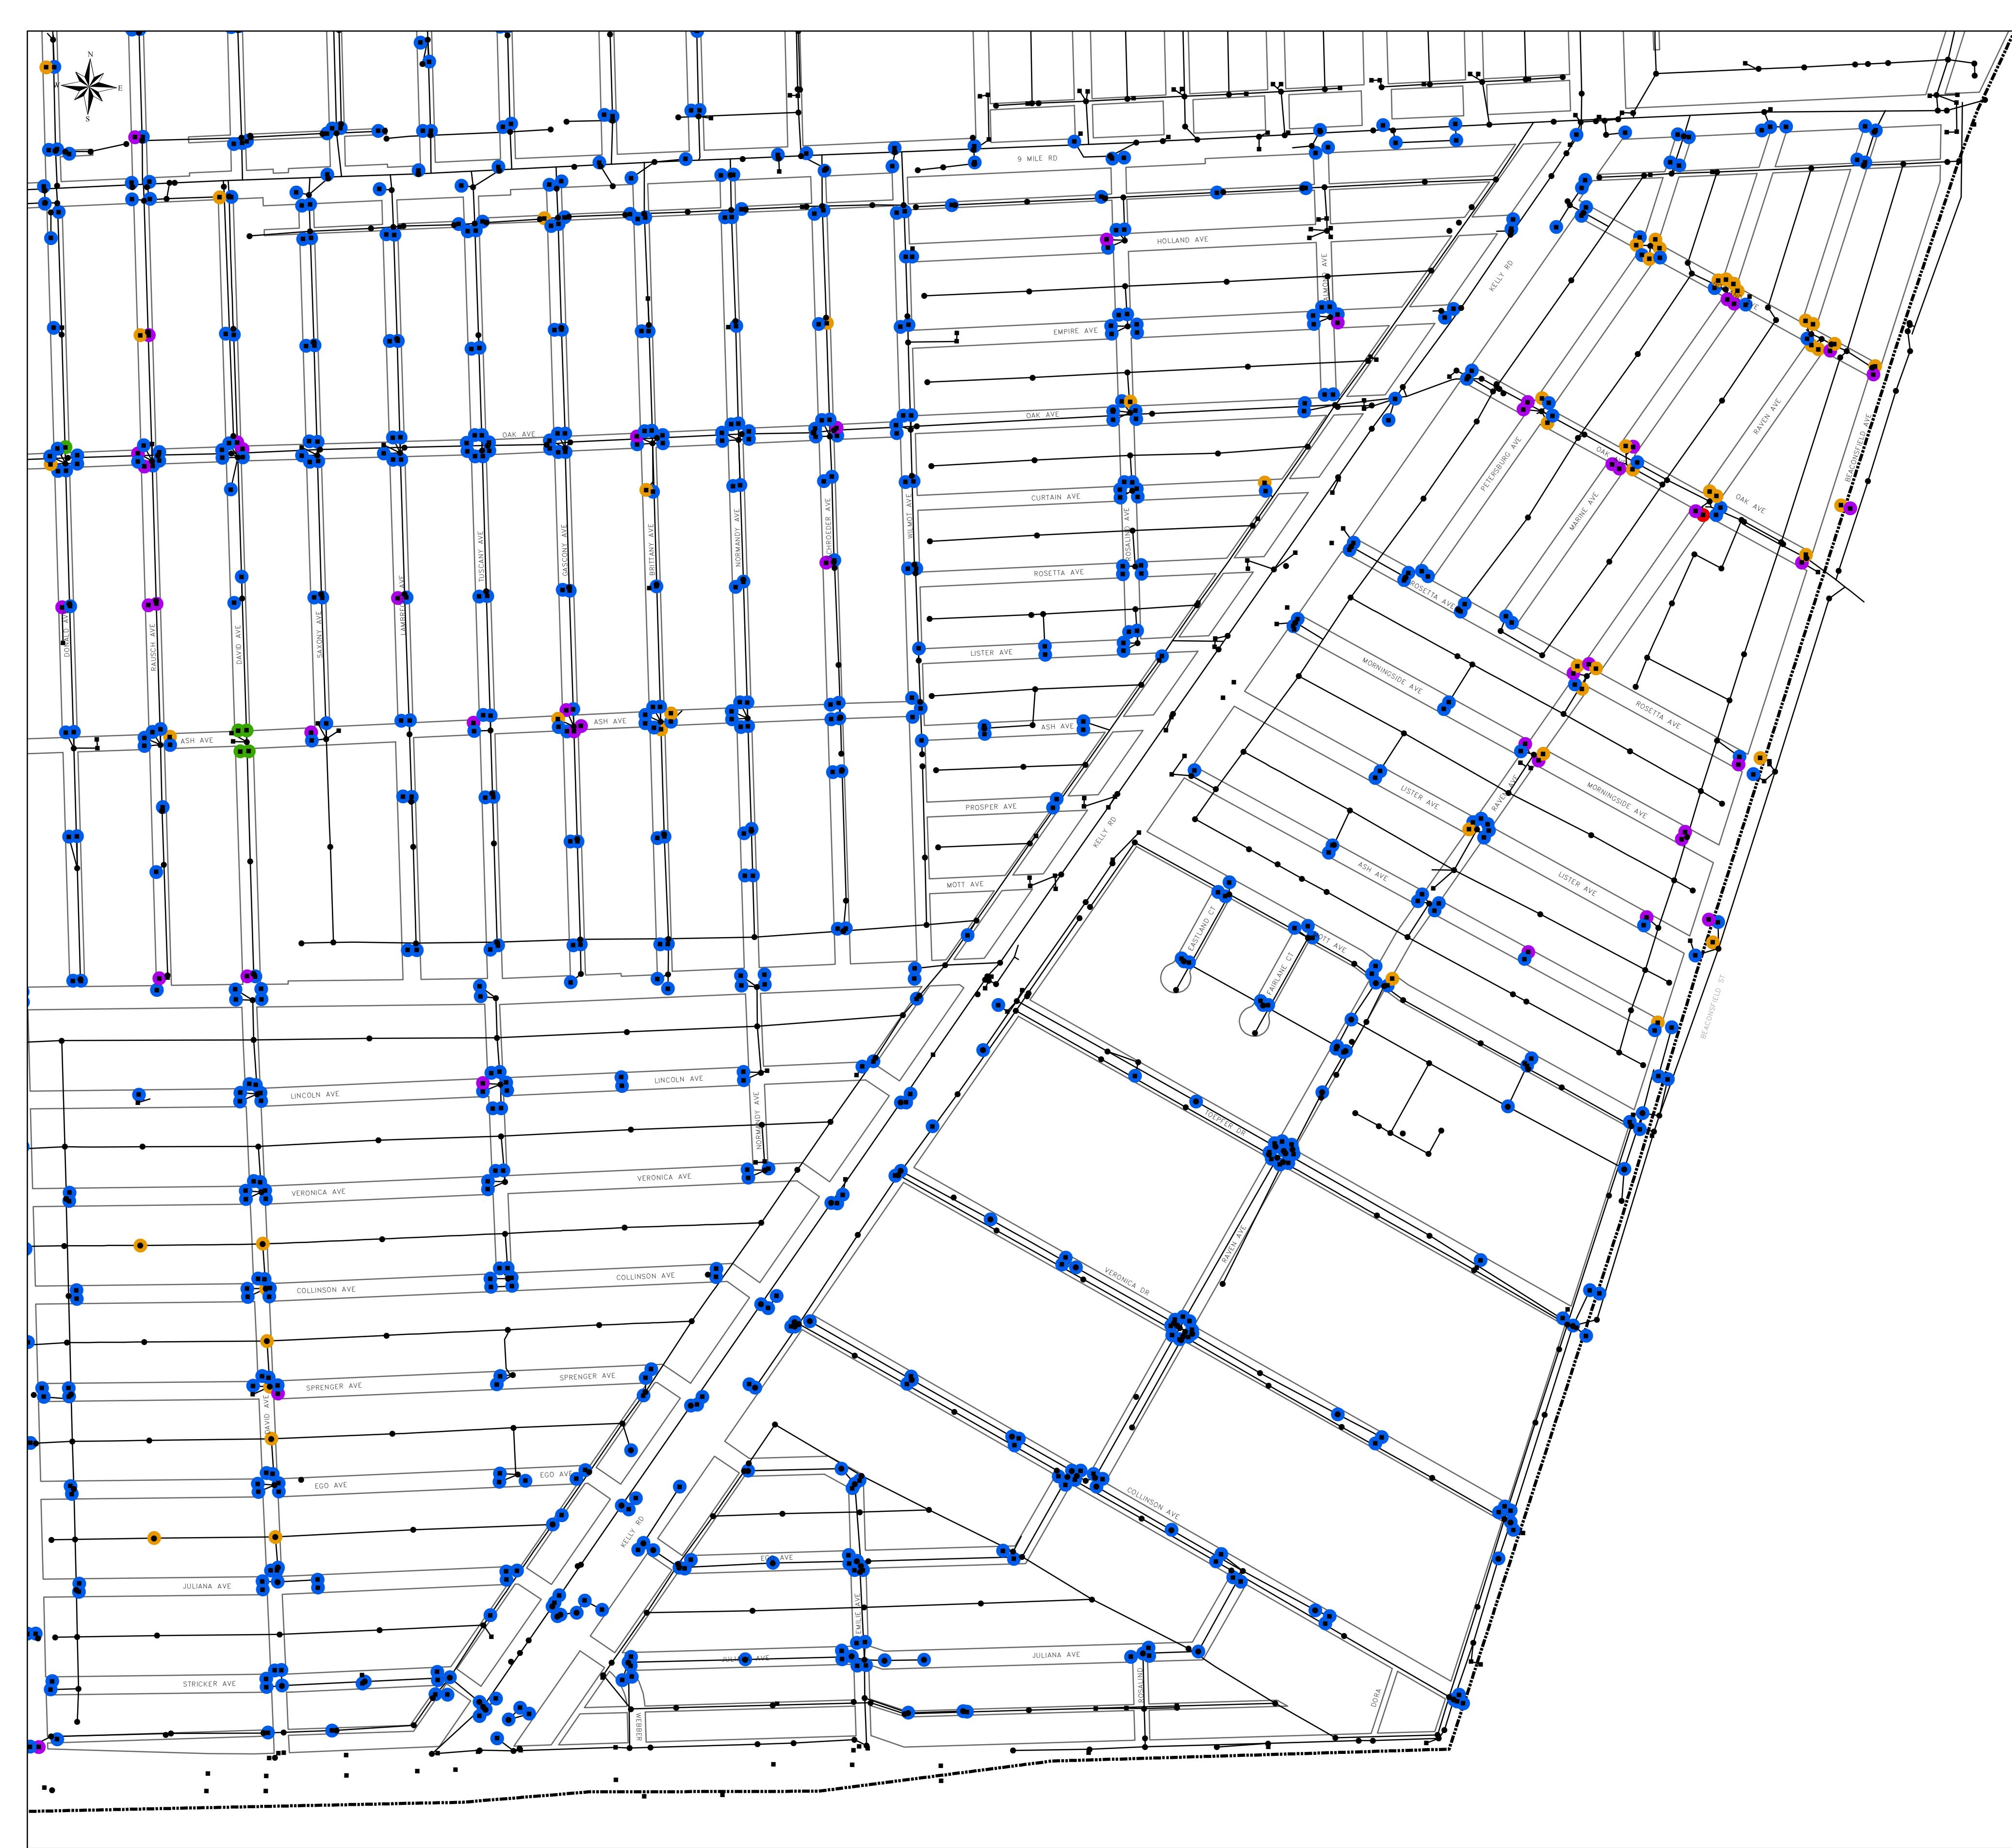
## Appendix C – Manhole Ratings Maps

- Manhole Rating**
- 1 – Excellent
  - 2 – Good
  - 3 – Fair
  - 4 – Poor
  - 5 – Immediate Attention

Note: This map includes the separated sewer system area of the City. All stormwater structures in this area were investigated as part of Eastpointe's Stormwater Asset Management Plan. Any wastewater structures not investigated in this area should be included in the next asset management condition investigation project.

The City's wastewater system contains approximately 5,860 wastewater structures. Of the 5,860 structures 3,326 have been inspected. A wastewater structure is considered any sanitary or combined manhole as well as any catch basin with sewer leads that outlet to a sanitary or combined structure/sewer. The wastewater structure inspections were performed by Manhole Assessment Certification Program (MACP) certified inspectors of Anderson, Eckstein and Westrick, Inc. Each structure was rated on a 1 to 5 scale, where 5 indicates failure or imminent failure and 1 indicates new or excellent condition. The inspection process yielded information pertaining to structure location, depth, inverts, material, size and much more. Table 8 summarizes the ratings for the inspected structures while 9 shows the projected dissemination of the total amount of wastewater structures in the City. Supporting data for the structure ratings can be found in Appendix H.

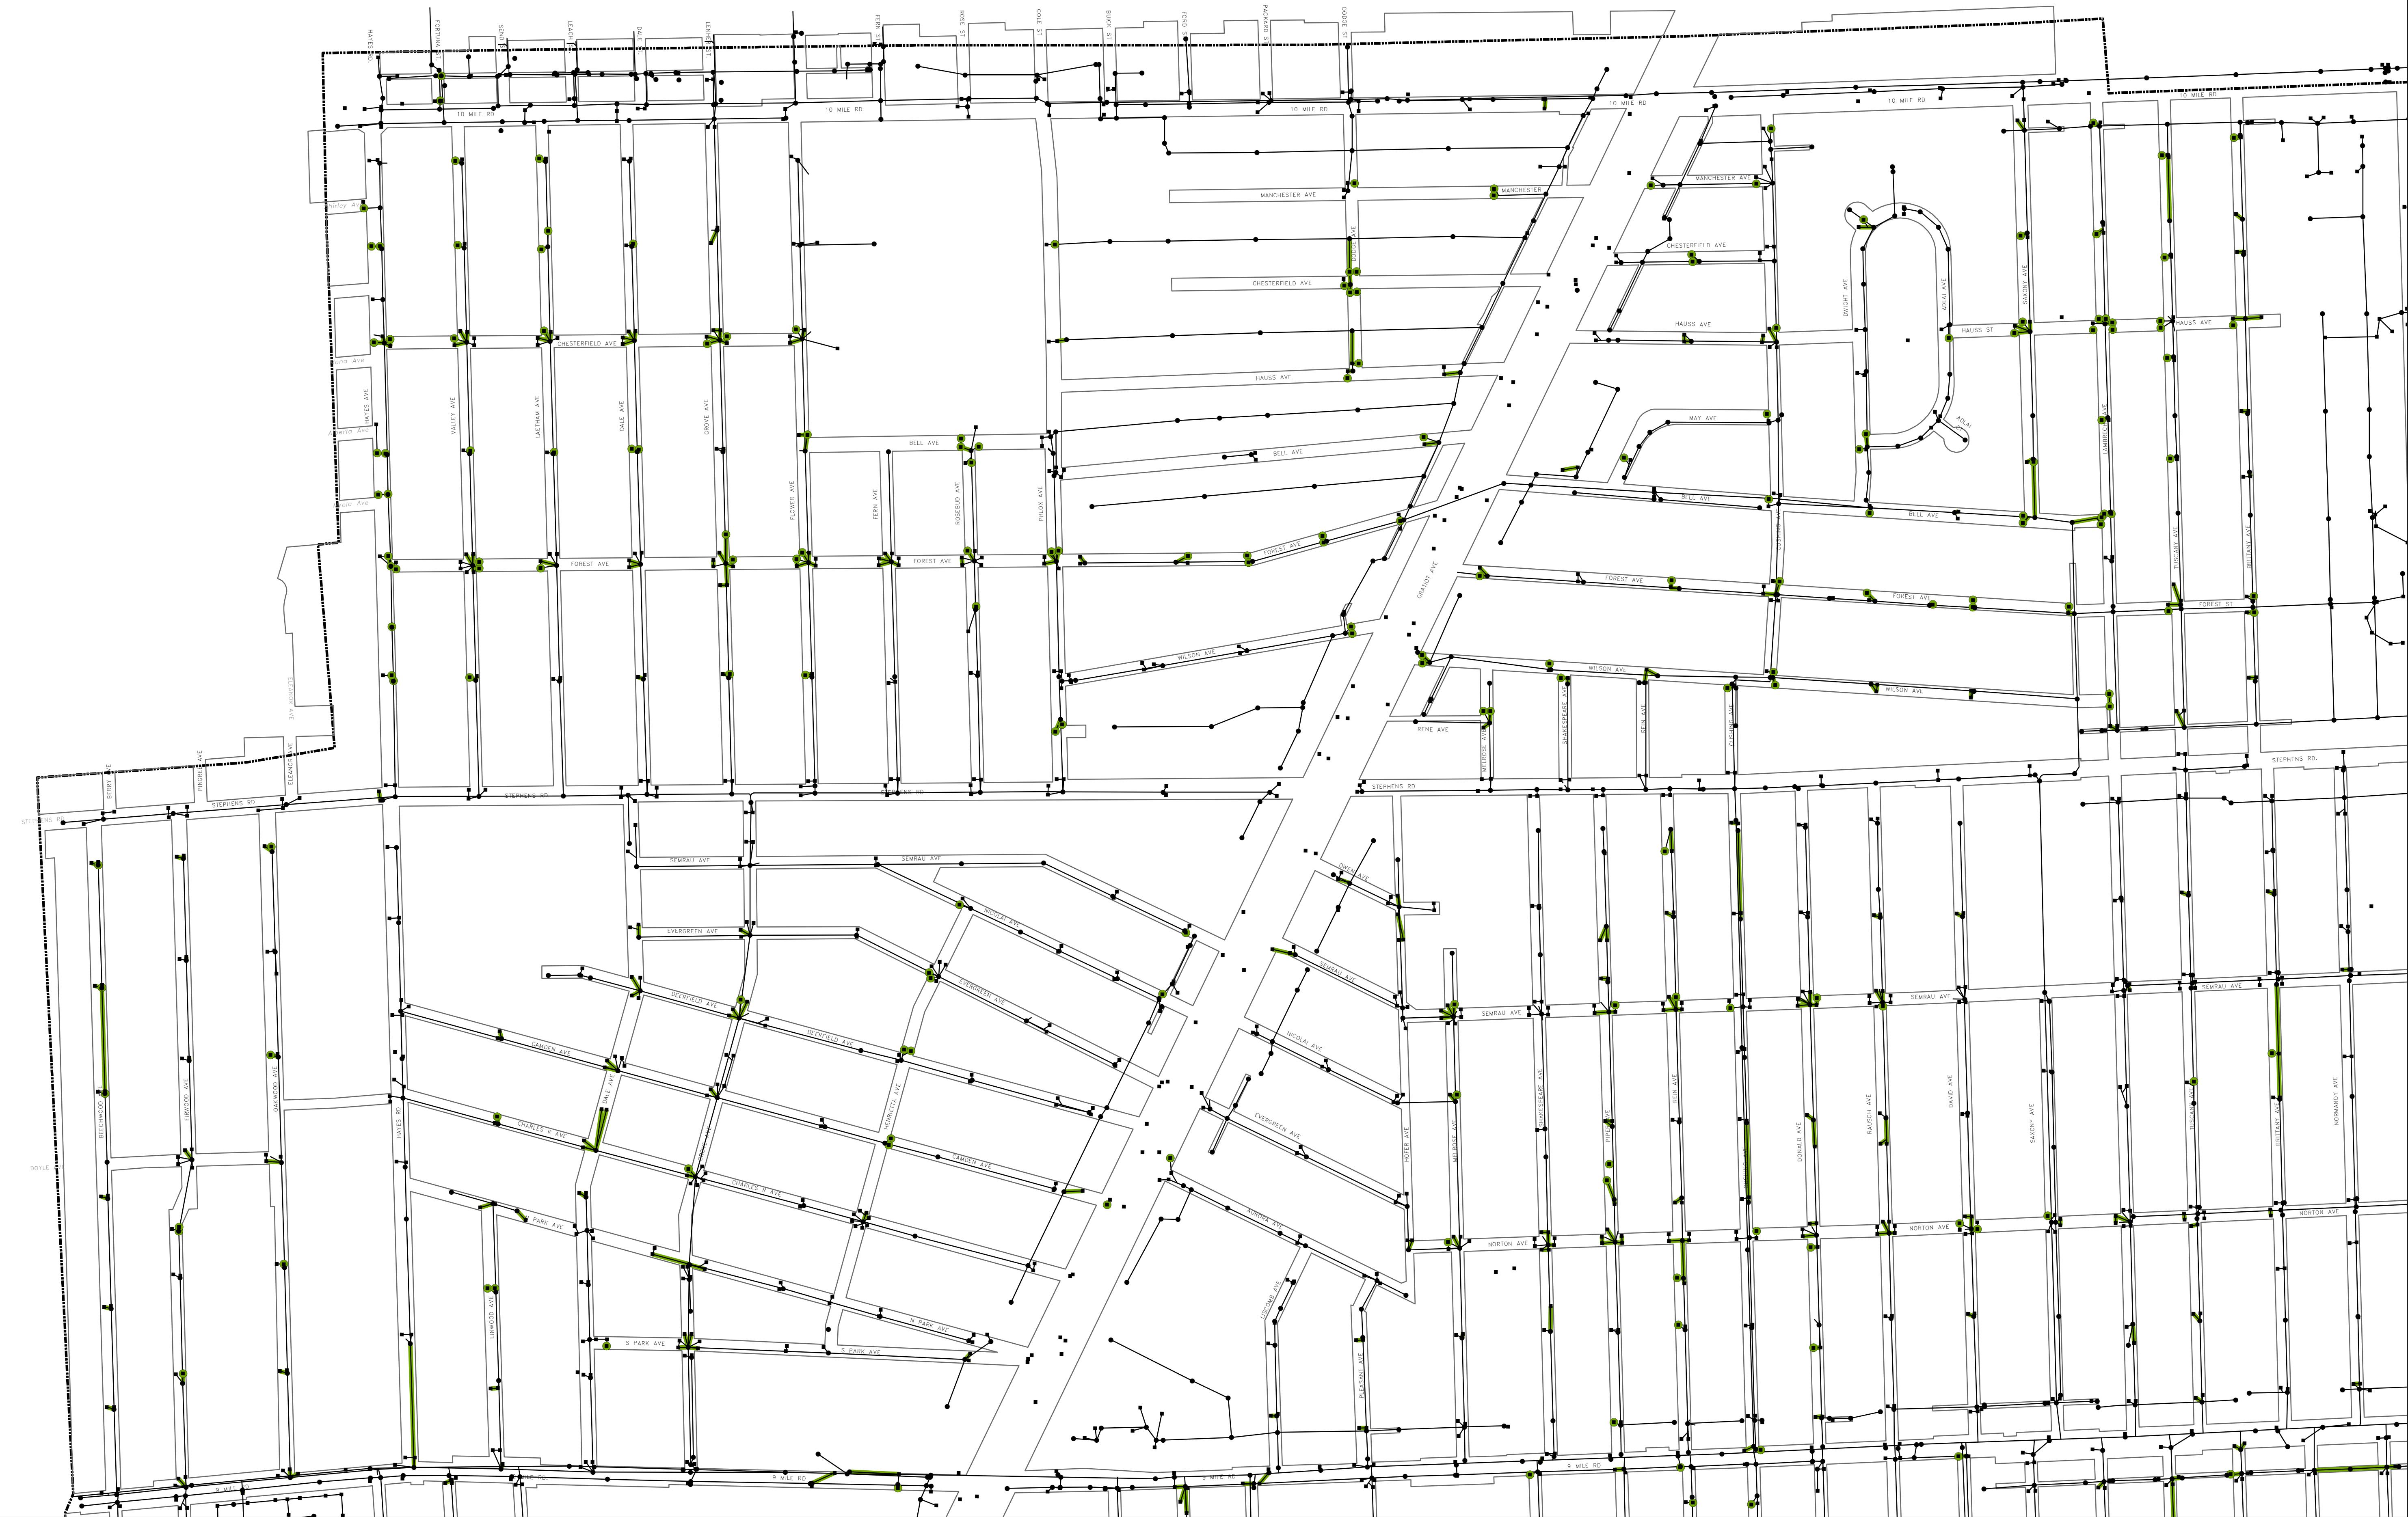
## Appendix D – Capital Improvement Plan Maps

## CIP Structures

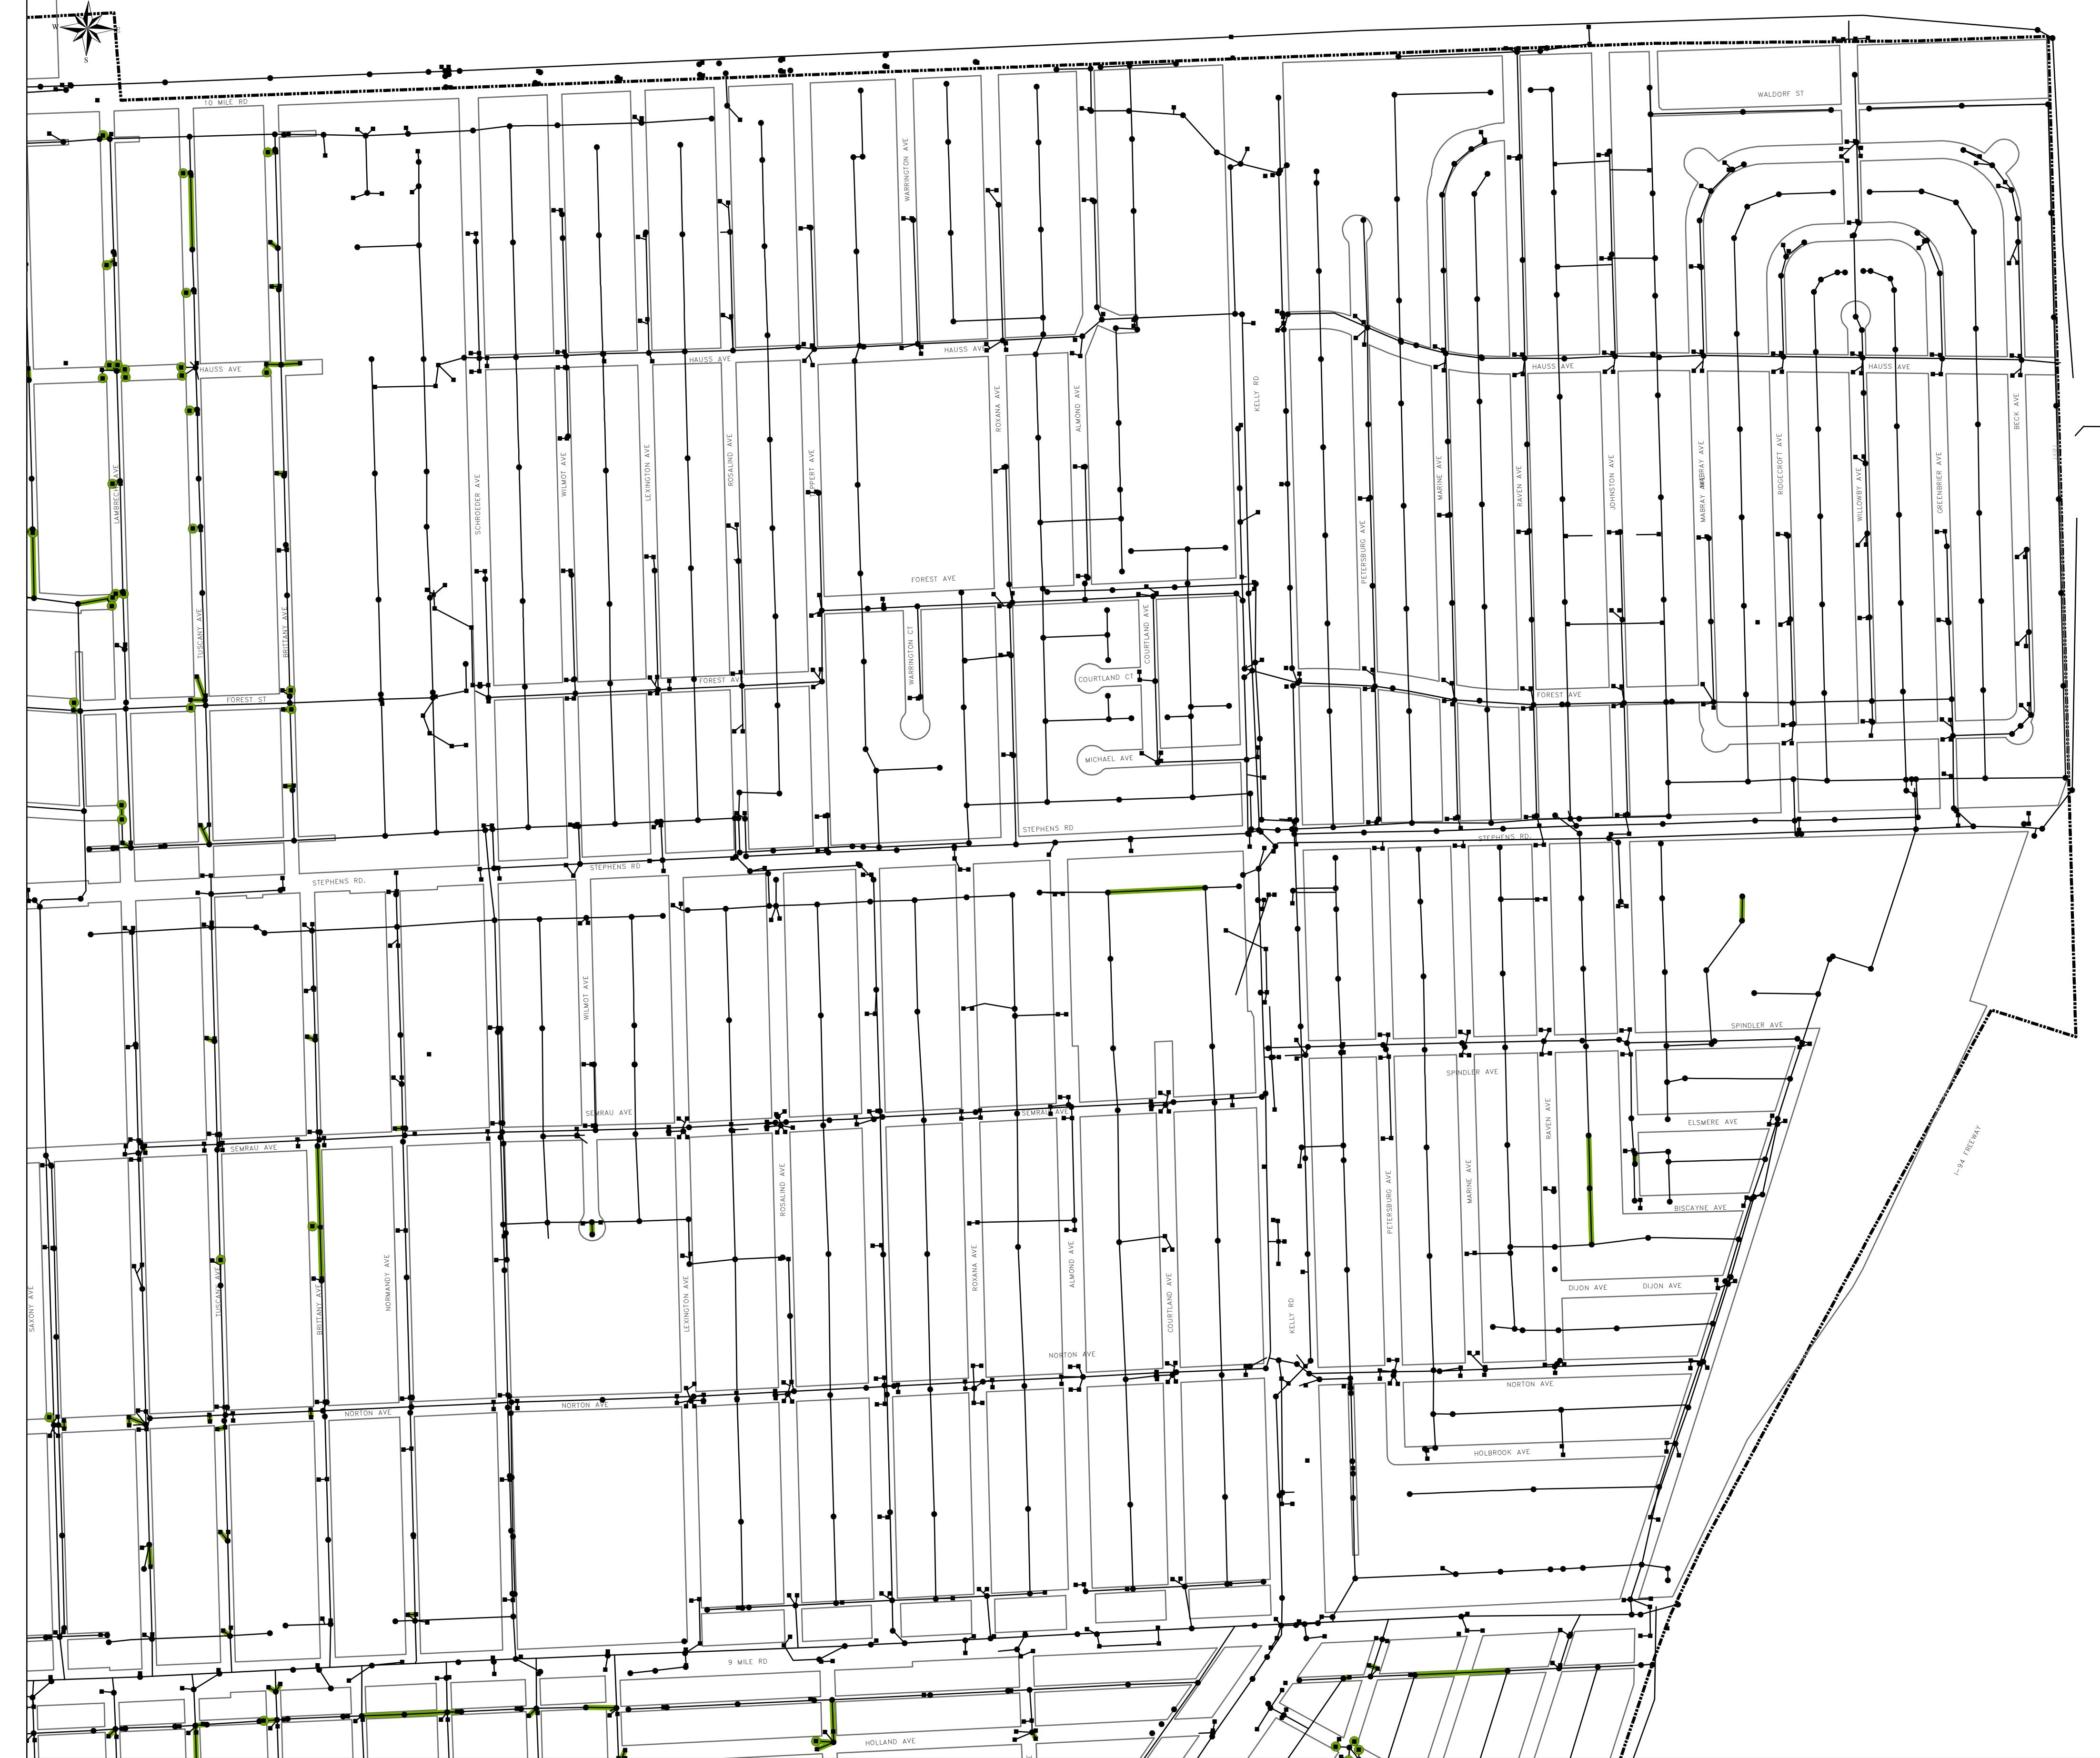
- CIP Structures
- CIP Sewers
