# CITY OF EASTPOINTE

## WASTEWATER ASSET MANAGEMENT PLAN

**AEW Project No. 0145-0458  
MDEQ SAW Grant No. 1417-01**

**Anderson, Eckstein and Westrick, Inc.**

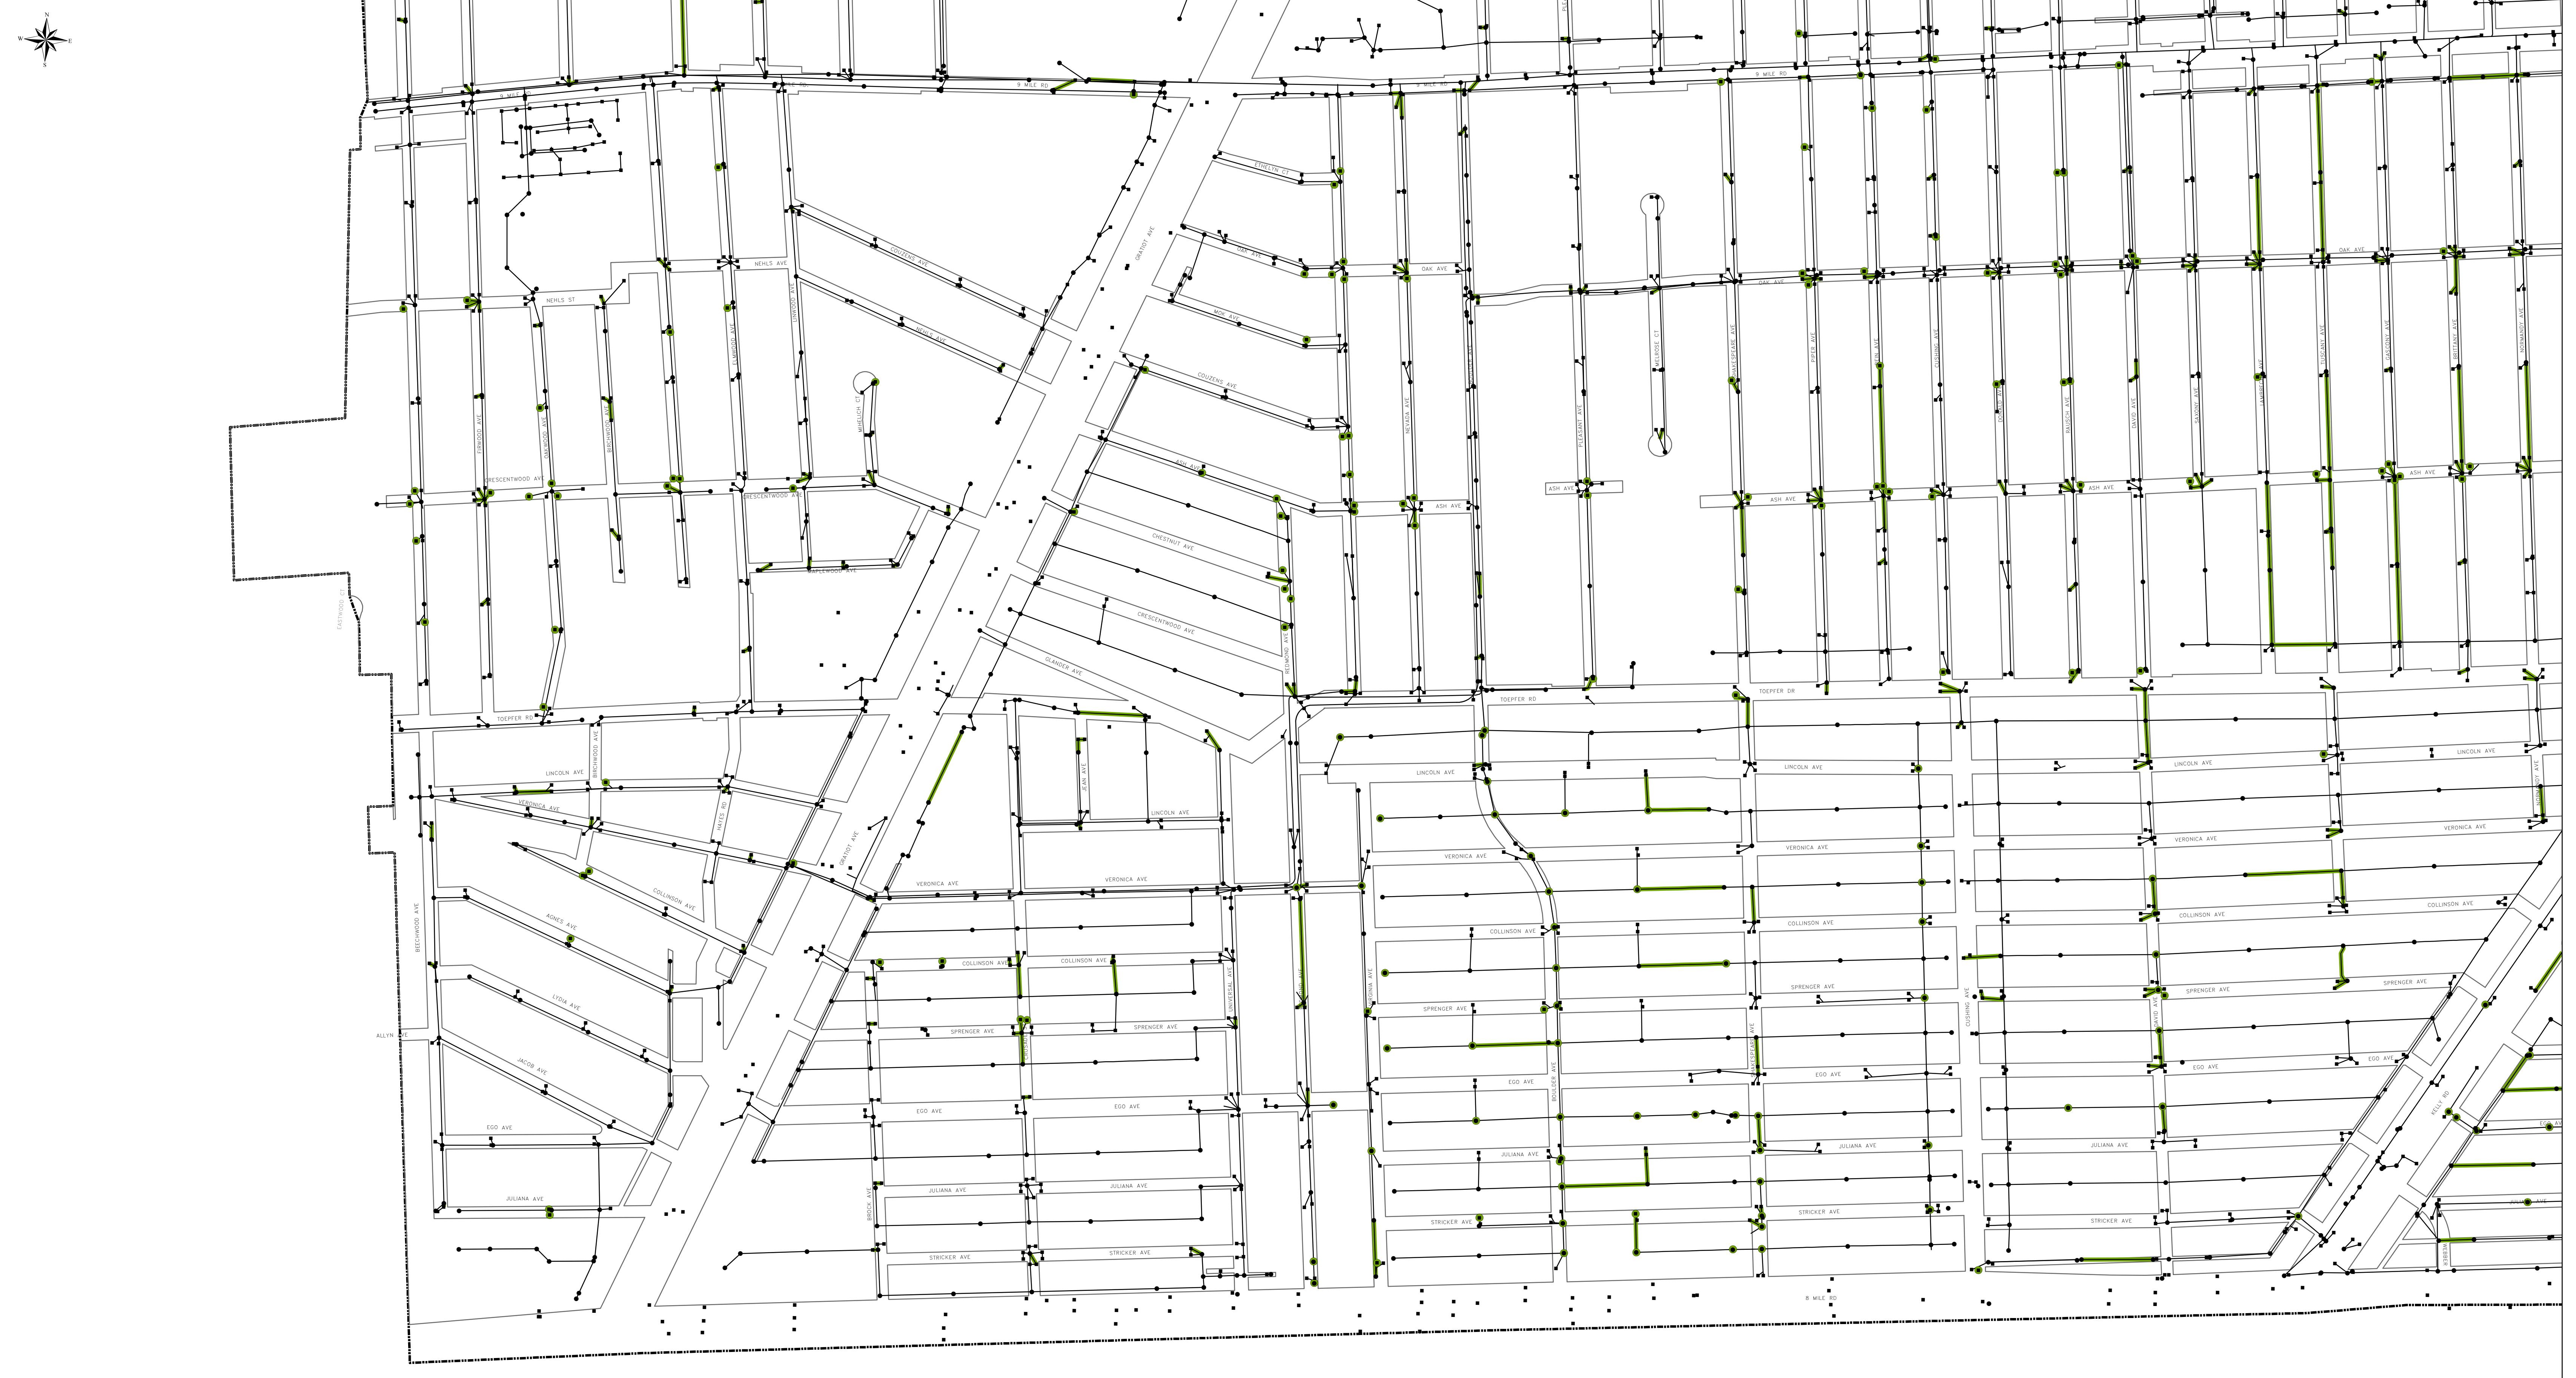
- CIP Structures
- CIP Sewers
