# **GROTON LONG POINT ROAD BRIDGE OVER PALMER'S COVE**

## **GROTON LONG POINT ROAD BRIDGE STRUCTURE TYPE STUDY REPORT**

Groton, Connecticut

September 22, 2015

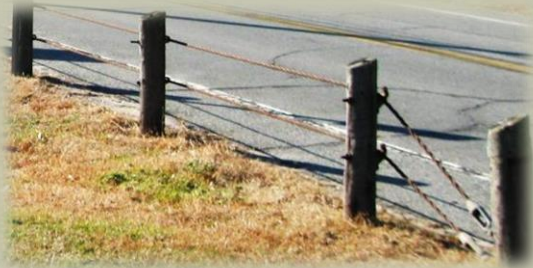
- **Wire Rope Guide Rail**
  - Substandard, poor condition
  - Not connected to bridge parapets
  - Minimal embedment due to erosion

1. The cables of the approach guide rails are typically slack, the timber posts are typically weathered and random posts are leaning/tilted. One post at the southeast approach is snapped off at ground level. Consider installing an improved guide rail system.
2. Both approach pavements have random longitudinal and transverse cracks. The pavement along the deck ends is breaking up with random areas of raveling, and is settled up to 2 in. (worst locations are in the north shoulder over the East Abutment). Seal the cracks (100± LF) and repair potholes and settlement (<½ TON).
3. There is an 8 in. diameter by 1 ft. deep erosion area at the northwest embankment adjacent to the first timber guard rail post, and a 10 ft. by 3 ft. by up to 1 ft. deep erosion area along the southwest embankment. Repair erosion areas (1 CY).

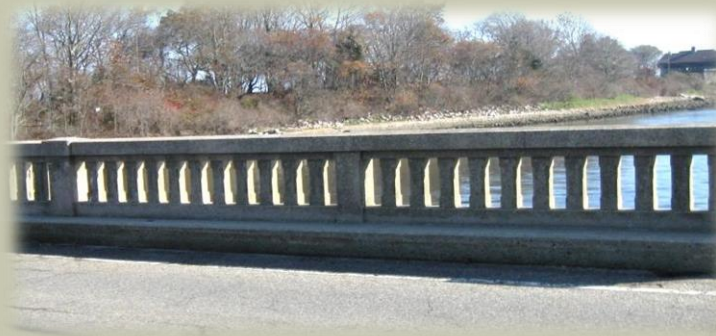
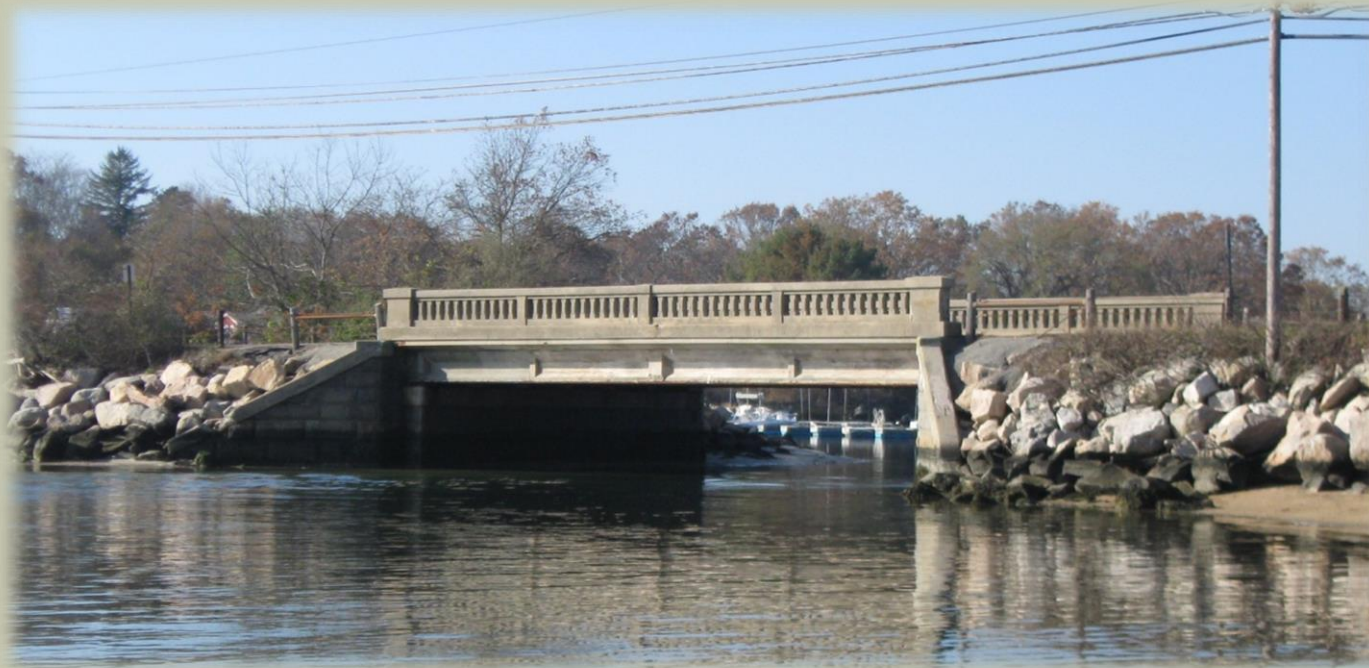
**EXISTING  
BRIDGE**

## ■ Superstructure

- Concrete Encased Steel Beams
- Cast-in-Place Concrete Deck
- Abutments and Flared Wingwalls with Stone Veneer
- Supported on Wood Piles
- Concrete Parapets

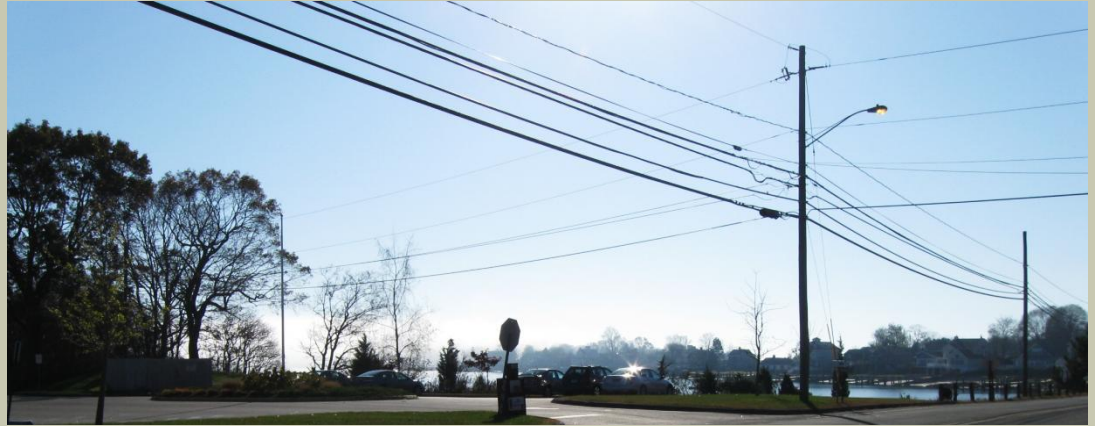
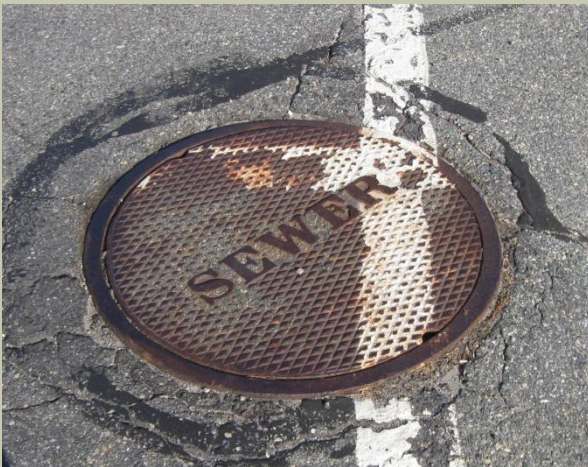
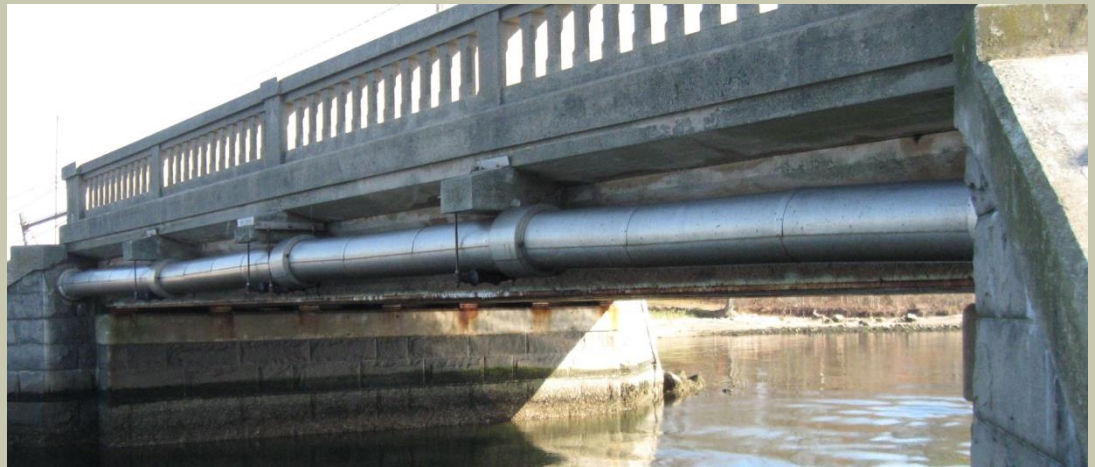
# UTILITIES

- Overhead Utilities
  - Electrical Feed to Fishers Island
- Watermain
- Sanitary Sewer Force Main

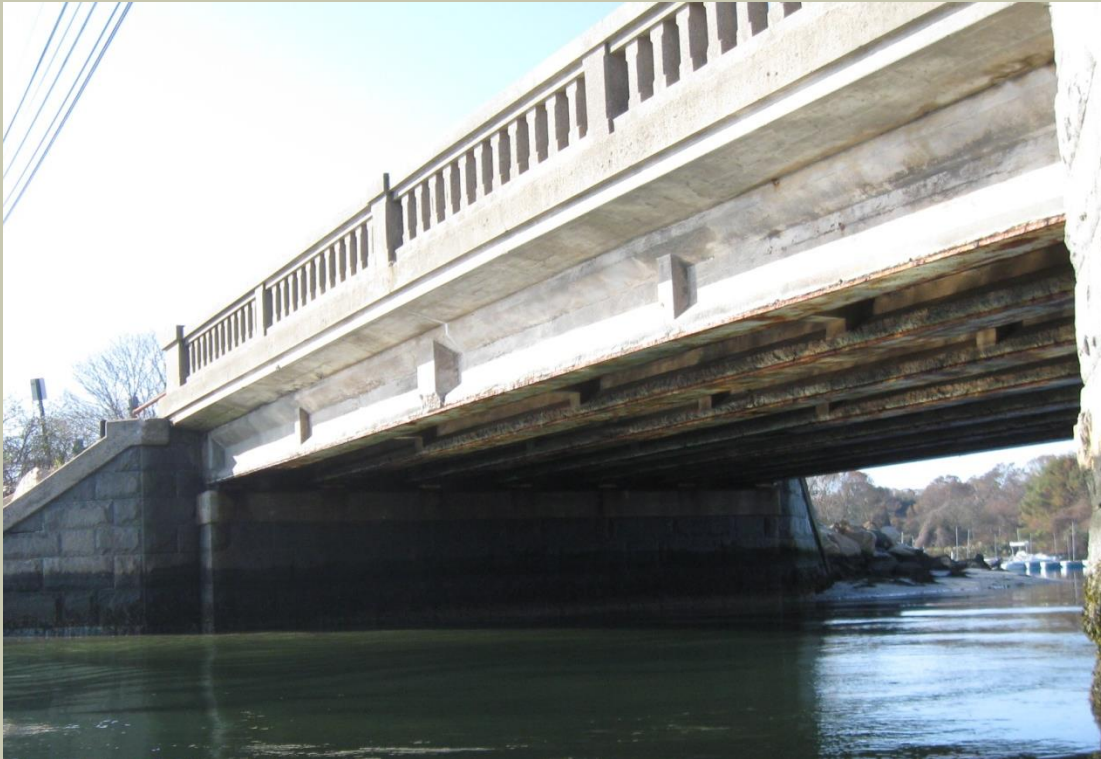
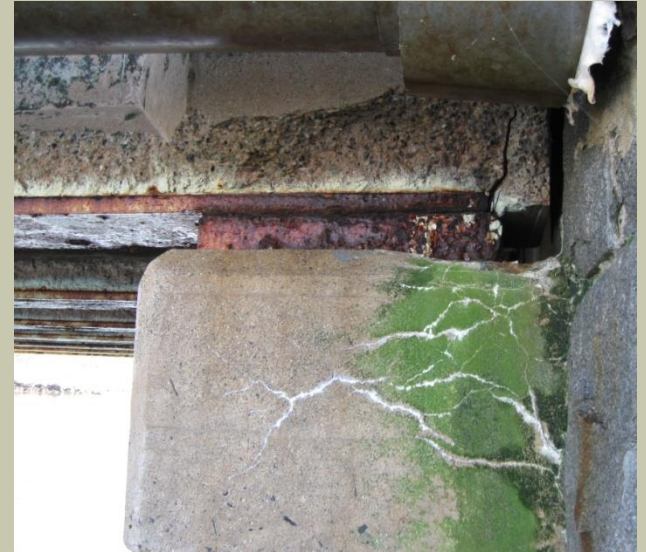
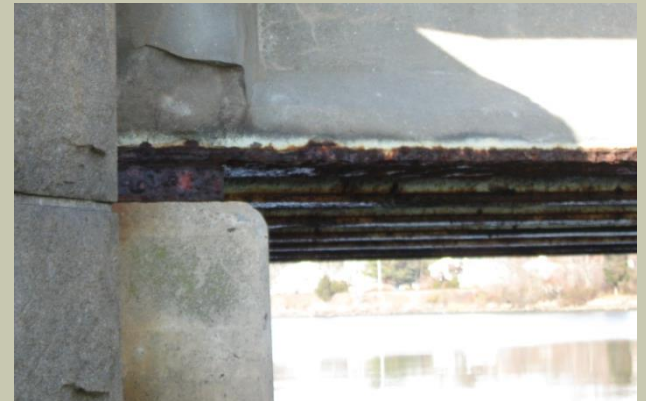
## ■ Superstructure

- Concrete encased beams
- Rated: 4

The superstructure is in poor condition (Overall rating = 4) due to the following:

1. Steel sliding plates at both abutments have light to moderate rust with random areas of painted over laminated rust and pack rust between plates up to 1 inch thick. West Abutment bearing plates have random areas of pitting up to 1/4 in. deep. No evidence of movement. Continue to monitor.
2. The bottom flanges at the bearing areas have as little as 3/4 in. remaining at the edge of the flange for up to 1 in. wide at both sides along the bearing plates (1 1/4 in. original, 2.7% loss in non

critical zone). The remaining flange length has spotty areas of 1/8 in. deep pitting (< 5% loss). The concrete encasement has random cracks and hollow areas/spalls along the webs, up to full length by 1 ft. high by 1 in. deep, and along the haunches of the top flanges, up to full length by 8 in. wide by 2 in. deep. The top flange edges have laminated rust and up to 1/16 in. loss of width where exposed. There is laminated rust along the bottom flange edges with up to 1/16 in. loss of width.

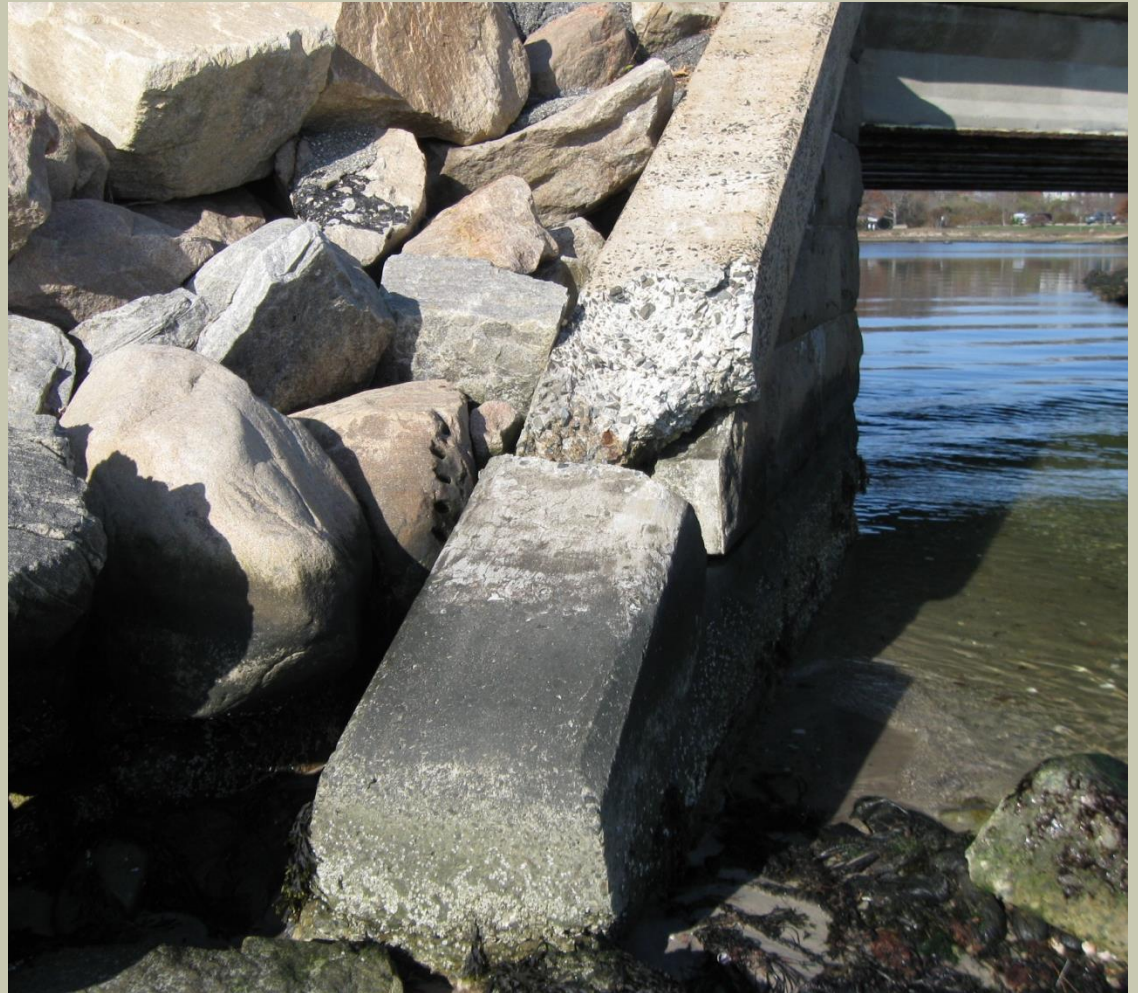
- Substructure

- Overall Condition:

- *Poor*

The substructure is in fair condition (Overall rating = 5) due to the following:

1. There are random vertical and transverse hairline cracks in the concrete abutment caps with rust stains. The West Abutment has hollow areas under G5 & G6, 6 square feet total. Also, hollow areas extend along the side of bearings with heavy scale areas ½ in. deep. The stone masonry has random hairline cracks in the mortar joints. Continue to monitor.

2. The concrete wingwall caps have hairline map cracking throughout and several random vertical and transverse cracks up to ½ in. wide. Stems have random displaced stones. All four wingwalls have spalls near the ends of the walls up to 4 ft. long by 0.9 ft. high by 0.8 ft. deep. The caps are typically displaced at these spall locations, up to 1½ in. (all wingwalls except northwest). The stone masonry has up to 20% of loose/missing mortar along the joints with up to 1.5 ft. of penetration. The northwest wingwall has a ¼ in. wide by up to 6 ft. high vertical crack adjacent to the abutment stem. Repair deteriorated concrete along the caps (1 CY).

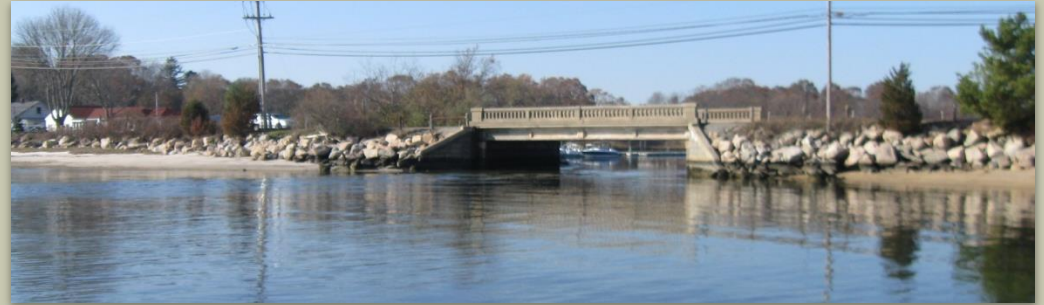
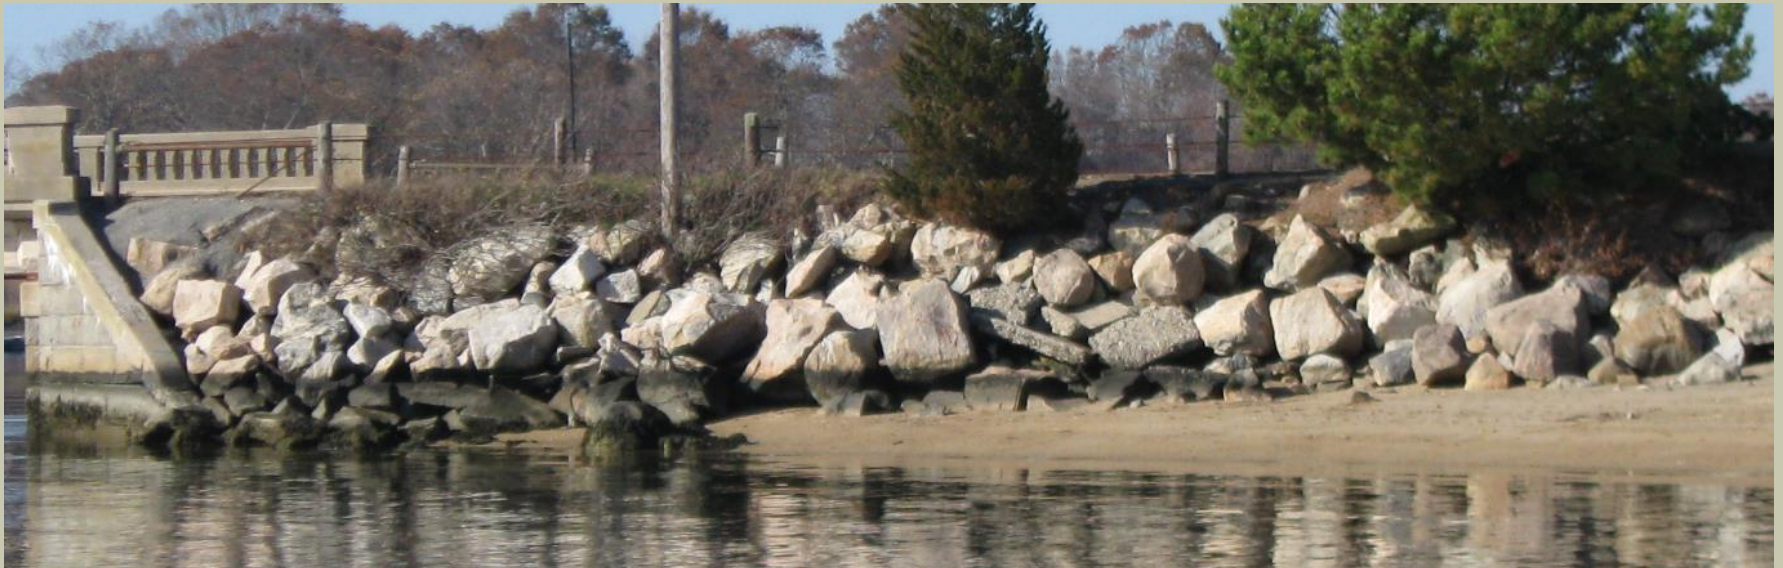
# CONDITIONS OF EXISTING CAUSEWAY

## ■ Causeway

- Randomly Placed Stone of Various Sizes
- Brush, Small Trees
- Sand Below High Tide Line

- Existing constructed after Hurricane Carol (1954)
- Revetment comprised of large riprap (stones with dimensions of 4-5 feet)
- Withstood numerous major storms since construction
  - Numerous Nor'easters
  - Tropical Storm Irene (2011)
  - Remnants of Hurricane Sandy (2012 – Storm of Record)
- Minor damage reported
- Revetment will be reconstructed to support widened roadway

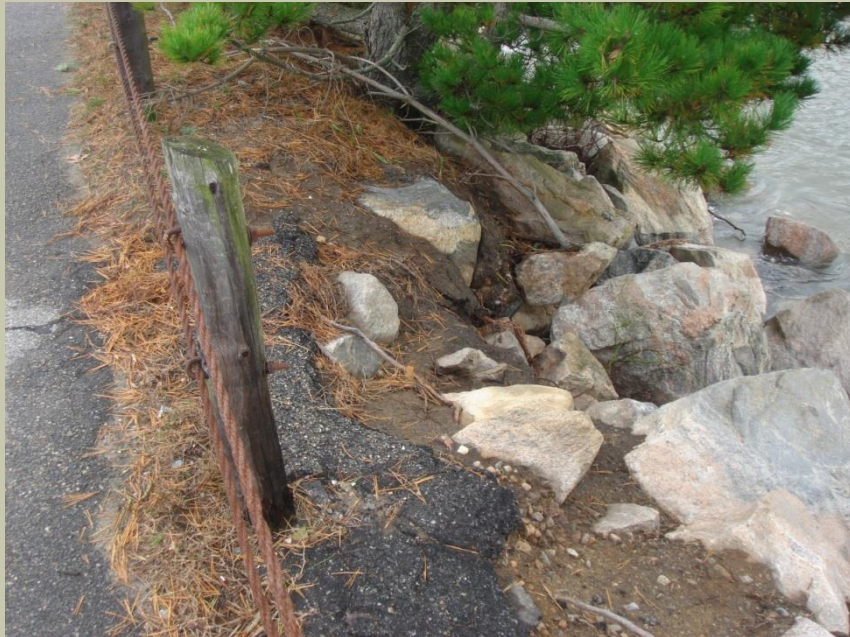
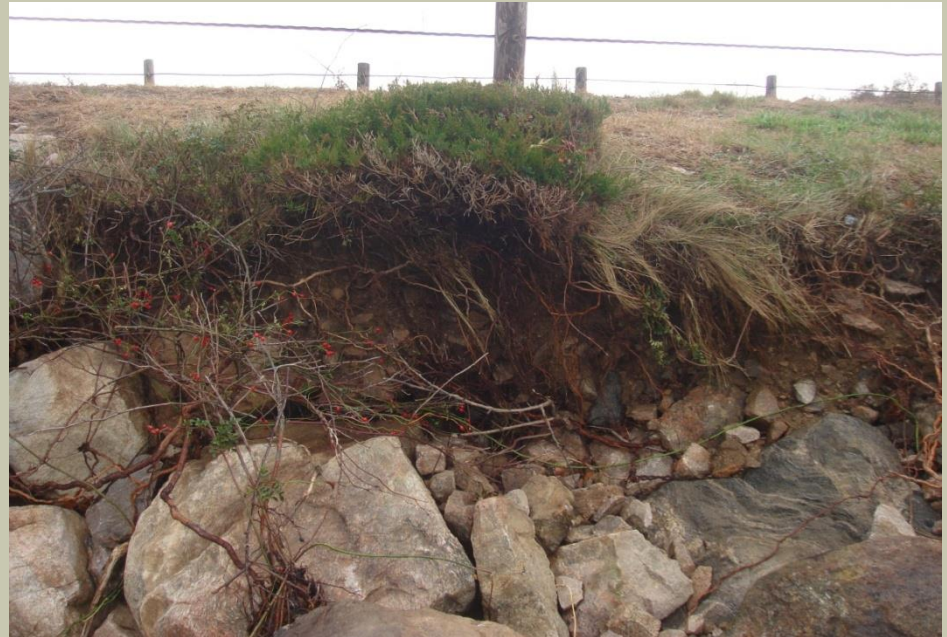
- Struck October 29, 2012
- No observable movement, cracking or shifting of substructure, substructure or roadway surface
- Eroded along edge of roadway on southern bank of causeway

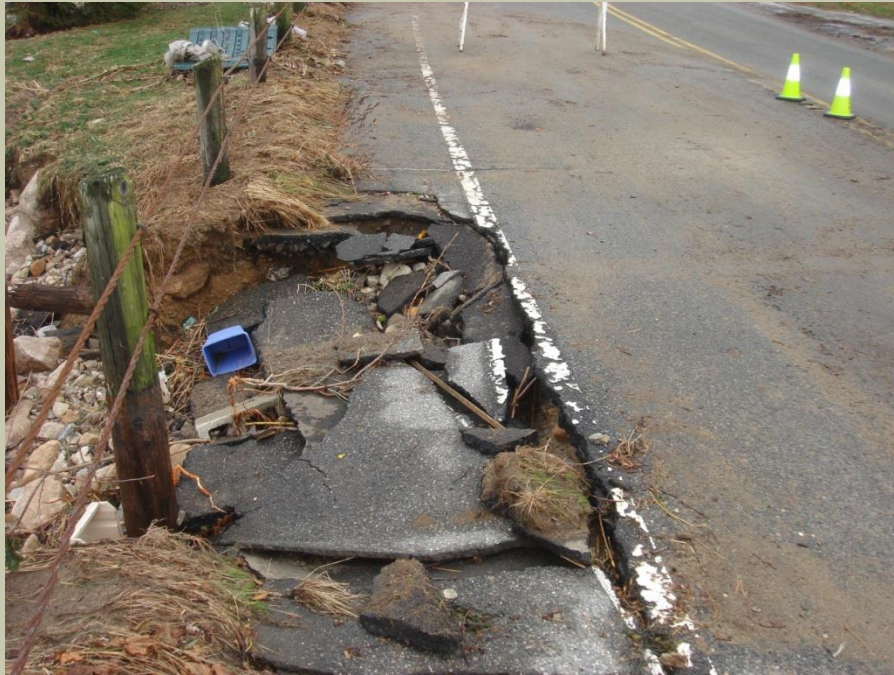
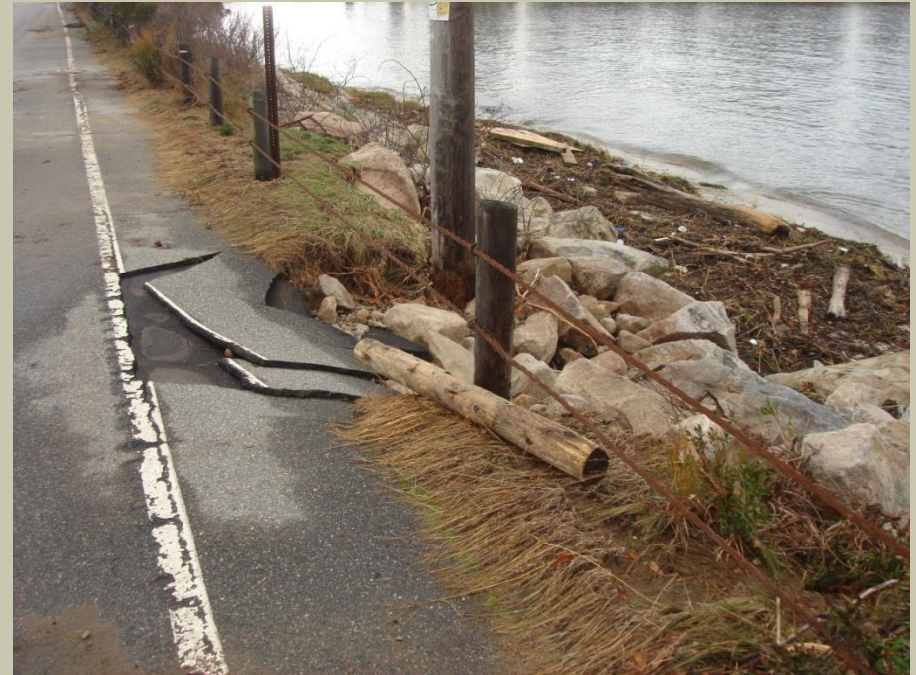
- Water over-topped roadway in low profile area west of bridge

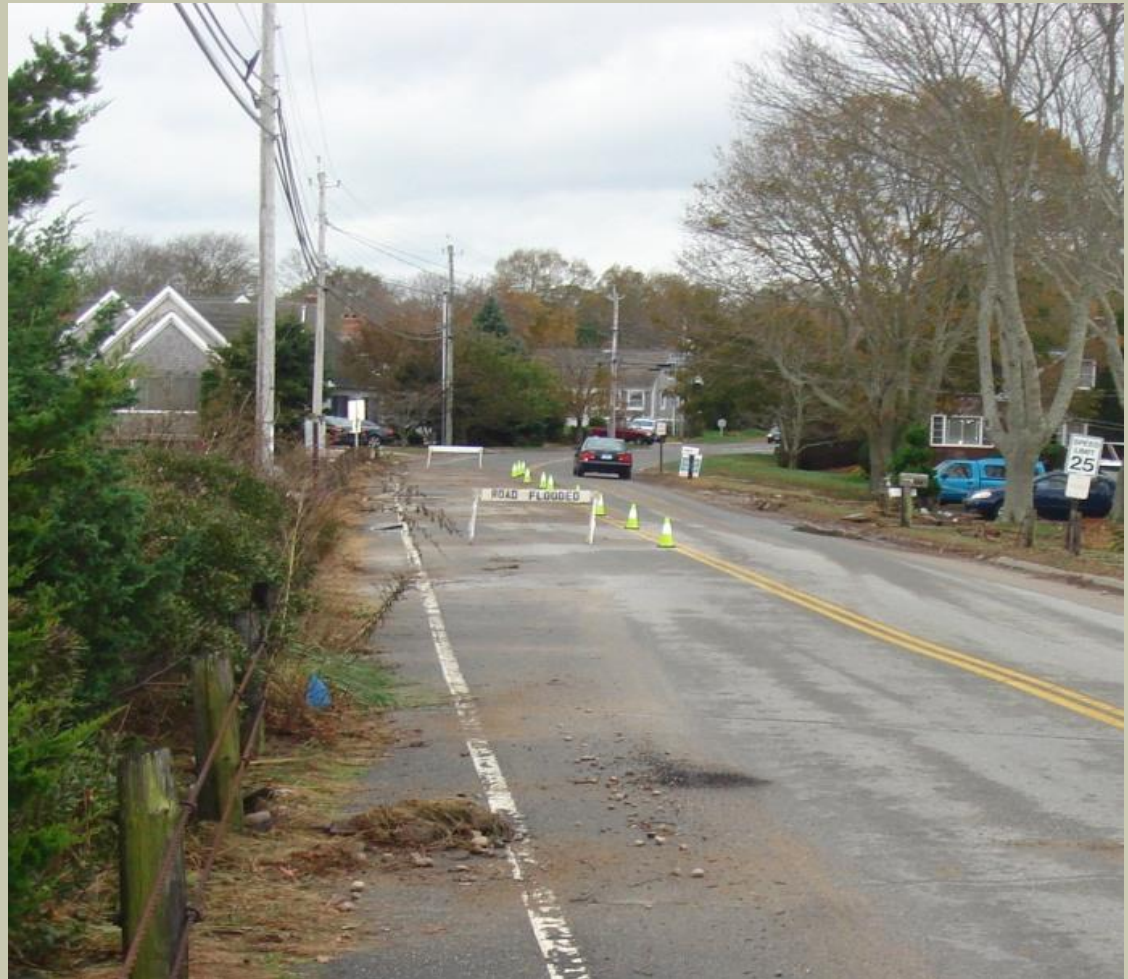
- Eastbound lane closed to traffic
- Roadway Elevations
  - Center of Bridge: Elevation 9.30
  - Roadway Low Point (240' West of Bridge): Elevation 7.96

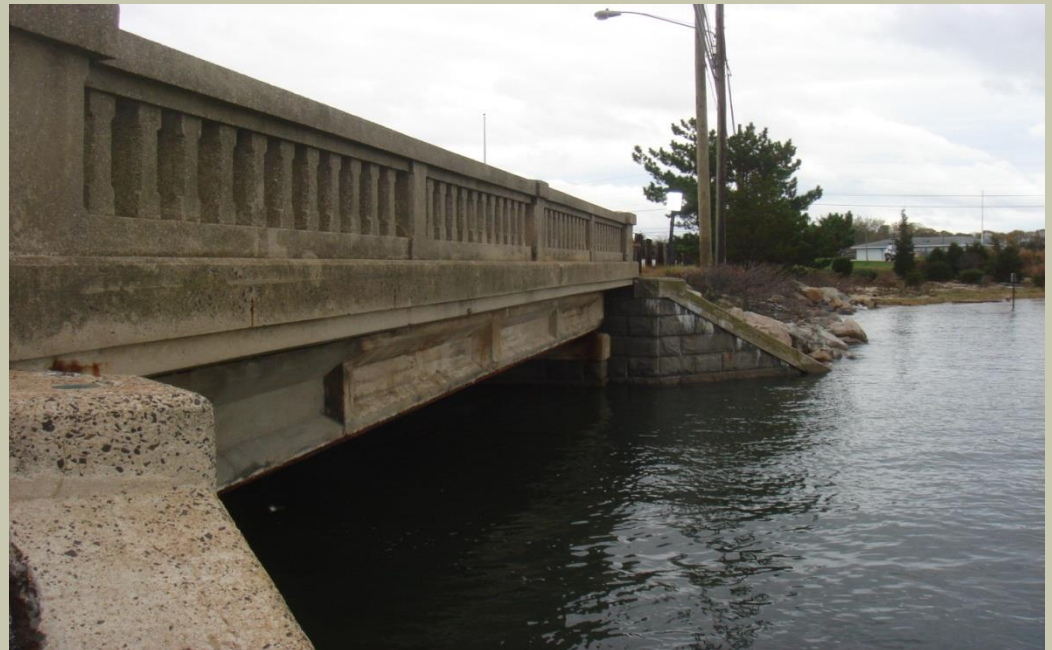
# NATIONAL OCEANIC AND ATMOSPHERIC ADMINISTRATION (NOAA) TIDE DATA

- New London Gauging Station
- Water level peaked October, 29, 2012 at 8:12pm
  - Water level peak: Elevation: 6.16
- Bridge Bottom Chord Elevation: Elevation 5.72
- Supports evidence wave action over-topped roadway
- From 7:48 PM to 8:54 PM
  - Water Level: Elevation 6.0
- From 6:00 PM to 10:36 PM
  - Water Level: Elevation 5.0

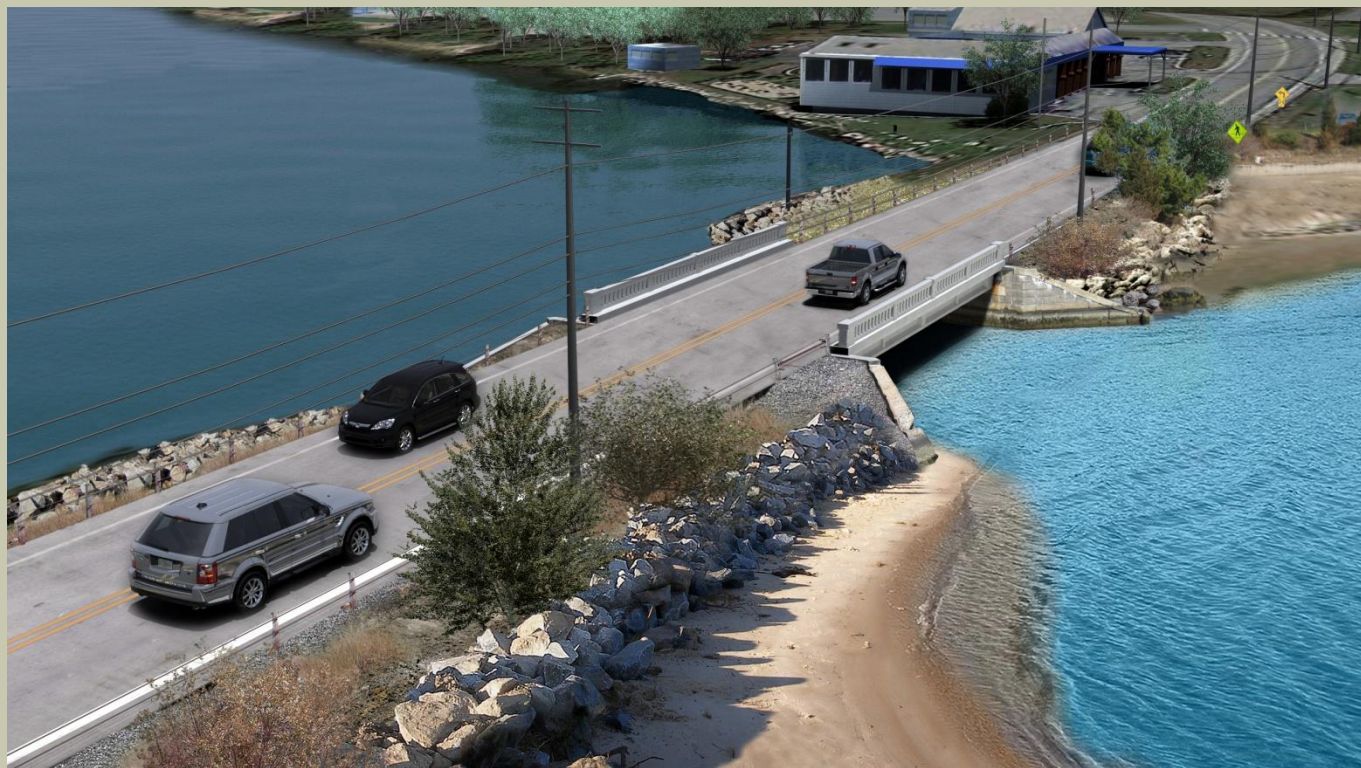
**EXISTING  
ROADWAY**

Roadway	30'
Travel Lanes	12'
Shoulders/Bike Lane	3'
Pedestrian Accommodations	None

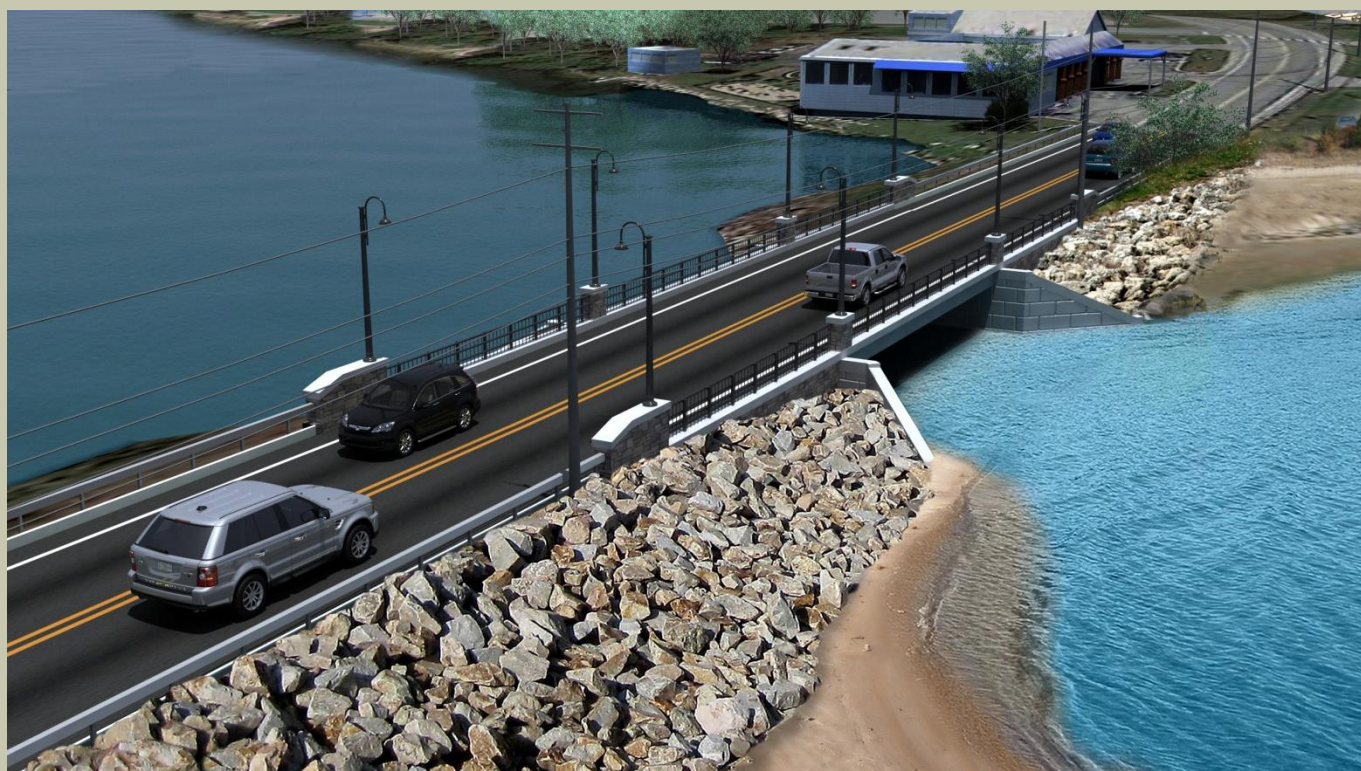
Roadway	33'
Travel Lanes	12'
Shoulders/Bike Lane	4' 6"
Pedestrian Accommodations	None

Superstructure  
Replacement

## ALTERNATIVE NO. 1 – Superstructure Replacement

**ALTERNATIVE  
NO. 1 -  
Superstructure  
Replacement**

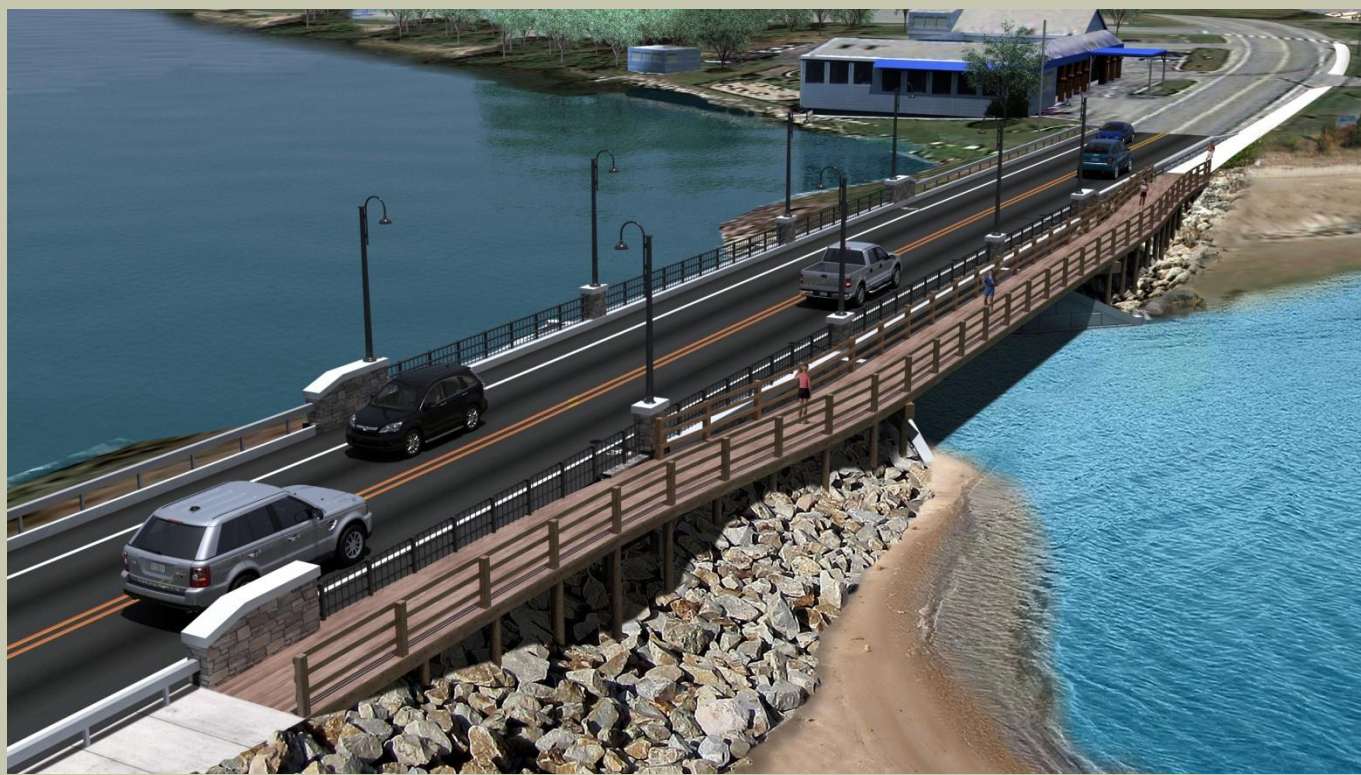
## ALTERNATIVE NO.2

Roadway	33'
Travel Lanes	12'
Shoulders/Bike Lane	4' 6"
Pedestrian Accommodations	6' Pedestrian Bridge

Superstructure  
Replacement  
with Sidewalk

## ALTERNATIVE NO. 2 – Superstructure Replacement with Sidewalk

**ALTERNATIVE  
NO. 2 -  
Superstructure  
Replacement with  
Sidewalk**

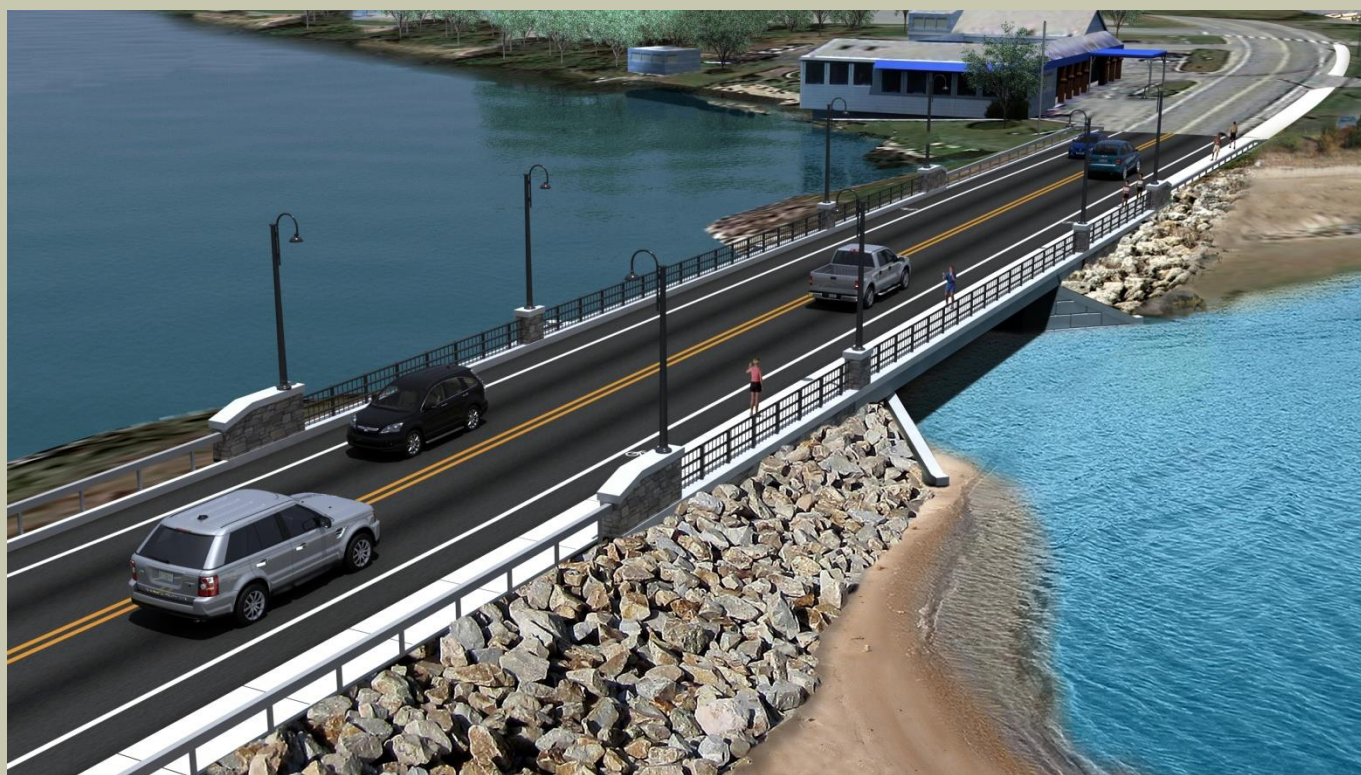
## ALTERNATIVE NO.3

Roadway	33'
Travel Lanes	12'
Shoulders/Bike Lane	4' 6"
Pedestrian Accommodations	6' Sidewalk

Bridge  
Replacement  
and Widening

## ALTERNATIVE NO. 3 – Bridge Replacement with Widening and Sidewalk

**ALTERNATIVE  
NO. 3 - Bridge  
Replacement and  
Widening**

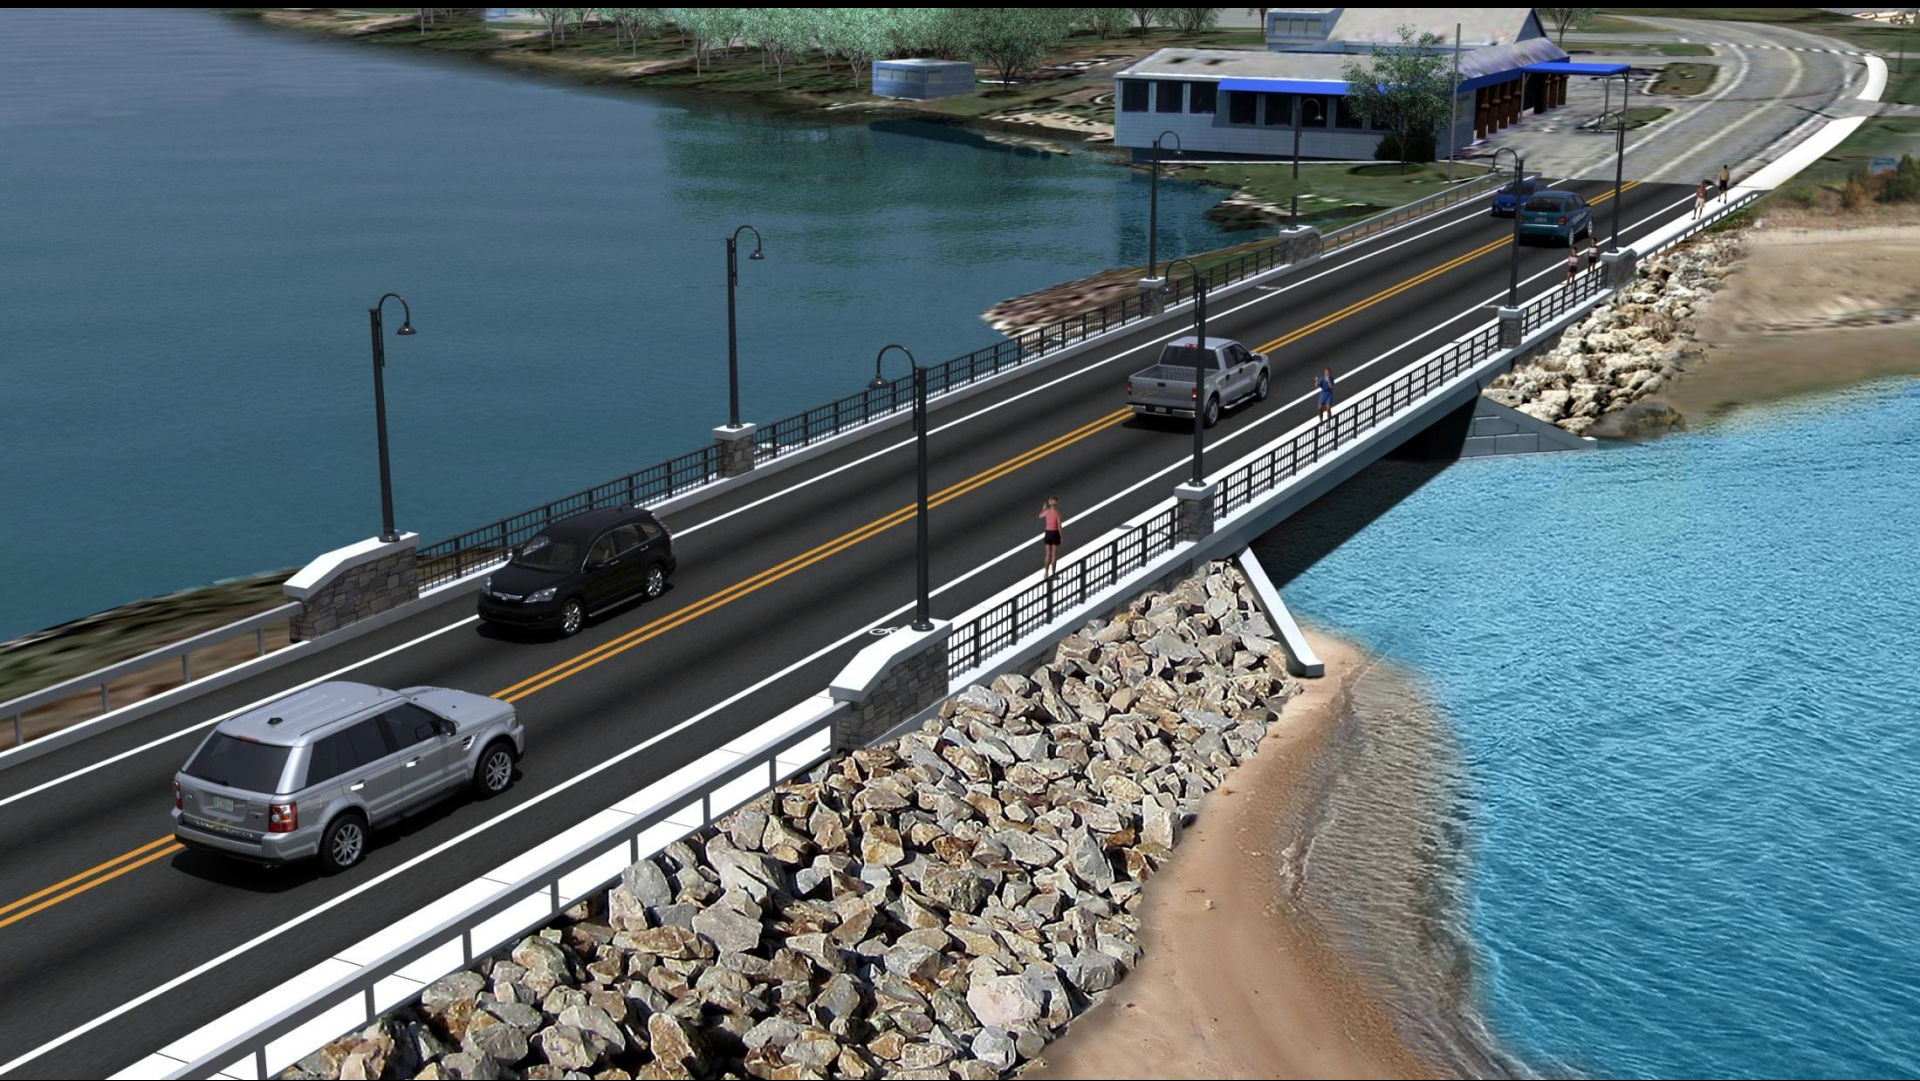
ALTERNATIVE NO.2 - SUPERSTRUCTURE  
REPLACEMENT WITH SIDEWALK

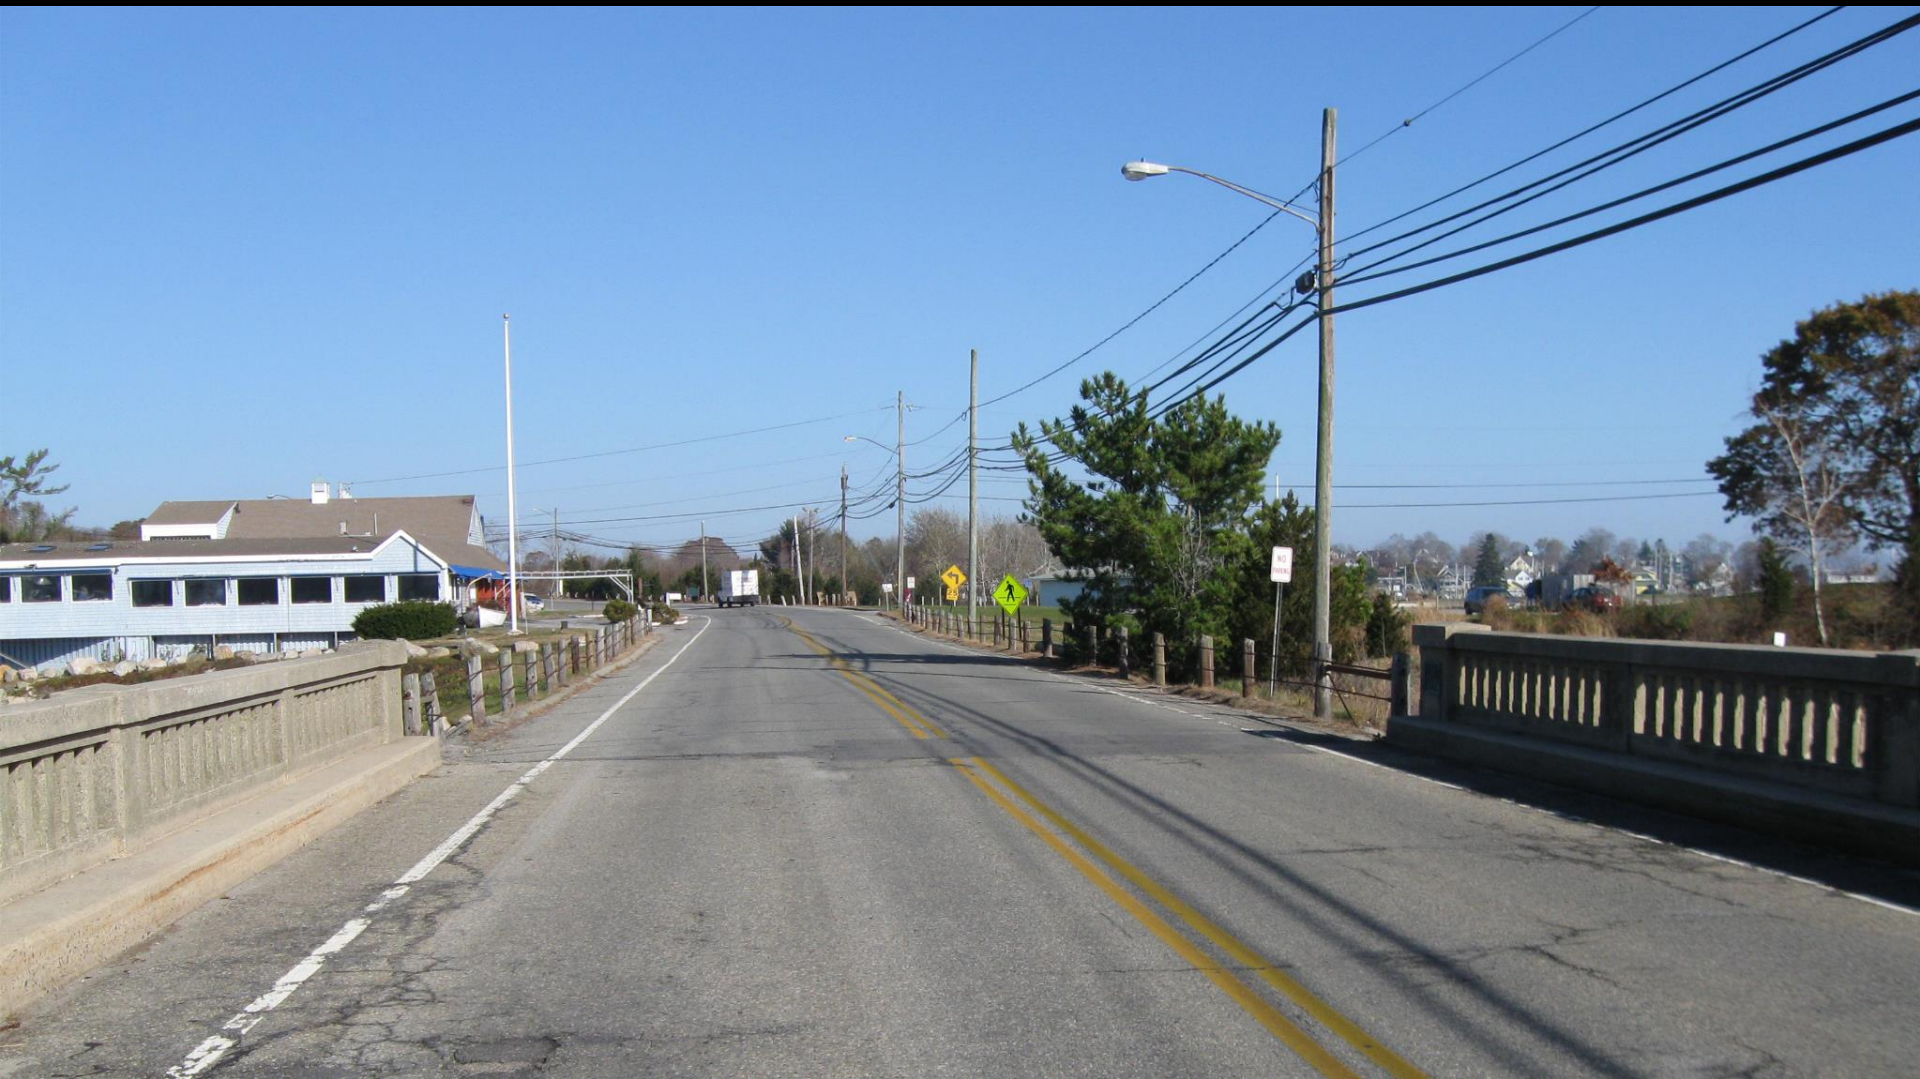
**ALTERNATIVE NO.3 - BRIDGE  
REPLACEMENT AND WIDENING**

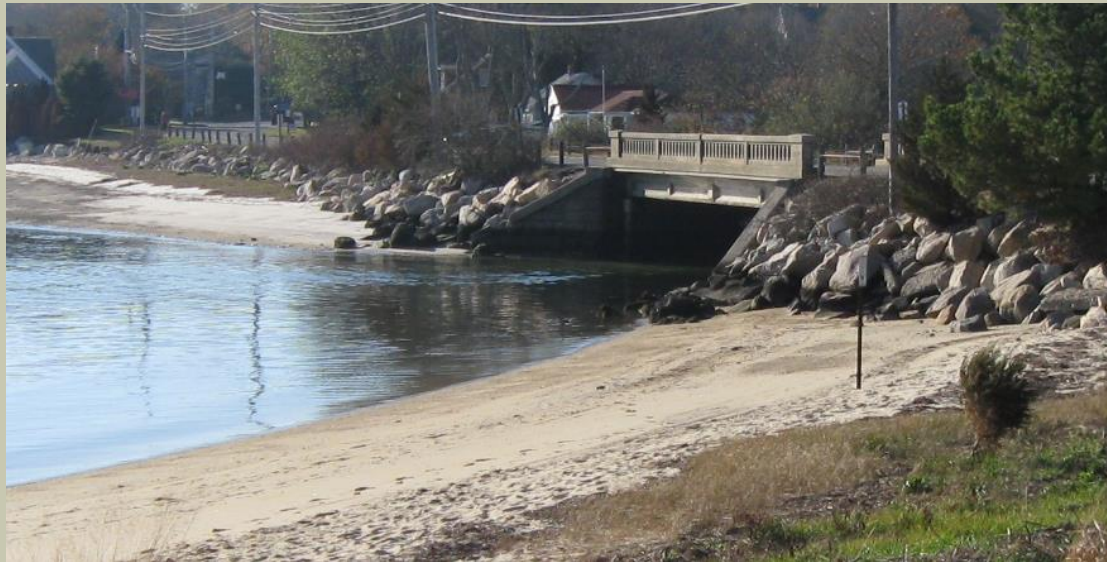
## Alternative B

Pile Support Retaining Wall

**ALTERNATIVE B – Pile  
Supported Retaining Wall  
to Support Widened  
Roadway**
