# **GROTON LONG POINT ROAD BRIDGE OVER PALMER'S COVE**

## **GROTON LONG POINT ROAD BRIDGE STRUCTURE TYPE STUDY REPORT**

Groton, Connecticut

September 22, 2015

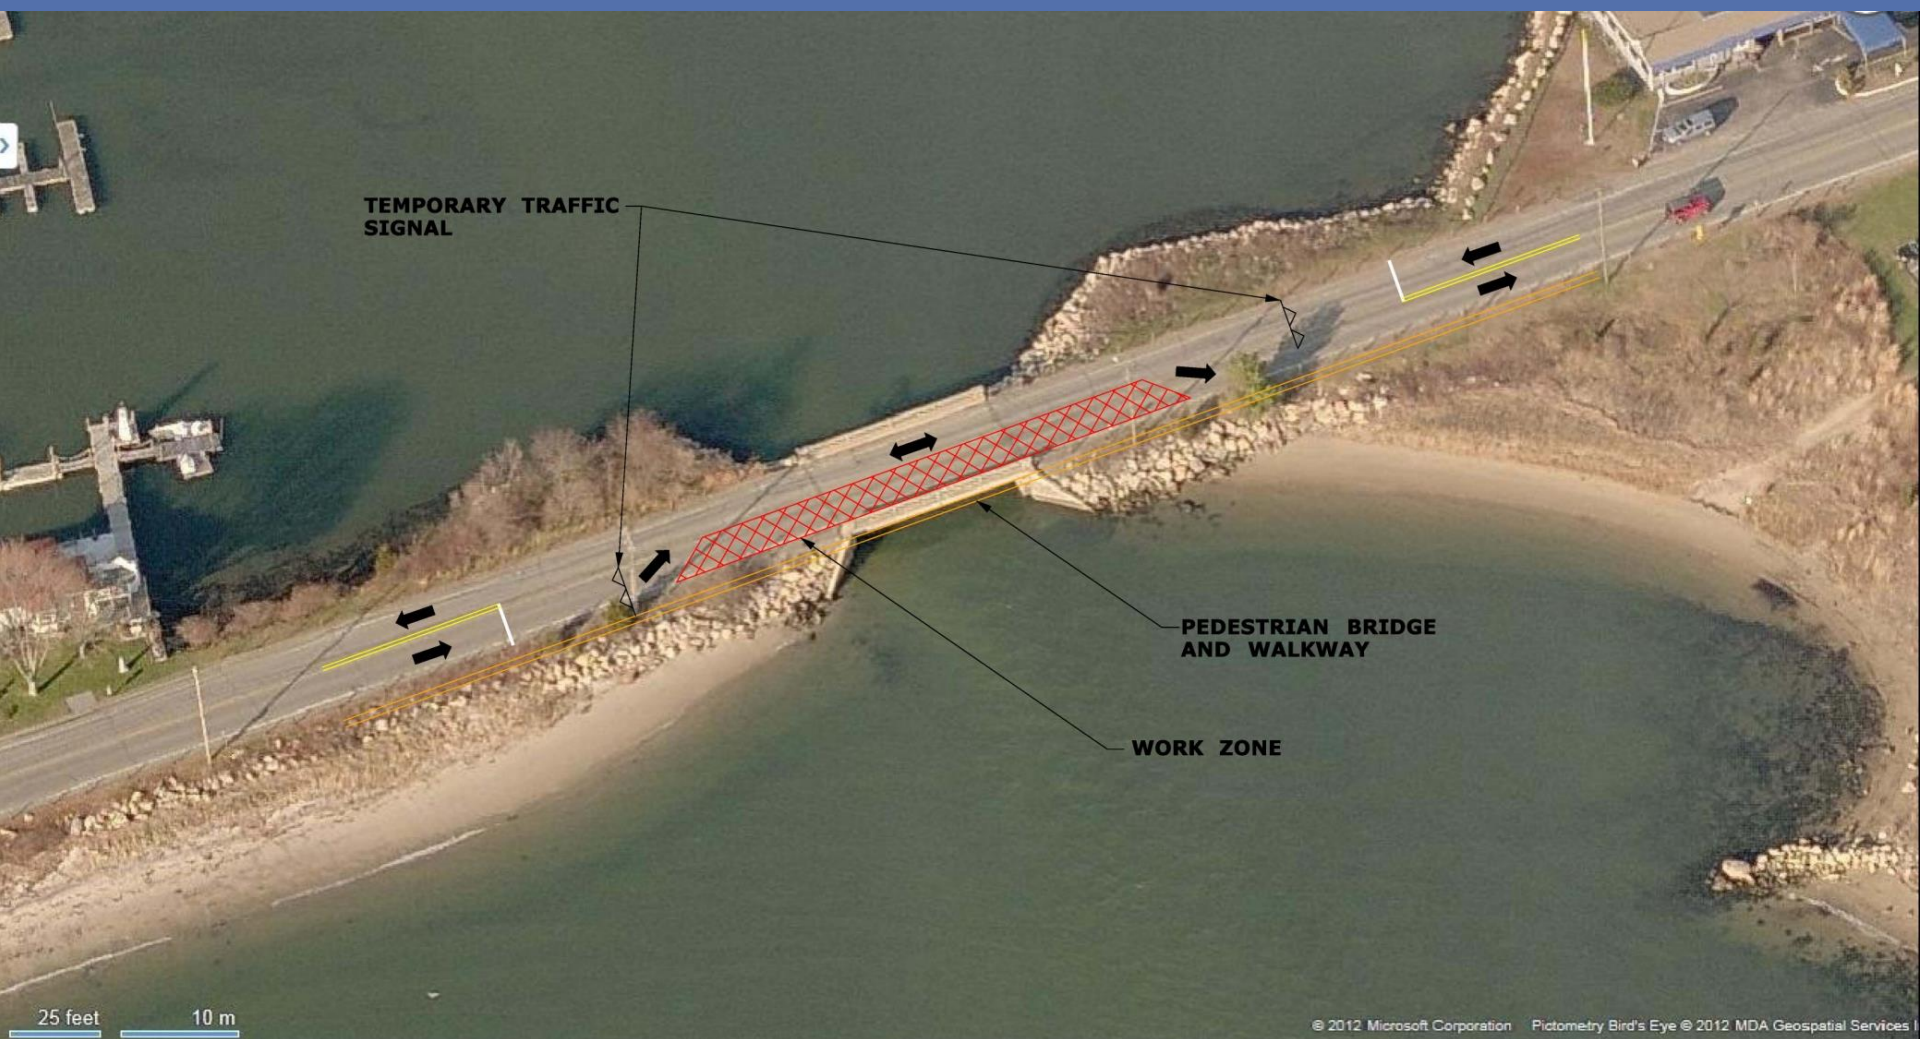
**STAGE 1**

- Driven by Environmental Permit Restrictions
- Stage 1
  - First Season
- Stage 2
  - Second Season

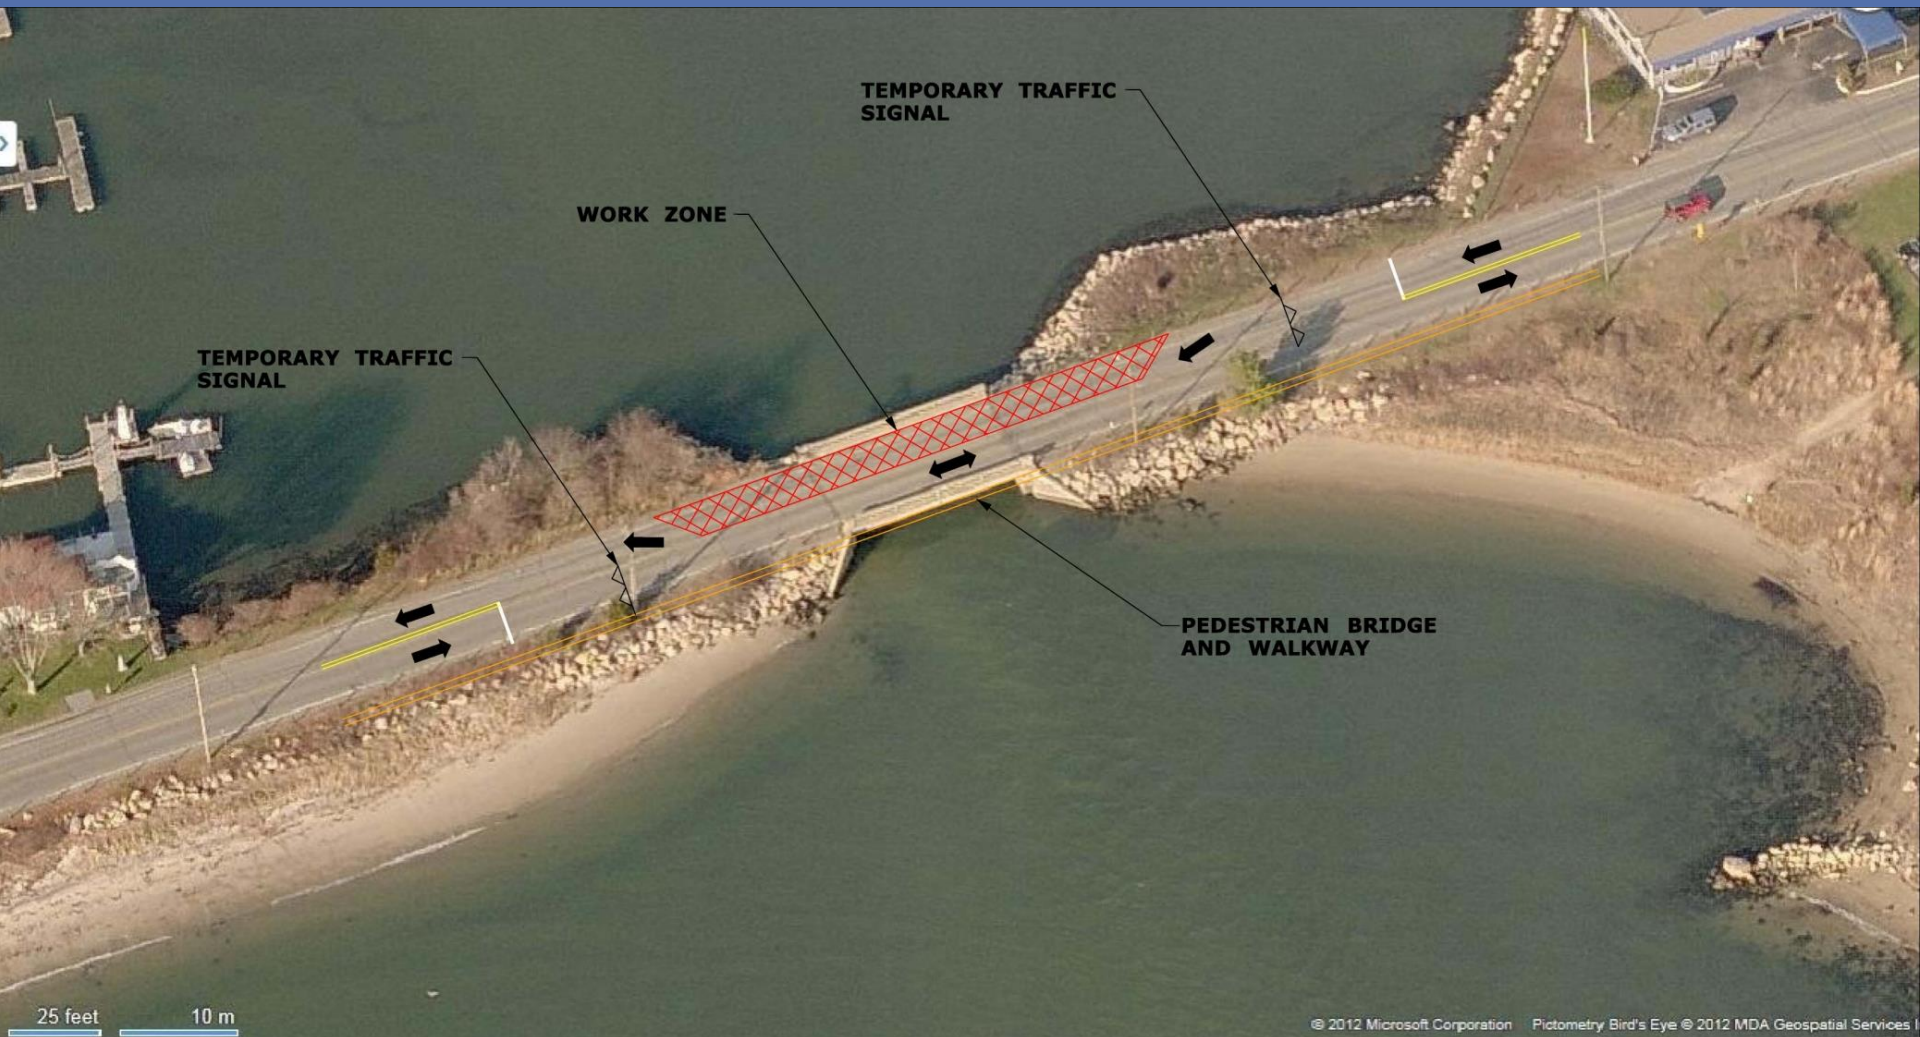
**Construct Stage 2 - Northerly Half of Bridge**

**Open New Bridge to Traffic**

**STAGE 2**

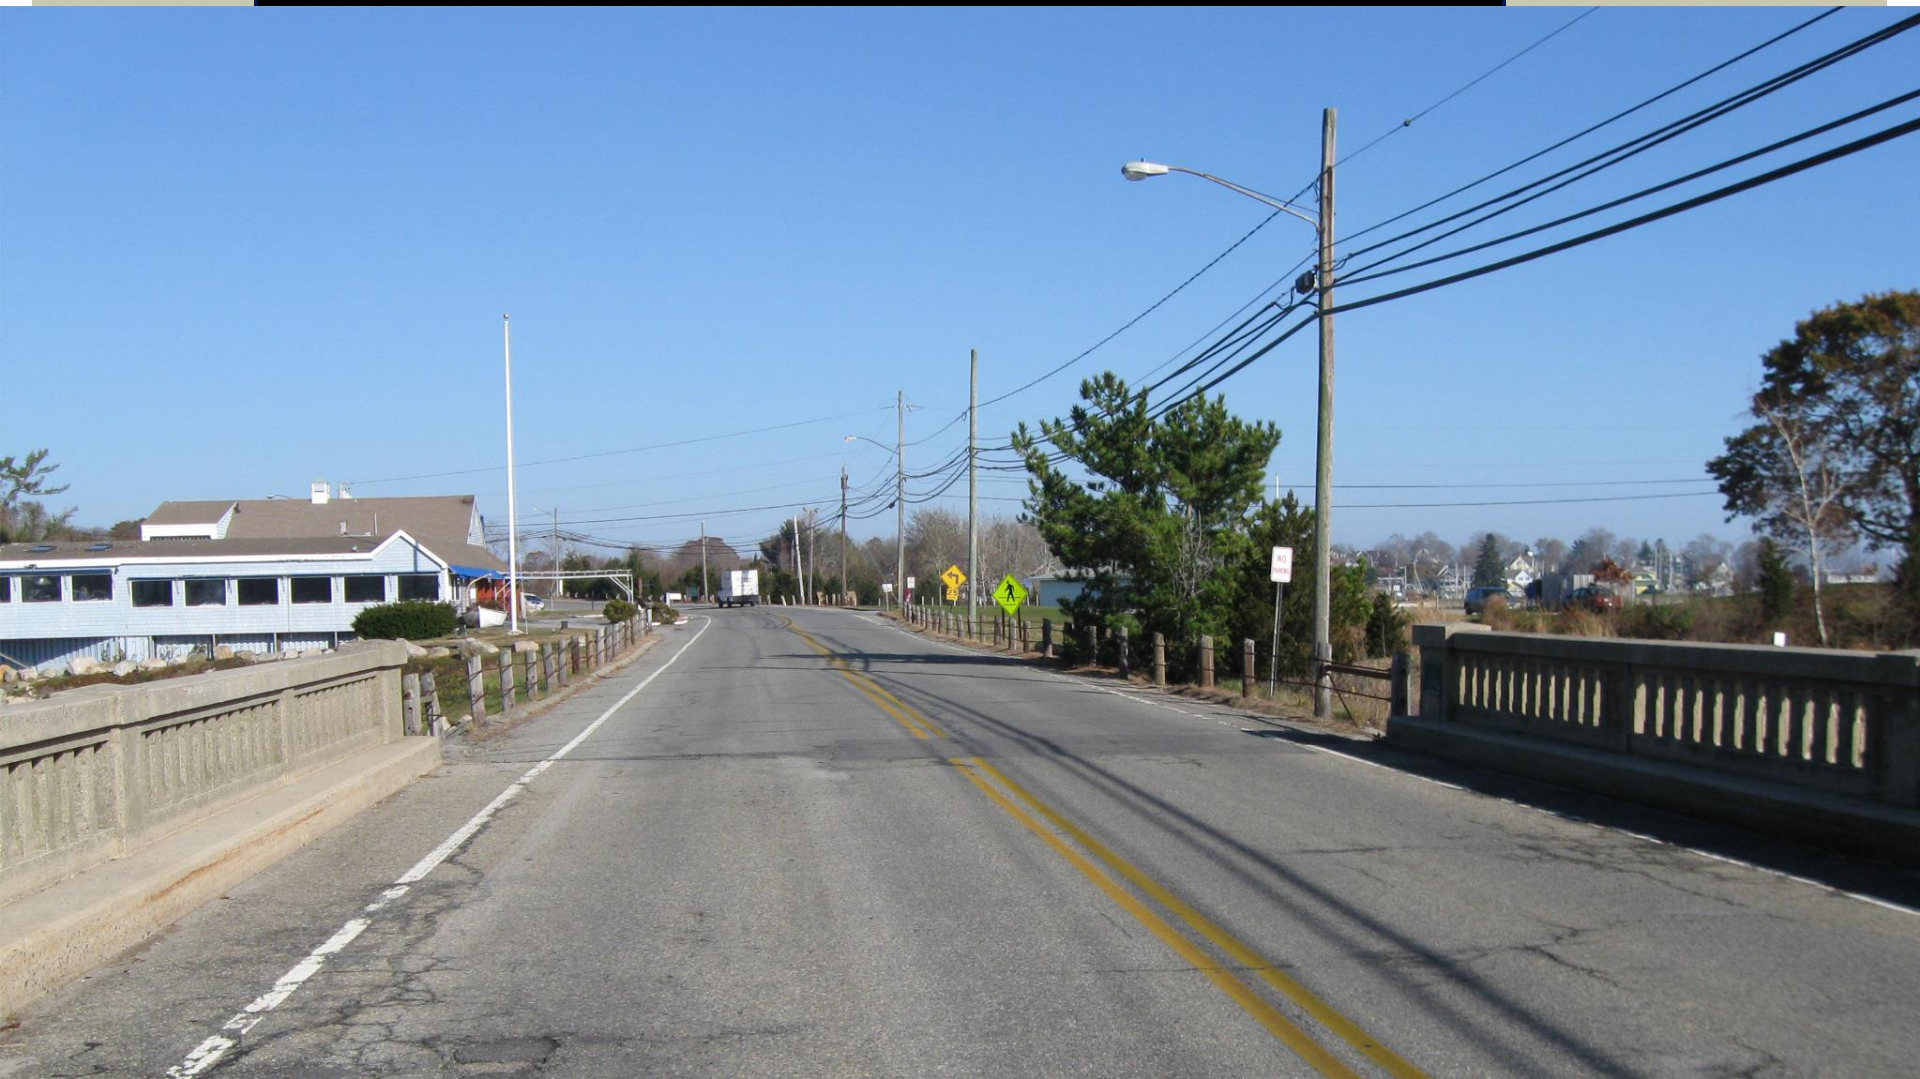
EXISTING

- **Maintain essentially same width within 60 R.O.W.**
  - Start at Fisherman Restaurant
  - End at East Shore Drive
- **Provide sidewalk on one side**
  - Need further study to determine North or South side
- **Maintain essentially same profile grade on approaches**
  - Grade at bridge about 1 foot higher

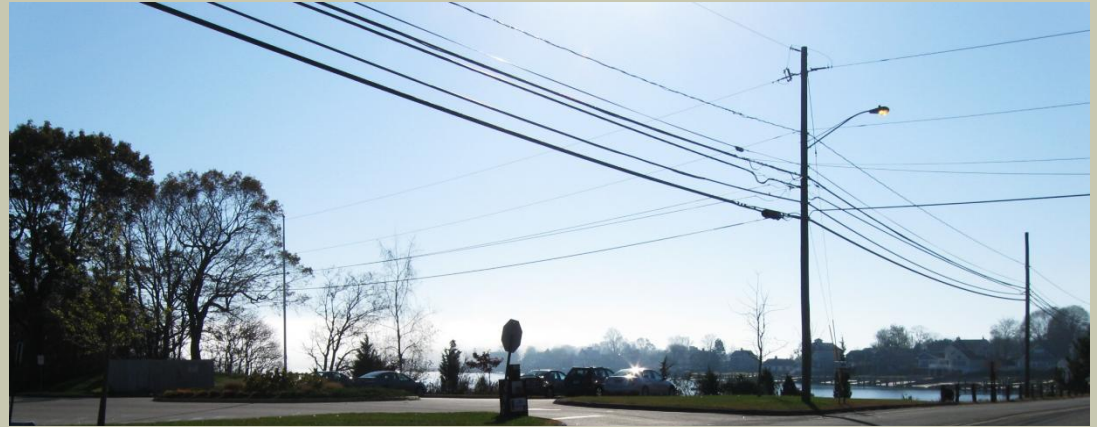
- Relocate Overhead Utilities

- Electrical
- Telephone
- Cable

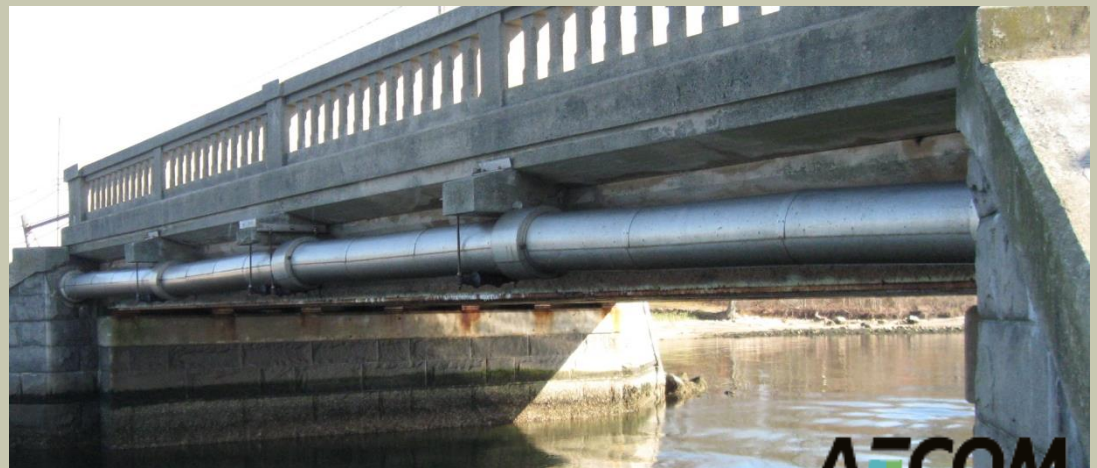
- Relocate Watermain to New Bridge

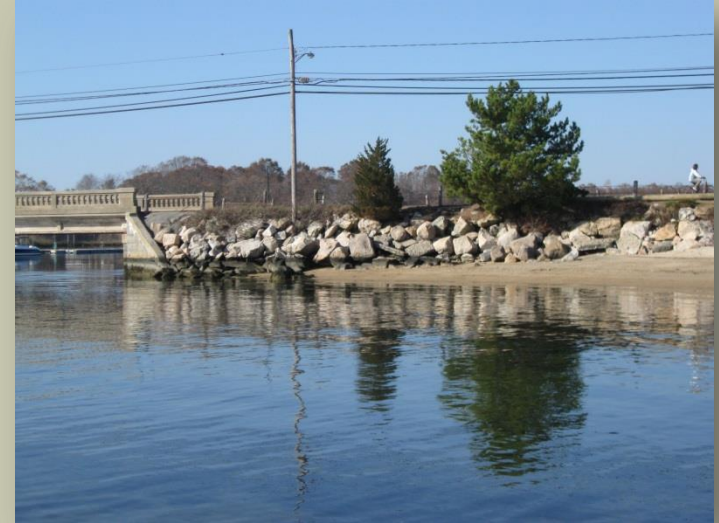
# CAUSEWAY

- Existing constructed after Hurricane Carol (1954)
- Revetment comprised of large riprap (stones with dimensions of 4-5 feet)
- Withstood numerous major storms since construction
  - Numerous Nor'easters
  - Tropical Storm Irene (2011)
  - Remnants of Hurricane Sandy (2012 – Storm of Record)
- Minor damage reported
- Revetment will be reconstructed to support widened roadway

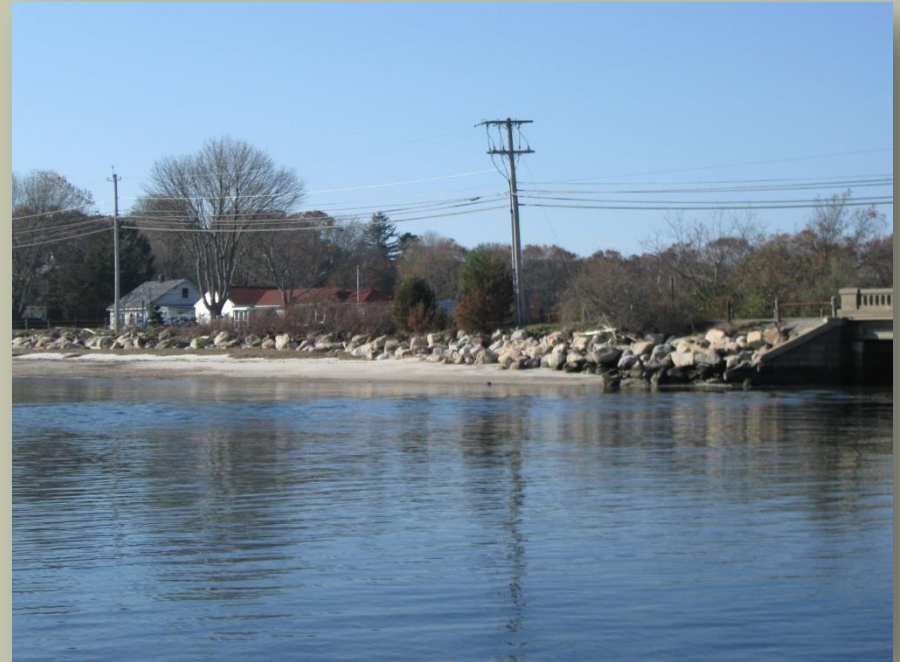
# CAUSEWAY (CONTINUED)

- New revetment designed according to state-of-the-art Federal Highway guidelines and procedures
- New revetment will comprise well-graded riprap of approximately the same size
- Designed with top and toe embedment
- New design considers projected sea level rise
  - 10" of the next 100 years
