WATER & SEWER COMMISSION October 22, 2019

AGENDA ITEMS

Water & Sanitary Pipe Inventory & Condition Assessment

Van Buren Township Private Fire Hydrant Inspection Program 2019

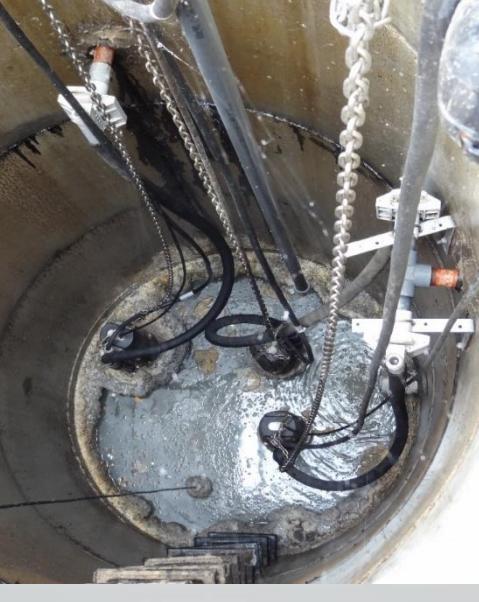
Vertical Asset Inventory & Condition Assessment

- 1. Site visits in August were performed to inspect each sanitary asset
- 2. Reviewed history of sanitary assets with Operators

Question	Condition Weight	Answer		
All Components Present	1			
		1	Yes	
		5	No	
All Safety Features Present	0			
		1	Yes (or Not Applicable)	
		5	No	
General Appearance	1			
		1	Excellent	
		2	Good	
		3	O perational	
		4	Failure Imminent	
		5	Failure	
Functional	1			
		1	Fully Eurotional	
		2	Mostly Eurotional	
		3	Requires Moderate	
		5	Cleaning/Maintenance	
		4	Requires Significant	
		5	Cleaning/Maintenance Siezed Binded not working	
Installation /A conscibility	1	5	ologod, Dillogo, not working	
Thistallation/Accessibility	1		Testellad annual a service a service	
		1	Installed property, easy to access	
		2	Installed properly, minor access	
		3	Minor installation problems, minor access	
			obstructions	
		4	Minor installation problems, access	
		5	Improperly installed, access obstructed	
Absence of Cavitation	1			
		1	Yes	
		5	No	
A branco of Looks	1	-		
Absence of Leaks	-	1	Vec

-	Ne	
		2	NO	
Acceptable Noise	1			
		1	Yes	
		5	No	
A cceptable V ibration	1			
		1	Yes	
		5	No	
Corrosion - Metal	1			
		1	Like New	
		2	Minor Corrosion	
		3	Pitting And Some Metal Loss	
		4	Significant Metal Loss	
		5	Severe Pitting	
Chain/Cable/Hooks	1			
		1	Excellent	
		2	Minor Wear	
		3	Moderate Wear	
		4	Major Wear	
			E siluro Imminont	
Connections Ob		5	i alute Infinitenc	
Connections OK	1			
		1	Yes	
		5	NO	
Festoon and Power Cable Condition	1			
		1	Excellent	
		2	Minor Wear/Deterioration	
		3	Moderate Wear/Deterioration	
		4	Significant Wear/Deterioration	
		5	System Failure	
Guide Rail Condition	1			
		1	Excellent	
		3	Minor Corrosion	
		5	Severe Corrosion

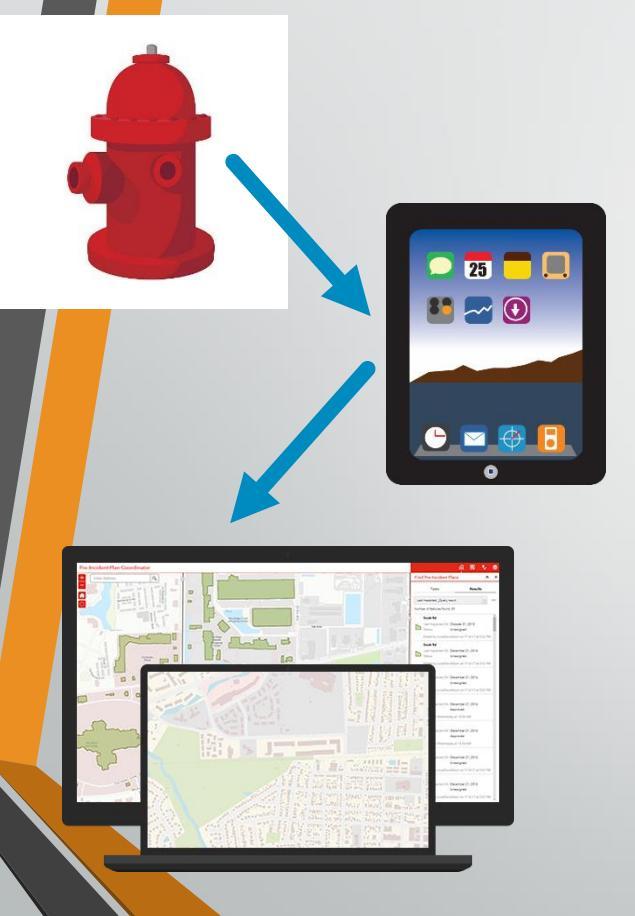
Data Collection Process

- VBT Fire Department to conduct scheduled inspections.
- FD Staff will record info on tablet provided by Water/Sewer Department.
- Info is then captured by GIS System and added as a layer to the map, allowing the Township to track and analyze private hydrant information, status, and issues.
