**The City of Lake Forest
Historic Preservation Commission Agenda**

**Monday, September 14, 2020
Remote Access Meeting**

3. Consideration of a request for approval of a Certificate of Appropriateness for the Deerpath Streetscape Improvement Report.
Representatives: Jim Lockefer, Management Analyst, Public Works Dept.
Craig Bergmann Landscape Design, Erin Herrera and Craig Bergmann

4. Continued consideration of a request for approval of a Certificate of Appropriateness for a new residence on a vacant lot located at **740 Washington Road**. The Commission will also consider the associated site plan, proposed tree removal and the landscape plan.
Property Owners: Hugh and Diane Zentmyer
Representative: Edward Deegan, architect

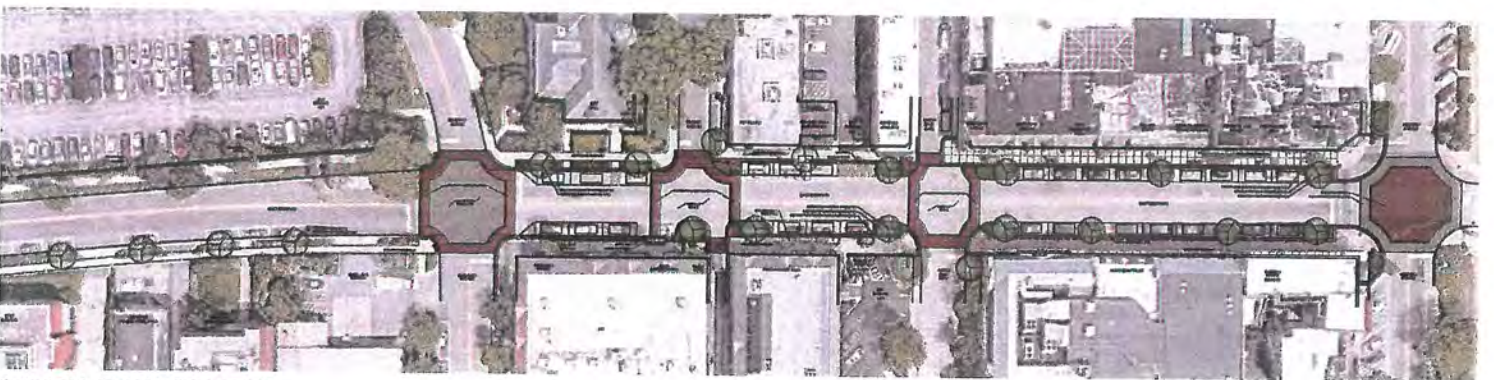
OVERALL PLAN WITH AERIAL

EXISTING PARALLEL PARKING SPACES: 39
PROPOSED PARALLEL PARKING SPACES: 27

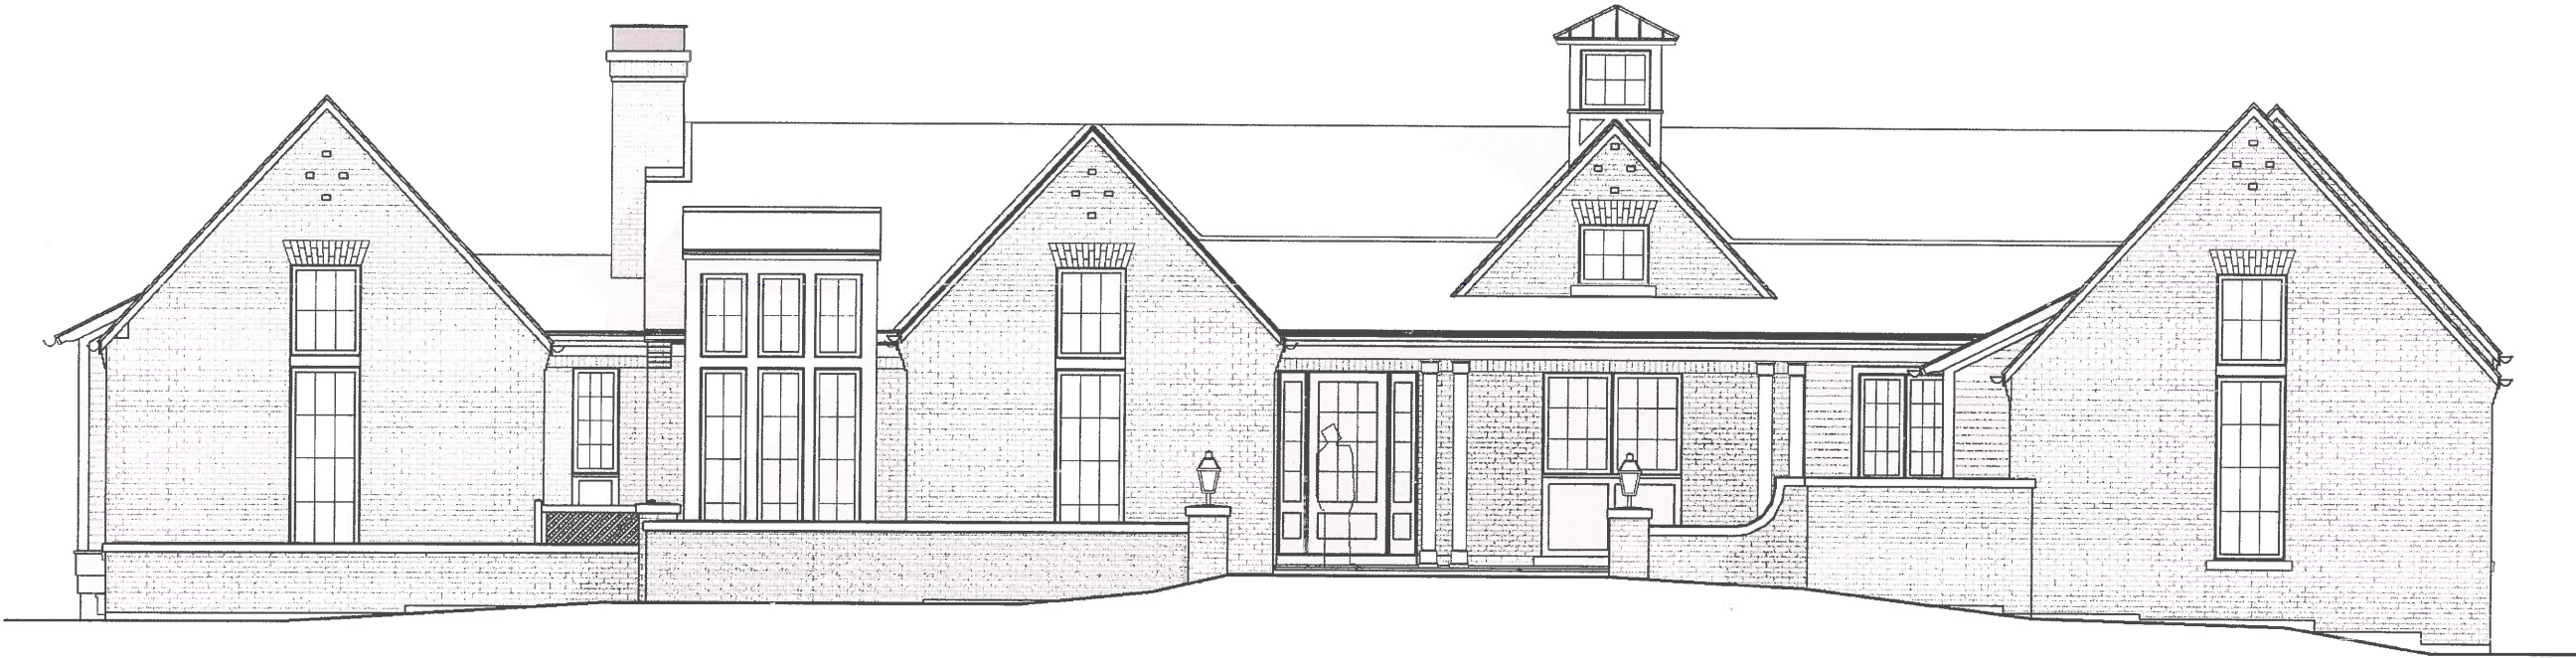
SHEET NO.
HPC2.6
ELEVATIONS
08/12/2020 HPC SET

East Elevation
1/8" = 1'-0"

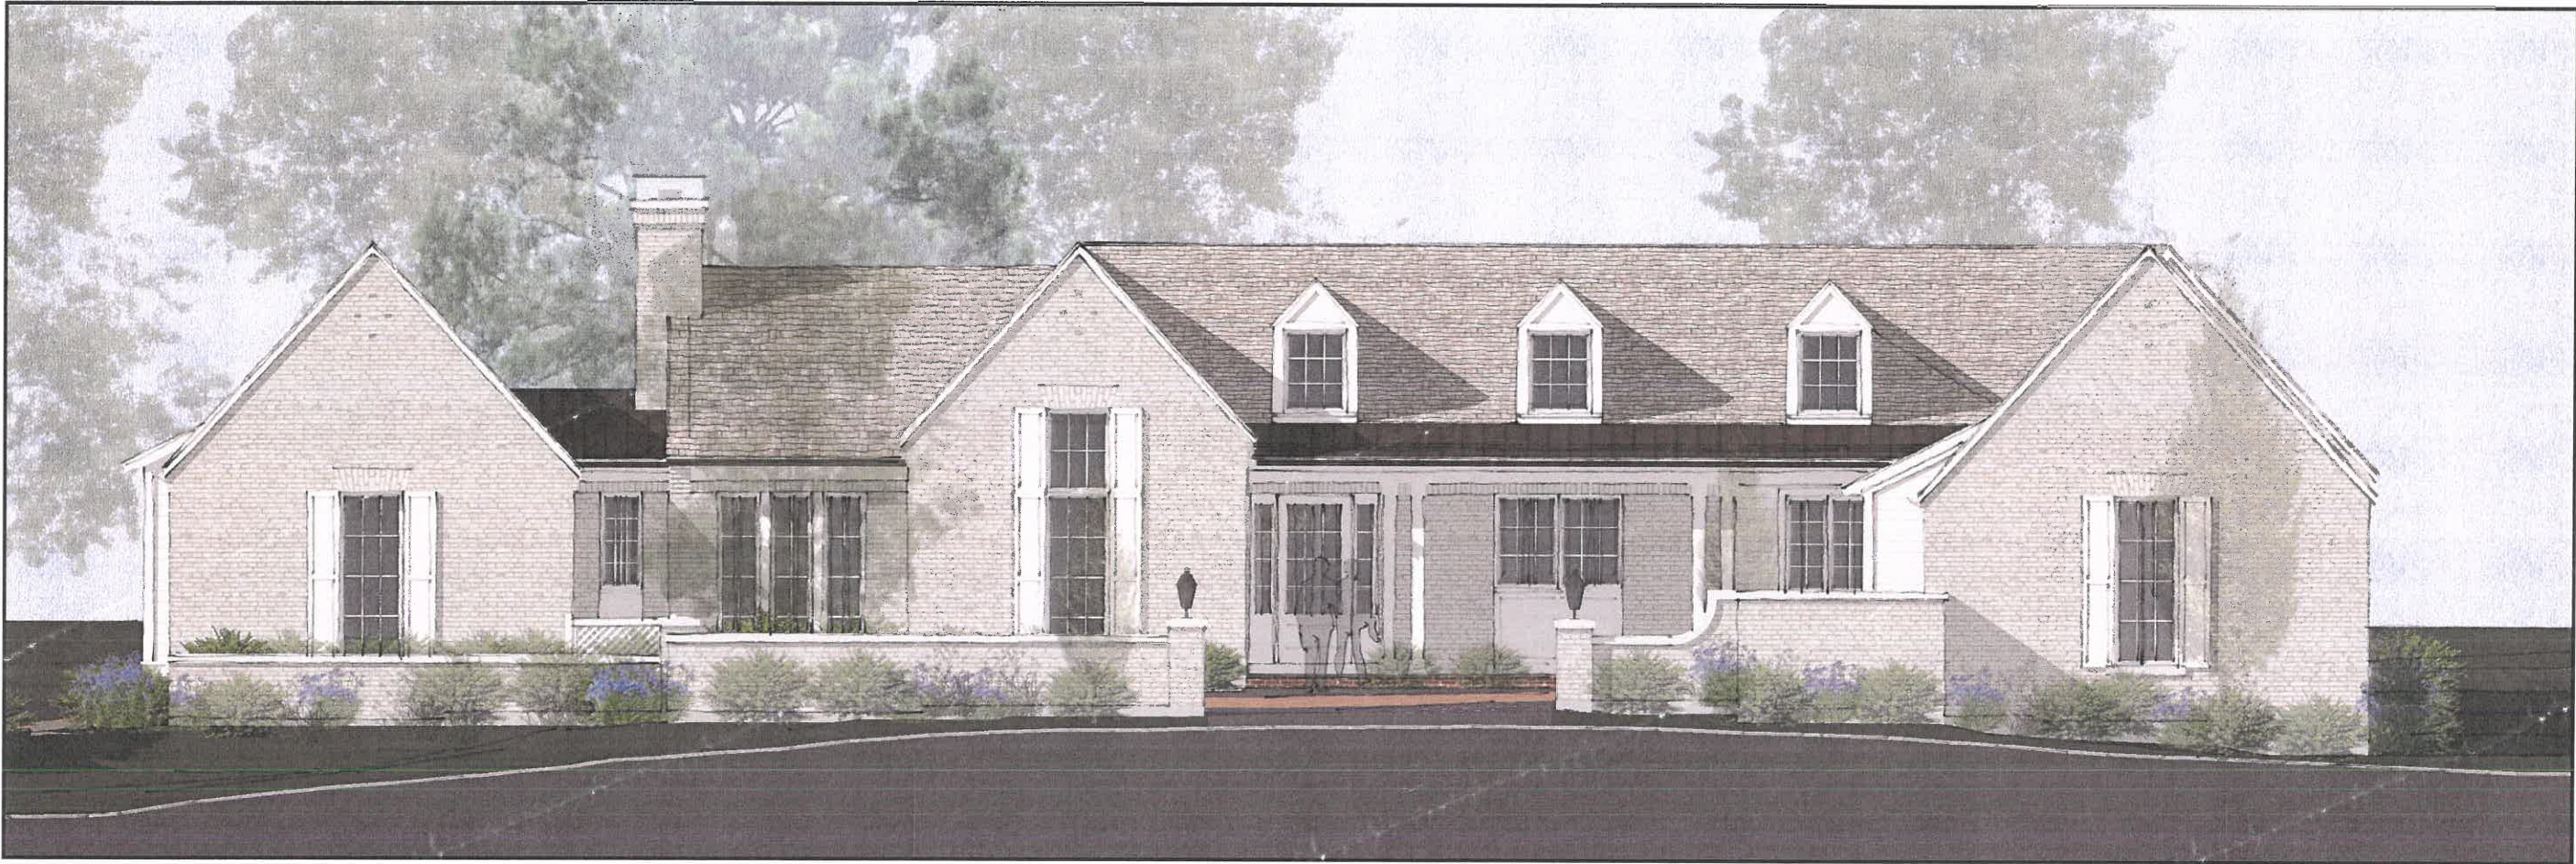
SHEET NO.
HPC2.2
REVISED
ELEVATIONS

East Elevation
Scale: 1/8"=1'-0"

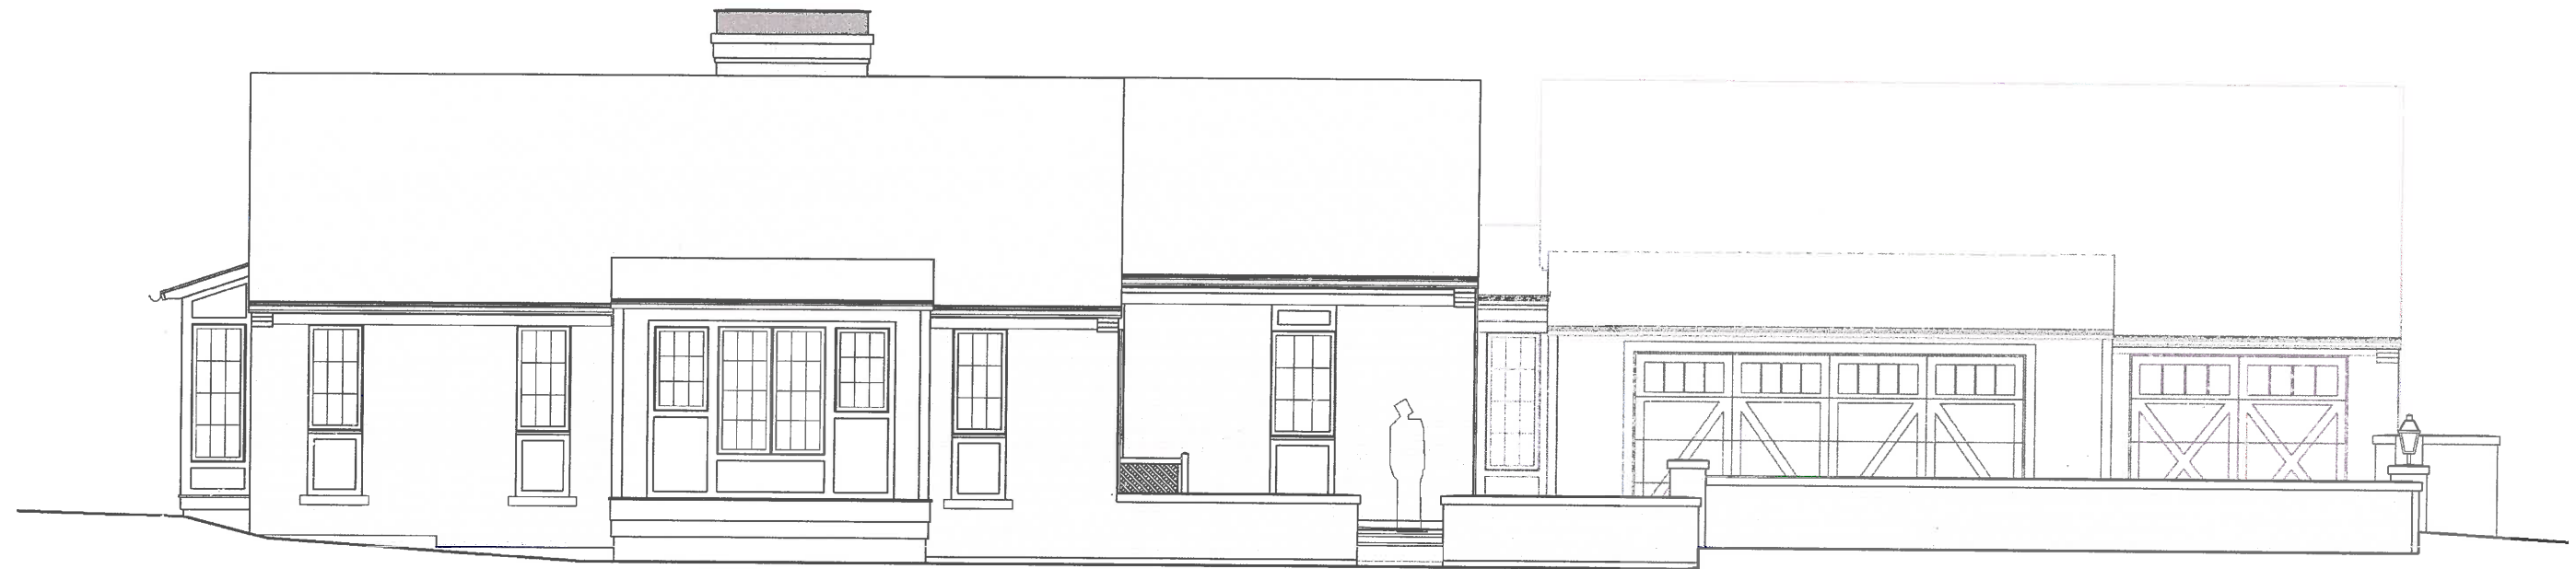
SHEET NO.
HPC2.7
REVISED
ELEVATIONS

South Elevation
1/8" = 1'-0"

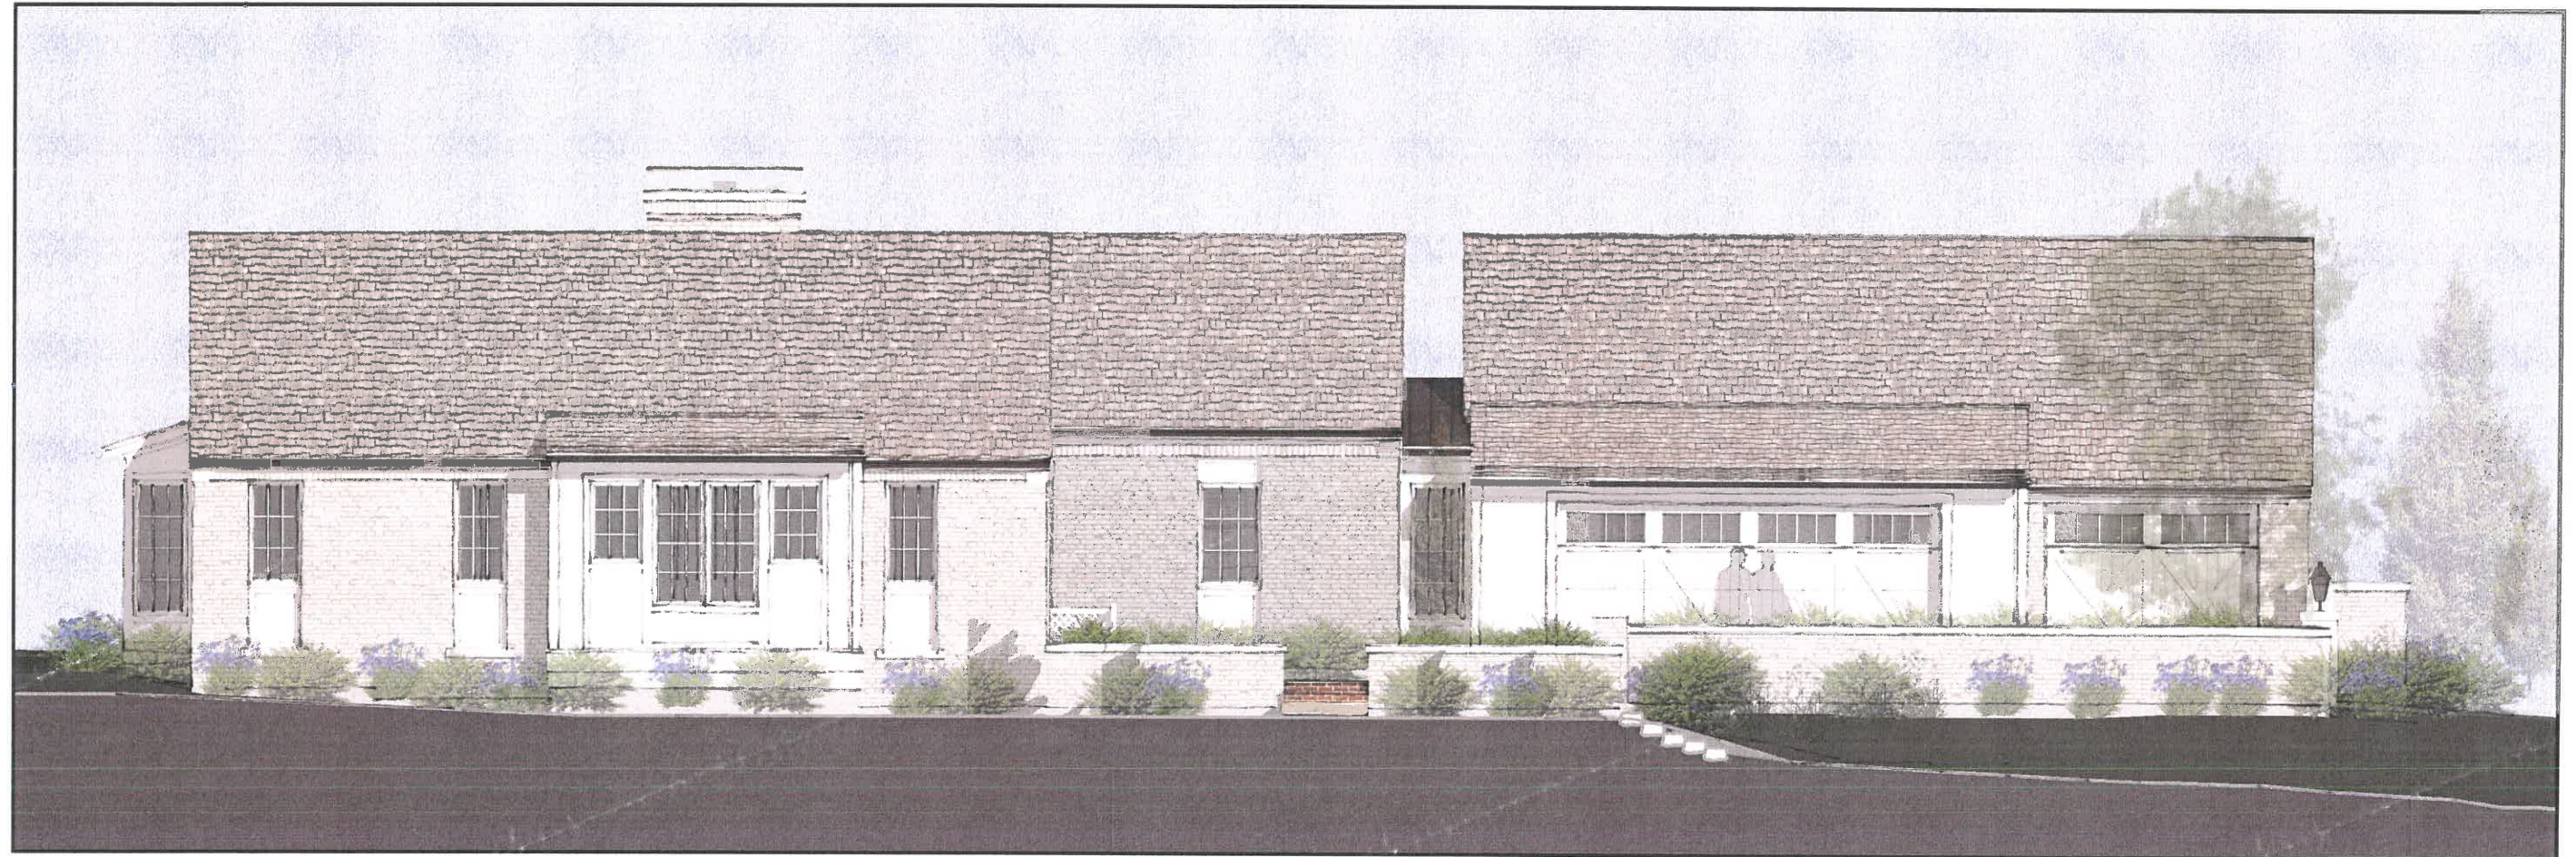
SHEET NO.
HPC2.3
REVISED
ELEVATIONS

South Elevation
Scale: 1/8"=1'-0"

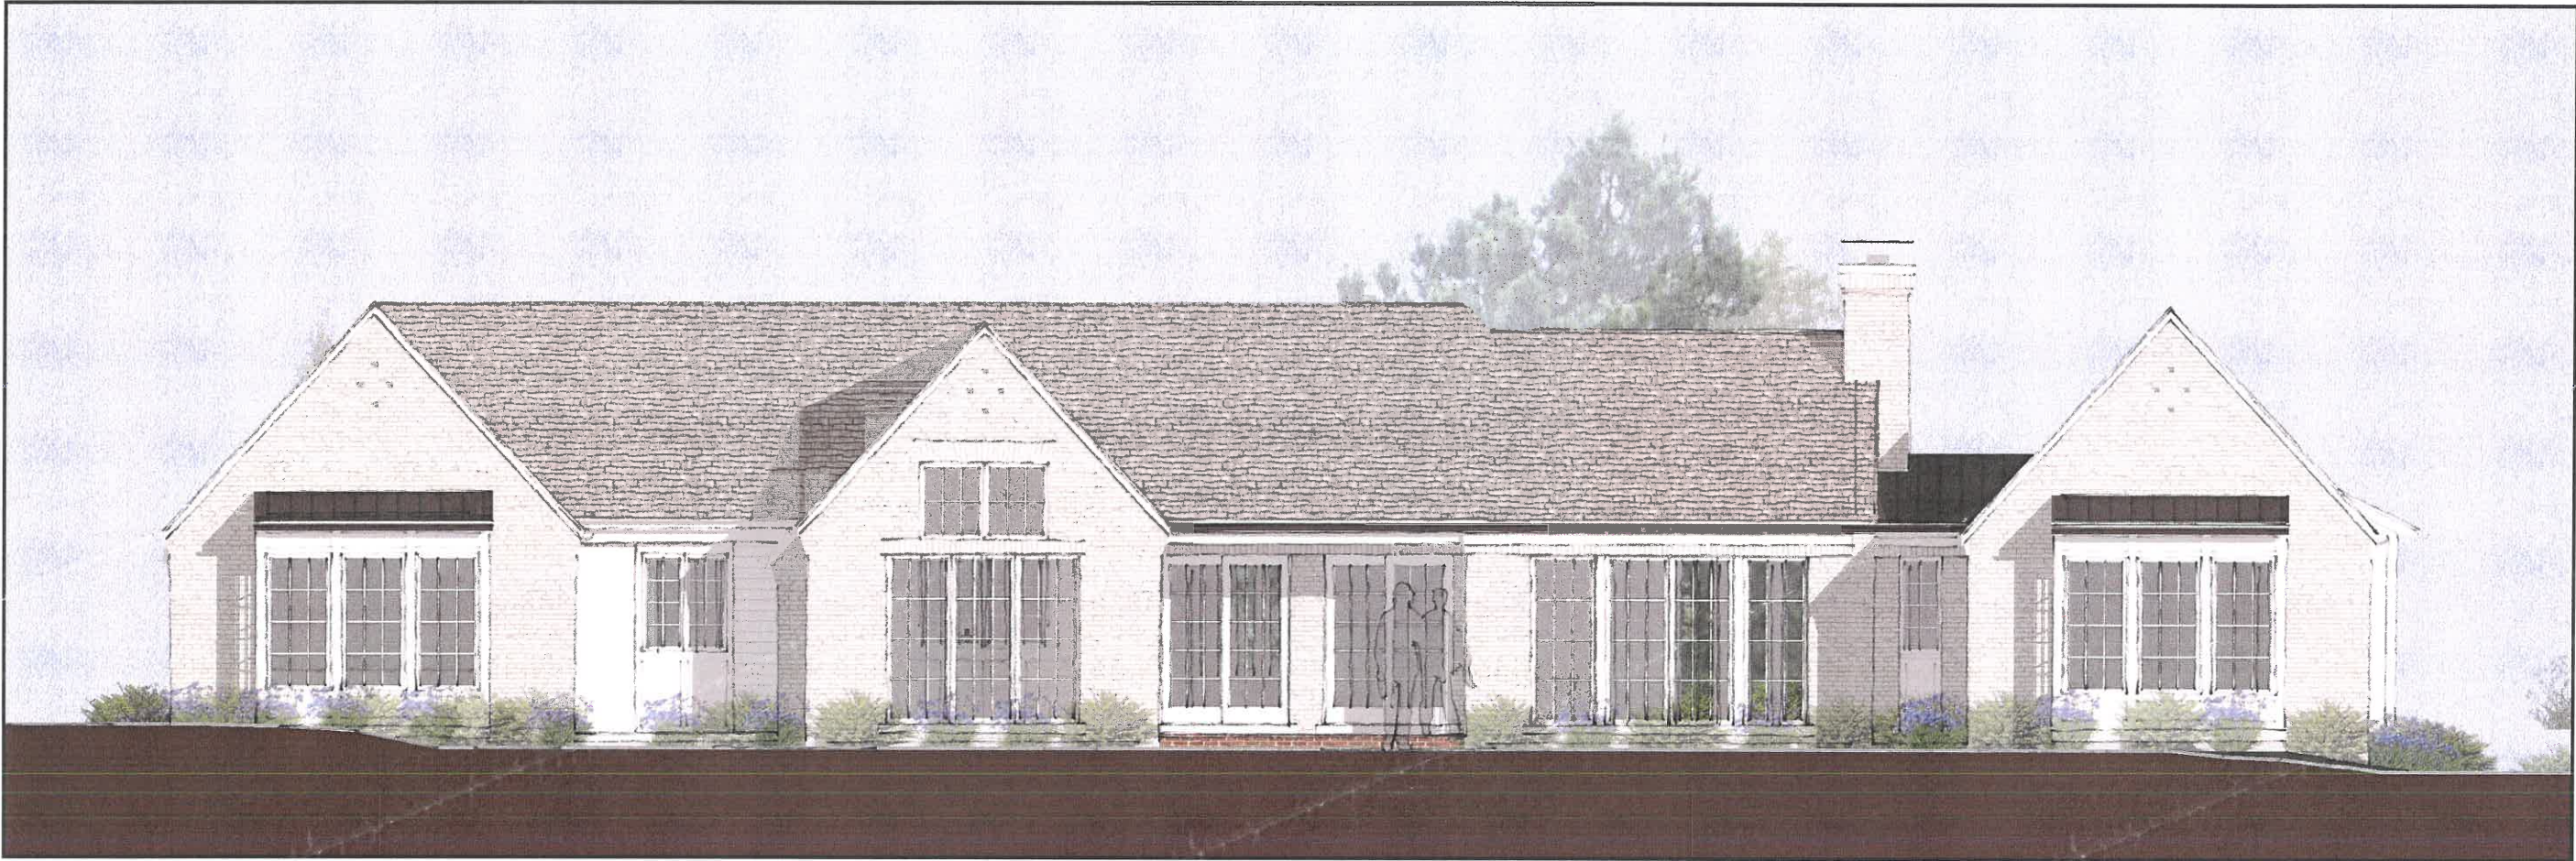
SHEET NO.
HPC2.4
REVISED
ELEVATIONS

West Elevation
Scale: 1/8"=1'-0"
