# ARCHITECTURAL REVIEW BOARD AGENDA

July 12, 2016 – 7:30 p.m.

**ARCHITECTURAL REVIEW BOARD  
No. 16-4000036**

## STAFF REPORT

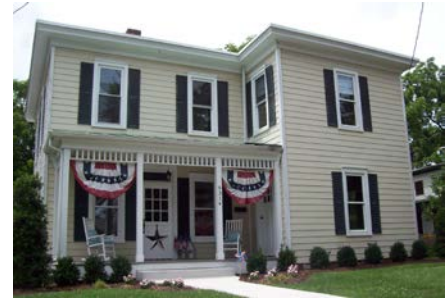
**ARB Case:** #2016-40000036  
**Applicant:** Alexis Iszard  
**Address:** 9314 West Street

**Historical Significance** – 9314 West Street is a Colonial Revival style residence constructed c. 1890. The home is two stories set on a stone foundation. Three additions have been constructed along the rear elevation. The home is representative of the late-nineteenth and early-twentieth century growth in Manassas following the relocation of the Prince William county seat. Though the home has been enlarged by the rear additions, they do not compromise the integrity of the design, workmanship or materials and the property is ranked contributing to both the local and National Register historic districts.

The applicant is proposing to replace 23 existing vinyl replacement windows on the home, which does not include several new windows which were recently installed on the rear of the home. The applicant is proposing 1/1 double-hung Sheffield vinyl replacement windows which will be installed within the existing openings.

The applicant is also proposing the installation of a scalloped wood picket fence which has a maximum height of 56" at the Gothic posts. The fence will be installed on the southern property line and connecting from the home to both side property lines. The fence is to match the neighbor's fence on the north. The rear property line is already fenced with a 6' board-on-board privacy fence.

The applicable design guidelines for windows are found on pages 56-63 of the City of Manassas Historic District Handbook. The guidelines state that replacement windows should duplicate historic windows in size, materials, and design. While vinyl is not recommended for use on a historic structure, the original windows on the home have already been replaced with vinyl. Generally, when replacing windows which have previously been changed, the new windows should be more compatible with the historic home. However, high quality vinyl windows were recently approved by the ARB for new openings on the side and rear elevations, for consistency with the existing vinyl replacement windows on the home. The new proposed replacement window maintains the dimensions of the existing openings, provides a profile which is similar to a historic wood window, and is a higher quality vinyl window than the existing replacements. The use of vinyl replacement windows is compatible with the recently approved new window openings and will maintain consistency of materials on all elevations of the home.

The guidelines for fences are found on pages 38-39 of the City of Manassas Historic District Handbook. The guidelines state that fence materials should relate to materials in the neighborhood and the design should take clues from nearby existing historic design. The proposed fence has been chosen to match the design and materials of the existing fence on the neighboring property to the north. The scalloped picket design is compatible with the architectural character of the home and the materials are appropriate for use in the historic district. Overall, the proposed fence is in keeping with the design guidelines.

Staff recommends **APPROVAL** of the application as submitted.

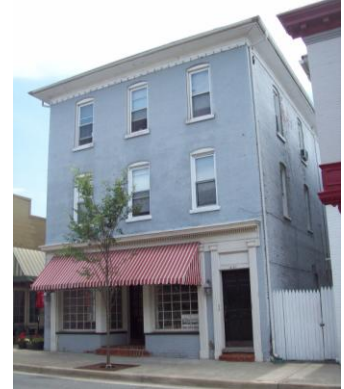
**ARB Case:** #2016-40000038  
**Applicant:** Bren Compton  
Jitterbugs Ice Cream Cafe  
**Address:** 9125 Center Street

**Historical Significance** – 9125 Center Street was constructed c. 1905. Although it was under construction under 1905, the building escaped the fire that destroyed a large number of buildings in the commercial core. The building was constructed by H.D. Wenrich. The building housed his jewelry business on the first floor and a photography business on the third floor. It is a three-story four-bay commercial building of masonry construction. A three-story addition is attached to the rear elevation and a second two-story addition is attached on the east elevation. Other alterations to the building include the Colonial-Revival style storefront, vinyl replacement windows on the upper floors, and the conversion of the second and third floors into apartments. The building is ranked as contributing to the local and National Register historic districts and has been designated as a Local Historic Landmark. The 2006 survey ranks the building as a notable structure.

The applicant is proposing to replace the Colonial Revival storefront windows. The current storefront windows are wood with true divided lites. The proposed windows are aluminum with simulated divided lites

(spacer bars between the glass) to replicate the Colonial Revival style. The windows will fit the existing openings.

The applicant is also proposing signage for the new business, Jitterbugs Ice Cream Cafe. The signage includes a 27" x 36" MDO projecting sign to be hung on the existing bracket above the front entrance. The sign is cut in the shape of the jitterbug logo and the color palette is primarily red and light blue. Other signage includes a small 6" x 19" acrylic logo hung above the sliding window on the east addition and a 60" x 48" aluminum menu sign on the west wall of the courtyard area.

The applicable design guidelines for windows are found on pages 56-63 and the guidelines for storefronts are found on pages 67-70 of the City of Manassas Historic District Handbook. The guidelines state that the use of windows with false muntins should be avoided. Storefronts should be restored to the original configuration, removing any false historical styles. While the Colonial Revival storefront is not original to the building, utilizing replacement windows with false muntins further negatively impacts the architectural character of the building. If the windows must be replaced, staff recommends investigating options for replacement windows which are in keeping with the original configuration of the storefront.

The applicable design guidelines for signage are found on pages 82-87 of the City of Manassas Historic District Handbook. The guidelines state that sign type can vary but should not obstruct the elements that define the design of the building. The proposed signage has been placed in appropriate locations where it does not obstruct the details of the building. The color palette has been coordinated with the existing light blue paint color and the red of the awnings. The projecting sign and small wall sign are appropriately sized. The menu board sign exceeds the size requirements of the zoning ordinance, which limits the size of convenience signs to 3 square feet, and cannot be approved as submitted.

Staff recommends **DENIAL** of the storefront window replacement. The proposed windows are not in keeping with the recommendations of the design guidelines and negatively impact the character of a significant historic structure. Staff recommends the applicant investigate replacement window options for restoring the original window configuration of the storefront.

Staff recommends **APPROVAL** of the wall sign and projecting sign. The menu board sign does not meet the size requirements of the zoning ordinance and cannot be approved.

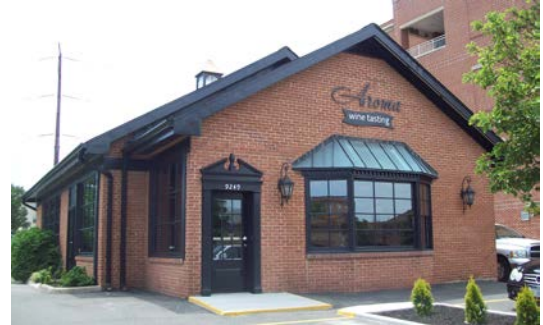
**ARB Case:** #2016-4000031 - REVISION  
**Applicant:** Morias Winery & Vineyard  
Jose Morias  
**Address:** 9249 Center Street

**Historical Significance** – 9249 Center Street was constructed c. 1972. It is a single story Colonial Revival style commercial building constructed of stretcher-bond brick. The building is covered by a front gable roof with a projecting gable and cupola. Less than 50 years old and constructed outside of the period of significance, the building is ranked non-contributing.

The sign which has been installed consists of "Aroma" in aluminum letters, and the text "wine tasting" in a black acrylic banner hung below. The overall dimensions have been slightly modified and are now 43" x 63.25". The placement of the sign above the front window is unchanged.

The applicable design guidelines for signs are found on pages 82-87 of the City of Manassas Historic District Handbook. The guidelines state that in general, a sign should fit the architecture. The modified sign design is still within the size recommendations of the design guidelines and continues to be placed in an appropriate location. The black banner anchors the more delicate script text above. While staff finds that a script font for the “wine tasting” text would be more compatible with the lettering above and the flowing shape of the banner than the sans serif font chosen, the sign does comply with the recommendations of the design guidelines and does not negatively impact the character of the structure.

Staff recommends **APPROVAL** the modified sign design as submitted.

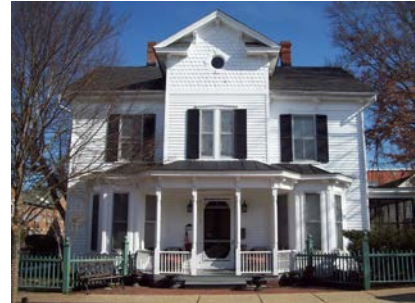
**ARB Case:** #2016-40000021  
**Applicant:** Battle & Church LLC  
**Address:** 9403 Battle Street

**Historical Significance** – Known as the Wagener House, the structure located at 9403 Battle Street is a 2½ story Queen Anne style single family dwelling constructed c. 1890. W.C. Wagener owned several businesses in the city and was Mayor of Manassas from 1901-1905. The home is wood-frame construction clad with weatherboard siding. Significant architectural features include the fish scale shingles, ogee cornice at the roof with raised frieze and scrolled brackets. Two additions have been added to the home and a two-bay garage has been constructed in the southeast corner of the property. The property is ranked contributing to both the local and National Register historic districts and is also a Local Historic Landmark. The 2006 survey ranked the home as notable for its association with W.C. Wagener and excellent Queen Anne Style, and labeled it as the “most intact example of the form documented in Manassas.”

The applicant is seeking approval for the construction of the wall and ramp which were installed to provide access and screening for the dumpster and utility area of the restaurants occupying the adjacent building. The project originally came before the ARB for approval and the project has been completed, however, the construction of the ramp and walls did not comply with the Certificate of Appropriateness and approved design. The original approved design for the ramp was a concrete wall, approximately 8’ in height, which was required to be clad with red brick on the north side, which faced the home and street.

As constructed, an approximately 25' section of the wall extending from Battle Street consists of a 6' cream colored brick fence with columns, topped with decorative ironwork, and includes a metal gate for access. Extending back from that point along the southern property line is a 9' concrete wall with three small windows. At the point where the brick fencing transitions to the concrete wall, a 10' pointed concrete arch with decorative metal gate has been added across the newly created alleyway to screen the trash and utility area. The applicant proposed to paint the concrete wall a cream color to match the brick portion of the wall. While the application was deferred at the February meeting to allow the applicant to propose a more appropriate treatment for the concrete wall, the proposed treatment is painting a cream colored faux texture on the concrete, similar to the texture on the brick fencing. At some point in the future, an expansion of the building may be planned in this location, and the owner does not want to invest in a brick or stone façade if it may be demolished in the future.

The applicant also requested approval to continue the brick and ironwork fence along the west and north property lines, replacing the existing green wood fence. The ARB deferred that request as well, allowing the applicant to modify the design for greater architectural compatibility with the character of the home. The revised proposal includes 5' white aluminum or vinyl fence posts with 42" high black ironwork fencing between the posts.

The applicable design guidelines for fencelines and walls are found on pages 38-39 of the City of Manassas Historic District Handbook. The guidelines state that privacy fences or walls in the rear of commercial areas should relate to the material of the building. In areas adjoining neighborhoods, care should be taken to relate to privacy fences in the area. For residential properties, the design of fencelines should take clues from nearby historic design and the materials should relate to the neighborhood.

The brick and decorative iron fence relates to the masonry buildings and metal fencing found throughout the downtown area, and the cream color of the brick and concrete wall to be painted is compatible with the color of the adjacent commercial building. With the additional ornamentation provided through the ironwork and the screening created by the gate, this section of the wall is actually more complementary to the character of the historic district than the original design. However, the remaining section of the wall creates a stark concrete barrier with no ornamentation, which is visible from the public street. The condition of approval of the original Certificate of Appropriateness required that brick be provided on the north side of the wall. Staff continues to agree with this condition, as the concrete wall is not compatible with the character of the home or the surrounding historic district.

The modified design for the ironwork fence is more compatible with the Queen Anne Style of the home and the revised massing is appropriate for the scale of the home. The use of aluminum fence posts as opposed to vinyl is more compatible with the materials of the home. Utilizing white posts between the black ironwork fencing as proposed may cause the posts to stand out as individual elements of the fence. Staff recommends black posts for consistency with the ironwork fencing.

Staff recommends **APPROVAL** of the fence replacement with the modification that the fence posts be black metal. Staff recommends **DENIAL** of the concrete wall. The concrete wall is not compatible with the historic and architectural character of the structure and the surrounding historic district, and is visible from the public street.

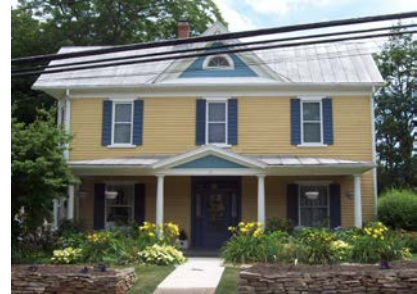
**ARB Case:** #2016-4000037  
**Applicant:** Scott Pendleton  
**Address:** 8801 Quarry Road

The applicant is requesting approval for a side yard addition with front porch extension and rear deck.

The applicable design guidelines for additions are found on pages 111-112 of the City of Manassas Historic District Handbook. The guidelines state that the size of an addition should be limited so that it does not visually overpower the existing building. Additions should be located on side or rear elevations that are not visible from the street. New design should be compatible with the size, scale, color, material and character of the building and structure. Wherever possible, new additions should be differentiated from the existing

With the exception of the fiberglass columns which are not consistent with the existing wood columns, the proposed materials are in keeping with the guidelines and are compatible with the existing materials on the home. However not all materials have been identified, such as the foundation or deck materials, or manufacturer's specifications have not been provided, such as the tin roof manufacturer. Window dimensions have not been specified on the drawings, but it appears that the new windows will be slightly smaller than the existing windows. For consistency between the addition and the original home, staff recommends utilizing the same window size as the existing.

The July meeting will serve as a work session for the project. Staff recommendations and an ARB decision will be made at the August meeting. Prior to the August meeting all outstanding material information including roof material manufacturer, foundation material and materials for deck must be provided. The design of the deck must be modified to meeting zoning setback requirements.
