# Evaluation of Adopted Flow Standards for the Trinity River, Phase 2

For: Trinity and San Jacinto Rivers and Galveston Bay Stakeholder Committee through the Texas Water Development Board

Contract No. 1600011940  
Final Report – November 2017

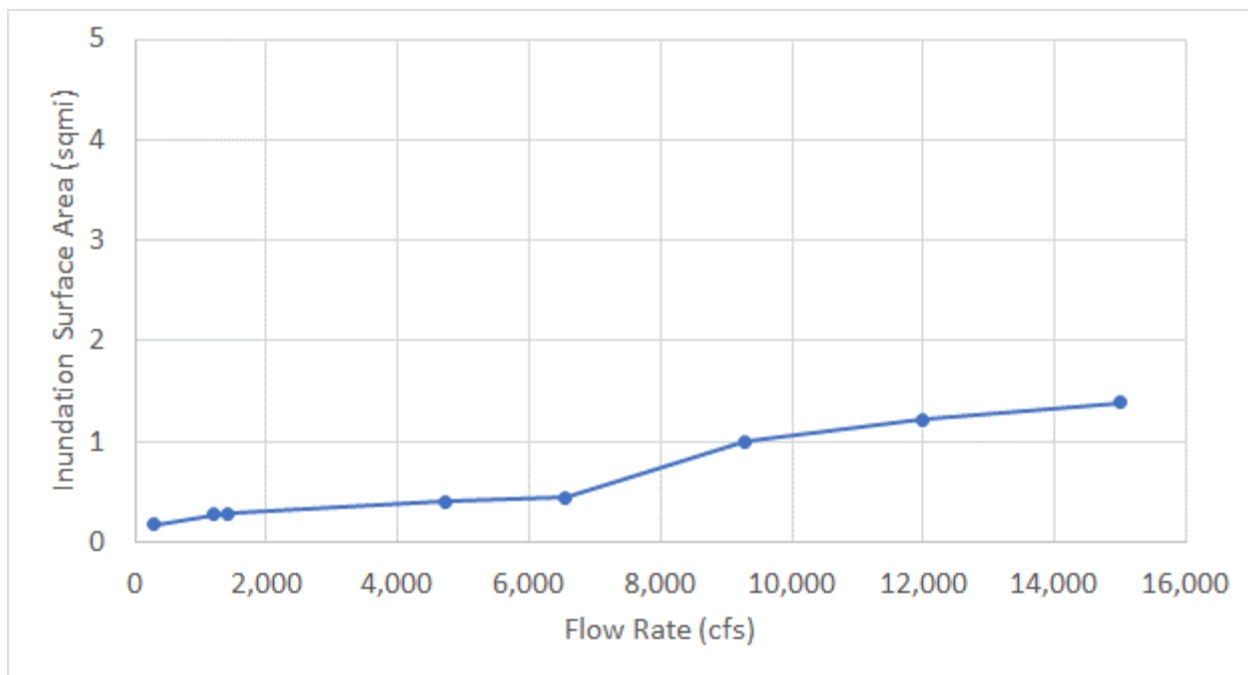
Figure 5. 080486 Grand Prairie - Inundation vs flow rate for pulse flows.

The urban site 080486 is located in Grand Prairie, within the Dallas/Fort Worth (DFW) metropolitan area. The channel is entrenched and is armored with rip rap in many locations. High flow pulses remain well within the banks with very little increase in inundated area as flow increases up to 15,000 cfs, the highest pulse observed during the study (Figure 5).

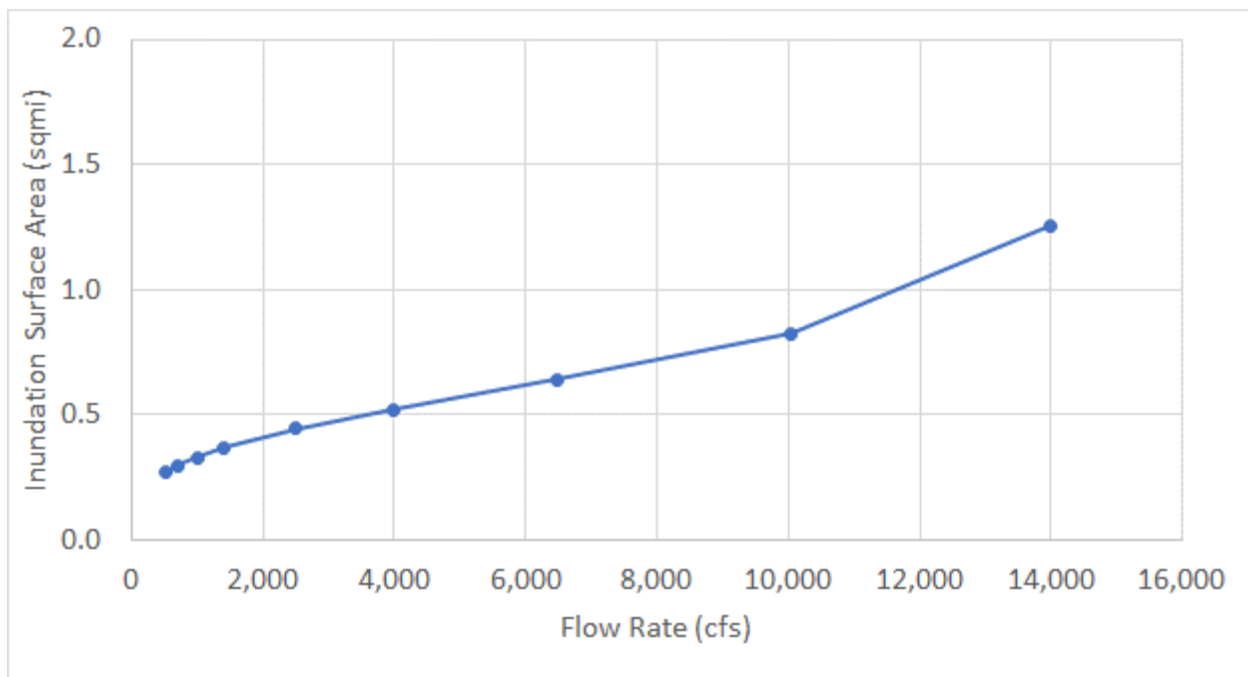
Figure 6. 080444 Dallas lock site - Inundation vs flow rate for pulse flows.

The lock site 080444 is located south of Dallas within a stream segment that is highly modified. Adjacent to the channel are flood control levees and within the channel exist lock and dam structures. Both locks within this reach have recently been flanked (erosion caused water to bypass the century-old structures). Up to 14,000 cfs, the river stays between the main banks of the river and does not overflow into the floodplain toward the levees (Figure 6). The riparian area adjacent to this site is affected since the floodplain is narrow between the levees. Primary connectivity of the river channel to the riparian area within this segment is through over banking flows on the lower half of this segment. Some inundation of backwater and oxbows occurs in the upper half of the reach near Interstate I-20 and the USGS gage Trinity River below Dallas (08057000).

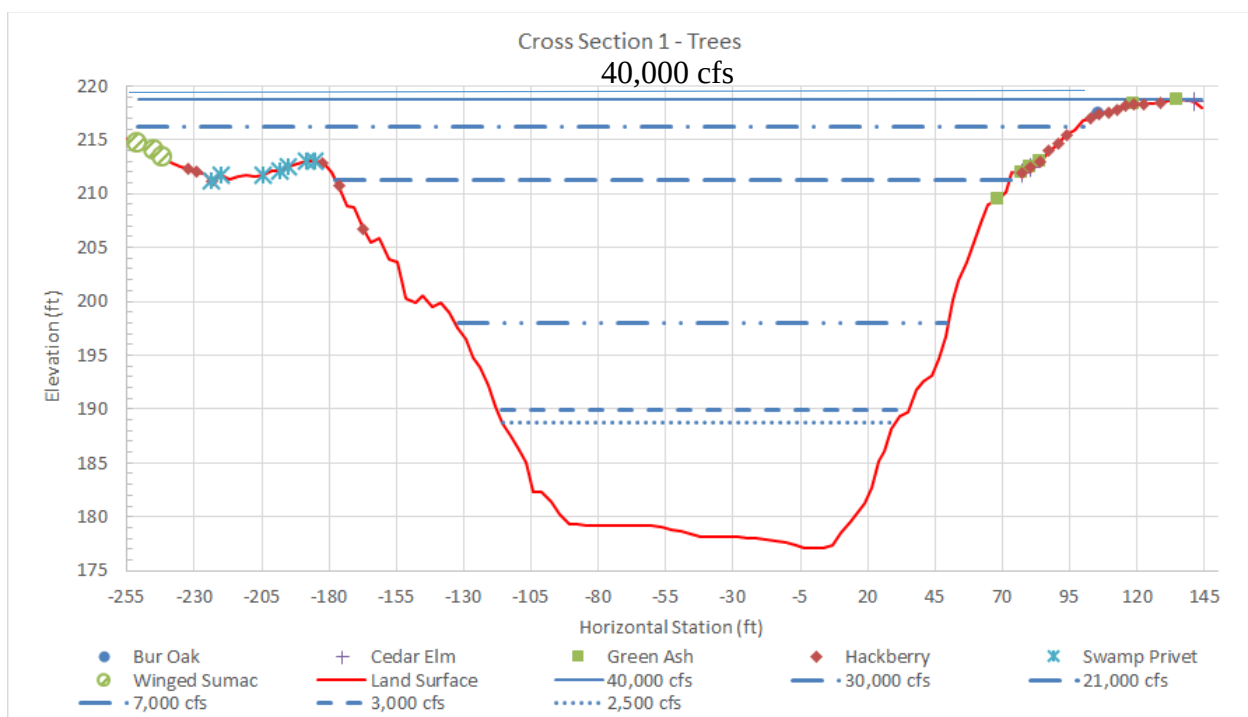
Figure 20. 080295 XS1 – Upstream riparian cross-section trees with flow levels. Note: 7,000 cfs, 3,000 cfs, and 2,500 cfs correspond to the SB3 pulses required for this site.

Additional analysis of pulse flow effects at the two riparian cross-sections was performed to evaluate the depth of water based on HEC-RAS modeled results (Mangham, Osting and Flores 2015). At these two cross-sections, flows ranging from 21,000 cfs to 30,000 cfs begin to provide inundation to the riparian forest community (Figure 20 through Figure 25). At 30,000 cfs the model predicts approximately 2 ft. depth of inundation over cross-section 1 left river bank benchmark and approximately 4 ft. depth at cross-section 2 left river bank benchmark.

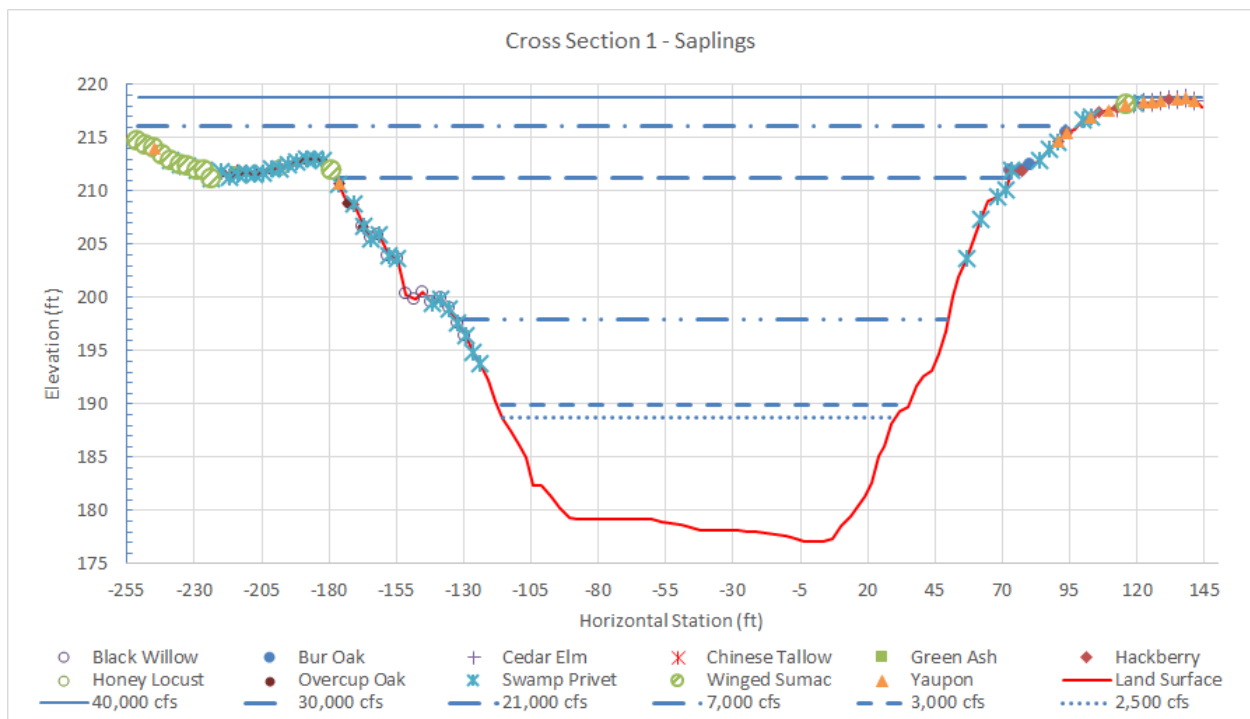
Figure 21. 080295 XS1 – Upstream riparian cross-section saplings

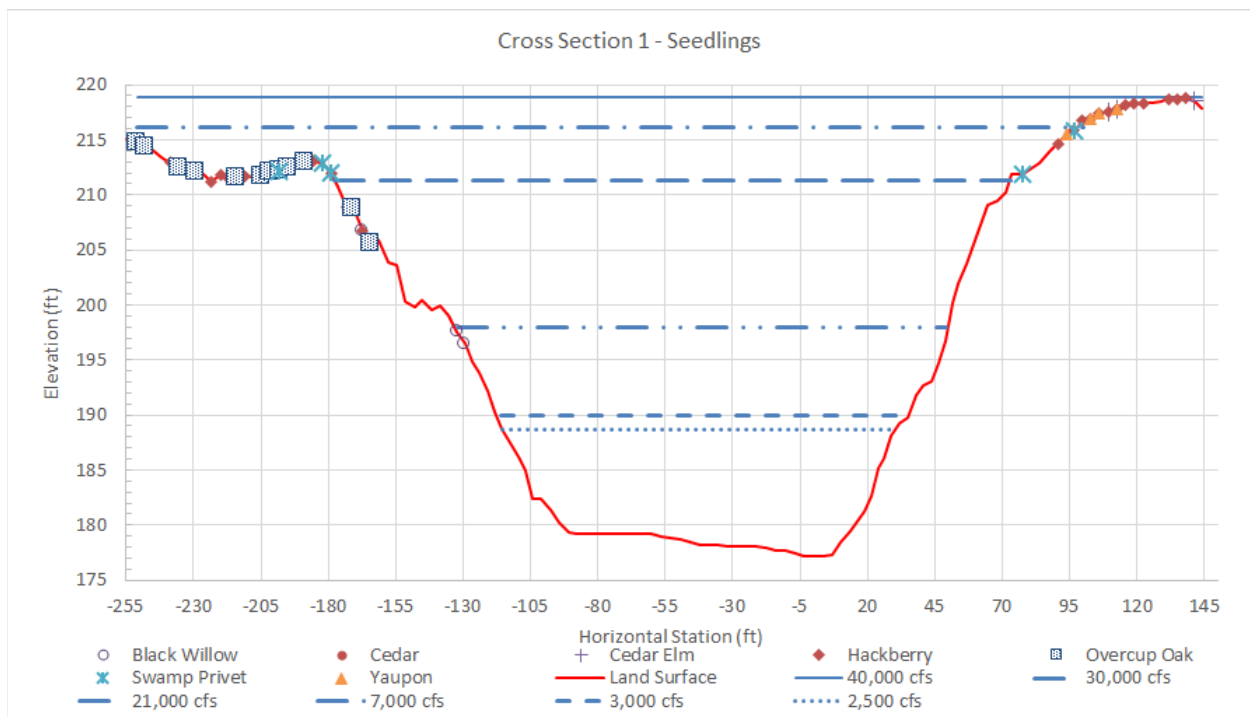
Figure 22. 080295 XS1 – Upstream riparian cross-section seedlings

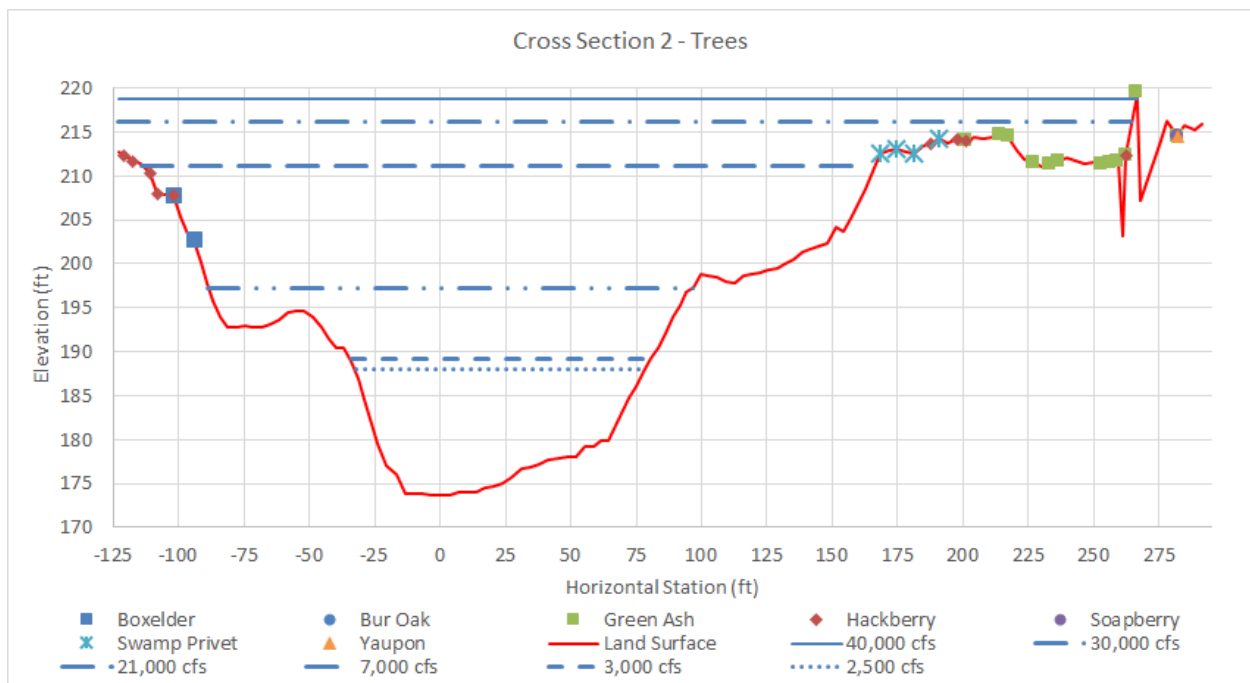
Figure 23. 080295 XS2 – Middle riparian cross-section trees with flow levels. Note: 7,000 cfs, 3,000 cfs, and 2,500 cfs correspond to the SB3 pulses required for this site.

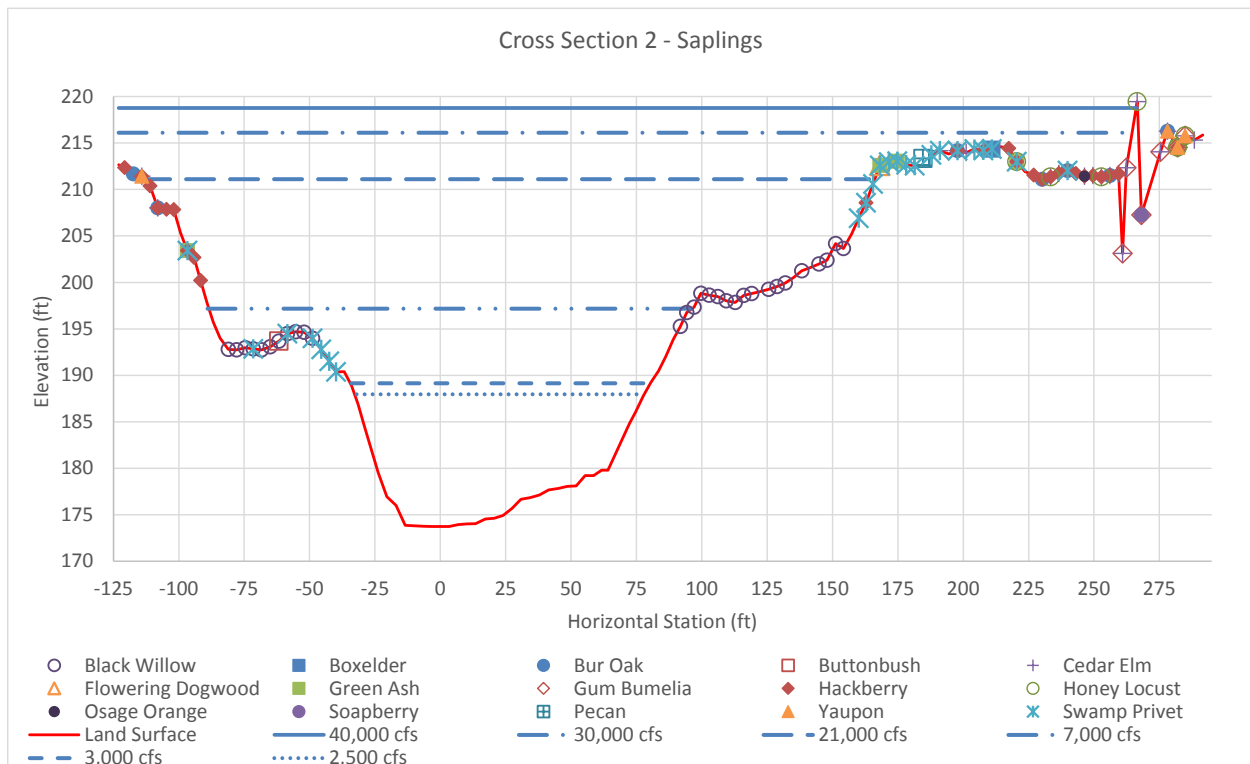
Figure 24. 080295 XS2 – Middle riparian cross-section saplings

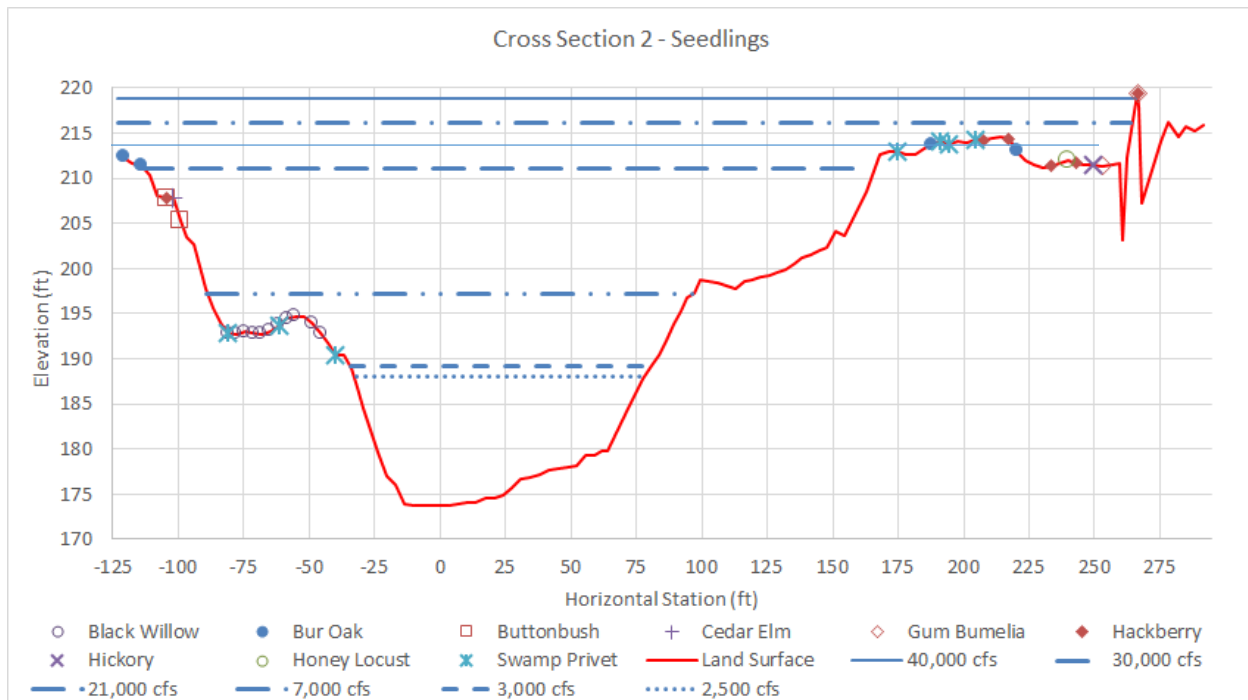
Figure 25. 080295 XS2 – Middle riparian cross-section seedlings

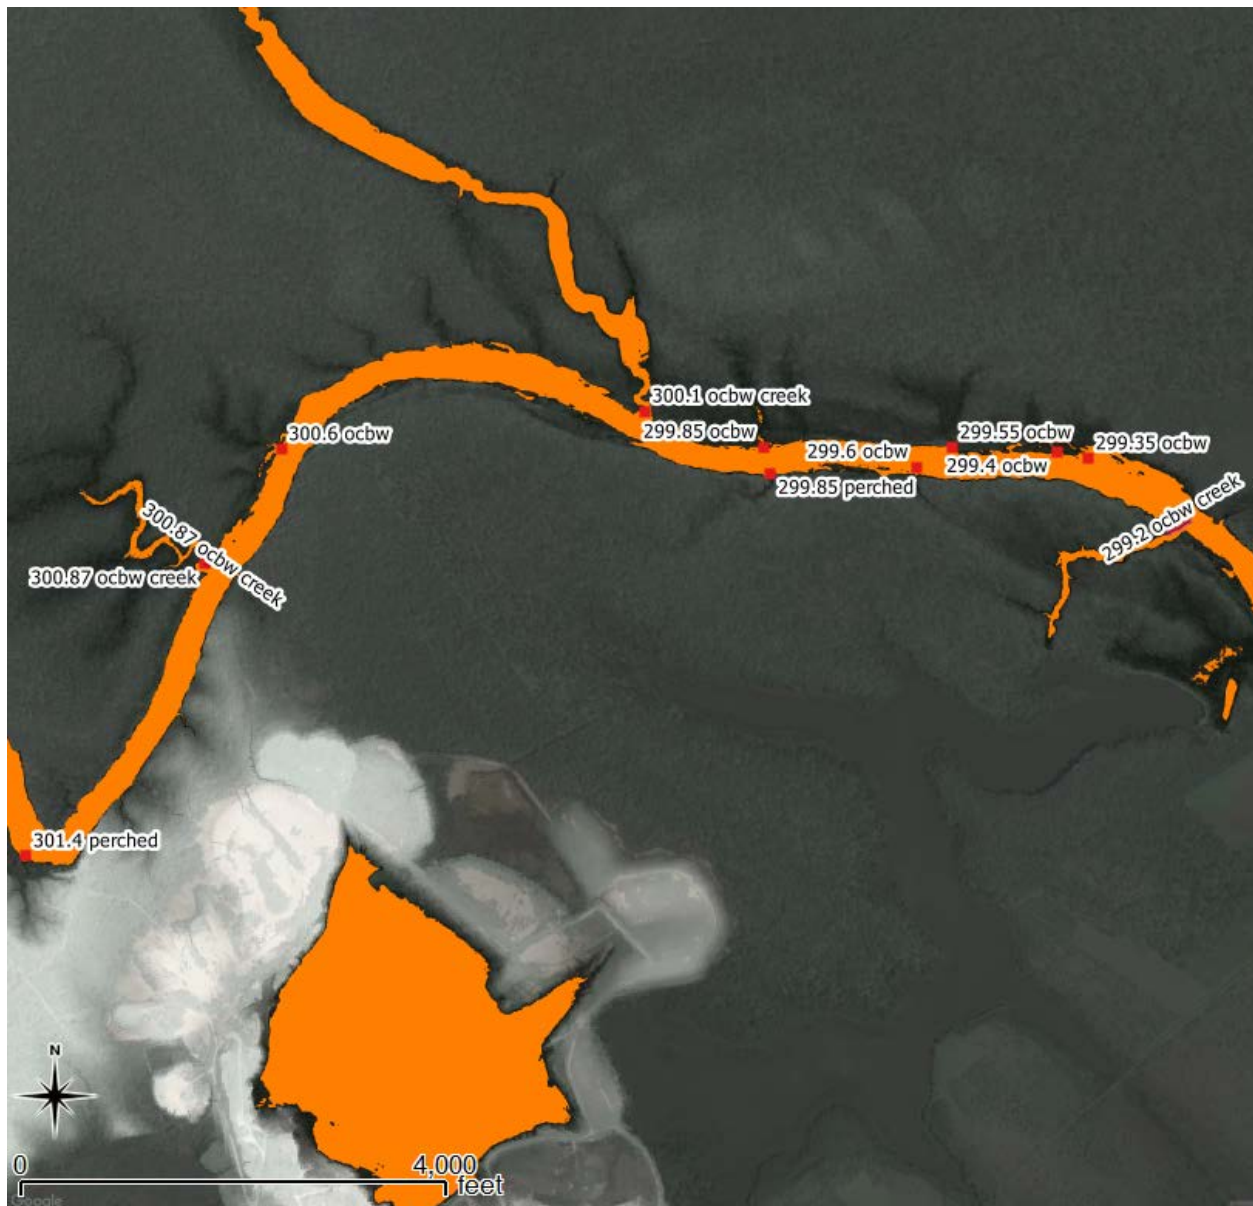
Figure 27. Segment C3 upstream of 080295 1 of 4- Observed inundation and connectivity areas over the RAS 13400cfs inundation map (orange). Note: Numbers represent approximate river mile.

Additionally, WSE and flow was collected as validation of the water surface profile (HEC-RAS) modeling efforts. Based upon mapping and inspection, the previous modeling appeared to adequately predict islands as is evident by the the mapping efforts (Figure 26 through Figure 29). Among the vegetation, velocities were slow. Flow at the Oakwood gage were between 15,600 and 13,200 cfs (stage difference of 1.2 feet); on-site observed flow (M9) was between 16,400 and 12,300 cfs.

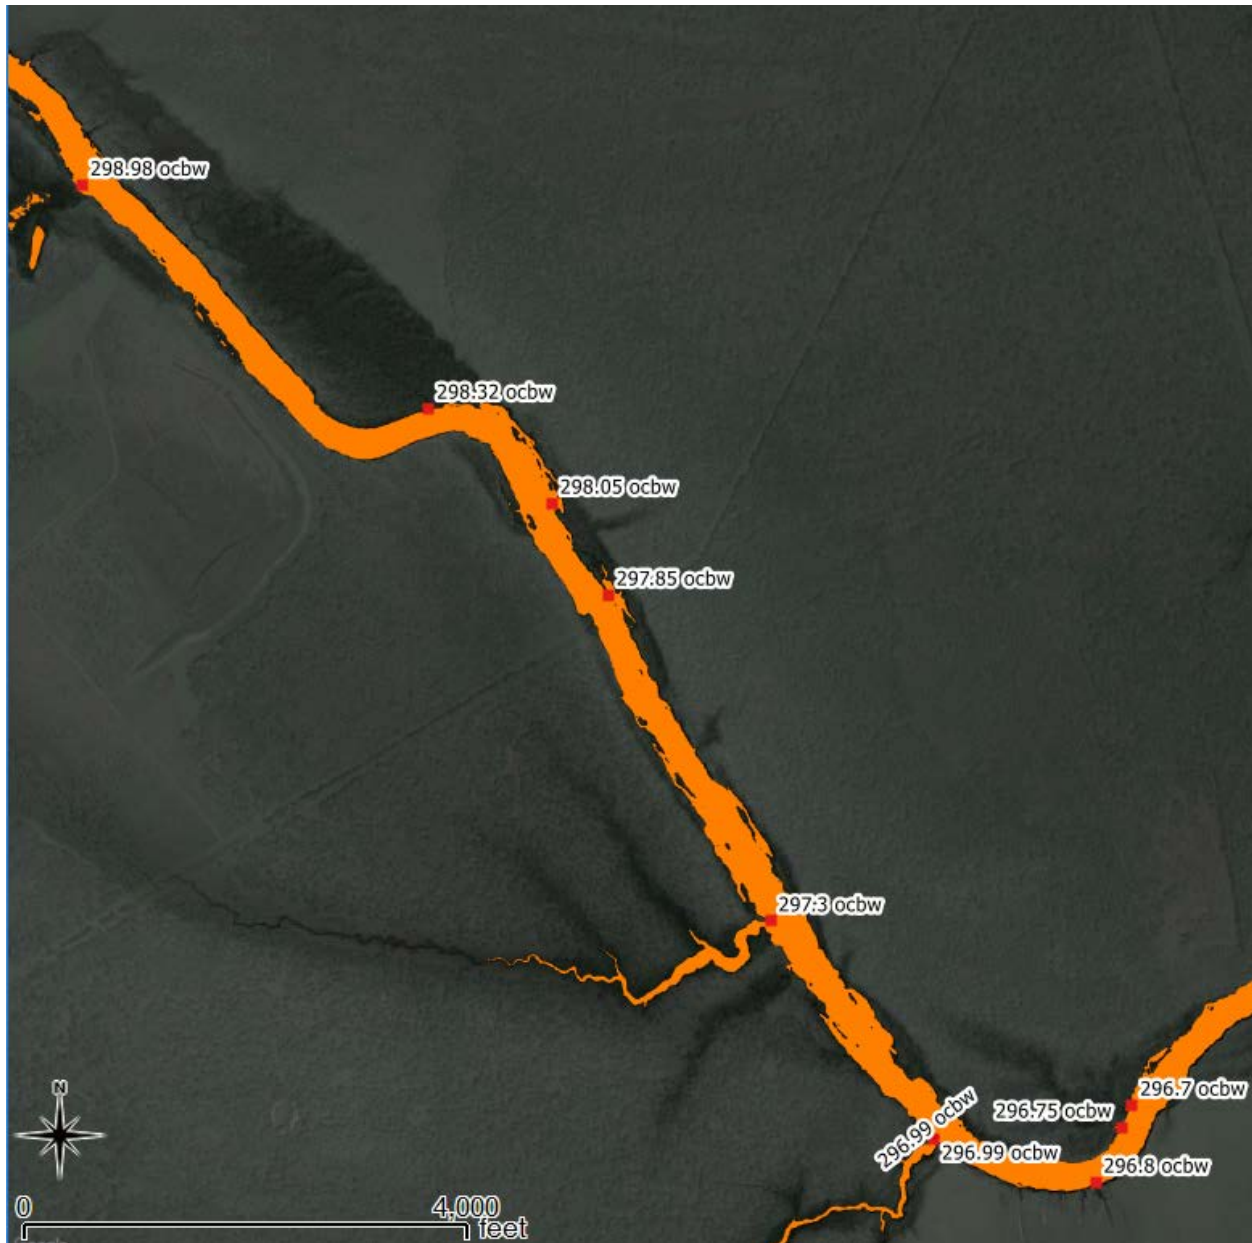
Figure 28. Segment C3 upstream of 080295 2 of 4 - Observed inundation and connectivity areas over the RAS 13400cfs inundation map (orange). Note: Numbers represent approximate river mile.

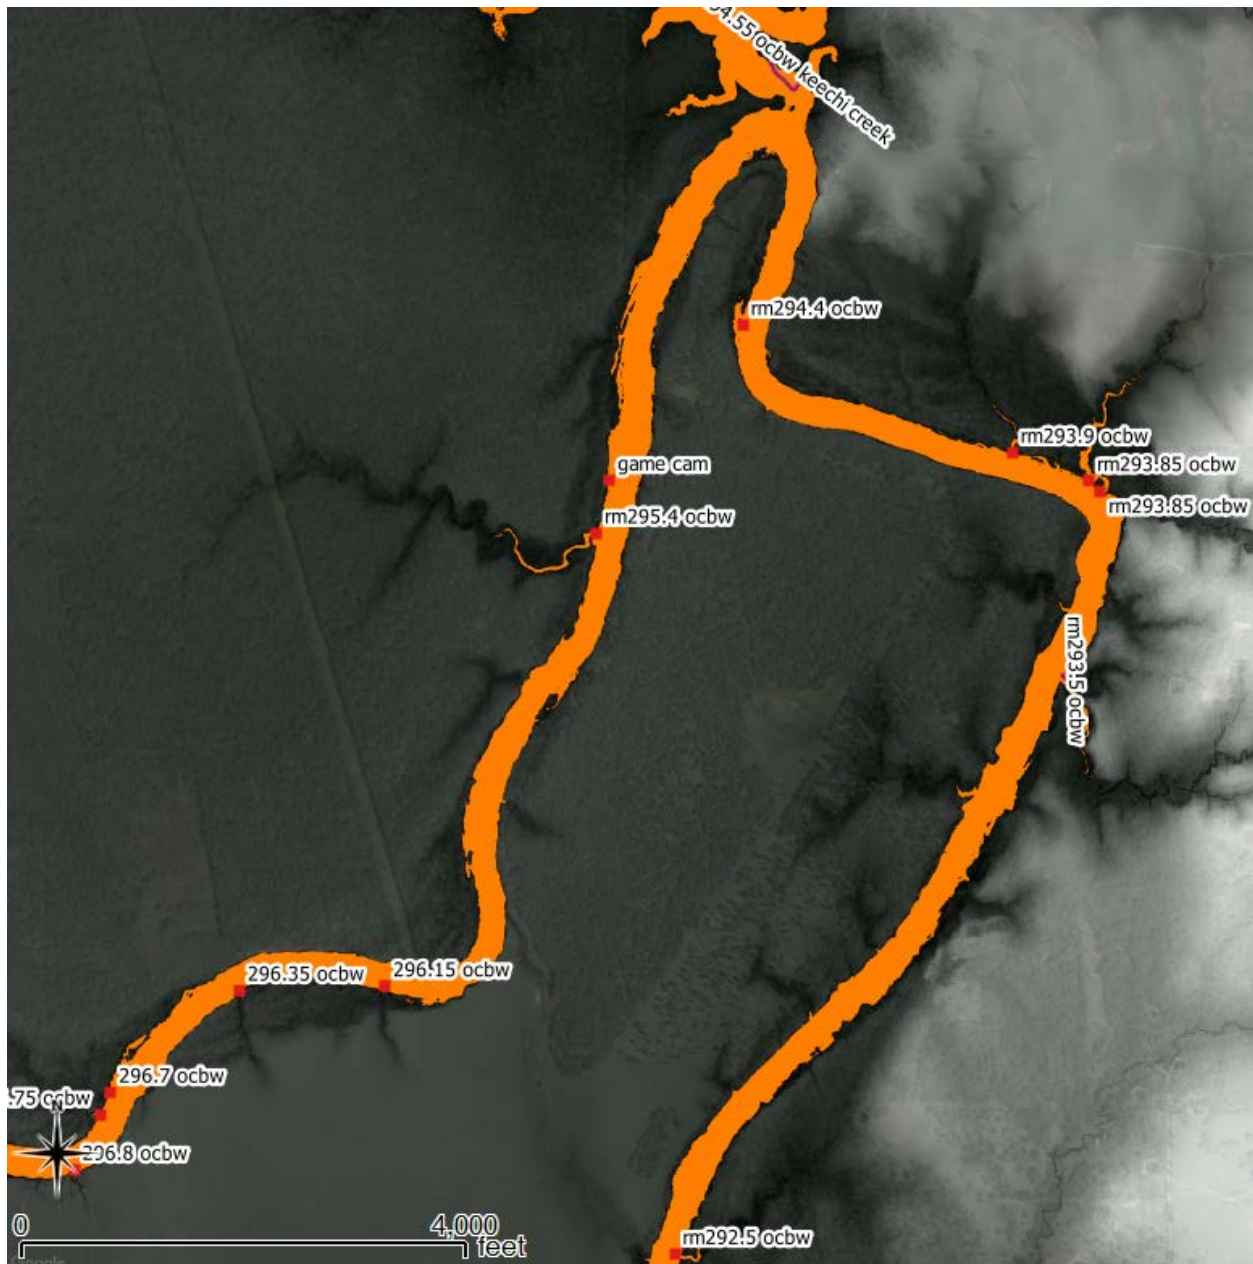
Figure 29. Segment C3 upstream and downstream of 080295 3 of 4 - Observed inundation and connectivity areas over the RAS 13400cfs inundation map (orange). Note: Numbers represent approximate river mile.

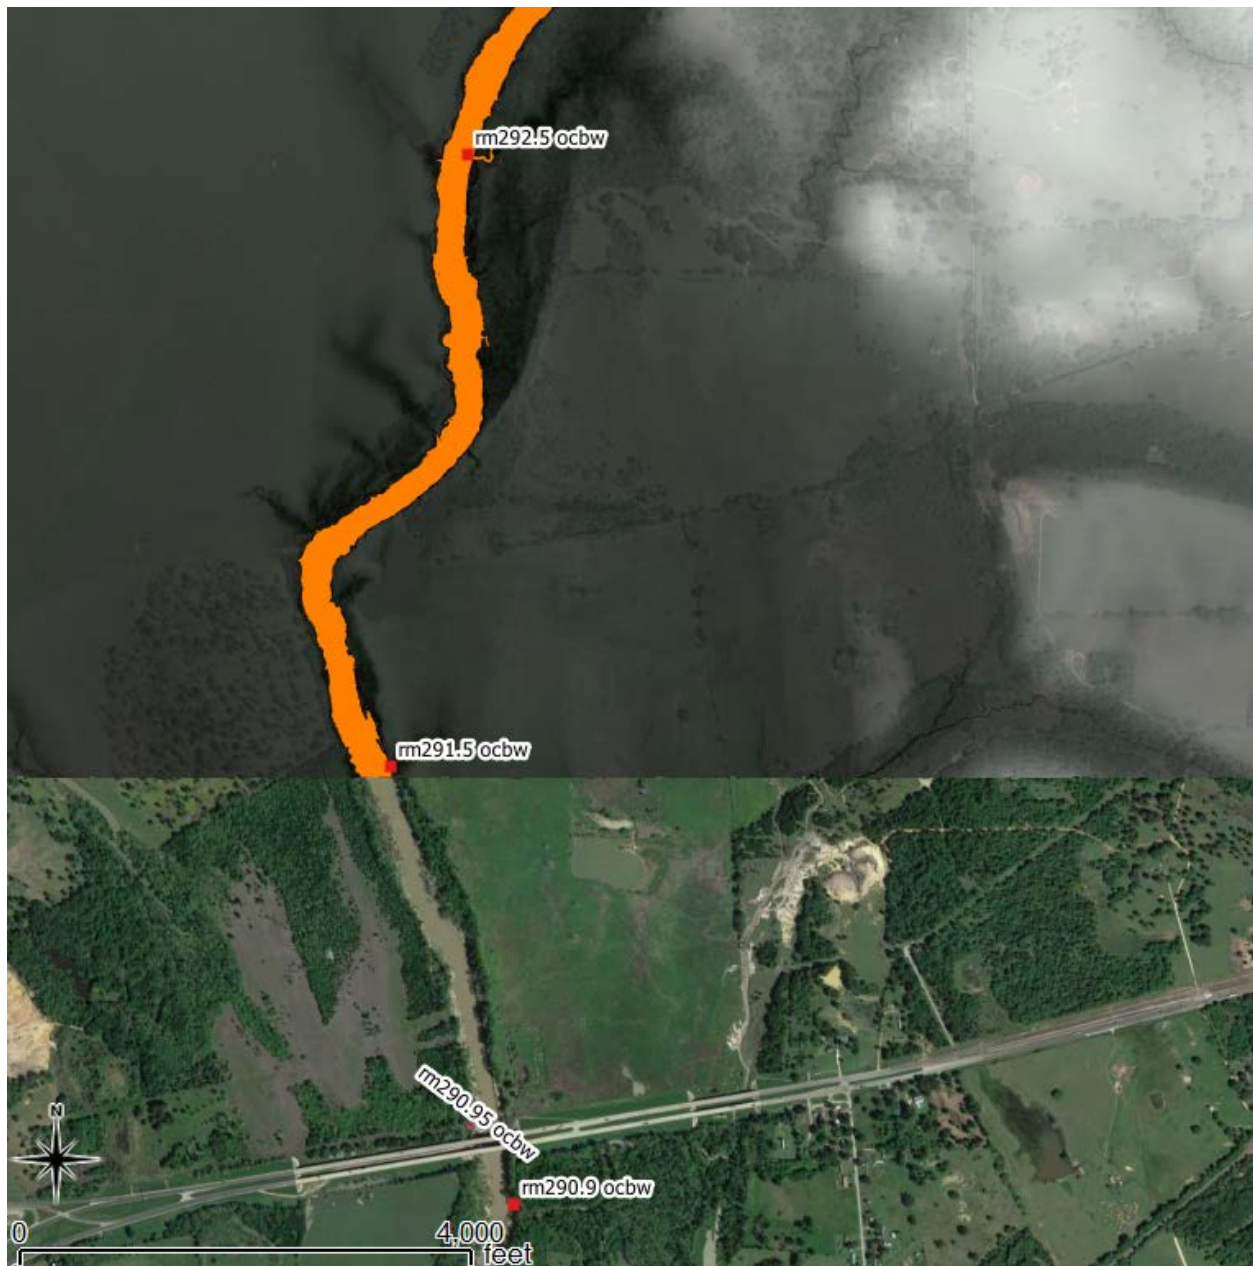
Figure 30. Segment C3 downstream of 080295 4 of 4 - Observed inundation and connectivity areas over the RAS 13400 cfs inundation map (orange). Note: Numbers represent approximate river mile.

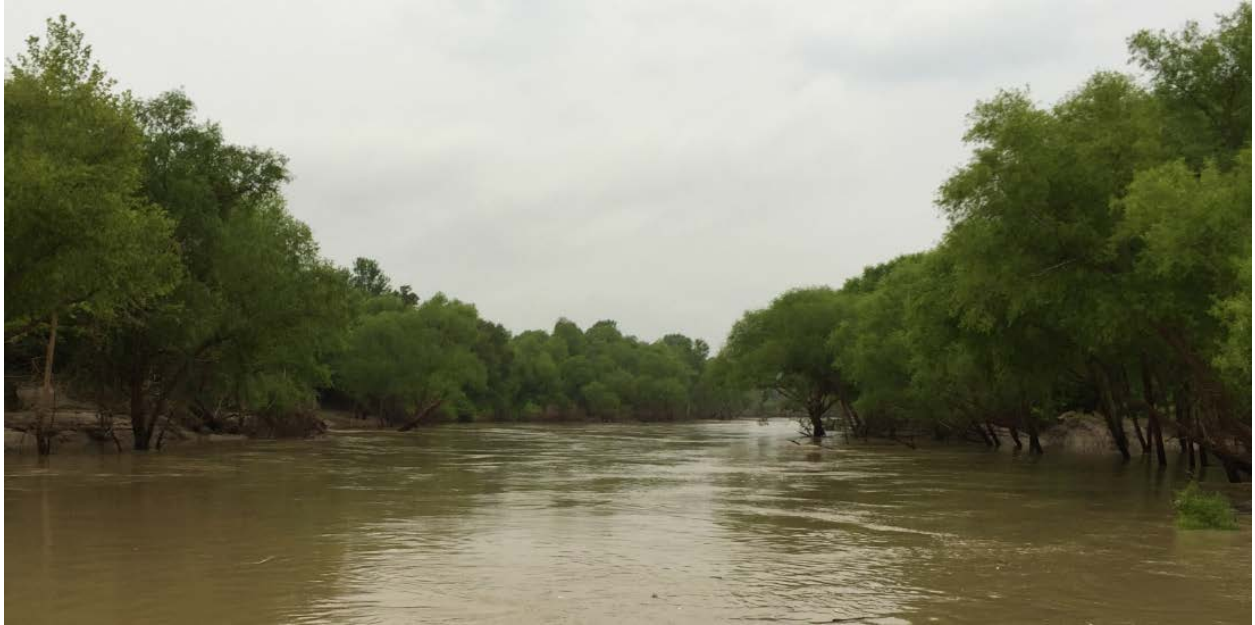
Figure 31. 080295 - in-channel willow habitat near river mile (RM) 297.

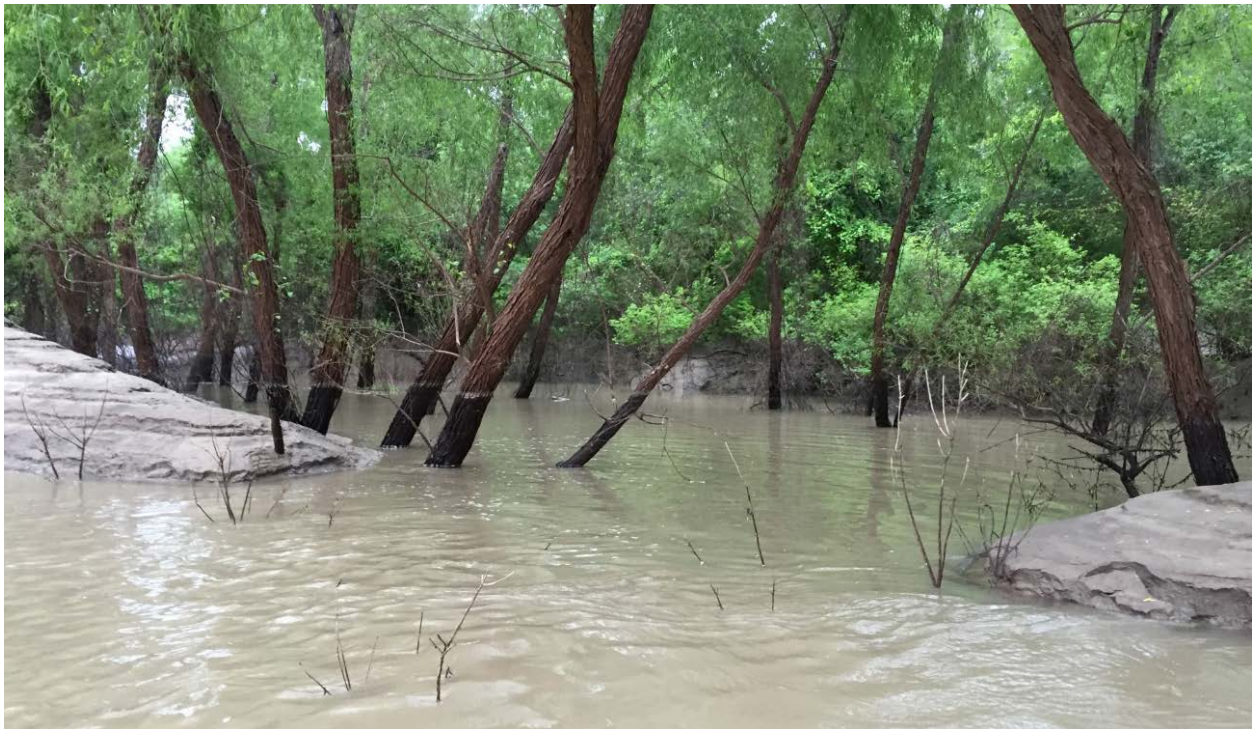
Figure 32. 080295 - Off-channel backwater habitat “296.99 ocbw”.

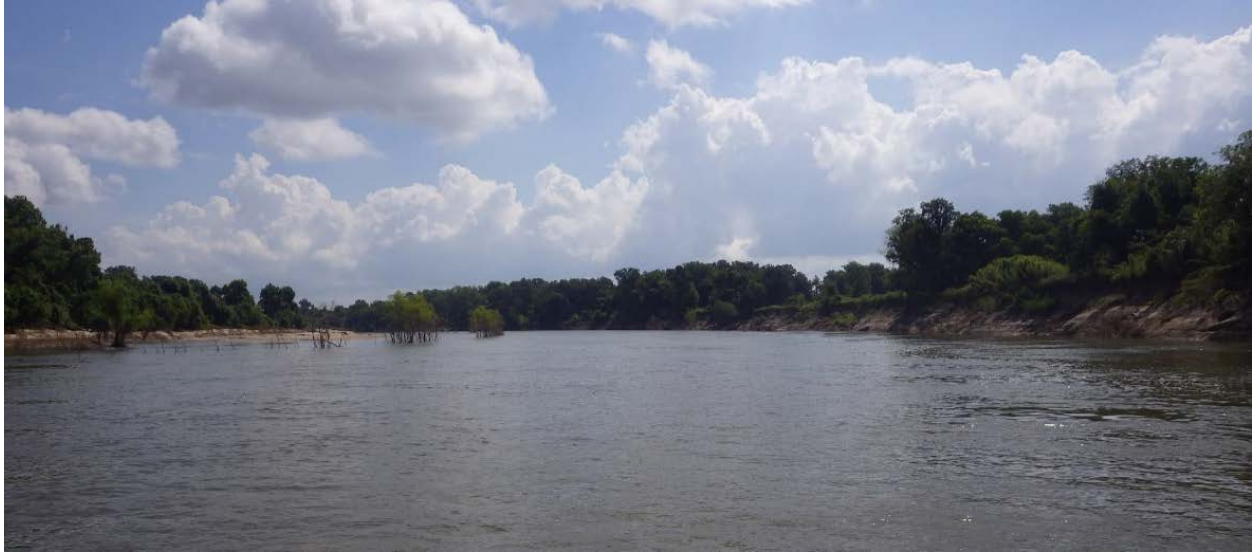
Figure 36. 080075 – Characteristic view of channel.

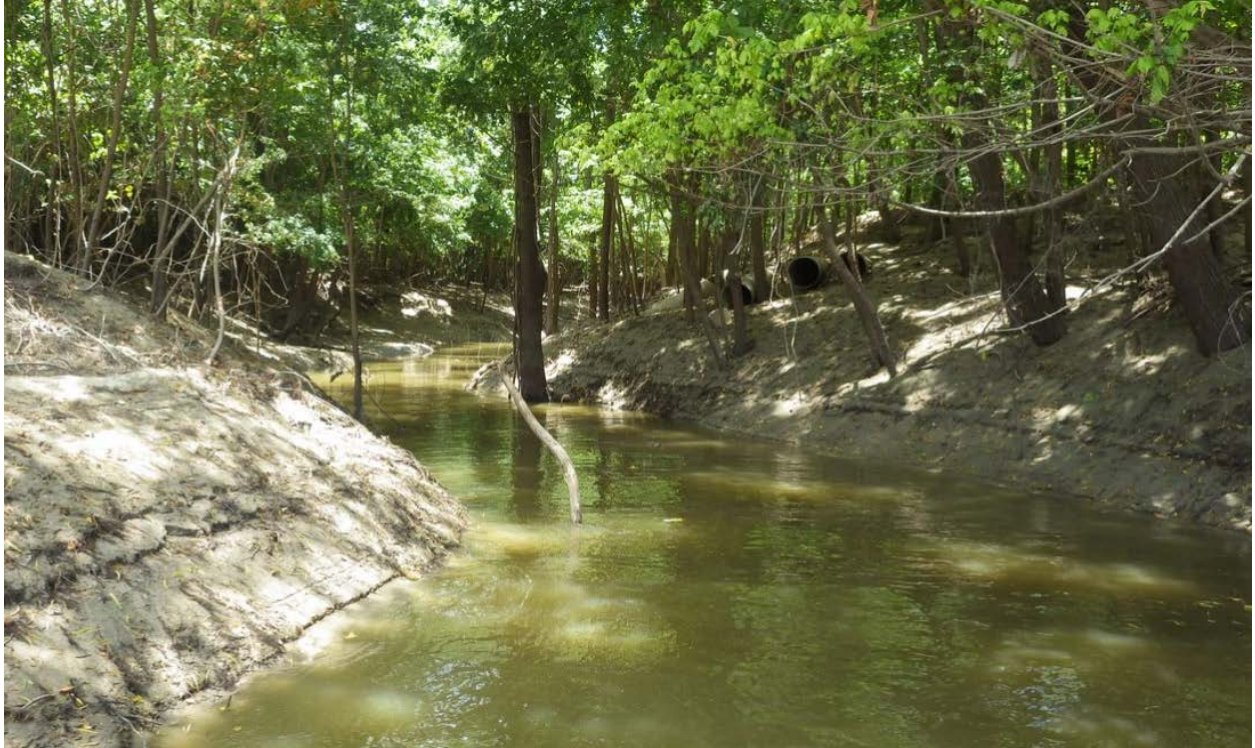
Figure 38. 080075 habitat mapping type – Disconnected oxbow.

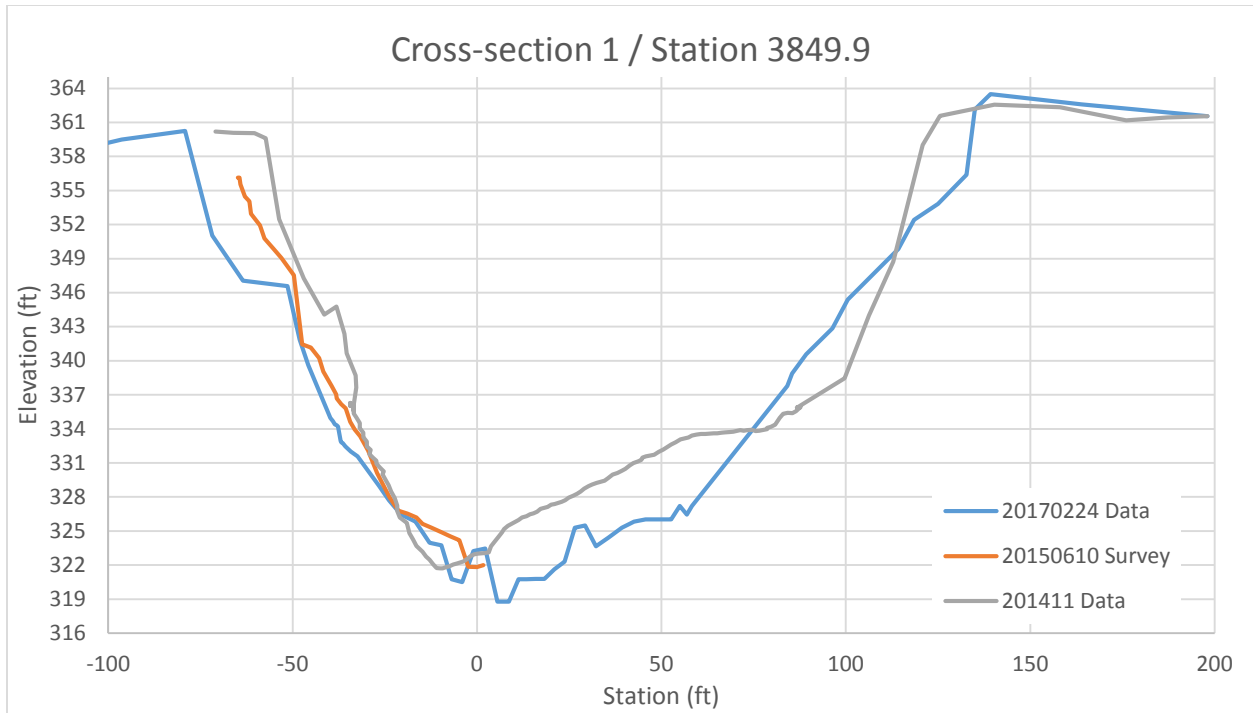
Figure 48. Changes in cross-section at station 3849.9.

Below are figures showing changes in five cross-sections from the 2014, 2015 and 2017 surveys.

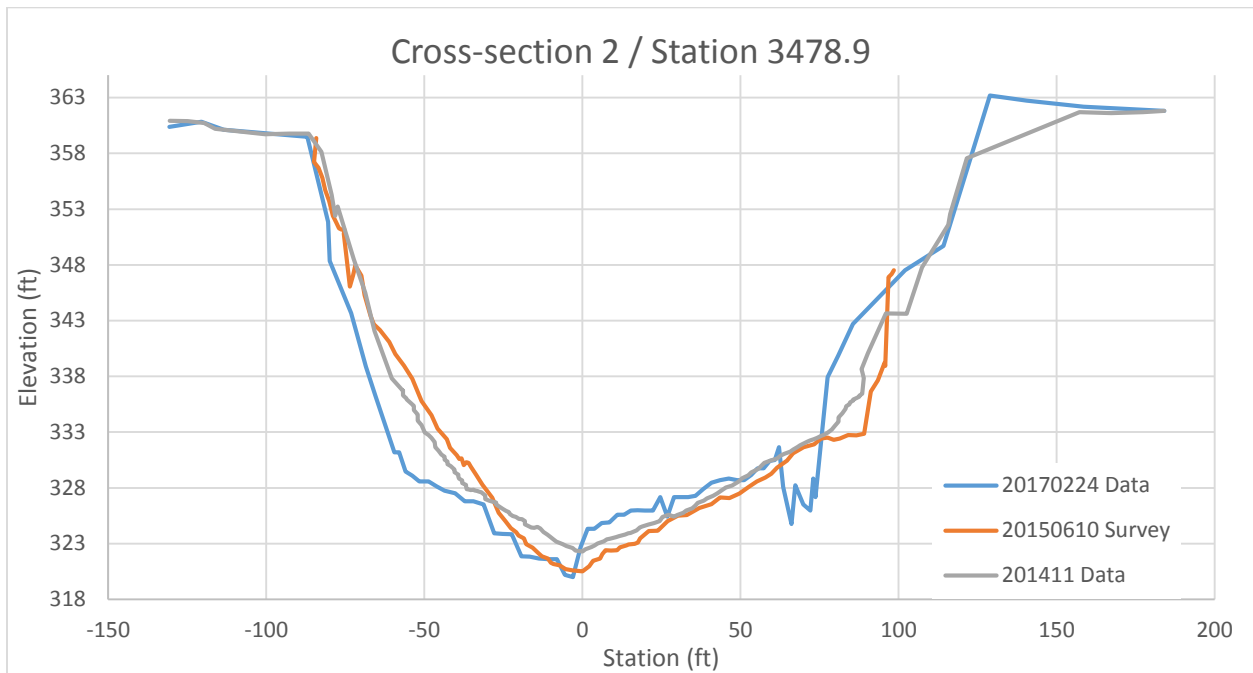
Figure 49. Changes in cross-section at station 3478.9.

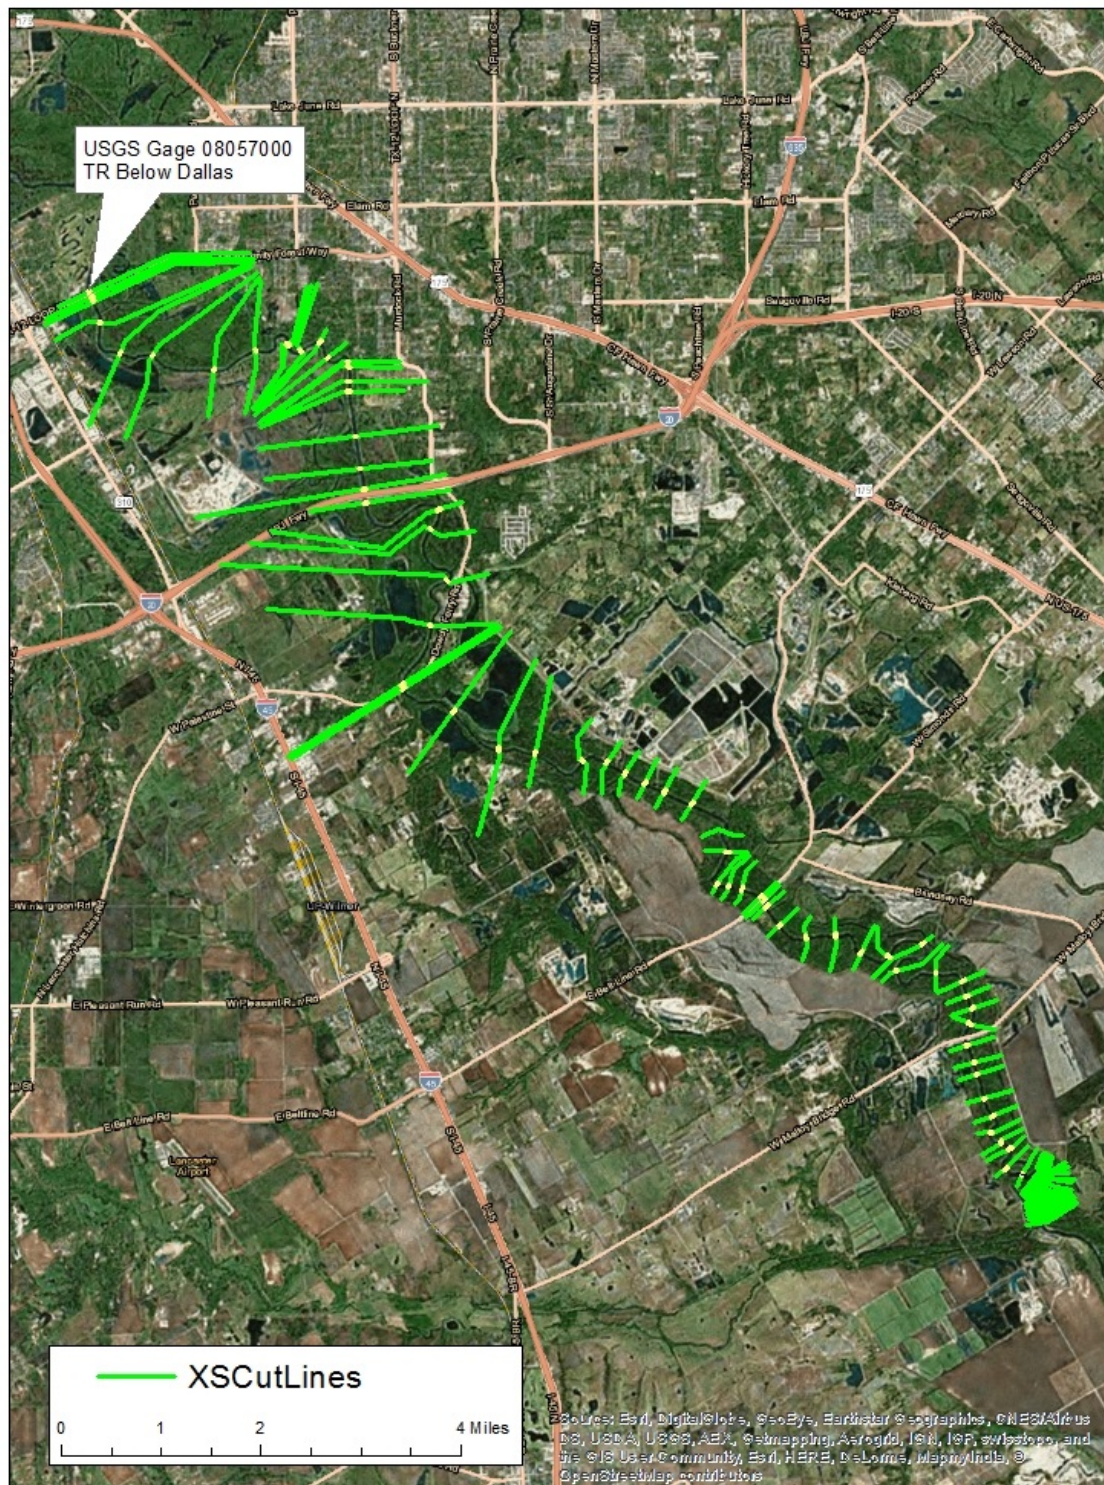
Figure 60. Site 080444 model overview map

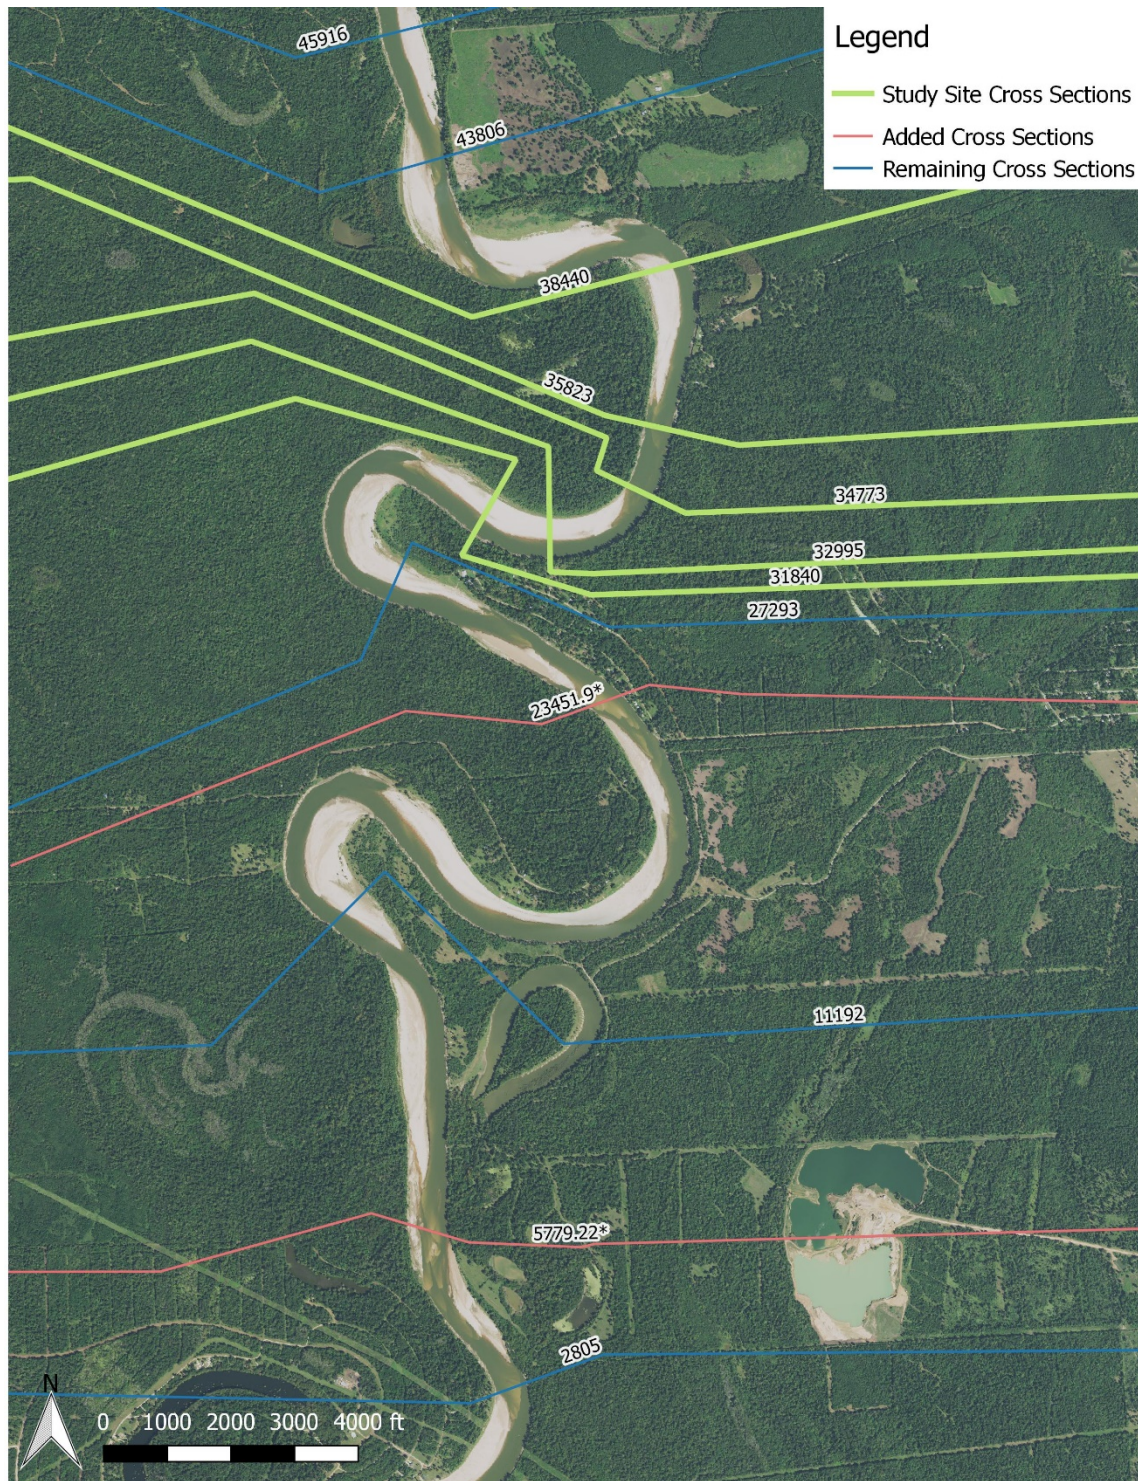
Figure 84. Map of existing and added cross-sections for the Romayor HEC-RAS model.
