# Evaluation of Adopted Flow Standards for the Trinity River, Phase 2

For: Trinity and San Jacinto Rivers and Galveston Bay Stakeholder Committee through the Texas Water Development Board

Contract No. 1600011940  
Final Report – November 2017

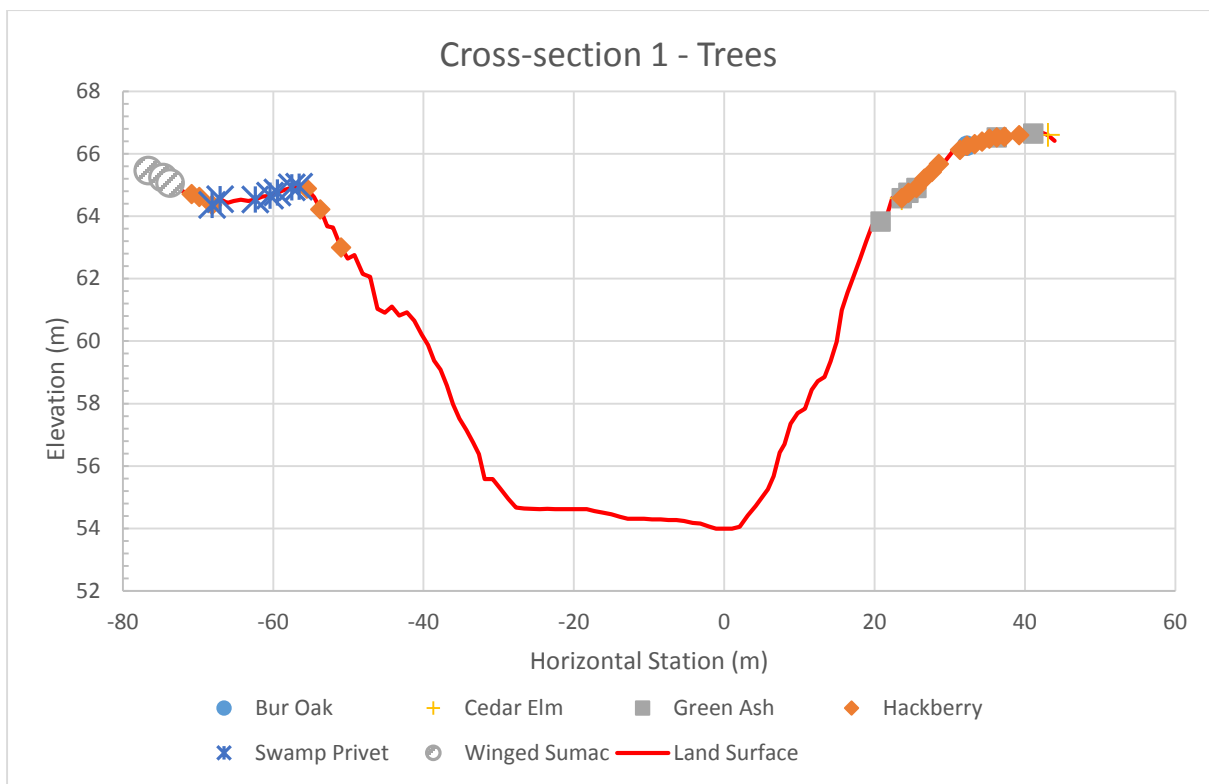
Figure 114. 080295 - Cross-section 1 - Trees - Location along cross-section
