RAD PHYSICAL CONDITION ASSESSMENT

RAD PROGRAM PHYSICAL CONDITION ASSESSMENT of CARUCCI APARTMENTS

281 Stuyvesant Avenue

EMG Project #: 107534.13R-002.306

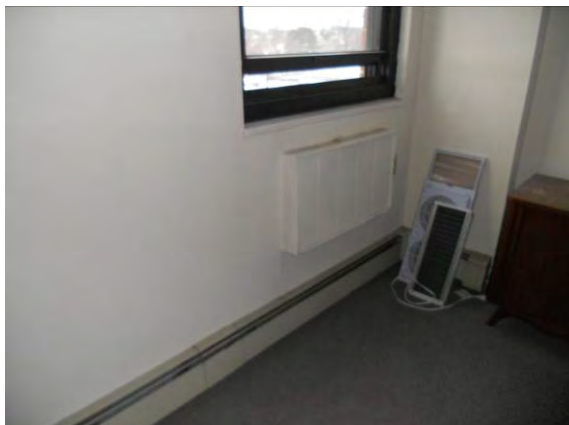
Photo #43: Apartment unit hydronic heat baseboard and covered through the wall air condition unit

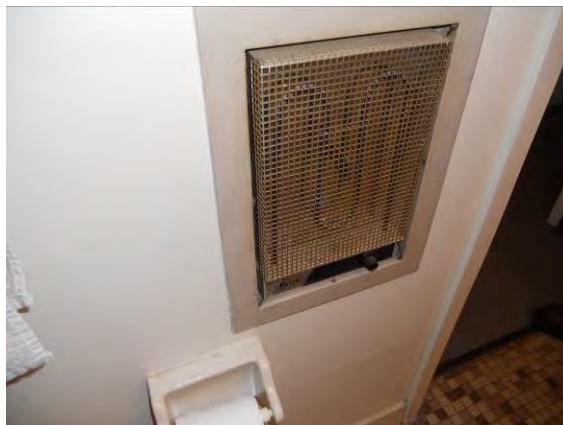
Photo #44: Electric resistance heater in apartment unit bathroom – 5th floor only

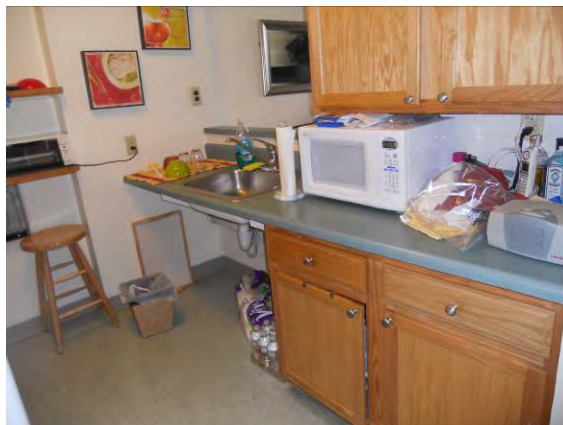
Photo #46: ADA unit kitchen

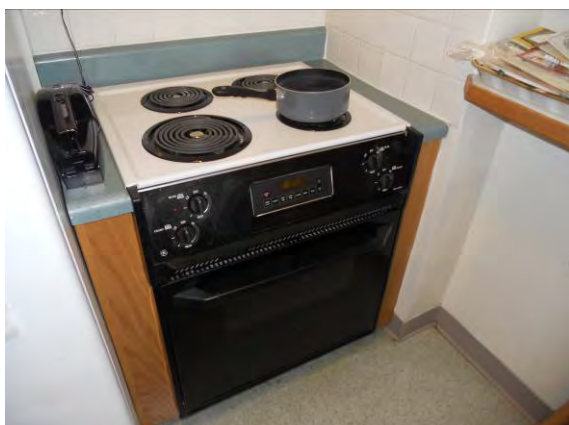
Photo #47: ADA unit range with front facing controls

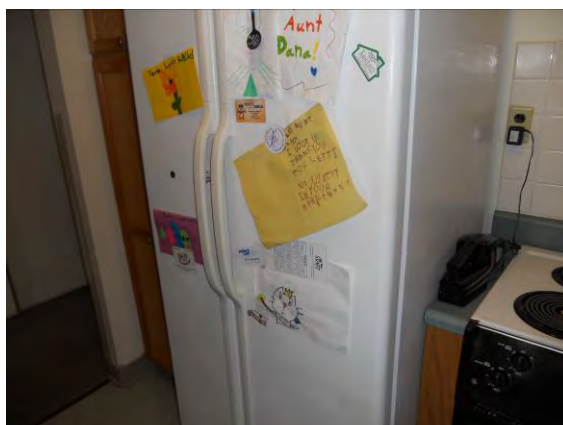
Photo #48: ADA unit refrigerator with reachable side by side

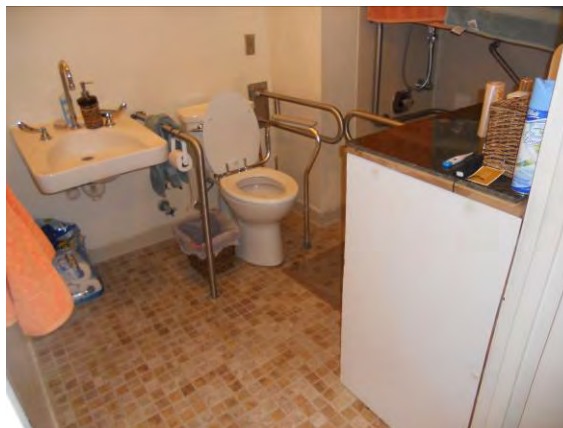
Photo #50: ADA unit bathroom

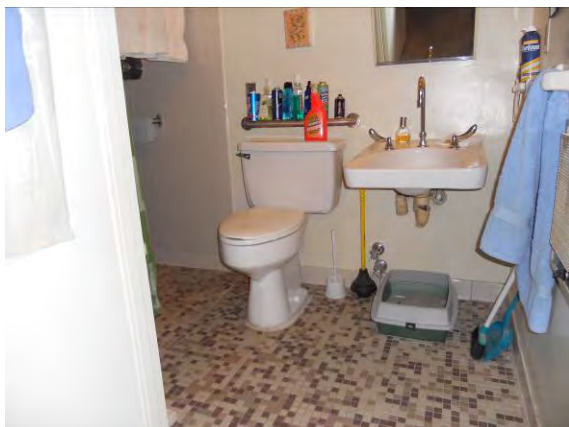
Photo #51: ADA unit with roll-in shower

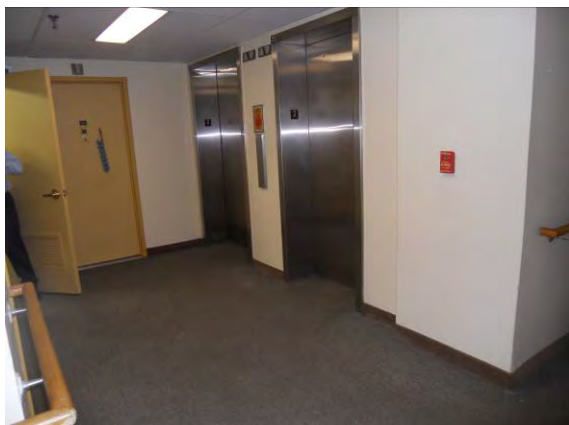
Photo #57: Elevator lobby

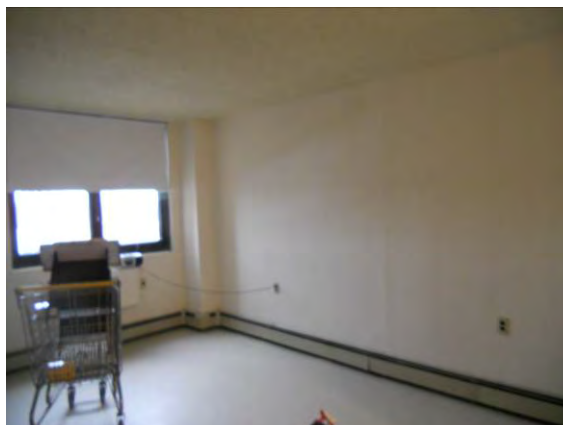
Photo #60: Vacant unit – 2K

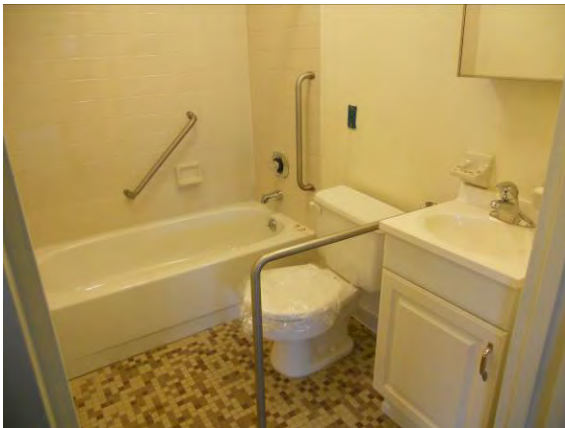
Photo #61: Vacant apartment bathroom – 2K

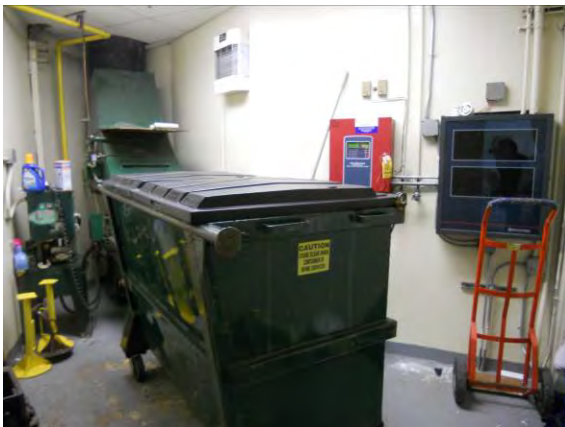
Photo #63: Dumpster at trash chute
