Underground Facility Inspection Report					
Facility Name	Manassas Station Redev	Facility ID	STMF0091651	Type of Inspection: Initial Inspection	
Location	Lat: 38.908792 Long: -77.474171	Watershed	Rocky Branch-Broad Run	Previous 48 Hour Precipitation Total	0.35"
Materials available for inspection	N/A	Owner Notification Date		Owners/ Owner's Representative	Prince Properties, LLC
Inspectors	gky_mfreeman	Date of Inspection	6/29/2023	Date of Last Inspection	N/A
Overall Condition Score					
	1	Adequate	No deficiencies identified.		
	2	Monitor	No maintenance may be needed at the time, but might become an issue in the future. Will revisit next inspection. Examples include minor erosion, small sediment accumulation, or small structural issues of facility components.		
3	3	Routine Maintenance Needed	Facility is functional but preventative maintenance is required. Examples includes minor structural damage, minor erosion, or trash/debris removal.

Facility ID: STMF0091651
Facility Name: Manassas Station Redevelopment

Inspection Date: 06/27/2023

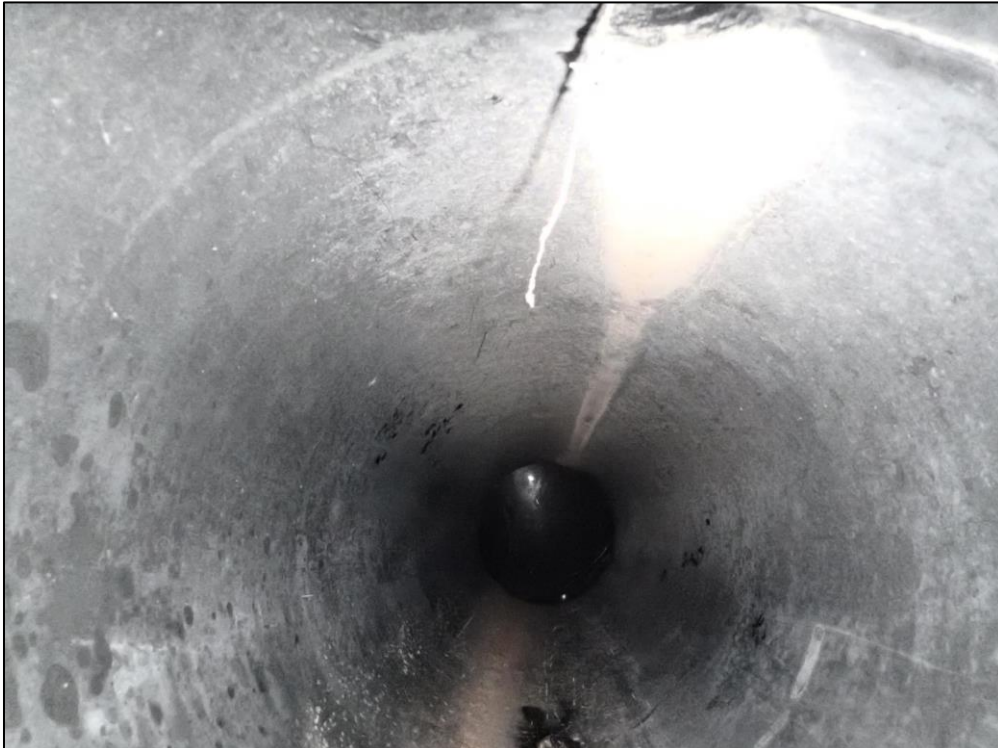
5056: Inside Inlet Structure 86, looking downstream toward the bypass plate.

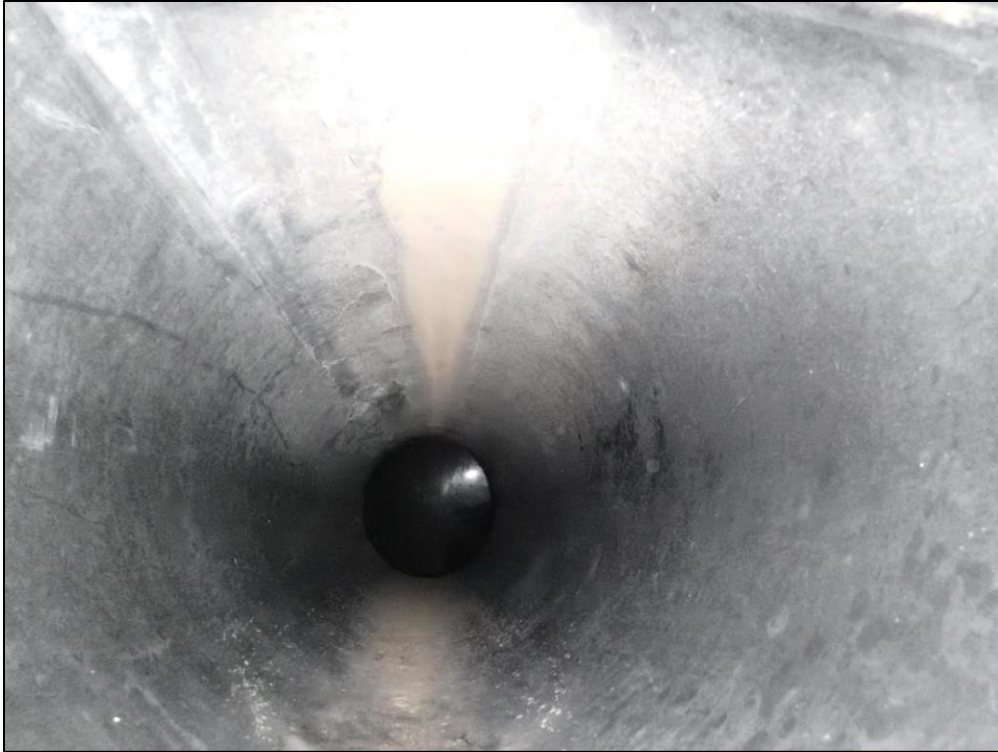
5057: Inside Inlet Structure 86, looking downstream along the Southern pipe.

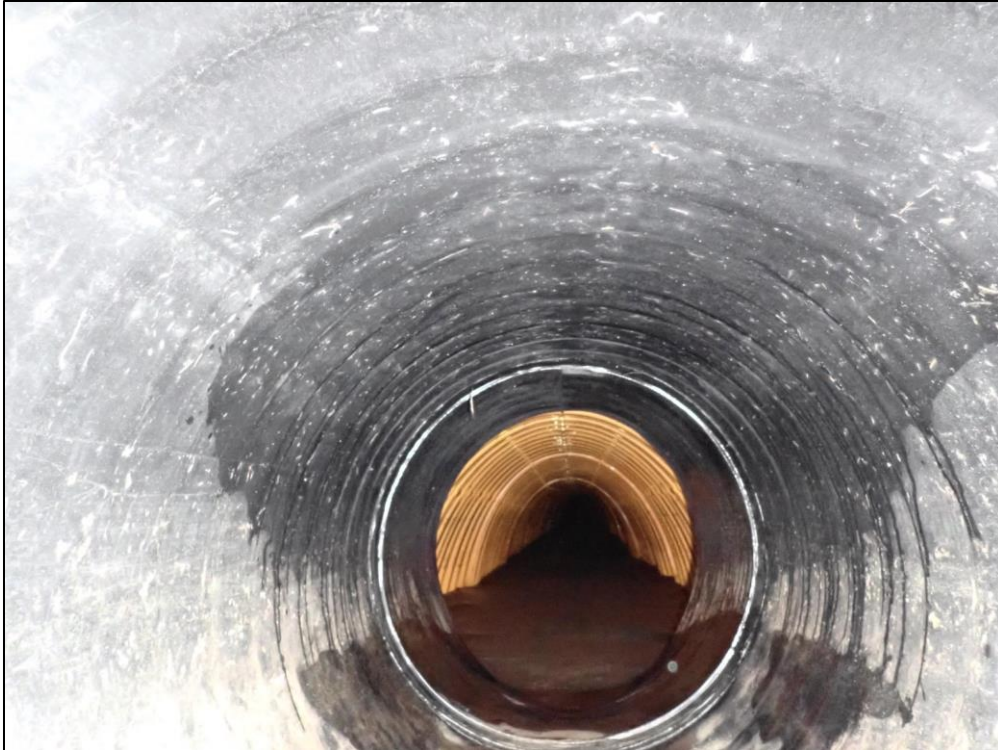
5067: Inside Manhole 3, looking downstream toward detention Northwest.

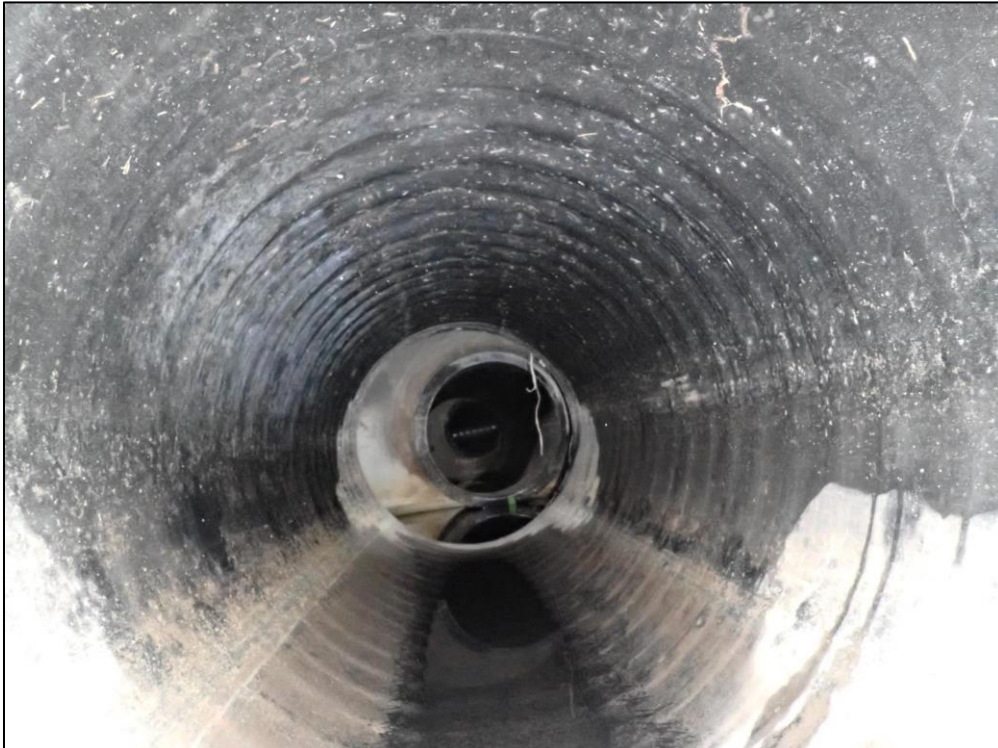
5068: Inside Manhole 3, looking downstream along the Southern Isolator Row.

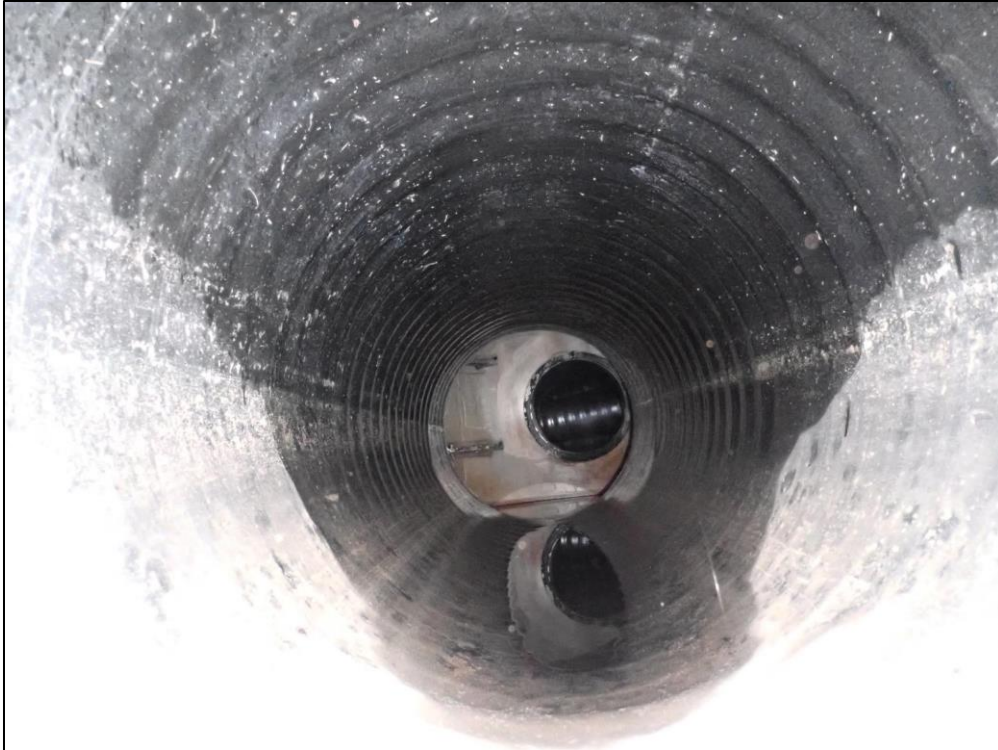
5073: Inside Manhole 4, looking downstream along the middle Isolator Row.

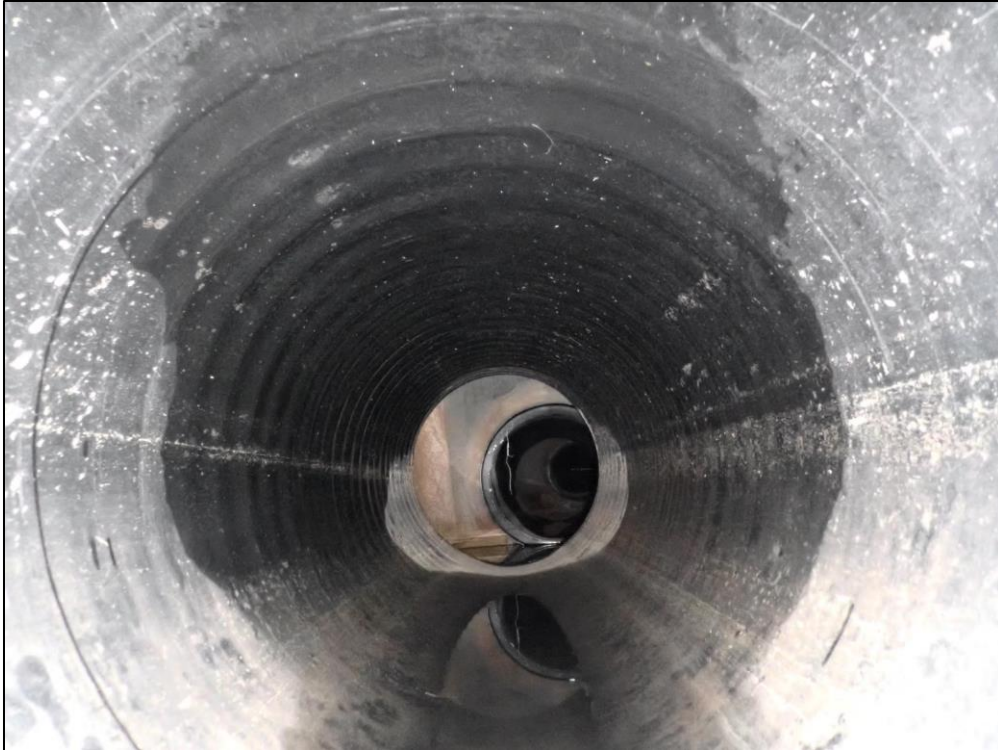
5077: Inside Manhole 5, looking upstream toward Inlet Chamber 86.

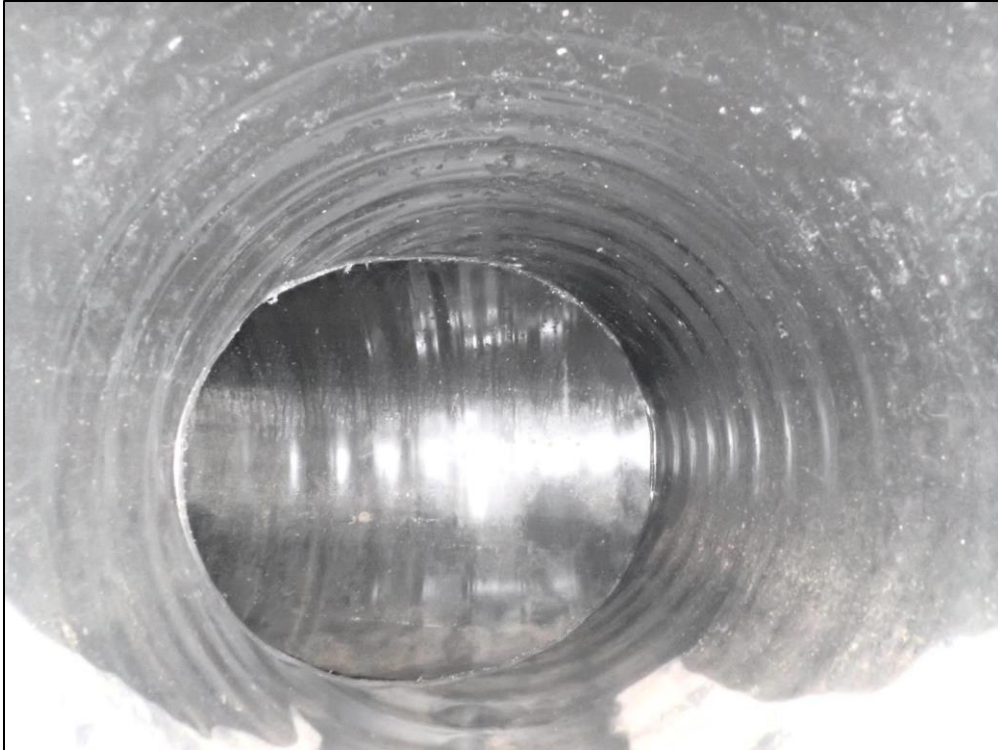
5079: Inside Manhole 5, looking downstream along the Northern Isolator Row.

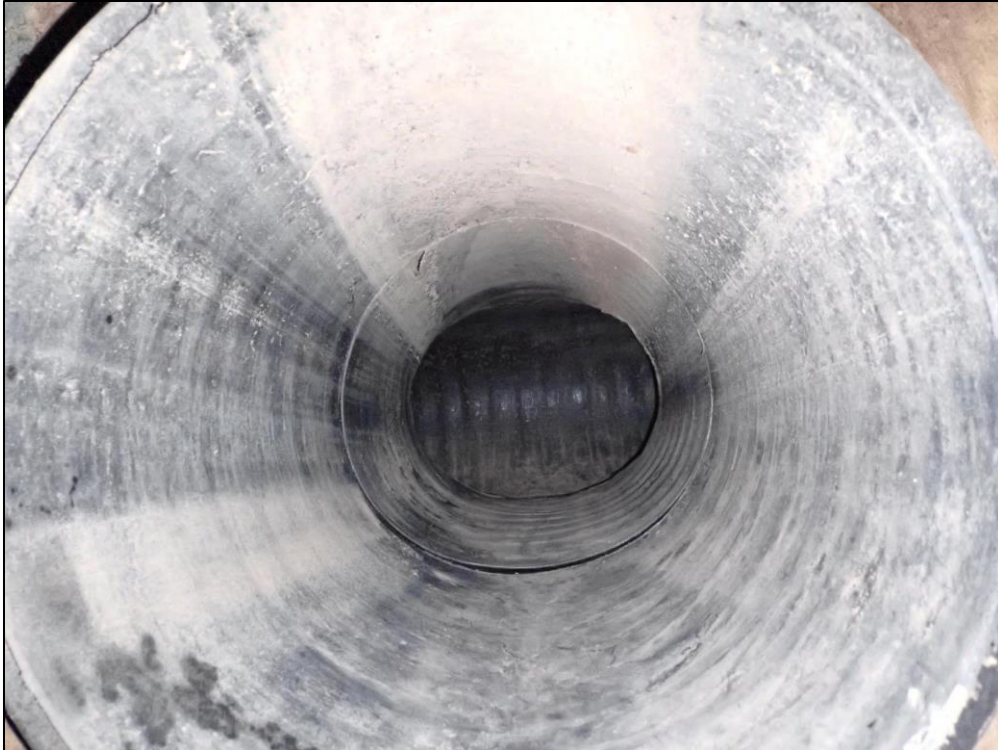
5083: Inside the upstream end of Cartridge Chamber 84, looking upstream along the underdrain.

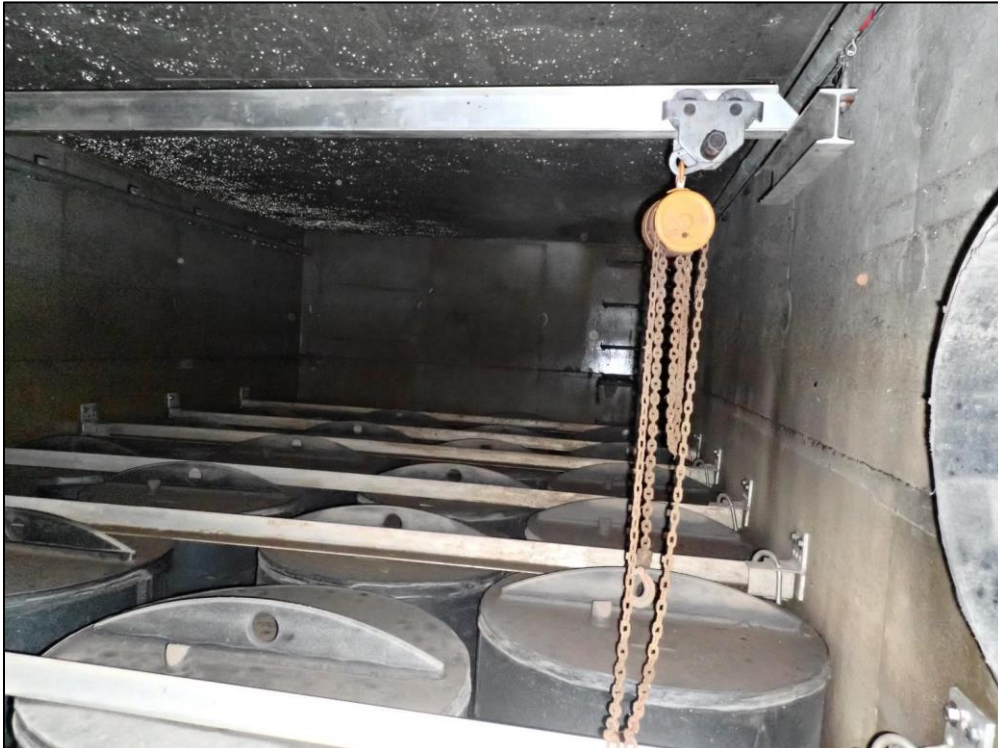
5084: Inside the upstream end of Cartridge Chamber 84, looking upstream toward detention.

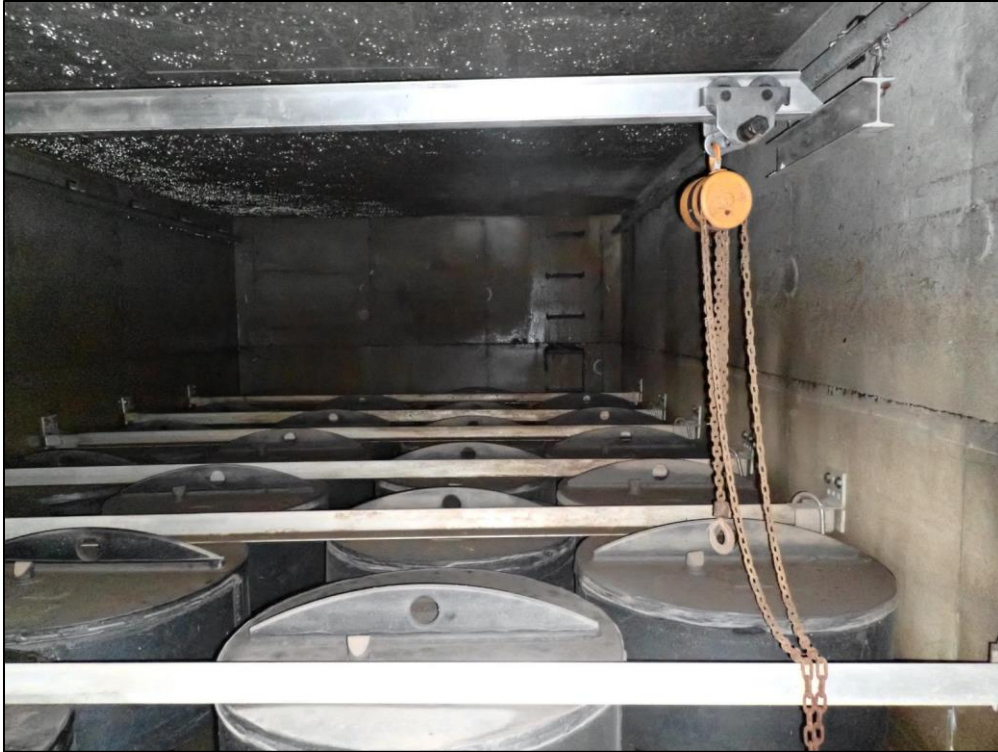
5085: Inside the upstream end of Cartridge Chamber 84, looking toward the filter cartridges.

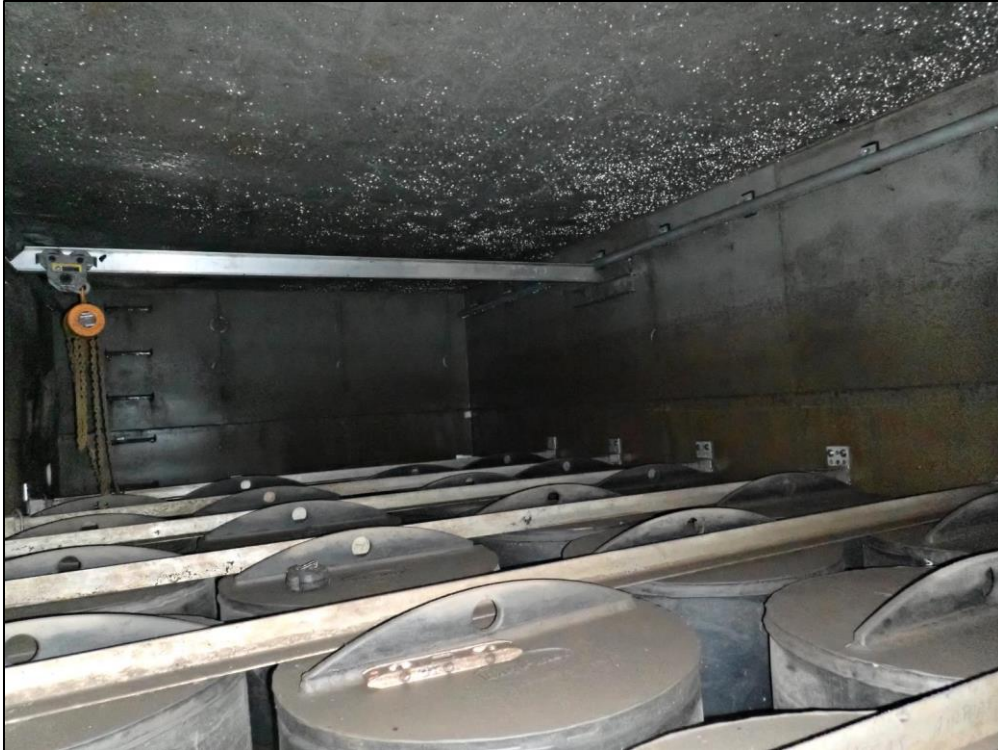
5089 Inside the downstream end of Cartridge Chamber 84, looking toward the filter cartridges.

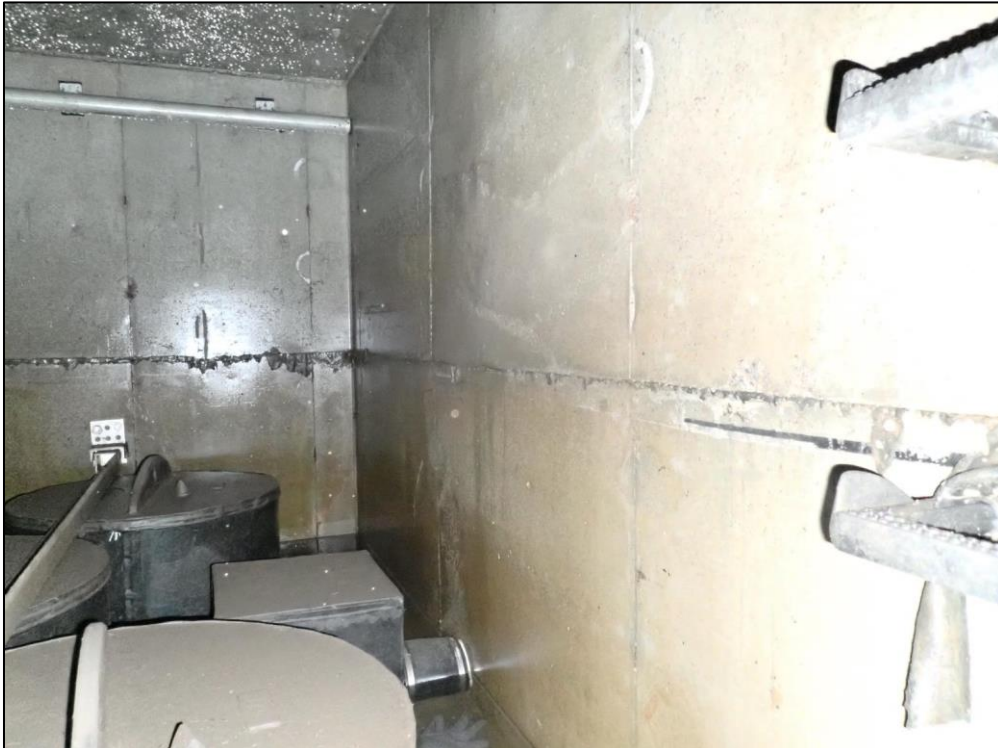
5090: Inside the downstream end of Cartridge Chamber 84, looking toward the filter cartridges.

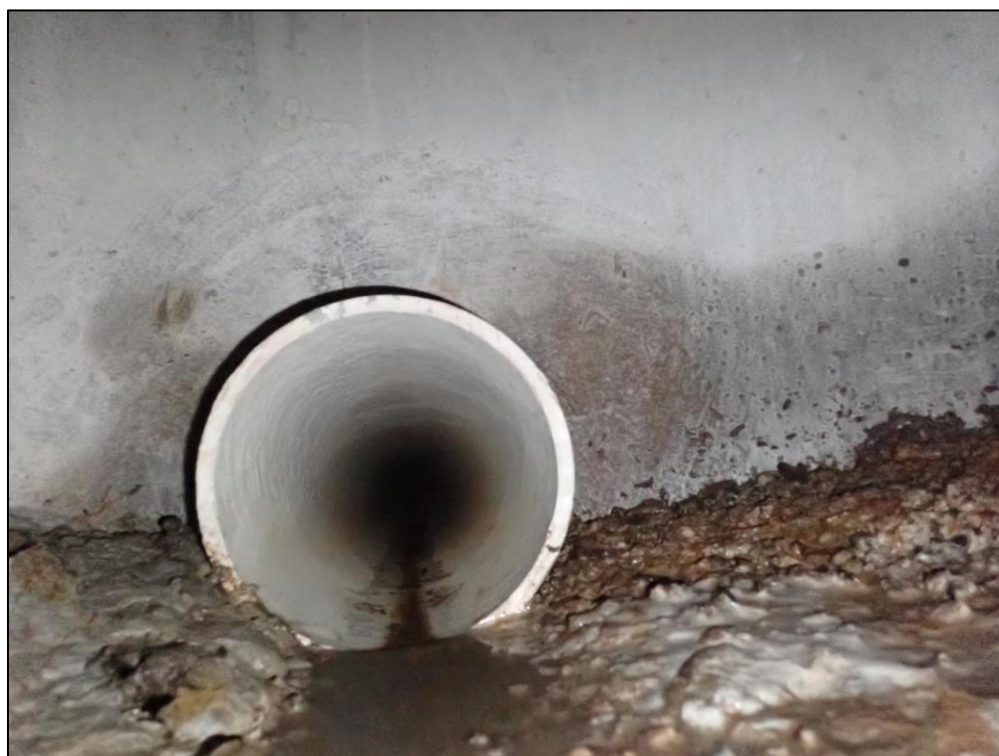
5097: Inside Outfall Structure Z, looking downstream.

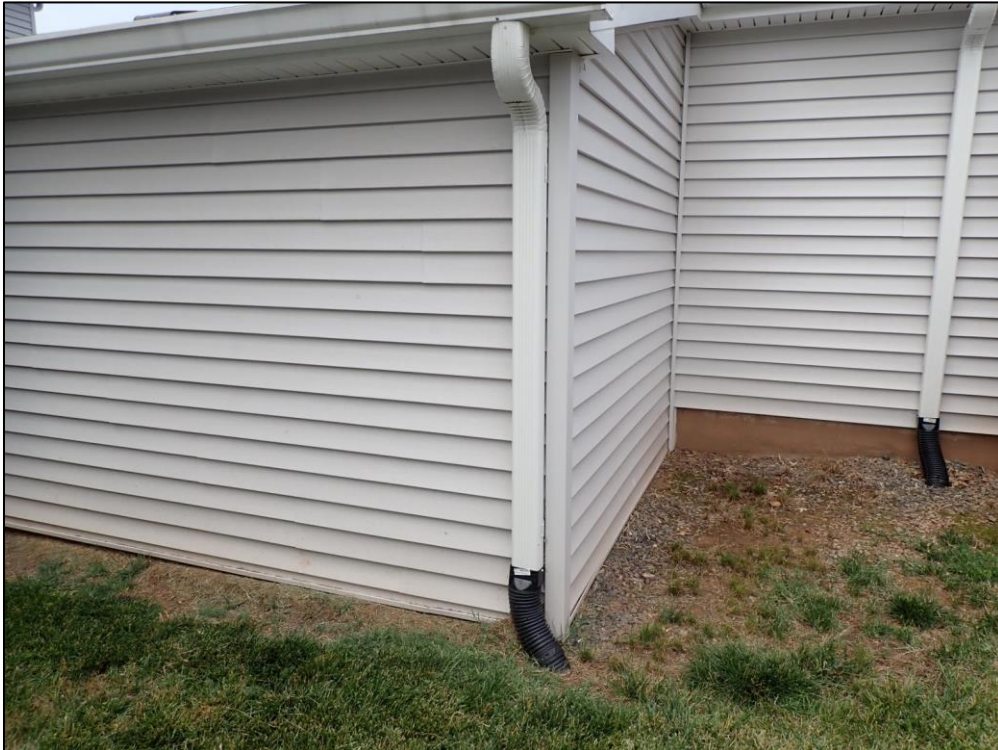
4759: Overall view of Downspout 1, piped underground toward the trench.

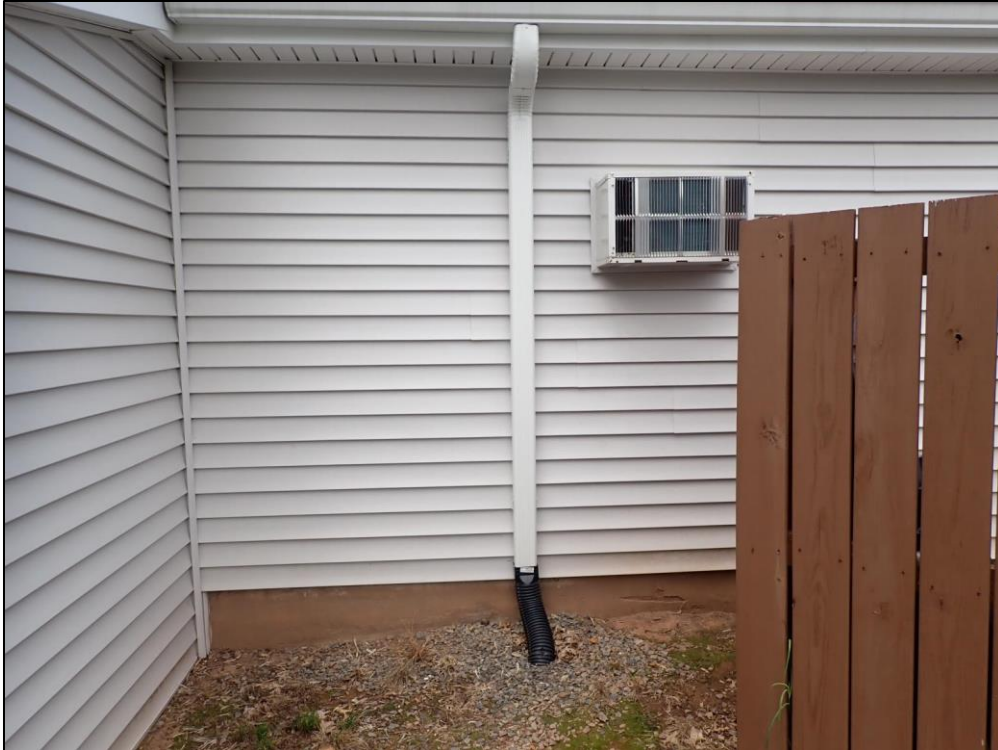
4760: Overall view of Downspout 2, piped underground toward the trench.

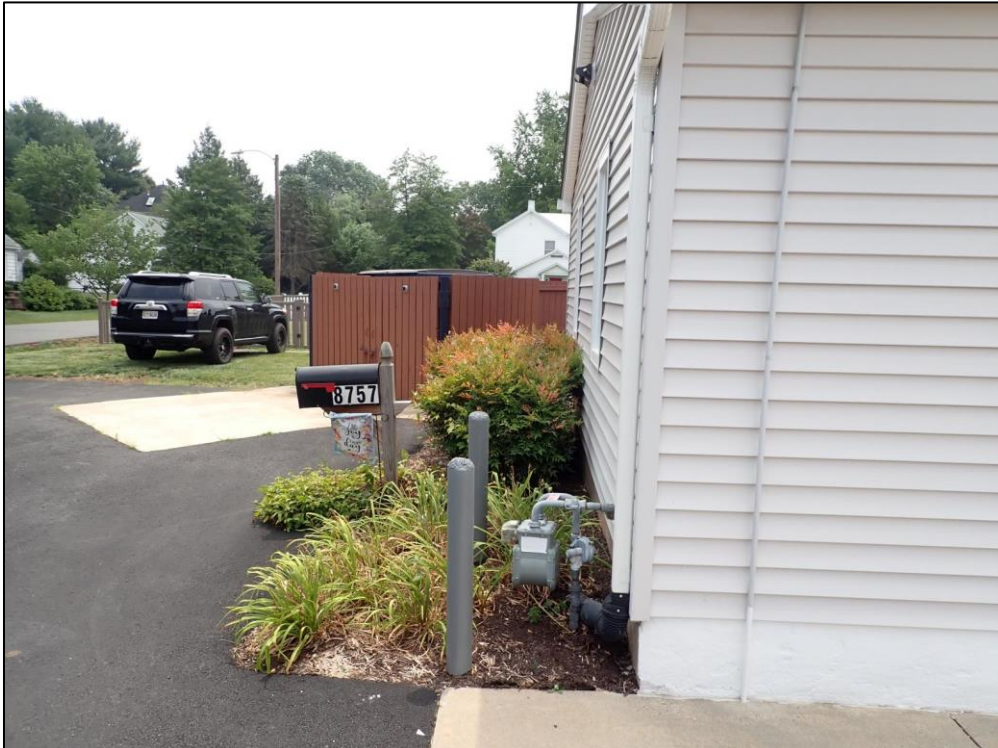
4761: Overall view of Downspout 3, flowing overland toward the trench.

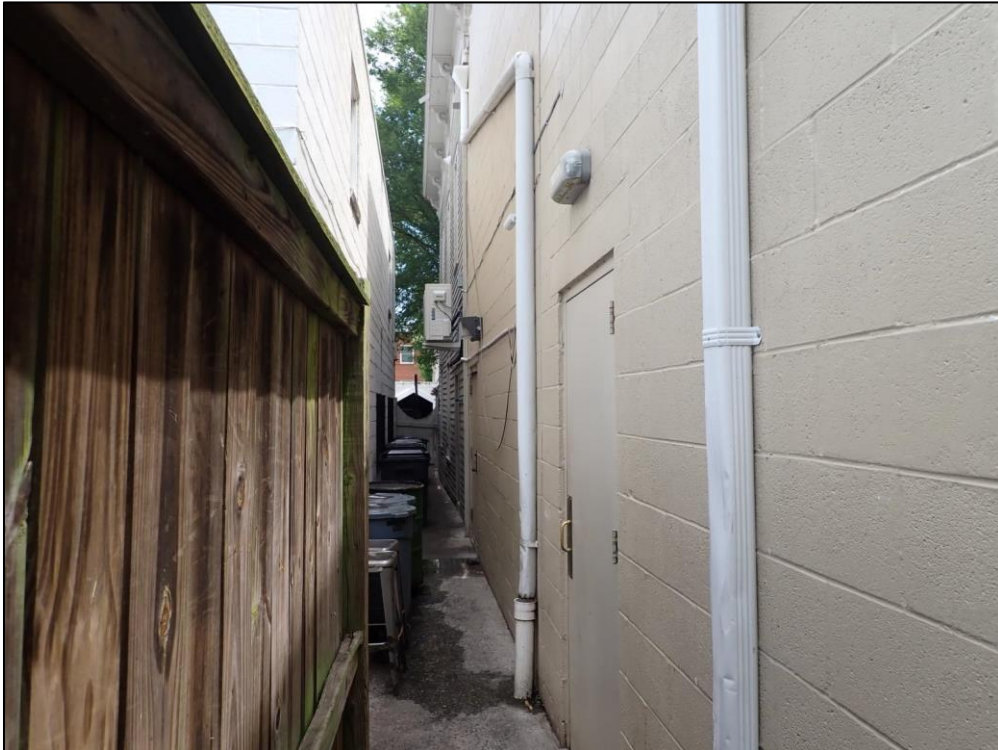
4499: Overall View of Roof Drain 1.

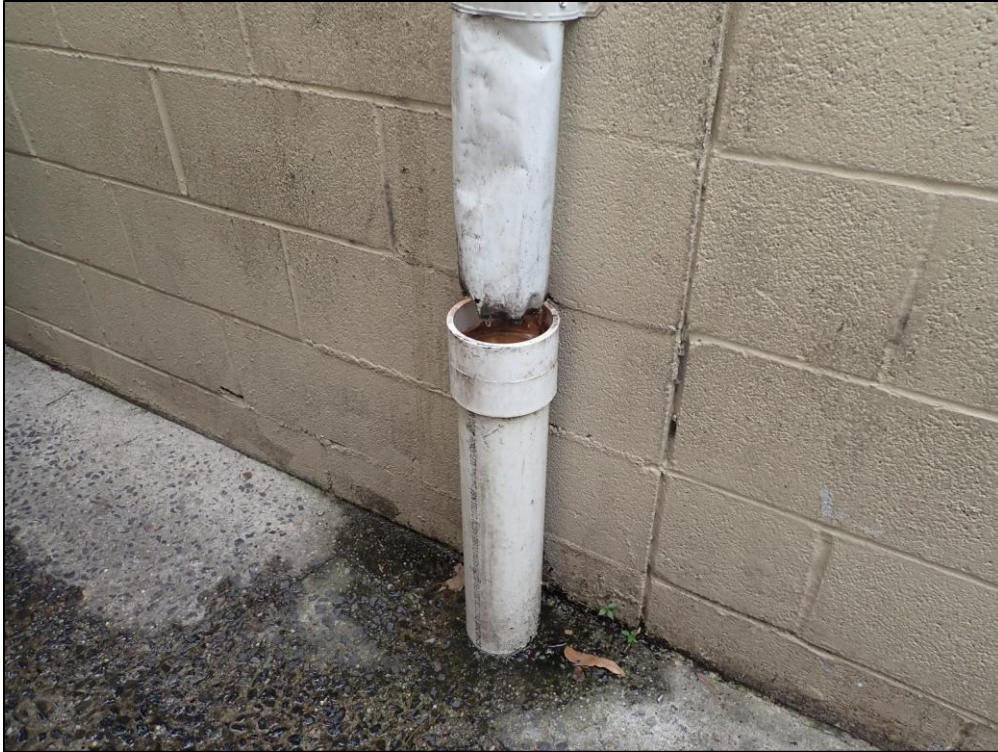
4500: Close-up view of Roof Drain 1.

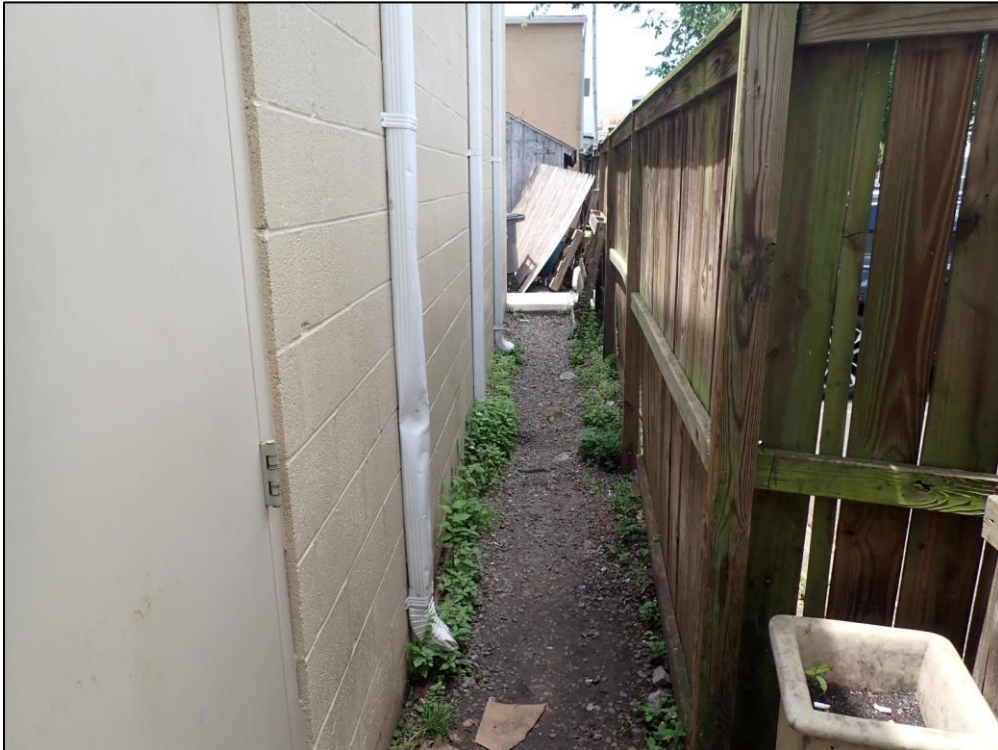
4501: Overall view of Roof Drains 2-4.

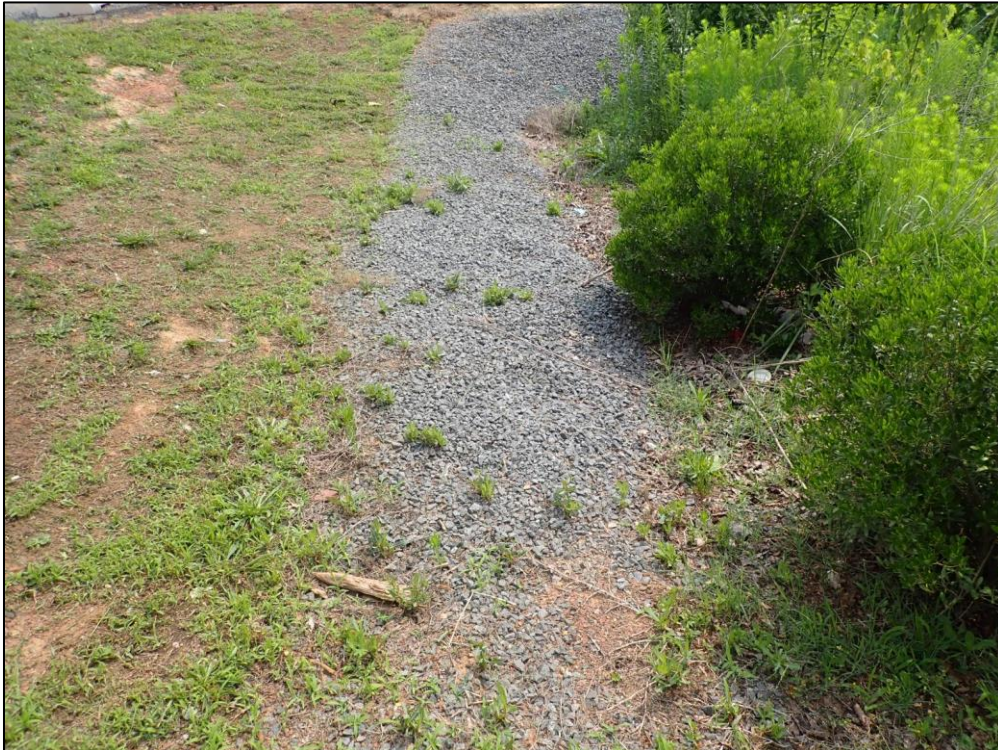
4995: Overall view of the Gravel Diaphragm. Buildup of sediment and vegetation (Routine Maintenance Needed).

Score	Description	Comment(s) / Corrective Action(s)	Reference Image
Side Slopes			
3	Evidence of erosion or bare spots	Bare spots and eroded areas were observed on the facility's Gravel Diaphragm and side slope. Stabilize the areas within the gravel diaphragm with additional stone and the side slopes with seed and straw.	4996, 4999, 5009
1	Shrubby, low growing vegetation, and/or vine material growing on slopes		
3	Evidence of nuisance animals	A 3 cubic foot animal hole was observed in the side slope. Fill this hole with topsoil and stabilize the area with seed and straw.	5015, 5016
3	Buildup of trash, debris, or sediment	Sediment accumulation and vegetation growth observed on the Gravel Diaphragm. Remove this material to ensure continued function.	4995, 4997, 4998
Vegetation			
1	Plant composition is inconsistent with the approved plans		
1	Vegetation is diseased, dying or dead		
1	Inadequate cover (mulch + vegetation should be 75-90% cover)

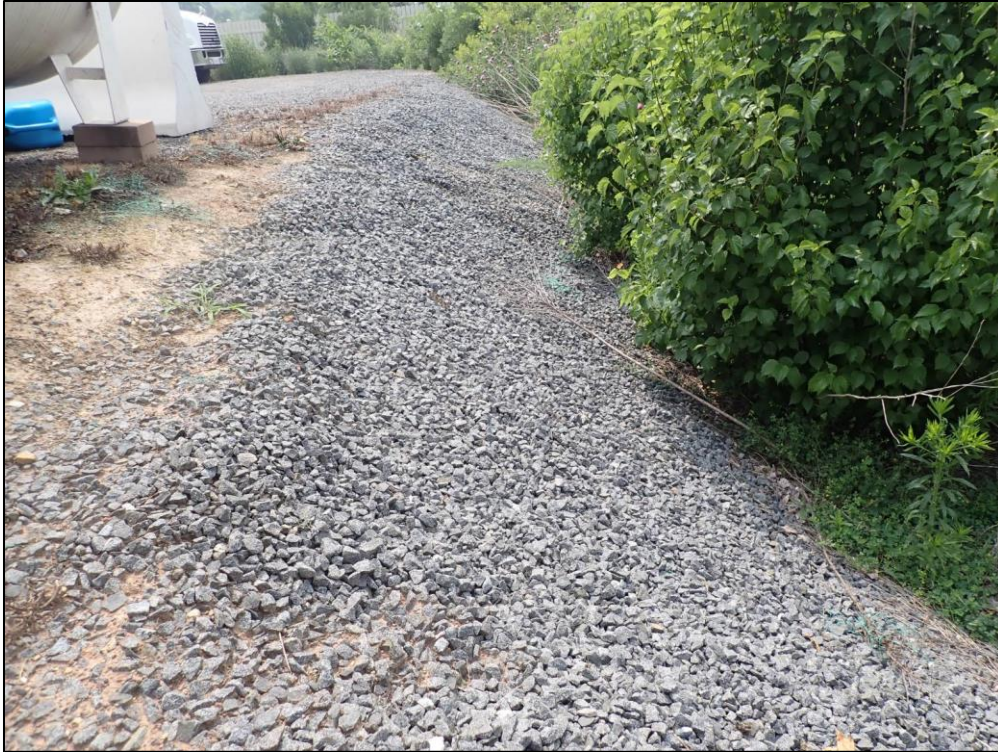
4996: Overall view of the Gravel Diaphragm. Evidence of erosion or bare spots (Routine Maintenance Needed).

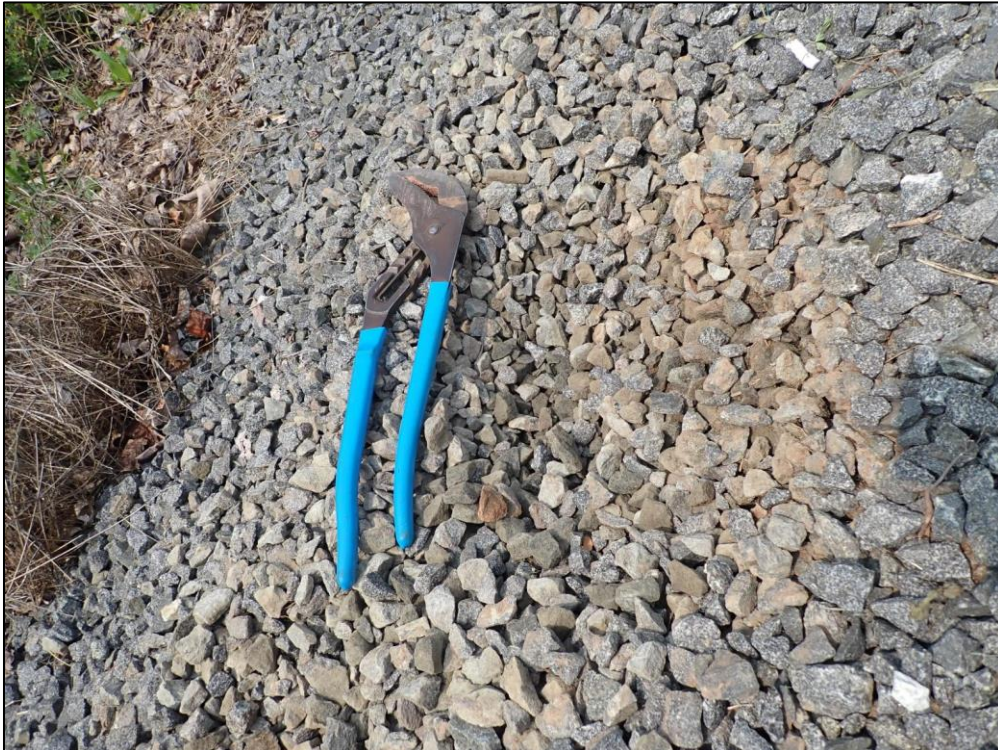
4997: Close-up of the Gravel Diaphragm, showing the gravel detail. Buildup of sediment and vegetation (Routine Maintenance Needed).

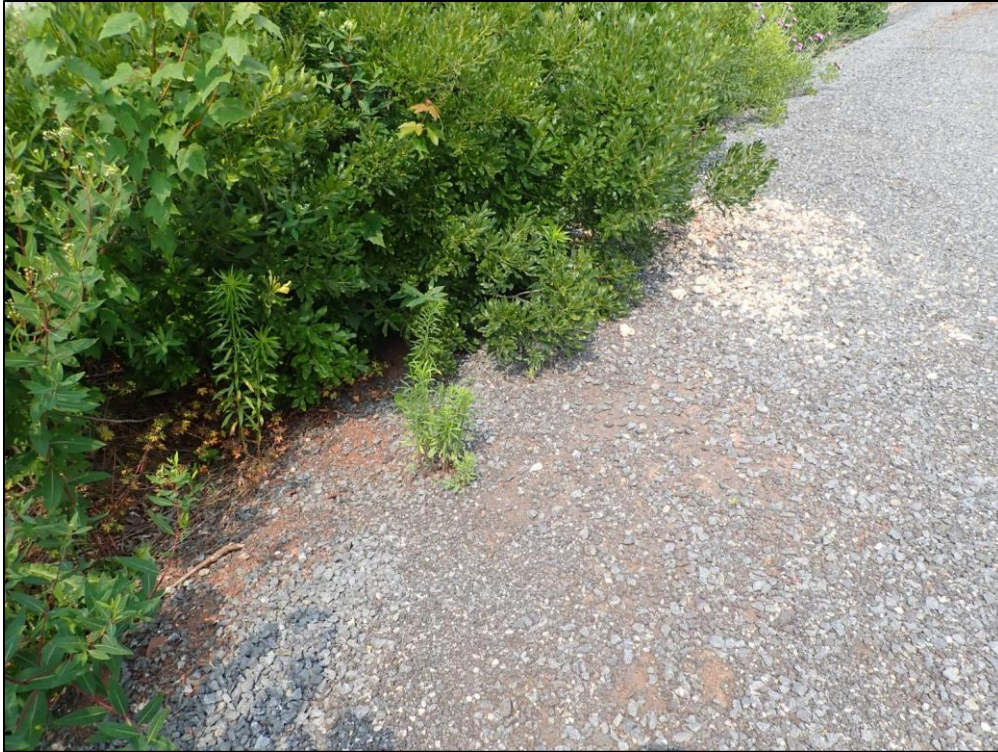
4998: Overall view of the Gravel Diaphragm. Buildup of sediment and vegetation (Routine Maintenance Needed).

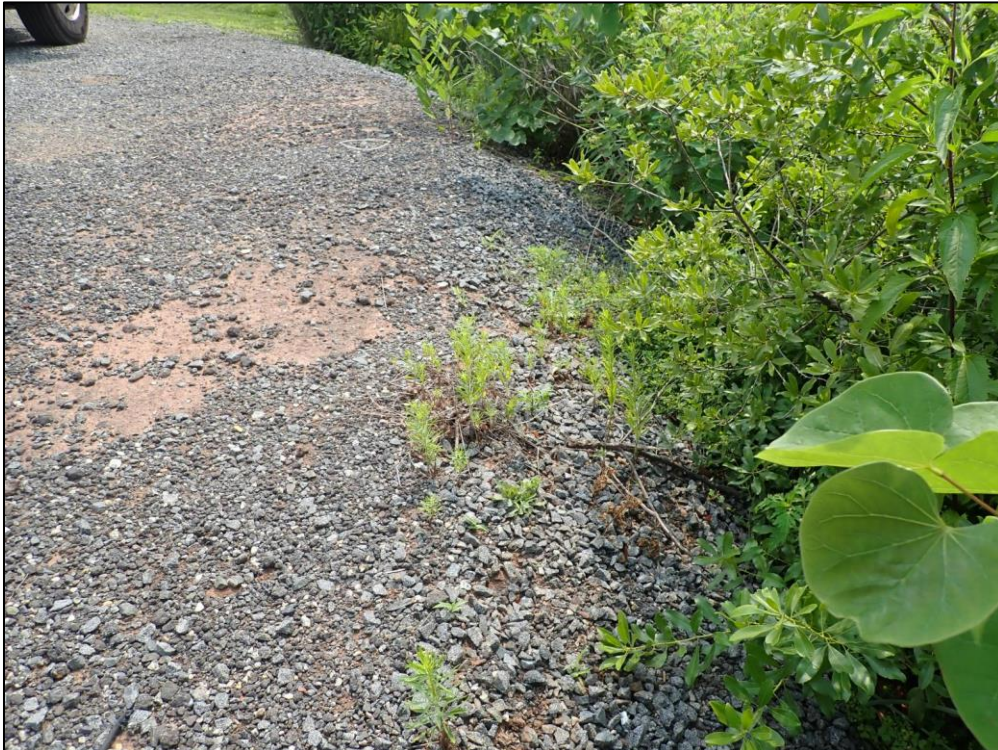
4999: Overall view of the Gravel Diaphragm. Evidence of erosion or bare spots (Routine Maintenance Needed).

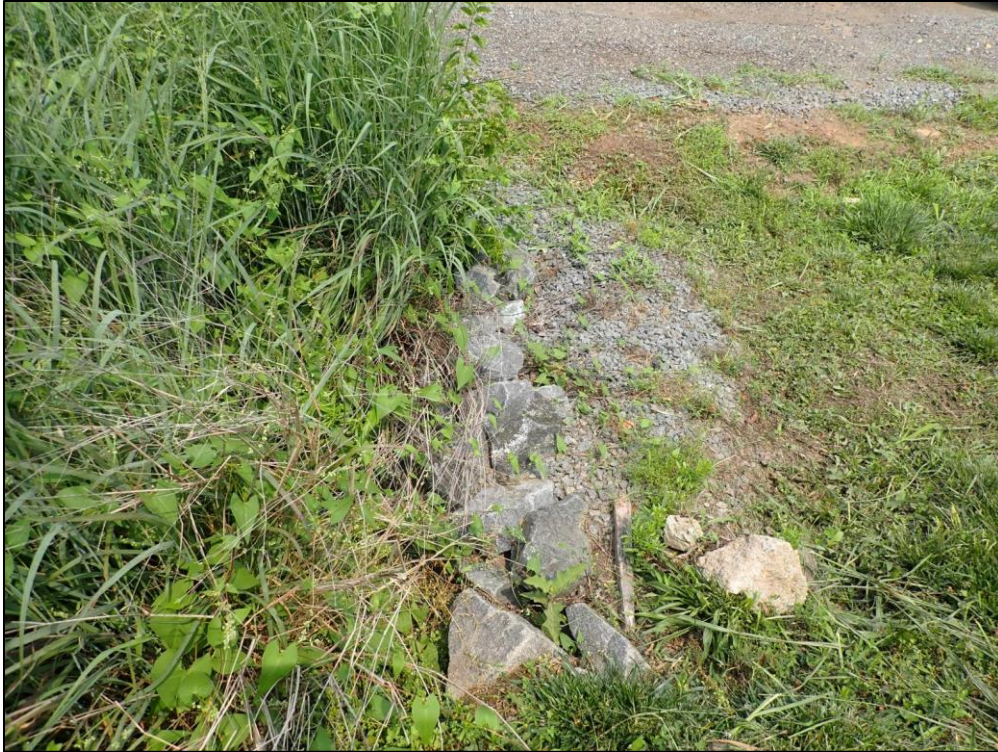
5002: Overall view of the Check Dam. Buildup of sediment and vegetation (Routine Maintenance Needed).

4	Immediate Repair Needed	Facility is close to or currently not carrying out intended function. Examples include major erosion, significant sediment accumulation , or structural component failure. <u>Repair Immediately</u>		
	N/A	Not Applicable	Does not pertain to this facility.		
Remarks					
Inspection Items					
Score	Description	Comment(s) / Corrective Action(s)		Reference Image	
Overall					
1	Inadequate access to complete thorough inspection				
1	Encroachment				
1	Missing or damaged safety signage				
1	Mosquitos				
1	Surrounding drainage area trash/debris/unauthorized substances that might affect facility				
1	Surrounding drainage area erosion that might be related to facility				
Pre-Treatment					
3	Buildup of trash or debris	Sediment accumulation and vegetation growth observed on the Check Dam. Remove this material to ensure continued function.		5002, 5003	
1	Signs of erosion or exposed soil

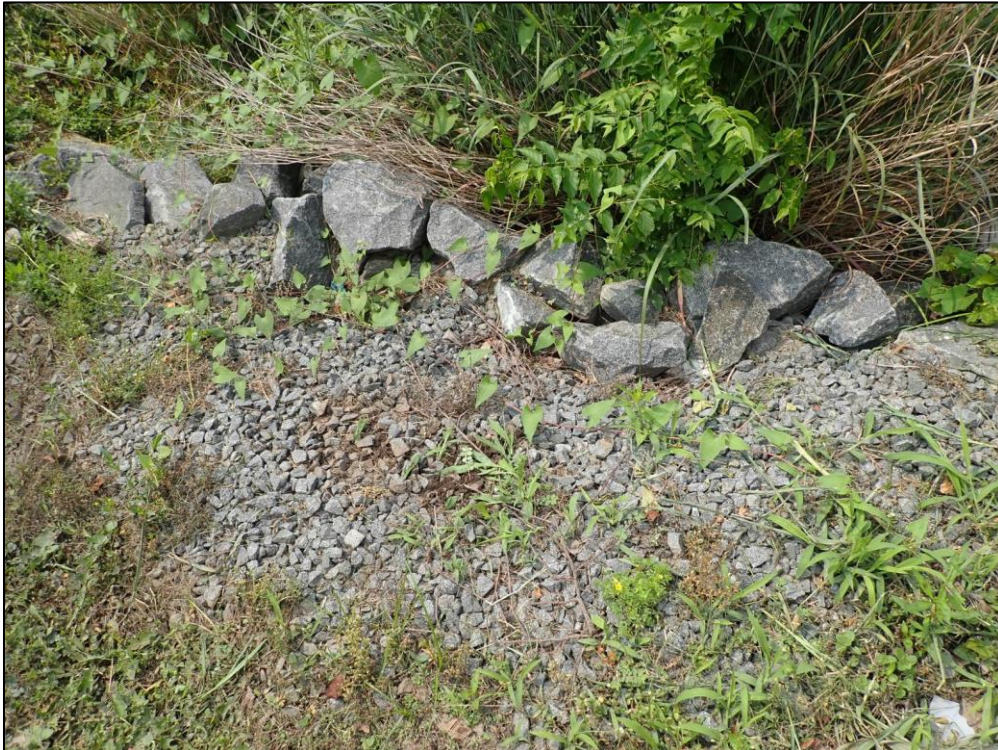
5003: Close-up of the Check dam. Buildup of sediment and vegetation (Routine Maintenance Needed).

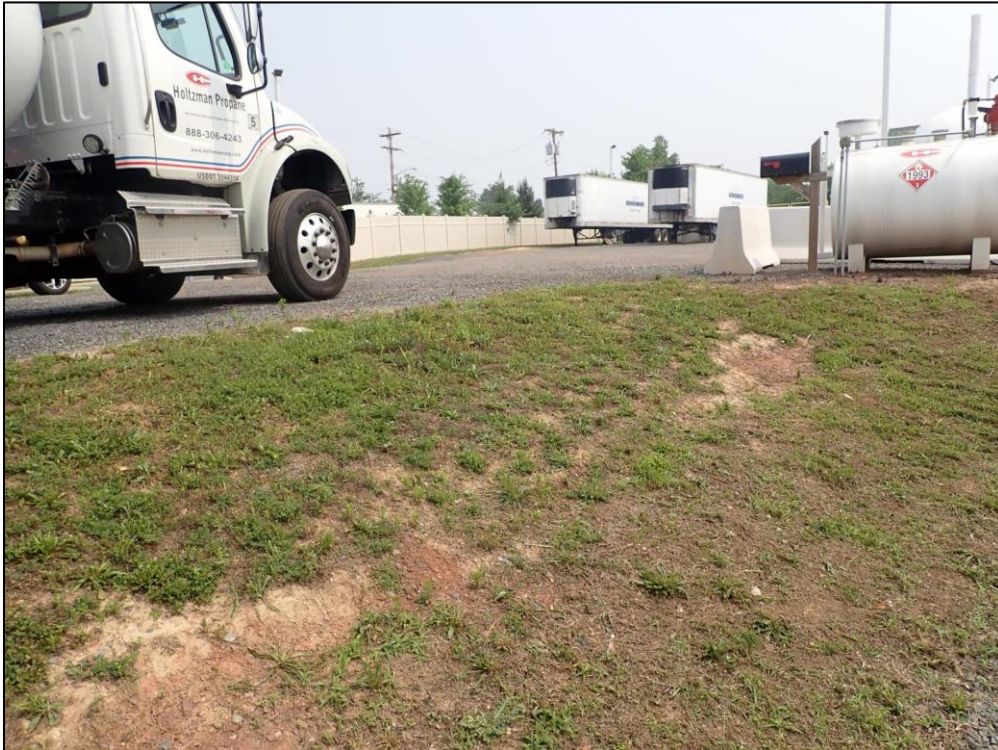
5009: Overall view of the overland inflow area, looking North. Evidence of erosion or bare spots (Routine Maintenance Needed).

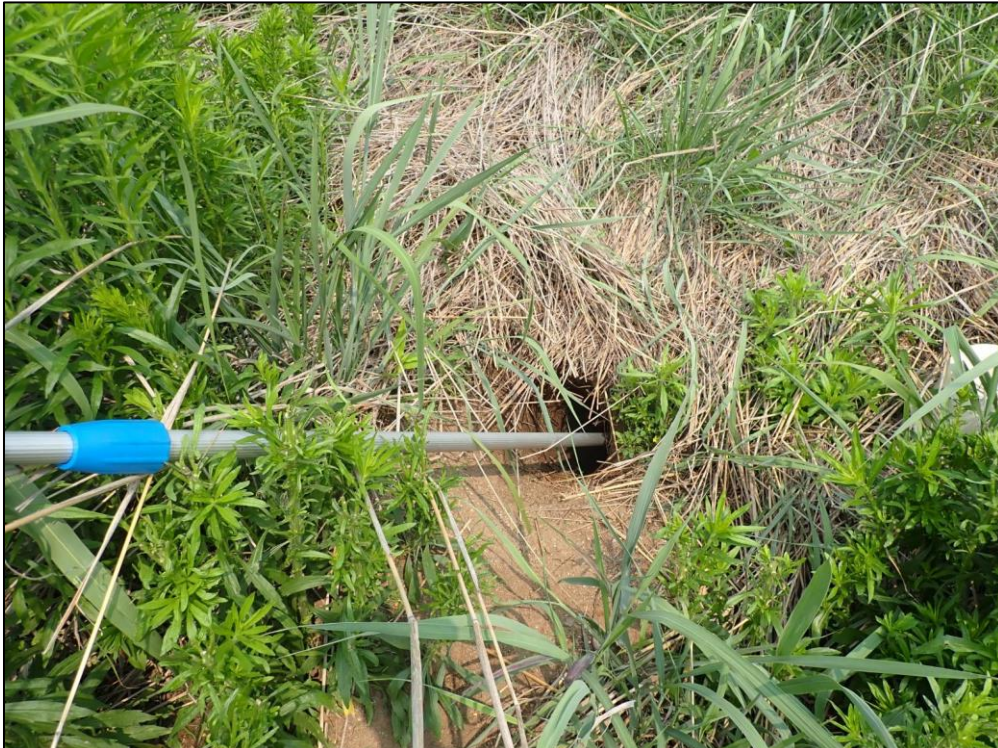
5015: Overall view of the Animal Hole. Evidence of nuisance animals (Routine Maintenance Needed).

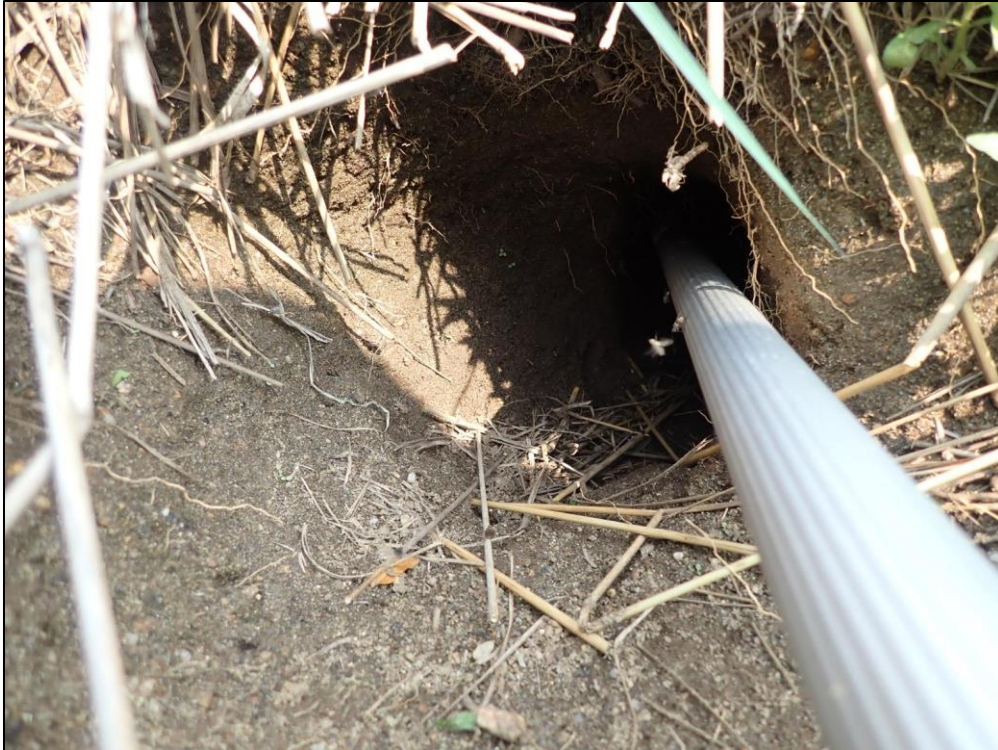
5016: Close-up of the Animal Hole. Evidence of nuisance animals (Routine Maintenance Needed).
