Underground Facility Inspection Report					
Facility Name	Manassas Station Redev	Facility ID	STMF0091651	Type of Inspection: Initial Inspection	
Location	Lat: 38.908792 Long: -77.474171	Watershed	Rocky Branch-Broad Run	Previous 48 Hour Precipitation Total	0.35"
Materials available for inspection	N/A	Owner Notification Date		Owners/ Owner's Representative	Prince Properties, LLC
Inspectors	gky_mfreeman	Date of Inspection	6/29/2023	Date of Last Inspection	N/A
Overall Condition Score					
	1	Adequate	No deficiencies identified.		
	2	Monitor	No maintenance may be needed at the time, but might become an issue in the future. Will revisit next inspection. Examples include minor erosion, small sediment accumulation, or small structural issues of facility components.		
3	3	Routine Maintenance Needed	Facility is functional but preventative maintenance is required. Examples includes minor structural damage, minor erosion, or trash/debris removal.

Facility ID: STMF0091651
Facility Name: Manassas Station Redevelopment

Inspection Date: 06/27/2023

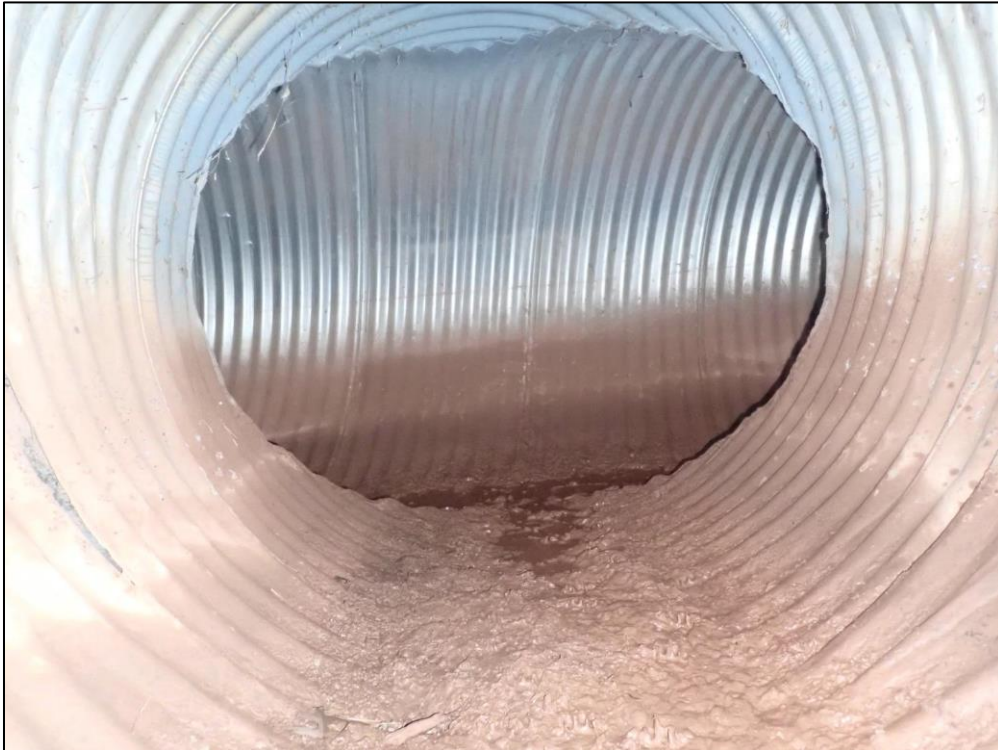
4552: Inside Manhole 1, looking upstream toward the Southern detention pipe joint. Buildup of trash, debris, and sediment (Monitor).

Score	Description	Comment(s) / Corrective Action(s)	Reference Image
Outlet			
2	Buildup of trash, debris, and sediment	Trash, debris, and sediment are beginning to accumulate in the facility's control structure. Monitor this situation to ensure a blockage doesn't occur in the future.	4552, 4553, 4561, 4565, 4566, 4567
3	Damage to outlet pipe or structure	The walls around the outfall pipes in the structure are not sealed. These areas need to be parged with concrete to seal the connections.	4572, 4576
1	Signs of erosion around outlet		
1	Orifice is clogged		
1	Leaking or failing joints		
1	Control Value is functional

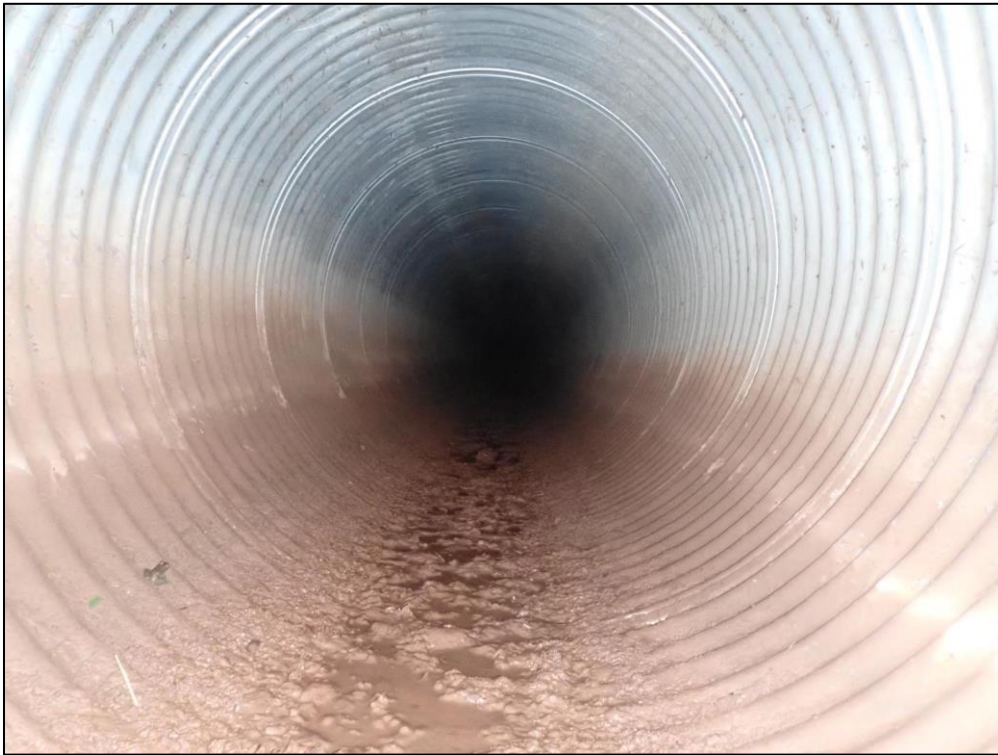
4553: Inside Manhole 1, looking downstream along the middle detention pipe. Buildup of trash, debris, and sediment (Monitor).

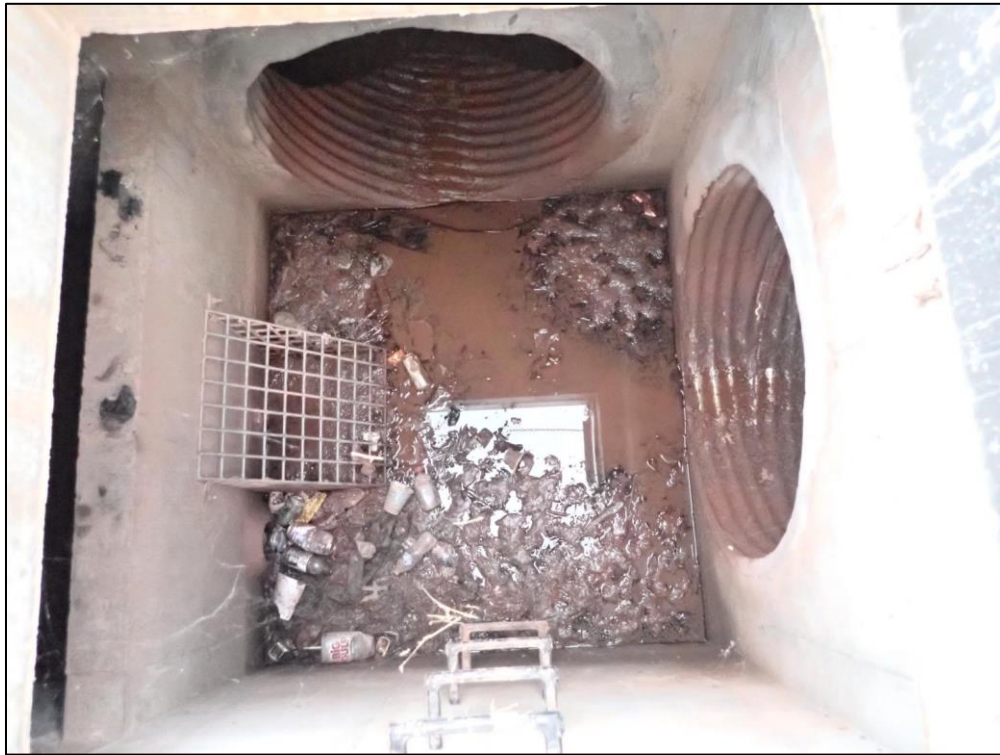
4561: Inside the upstream end of Control Structure 12. Buildup of trash, debris, and sediment (Monitor).

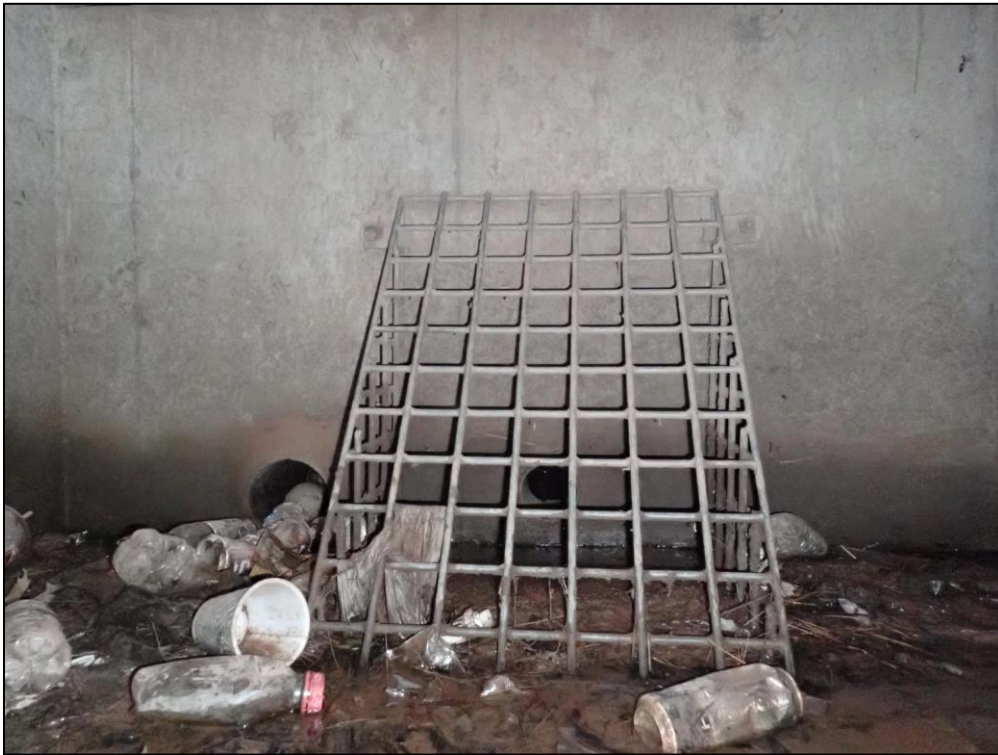
4565: Inside the upstream end of Control Structure 12, looking toward the trash rack. Buildup of trash, debris, and sediment (Monitor).

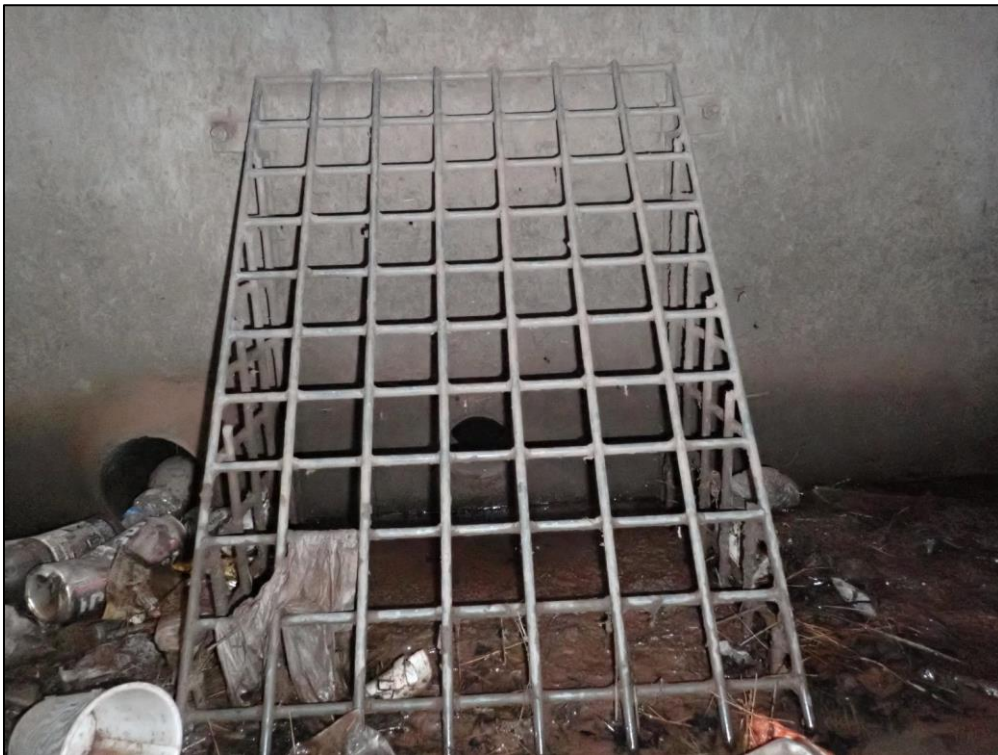
4566: Inside the upstream end of Control Structure 12, looking toward the low-flow orifice. Buildup of trash, debris, and sediment (Monitor).

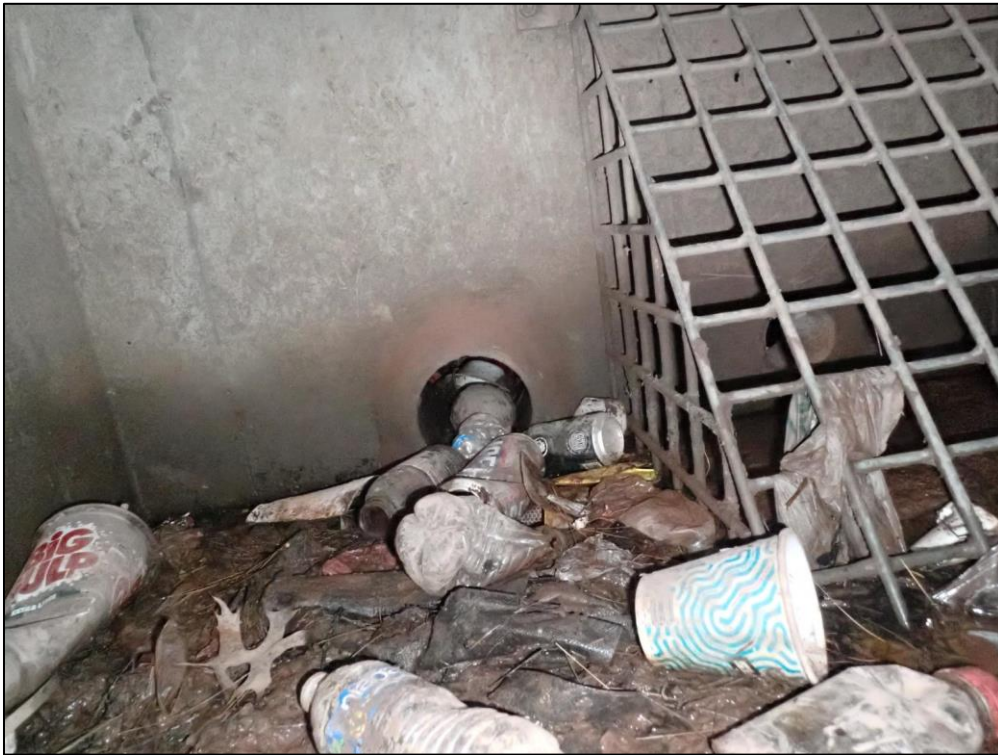
4567: Inside the upstream end of Control Structure 12, looking toward the dewatering valve orifice.
Buildup of trash, debris, and sediment (Monitor).
