Wet Pond Inspection Report									
Facility Name	Sumner Pond		Facility ID	STMF0090056	Type of Inspection: Initial Inspection				
Location	Lat: 38.774472 Long: -77.477521		Watershed	Middle Bull Run	Previous 48 Hour Precipitation Total	0.00"			
Materials available for inspection	N/A		Owner Notification Date	N/A	Owners/Owner's Representative	City of Manassas			
Inspector	gky_n	nfreeman	Date of Inspection	6/27/2023	Date of Last Inspection	5/19/2022			
	Overall Condition Score								
	1	Adequate		No deficiencies identified.					
	2	Monitor		No maintenance may be needed at the time, but might become an issue in the future. Will revisit next inspection. Examples include minor erosion, small sediment accumulation, or small structural issues of facility components.					
3	3	Routine Maintenance Needed		Facility is functional but preventative maintenance is required. Examples includes vegetation management, minor erosion, or trash/debris removal.

Facility ID: STMF0090056 Inspection Date: 06/27/2023

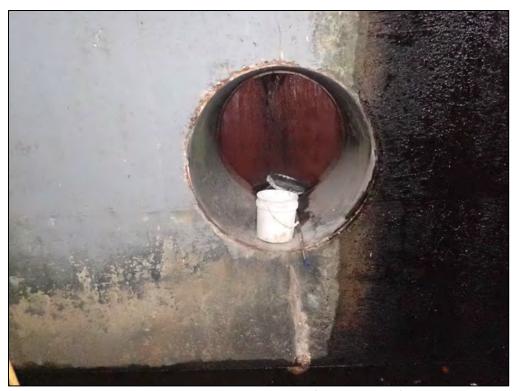
4352: Inside Control Str., looking toward dewatering valve orifice. Buildup of trash, debris, and sediment (Routine Maintenance Needed).

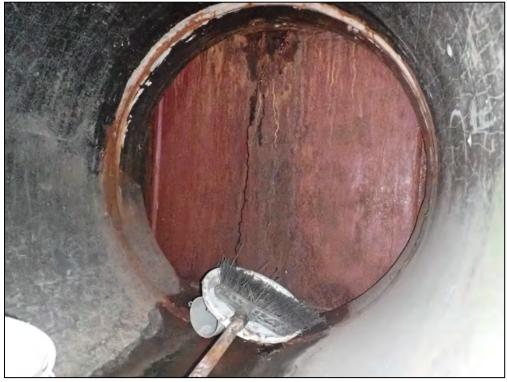
4355: Inside Control Str., closeup of dewatering valve orifice. Buildup of trash, debris, and sediment (Routine Maintenance Needed).

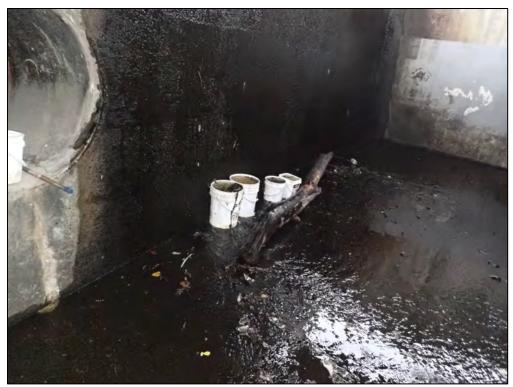
4357: Inside Control Str., Buildup of trash, debris, and sediment (Routine Maintenance Needed).

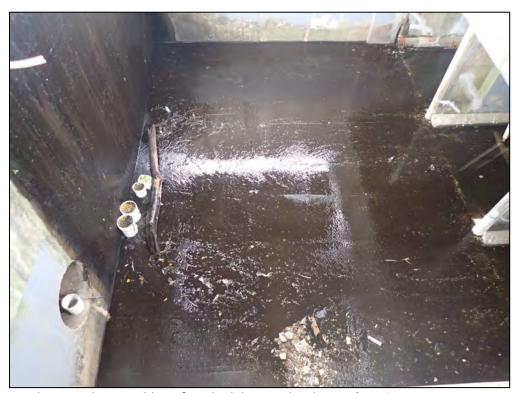
4358: Inside Control Str., Buildup of trash, debris, and sediment (Routine Maintenance Needed).

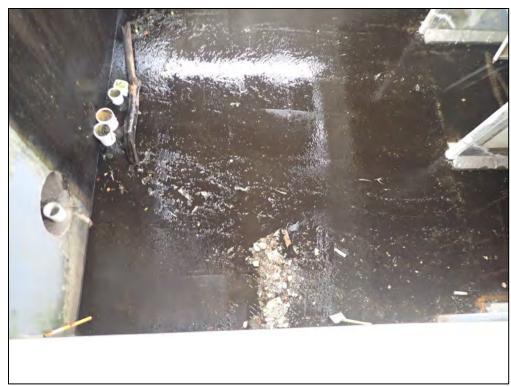
4359: Inside Control Str., Buildup of trash, debris, and sediment (Routine Maintenance Needed).

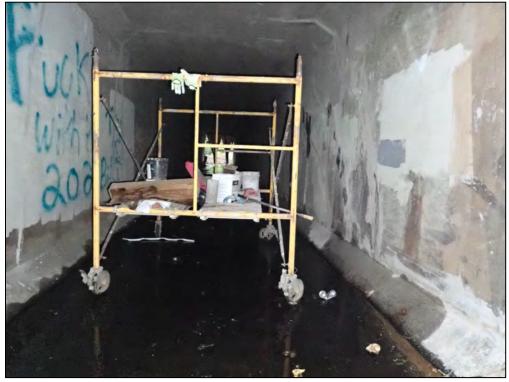
4360: Inside Control Str., looking downstream, North pipe. Buildup of trash, debris, and sediment (Routine Maintenance Needed).

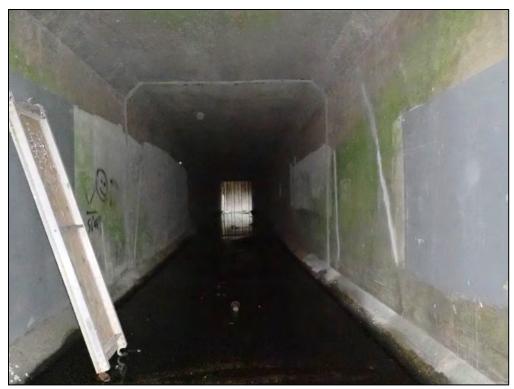
4361: Inside Control Str., looking downstream, middle pipe. Buildup of trash, debris, and sediment (Routine Maintenance Needed).

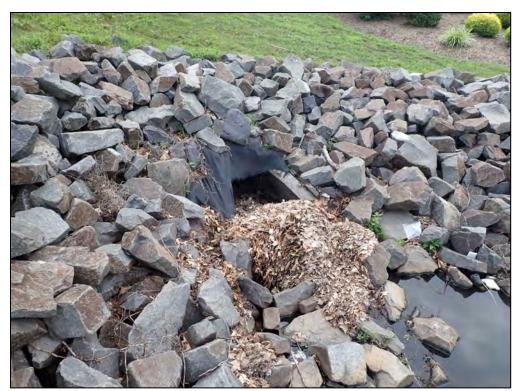
4379: Inflow 2, front. Buildup of trash, debris, and sediment (Routine Maintenance Needed).

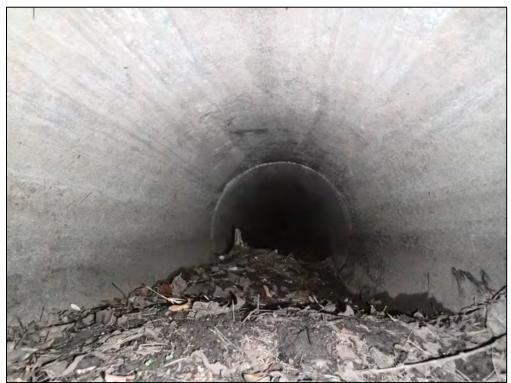
4380: Inside Inflow 2. Buildup of trash, debris, and sediment (Routine Maintenance Needed).

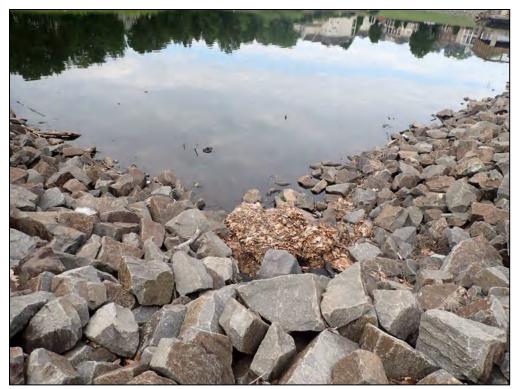
4381: From Inflow 2, looking downstream. Buildup of trash, debris, and sediment (Routine Maintenance Needed).

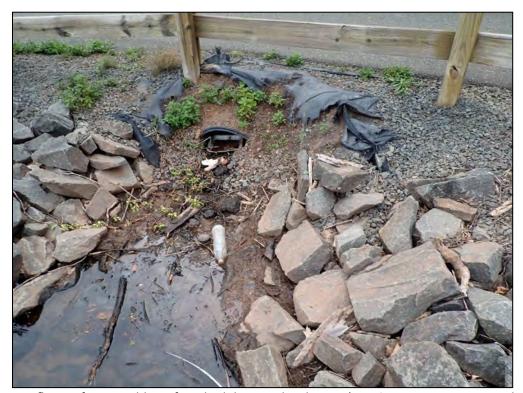
4384: Inflow 3, front. Buildup of trash, debris, and sediment (Routine Maintenance Needed).

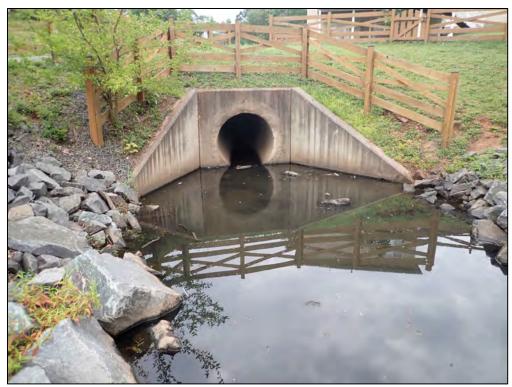
3	Woody growth around inlet structure	Inflow 4 (1, 2-6" tree)	4391						
1	Evidence of nuisance animals								
4	Damage to inlet pipe or structure	Inflow 3, the pipe is breached and bedding material is visible. Inflow 7, the pipe appears to be collapsed.	4385, 4411

4391: Inflow 4, front. Woody growth around inlet structure (Routine Maintenance Needed).

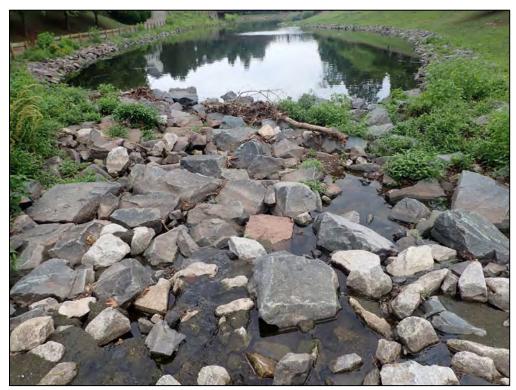
4396: From Inflow 5, looking downstream. Buildup of trash, debris, and sediment (Routine Maintenance Needed).

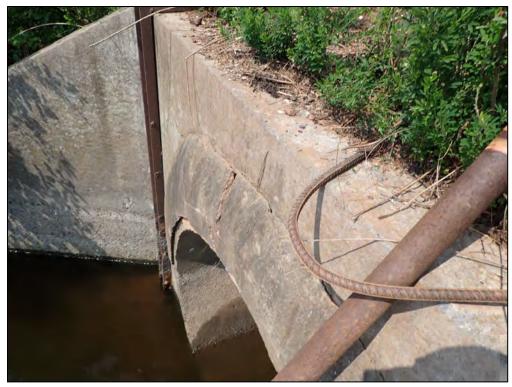
1	Evidence of nuisance animals								
3	Damage to inlet pipe or structure	Spalling/deterioration at Inflow 2 and Inflow 6.	4827, 4828, 4875

4828: Inflow 2, closeup. Damage to inlet pipe or structure, Spalling (Routine Maintenance Needed).

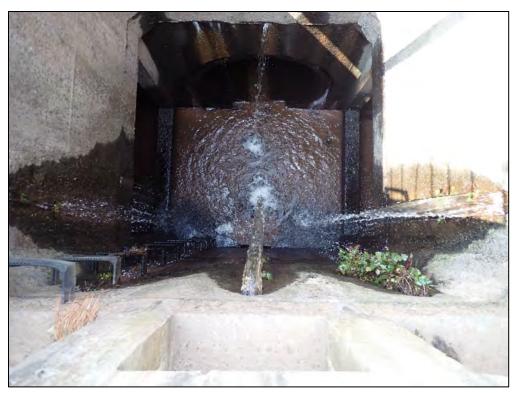
4839: Inside Control Str., closeup. BMP device is deteriorated, misaligned, and/or damaged (Immediate Repair Needed)

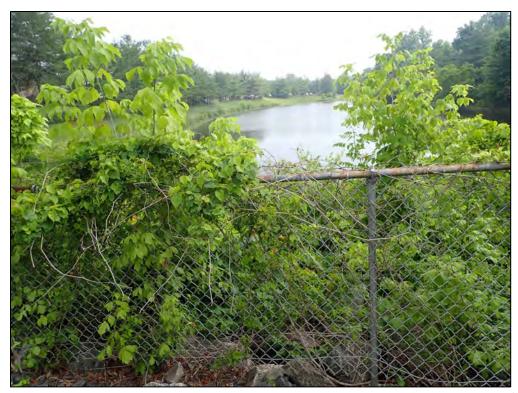
4855: Emergency Spillway, overall. Shrubbery, low growing vegetation, and/or vine material growing on embankment (Routine Maintenance Needed).

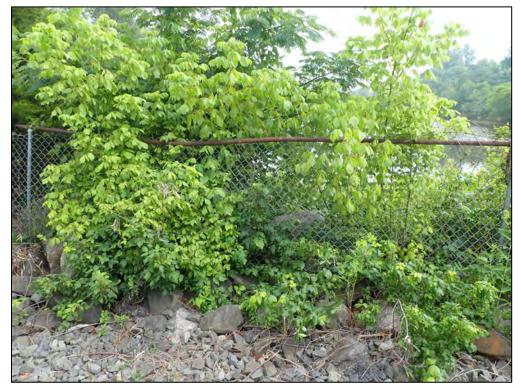
4856: From Emergency Spillway, looking upstream. Shrubbery, low growing vegetation, and/or vine material growing on embankment (Routine Maintenance Needed).

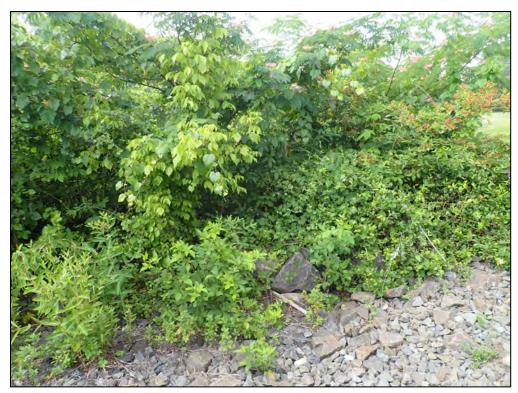
4857: From Emergency Spillway, looking upstream. Shrubbery, low growing vegetation, and/or vine material growing on embankment (Routine Maintenance Needed).

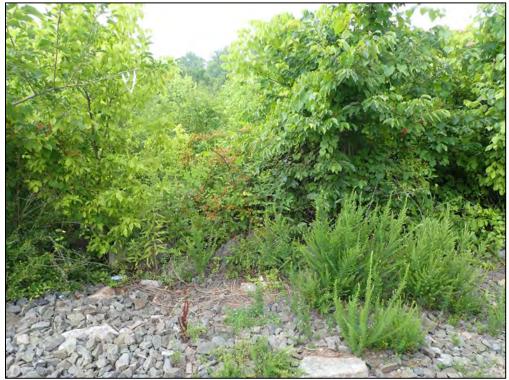
4858: From Emergency Spillway, looking downstream. Shrubbery, low growing vegetation, and/or vine material growing on embankment (Routine Maintenance Needed).

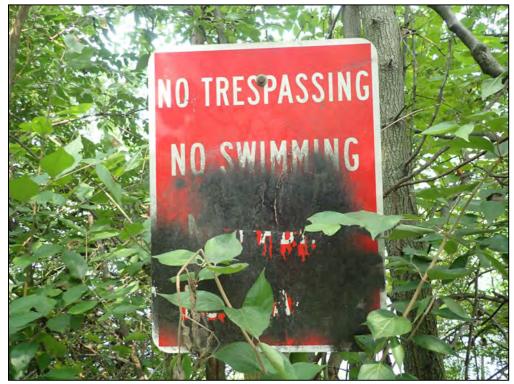
4865: Sign, closeup. Missing or damaged safety signage (Routine Maintenance Needed).

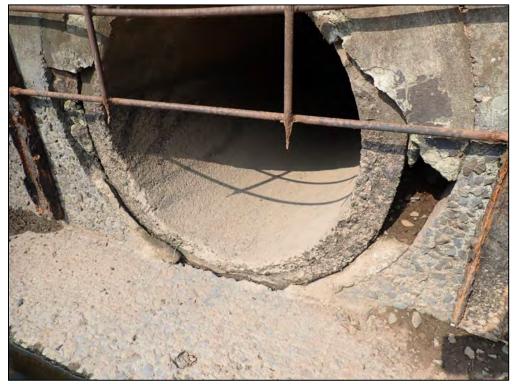
4875: Inflow 6, closeup. Damage to inlet pipe or structure (Routine Maintenance Needed).

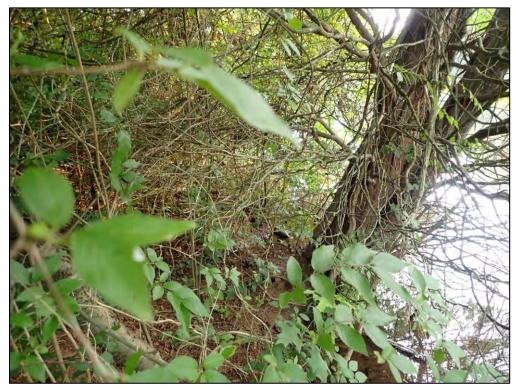
1	inlet							
		Trees observed growing adjacent to Inflow 2						
3	Woody growth around inlet structure	(6, 2-6" trees, 2, 7-12" trees, 1, 13-24" tree),	4895, 4896, 4897, 4898,					
		Inflow 3 (3, 2-6" tree and 1, 13-24" tree), and	4900, 4908					
1	Evidence of nuisance animals	Inflow 5 (1, 13-24" tree).						
т.	Evidence of fluisance affillidis	Challing was absorved on the nine force of						
3	Damage to inlet pipe or structure	Spalling was observed on the pipe face of Inflow 3. (1 Bag of Concrete)	4901

4895: Inflow Structure EX. ES-1, Overall. Woody growth around inlet structure (Routine Maintenance Needed).

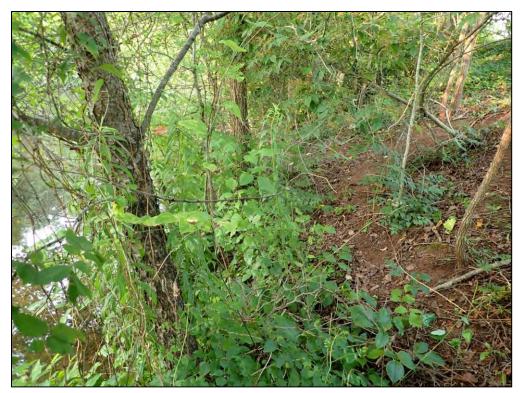
4896: Inflow Structure EX. ES-1, Overall. Woody growth around inlet structure (Routine Maintenance Needed).

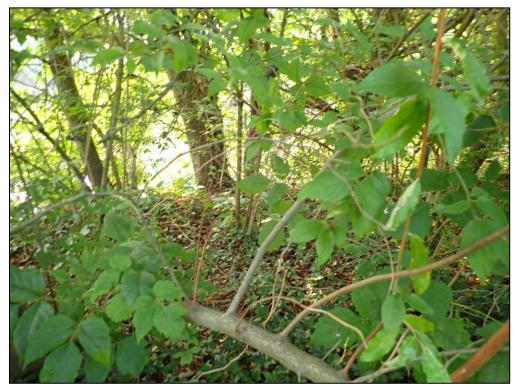
4897: Inflow Structure EX. ES-1, Overall. Woody growth around inlet structure (Routine Maintenance Needed).

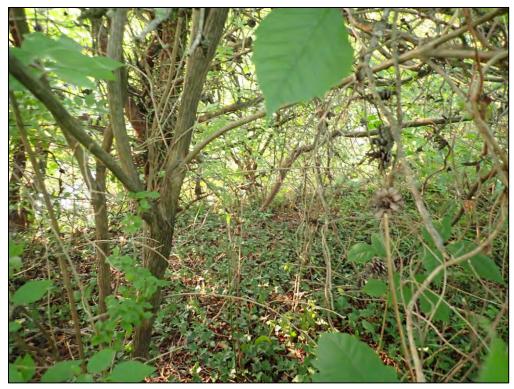
4898: Inflow Structure EX. ES-1, Overall. Woody growth around inlet structure (Routine Maintenance Needed).

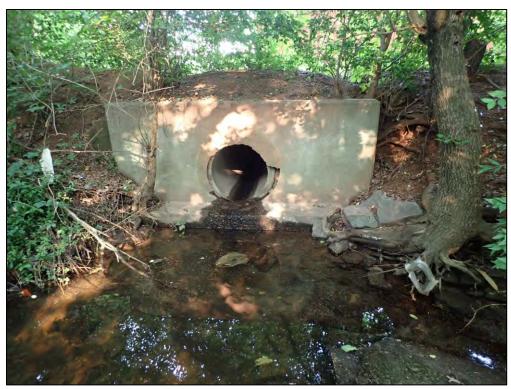
4900: Inflow Structure EX. EW-1, front. Woody growth around inlet structure (Routine Maintenance Needed).

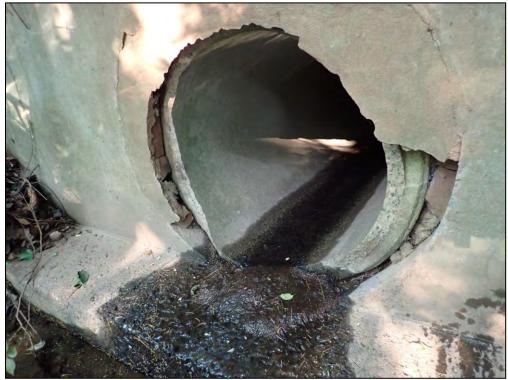
4901: Inflow Structure EX. EW-1, closeup. Damage to inlet pipe or structure, Spalling (Routine Maintenance Needed).

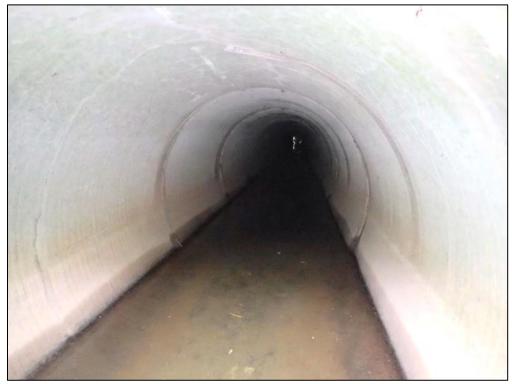
Inflow 7, the pipe appears to be at least partially collapsed and obstructing flow. Immediate repair is needed at this location.

4917: Inside Inflow 7.

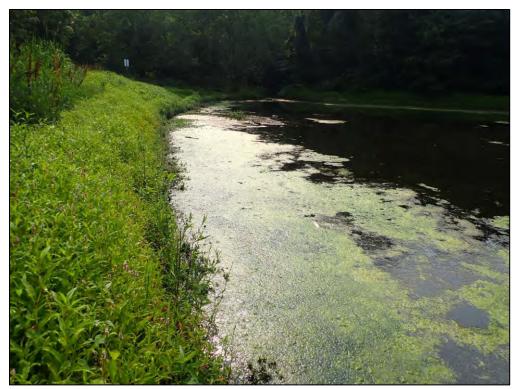
4921: Impoundment area, Overall. The ponding area shows signs of poor health (i.e. nutrient overload, excess aquatic vegetation, or turbidity) (Monitor).

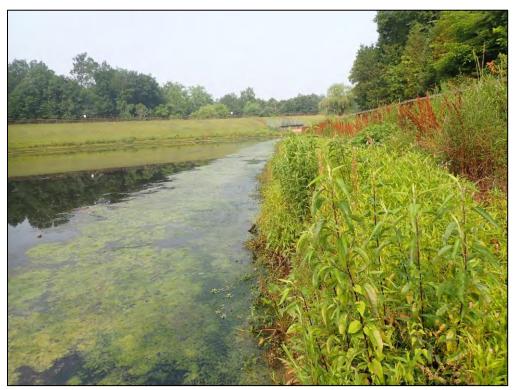
4922: Impoundment area, Overall. The ponding area shows signs of poor health (i.e. nutrient overload, excess aquatic vegetation, or turbidity) (Monitor).

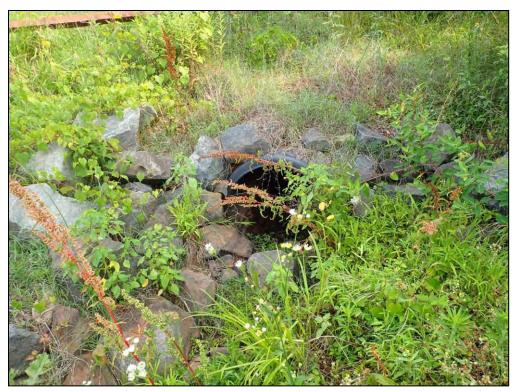
4938: Inflow 1, front. Overgrown Vegetation (Routine Maintenance Needed).

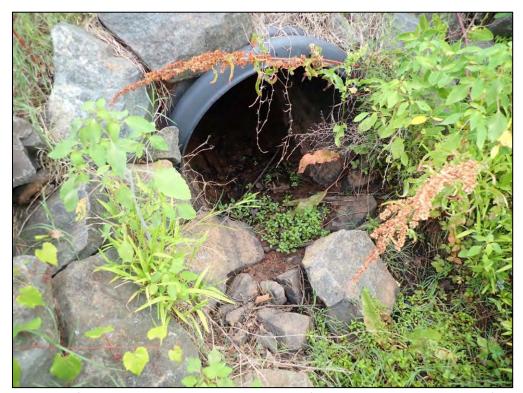
4939: Inflow 1, closeup. Overgrown Vegetation (Routine Maintenance Needed).

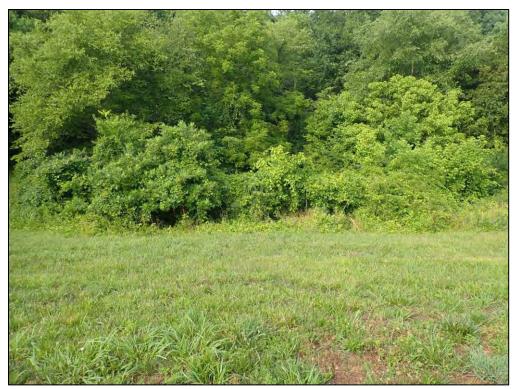
<u> </u>		adjacent to the trash rack (13 Cubic Feet).	4920, 4927
	Princ	ipal Spillway Pipe	
1	Spillway is blocked by debris or sediment		
1	Evidence of leaking joints		
	One or more sections of the pipe have settled		
1	to the point that it threatens the integrity of		
	the dam		
	<u> </u>	ent Area and Side Slopes	
1	Buildup of trash and debris		
1	Silt and sedimentation buildup		
	Ponding area is showing signs of poor health	An Algal Bloom was observed at the water's	
2	(i.e. nutrient overload, excess aquatic	edge around most of the pond.	4921, 4922, 4955, 4956
	vegetation, or turbidity)	g .	
1	Signs of erosion along shoreline		
1	Sparse vegetation or erosion		
1	Evidence of nuisance animals		
	Outfall St	tructure and Channel	
1	Outflow is causing undercutting or erosion		
1	Outfall structure has separated more than three inches from principal spillway barrel		
1	Outfall structure is damaged or rusting		
3	Woody vegetation growing within 5' of outlet and barrel	4, 2-6" trees observed growing adjacent to the outfall structure on the back slope of the dam.	4942, 4943

4942: Outfall Structure A, From dam. Woody vegetation growing within 5' of outlet and barrel (Routine Maintenance Needed).

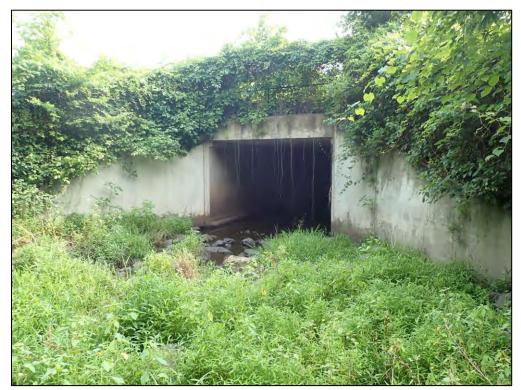
4943: Outfall Structure A, front. Woody vegetation growing within 5' of outlet and barrel (Routine Maintenance Needed).

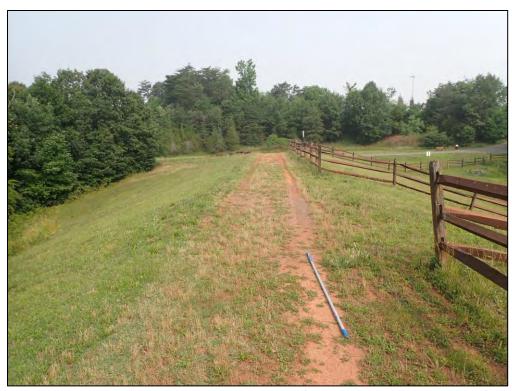
4946: Dam overall. Sparse vegetative coverage (Routine Maintenance Needed).

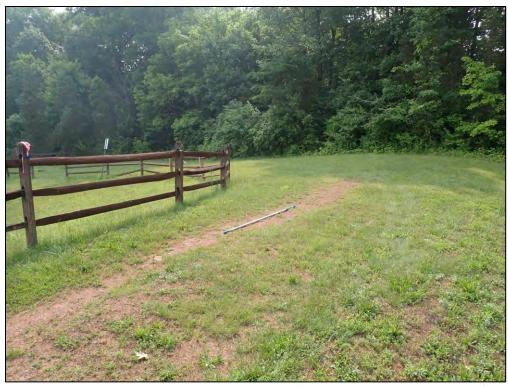
4948: Dam overall. Sparse vegetative coverage (Routine Maintenance Needed).

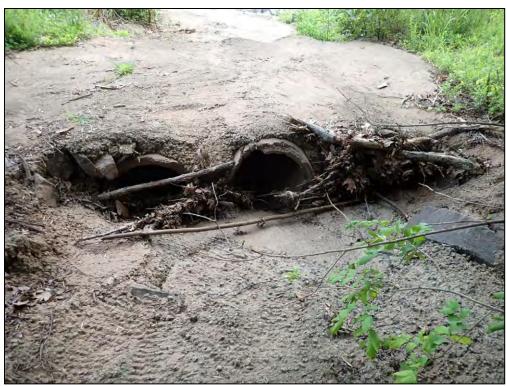
4954: Inflow 2, overall. Buildup of trash, debris, and sediment (Routine Maintenance Needed).

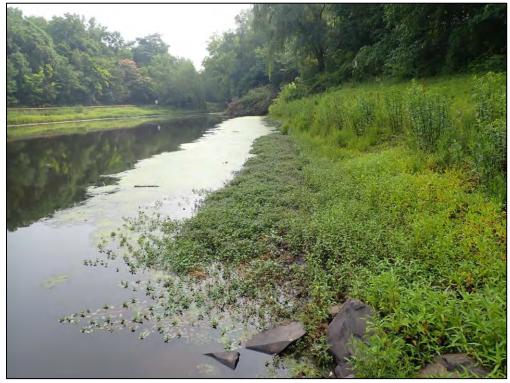
4955: Impoundment area, overall. The ponding area shows signs of poor health (i.e. nutrient overload, excess aquatic vegetation, or turbidity) (Monitor).

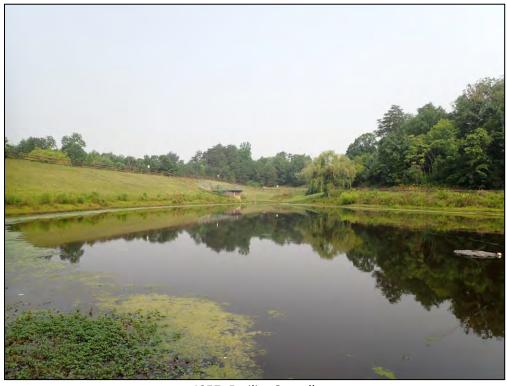
4956: Impoundment area, overall. The ponding area shows signs of poor health (i.e. nutrient overload, excess aquatic vegetation, or turbidity) (Monitor).

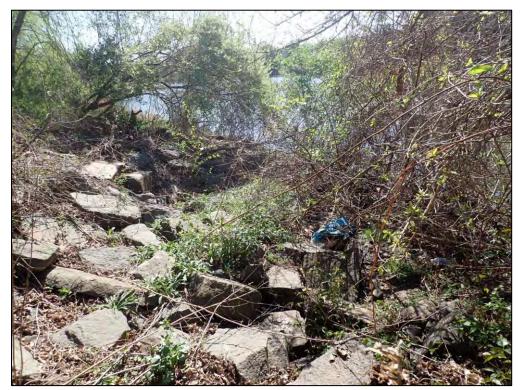
9573: From Inflow Structure EX. 19, looking downstream. Buildup of trash, debris, and sediment (Routine Maintenance Needed).

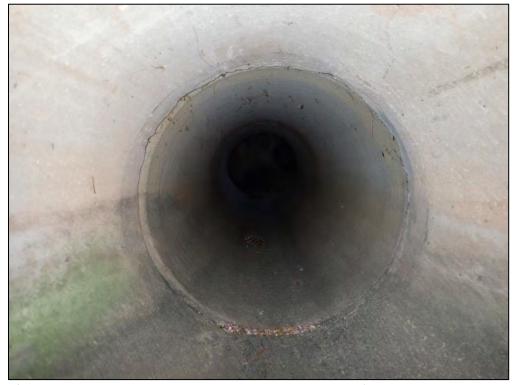
inlet	Cubic Feet).	3333		
1	Woody growth around inlet structure				
1	Evidence of nuisance animals				
		Inflow 4, spalling (2 bags of concrete) and			
		joint separation (6.28 Linear Feet), Inflow 6,	9593, 9594, 9600, 962 9632		
3	Damage to inlet pipe or structure	joint separation (6.28 Linear Feet), Inflow			
		Structure 9, joint separation (7.85 Linear			
		Feet).

9594: Inflow 4. Damage to inlet pipe or structure, Joint separation (Routine Maintenance Needed).

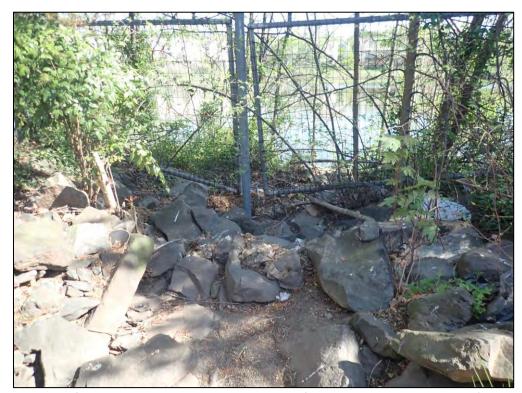
9596: From Inflow 4, looking downstream. Buildup of trash, debris, and sediment (Monitor).

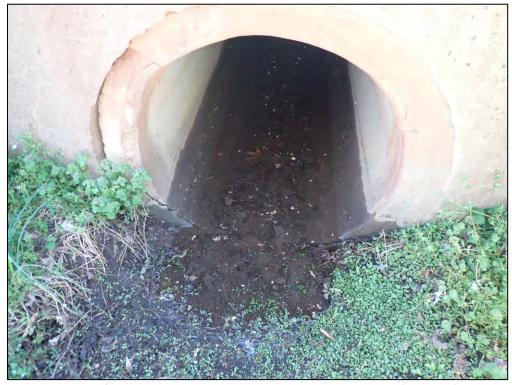
9600: Inflow 5, closeup. Damage to inlet pipe or structure (Monitor).

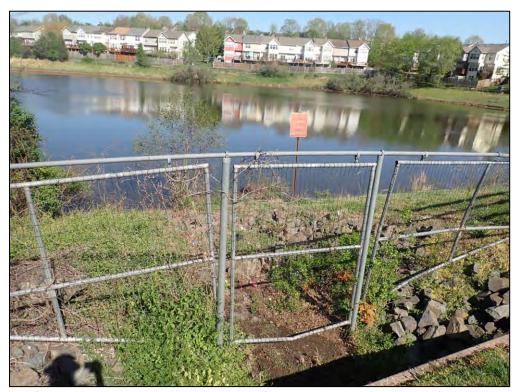
9602: From Inflow 5, looking downstream. Buildup of trash, debris, and sediment (Routine Maintenance Needed).

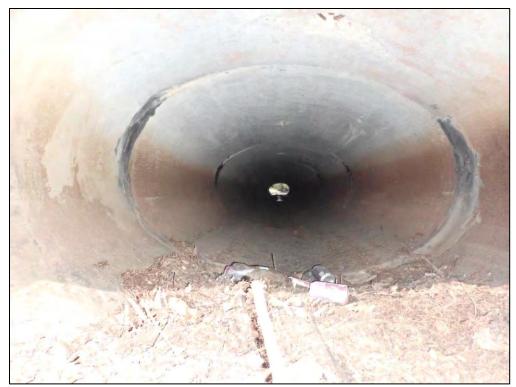
9612: Outfall Structure 2, front. Buildup of trash, debris, and sediment around the outfall or in the channel (Routine Maintenance Needed).

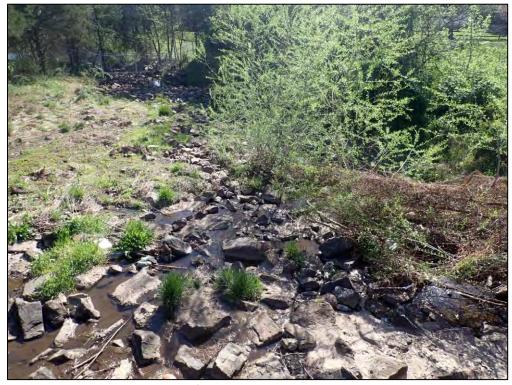
9617: Outfall Structure 2, front. Buildup of trash, debris, and sediment around the outfall or in the channel (Routine Maintenance Needed).

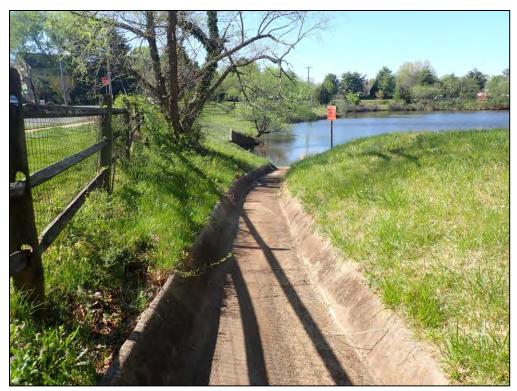
9624: Inside Inflow 6. Damage to inlet pipe or structure (Routine Maintenance Needed).

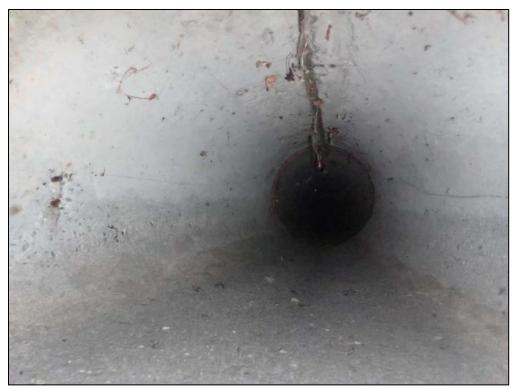
3	Damage to inlet pipe or structure	Spalling observed at Inflow 3 (1 bag of concrete).	9520, 9522

9521: Inside Inflow 3.

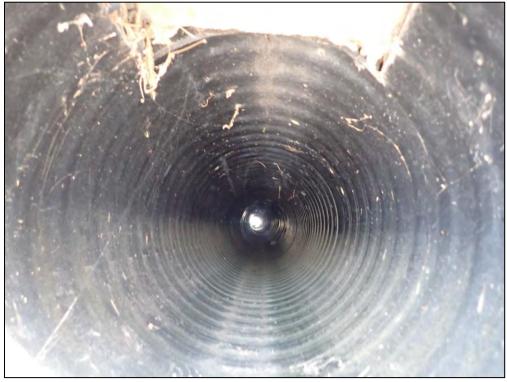
9475: Inflow 1, front. Damage to inlet pipe or structure (Routine Maintenance Needed).

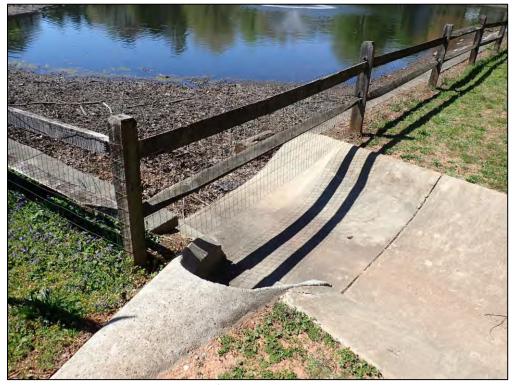
9481: Inside Inflow 3. Damage to inlet pipe or structure (Monitor).

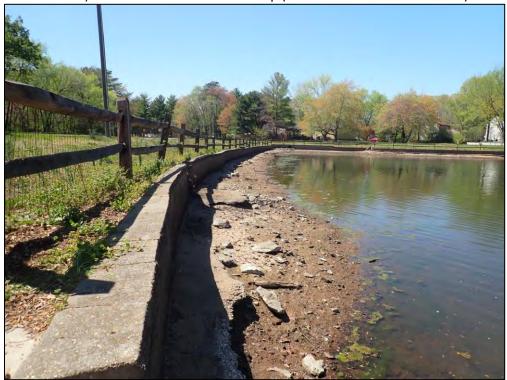
9483: Impoundment area, Sediment 1 overall. Buildup of trash and debris (Routine Maintenance Needed). Silt and sedimentation buildup (Routine Maintenance Needed).

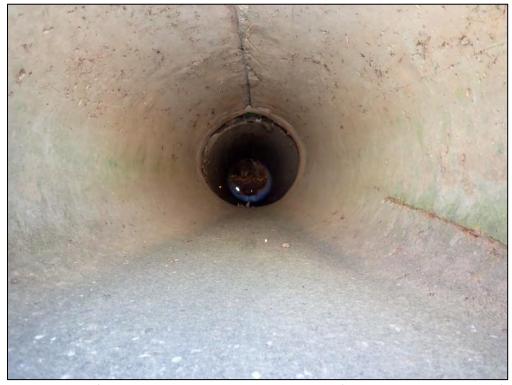
9485: Inflow 4, front. Damage to inlet pipe or structure (Monitor).

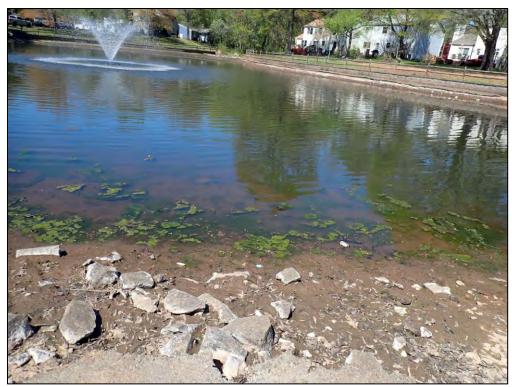
9486: Inside Inflow 4. Damage to inlet pipe or structure (Immediate Repair Needed).

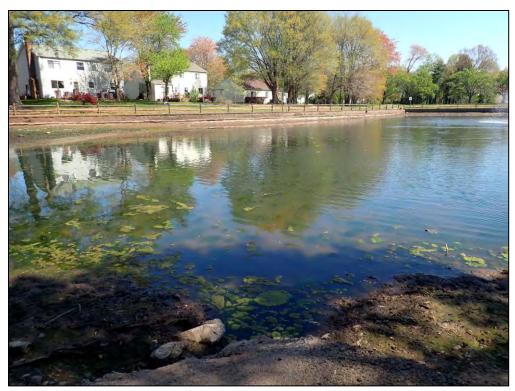
9498: Inside Inflow Structure 3. Damage to inlet pipe or structure (Monitor).

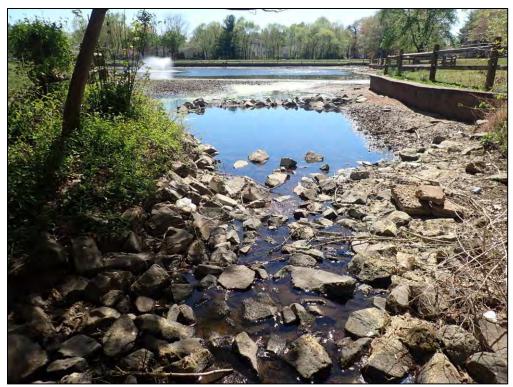
9500: Looking upstream along Inflow 9. Buildup of trash, debris, and sediment (Monitor).

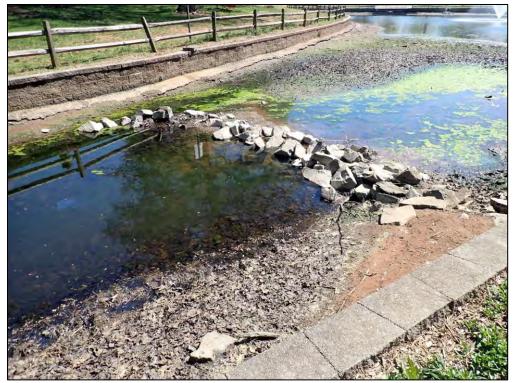
9502: Facility overall. Silt and sedimentation buildup (Routine Maintenance Needed).

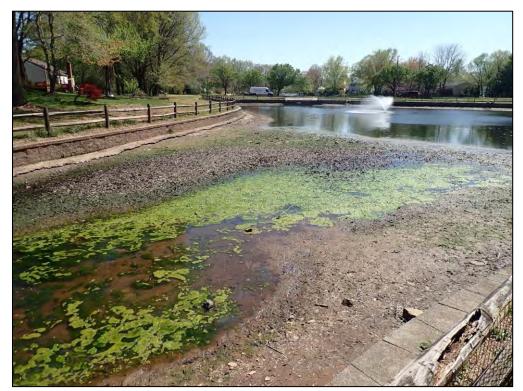
9507: Facility overall. Silt and sedimentation buildup (Routine Maintenance Needed).

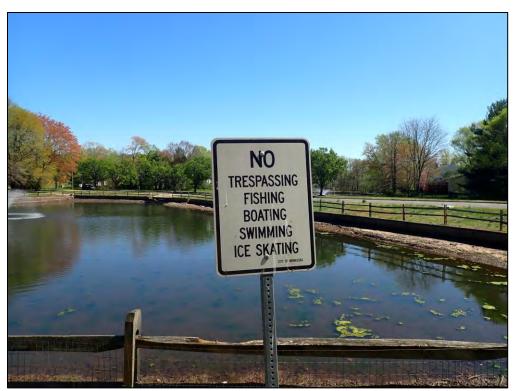
9508: Impoundment area, Sediment 3 overall. Silt and sedimentation buildup (Routine Maintenance Needed).

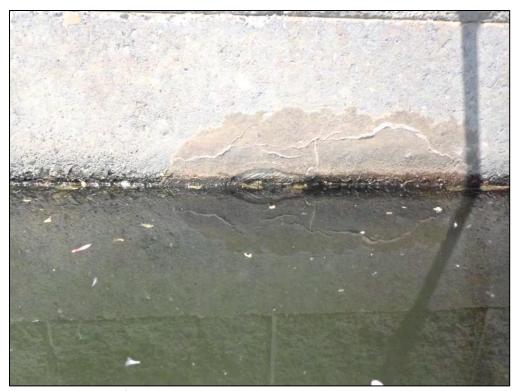
9513: Outfall Structure 12, looking toward the middle Eastern PSP.

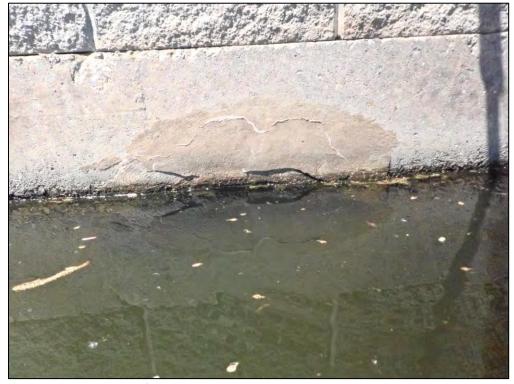
9514: Outfall Structure 12, looking toward the Eastern PSP.

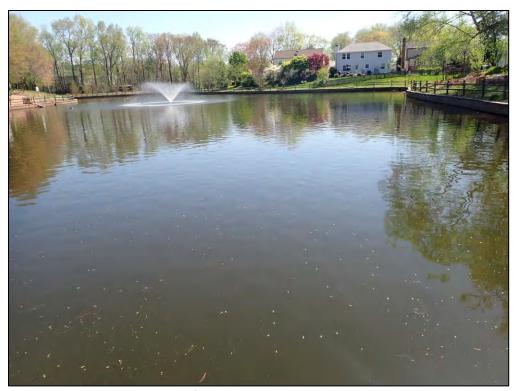
9515: From Outfall Structure 12, looking downstream.

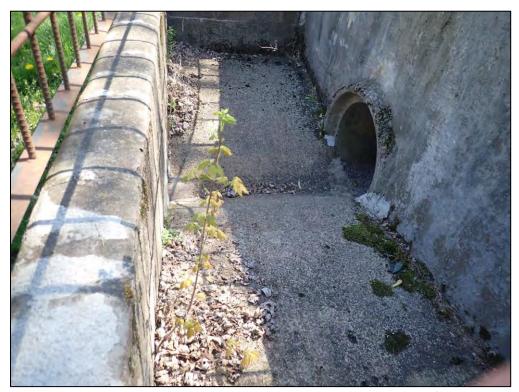
9391: Inside Control Structure 16. Trash, debris, or other material in BMP device (Routine Maintenance Needed).

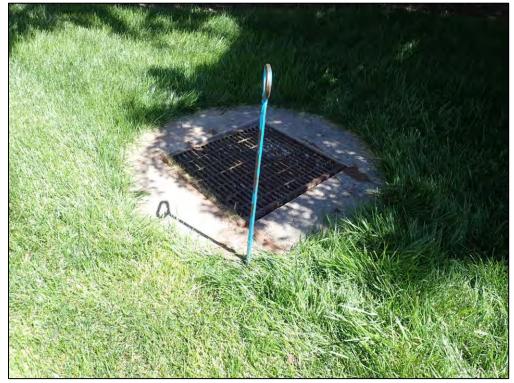
9411: Outfall Structure 54, overall. Signs of erosion around outfall or channel (Routine Maintenance Needed).

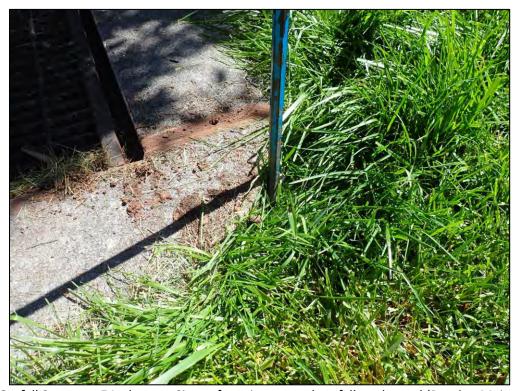
9412: Outfall Structure 54, closeup. Signs of erosion around outfall or channel (Routine Maintenance Needed).

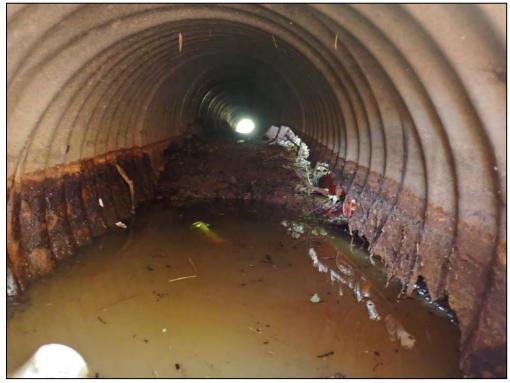
The bottom of the PSP has rusted out, the PSP is mostly blocked, and there is significant erosion on the dam adjacent to both sides of the PSP. The PSP Replacement was not included in the Cost Estimate. City of Manassas personnel were notified of these issues on the day of the inspection (04/13/2023).

9421: Control Structure 1A, inside. Trash, debris, or other material in BMP device (Immediate Repair Needed). Extreme Invert Erosion Observed (Immediate Repair Needed).

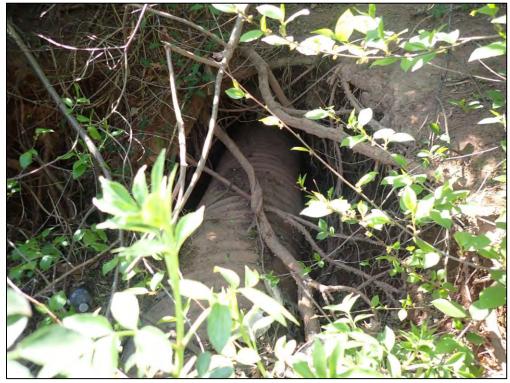
9423: Control Structure 1A, closeup. Signs of erosion, settlement, piping, or slope slippage (Immediate Repair Needed).

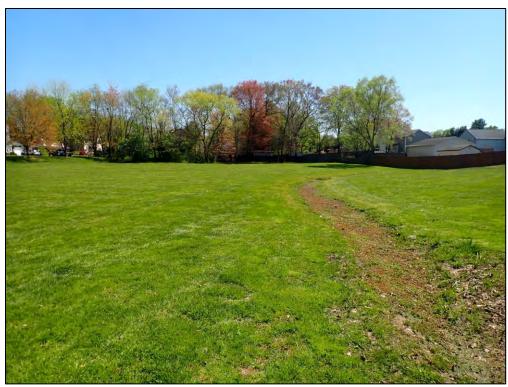
9425: Facility Overall.

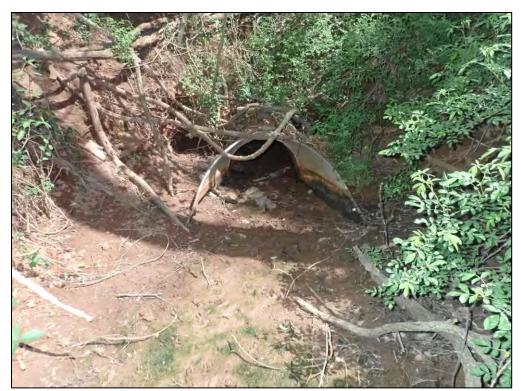
9429: Dam Overall. Woody vegetation on the embankment (Routine Maintenance Needed).

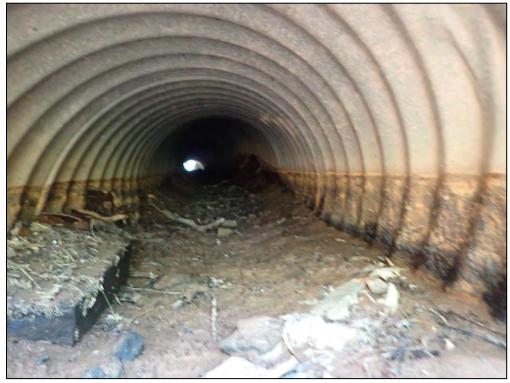
1	Sections of low-flow dich are cracked or								
1	showing signs of undercutting Sparse vegetation or erosion								
1	Evidence of nuisance animals								
		tructure and Channel							
1	Outflow is causing undercutting or erosion								
1	Outfall structure has separated more than three inches from principal spillway barrel								
А	<u> </u>								
1	Outfall structure is damaged or rusting Woody vegetation growing within 5' of outlet and barrel								
3	Buildup of trash, debris, and sediment around outfall or in channel	Trash, debris, and sediment are accumulating in and adjacent to Outfall Structure 1B (1.33 CY).	9430, 9431						
1	Signs of erosion around outfall or channel

9430: Outfall Structure 1B, front. Buildup of trash, debris, and sediment around the outfall or in the channel (Routine Maintenance Needed).

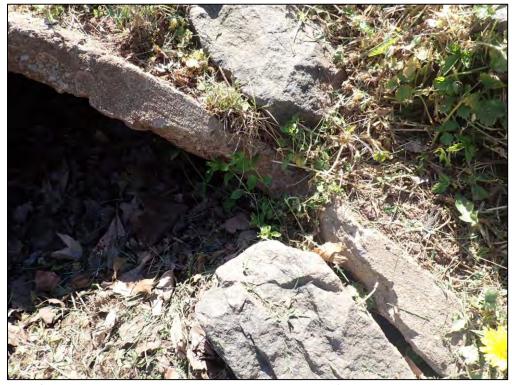
9436: Inside Inflow 1. Joint Separation (Immediate Repair Needed). Buildup of trash, debris, and sediment (Immediate Repair Needed).

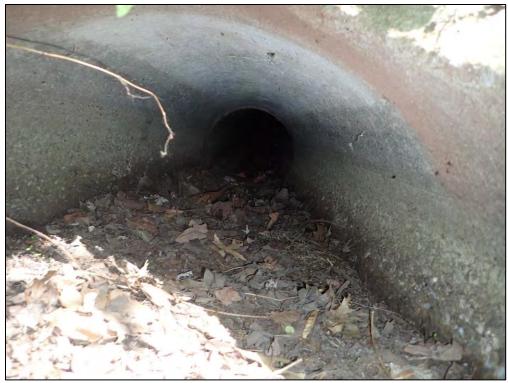
9439: Inflow Structure 11, front. Buildup of trash, debris, and sediment (Routine Maintenance Needed).

Woody growth around inlet structure (Routine Maintenance Needed).

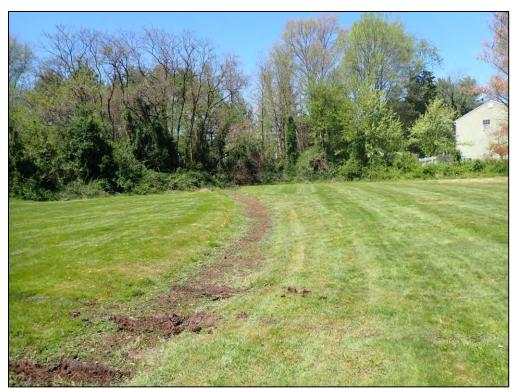
1	and/or damaged								
1	BMP device is missing								
1	Low-level gate drain is accessible and operational. Drain has been exercised in last three years.								
4	Trash, debris, or other material in BMP device	Trash, debris, and sediment are nearly completely blocking the PSP (4.3 CY).	9419, 9420, 9421						
	Princi	ipal Spillway Pipe							
1	Spillway is blocked by debris or sediment								
4	Evidence of leaking joints	The bottom of the PSP has entirely rusted away.	9421						
1	One or more sections of the pipe have settled to the point that it threatens the integrity of								
	the dam	ent Area and Side Slopes							
1	Buildup of trash and debris								
1	Silt and sedimentation buildup								
1	Ponding area is showing signs of poor health (i.e. nutrient overload, excess aquatic vegetation, or turbidity)								
1	Signs of erosion along shoreline								
3	Low-flow ditch is clogged with sediment/debris	The trickle ditch is clogged with sediment (61 CY).	9442, 9443, 9444

9443: Looking downstream along the Trickle Ditch toward Control Structure 1A. Low-flow ditch is clogged with sediment/debris (Routine Maintenance Needed).

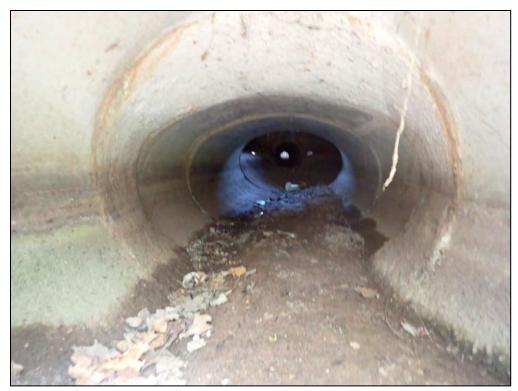
9445: Inflow 3, front. Woody growth around inlet structure (Routine Maintenance Needed). Buildup of trash, debris, and sediment (Routine Maintenance Needed).

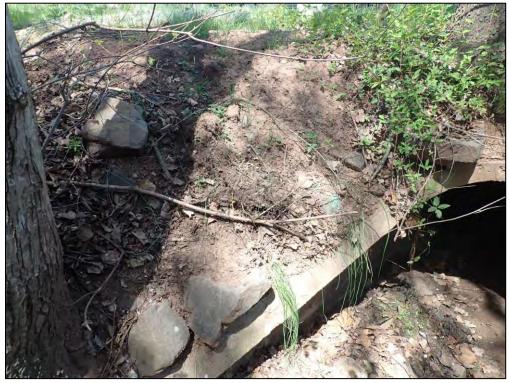
9446: Inside Inflow 3. Buildup of trash, debris, and sediment (Routine Maintenance Needed).

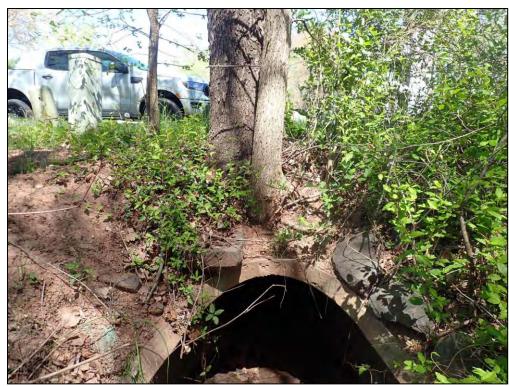
9447: Inflow 3, closeup. Evidence of erosion or undermining around the inlet (Routine Maintenance Needed).

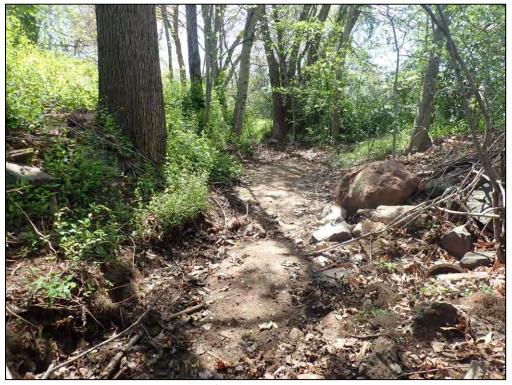
9448: Inflow 3, closeup. Woody growth around inlet structure (Routine Maintenance Needed).

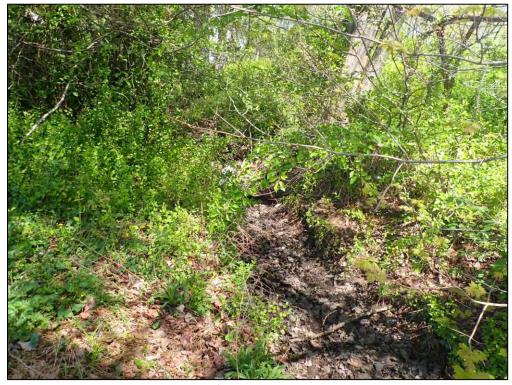
9450: Inflow 3, closeup. Woody growth around inlet structure (Routine Maintenance Needed).

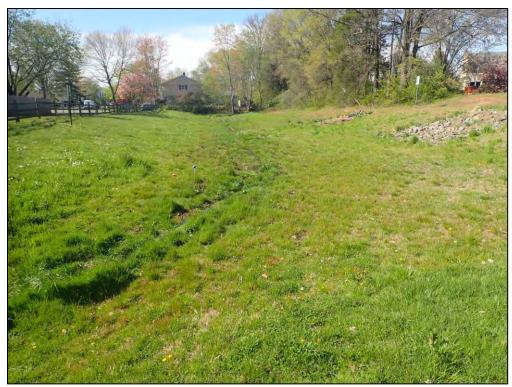
2867: Facility Overall. Low-flow ditch is clogged with sediment/debris (Routine Maintenance Needed).

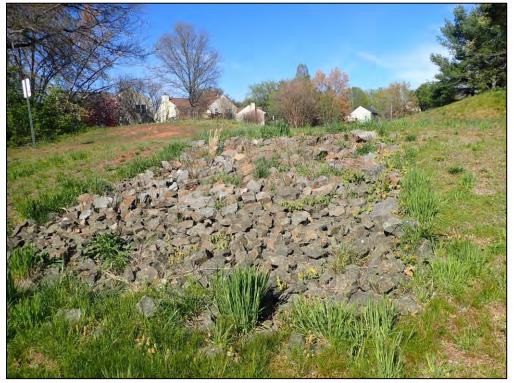
2868: Looking upstream along Inflow 1. Buildup of trash, debris, and sediment (Routine Maintenance Needed).

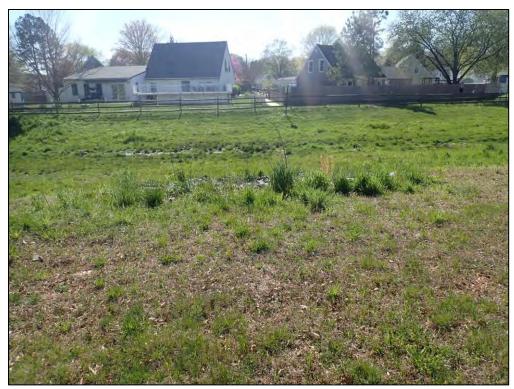
2869: From Inflow 1, looking downstream. Buildup of trash, debris, and sediment (Routine Maintenance Needed).

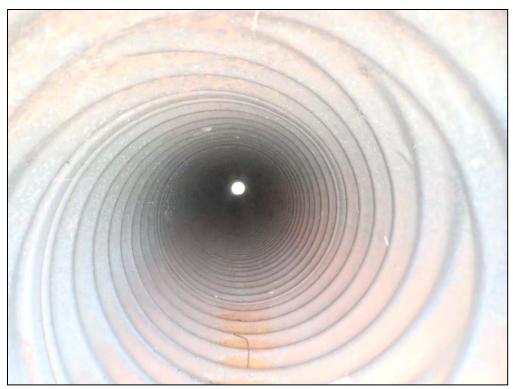
The apron and pipe of Inflow 2 are beginning to rust. The pipe in Inflow Structure E-3 has almost completely rusted away.

2872: Inflow 2, front. Damage to inlet pipe or structure (Monitor).

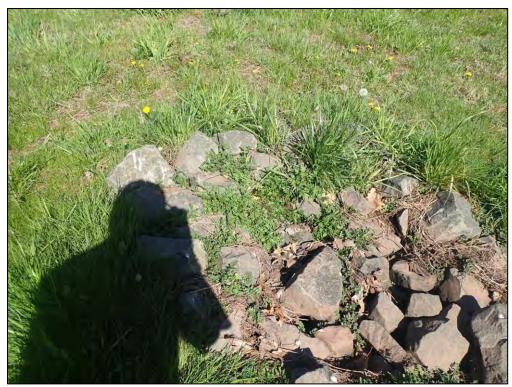
2874: From Inflow 2, looking downstream. Buildup of trash, debris, and sediment (Routine Maintenance Needed).

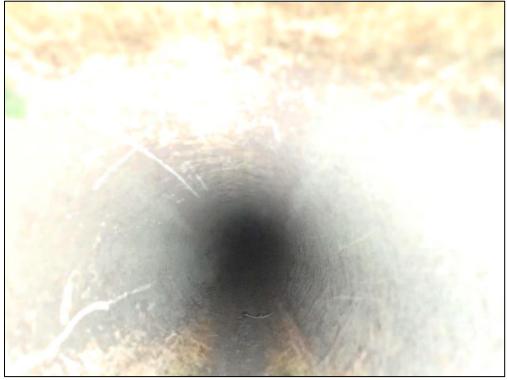
2875: Inflow 3, front. Buildup of trash, debris, and sediment (Routine Maintenance Needed).

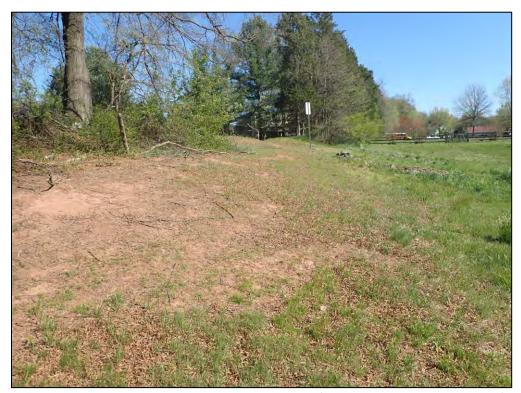
2877: From Inflow 3, looking downstream. Buildup of trash, debris, and sediment (Routine Maintenance Needed).

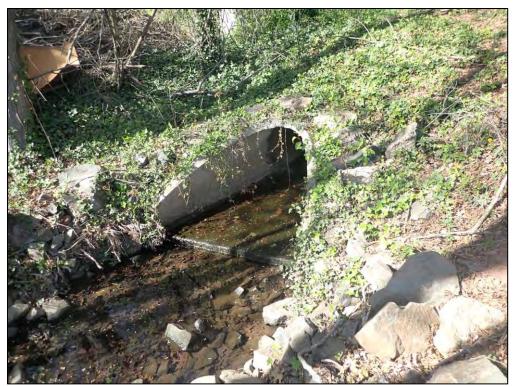
2880: Looking downstream along the Trickle Ditch toward Control Structure E-2. Low-flow ditch is clogged with sediment/debris (Routine Maintenance Needed).

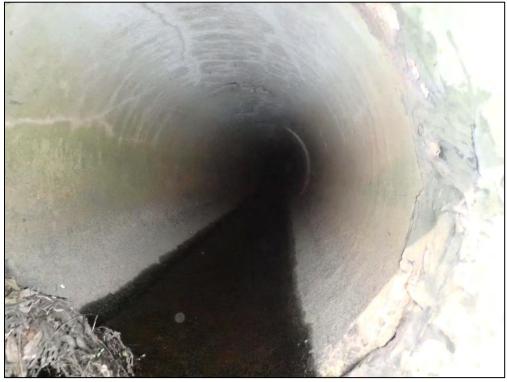
2882: Inside Inflow 4.

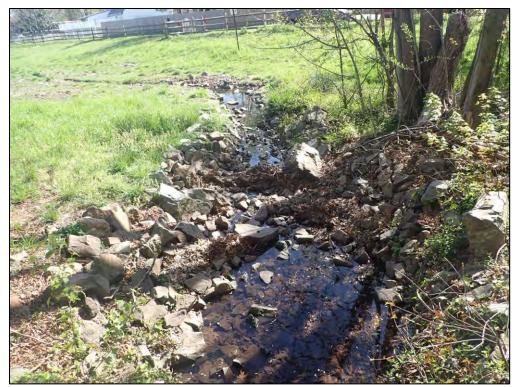
2883: From Inflow 4, looking downstream. Buildup of trash, debris, and sediment (Monitor).

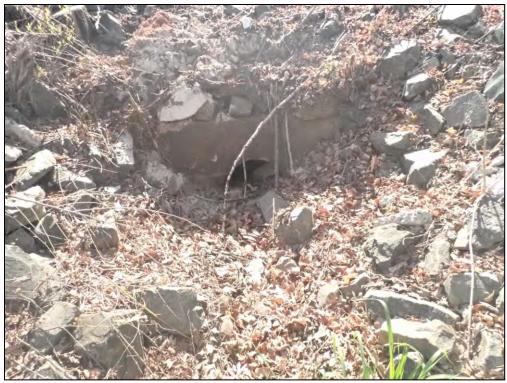
2885: Inflow E-3, front. Buildup of trash, debris, and sediment (Routine Maintenance Needed).

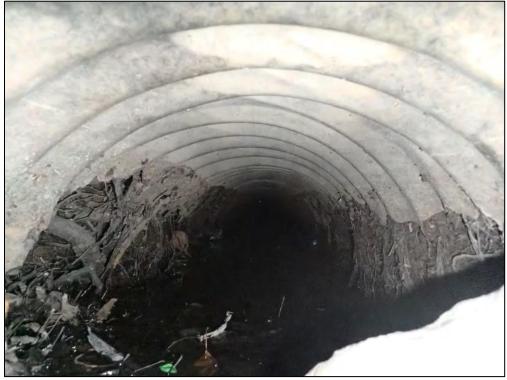
2886: Inside Inflow E-3. Damage to inlet pipe or structure (Immediate Repair Needed).

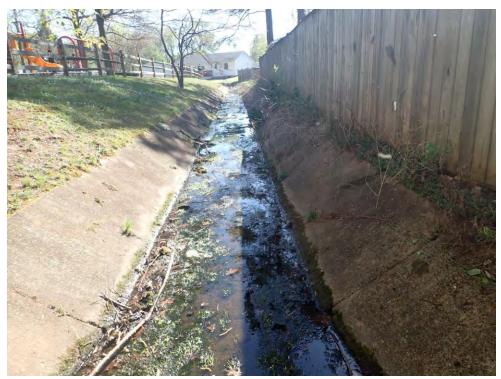
2891: From Outfall Structure E-1, looking downstream.

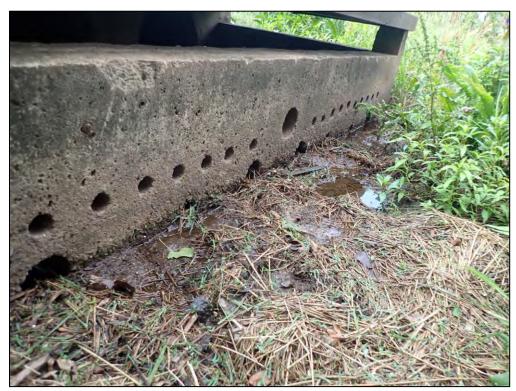
4610: Control Structure 21, low-flow orifices close-up. Sediment, debris, and vegetation accumulation. (Routine Maintenance Needed).

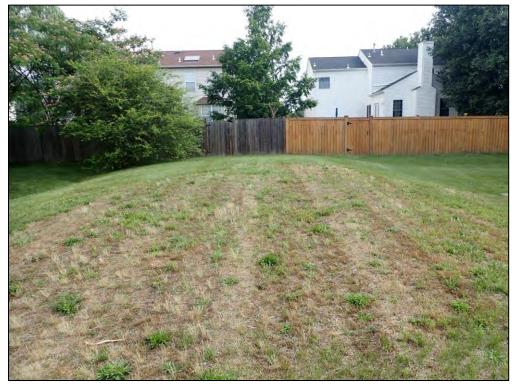
4622: Dam Overall. Sparse vegetative coverage (Routine Maintenance Needed).

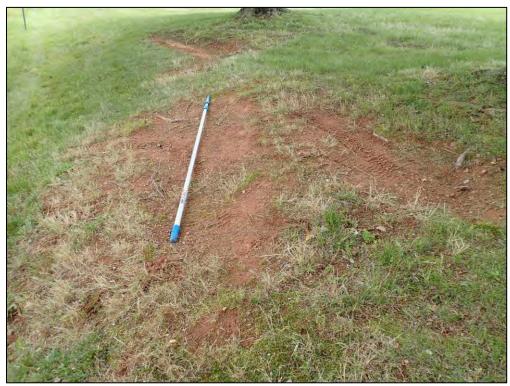
4629: Dam Overall. Sparse vegetative coverage (Routine Maintenance Needed).
