Wet Pond Inspection Report									
Facility Name	Sumner Pond		Facility ID	STMF0090056	Type of Inspection: Initial Inspection				
Location	Lat: 38.774472 Long: -77.477521		Watershed	Middle Bull Run	Previous 48 Hour Precipitation Total	0.00"			
Materials available for inspection	N/A		Owner Notification Date	N/A	Owners/Owner's Representative	City of Manassas			
Inspector	gky_n	nfreeman	Date of Inspection	6/27/2023	Date of Last Inspection	5/19/2022			
	Overall Condition Score								
	1	Adequate		No deficiencies identified.					
	2	Monitor		No maintenance may be needed at the time, but might become an issue in the future. Will revisit next inspection. Examples include minor erosion, small sediment accumulation, or small structural issues of facility components.					
3	3	Routine Maintenance Needed		Facility is functional but preventative maintenance is required. Examples includes vegetation management, minor erosion, or trash/debris removal.

Facility ID: STMF0090056 Inspection Date: 06/27/2023

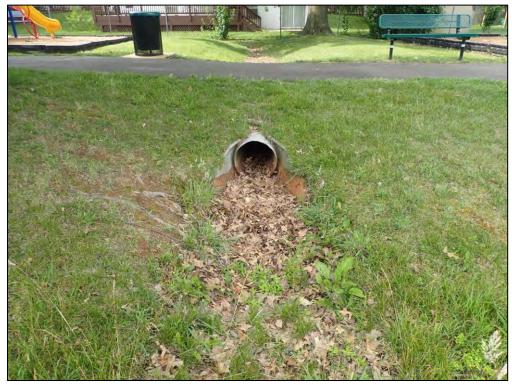
4630: Inflow 1, front. Buildup of trash, debris, and sediment (Routine Maintenance Needed).

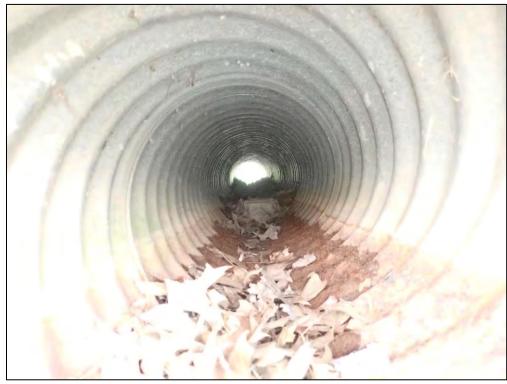
4631: Inside Inflow 1. Buildup of trash, debris, and sediment (Routine Maintenance Needed).

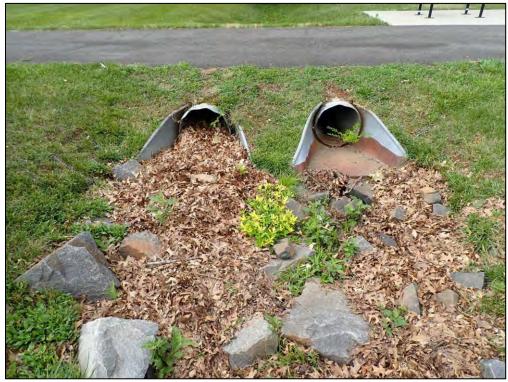
4633: Inflow 2, front. Buildup of trash, debris, and sediment (Routine Maintenance Needed).

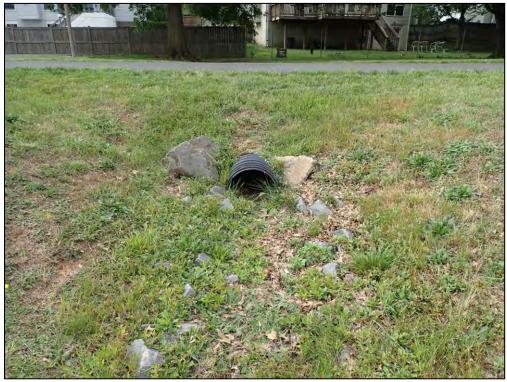
4639: Inflow 3, front. Buildup of trash, debris, and sediment (Routine Maintenance Needed).

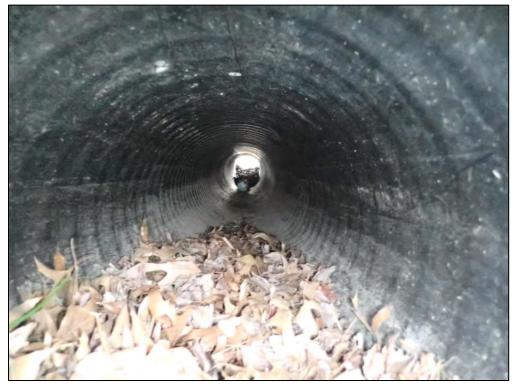
4640: Inside Inflow 3. Buildup of trash, debris, and sediment (Routine Maintenance Needed).

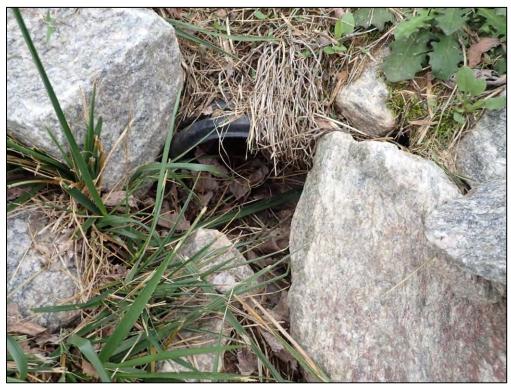
4645: Inflow 4, closeup. Buildup of trash, debris, and sediment (Routine Maintenance Needed).

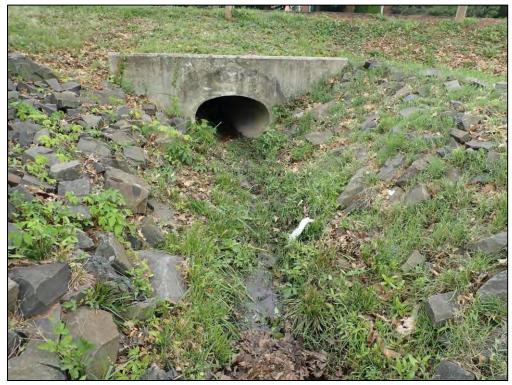
4656: Inflow 7, front.

Inflow 7, the pipe appears to be at least partially collapsed and obstructing flow. Immediate repair is needed at this location.

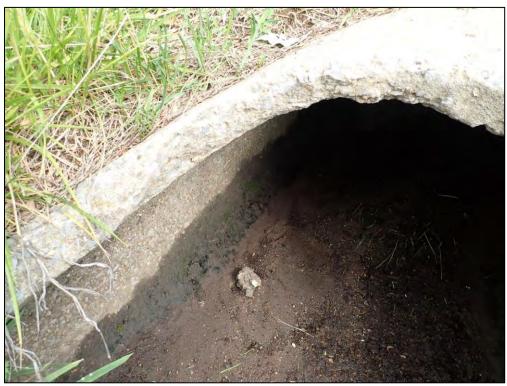
4663: Inflow 8, closeup. Damage to inlet pipe or structure, Spalling (Routine Maintenance Needed).

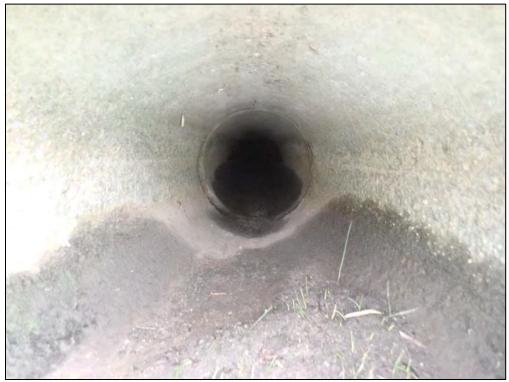
4664: Inside Inflow 8. Damage to inlet pipe or structure, Joint separation (Routine Maintenance Needed).

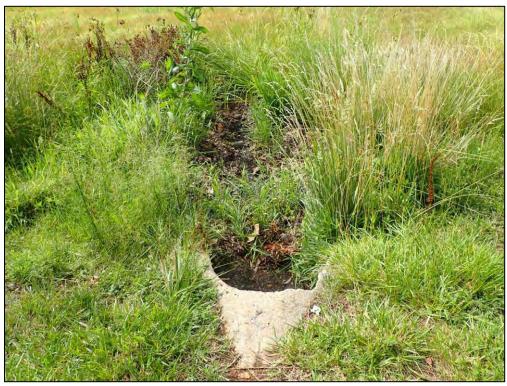
4665: From Inflow 8, looking downstream. Buildup of trash, debris, and sediment (Routine Maintenance Needed).

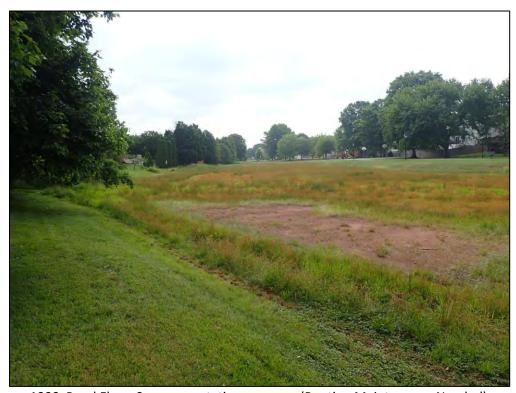
4666: Pond Floor. Sparse vegetative coverage (Routine Maintenance Needed).

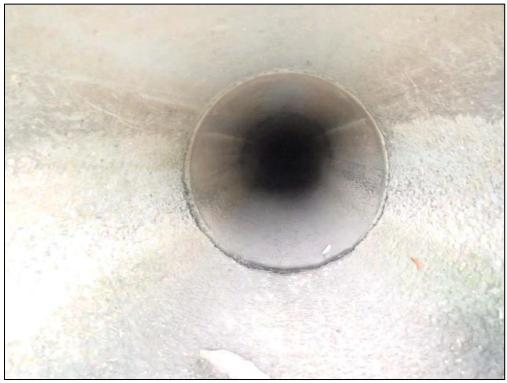
4670: Inside Inflow 9. Damage to inlet pipe or structure, Joint separation (Routine Maintenance Needed).

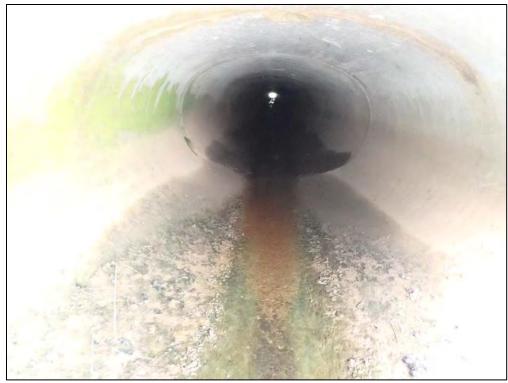
4685: Inside the Middle Southern pipe of Inflow Structure 1.

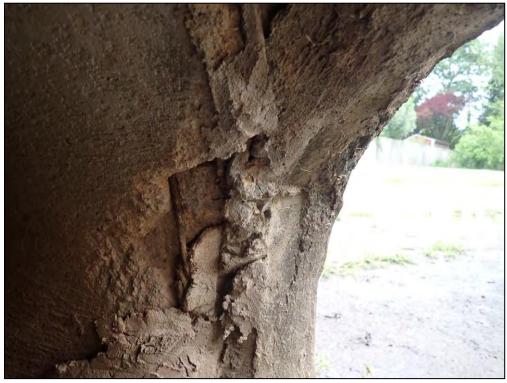
4686: Inflow Structure 1, closeup of the Middle Southern pipe. Damage to inlet pipe or structure, Spalling (Routine Maintenance Needed).

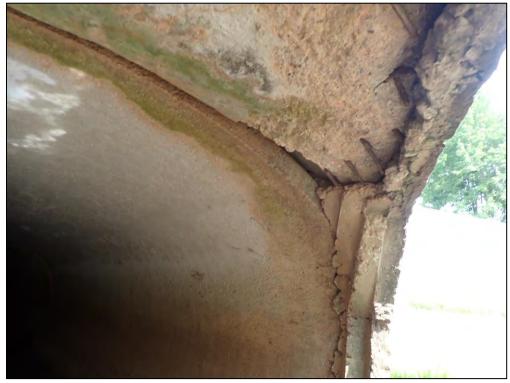
4690: Inflow Structure 1, closeup of the Middle Northern pipe. Damage to inlet pipe or structure, Spalling (Routine Maintenance Needed).

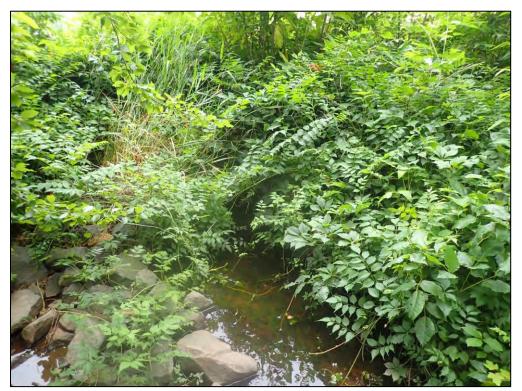
4714: Outfall Structure 22, front. Overgrown vegetation adjacent to the outfall (Routine Maintenance Needed).

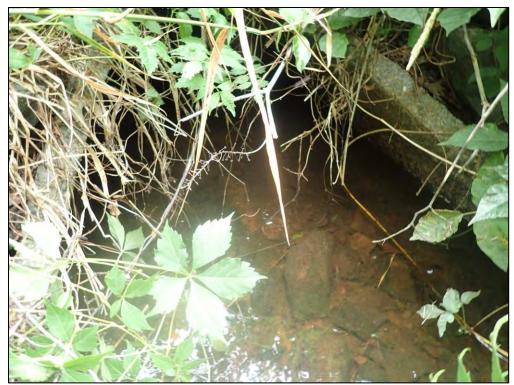
4715: Outfall Structure 22, closeup. Overgrown vegetation adjacent to the outfall (Routine Maintenance Needed).

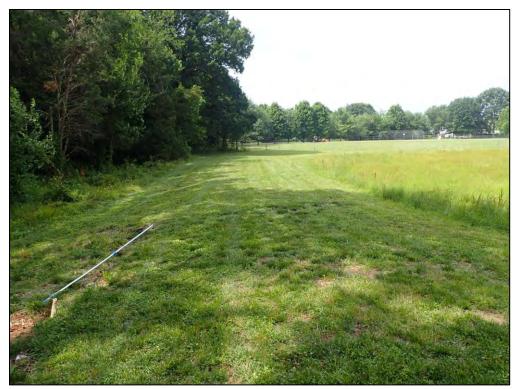
4719: Dam Overall. Signs of erosion, settlement, piping, or slope slippage (Routine Maintenance Needed).

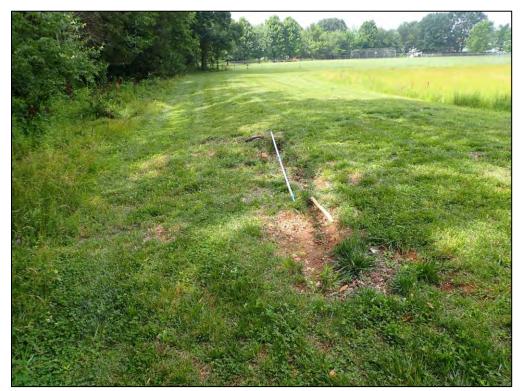
4720: Dam Overall. Signs of erosion, settlement, piping, or slope slippage (Routine Maintenance Needed).

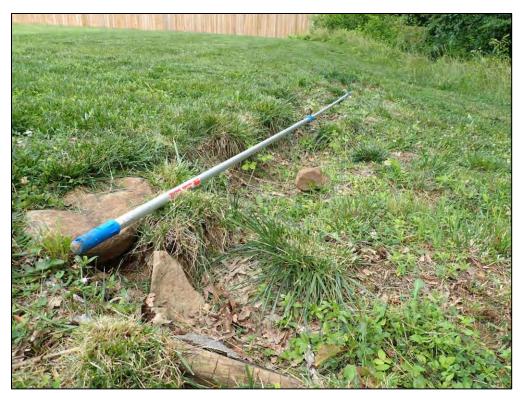
4721: Dam closeup. Signs of erosion, settlement, piping, or slope slippage (Routine Maintenance Needed).
