Infiltration Trench Inspection Report					
Facility Name	Fairview Riverdale	Facility ID	STMF0090080	Type of Inspection: Initial Inspection	
Location	Lat: 38.747968 Long: -77.460524	Watershed	Lower Bull Run	Previous 48 Hour Precipitation Total	0.35"
Materials available for inspection	N/A	Owner Notification Date	N/A	Owners/ Owner's Representative	City of Manassas
Inspectors	gky_mfreeman	Date of Inspection	6/28/2023	Date of Last Inspection	3/29/2022
Overall Condition Score					
	1	Adequate	No deficiencies identified.		
	2	Monitor	No maintenance may be needed at the time, but might become an issue in the future. Will revisit next inspection. Examples include minor erosion, small sediment accumulation, or small structural issues of facility components.		
	3	Routine Maintenance Needed	Facility is functional but preventative maintenance is required. Examples includes vegetation management, minor erosion, or trash/debris removal.

Facility ID: STMF0090080
Facility Name: Fairview Riverdale

Inspection Date: 06/28/2023

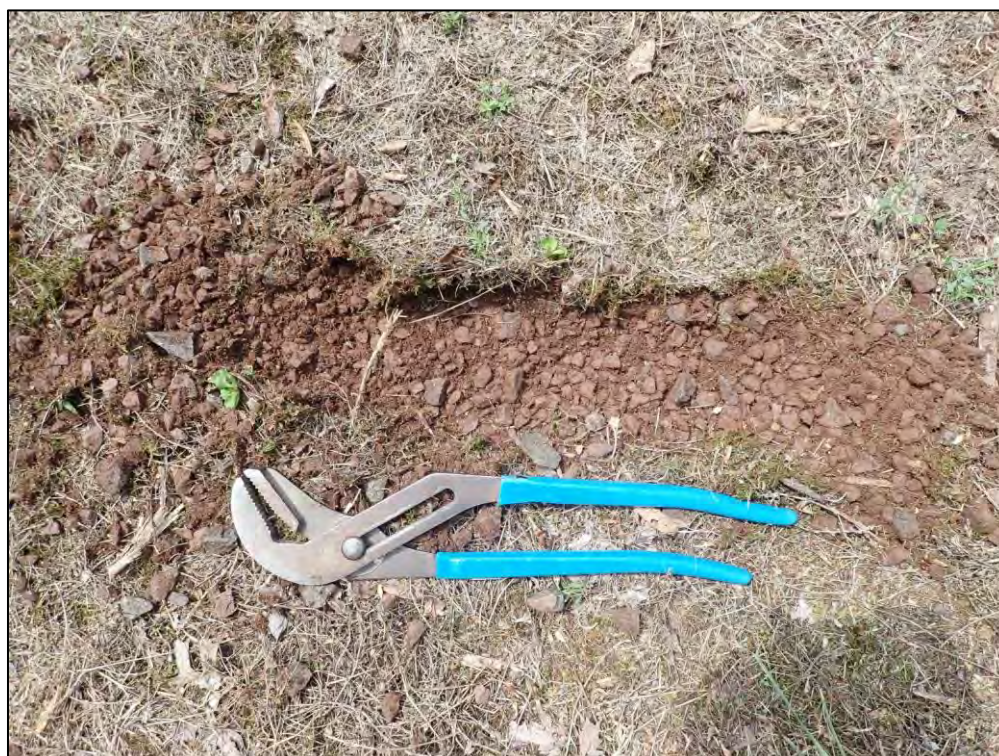
4801: Close-up showing the Gravel Detail. Evidence of clogging (Immediate Repair Needed).

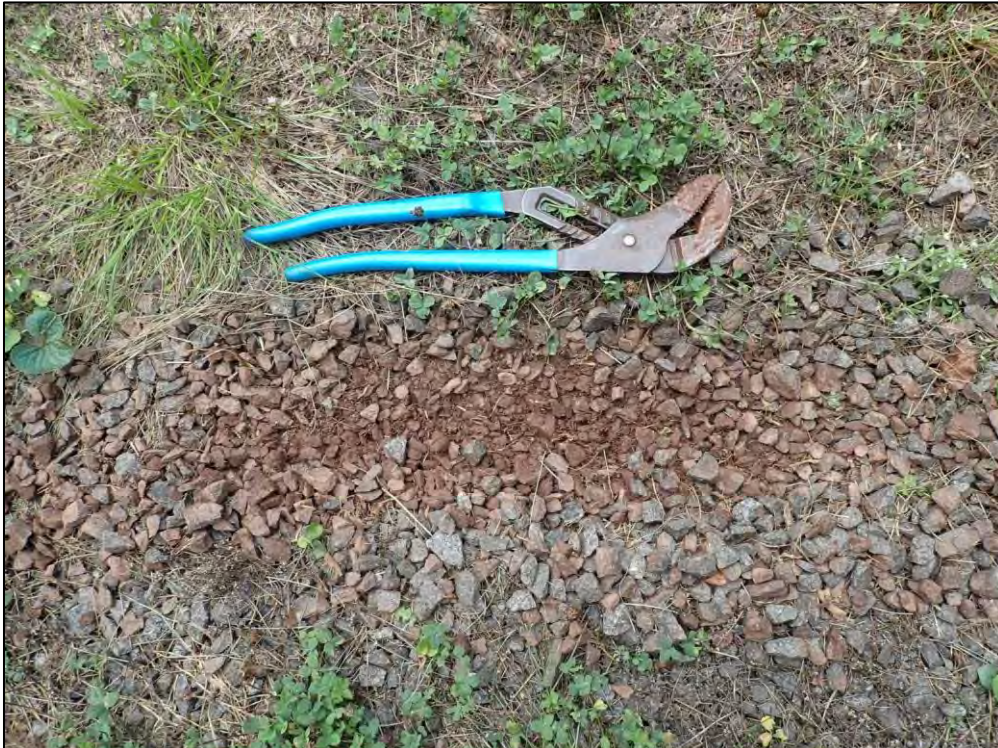
4805: Another close-up showing the Gravel detail. Evidence of clogging (Immediate Repair Needed).

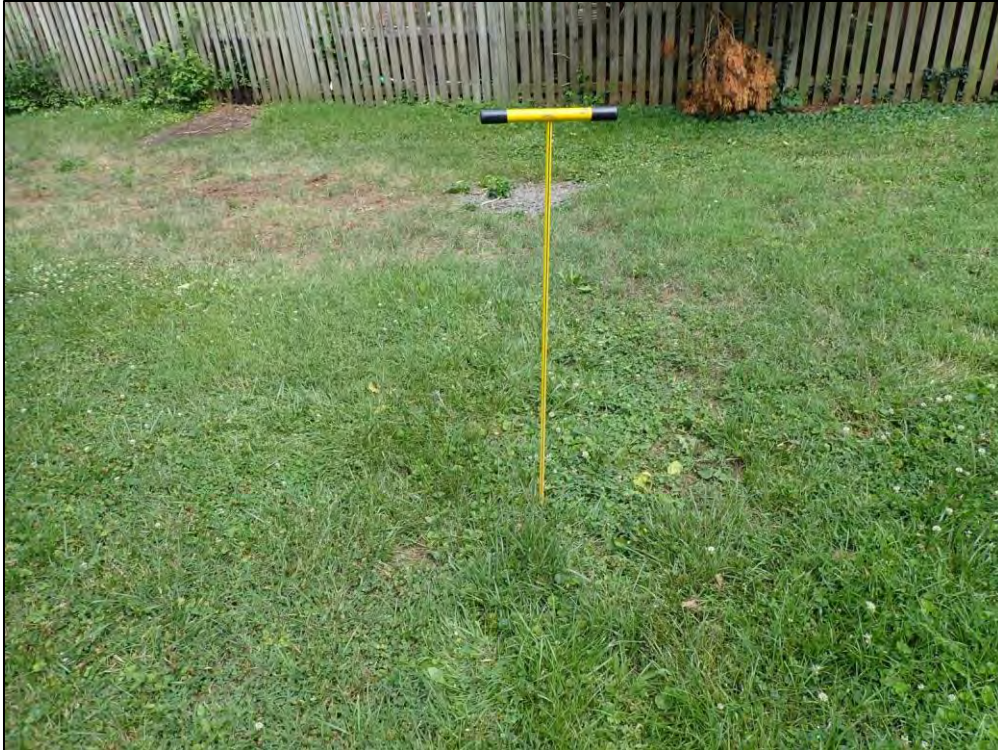
4811: Gravel detected approximately 3" beneath the surface. Evidence of clogging (Immediate Repair Needed).

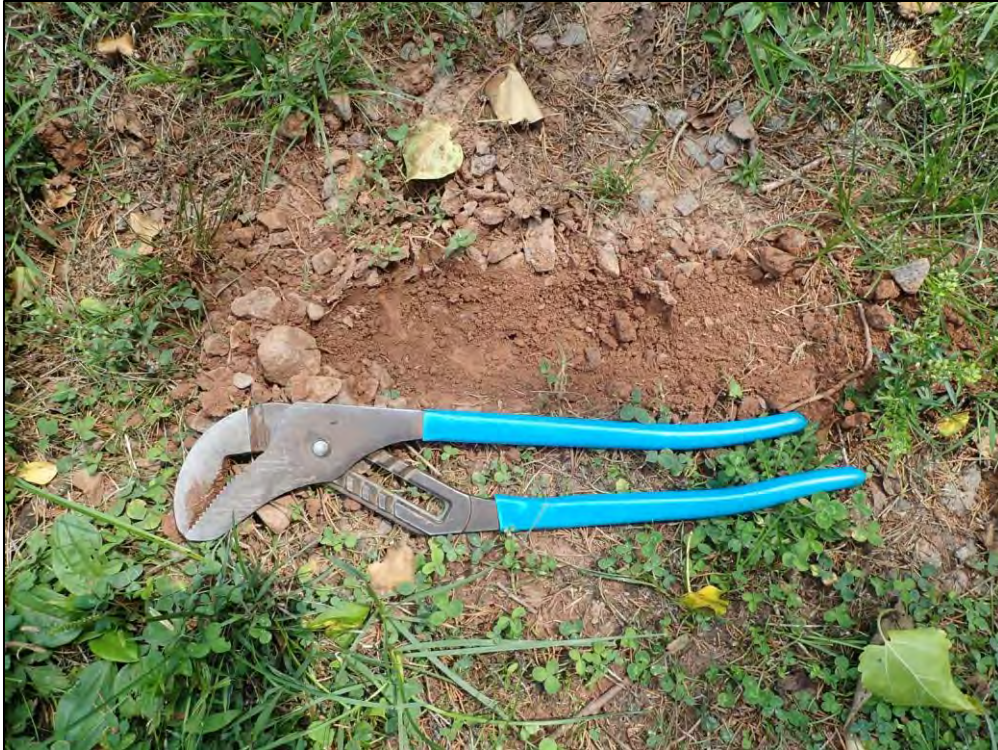
4813: Another close-up showing the Gravel Detail. Evidence of clogging (Immediate Repair Needed).

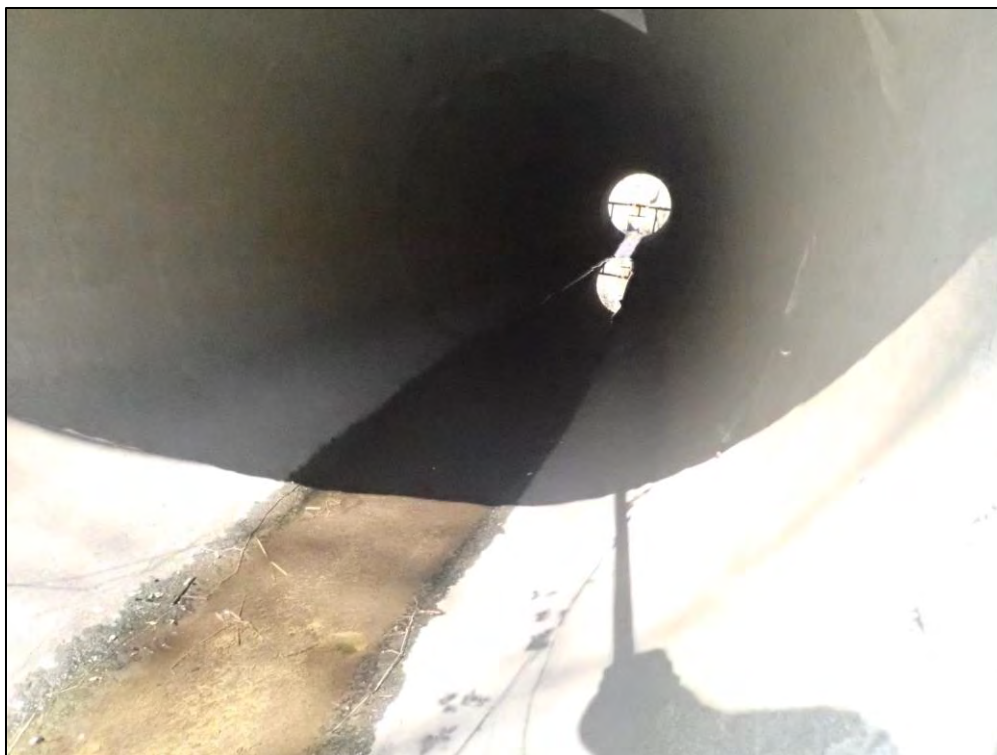
2843: Outfall Structure 4, front. Woody vegetation growing within 5' of outlet and barrel (Routine Maintenance Needed).

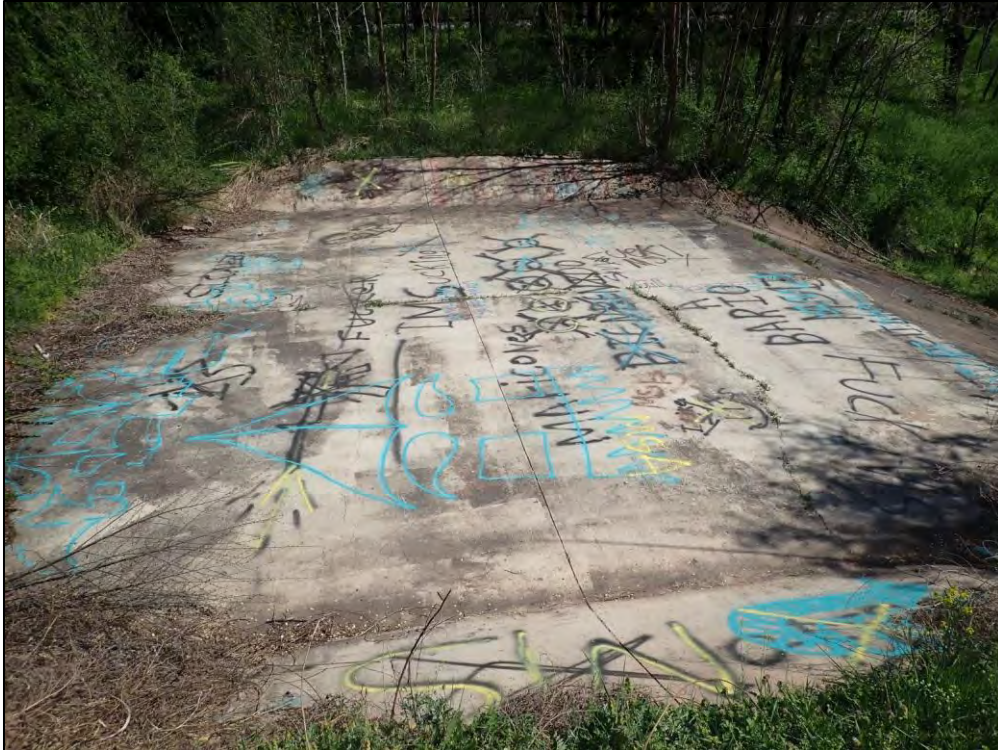
2847: Looking downstream along the Emergency Spillway. Woody vegetation on the embankment (Routine Maintenance Needed).

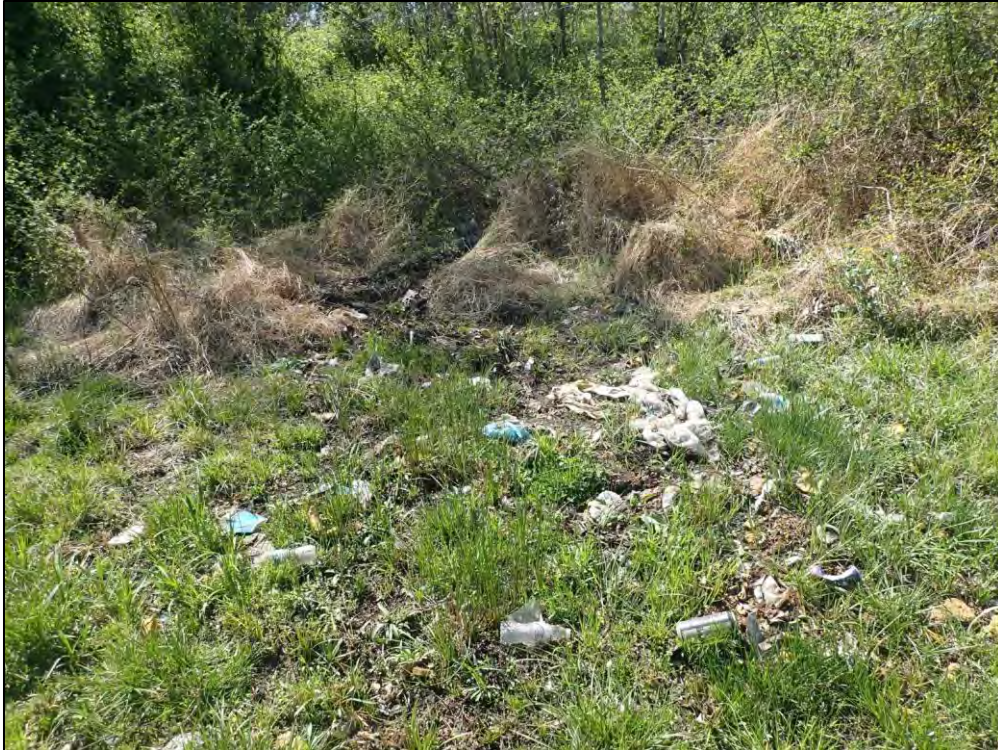
2851: Looking upstream along Inflow 1. Woody growth around inlet structure (Routine Maintenance Needed).

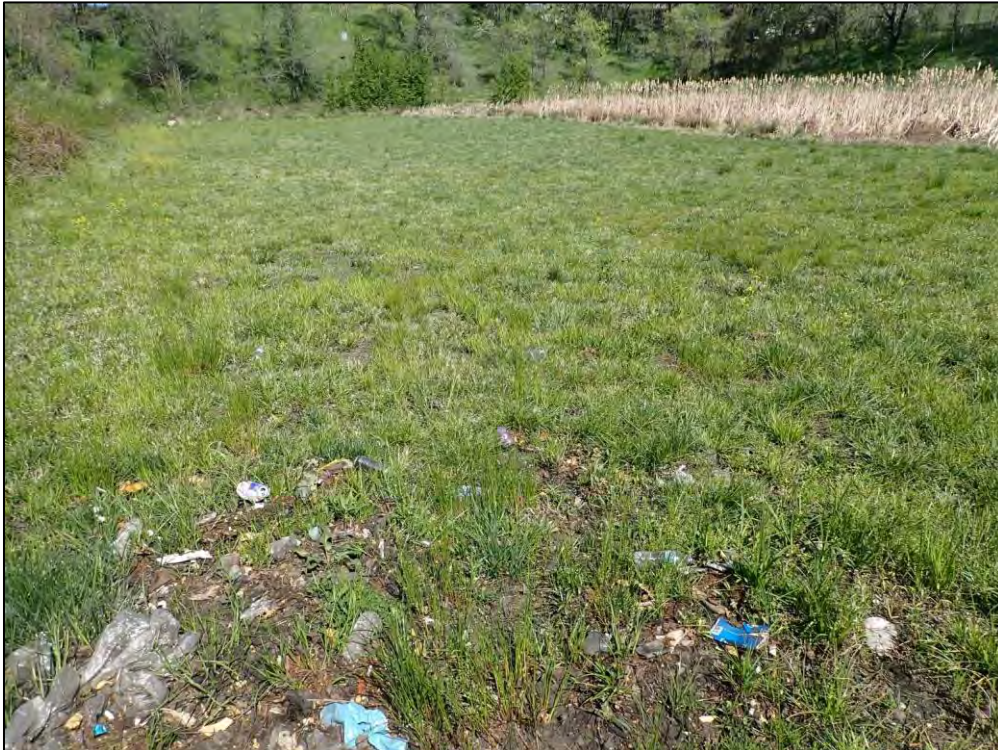
2852: Inflow 1, Overall. Buildup of trash, debris, and sediment (Routine Maintenance Needed).

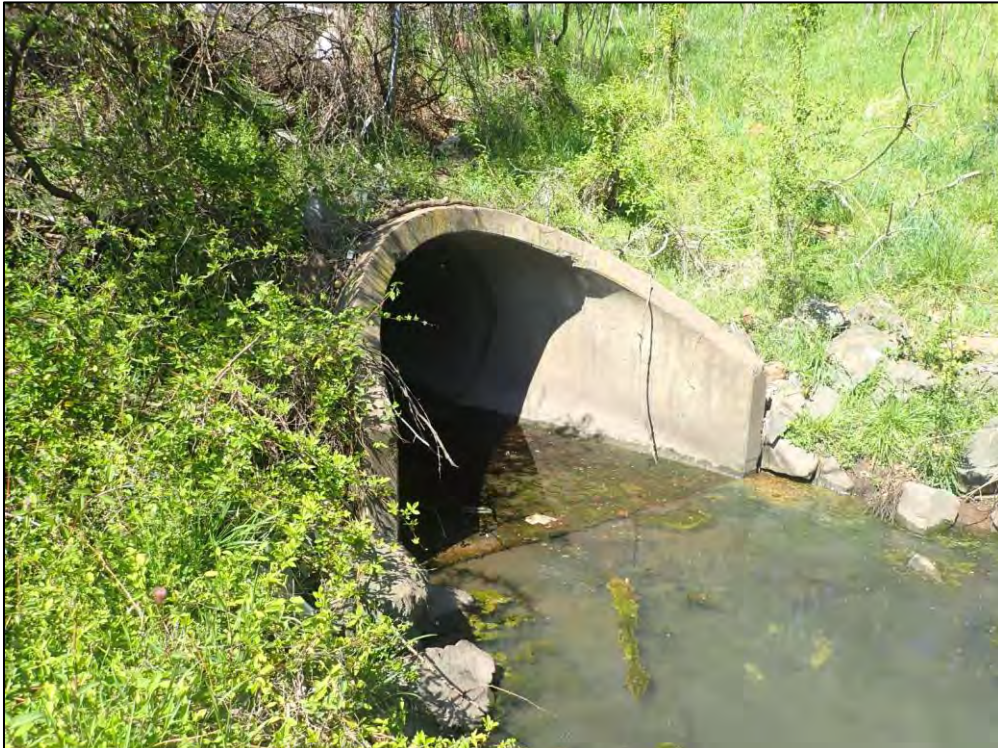
2854: Inflow Structure 2, Overall. Buildup of trash, debris, and sediment (Monitor).

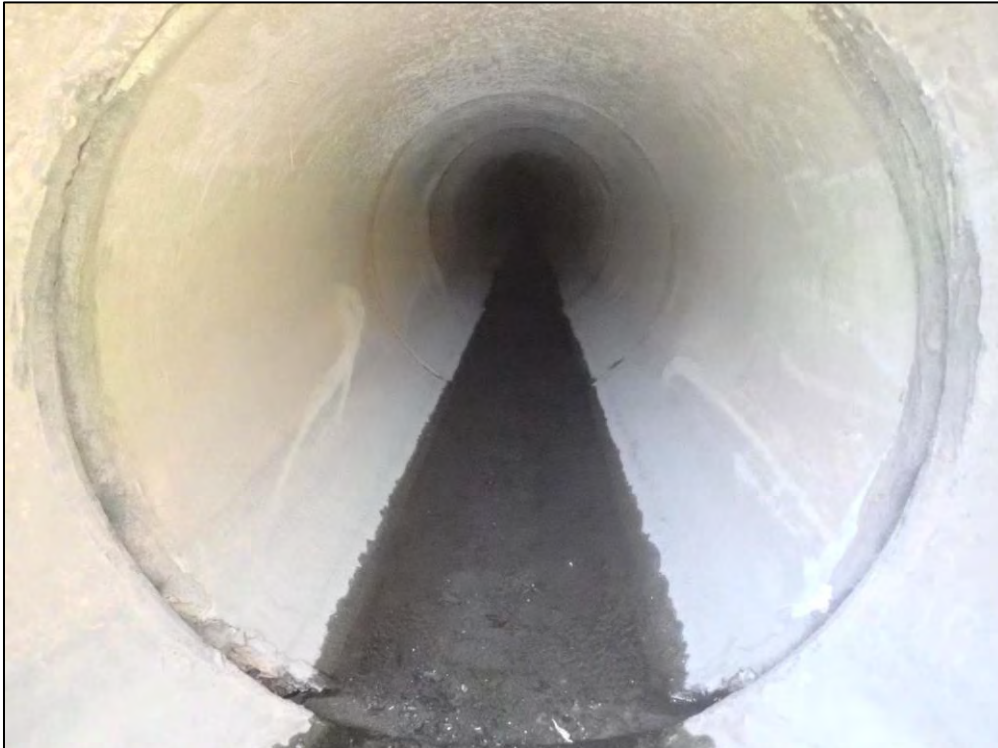
1	Signs of erosion or exposed soil				
1	Sediment in forebay has reached 50% or more of capacity				
1	Evidence of clogging				
1	Vegetation does not match original design				
Inlet					
3	Buildup of trash, debris, and sediment	Trash, debris, and overgrown vegetation observed at Inflow 1 (5 Cubic Feet, 30 Square Feet).	2852, 2854		
1	Evidence of erosion or undermining around inlet				
3	Woody growth around inlet structure	Trees observed growing adjacent to Inflow 1 (4, 2-6" trees).	2851		
1	Evidence of nuisance animals				
3	Damage to inlet pipe or structure	Joint separation observed in Inflow Structure 2 (12.57 Linear Feet).	2856, 2857

2856: Inflow Structure 2, closeup. Joint separation observed (Routine Maintenance Needed).

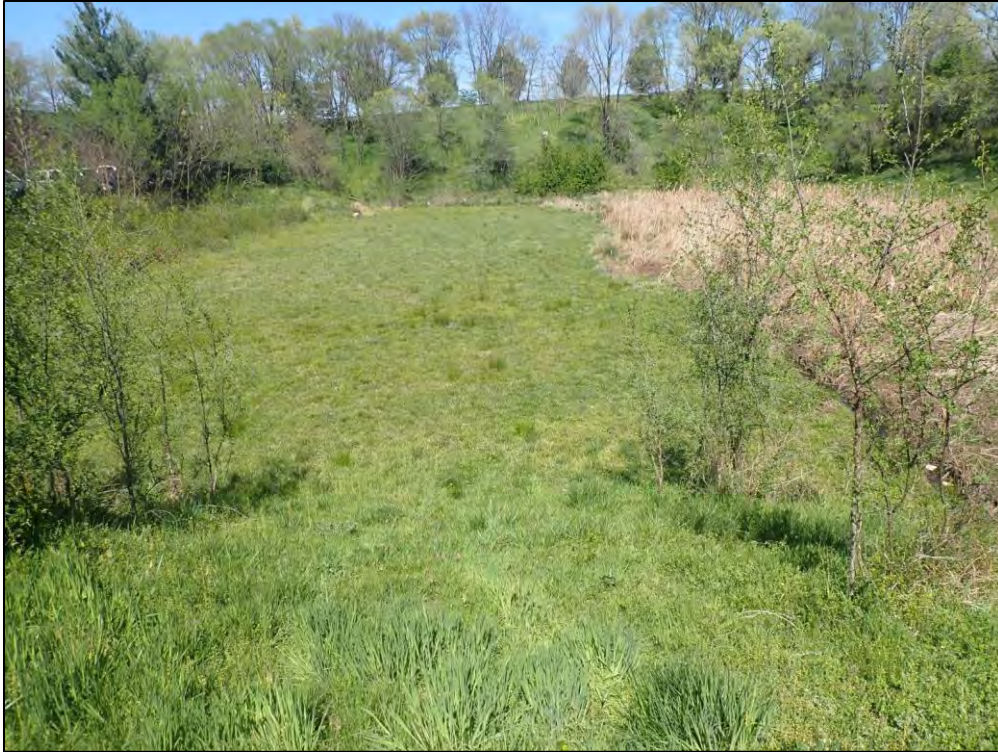
2859: Facility Overall. The ponding area is showing signs of poor health (i.e. nutrient overload, excess aquatic vegetation, or turbidity (Routine Maintenance Needed)).

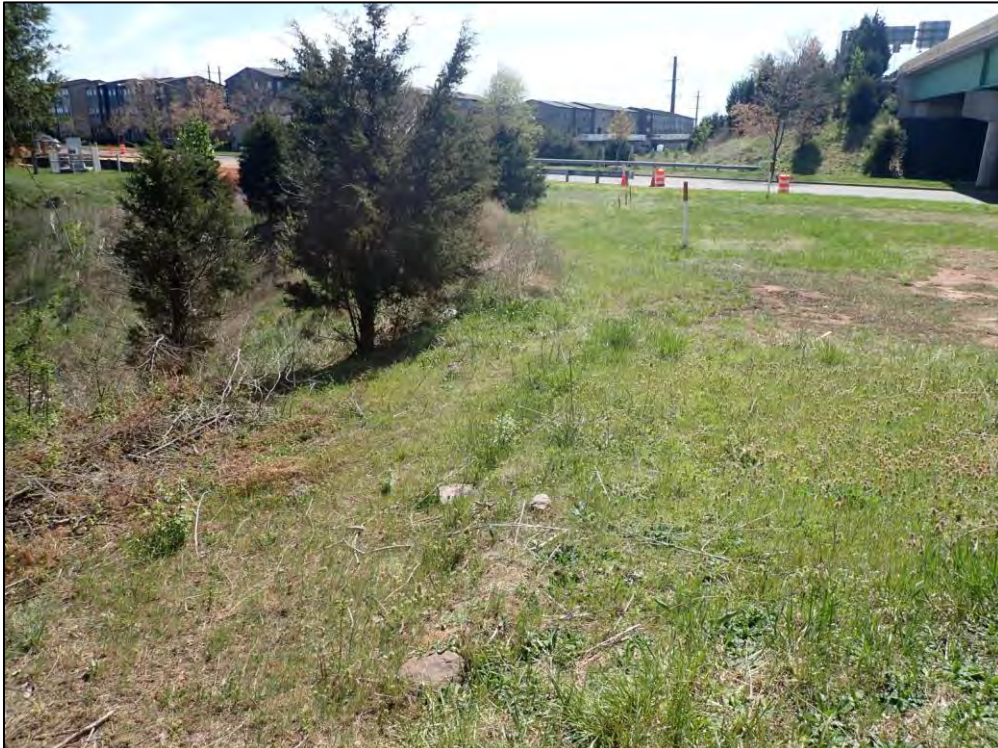
2767: Dam overall. Woody vegetation on the embankment (Routine Maintenance Needed).

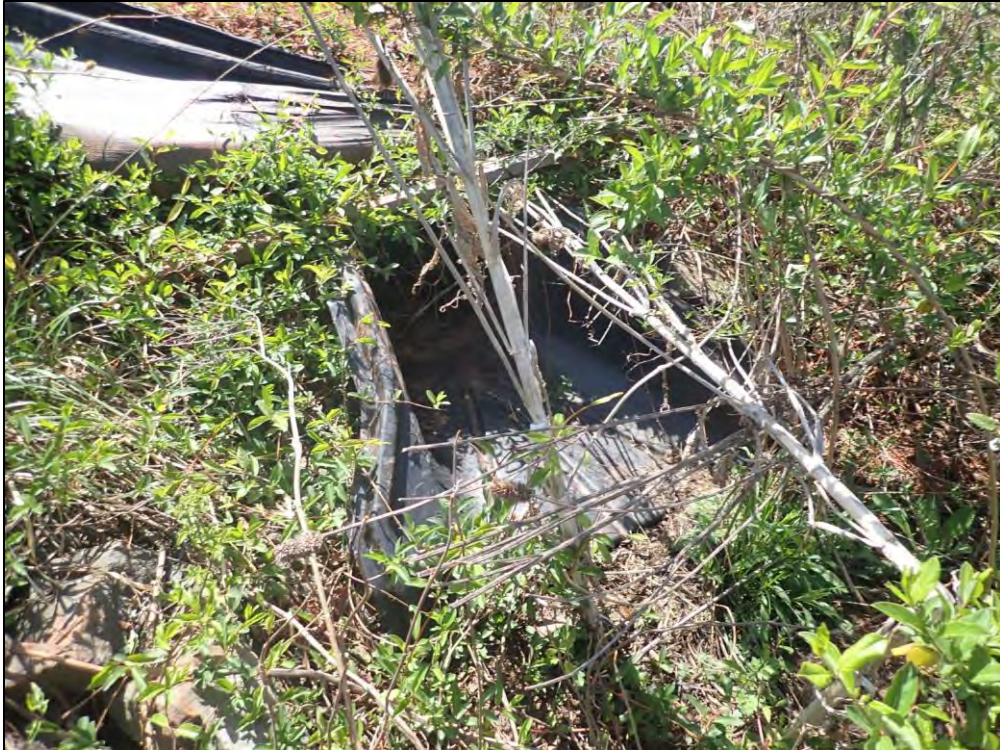
2768: Dam overall. Woody vegetation on the embankment (Routine Maintenance Needed).

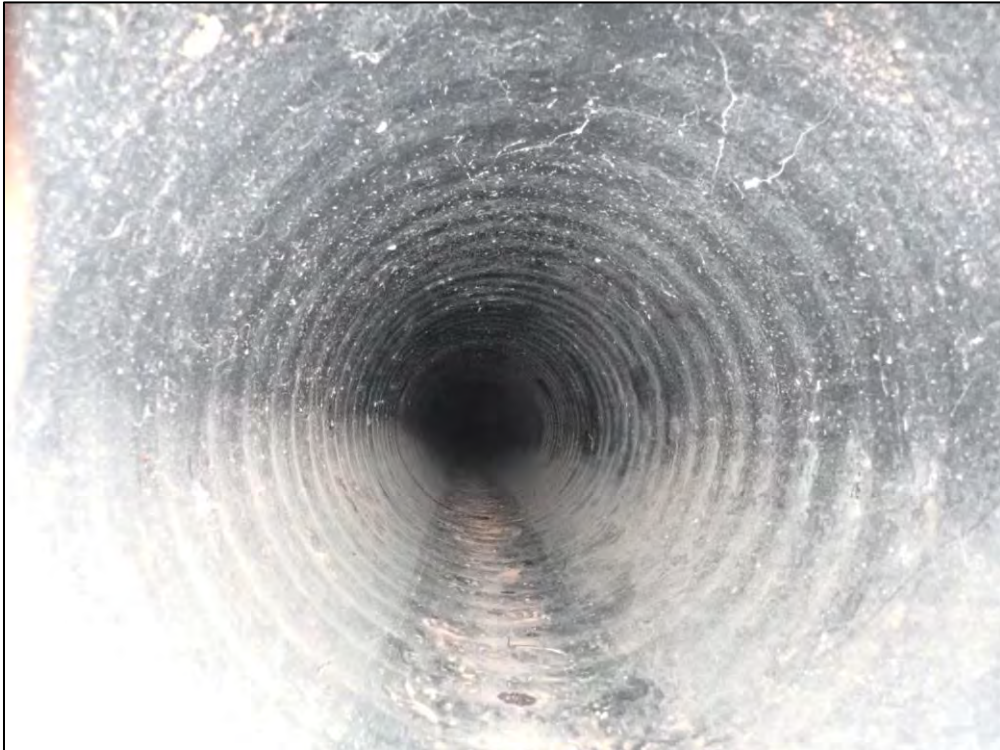
2769: Inflow 1, front. Buildup of trash, debris, and sediment (Routine Maintenance Needed).

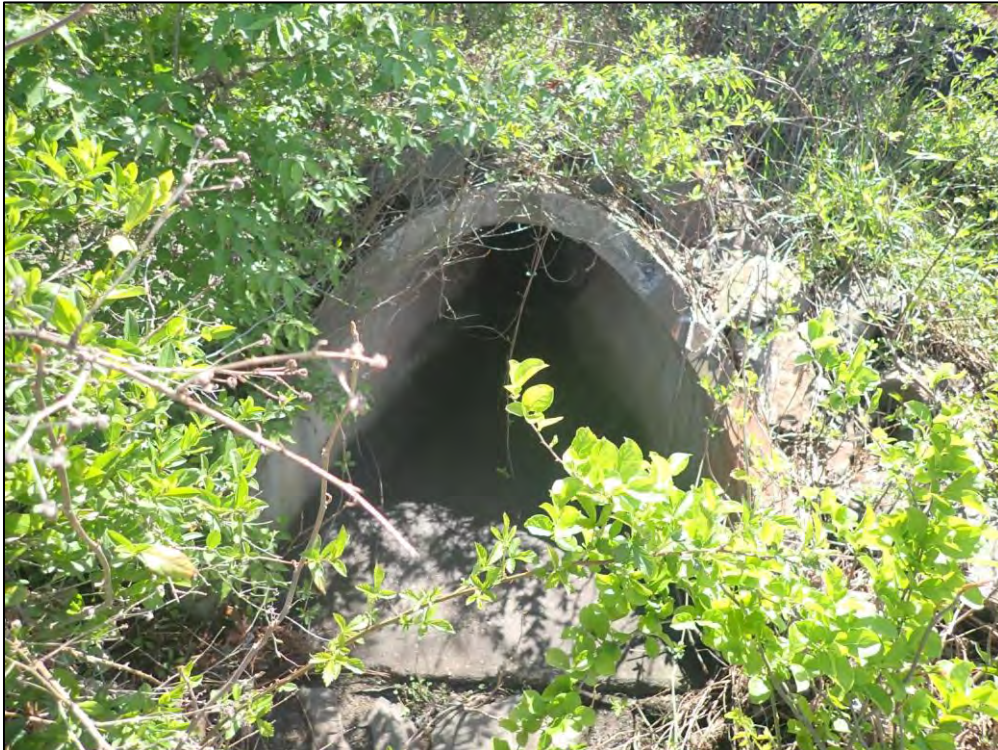
2771: Inside Inflow 1, looking downstream. Buildup of trash, debris, and sediment (Routine Maintenance Needed).

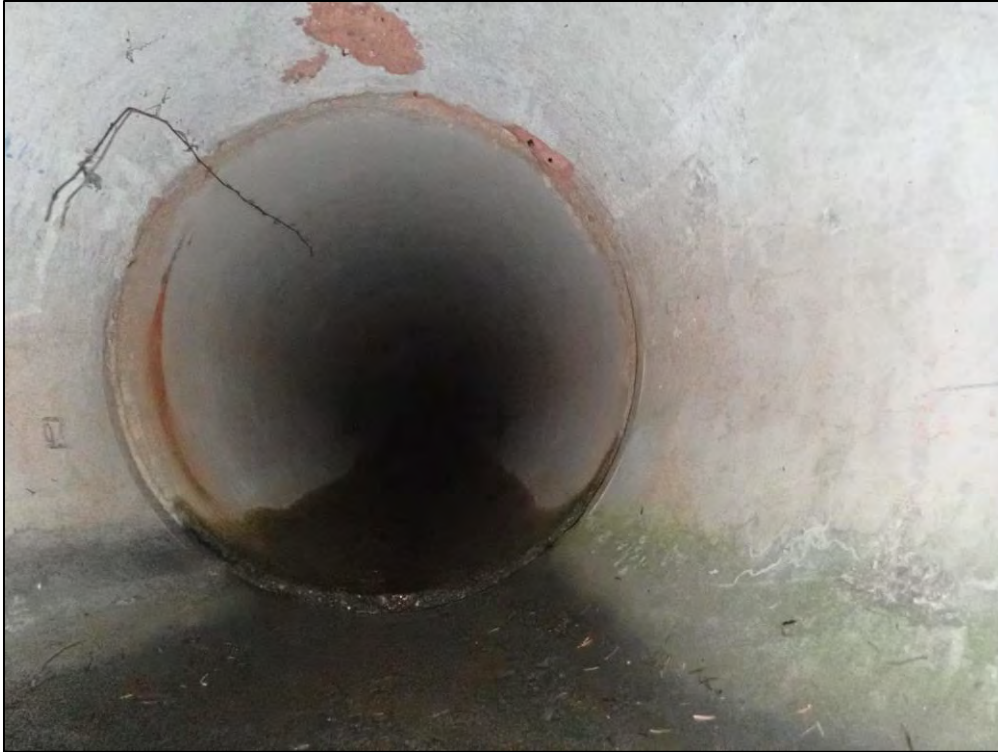
2772: Inflow 2, front. Buildup of trash, debris, and sediment (Routine Maintenance Needed).

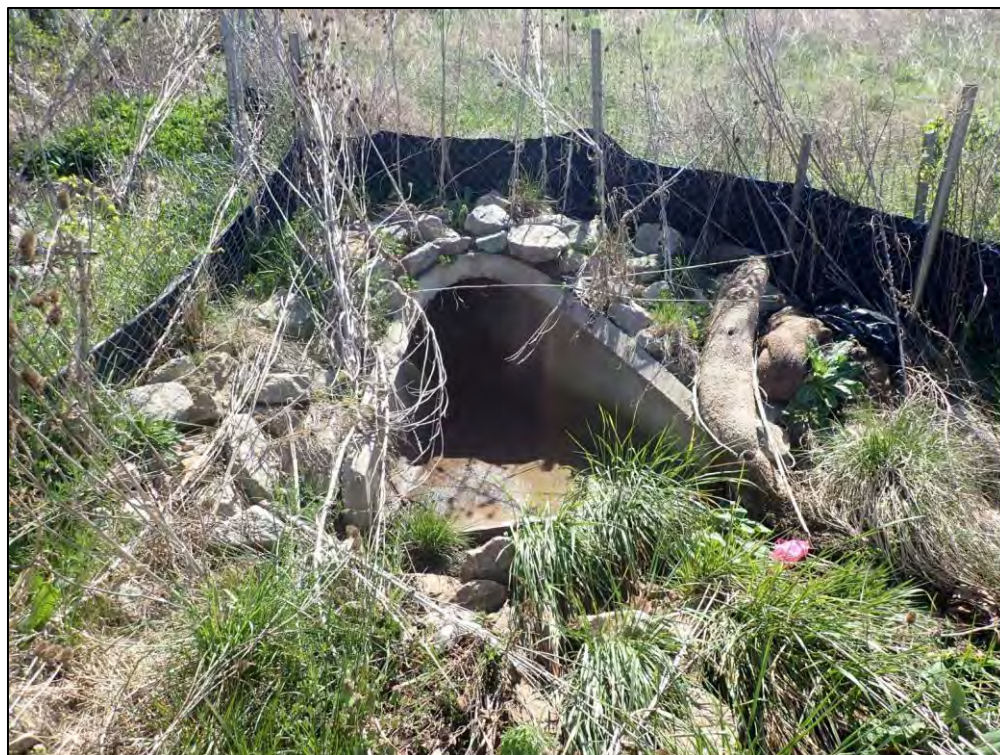
2774: From Inflow 2, looking downstream. Buildup of trash, debris, and sediment (Routine Maintenance Needed).

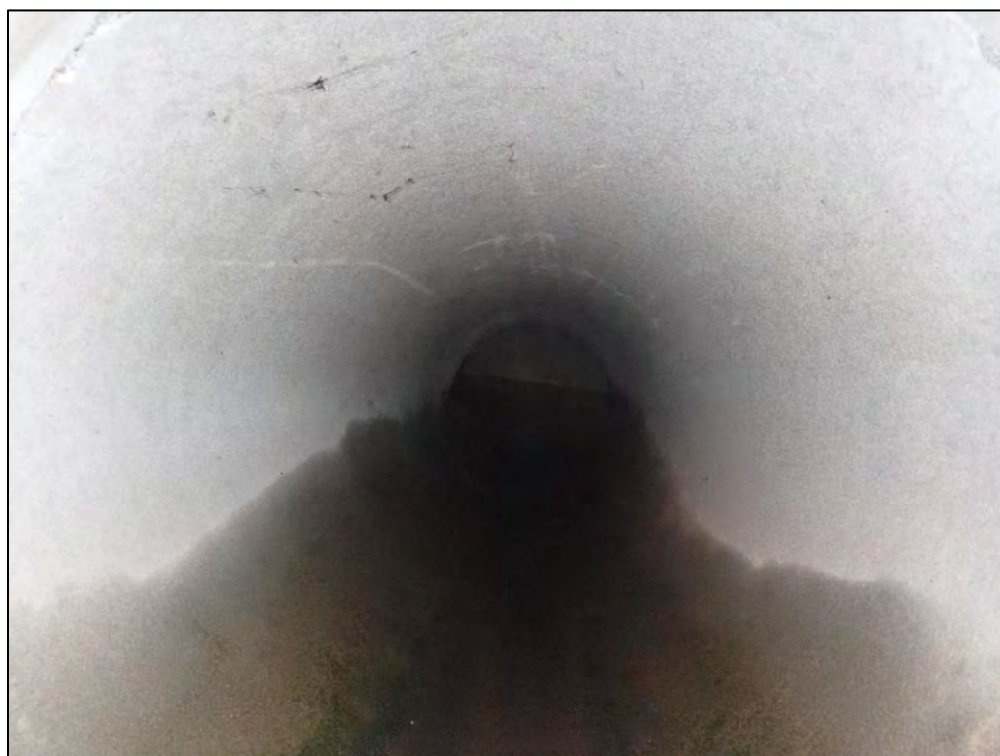
2775: Inflow 3, front. Buildup of trash, debris, and sediment (Routine Maintenance Needed).

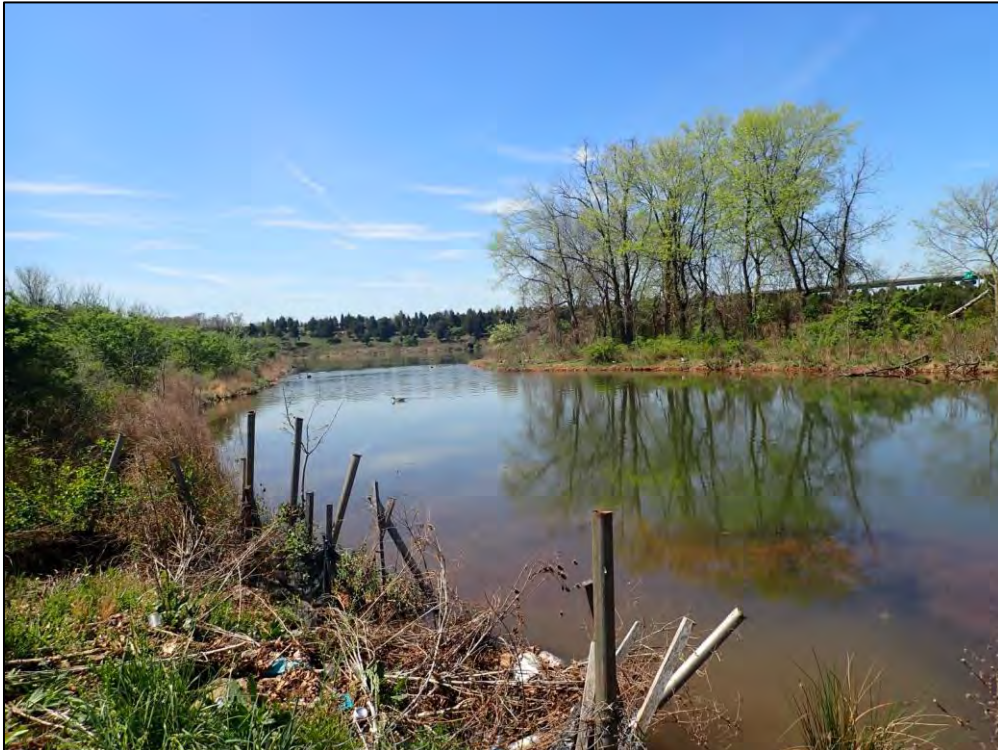
2777: Inflow 3, downstream. Buildup of trash, debris, and sediment (Routine Maintenance Needed).

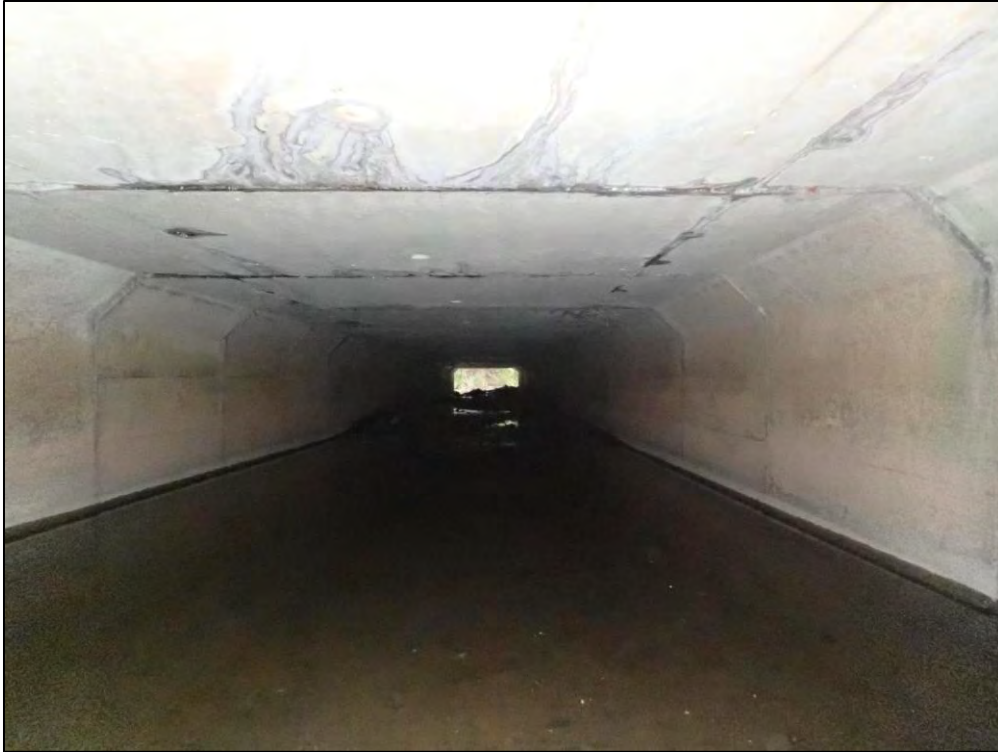
2780: Inflow 4, front. Buildup of trash, debris, and sediment (Routine Maintenance Needed).

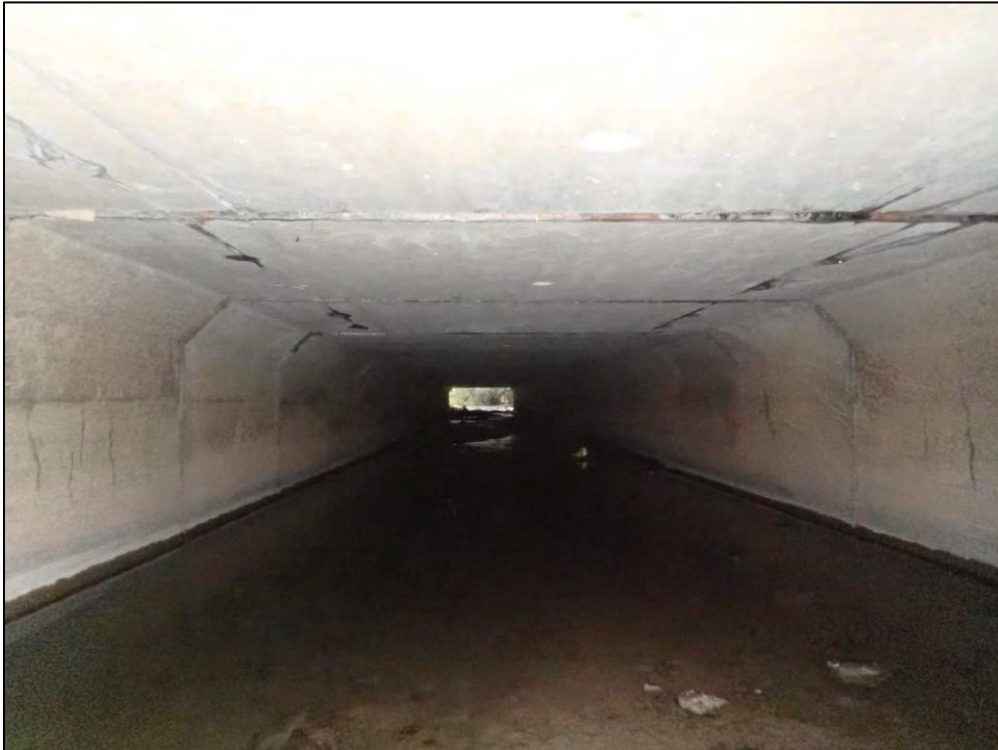
2781: Inside Inflow 4, looking along the Northern pipe. Buildup of trash, debris, and sediment (Routine Maintenance Needed).

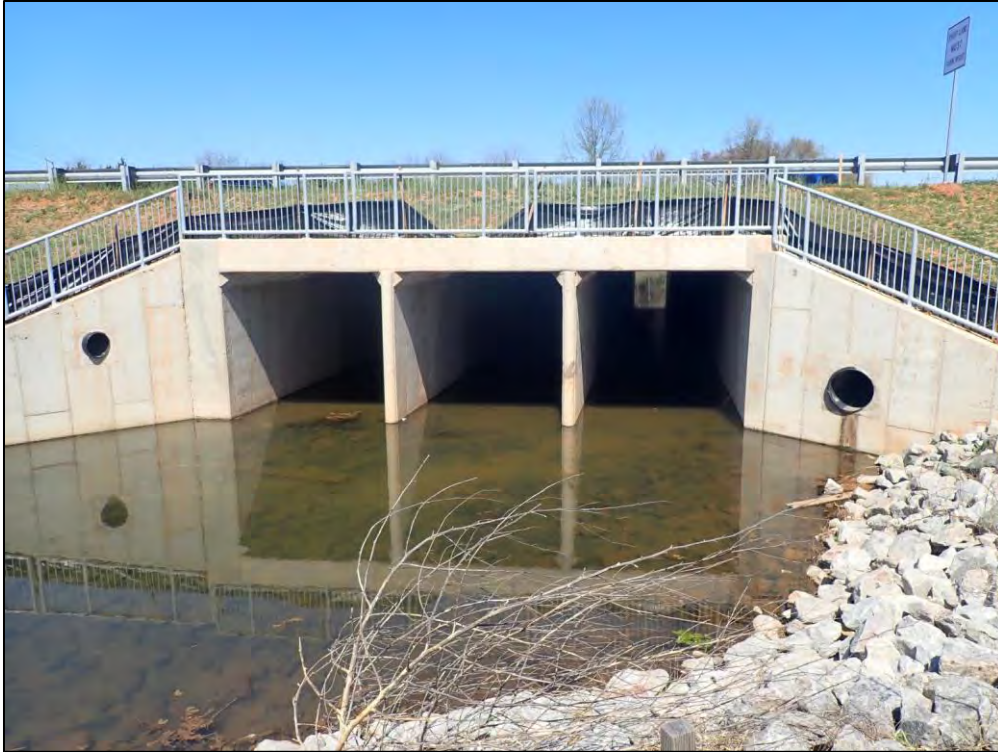
2784: From Inflow 4, looking downstream. Buildup of trash, debris, and sediment (Routine Maintenance Needed).

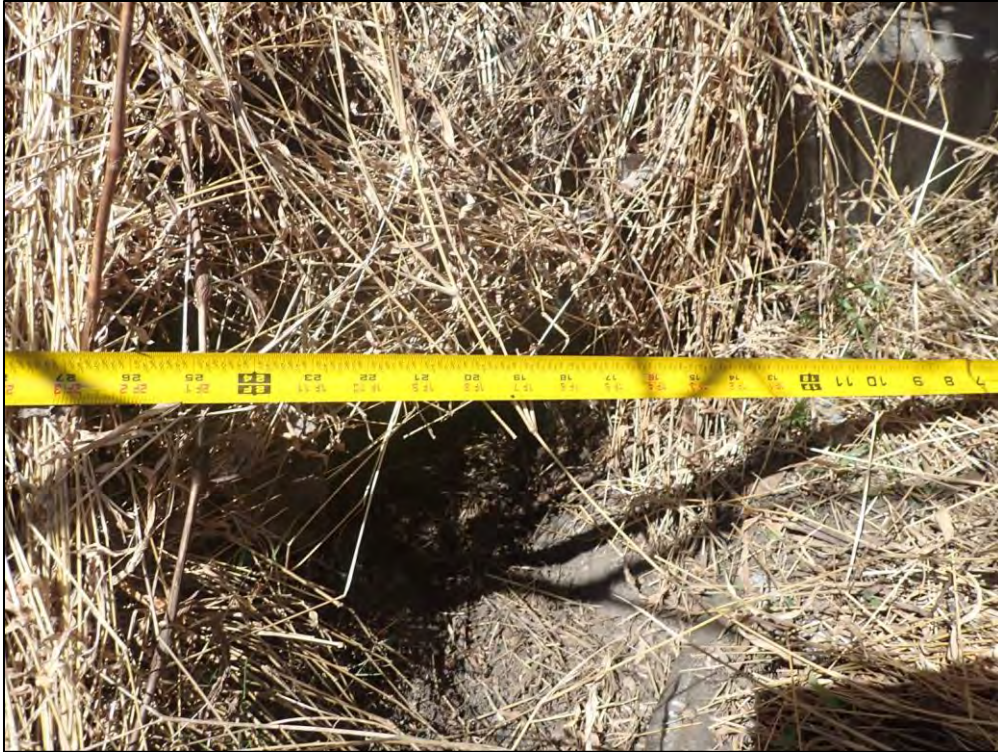
2807: Inflow 8, closeup. Evidence of nuisance animals (Routine Maintenance Needed).

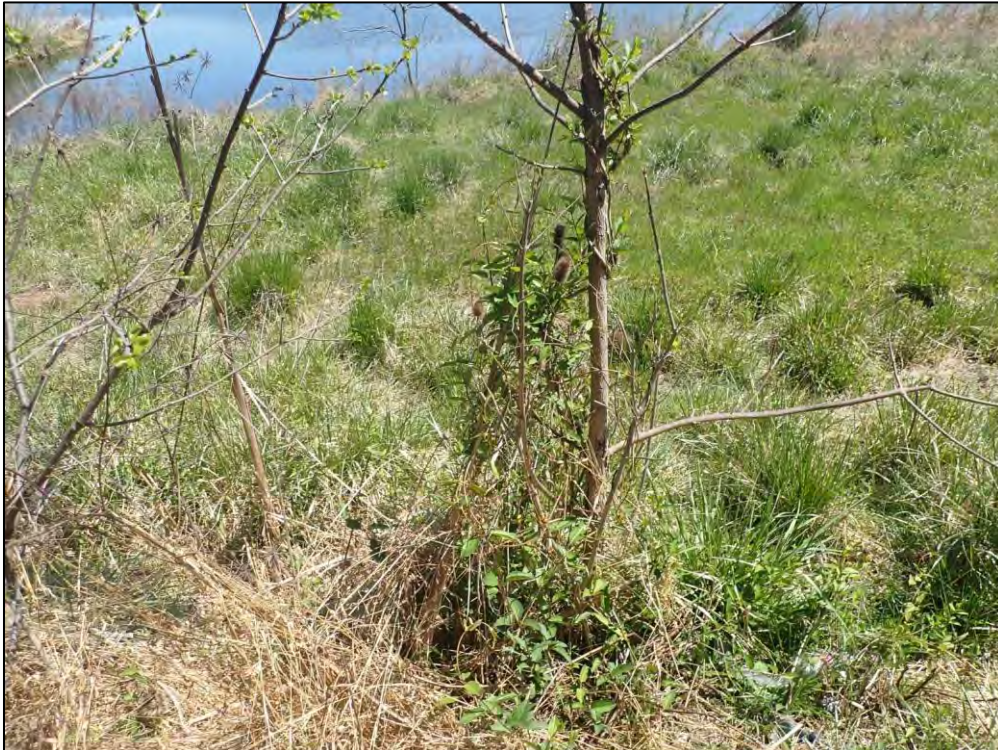
2808: From Inflow 8, looking downstream. Woody growth around inlet structure, 3, 2-6" trees growing adjacent to the str. (Routine Maintenance Needed).

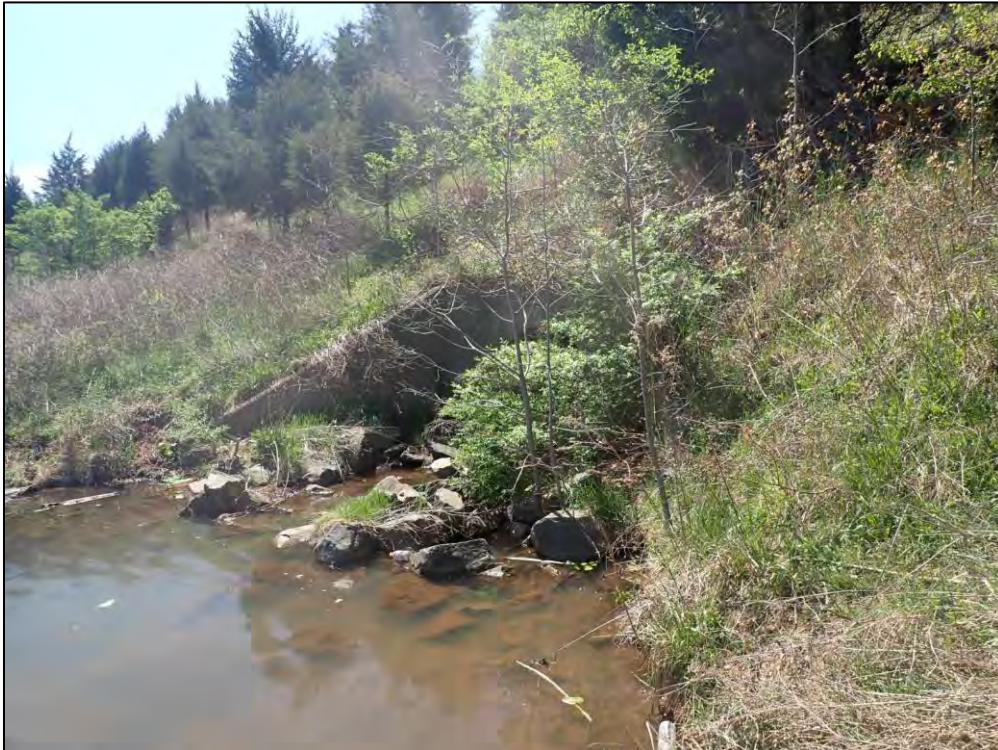
2812: Inflow 10, overall. Woody growth around inlet structure (Routine Maintenance Needed).

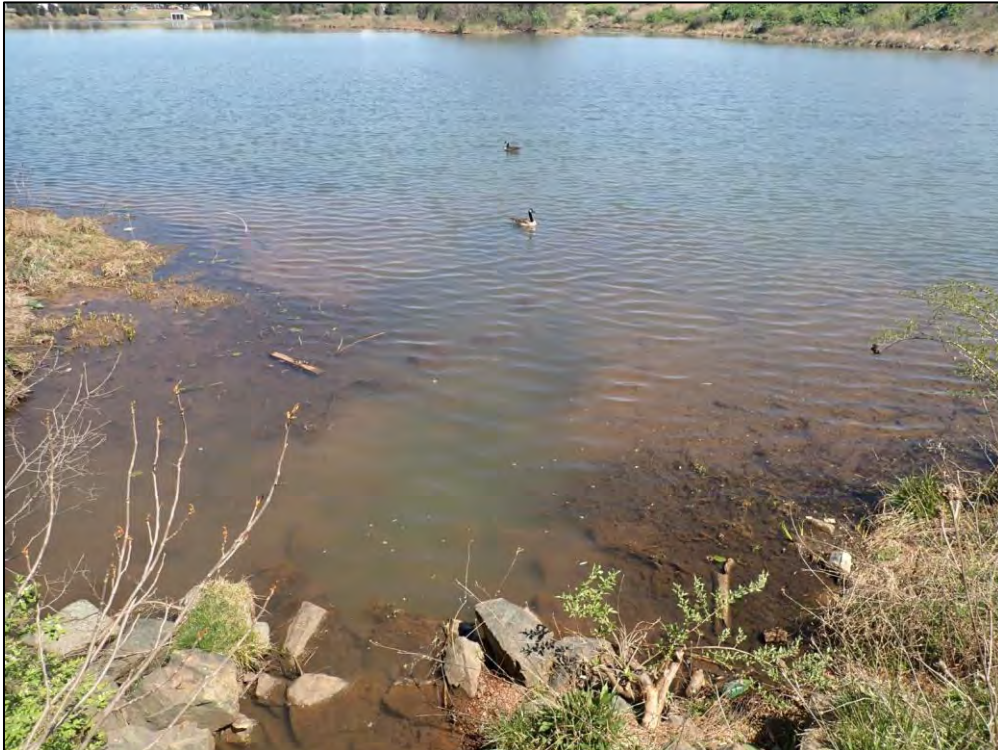
2814: From Inflow 10, looking downstream. Buildup of trash, debris, and sediment (Routine Maintenance Needed).

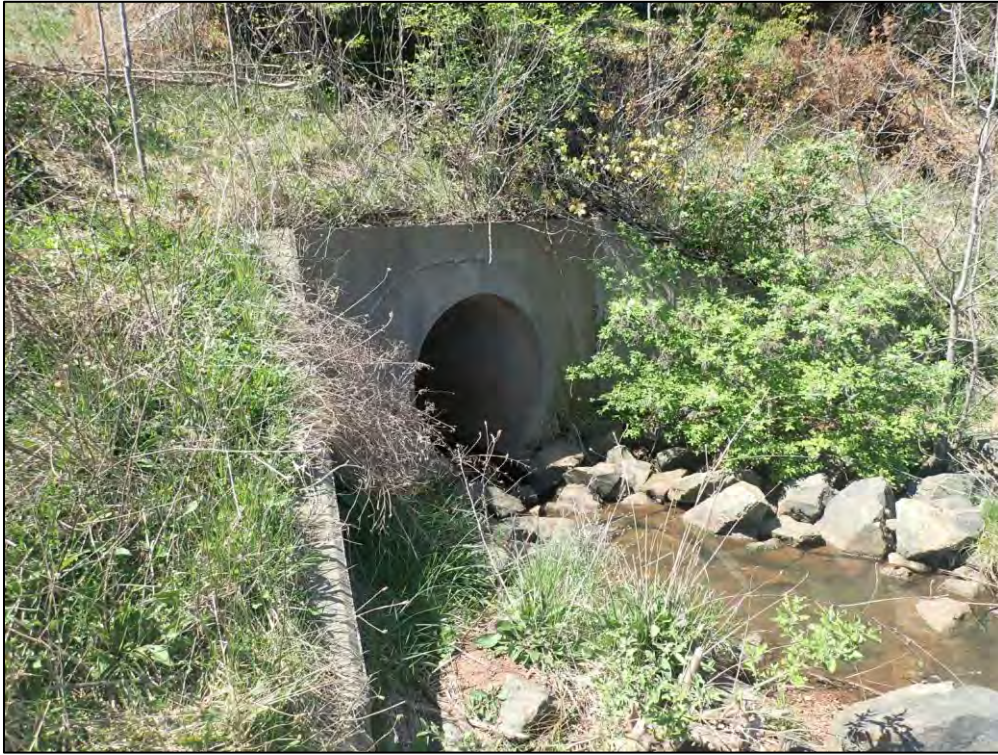
2815: Inflow 10, front. Woody growth around inlet structure (Routine Maintenance Needed).

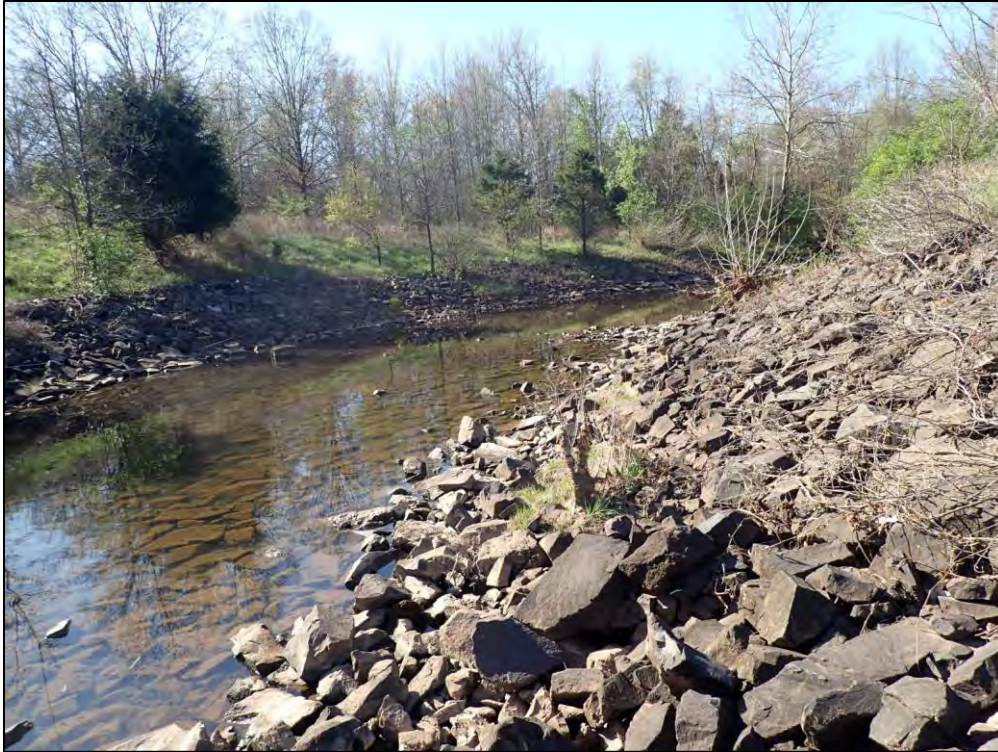
Score	Description	Comment(s) / Corrective Action(s)	Reference Image
Dam Embankment (Includes emergency spillway if applicable)			
3	Woody vegetation on embankment	Trees observed growing on the dam (1, 2-6" tree and 4, 7-12" trees).	2734, 2737
1	Shrubbery, low growing vegetation, and/or vine material growing on embankment		
1	Sparse vegetative coverage		
1	Signs of erosion, settlement, piping, or slope slippage		
1	Signs of seepage, soft spots, and sinkhole formation		
1	Evidence of nuisance animals		
1	Buildup of trash or debris on embankment		
1	Trash, debris, or obstructions in emergency spillway		
Outlet/Riser Structure			
1	Low-flow orifice is blocked		
1	BMP device is deteriorated, misaligned, and/or damaged		
1	BMP device is missing		
1	Low-level gate drain is accessible and operational. Drain has been exercised in last three years.		
1	Trash, debris, or other material in BMP device		
Principal Spillway Pipe

2734: Dam Overall, back slope. Woody vegetation on the embankment (Routine Maintenance Needed).
